Hidden Architecture
The timber roof structure of the dome of Vercelli
Inspection-Diagnostics- Interventions

A Master's thesis submitted for the degree of
"Master of Science"

DI Pia Therese Panosch
0126769

Milan, 05.02.2010

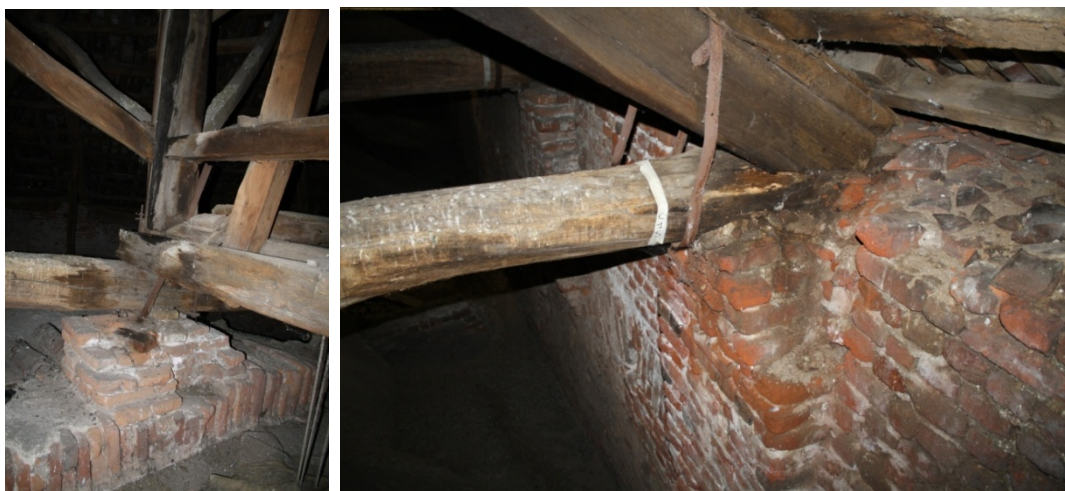
Illustration 27 wet beam

Water in wood

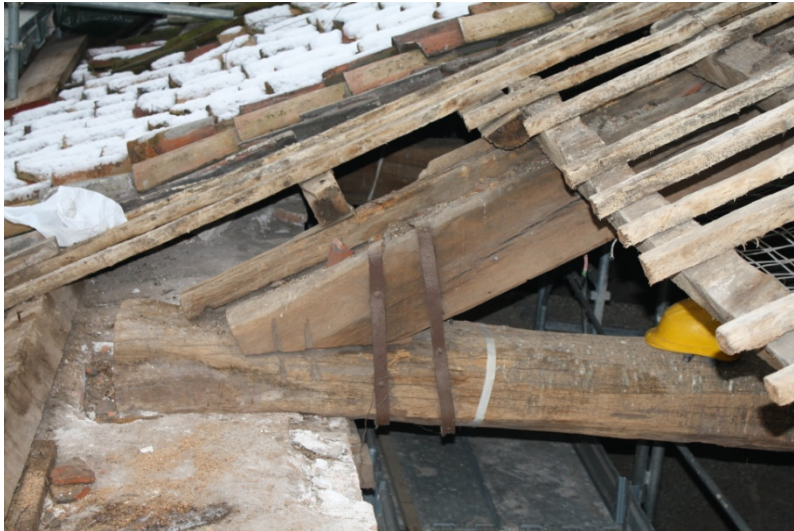
Illustration 62 Truss3 south end

Truss 3 has been in a moderate condition no intervention has been necessary.

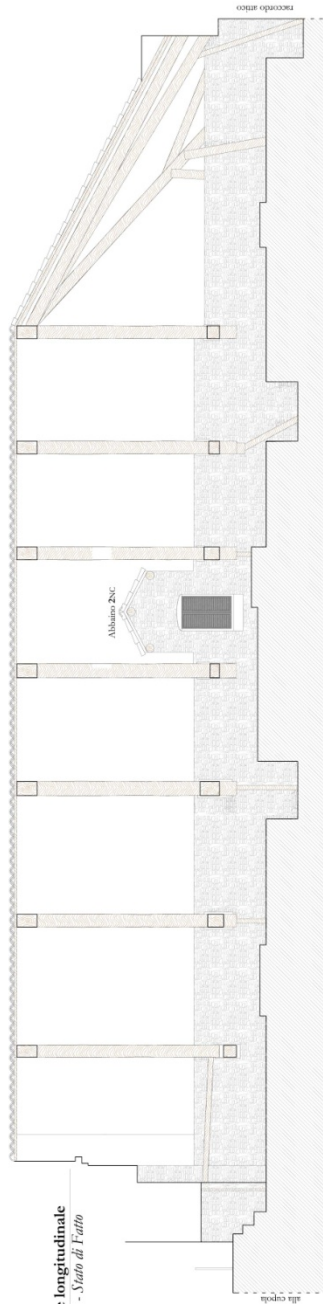
Lo stato delle **orditure lignee**, gli rimangono più vive negli archi, manifestano ormai forti segni di disallineamento, convassità e cedimenti, che costituiscono elementi di grave degrado.
