TECHNICAL ARTICLE

Corrosion of 1.4016 Ferritic Steel by Urea at High Temperature

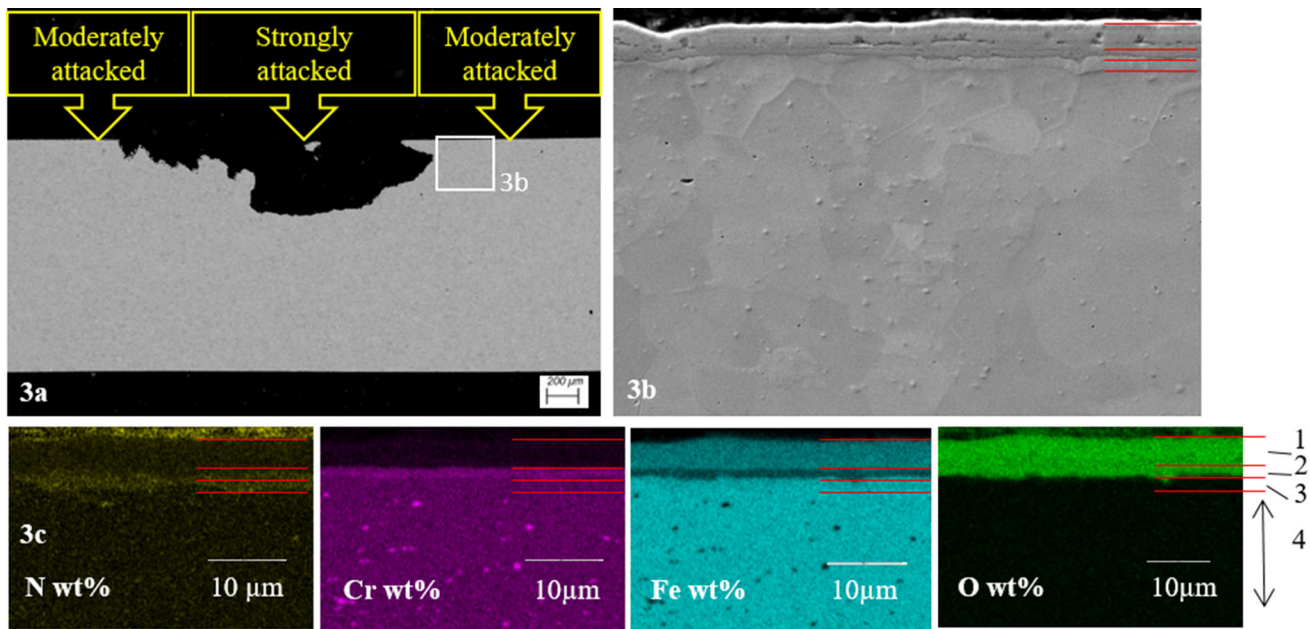
3.1.1 SEM Analysis. Examining the cross section of the corroded area A (microscopic image in Fig. 3(a), for macroscopic image look at yellow dashed line in Fig. 2c), one can observe parts that are slightly corroded and parts that are more attacked. The total wall thickness of the investigated steel sheet was 1.6 mm before testing and in the slightly corroded area after the experiment no reduction of wall thickness was detected with a caliper (caliper accuracy $\pm 10 \mu\text{m}$). In the center of the SEM image (Fig. 3a) can be seen the strongly attacked area, with an indication of attack along grain boundaries as well as uniformly. Here, the material loss is $650 \pm 50 \mu\text{m}$ and most of the grains tend to fall off. To the left

Fig. 3 FE-SEM image of the corroded sample in area A after 100 h experiment. (3a) BS detector, (3b) SE detector, (3c) EDS image by element distribution mapping shows three layers: 1— FeO_x with a bit of Cr_2O_3 ; 2— Cr_2O_3 ; 3—nitrogen and 4—matrix

and right from the strongly attacked area, a moderately attacked region is visible when looking under higher magnification. (The place of interest is highlighted by white frame in Fig. 3a, and magnified in Fig. 3b.) This region of interest indicates multilayers on the surface (Fig. 3b). The element mapping of multilayers between surface and matrix is shown in Fig. 3c. Additionally, the concentration profile of the involved elements of the same location is shown in Fig. 4. The EDS analysis revealed the presence of 3 different layers. Starting from the outside, the depth profile shows FeO_x with a bit of Cr_2O_3 at the

surface (layer 1), under which a chromium-rich oxide (Cr_2O_3) layer can be seen (layer 2). The inner chromium oxide layer also appears to contain some FeO . At the oxide/matrix interface, a high level of nitrogen was found (layer 3). When looking at the whole width of the sample, it is noticeable that the nitrogen layer is not constant and sometimes drops. In small quantities, nitrogen was found in the oxide layers. The results of chemical analysis by element mapping are in full agreement with the concentration profiles of the involved elements. Neither a sign of nitrogen nor any precipitation of chromium-rich phases at

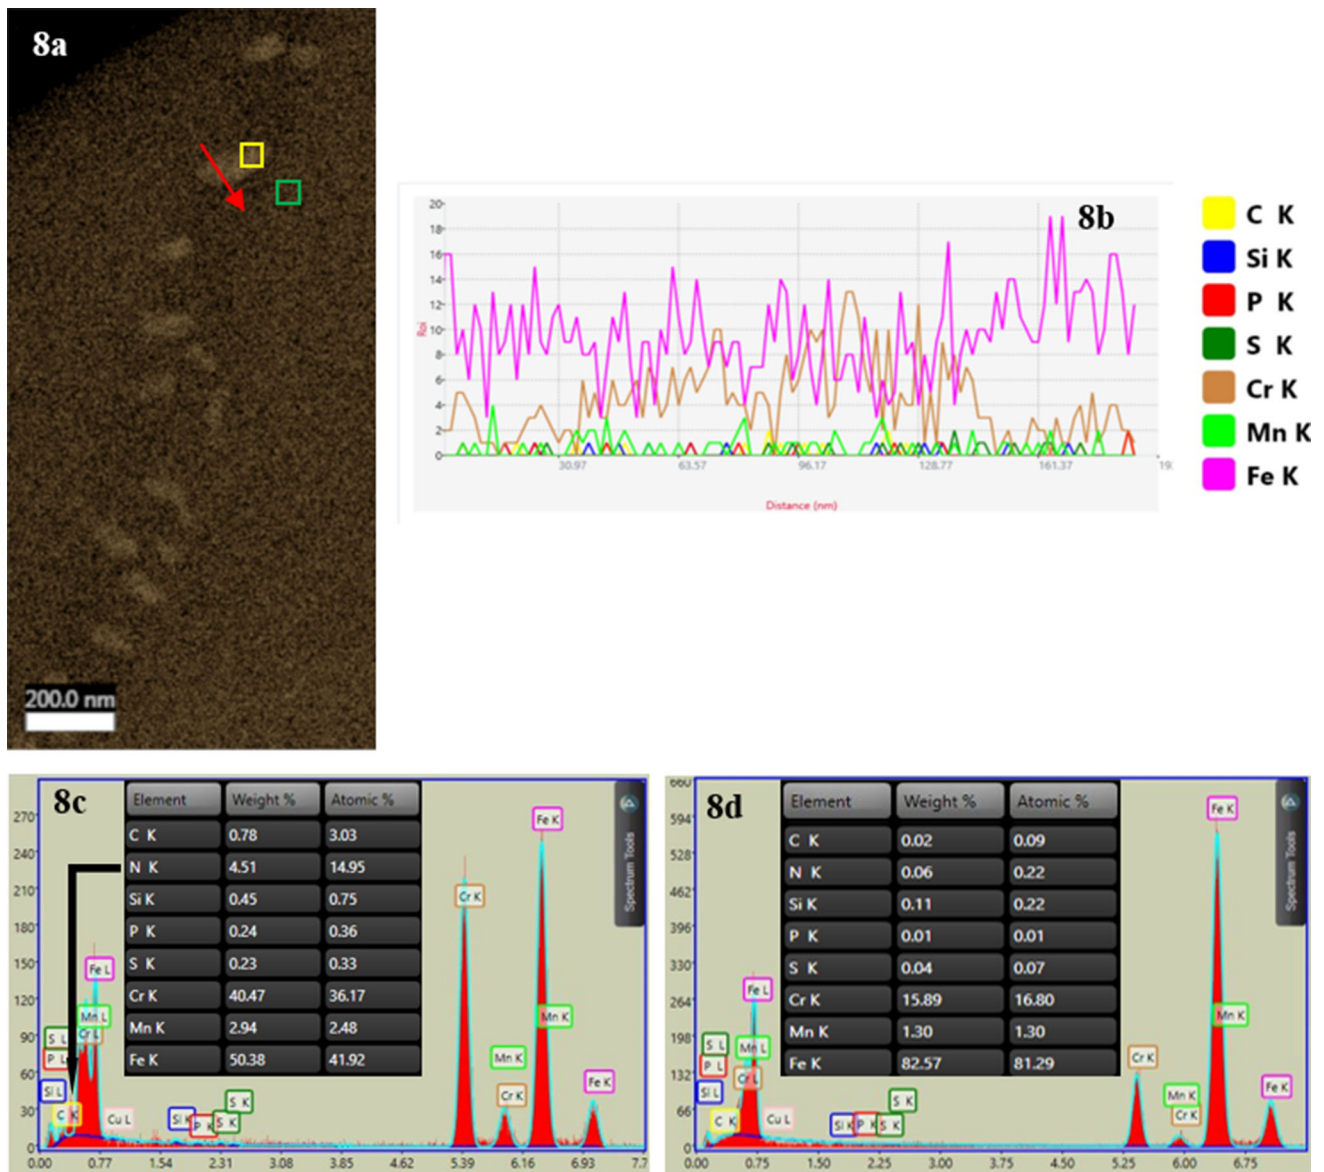
carbon were more difficult to detect by EDS analysis with the described EDAX detector (see chapter 2.3), the analysis was possible even quantitatively, and the results of calculation clearly showed the presence of these two elements in the particle (Fig. 8c) when comparing with matrix (Fig. 8d). Even when quantitative EDS analysis of light elements such as carbon and oxygen is not reliable, the analysis of Fig. 8c and d shows substantial differences in carbon content on the same specimen. This is a strong argument that the precipitate in Fig. 8a contains carbon. The absolute value given in Fig. 8c is not too important.

Fig. 8 (a) EDS image of the grain boundary with precipitates, (b) qualitative element concentration profile of one of the particles (marked by red arrow in 8a), (c) EDS measurement and quantification of elements in the area of particle (marked by yellow square in 8a), (d) EDS measurement and quantification of elements in the matrix (marked by green square in 8a)
