# Diploma Thesis

# **Universal Design in Metro Stations** A Case Study in Copenhagen and Vienna

E230-01 Research Unit of Transport Planning and Traffic Engineering

Vienna August 18, 2023

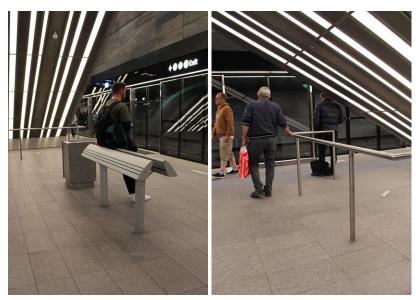
Figure 19: Leaning options on platform M3

More leaning options would be desirable.

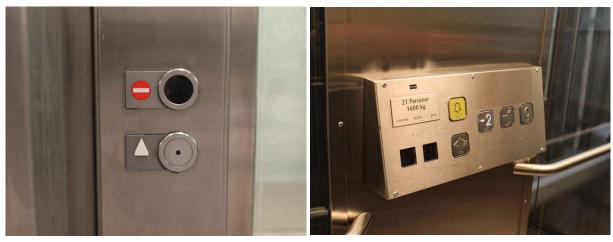
Figure 39: Operating elements inside and outside E3 and E4

The arrow on the outside of the elevator was clear. It was easier to see the operating 17 elements inside this elevator than the one before. The participant was fast when pressing buttons and mentioned that the palpable numbers helped with orientation. The loudspeaker was considered loud and clear.

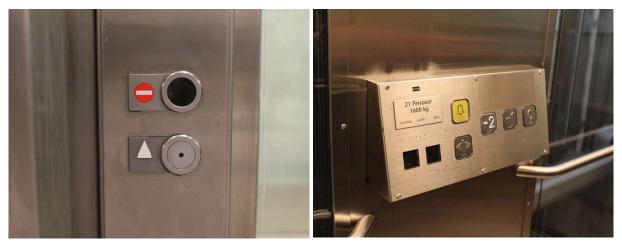
Figure 55: Operating elements inside and outside E3 and E4

Buttons on the outside and the inside of the elevator were stated as good to reach.

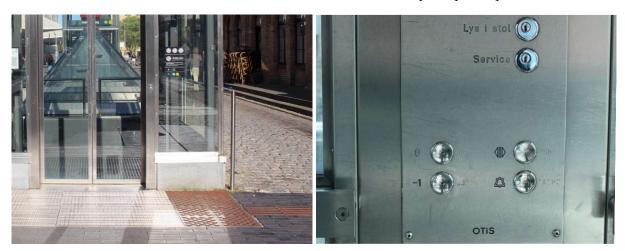
Figure 88: Exemplary operating element outside E1 and operating elements inside E2 on platform M1/M2

- The bell could be more clear to feel (Figure 87).
- The buttons on the outside of the elevator were hard to find. The recessed numbers inside the elevator were hard to read and smaller than inside the first elevator. The voice announcement "Døren åbnes" was considered "useless" by the participant.
