# TEM analysis of coatings for RF cavities

J. Bernardi, A. Steiger-Thirsfeld – USTEM / TU Wien

S. Leith, G. Rosaz, C. P. A. Carlos - CERN

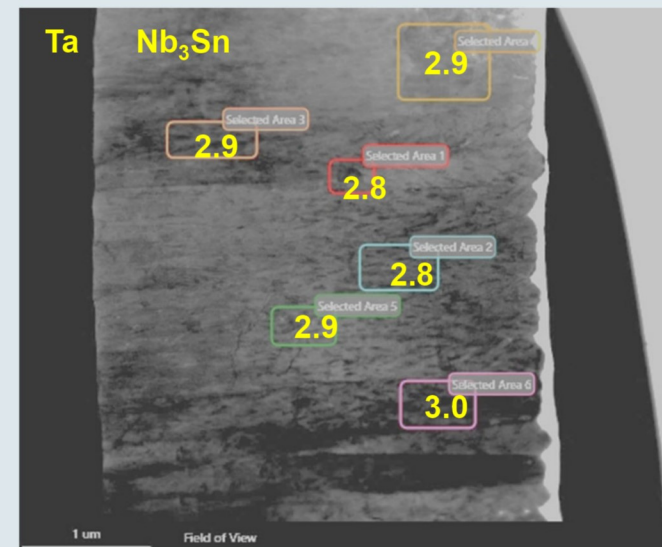
- Smooth surface
- Large columnar grains
- No Cu at GB
- But: Inhomogeneous Nb:Sn ratio

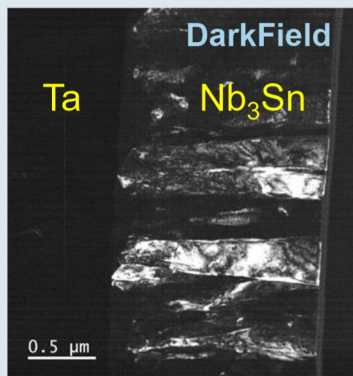
- Rougher surface
- Defects on Cu → surface defects
- Homogeneous Nb:Sn ratio

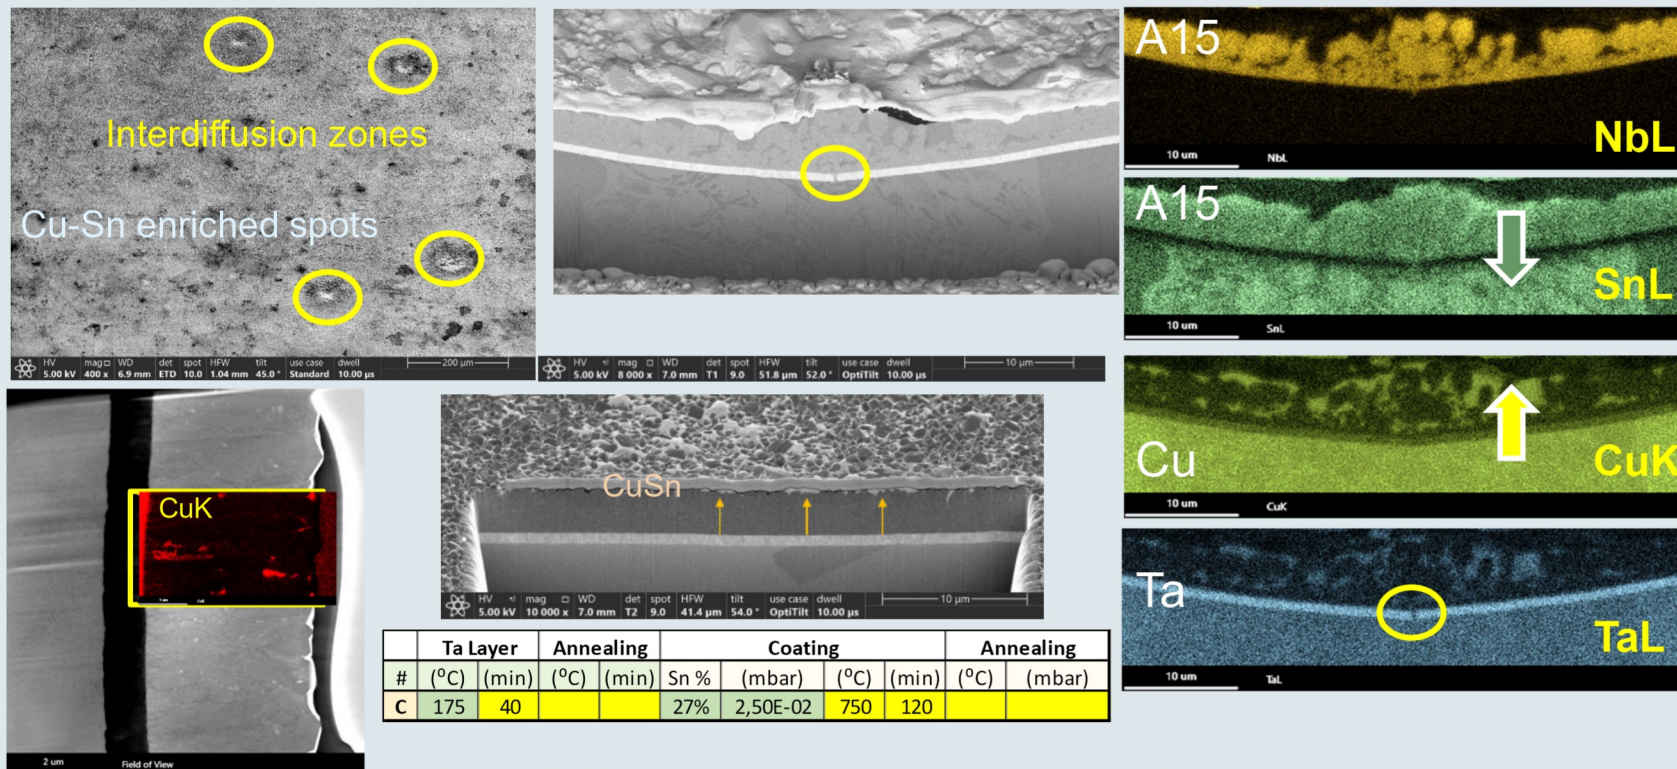
# Damaged Ta interlayer

- Crack in Ta layer → interdiffusion of Cu
- High pressure coating → rough surface
- Cu and Sn enriched areas on the surface

- 👉 Quality of the Ta interlayer is decisive for homogeneous Nb<sub>3</sub>Sn layers
- 👉 Purity of the Cu surface is the top priority

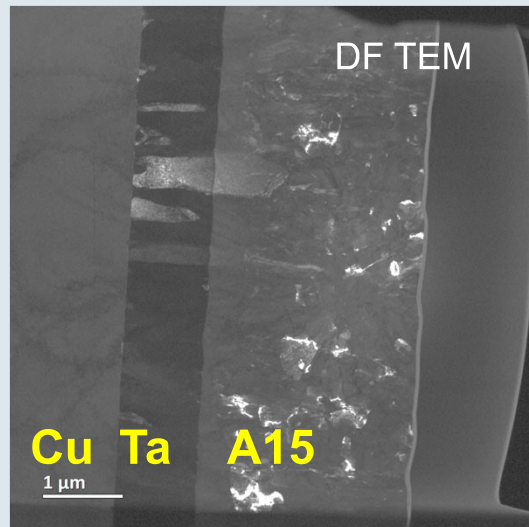
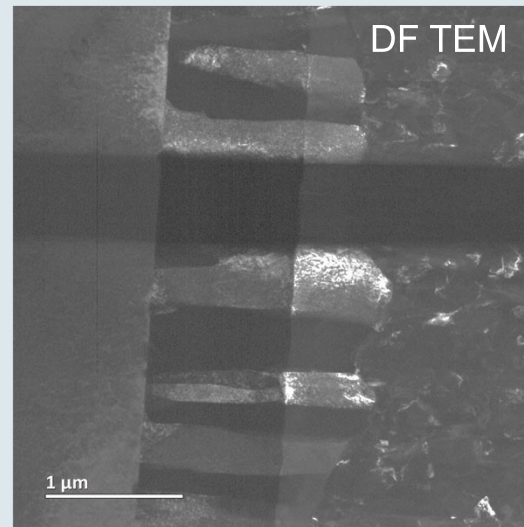
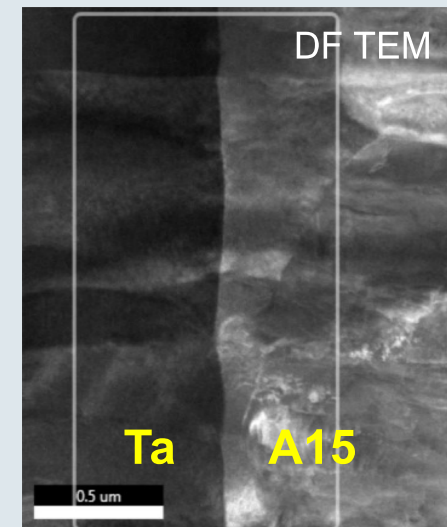
# Ta - A15 interface

The orientation of the Ta grains appears to influence the orientation of the A15 grains.
