TECHNISCHE  
UNIVERSITÄT  
WIEN

## **MASTER THESIS**

# **Performance Assessment of a Mountain Base Station in a Cold Climate**

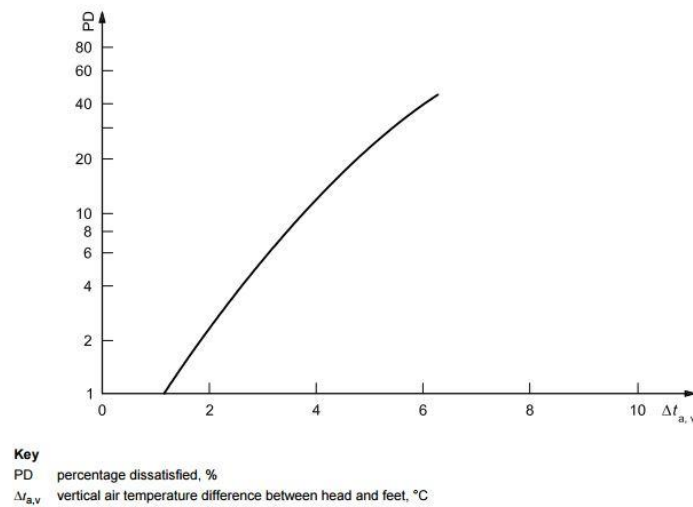
Figure 2. Local discomfort caused by the vertical air temperature difference  
 (Source: ISO 7730 2005)

The correlation between vertical air temperature difference and the percentage of dissatisfied people is presented in the Figure 2. The categories of the thermal environment regarding this parameter are assigned as shown in Table 2.

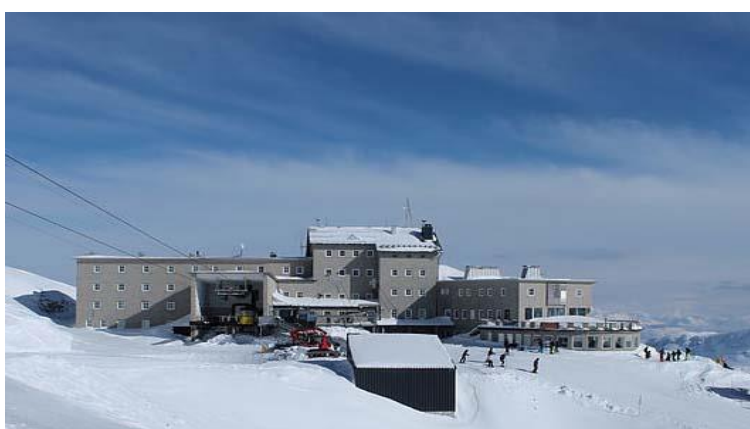
*Figure 7. Krippenstein mountain base station before refurbishment (Source: Mein Bezirk 2015)*

2003, the building (Figure 7) was serving only as a cable car station and was merely producing costs of about 50 000 Euros annually. Finally, Österreich Seilbahnholding GmbH invested 4 million Euros in the refurbishment project of the station, with an idea to open a 150-seats restaurant and in addition a multi functional conference room (Mein Bezirk 2015). By the end of year 2015, the refurbishment was finished (Figure 8, Figure 9).

As seen from the comparison of the Figure 7 and Figure 8, the main interventions of the refurbishment are visible on the south wing of the building with external changes of the facade (Figure 9). The internal renovation and redesign of the Restaurant Area is shown in the Figure 10 and Figure 11 and of the Seminar Room in Figure 12.

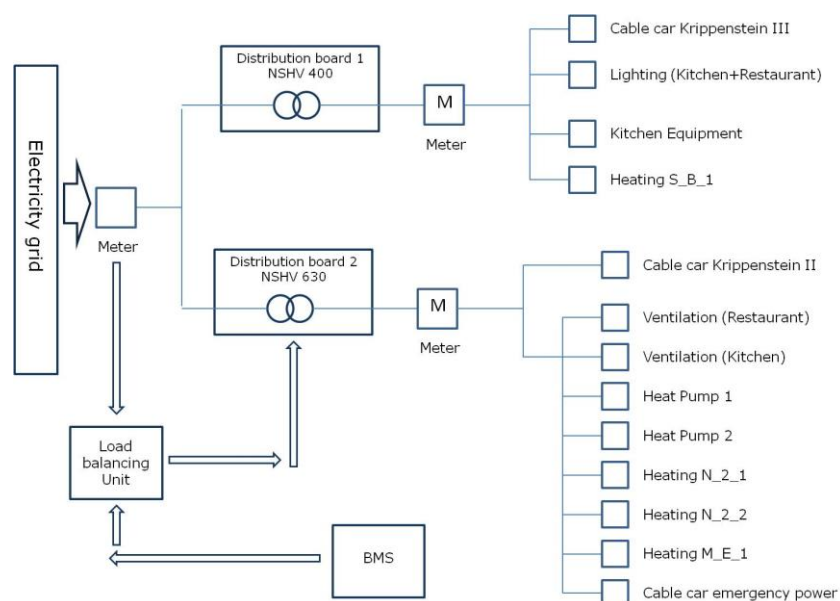
Figure 13. Scheme of the electrical power feed distribution from two of the Krippenstein distribution boards

The building's electricity feed is dispensed by two distribution boards (NSHV 400 and NSHV 630) to the subsidiary circuits. Distribution board 1, with the maximum power of 400 kVA distributes its total feed to cable car Krippenstein III, lighting for kitchen and restaurant, kitchen equipment and heating of the Restaurant area and Seminar room. As may be concluded from Figure 13, the load balancing unit is in charge of providing, in the first place, no electricity shortcuts to the cable car due to occasional high loads of other circuits, while in the same time ensuring the thermal comfort according to the data received from BMS. Distribution board 2, with the maximum power of 630 kVA, is in charge of dividing the electricity feed to the cable car Krippenstein II, ventilation of restaurant and kitchen, heat pumps but also the heating circuits of other parts of the building (Figure 13). Since Distribution board 1 supplies the heating circuits of the two areas of interest, Restaurant and Seminar Room, the focus of the load balancing assessment will be on it.

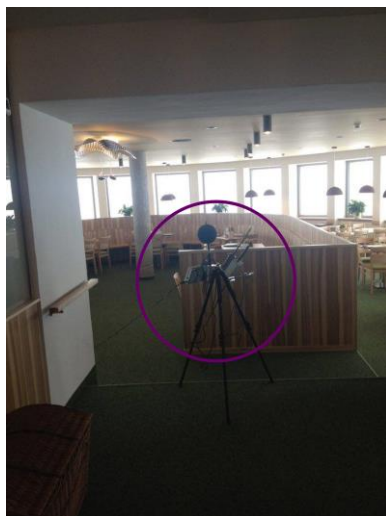
The location 1 of the TCS (Figure 15, Figure 16) is set in the northern part of the Restaurant and is not directly exposed to ventilation draft or heating radiation. The locations 2 (Figure 17, Figure 18), 3 (Figure 19, Figure 20), and 4 (Figure 21, Figure 22) are chosen close to the south oriented part of the Restaurant.

Figure 15. TCS Pos.1, 8<sup>th</sup> of March, 2016    Figure 16. TCS Pos.1, 11<sup>th</sup> of April, 2016

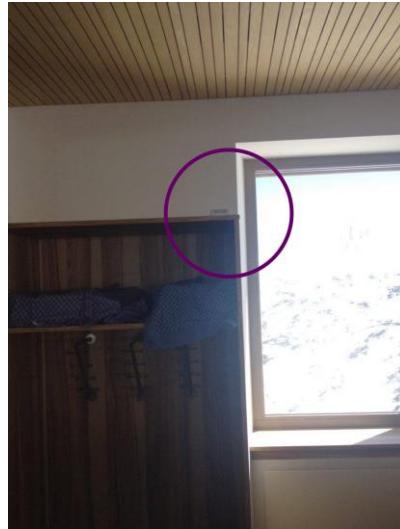
First Multi Sensor Device is placed close to the south-east wall of Restaurant (Figure 33, Figure 32), while the second one is located in the hallway of the

*Figure 33. Restaurant-Measuring Location1. Multi Sensor (Temp, RH and CO<sub>2</sub>) Device 1*

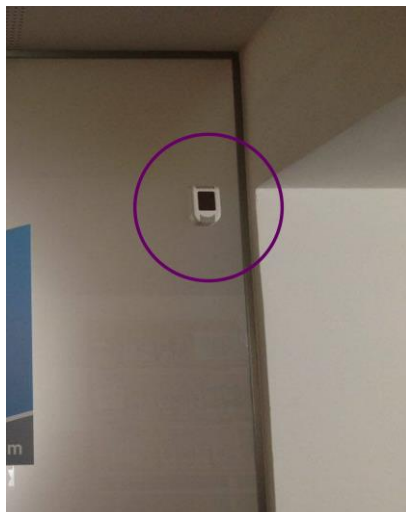
room close to the north-west wall and could be more exposed to the external influences from the double wing door in front (Figure 34).

*Figure 34. R-ML2. Multi Sensor (Temp, RH and CO<sub>2</sub>) Device 2*

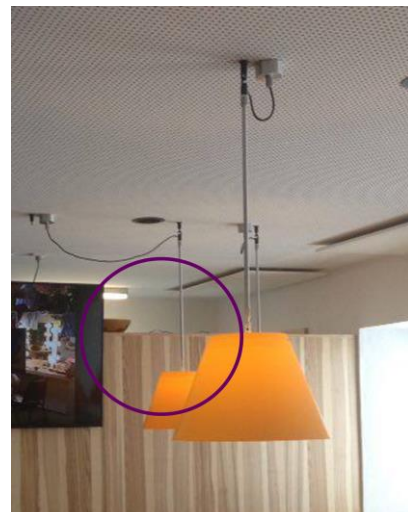
*Figure 35. R-ML3. Multi Sensor (Temp, RH and CO<sub>2</sub>) Device 3*

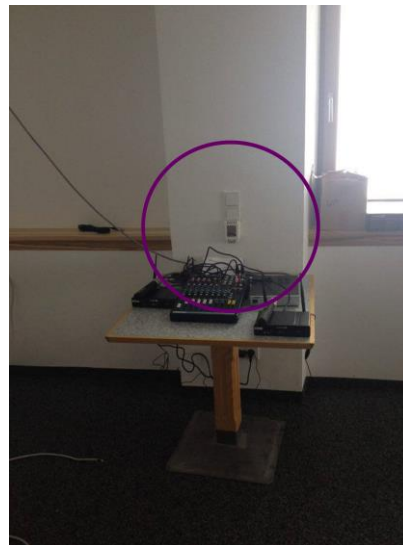
The Seminar Room was also equipped with a Multi Sensor Device for measuring the temperature, relative humidity and CO<sub>2</sub> levels. The device was mounted at the south-east wall of the Seminar Room as shown in the Figure 36 and Figure 37.

*Figure 37. Seminar Room Measuring Location 1. Multi Sensor (Temp, RH and CO<sub>2</sub>) Device 1*

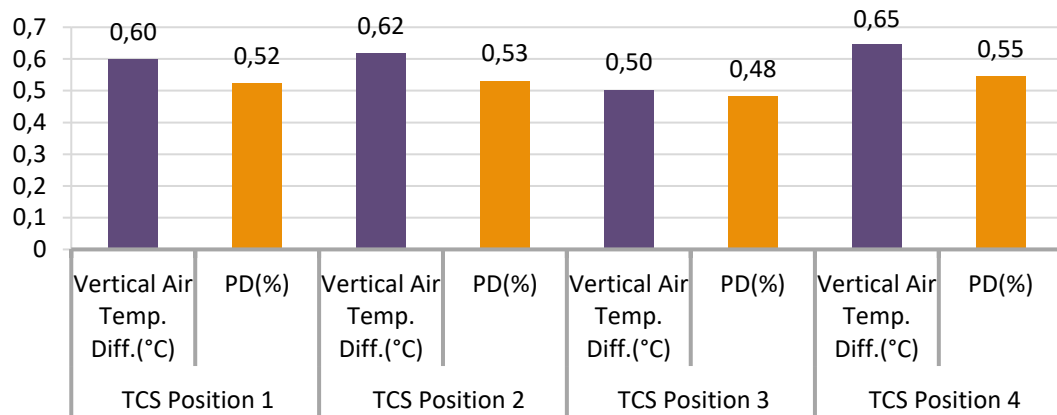
Figure 42. Vertical Air Temperature Difference between 1.10 m and 0.10 m height. Seminar Room. Date: 11<sup>th</sup> of April, 2016

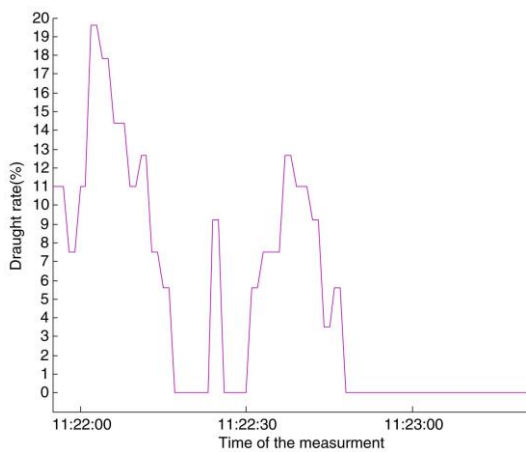
*Figure 47. Draught Rate at the Location 1. Seminar Room. Date: 11<sup>th</sup> of April, 2016*

Seminar Room is not mechanically ventilated and varying events of Draught Rates may be present due to opening of the windows. This is also visible in the uneven graphs on all four locations (Figure 47, Figure 48, Figure 49, Figure 50). Maximum DR of 20% was measured at the location 1, which belongs to the B category of ISO 7730 regarding the discomfort caused by Draught. In rest of the cases, monitored DR was between category A and B with no other significant peaks (Figure 1).

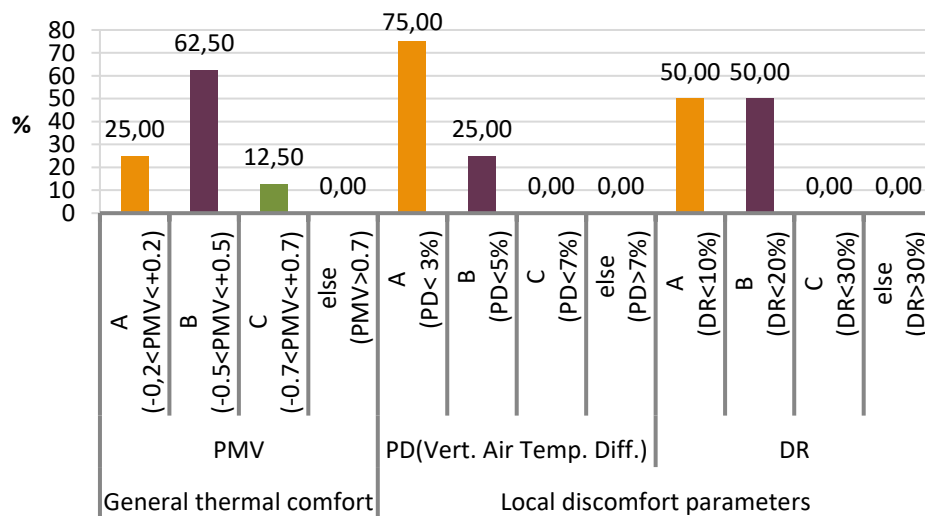
Figure 51. Distribution of short term results of general thermal comfort and local discomfort over ISO 7730 categories of thermal environment. Restaurant Area. Dates: 8<sup>th</sup> of March and 11<sup>th</sup> of April, 2016

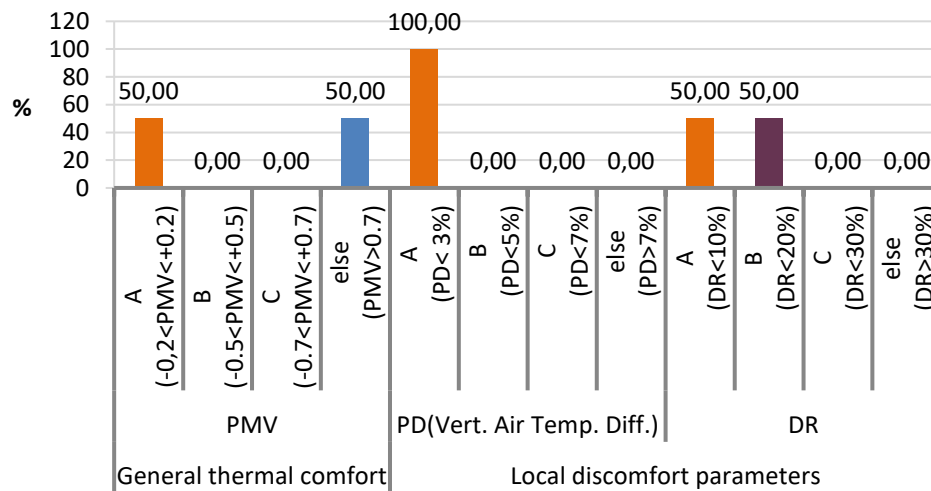
Figure 52. Distribution of short term results of general thermal comfort and local discomfort over ISO 7730 categories of thermal environment. Seminar Room. Dates: 8<sup>th</sup> of March and 11<sup>th</sup> of April, 2016

Seminar Room's results of general thermal comfort and local discomfort were also categorized according to ISO 7730. Although the category A is mostly present for both thermal comfort and local discomfort, the PMV evaluation is rather split between extremes (Figure 52). This is due to the two opposing measuring conditions where on the first date room was heated while for the second measurement that was not the case.

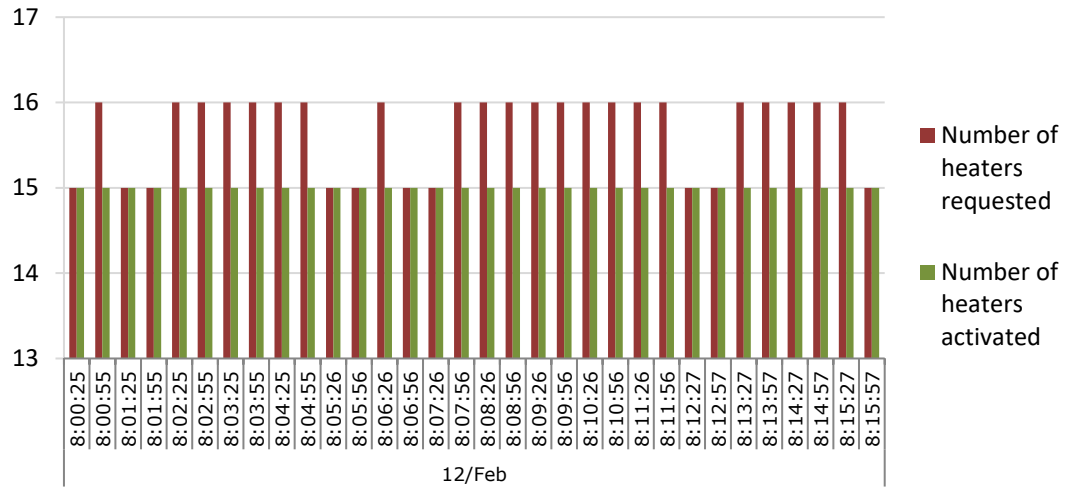
Figure 165. Number of heaters requested by BMS and corresponding number of heaters activated by load balancing unit from 08:00-08:15 o'clock.  
Date:12.02.2016
