PROTECTION AND REHABILITATION OF FORT KOSMAČ  
AT BRAJIĆI, MONTENEGRO

# PROTECTION AND REHABILITATION OF FORT KOSMAČ

Brajići, Montenegro

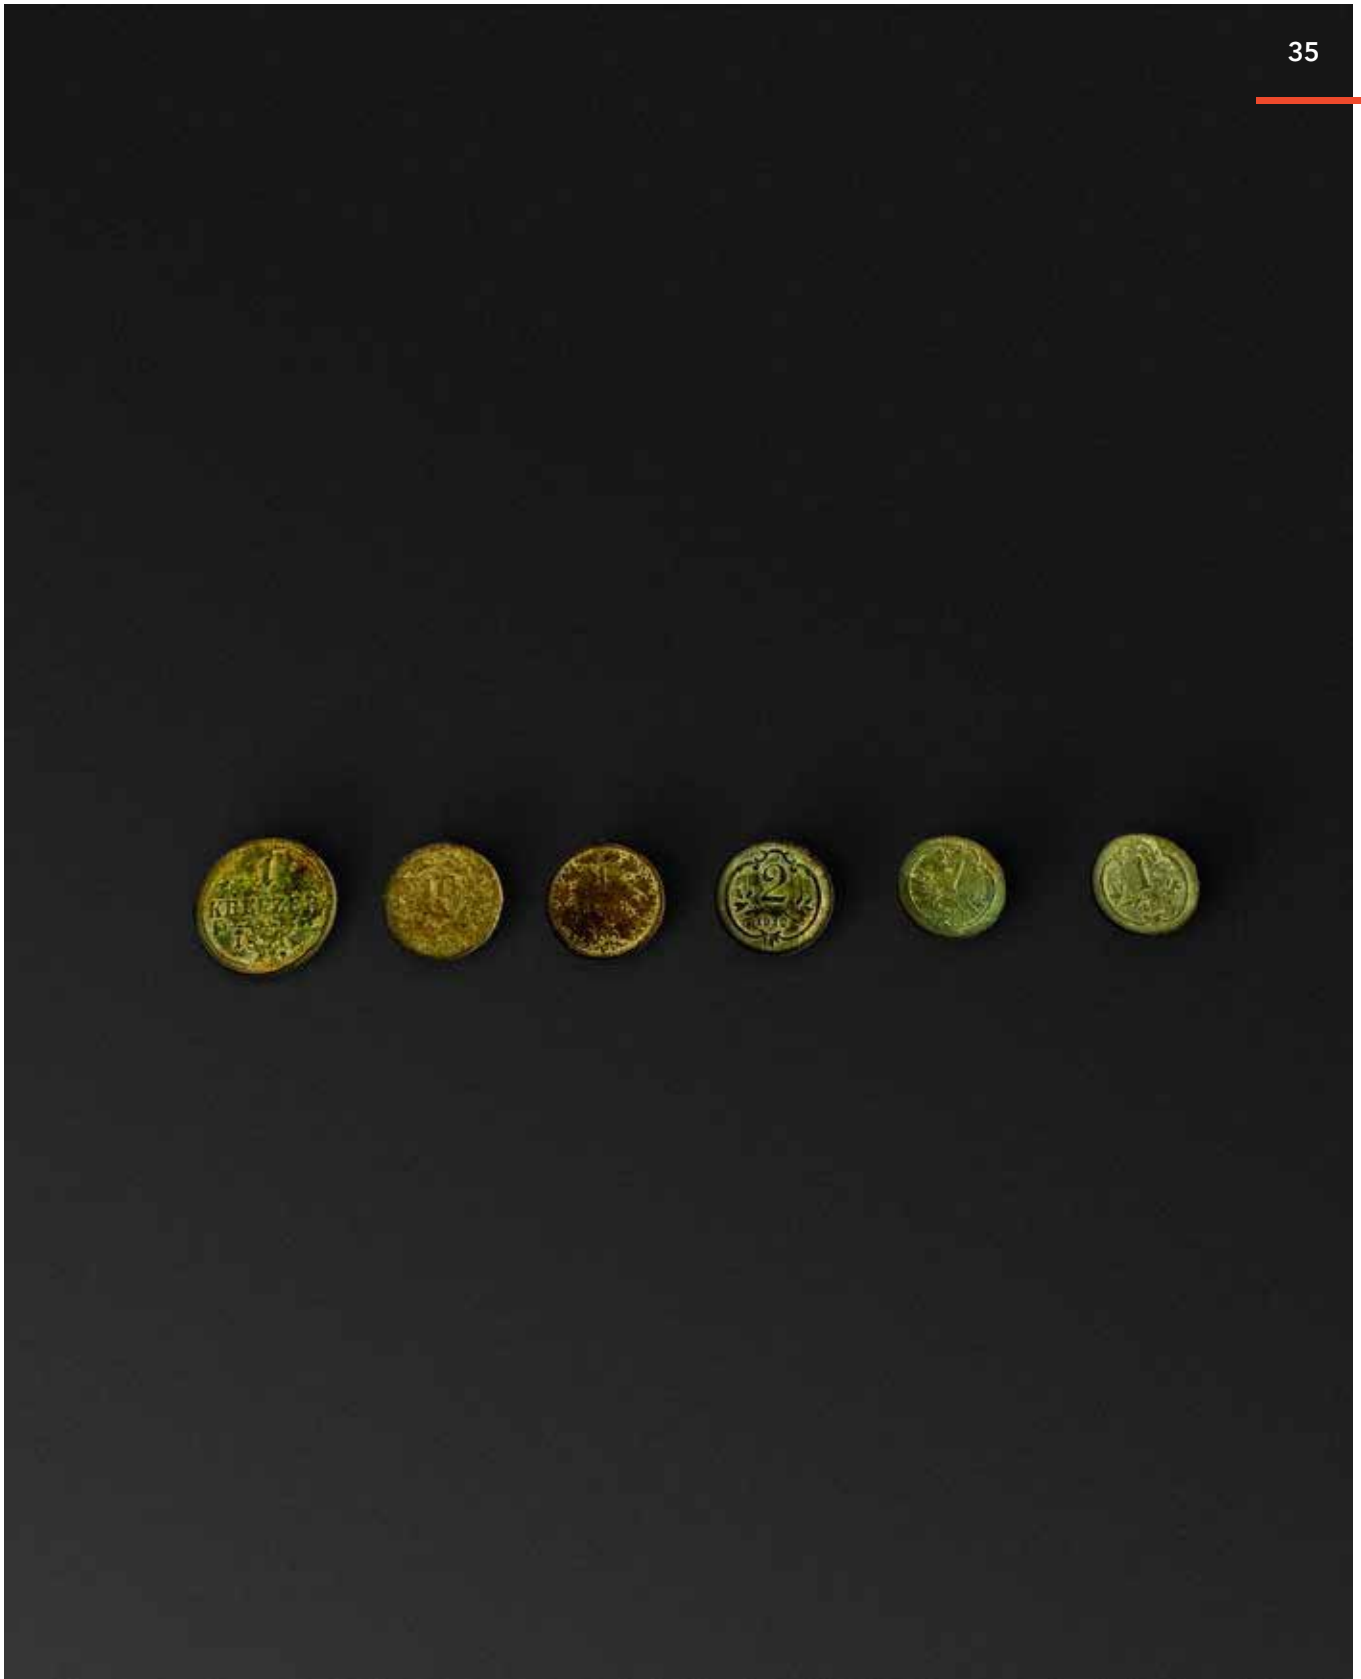
Fig. 12:  
Fort Kosmac, 2018  
Credits: Ivan Vratnica

Finished in year 1858, after more than 160 years, Fort Kosmač is a ruin today. After it was demolished and set on fire by the imperial army in summer of 1914, just after the beginning of the First World War, it was left in inadequate condition for military use and the locals slowly started taking stone and other parts for construction material after the war. In the Second World War, the ruin was used by Italians as a fortified position, but no reparations were made.

ruin was damaged during these battles. Some cannon shots are still visible on the walls. On the northwestern part of the building, in the corner of the joint of the southern wing and the central part, there is a big opening in the wall on the first floor, probably made by the cannon shoot in the Second World War according to the stories of some locals. Due to its critical location, the opening was getting bigger as the time passed. The stones above the opening became unstable and everything slowly crumbled. This hole is a bigger structural damage on the outside walls.

Other than the big structural walls, all the inside walls are gone, and their material lies on the ground floor mixed with the material from the first and second floor.

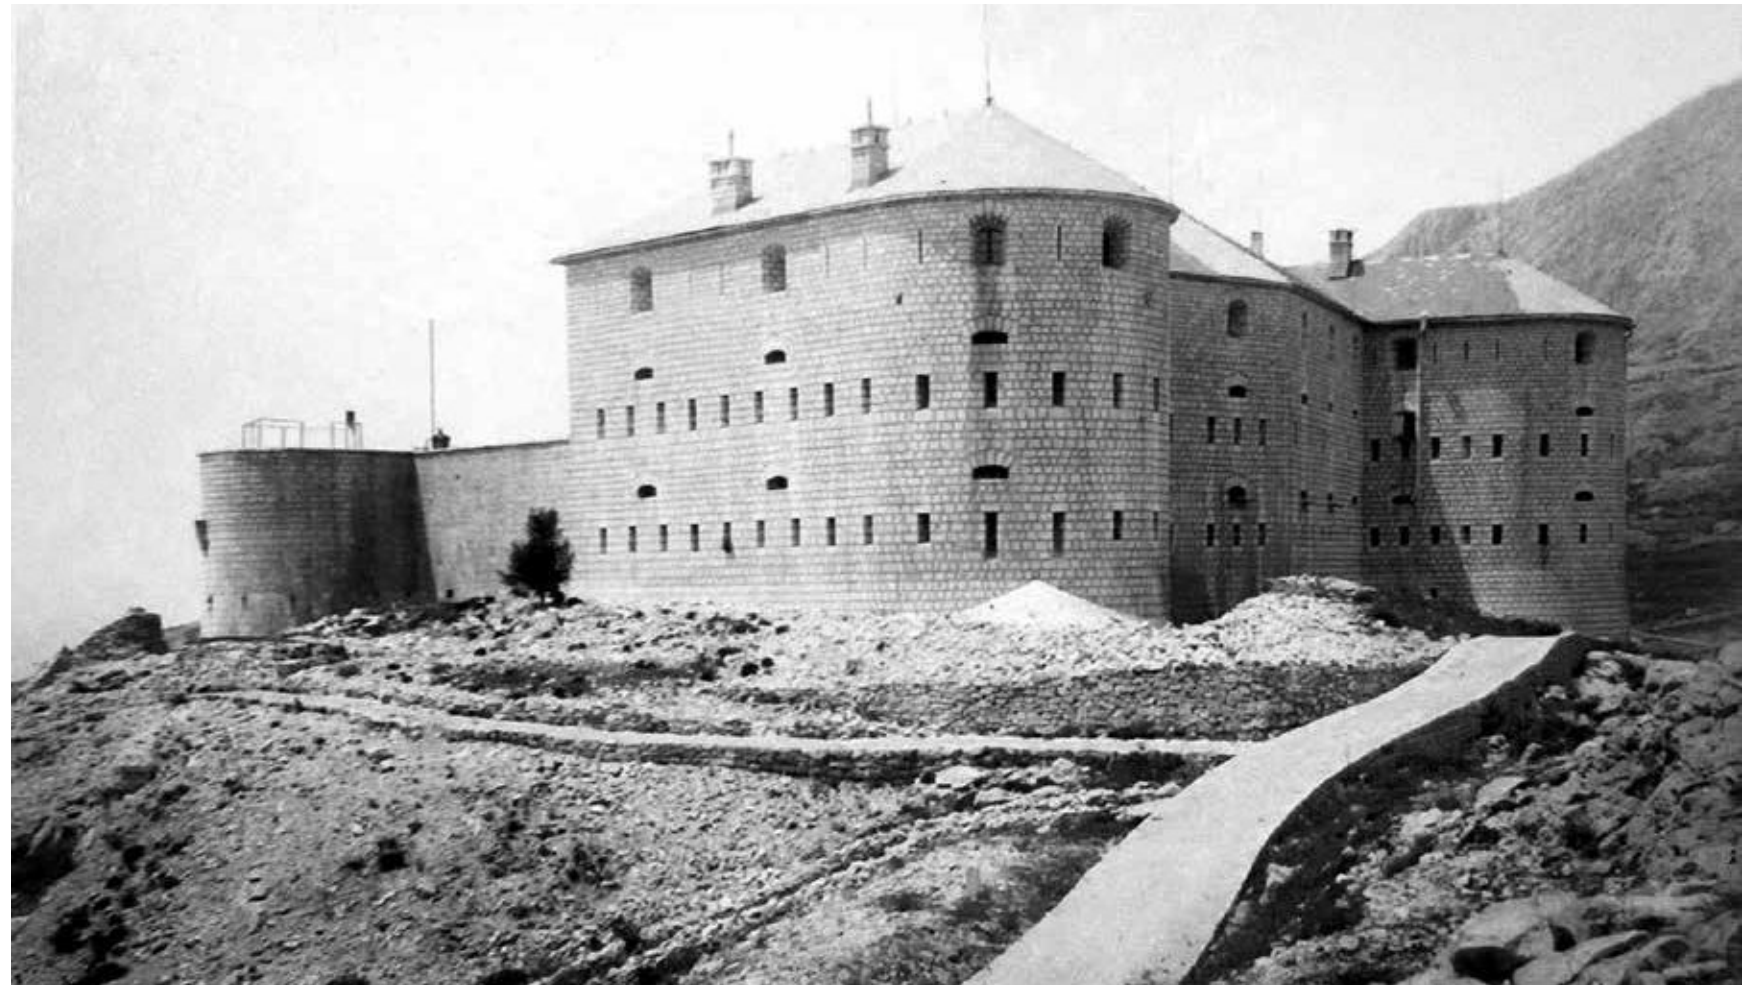
Fig. 28: Fort Kosmač around, 1860  
(southern side - road to Fort Spiridone)  
Credits: King Nikola's Museum - Cetinje

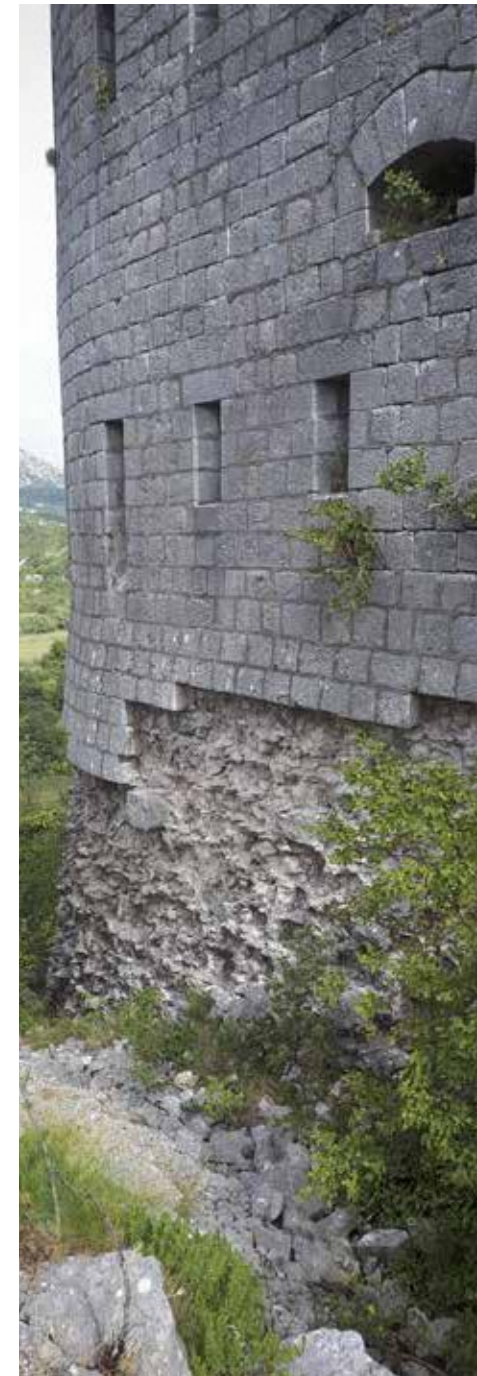
Fig. 38 (left): Fort Kosmač, 2018  
(Northern wall of the barracks)  
Credits: Ivan Vratnica

Fig. 38 (left): Fort Kosmač, 2018 (Northern wall of the barracks)  
Credits: Ivan Vratnica

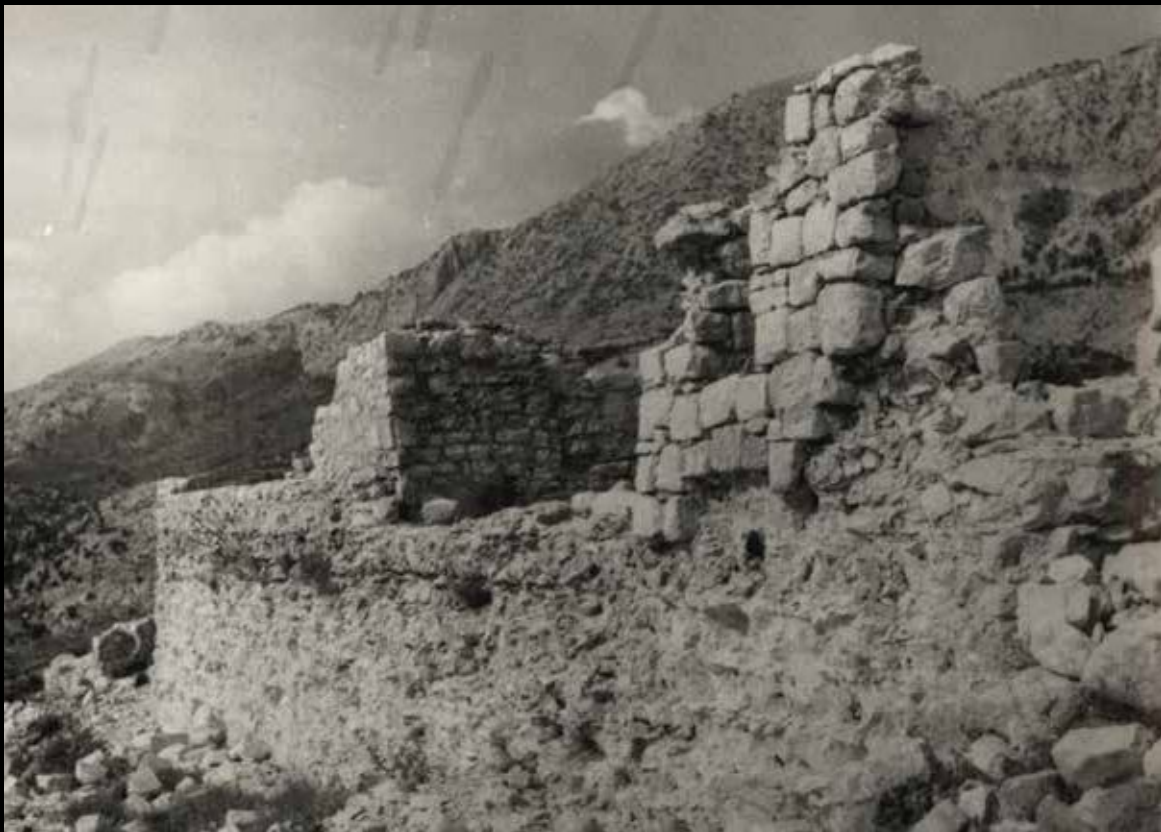
Fig. 44: Fort Kosmač, 1964  
(Southern side of the courtyard wall)  
Author: M. Petrović  
Credits: Administration for the Protection of Cultural Properties

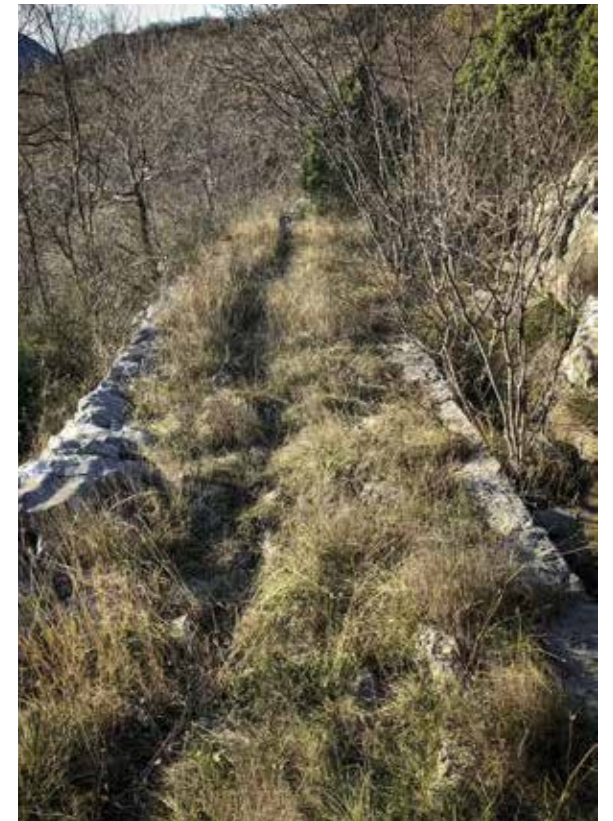
Fig. 46: Old Austro-Hungarian road from Budva to Fort Kosmač, 2020  
(Even though the slope was mostly constant, on some steeper places long stairs were needed to overcome the slope)  
Credits: Savo Martinović

The aim was to make it constant as possible, so they built embankments, bridges and carved rocks to adapt it with terrain. The draining system was built all along on the places where it was needed. To overcome the steep slopes of the mountains they used the serpentine, zigzagging one above the other, to keep the slope as constant as possible with occasional long steps when needed. The side to the abyss was secured with stone walls and small posts, engraved with the kilometer marker and the next destination it led to, as well as "k.u.k" (Ger. "keiserlich und königlich") meaning imperial and royal. Part of the serpentine road, climbing from the field up to the fortress, gives the fortress a unique appearance, emphasizing it as a peak of the hill. It is carefully positioned on the western side of the hill protecting it from three other directions. Today, it is still in usable condition but the supporting walls are damaged and collapsed on some spots along the approach. The securing walls and stone posts are all gone, even though the stone material from the supporting walls is still lying around. The road has

Fig. 46: Old Austro-Hungarian road from Budva to Fort Kosmač, 2020  
(Even though the slope was mostly constant, on some steeper places long stairs were needed to overcome the slope)  
Credits: Savo Martinović

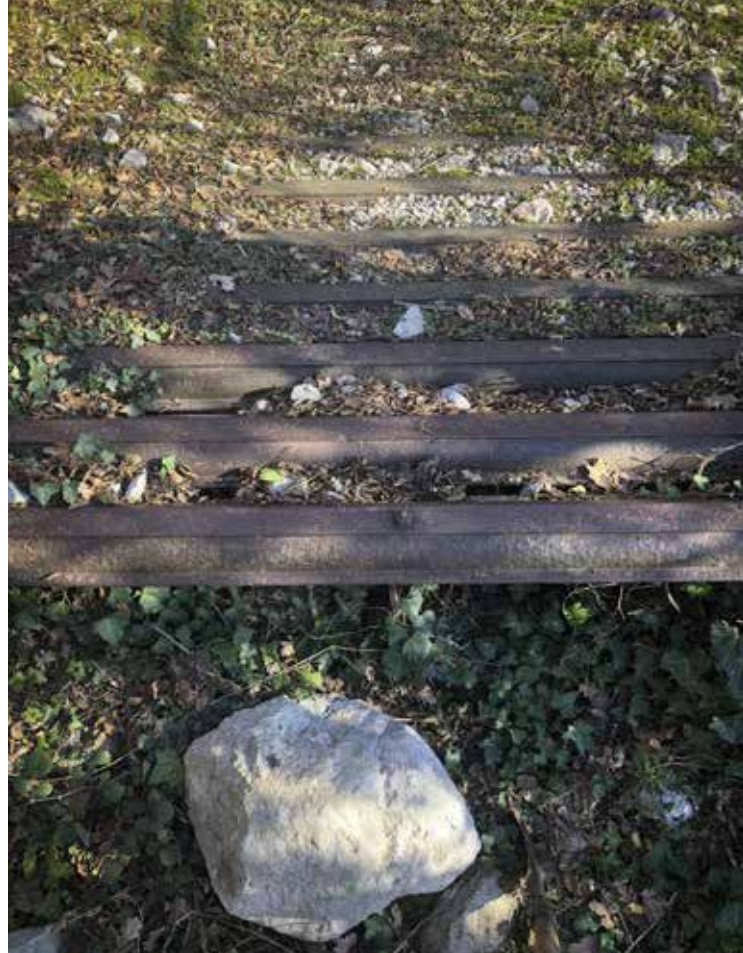
Fig. 49 (right): Bridge over the creek on the old Austro-Hungarian road from Budva to Fort Kosmač, 2020  
Credits: Savo Martinović

Fig. 49 (right): Bridge over the creek on the old Austro-Hungarian road from Budva to Fort Kosmač, 2020  
Credits: Savo Martinović

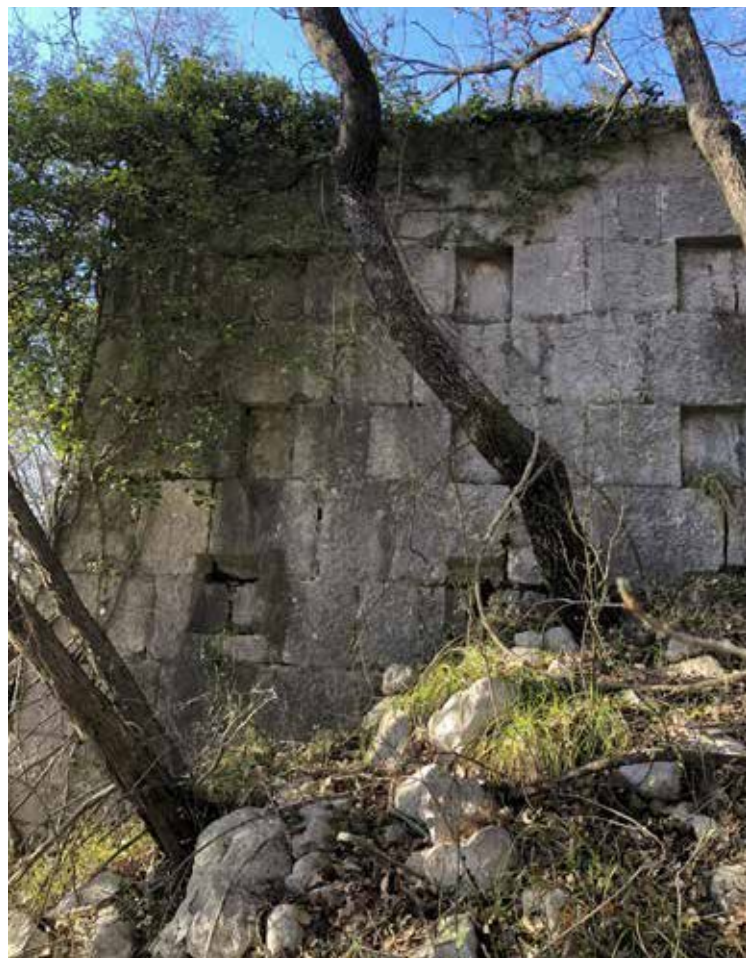
Fig. 50: Base of a bridge on the  
Old Austro-Hungarian road from  
Budva to Fort Kosmač, 2020  
Credits: Savo Martinović

Fig. 50: Base of a bridge on the Old Austro-Hungarian road from Budva to Fort Kosmač, 2020  
Credits: Savo Martinović

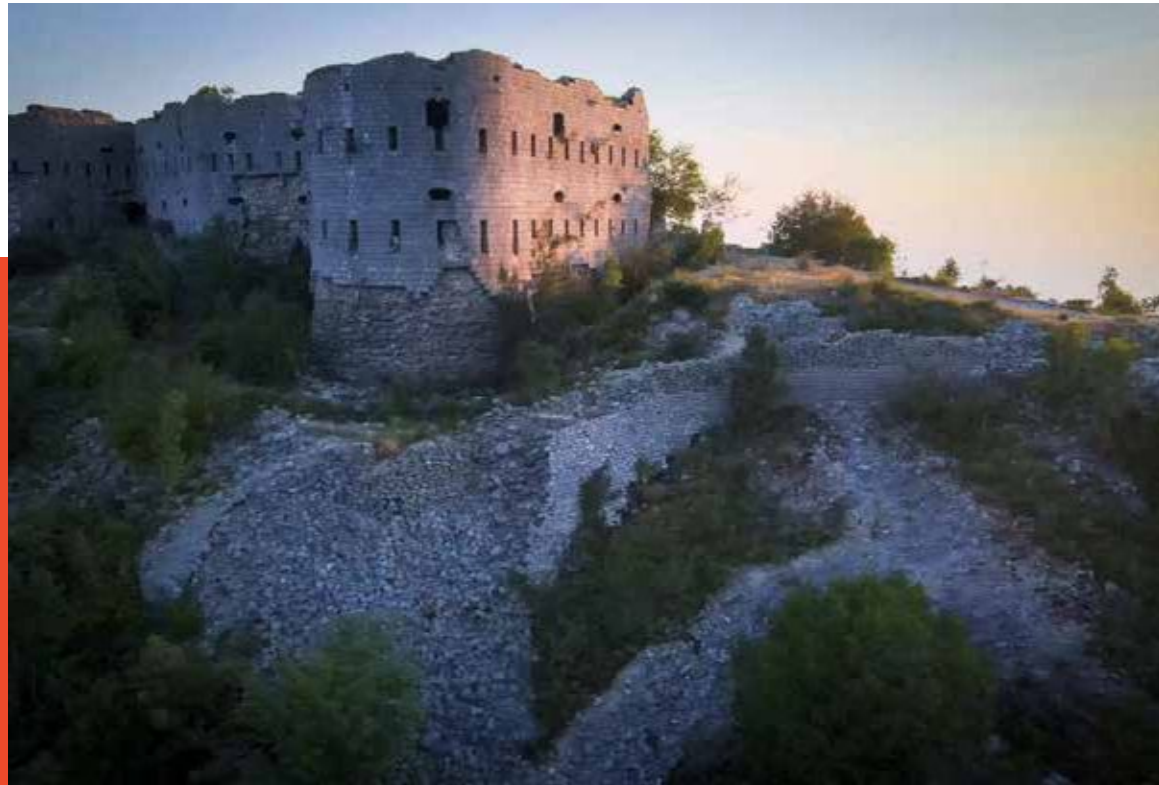
Fig. 52 (left): Curve in front of the northern wing of Fort Kosmač, 2020  
(The embankments collapsed)  
Credits: Ivan Varatnica

Fig. 52 (left): Curve in front of the northern wing of Fort Kosmač, 2020 (The embankments collapsed)  
Credits: Ivan Vratnica

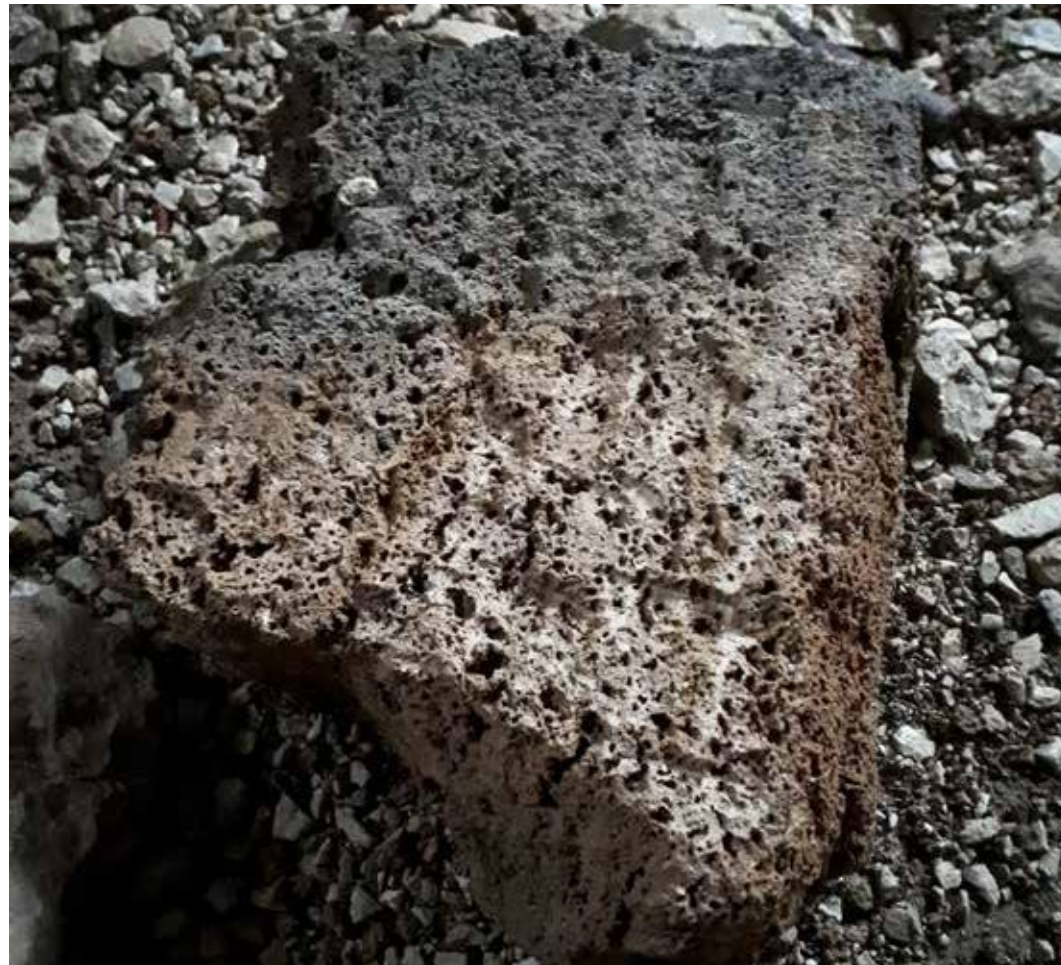
Fig. 65: The rock type used for the vaults inside (local "Siga")  
Credits: Ivan Vratnica

This one was lighter, due to its structure and high porosity and much easier to shape into precisely made blocks to construct the arches, domes, and vaults. Even though this type of stone can be found near the shore in Perazića Do, most of it was probably imported from the other parts of the empire

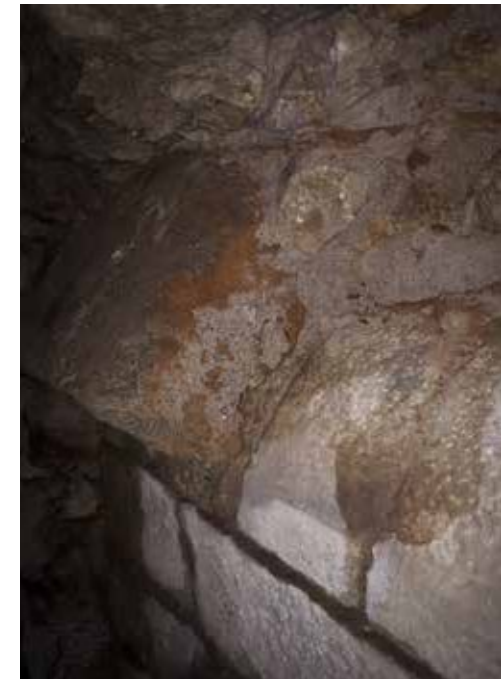
Fig. 66: The rock type used for the vaults inside (local "Siga")  
Credits: Ivan Vratnica

the local limestone was used, among all due to its resistance to the climate of the area. The other stone type was used for the vaults of the floor construction, known among the locals as "Siga".

Fig. 66: The rock type used for the vaults inside (local "Siga")

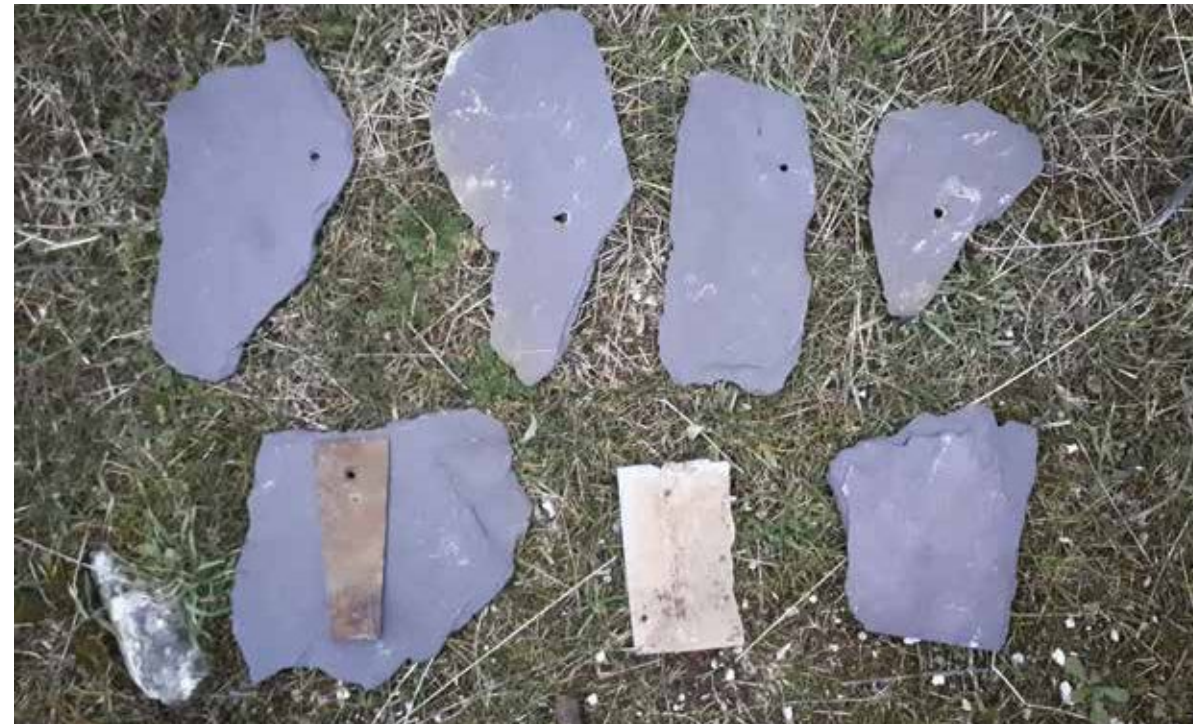
Fig. 67 (top left): Parts of the roofing tiles  
(Hole where the metal sheet was attached,  
that held the tile in place)  
Credits: Ivan Vratnica

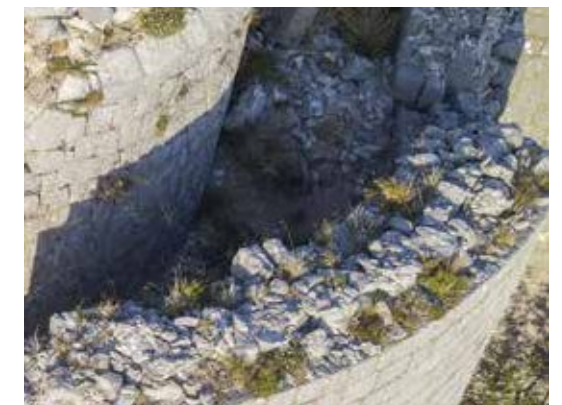
Fig. 69: Stone layer of the western  
wing outer wall  
Credits: Ivan Vratnica

Fig. 69: Stone layer of the western wing outer wall

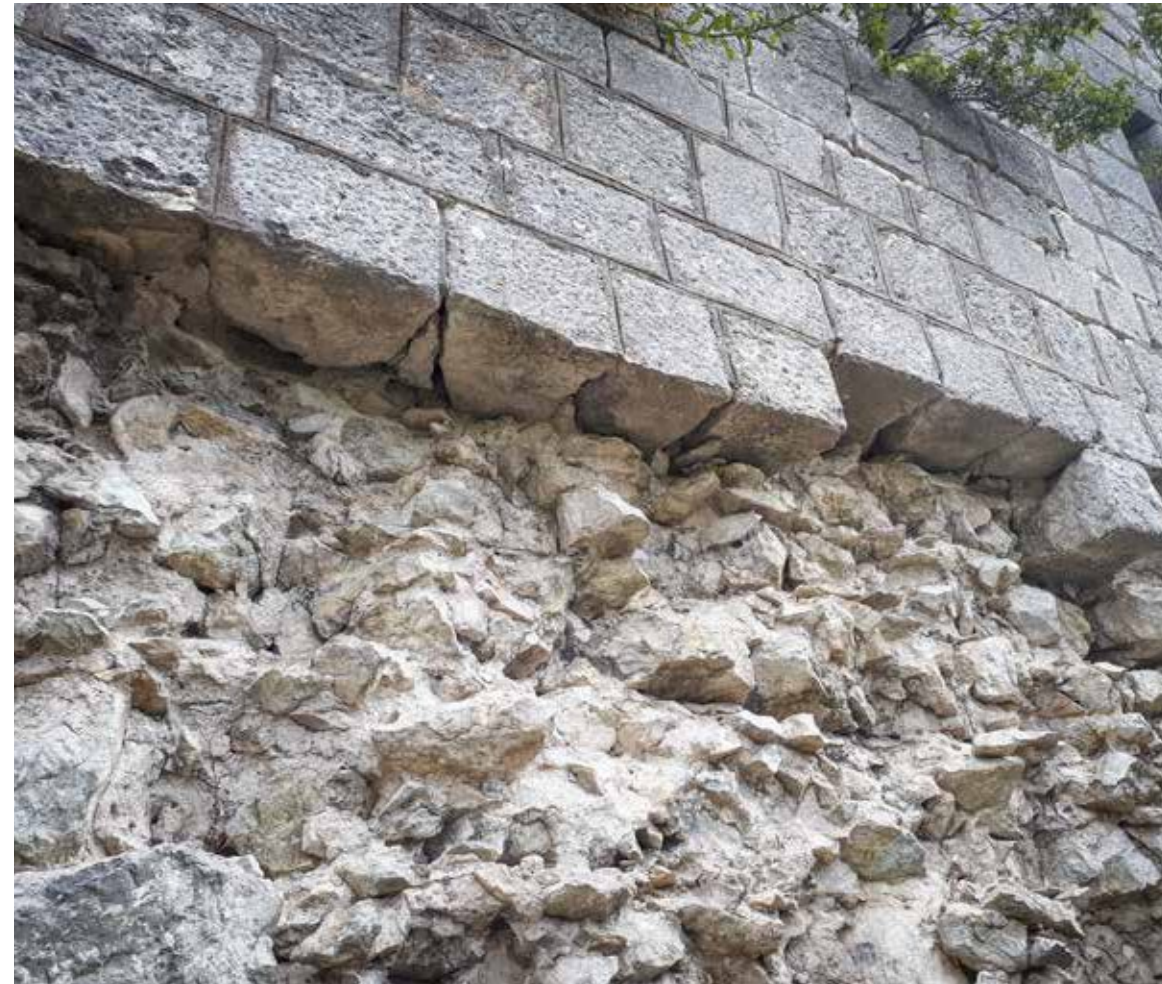
On the rapport plans and photos of the ruin, it can be clearly seen that the load bearing walls are inside, unexposed to possible enemy fire. Construction was made with the outer walls bearing minimal loads from the floor vaults, due to their function as protection. Instead outer walls were made as a hull, so if damaged or destroyed, the rest would still stand uninterrupted, which is the reason that, the walls are still standing firmly, even though everything is demolished from the inside. They are 1.26m thick, except the western wall and the rounded walls of the wings which are 1.56m thick due to their load-bearing function of the floor vaults. The floors are vaults composed out of 30cm thick stone blocks in the first floor. In the second floor the vaults were 47cm thick, so they could support the artillery on the terrace above. On them there was fine gravel filling for leveling and the wooden flooring placed on it. The face of the outer walls was made out of stone blocks, 25cm high and flat, fine formed face, precisely joined, with a thin gap closed with cement. The inner side of these stone blocks was always narrowed, creating a pyramidal form of the stone block with the flattened peak pointing inwards. This shape and the way of laying them together enables them to sink in when hit by the projectile and transfer its force

on a larger area than the initial hit, thus minimizing the damage and lowering its pricing capabilities. This technique was developed to withstand the cannon ball hits but it was not as effective against the much faster and thinner, pointed rotating projectiles that were developed after the fortress was constructed. Inside, the face was not fine formed, as it was covered with white plaster. In between these two rows, there were roughly shaped stones mixed with mortar, holding all layers together. The construction walls on the first floor are the same, as well as outer walls. On the second floor the walls were 79cm thick, thinner than the ones below, only bearing a slanted roof over them.

Fig. 70: The outer wall of the barracks,  
Fort Kosmač, 2019  
(With the wall construction clearly visible, due to  
the stealing of the fine formed outer stone layer)  
Credits: Ivan Vratnica

Fig. 70: The outer wall of the barracks, Fort Kosmač, 2019

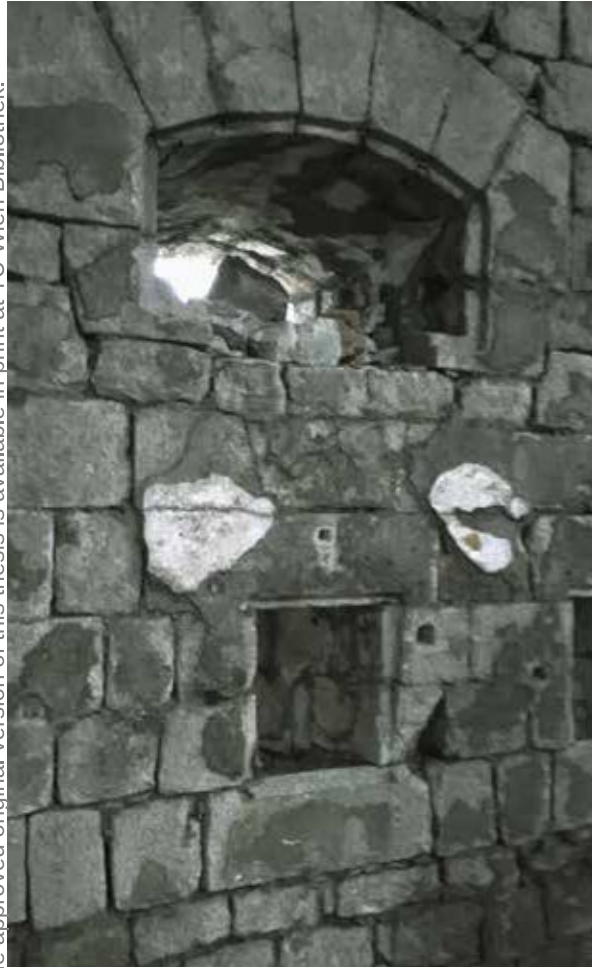
Fig. 73: Wall surface inside the ground floor, 2019  
(The parts of the cement and white plaster are still visible on some spots, as well as the carvings around the window frames where the wooden frames with casements were attached to the stone wall with metal nails)

Fig. 73: Wall surface inside the ground floor, 2019

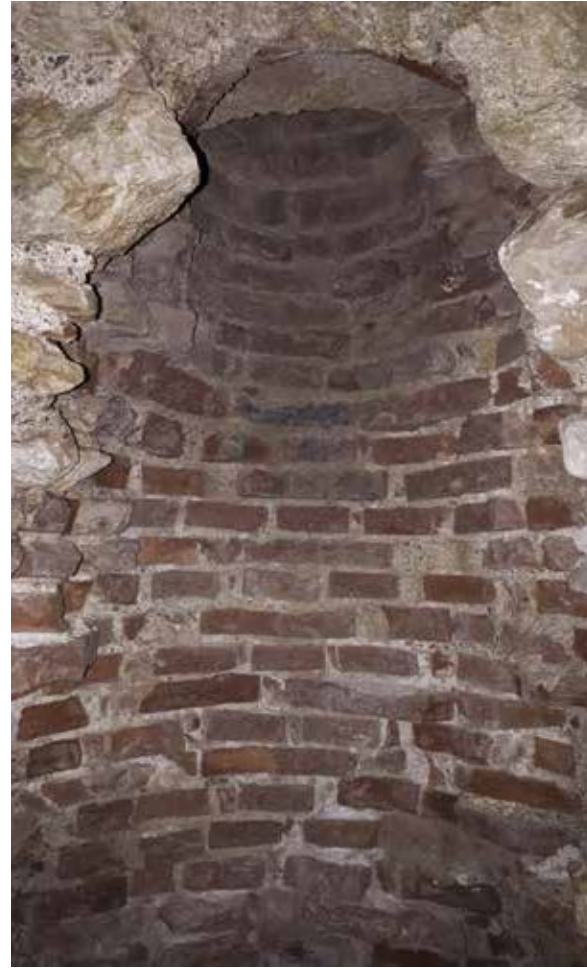
Fig. 74: Remaining of a chimney in the ground floor, 2019  
(Chimneys are the few elements where bricks were used instead of stones)  
Credits: Ivan Vratnica

Fig. 74: Remaining of a chimney in the ground floor, 2019

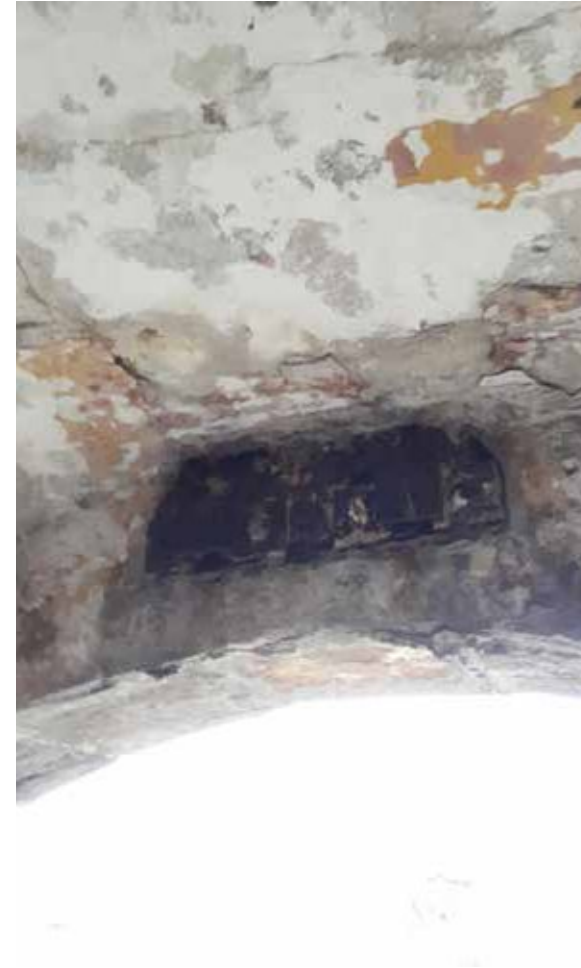
Fig. 75: Metal part of the gates locking mechanism still existing on the vault above the entrance of the barracks, 2019  
(One of the few spots where the plaster is still visible)  
Credits: Ivan Vratnica

Fig. 75: Metal part of the gates locking mechanism still existing on the vault above the entrance of the barracks, 2019 (One of the few spots where the plaster is still visible)

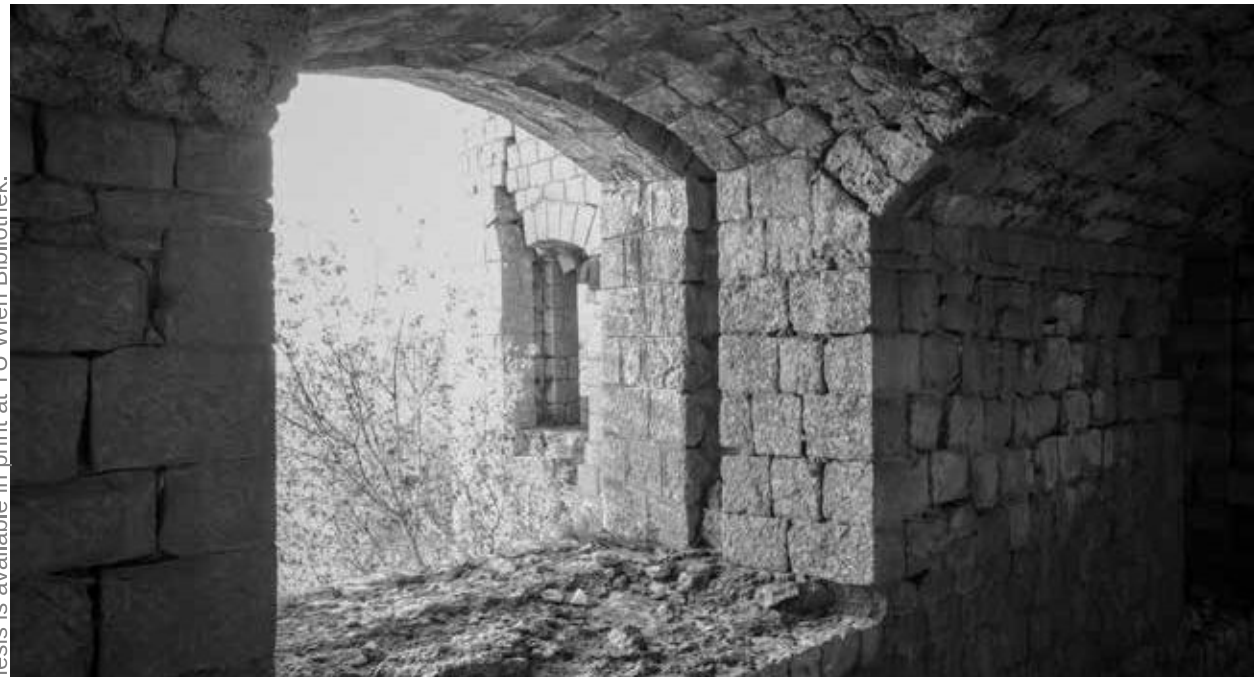
Fig. 78: Stone layers of the eastern barracks wall  
(Regular stone layer was made out of 25cm high stone blocks at wall faces. Inner faces were plastered with lime plaster)  
Credits: Ivan Vratnica

Fig. 78: Stone layers of the eastern barracks wall

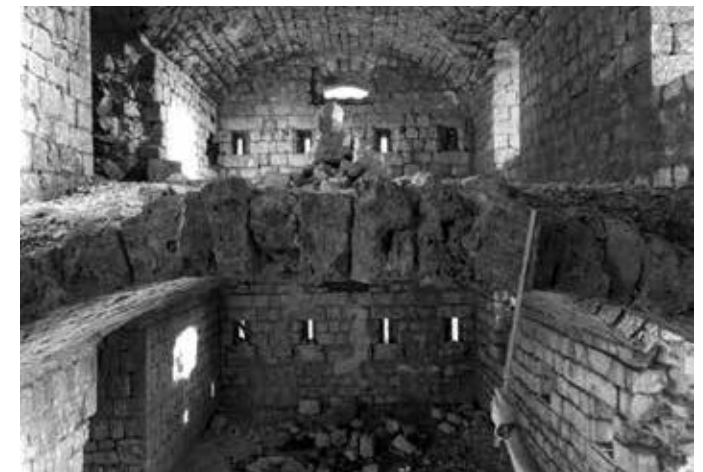
Fig. 81: Stone layers of the western barracks wall  
(Regular stone layer was made out of 25cm high stone blocks at wall faces. The gaps were thin and precisely formed, closed with cement)  
Credits: Ivan Vratnica

Fig. 81: Stone layers of the western barracks wall

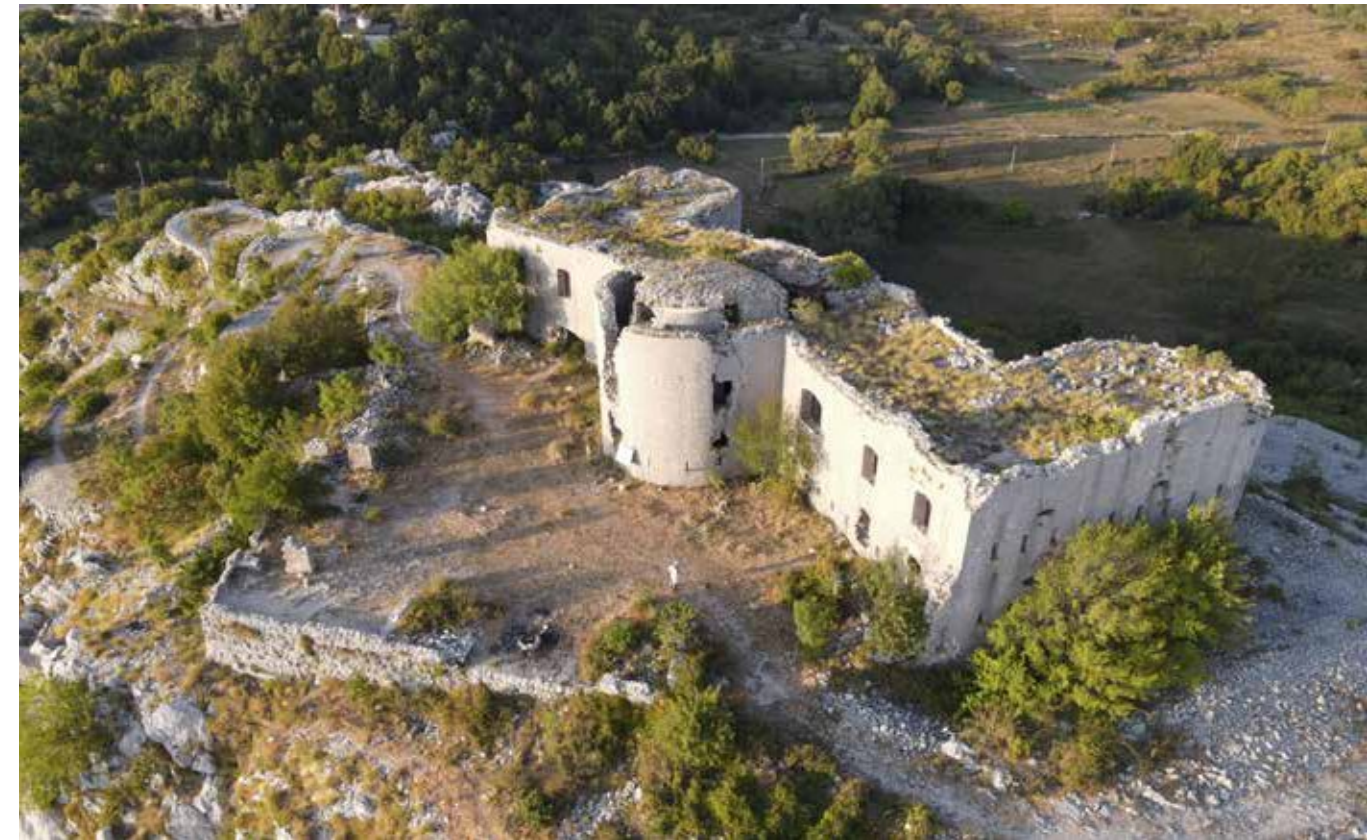
Fig. 84: Southern side of Fort Kosmač, 2019 Credits: Ivan Vratnica

A lot of the initial substance and form has been lost till today but most of the substance is still there. The initial form can't be recognized, as most of the courtyard is gone, as well as the ditch, road and fences too. Most of the remaining substance is concentrated in the barracks. Even though badly damaged, outer walls are still standing

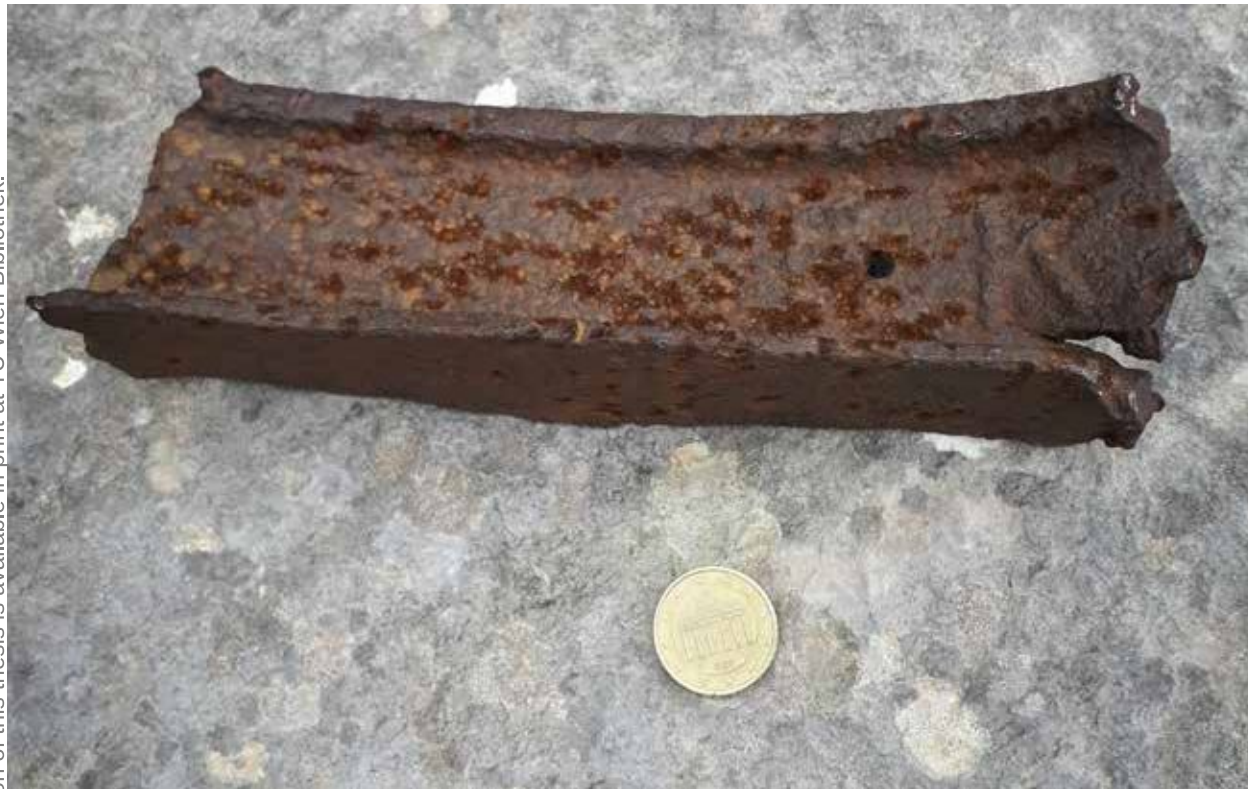
Fig. 85: Piece of the fence pole - I beam with K.u.K. inscribed on it  
Credits: Ivan Vratnica

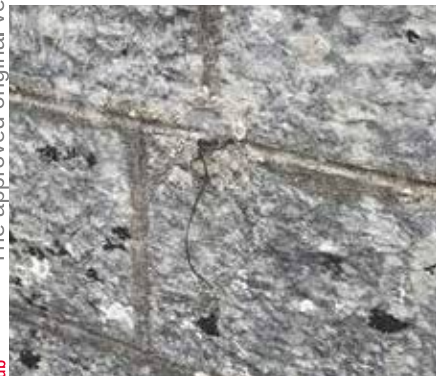
Fig. 86: Joint of the wiring with the barracks wall in the eastern part of the ditch  
Credits: Ivan Vratnica

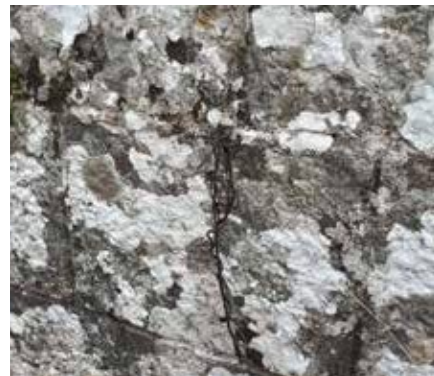
Fig. 87: Joint of the wiring with the barracks wall on the south-eastern part of the ditch  
Credits: Ivan Vratnica
