PROTECTION AND REHABILITATION OF FORT KOSMAČ  
AT BRAJIĆI, MONTENEGRO

# PROTECTION AND REHABILITATION OF FORT KOSMAČ

Brajići, Montenegro

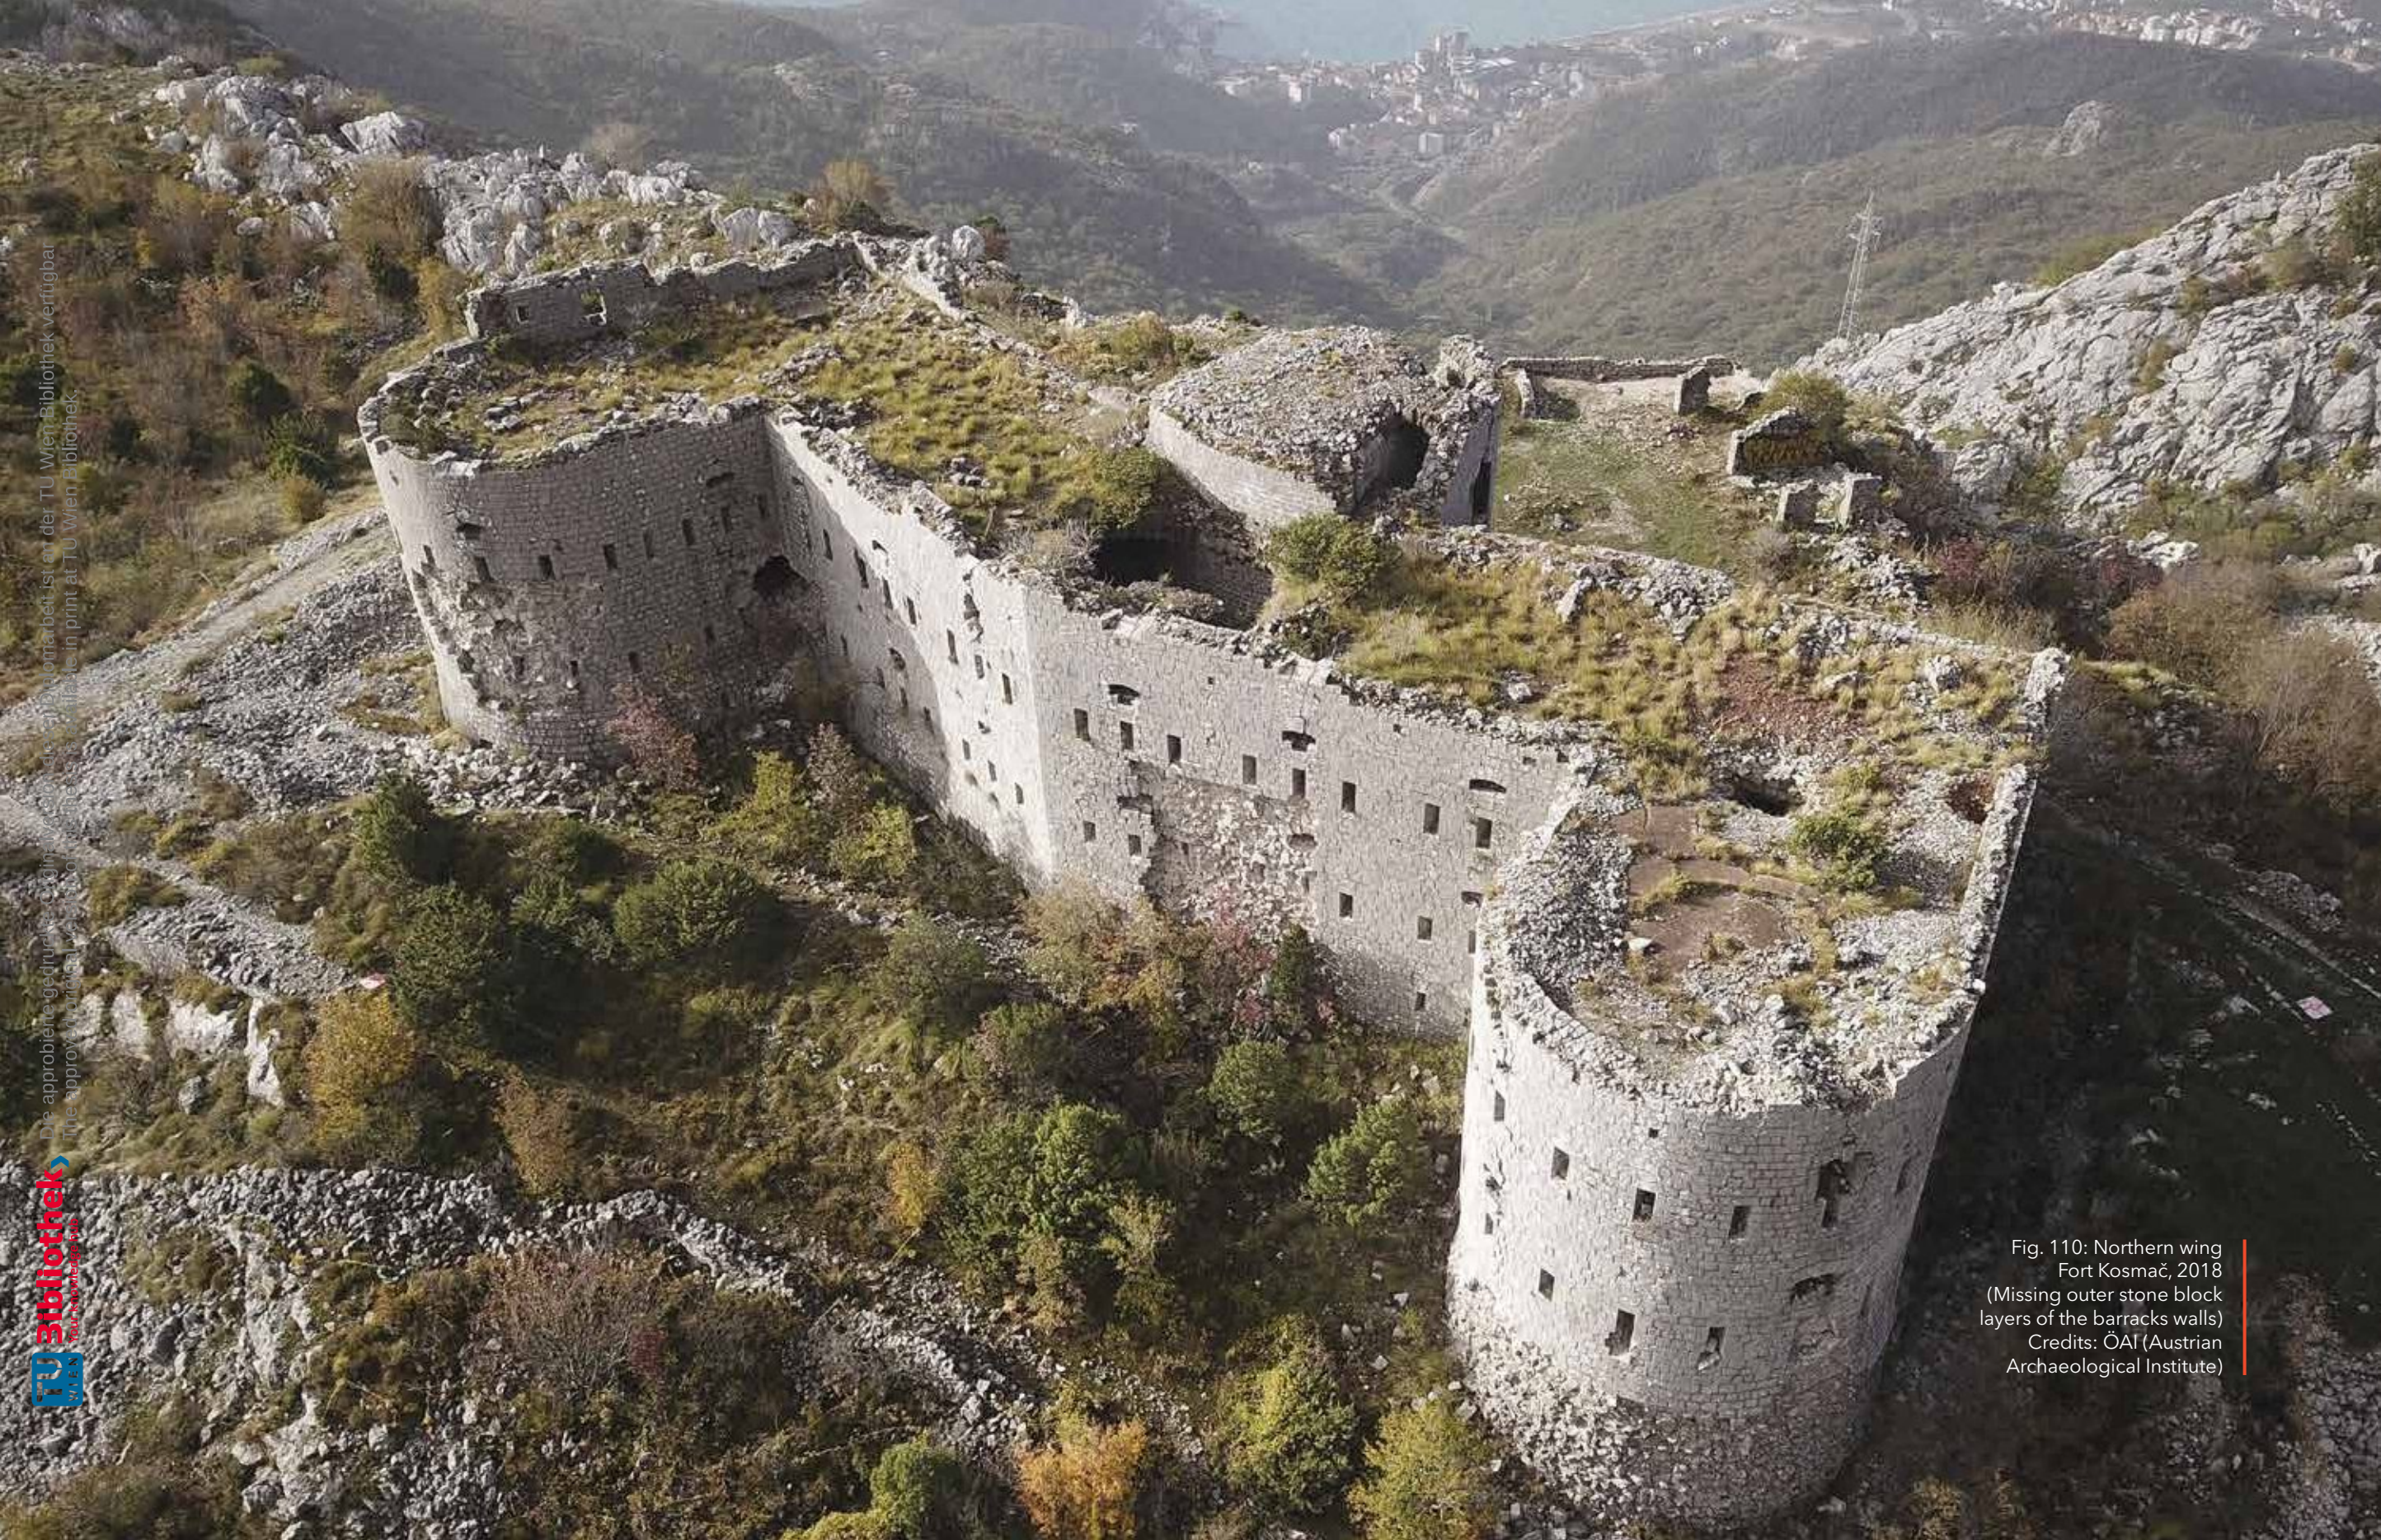
Fig. 110: Northern wing  
Fort Kosmač, 2018  
(Missing outer stone block  
layers of the barracks walls)  
Credits: ÖAI (Austrian  
Archaeological Institute)

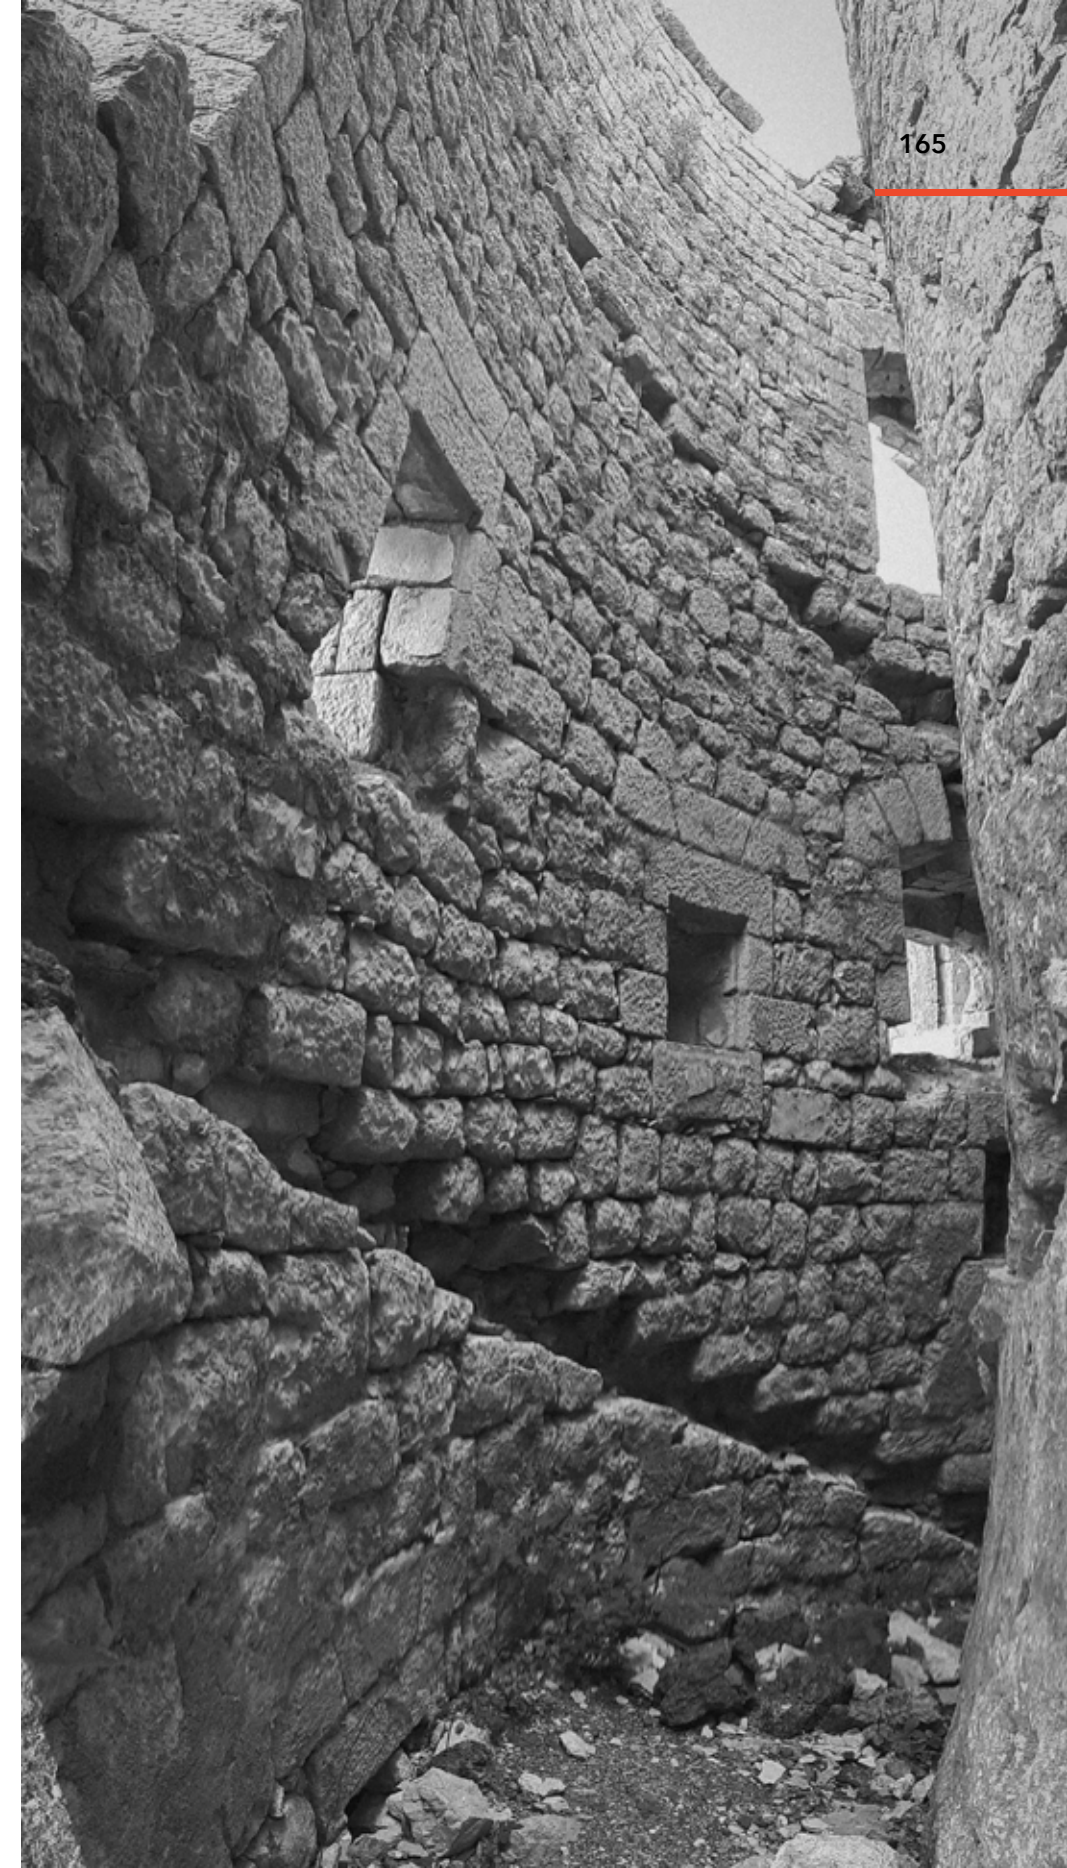
Fig. 111: Stairway in the western wing  
 Fort Kosmač, 2019  
 (Monolith stair blocks were carefully pulled out)  
 Credits: Ivan Vratnica

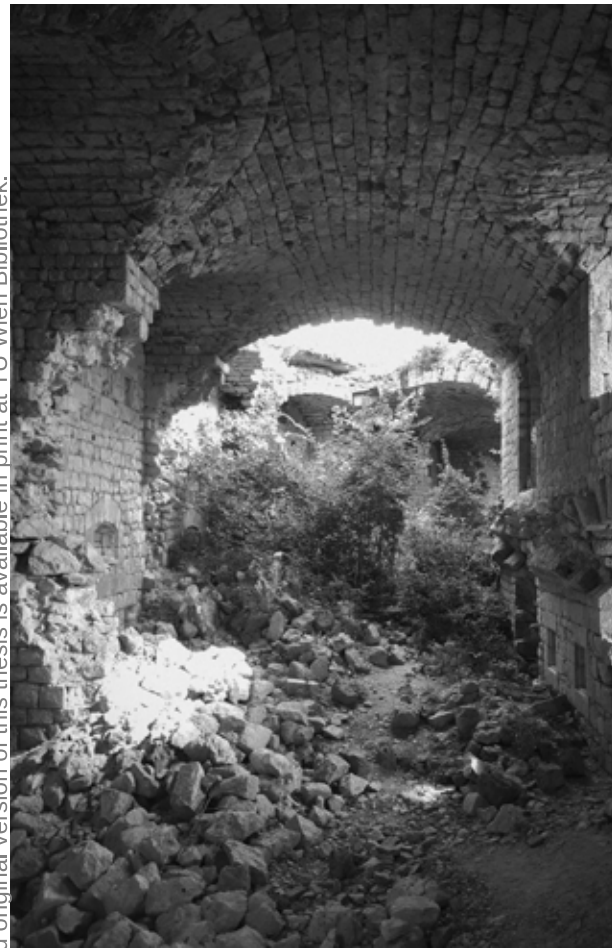
Fig. 112: (top right) Interior of the barracks  
Fort Kosmač, 2019  
(Crew quarters in the ground floor(18)  
and above (28, 29, 29))  
Credits: Ivan Vratnica

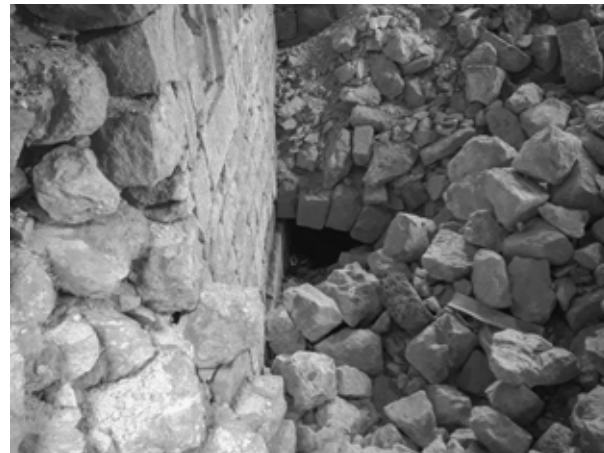
Fig. 113 (top right): Interior of  
the barracks  
Fort Kosmač, 2019  
(Entrance shaft to the defensive gallery (19))  
Credits: Ivan Vratnica

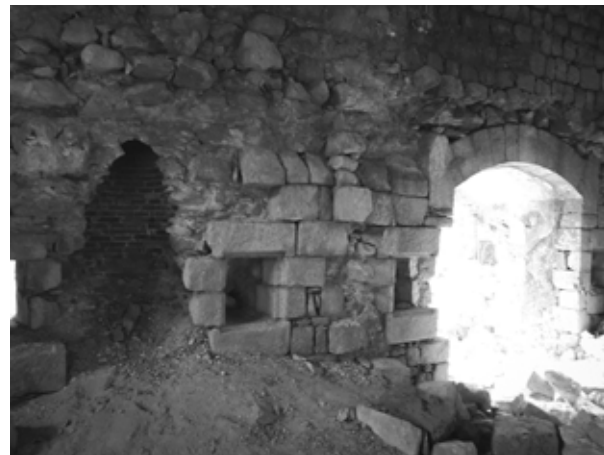
Fig. 114 (bottom right): Interior of the barracks  
Fort Kosmač, 2019  
(Entrance door. The wall between the entrance  
(14) and the crew quarters (18) is missing but the  
identical upper one still remains with the original  
vaults merging under a 90° angle)  
Credits: Ivan Vratnica

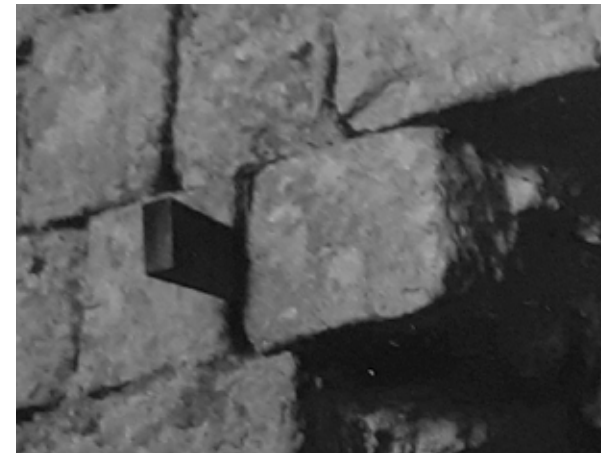
Fig. 115 (top left): Stone chisel  
Fort Kosmač  
(Forgotten chisel used to break off  
the outer stone blocks)  
Credits: Norbert Zsupanek - K.u.K.  
Befestigungen, Militärbauten und Anlagen  
im Raum Cattaro (Kotor), 2009

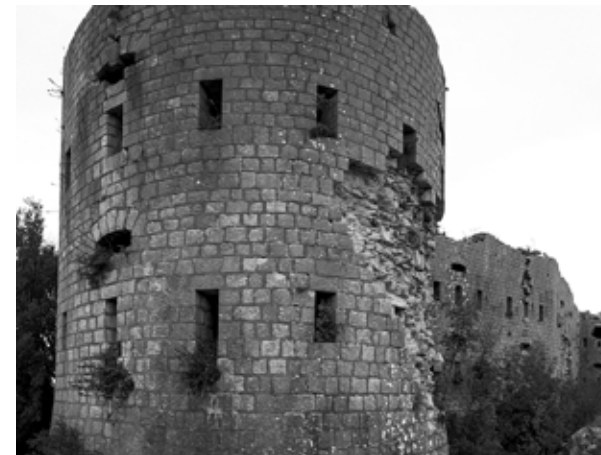
Fig. 116 (bottom left): South-eastern wing  
Fort Kosmač 2019  
(The upper stone blocks collapsed as the bottom ones  
were broken off)  
Credits: Ivan Vratnica

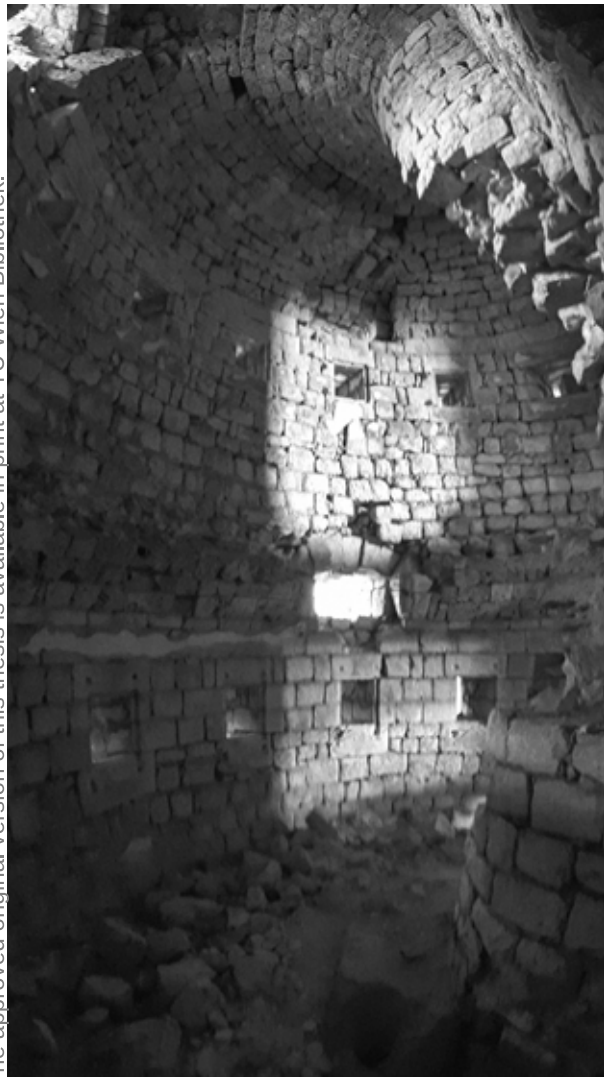
Fig. 118 (left): Toilets (17) and Equipment room (38) in the North-eastern wing  
Fort Kosmač, 2019  
(The vault between collapsed but it's material has been removed)  
Credits: Ivan Vratnica

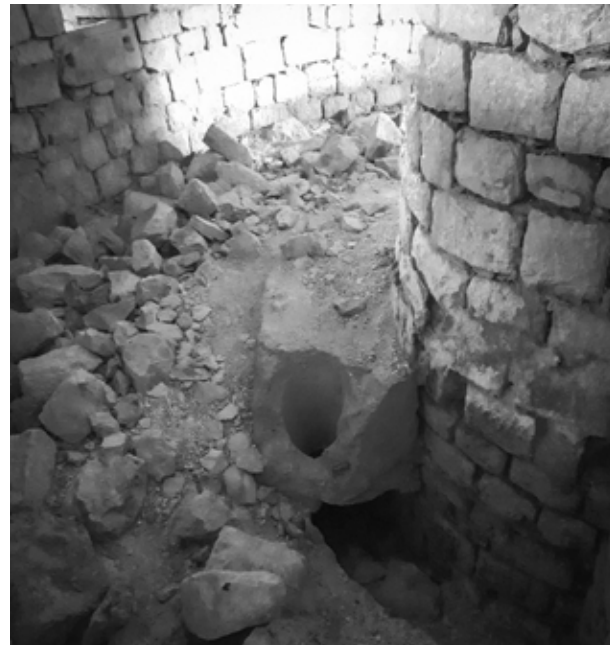
Fig. 119 (right): Toilets (17) in the North-eastern wing  
Fort Kosmač, 2019  
(The special toilet stone blocks are broken and missing)  
Credits: Ivan Vratnica

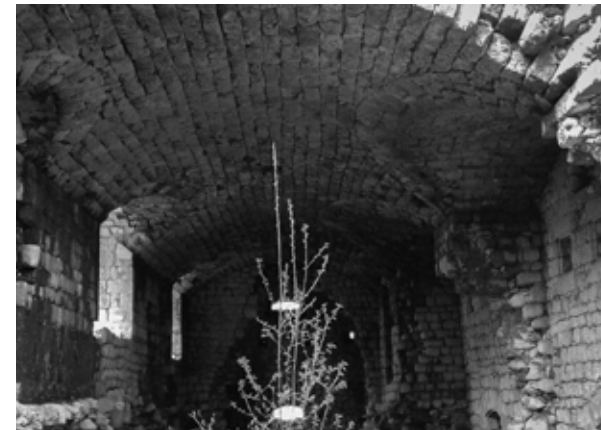
Fig. 120 (top left): Interior of the barracks  
Fort Kosmač, 2010  
(Still Visible in the background is the inner wall of the officer's quarters (35))  
Credits: Radojica Pavičević

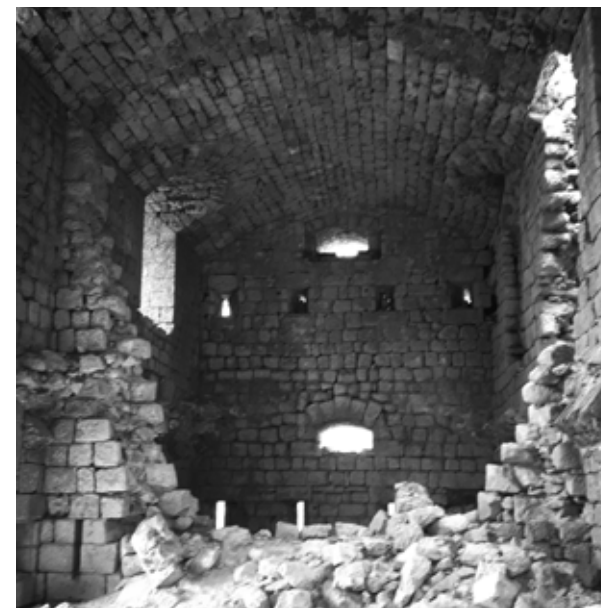
Fig. 121 (bottom left): Interior of the barracks  
Fort Kosmač, 2019  
(Position of the guards room (15) and officers quarters (35) on the floor above. The inner wall collapsed in the recent years)  
Credits: Ivan Vratnica

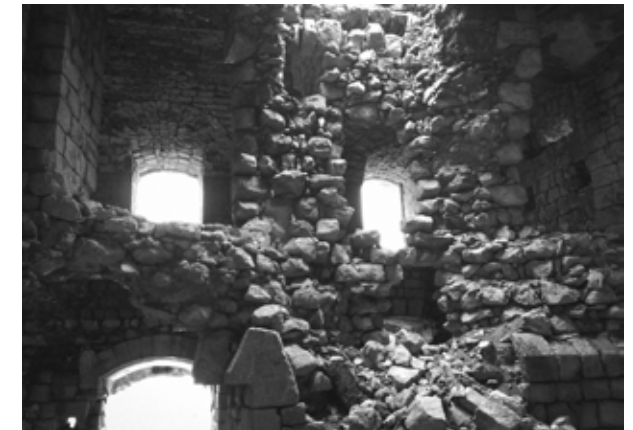
Fig. 122 (top right): Interior of the barracks  
Fort Kosmač, 2010  
(Position of the chimney in the kitchen (16) that collapsed, critically weakening the bearing wall, making it deteriorate more over time)  
Credits: Radojica Pavičević

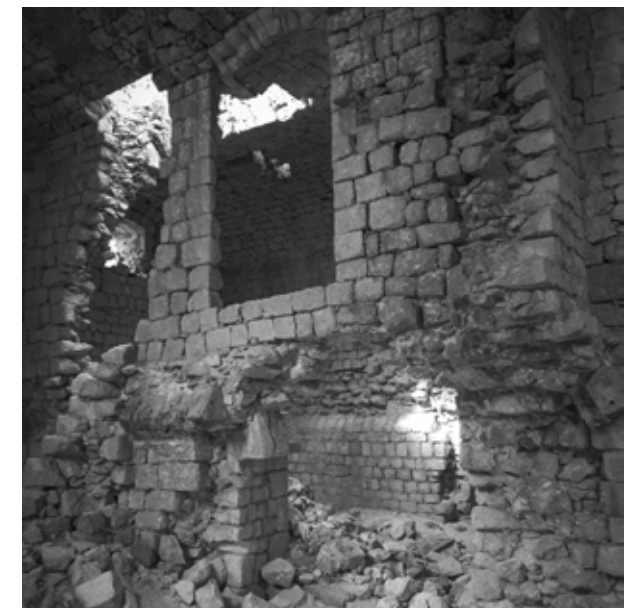
Fig. 123 (bottom right): Interior of the barracks  
Fort Kosmač, 2019  
(Entrance to the kitchen (16) and to the officer's quarters (36, 37) on the first floor)  
Credits: Ivan Vratnica

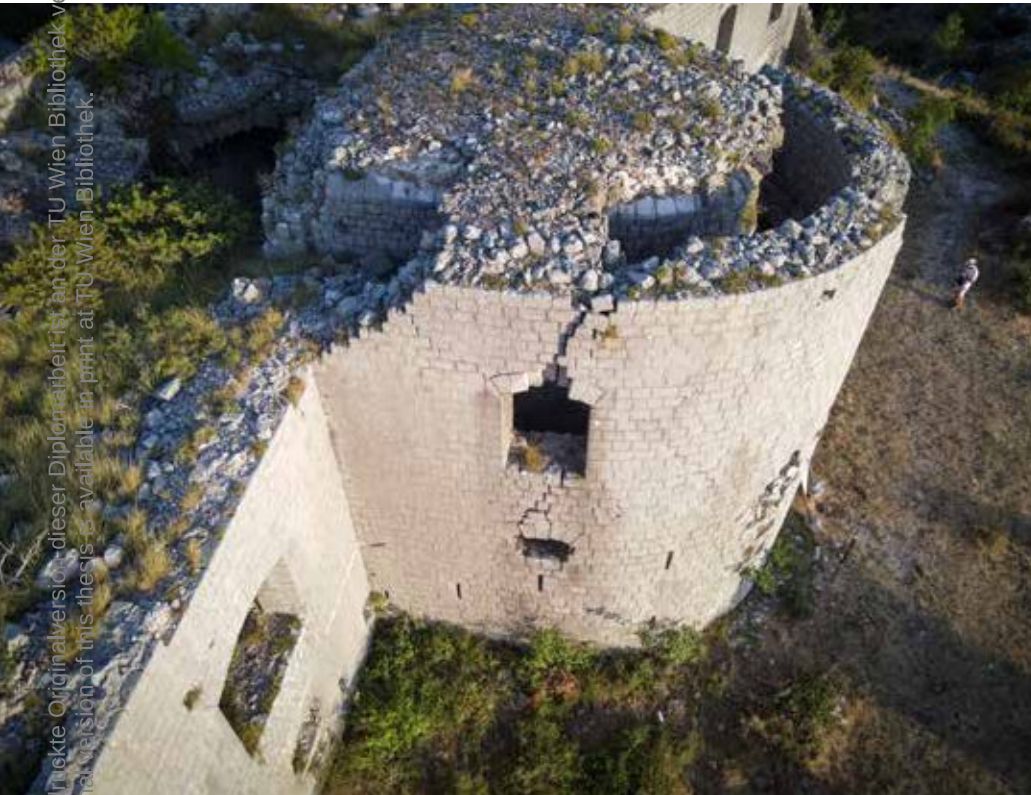
Fig. 128: Western wing  
 Fort Kosmač, 2020  
 (The damage on the northern outer wall resulted from the  
 further tilting outwards from the earthquake due to the lack of  
 bracing)  
 Credits: Ivan Vratnica

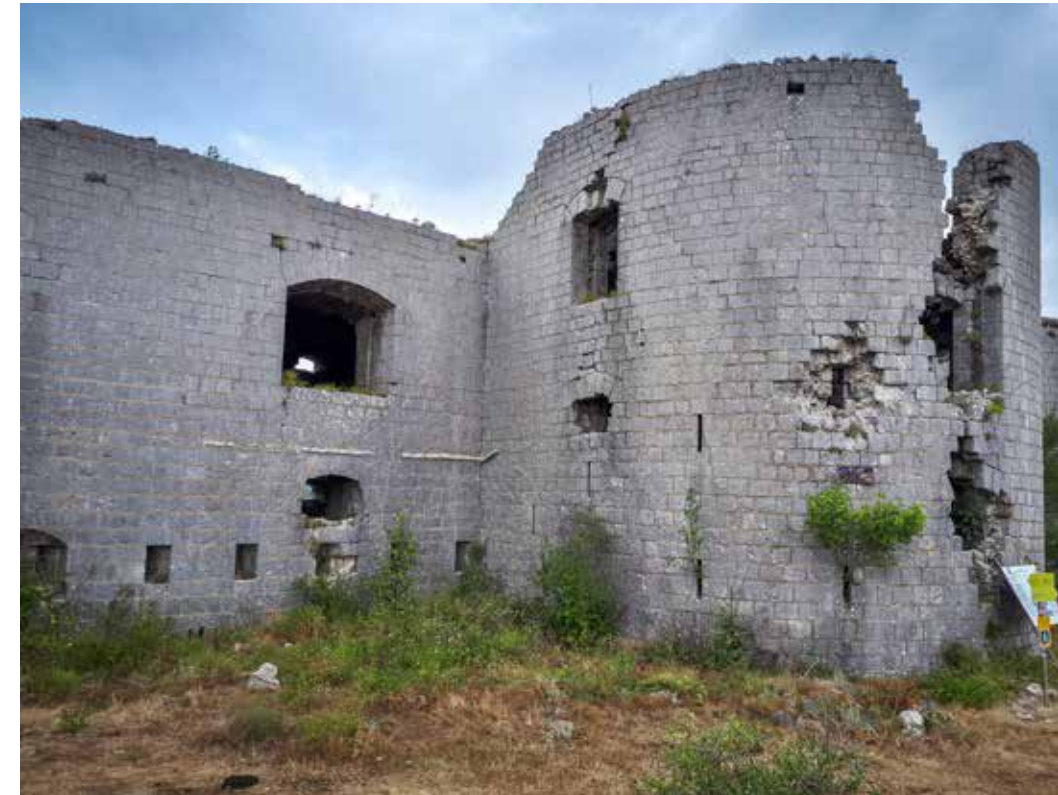
Fig. 129: Western wing  
 Fort Kosmač, 2019  
 (The northern outer wall tilted outwards from the earthquake  
 due to the lack of bracing)  
 Credits: Ivan Vratnica

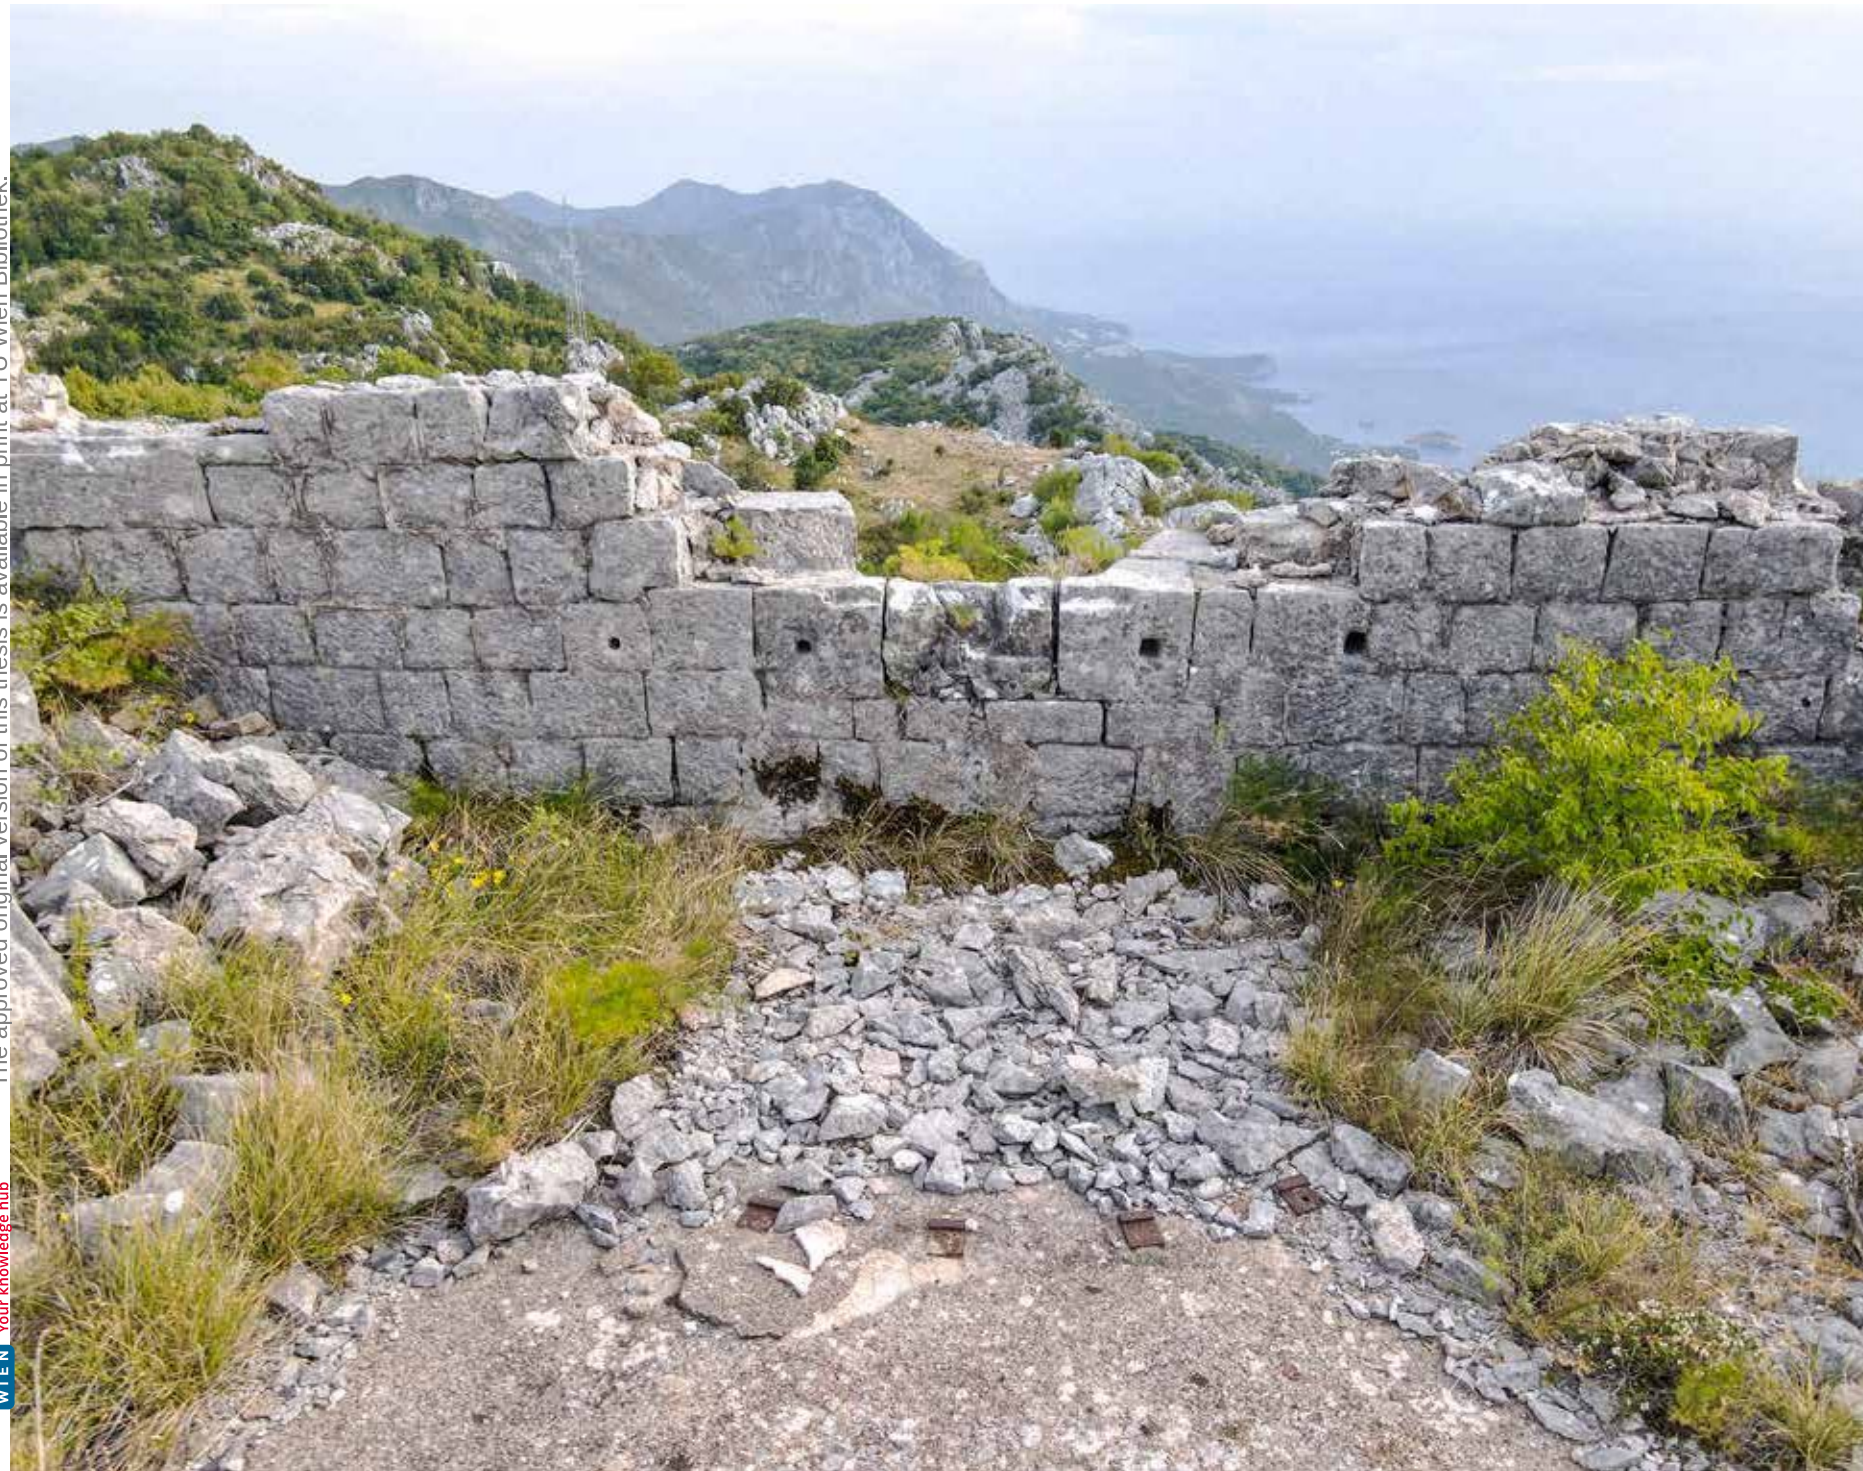
Fig. 130: Cannon terrace wall in the Southern wing  
Fort Kosmač, 2019  
(The only remaining part of the wall on, with the only part of  
the M4 90mm lafette still present )  
Credits: Ivan Vratnica

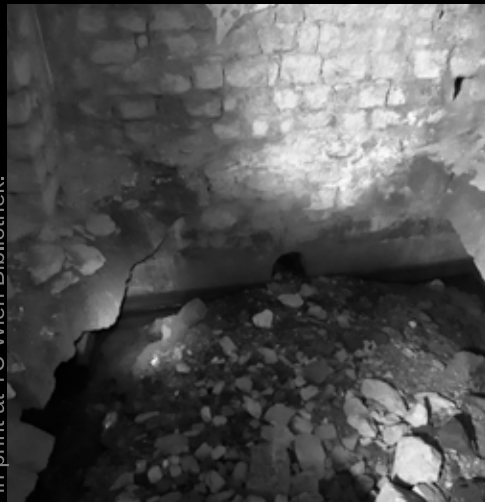
Fig. 132 (top left): Water reservoir (45)  
in the western wing  
Fort Kosmač, 2019  
(Full of water and material)  
Credits: Ivan Vratnica

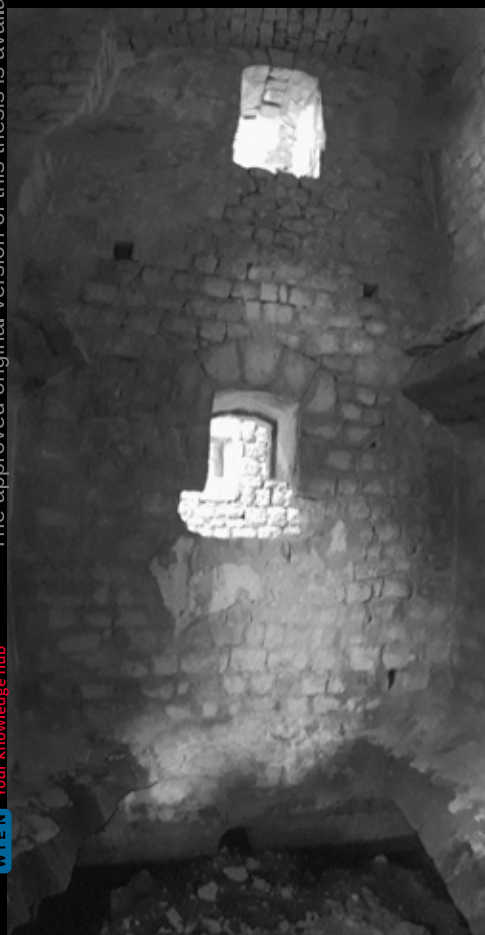
The vaults in the ammunition storages and of the reservoir in the western wing have also collapsed, laying piled up in the reservoir, which is still full with water. When the walls of the gun terrace were gone, the lower sections of the fortress outer walls were the next easiest part to dismantle. Starting mostly from below or at some weak points like windows, the stone blocks were carefully broken out with the chisel at the gaps. The outer layer of stones on the outer walls are missing on the spots like the bottom of the walls, easy enough to reach but also some upper layers collapsed as the bottom layers, supporting them, were broken off.

Fig. 133 (bottom left): Ammunition storages (24, 27)  
in the western wing  
Fort Kosmač, 2019  
(Vaults collapsed into the water reservoir below)  
Credits: Ivan Vratnica

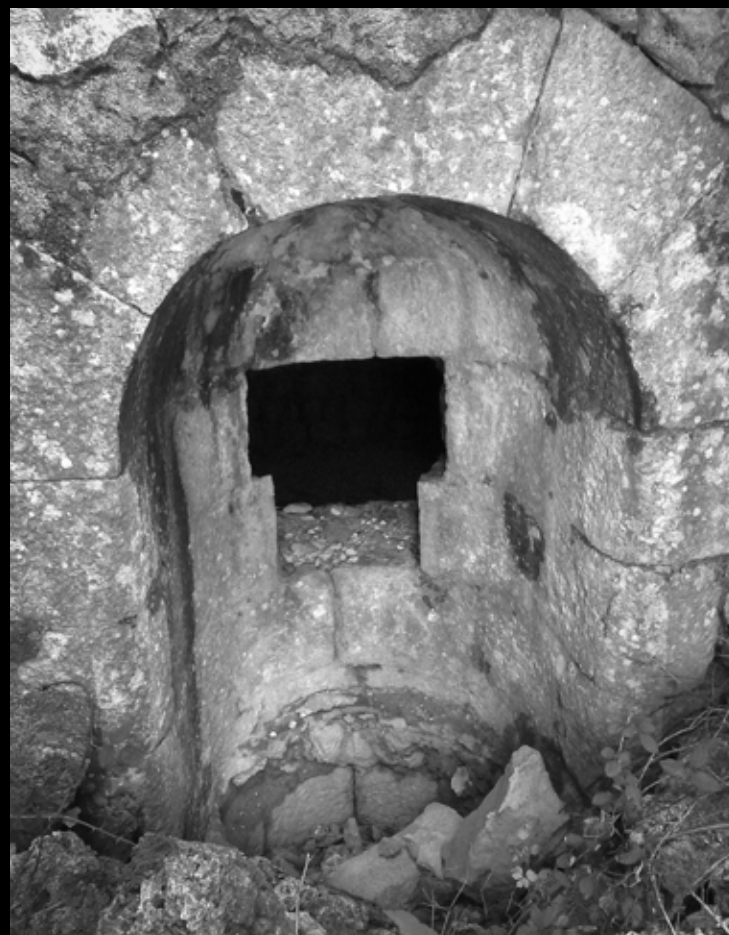
Fig. 134 (bottom right): Place of the water pump in  
the passage (25)  
in the western wing  
Fort Kosmač, 2010  
Credits: Radojica Pavičević

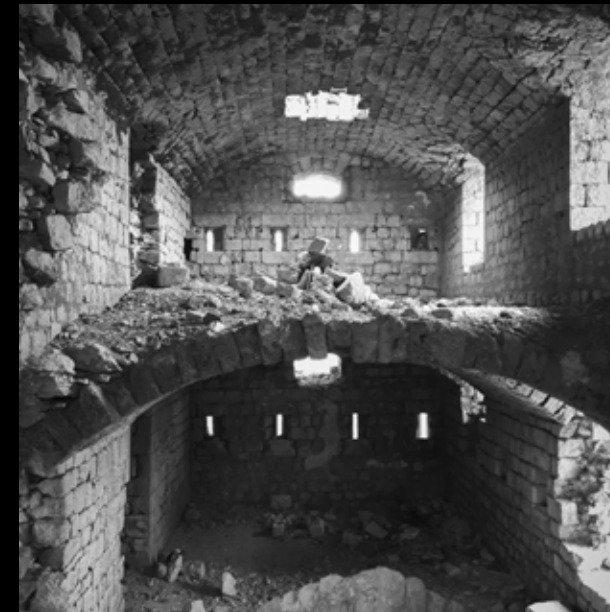
Fig. 135 (top left): South-eastern wing Fort Kosmač, 2019  
(Provisions storage (21) in the ground floor and crew quarters (30, 31) above. The only remaining part of the vault between ground and the first floor)  
Credits: Ivan Vratnica

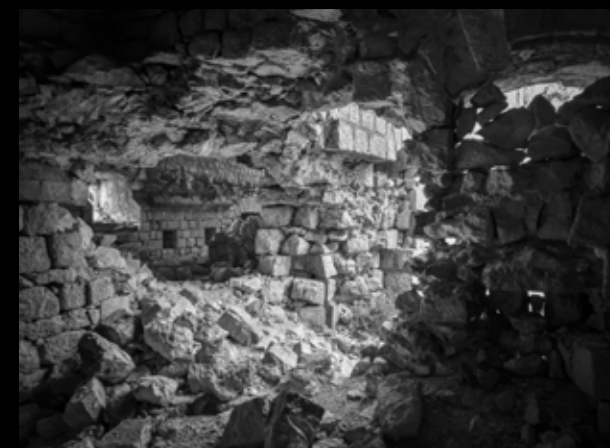
Fig. 136 (bottom left): Hole in the eastern wall  
Fort Kosmač, 2019  
(The collapsed corner between the provisions storage (22) and the crew quarter (18))  
Credits: Ivan Vratnica

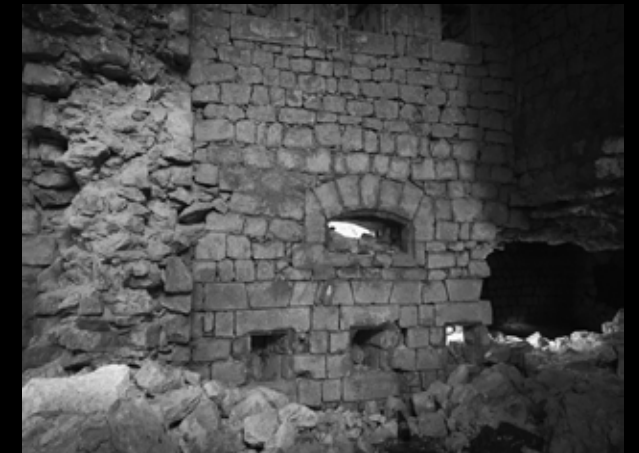
Fig. 137 (top right): Southern part of the main tract  
Fort Kosmač, 2019  
(The biggest hole in the eastern wall in the corner of the crew quarters (18) and the provisions storage (22).  
Loopholes closed during the uprising 1869 )  
Credits: Ivan Vratnica

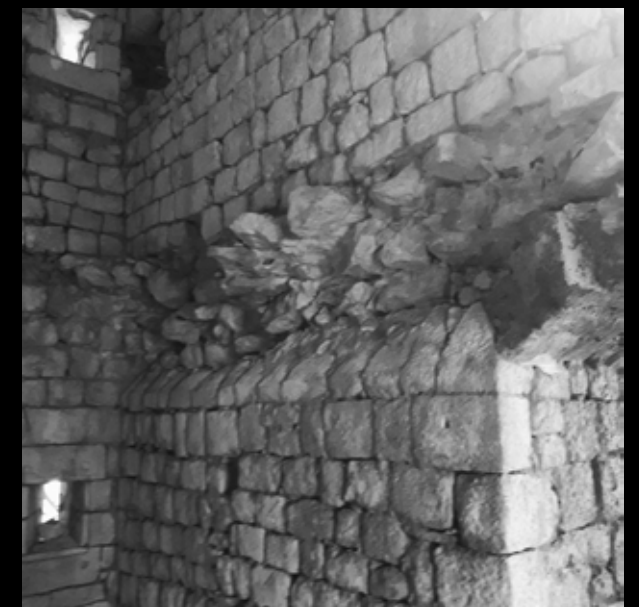
Fig. 138 (bottom right): Provisions storage (22)  
in the south-eastern wing  
Fort Kosmač, 2019  
(Base of the collapsed vault)  
Credits: Ivan Vratnica

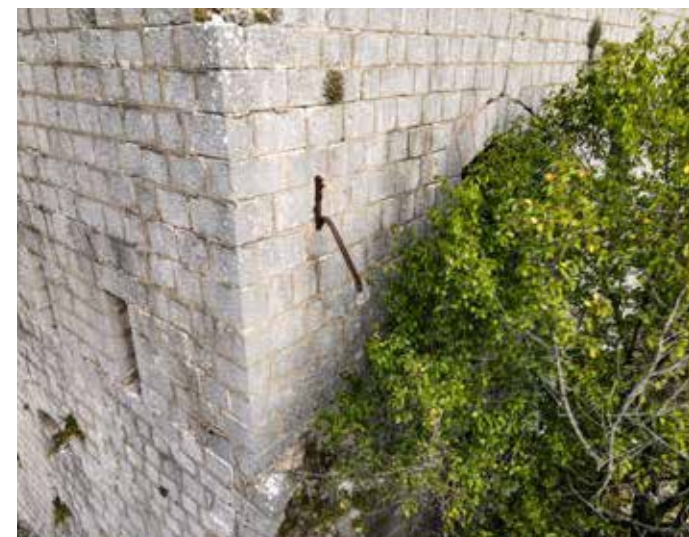
Fig. 139: Metal part  
Fort Kosmač, 2020  
(Possibly for connecting the  
telephone line)  
Credits: Ivan Vratnica

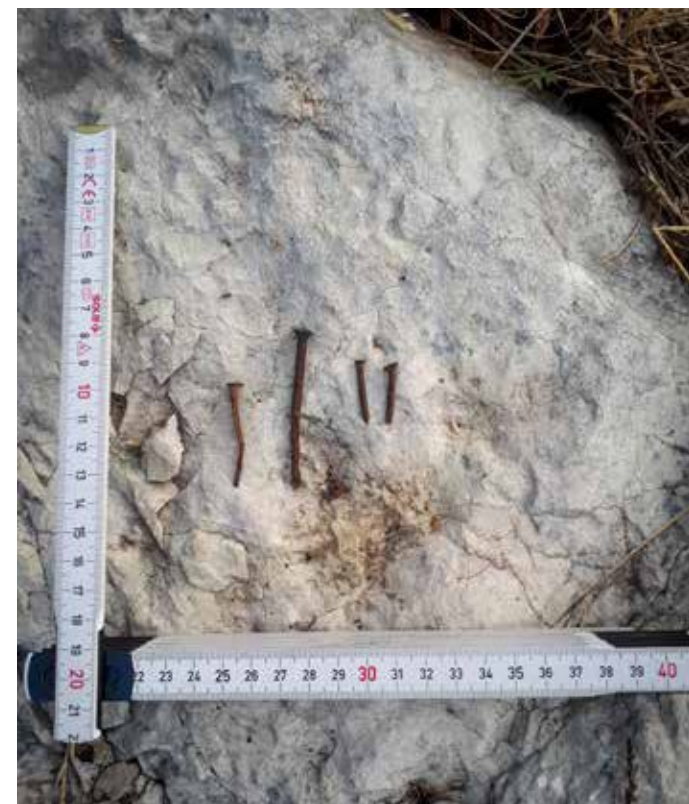
Fig. 140: Metal nails  
Fort Kosmač, 2020  
(Possibly from the wooden  
roof construction)  
Credits: Ivan Vratnica

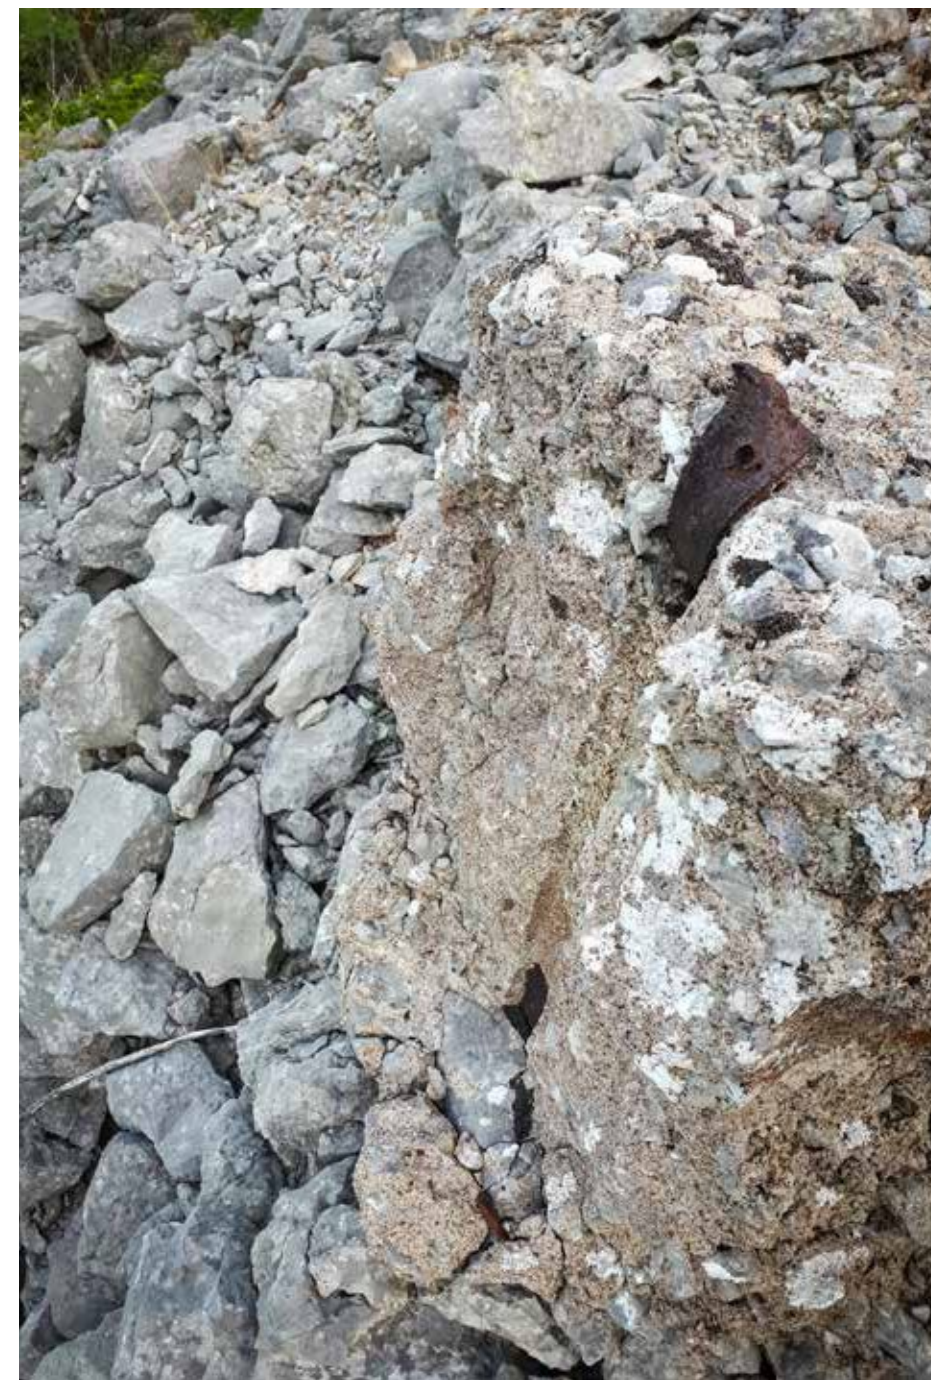
Fig. 141: I-profile pole  
foundation  
Fort Kosmač, 2020  
(Some pieces of the pole  
still visible)  
Credits: Ivan Vratnica

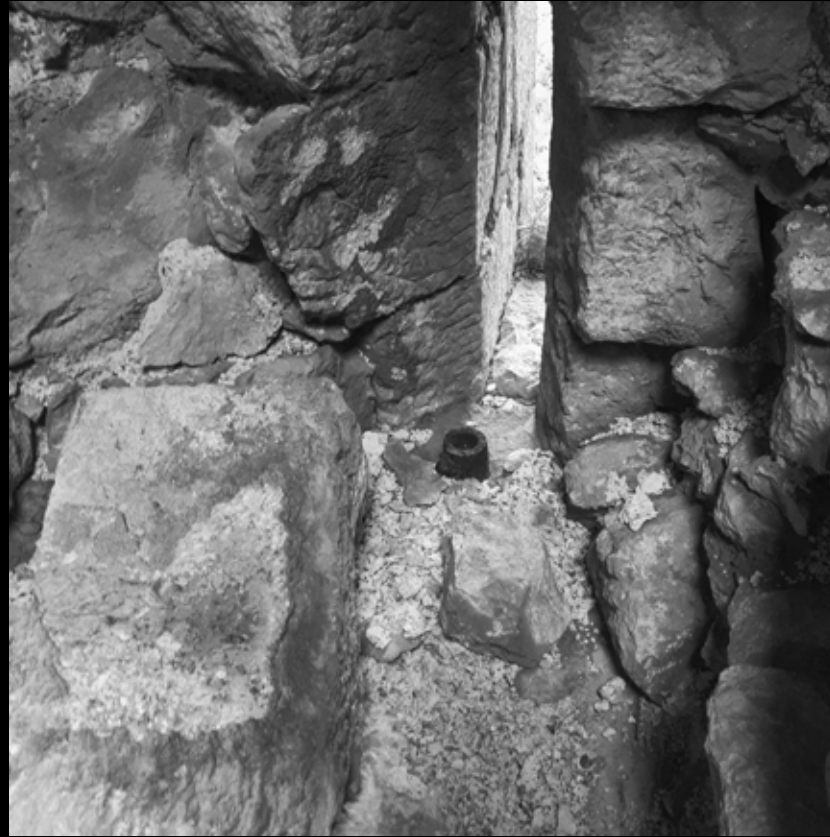
Fig. 143: Stone arch construction of the door to the passage (26)  
Fort Kosmač, 2019  
(The vault construction above collapsed leaving the arch visible)  
Credits: Ivan Vratnica

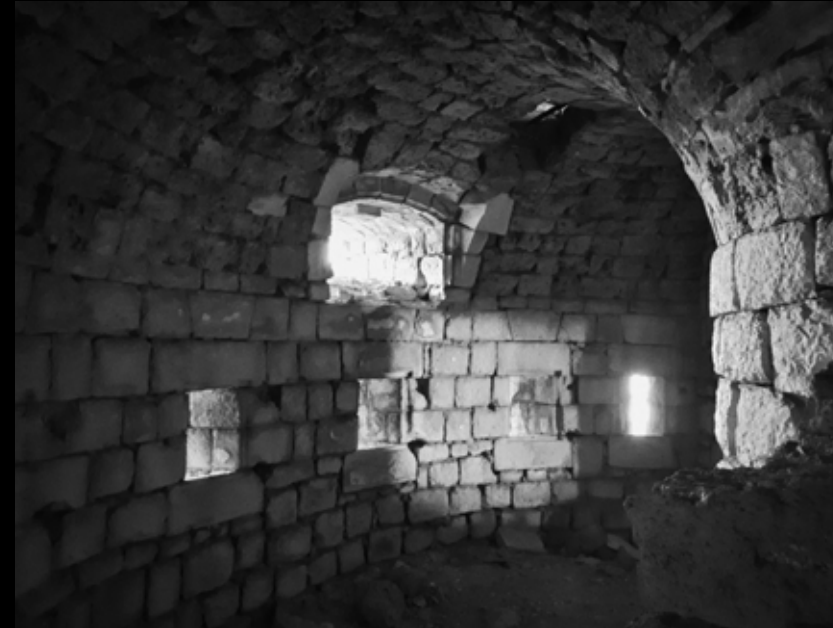
Fig. 144: The provision storage (23) in the south-eastern wing  
Fort Kosmač, 2019  
(The half circular vault construction still present)  
Credits: Ivan Vratnica

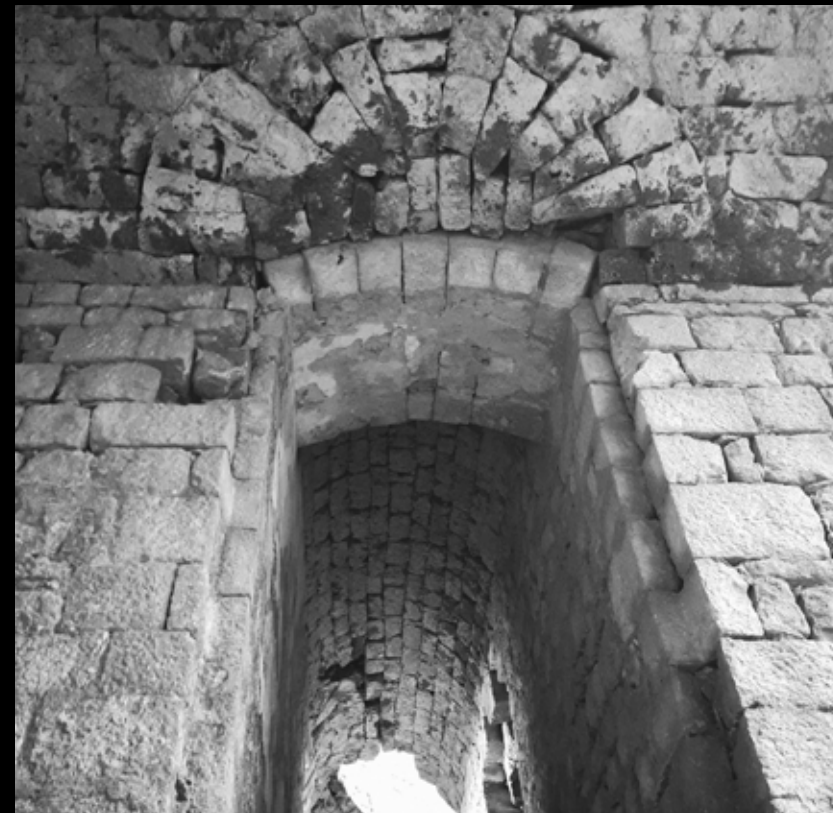
Fig. 145: Stone arch construction of the door to the stairway (26)  
Fort Kosmač, 2019  
(The vault construction of the door above is still visible compared to the previous photo)  
Credits: Ivan Vratnica
