PROTECTION AND REHABILITATION OF FORT KOSMAČ  
AT BRAJIĆI, MONTENEGRO

# PROTECTION AND REHABILITATION OF FORT KOSMAČ

Brajići, Montenegro

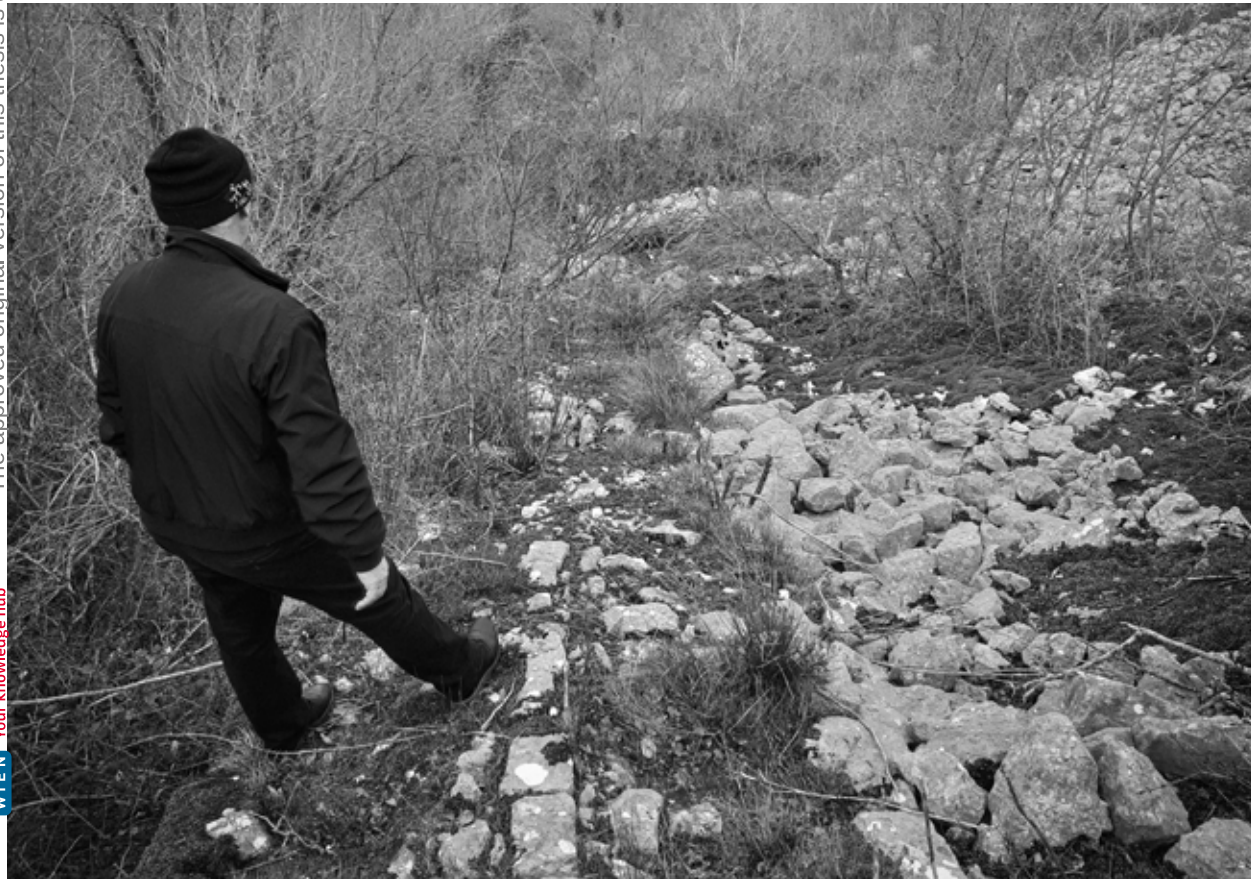
Fig. 146: The Sewers drain leading  
 to the field below on the east  
 Fort Kosmač, 2020  
 (The ending of the drain does not  
 exist as the newly made road to  
 the east cuts it)  
 Credits: Ivan Vratnica

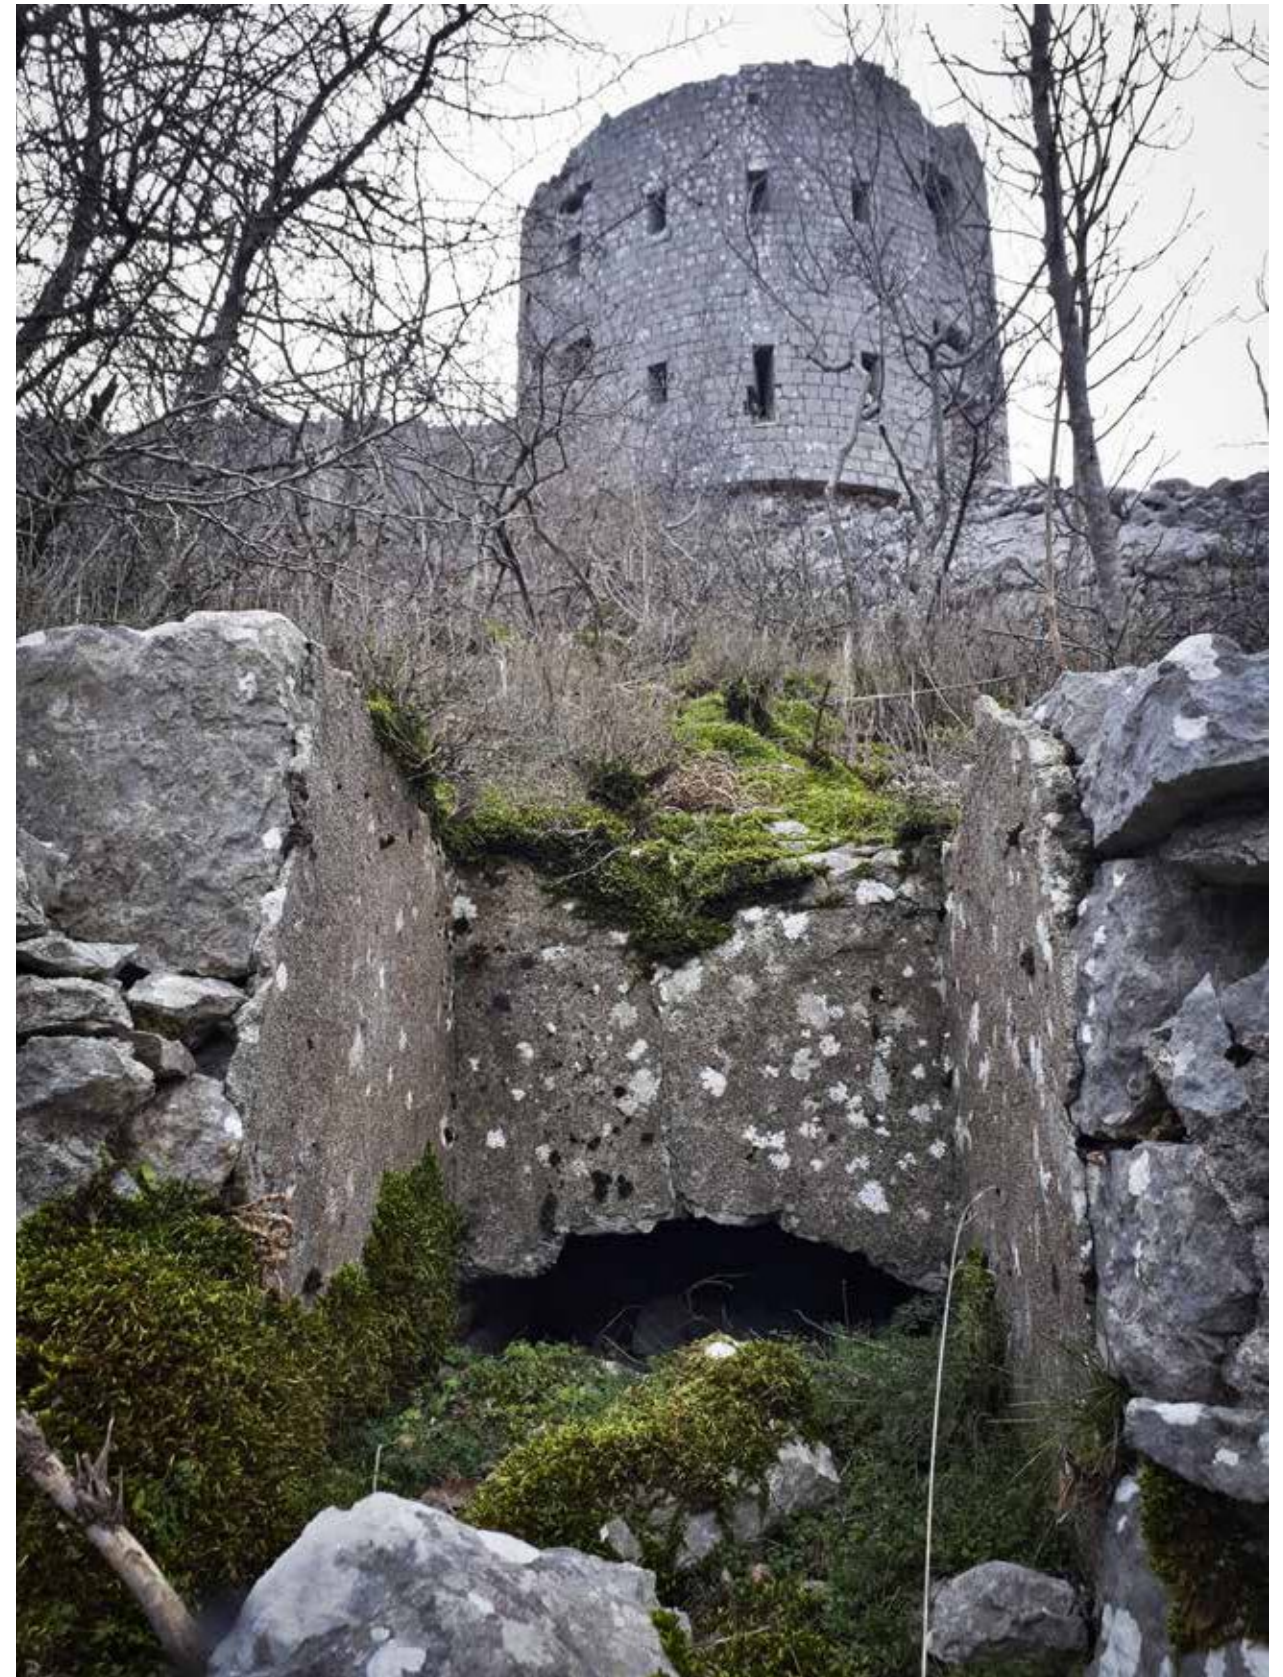
Fig. 147 (right): The manhole on the  
 drain of the sewers from  
 the toilets (17)  
 Fort Kosmač, 2020  
 (Used for cleaning in case of  
 clogging)  
 Credits: Ivan Vratnica

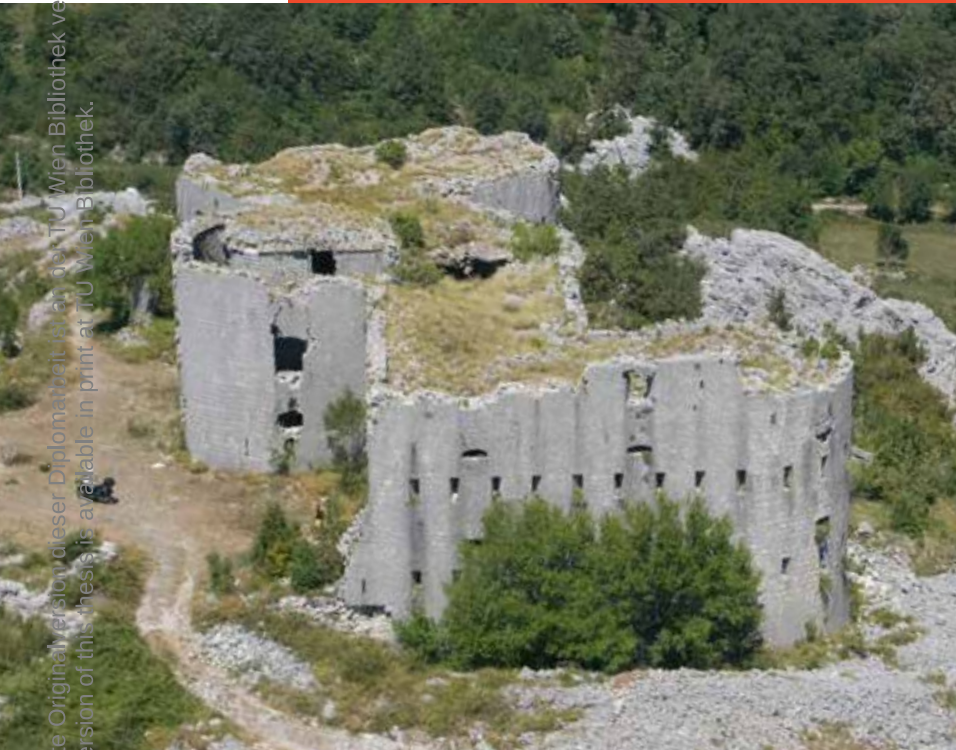
Fig. 148: Southern side  
Fort Kosmač, 2010  
(The cracks above the window in the outer  
wall of the western wing looks like the  
damage from the 1979 earthquake)  
Credits: Radojica Pavićević

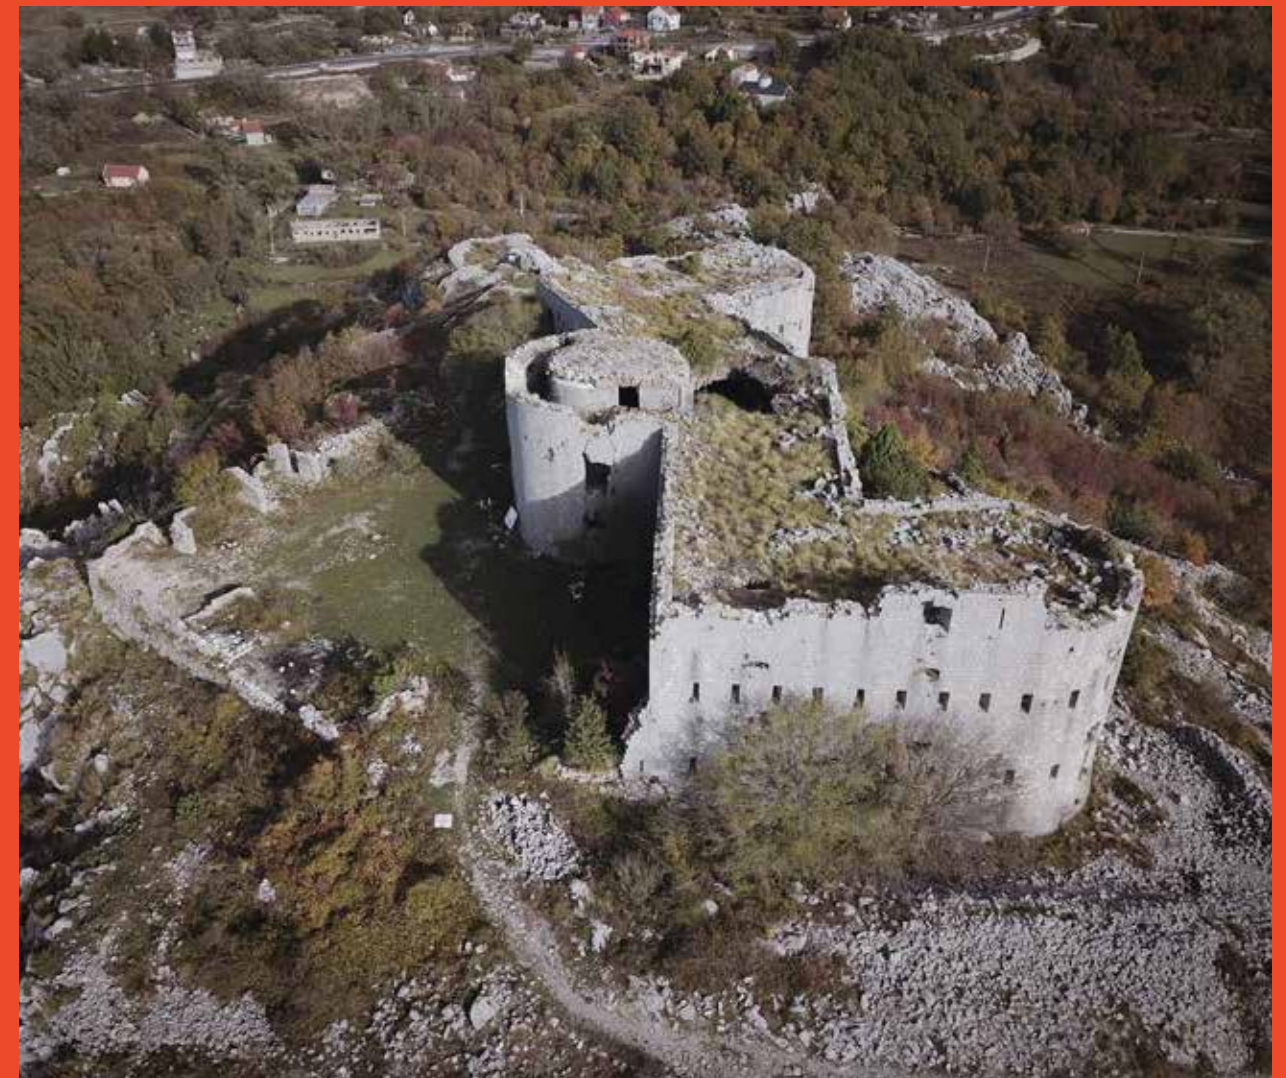
Fig. 149: Southern side  
Fort Kosmač, 2018  
(Even though no significant change compared to 2010 is visible the  
state of the outer walls slowly deteriorates)  
Credits: ÖAI (Austrian Archaeological Institute)

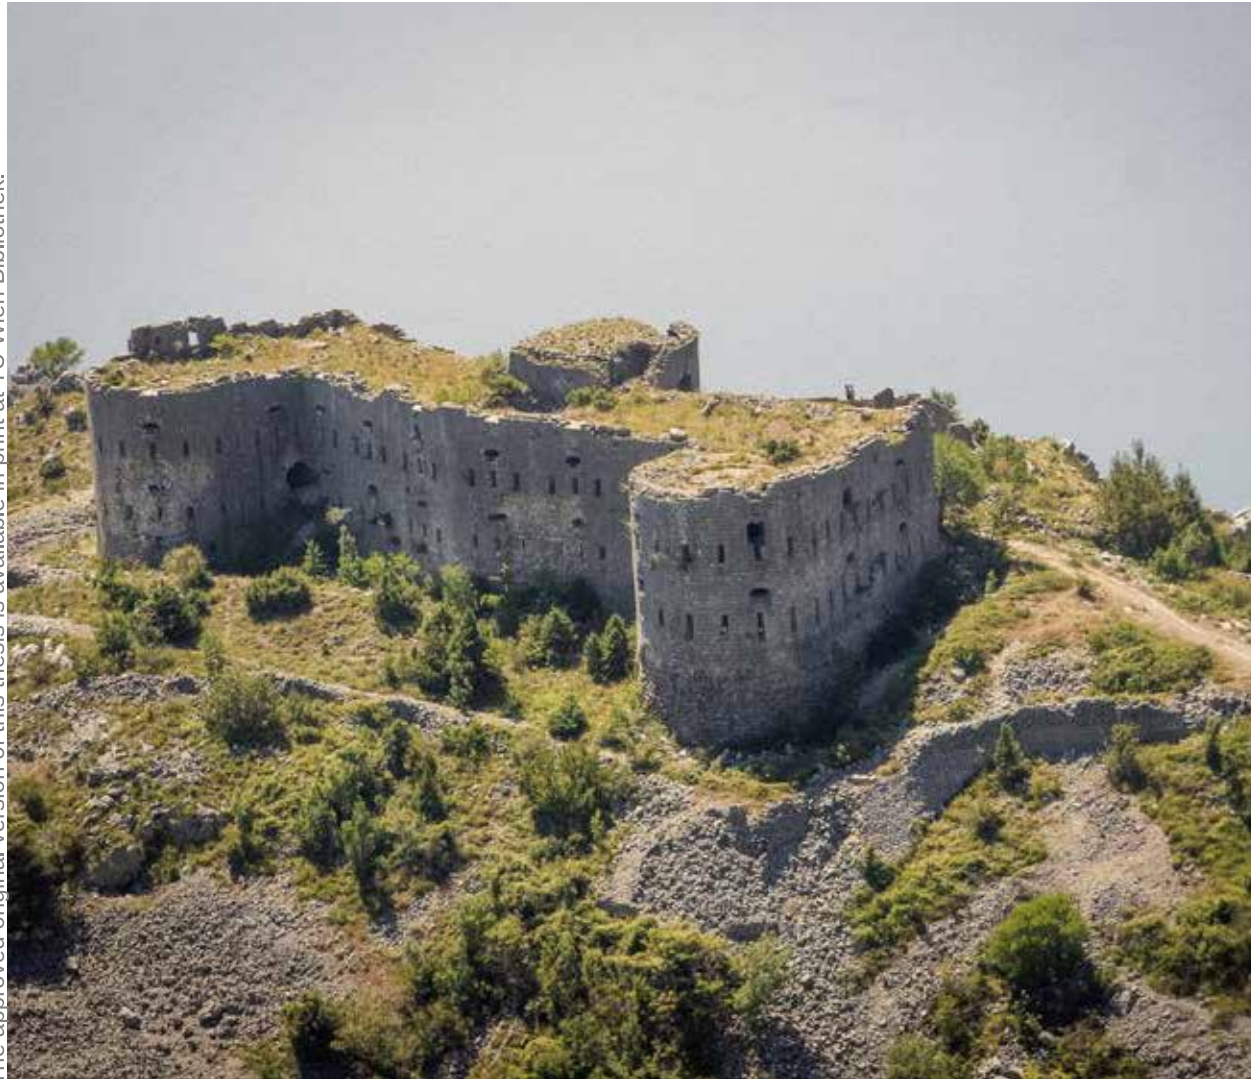
Fig. 150: Eastern side  
Fort Kosmač, 2010

((The embankment of the curve the  
blocking gate on the road from Budva  
to Fort Spiridone collapsed but most  
of the material lies underneath))

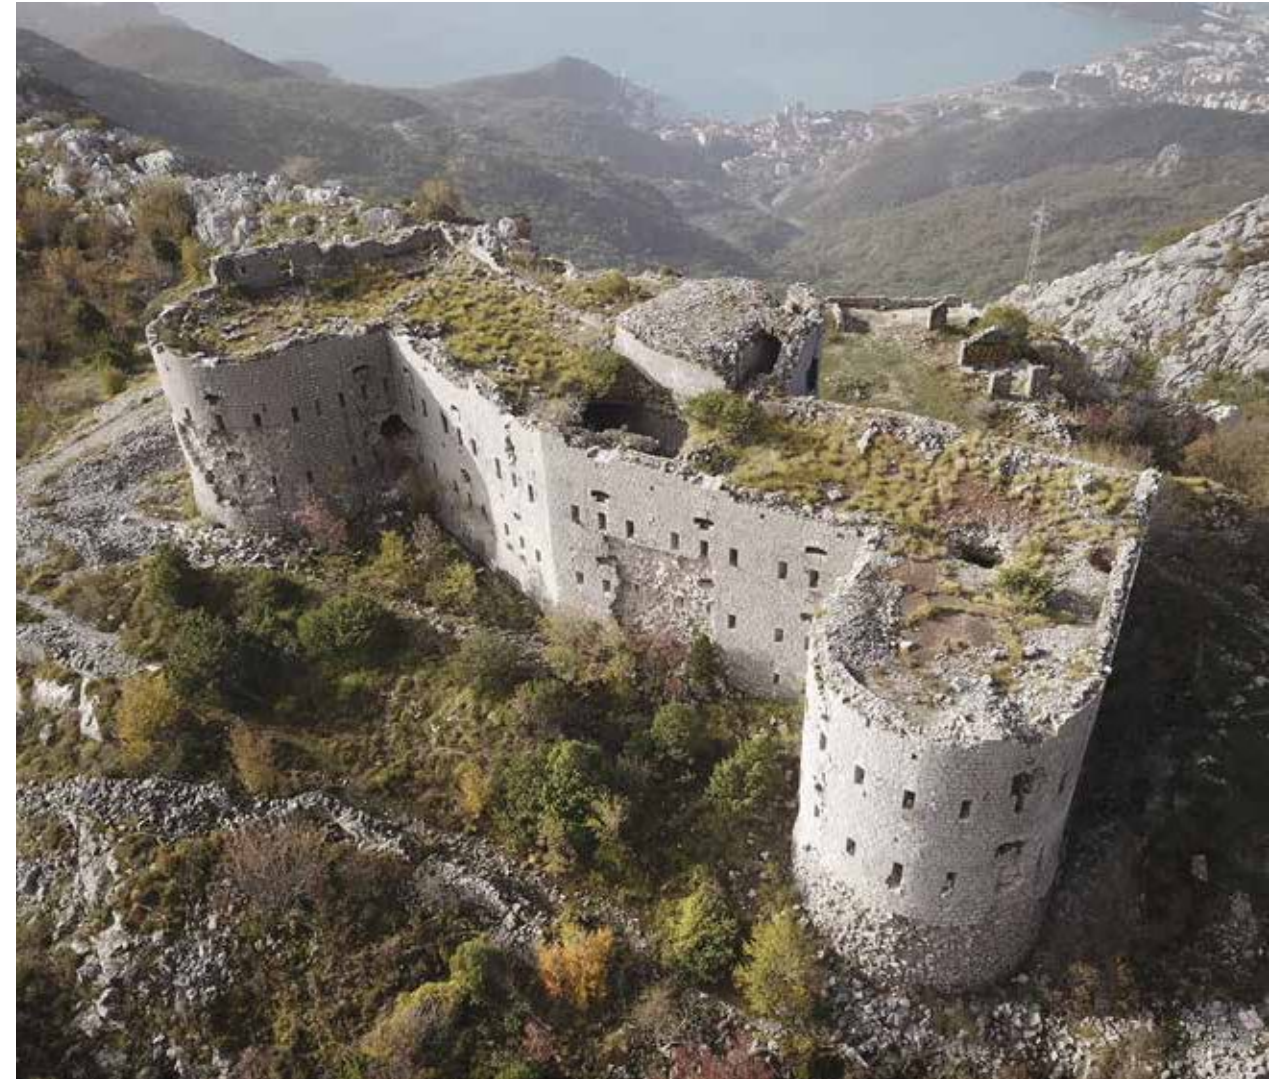
Fig. 151: Eastern side  
Fort Kosmač, 2018

((The state of the fortress slowly deteriorates  
especially on the cannon terrace floor,  
dough not clearly visible))

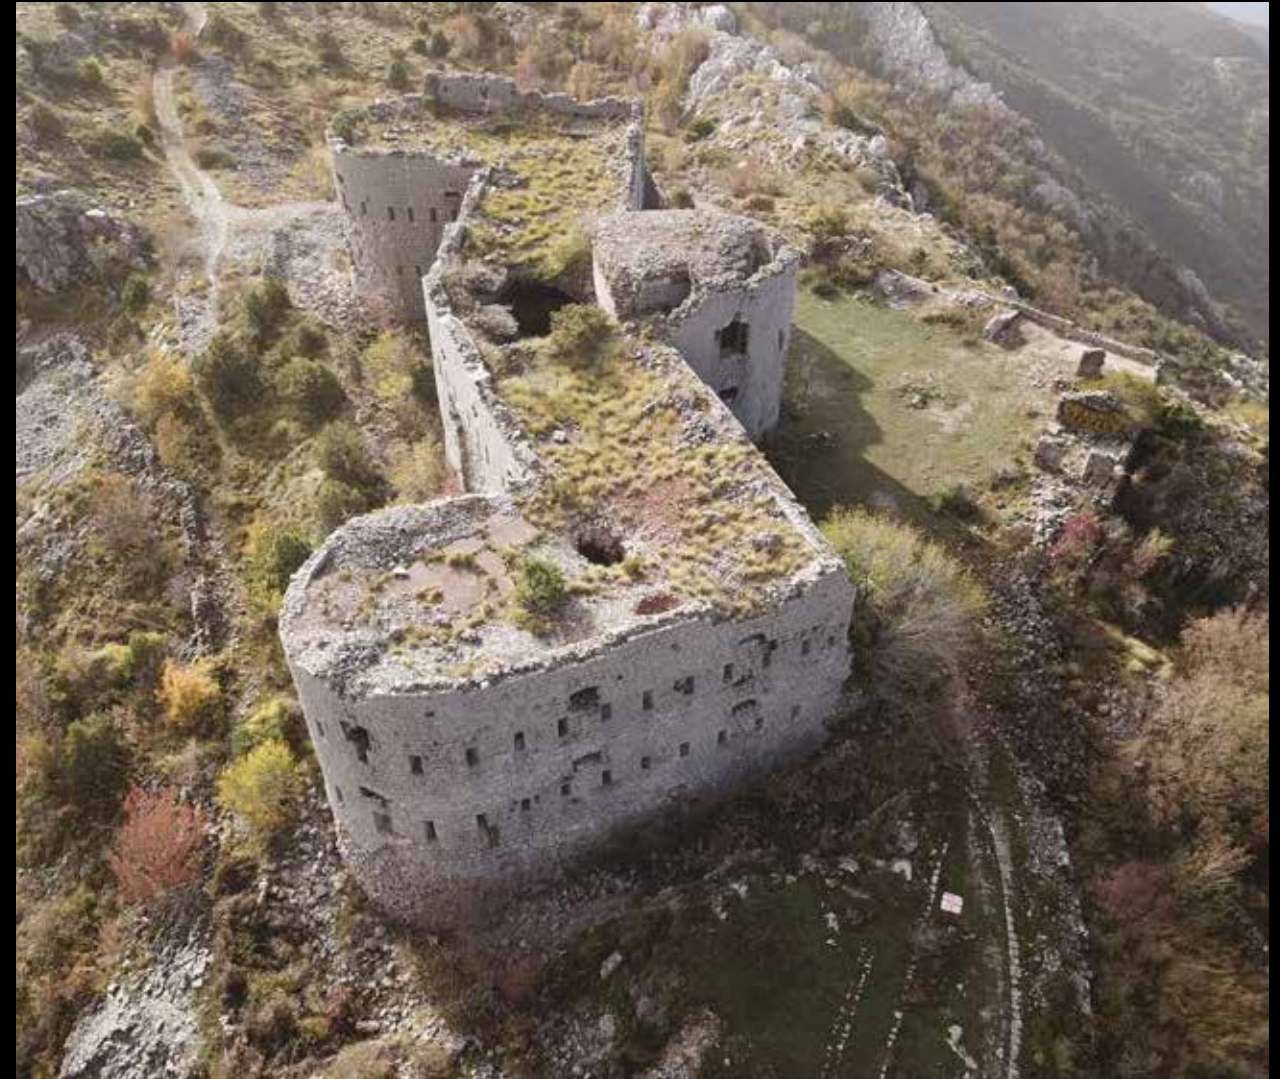
Fig. 153: Northern side  
Fort Kosmač, 2018  
(The holes in the cannon terrace floor are slowly getting bigger leading to the sudden collapse of the whole floor as the inner bearing walls have already collapsed)  
Credits: ÖAI (Austrian Archaeological Institute)

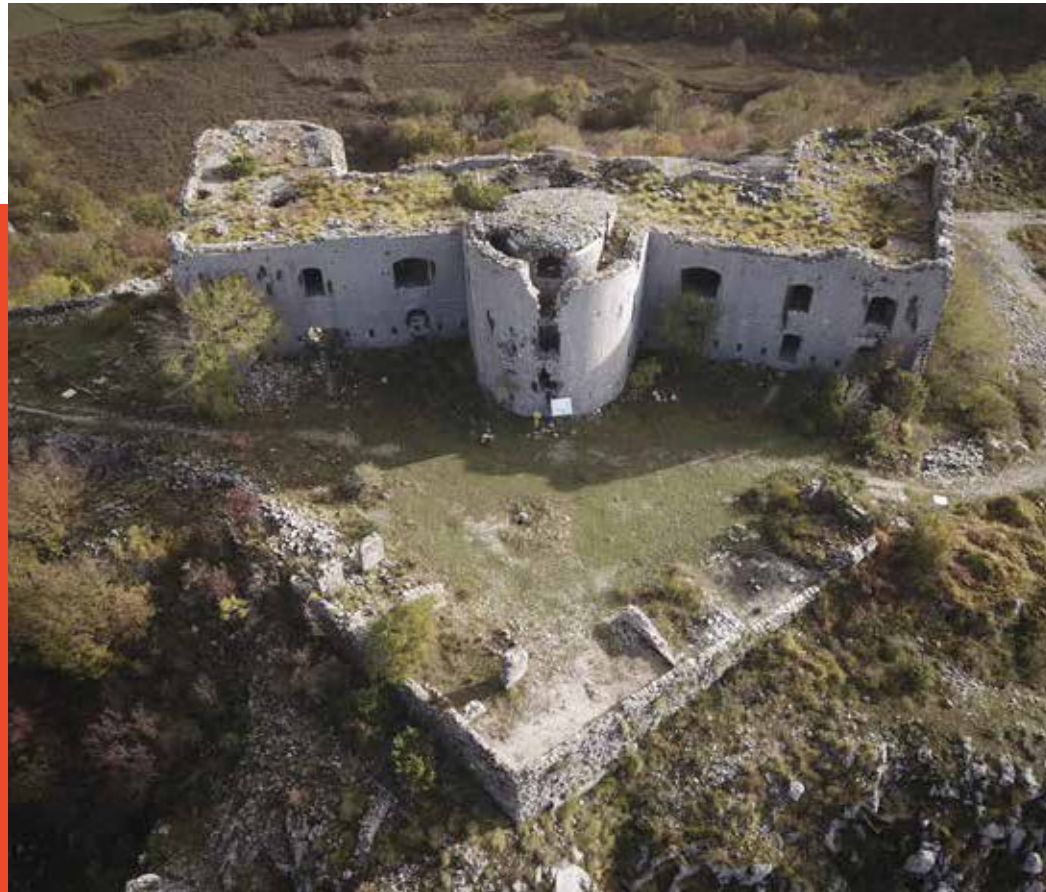
Fig. 155: Top view  
Fort Kosmač, 2020  
(The hole in the north-eastern wing of  
the cannon terrace is the most critical,  
as the supporting walls underneath  
have almost completely collapsed)  
Credits: Ivan Vratnica

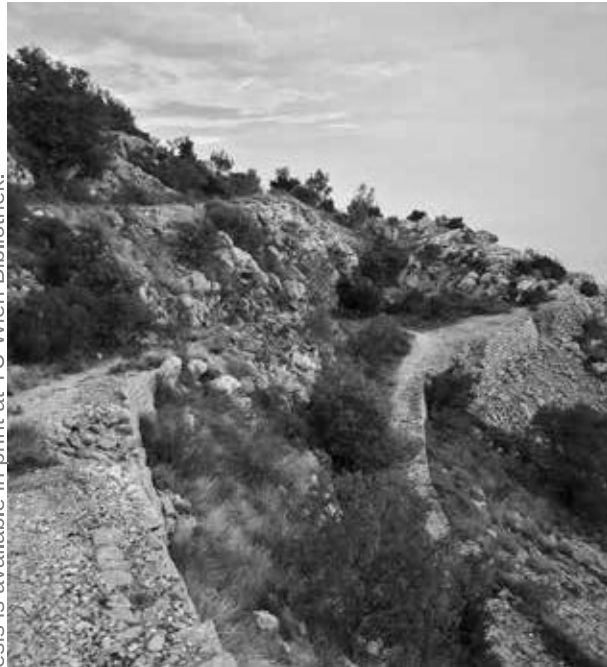
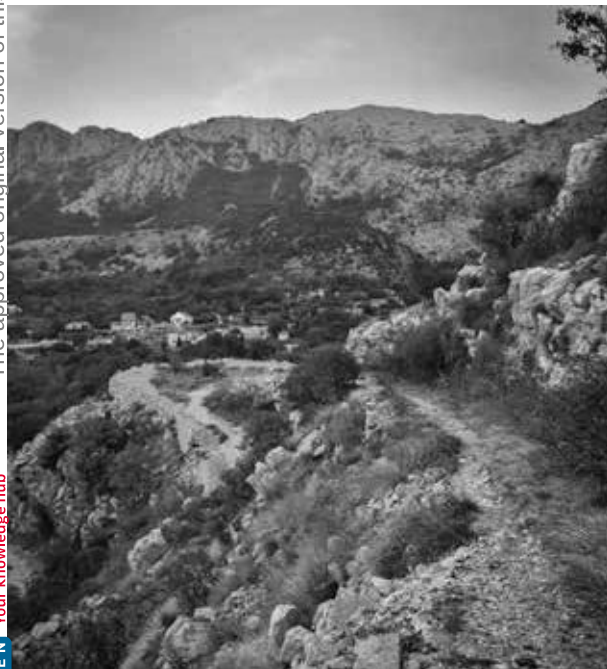
Fig. 167: Damaged embankments  
on the serpentine approach  
Credits: Ivan Vratnica

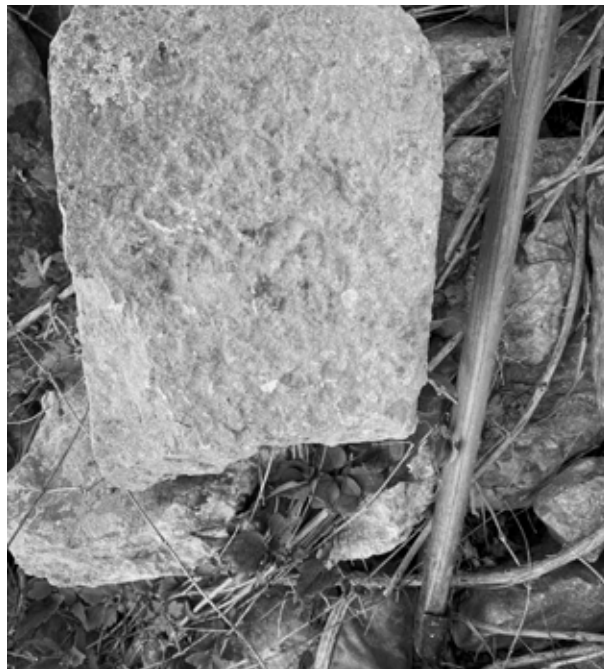
Fig. 170: (bottom right)  
The piece of the stone post  
(Found along the serpentine approach to  
Fort Kosmač this tip of the post was placed  
somewhere along the road.)  
Credits: Savo Martinović

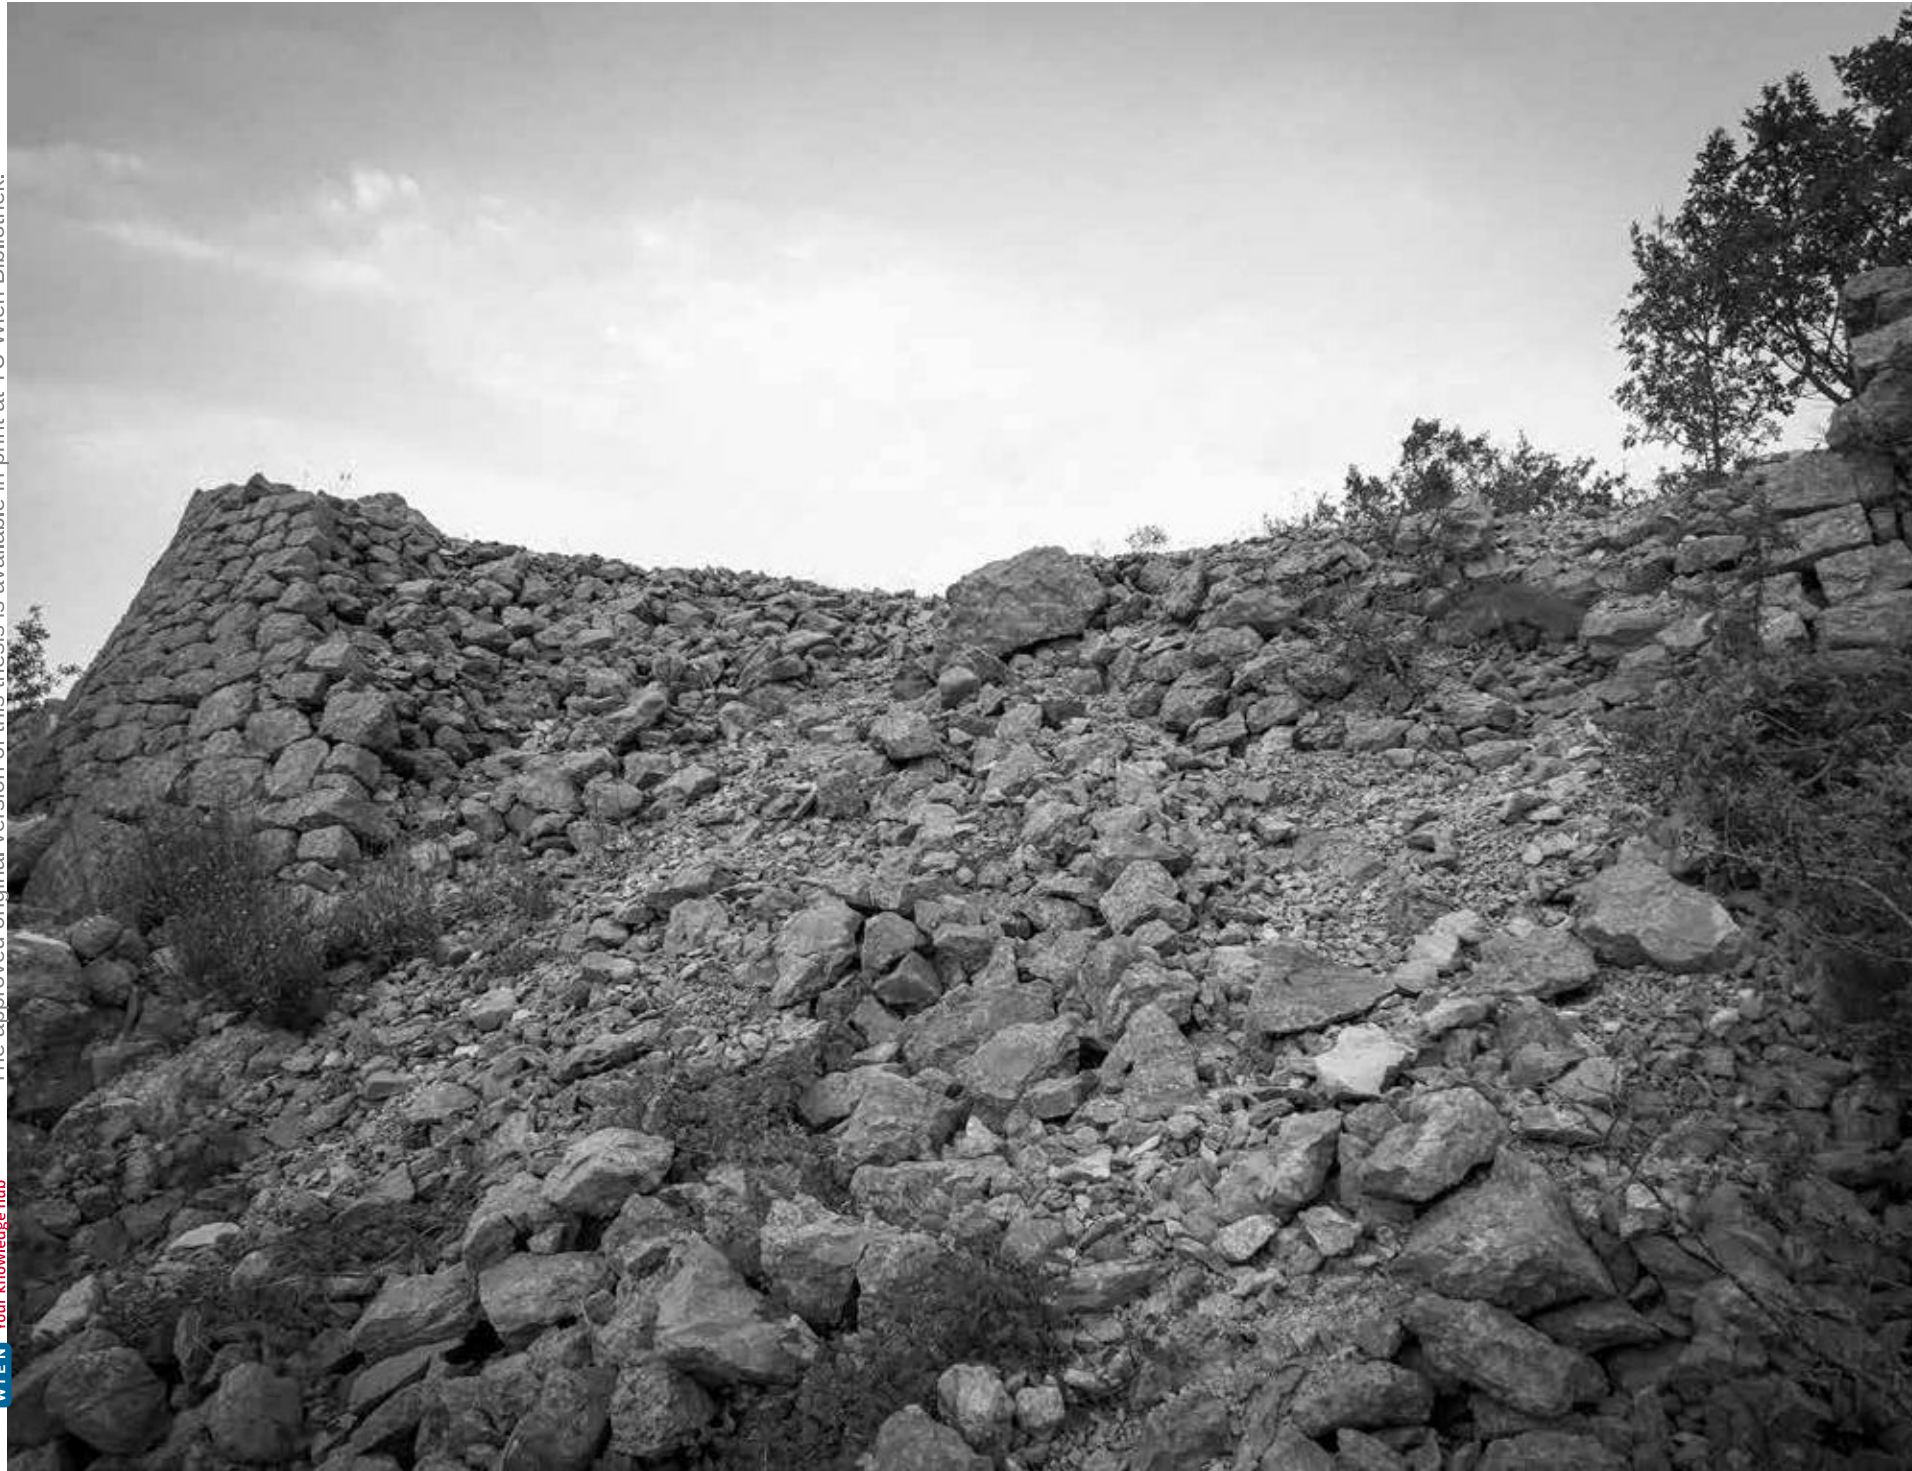
Fig. 171: Collapsed embankment of a curve  
 at the serpentine approach  
 Credits: Ivan Vratnica

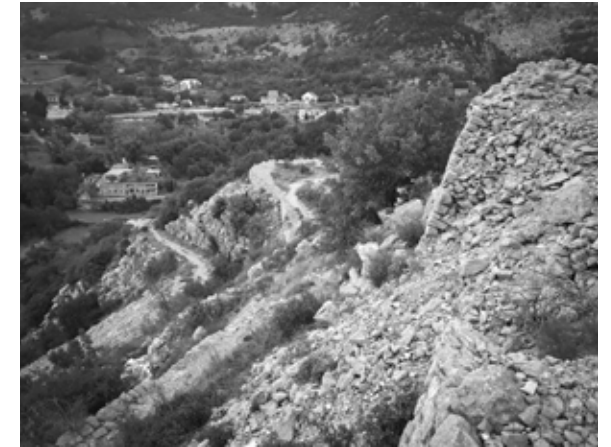
Fig. 172 (top left): Location of the quarry just under the fortress next to the road, 2019  
Credits: Ivan Vratnica

The rock quarry at the bottom of the serpentine road can be highlighted with explanatory info boards as it is getting obscured by the growing vegetation. This way the road would be a part of the monumental site, leading to the fortress and introducing it at the same time.

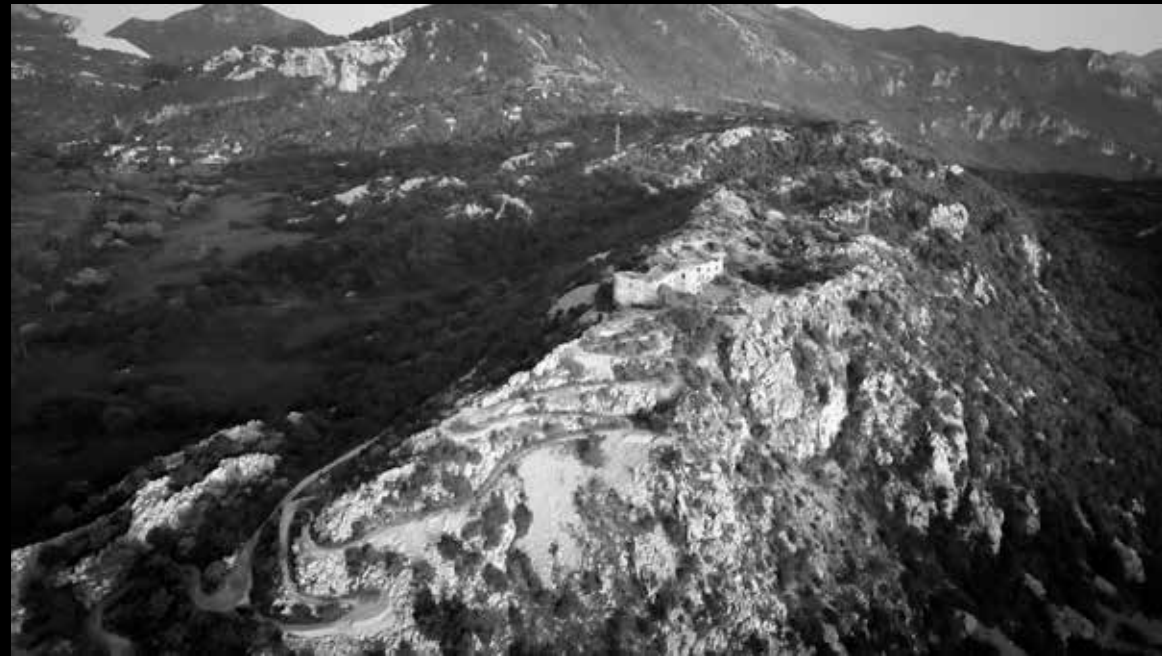
Fig. 176: The serpentine approach road to Fort Kosmač, 2019  
(Mostly narrowed due to overgrown vegetation and the collapse of the supporting walls)  
Credits: Ivan Vratnica

To preserve and save it from further deterioration, it needs to be cleared, secured, repaired and maintained. First, the vegetation needs to be cleared to make the way as wide as it originally was. This would be a big improvement as it would make it wide enough for people to walk and pass

by each other at the safe distance from the cliff. This way the danger would be significantly smaller, both for the visitors and for the support walls along the road. The second step would be to sort and use the original blocks still lying along the road to repair the support walls and embankments. This way the road could be safely used by everyone without the imminent danger of collapsing. After the vegetation clearing and needed reparations, the original safety walls and posts on the edges of the road should be restored, so the road can be used by bikers and bigger groups of people, as well as for

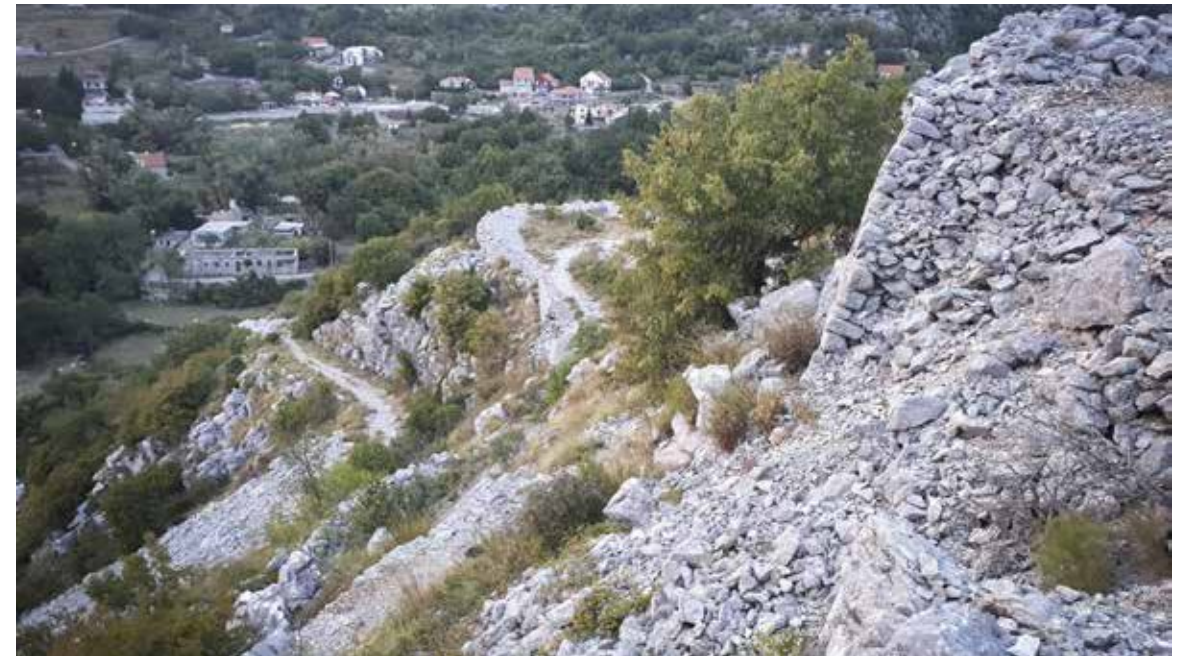
Fig. 177: The serpentine approach road to Fort Kosmač, 2019  
(Mostly narrowed due to overgrown vegetation and the collapse of the supporting walls)  
Credits: Ivan Vratnica

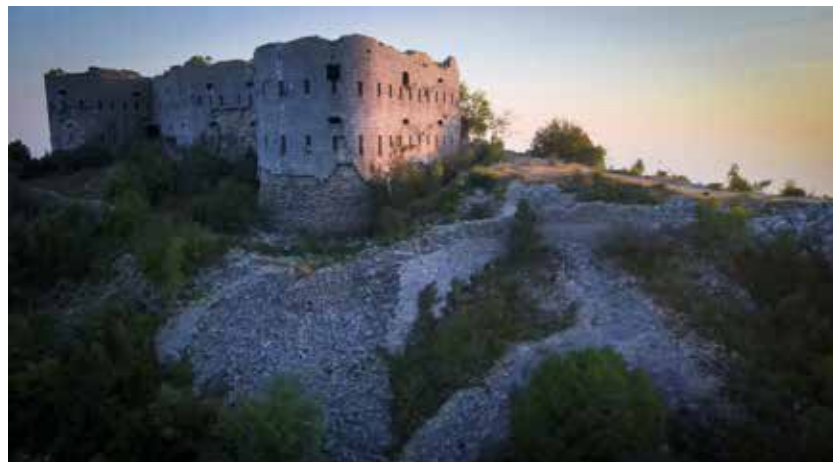
Fig. 179: Curve in front of  
the northern wing of  
Fort Kosmač, 2020  
(The embankments  
collapsed)  
Credits: Ivan Varatnica

Beside the ditch support walls, the curve on the road in front of the northern wing, needs to be rebuilt as well, as it is the key for securing the northern side from further collapse. This curve was made on a stone embankment protecting the northern wing's foundation wall and stabilizing the terrain on this steep, unstable part of the hill. The sewers were

integrated inside of this embankment, leading down to the field bellow. The openings in the sewer channel are buried under the debris which indicates that only the upper part of the curve's embankment is missing and the foundations still remain. After the clearing of the vegetation on the eastern side, restoring the original road would only need a little more effort. This would also mean to reconstruct the embankment of the road on the northern side, leading from the last serpentine to the curve. With this road restored, a small plateau would be formed in front of the entrance. Restoring it, the original way around

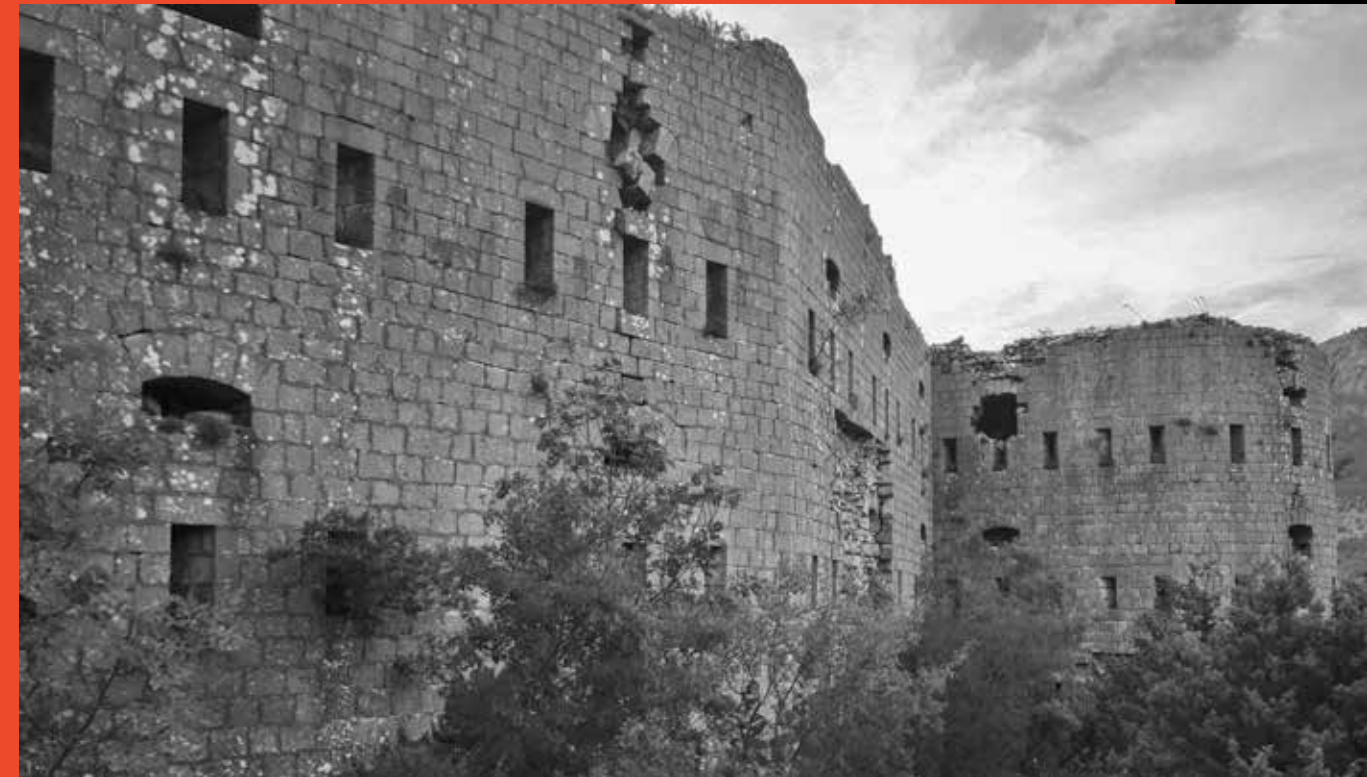
Fig. 182: Fort Kosmač, 2020  
(Eastern side where the vegetation in the defense ditch overgrown)  
Credits: Ivan Vratnica

The eastern side is easily accessible by road from the south, therefore clearing the vegetation should not pose a problem. Clearing it, the approach to the curve mentioned above would be established, making the works on the curve much easier. After all the

vegetation is gone, the excessive soil in the ditch can be excavated and the support walls repaired. Even though this side is easily accessible by a small excavator, a good part would have to be done by hand to avoid the possible damage of the material. To ensure the proper handling and sorting of the material during excavation, constant monitoring by the experts is required.

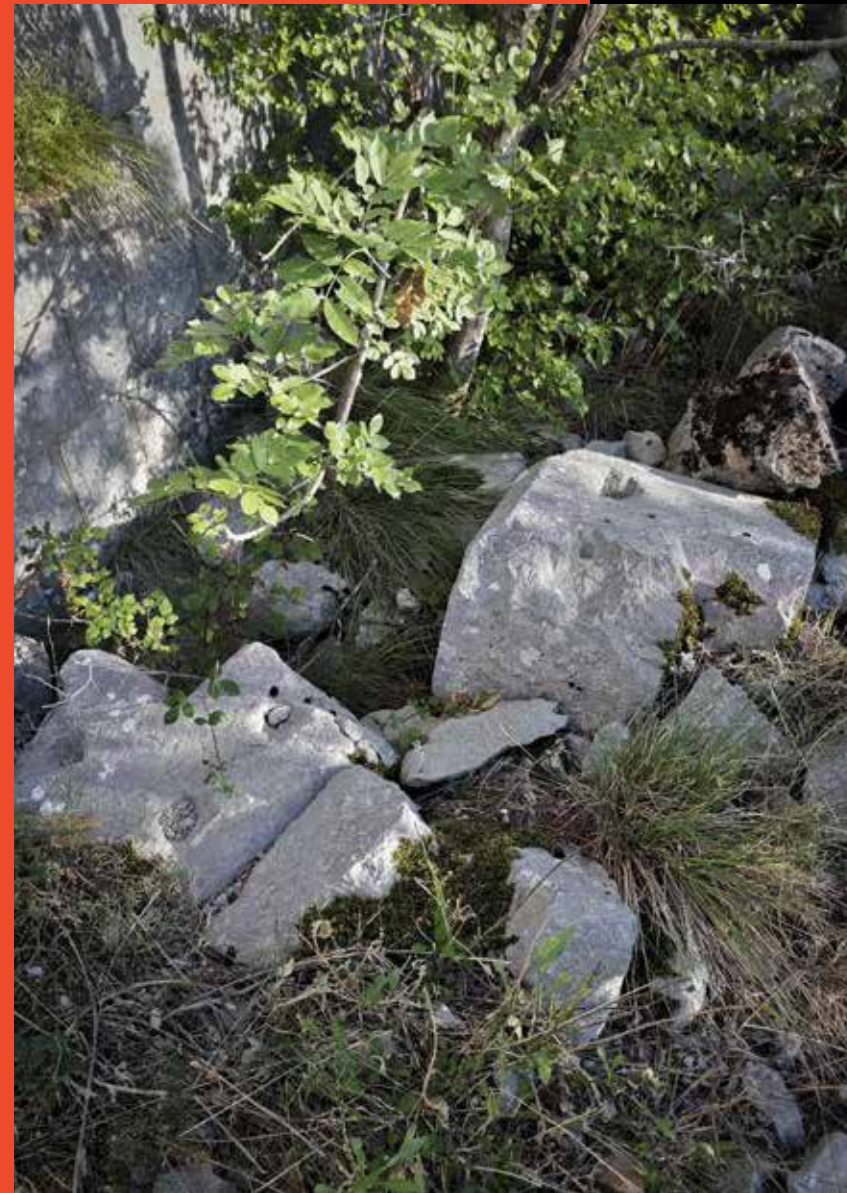
Fig. 190: Fort Kosmac, 2019  
(Corner of the courtyard where the Lt. März was buried. The big cornerstone was part of the grave stone)  
Credits: Ivan Vratnica

In the southeastern corner of the courtyard there was a grave of First Lt. März, commander of the fort, killed in the 1869 uprising. As the fortress was under siege, he had to be buried inside of the fortress courtyard. Later, the tombstone was made, which parts can be still found in the courtyard, indicating that it was still there when the fort was destroyed decades after. How much of it remains, can only be determined when the corner is cleared and the piled up stones are sorted. Afterwards, it needs to be determined if the remains of the commander are still buried there. The first step is to search for the diaries and logs of the fort commanders who served at the fort but it is not known if all the documents still exist in the War Archive of Vienna or somewhere else. This would require a lot of effort and time, so the more practical approach would be to conduct the archaeological excavations and research of the area where the tomb was. In case the commanders remains are found, the question will be raised, weather the remains should stay in the fort or should they be moved to his homeland, considering the new use of the fortress.

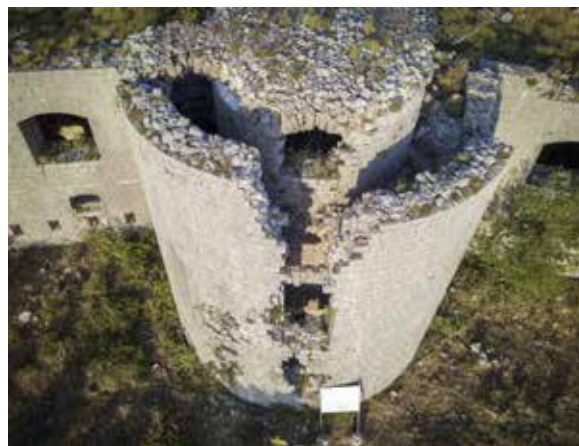
Fig. 192: Fort Kosmač, 2020  
(Outer wall of the western wing almost split in two as the window arches collapsed)  
Credits: Ivan Vratnica

Except the western wing, the barracks walls in the courtyard are mostly in good condition. The outer wall of the western wing is in danger of collapsing during the next earthquake. As shown in the analysis, the half circular wall stands without any bracing and it is almost split in two now, as the middle window arches collapsed. On the rapport plans from 1902, it can be seen that these walls have a deep and big foundations, therefore the probability of the foundation sinking is small, as they are probably resting on the rock. Anyhow, this would need further examination before the needed measures can be implemented. To save this wall, it would take significant amount of effort and engineering, which would include additions and

wing's core. These connections would have to work simultaneously with the outside supports to correct the tilt by pulling the wall back in its position. As the upper arches disconnected due to the tilt, they would need to be disassembled and reconstructed again when the tilt is corrected.

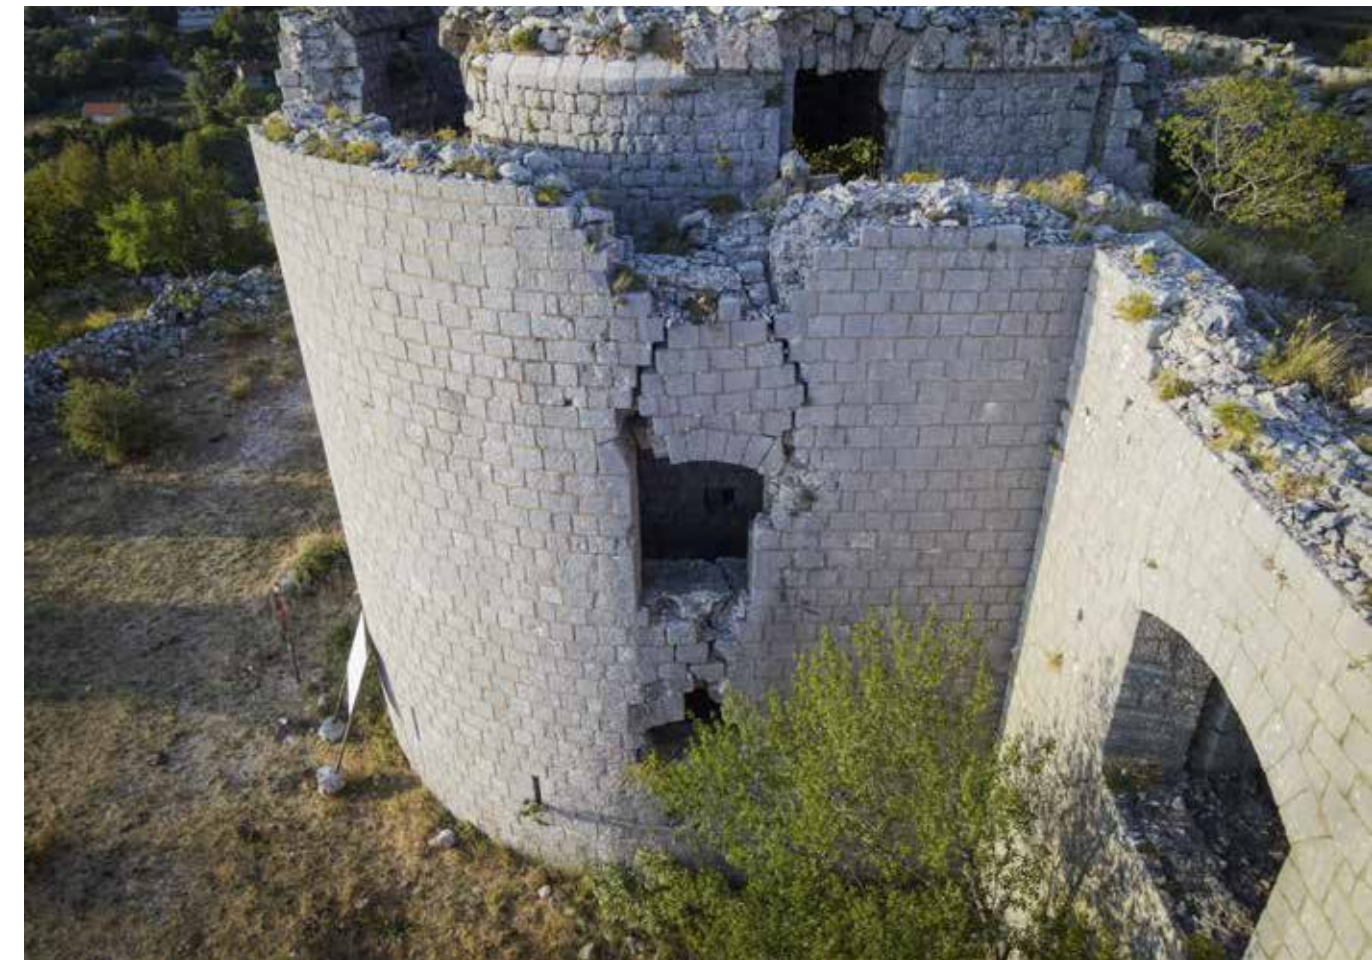
Fig. 193: Fort Kosmač, 2020  
(The side window arch loosened as the outer wall of the wing tilted outwards)  
Credits: Ivan Vratnica
