PROTECTION AND REHABILITATION OF FORT KOSMAČ  
AT BRAJIĆI, MONTENEGRO

# PROTECTION AND REHABILITATION OF FORT KOSMAČ

Brajići, Montenegro

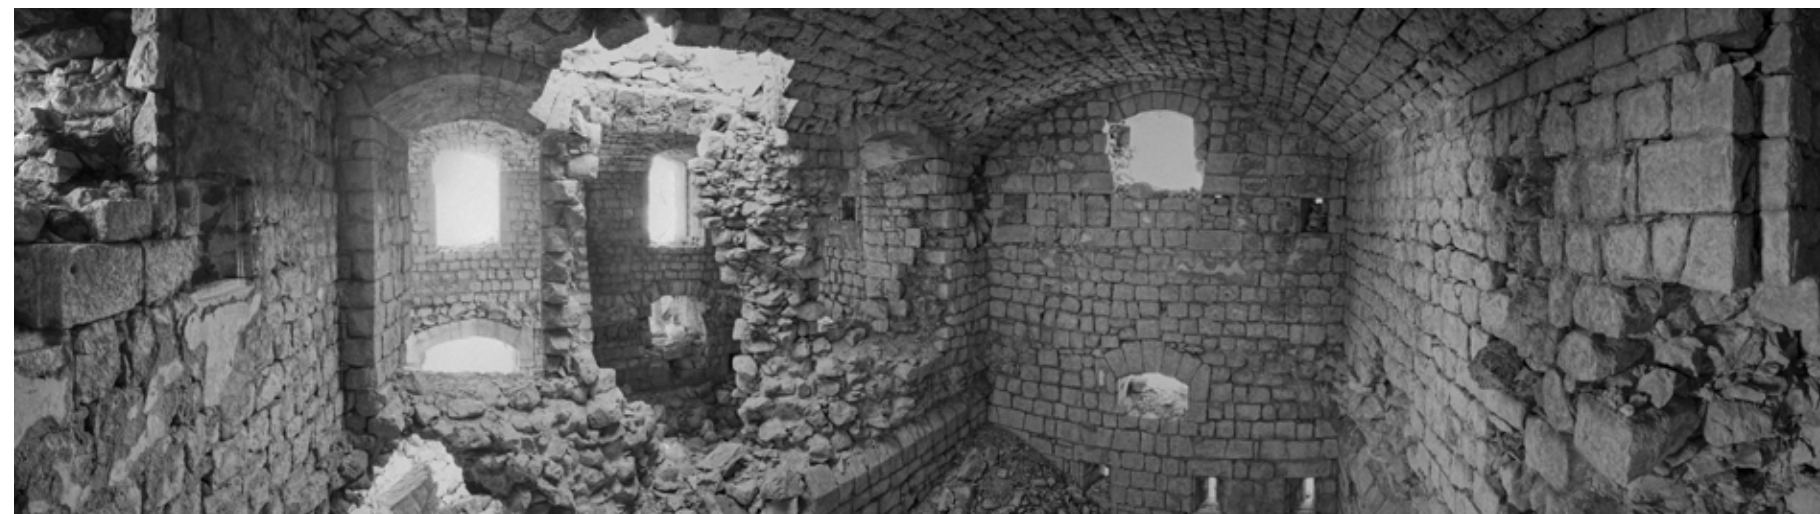
Fig. 194: Fort Kosmač, 2020  
(Middle structural wall in the northern  
wing seen from the kitchen)  
Credits: Ivan Vratnica

The analysis showed that the barracks are in bad and unstable condition, in imminent danger of collapsing and permanent substance loss. Considering its condition, pure preservation would not stop further deterioration, which means that several collapsed parts need to be rebuilt just to stop further collapse. As described in the analysis, the structure was made so that the load bearing elements are independent from the hull, which served as protection. All the inside reconstructions would have to be done gradually, meaning that the rubble between the entrance and the element, would have to be cleared first, freed element secured and then proceeded to the next one. This would have to be done by hand to avoid potentially dangerous vibrations that could trigger the collapse of an unstable and unsupported structure. Simultaneously the cleared material would be sorted outside to be reused

in the following reconstruction. Next step would be to secure the unstable structure by inserting the temporary support elements, such as beams and extending metal support poles. After these are secured and the protection for the workers installed, the stone masons could start reconstructing. The walls would be reconstructed with the original slanted stone layer on which the vaults were resting, so that they could be rebuilt later if needed. Using this method ensures that every cleared element would be secured before the other is freed. The restoration of the hull's outer layer would have to be done synchronized with the restoration works done inside to avoid destabilization of the elements caused through loss of support as the pressing rubble is removed.

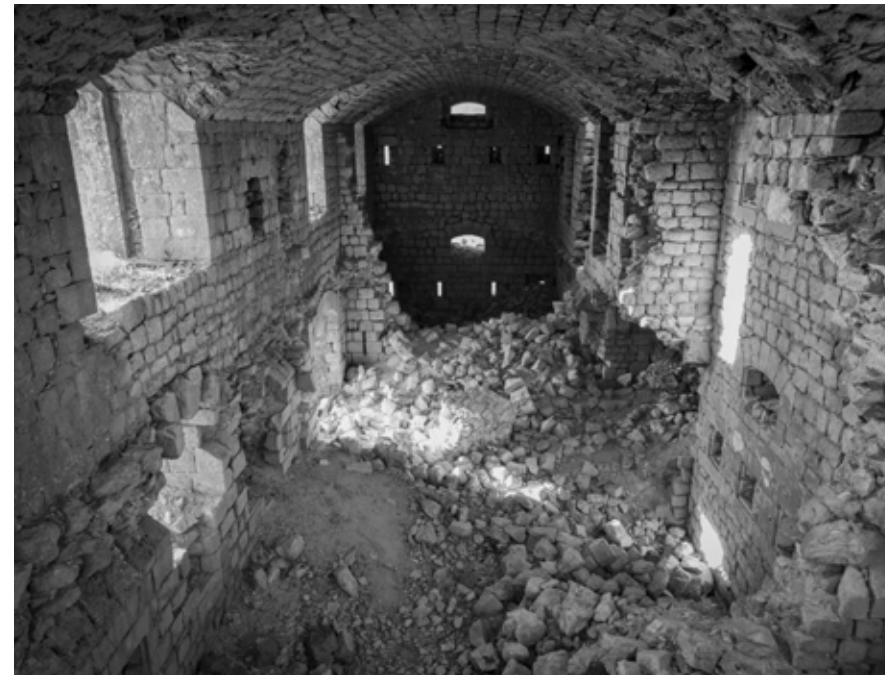
Fig. 195: Fort Kosmač, 2020  
(Entrance to the barracks and the northern wing middle wall, missing its lower part)  
Credits: Ivan Vratnica

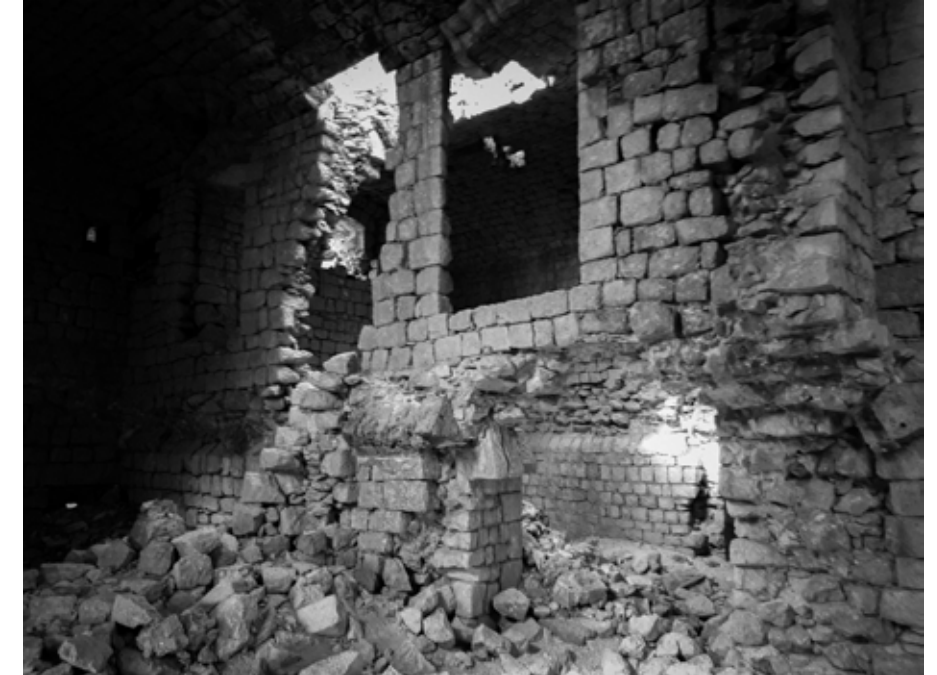
Fig. 196 (top right): Fort Kosmač, 2020  
(Middle structural wall in the northern wing seen from the entrance hall)  
Credits: Ivan Vratnica

Fig. 196 (top right): Fort Kosmač, 2020  
(Middle structural wall in the northern wing seen from the entrance hall)  
Credits: Ivan Vratnica

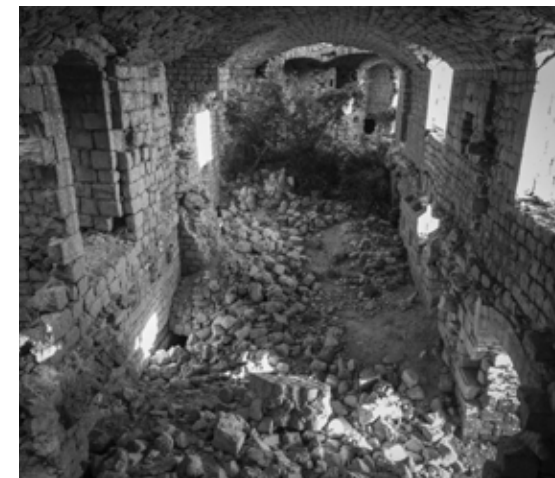
Fig. 197: Fort Kosmač, 2020  
(Eastern wall inside the barracks. The "pillars" of the main tract blown up in the middle. View from the entrance hall)  
Credits: Ivan Vratnica

Fig. 197: Fort Kosmač, 2020  
(Eastern wall inside the barracks. The "pillars" of the main tract blown up in the middle. View from the entrance hall)  
Credits: Ivan Vratnica

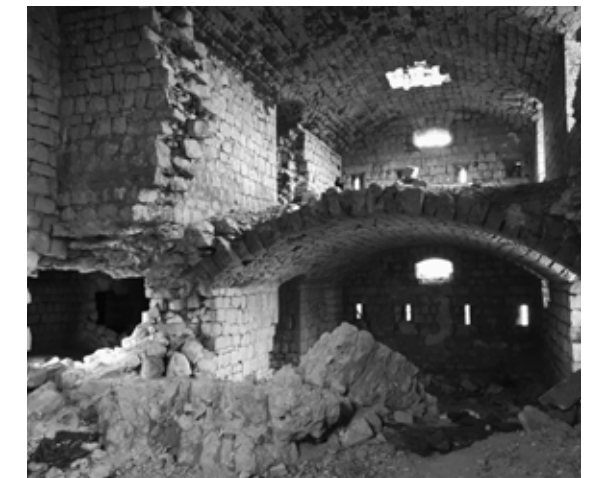
Fig. 198: Fort Kosmač, 2020  
Corner where the eastern barracks wall meets the southern wing (seen from the inside)  
Credits: Ivan Vratnica

Fig. 198: Fort Kosmač, 2020 Corner where the eastern barracks wall meets the southern wing  
(seen from the inside)  
Credits: Ivan Vratnica

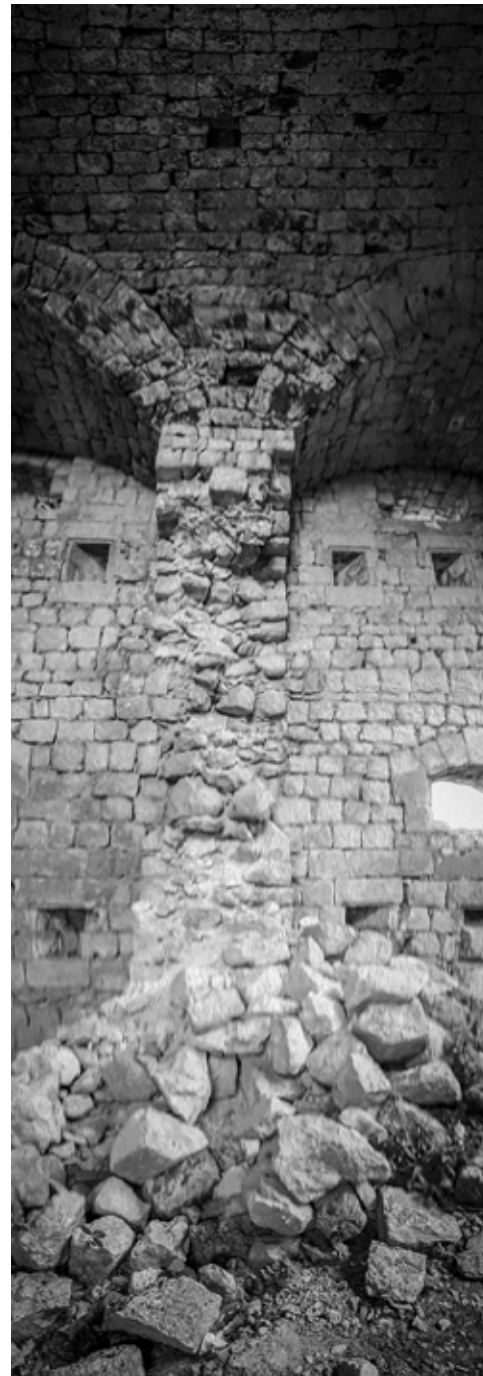
Fig. 200 (top right): Fort Kosmač, 2020  
(Eastern wall inside the barracks. The “pillars” of the main  
tract blown up in the middle. View from the entrance hall)  
Credits: Ivan Vratnica

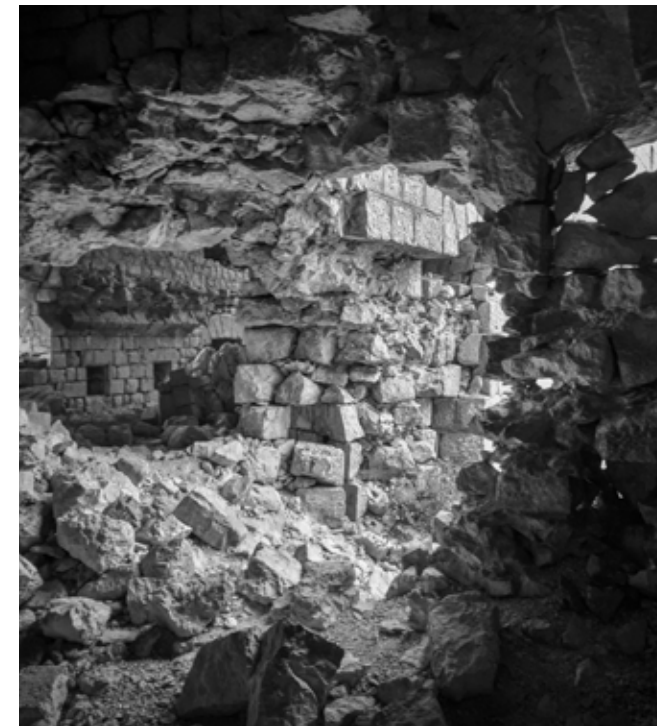
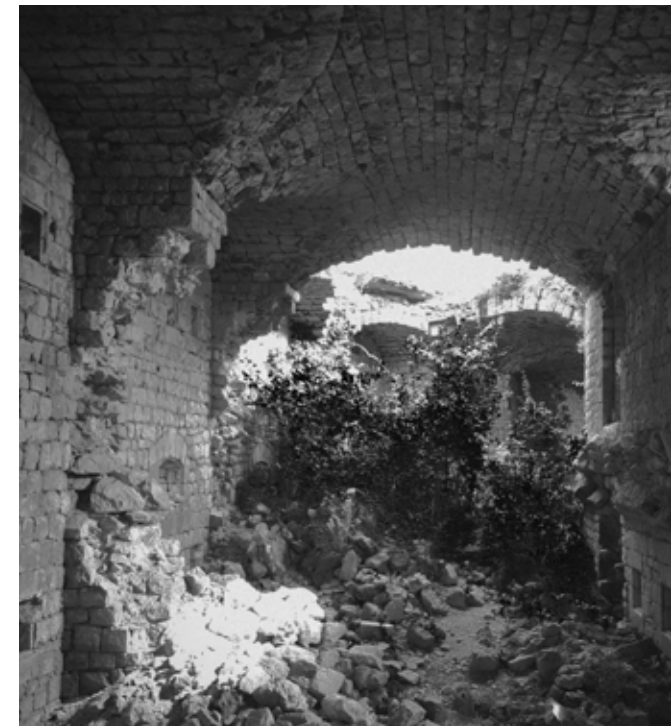
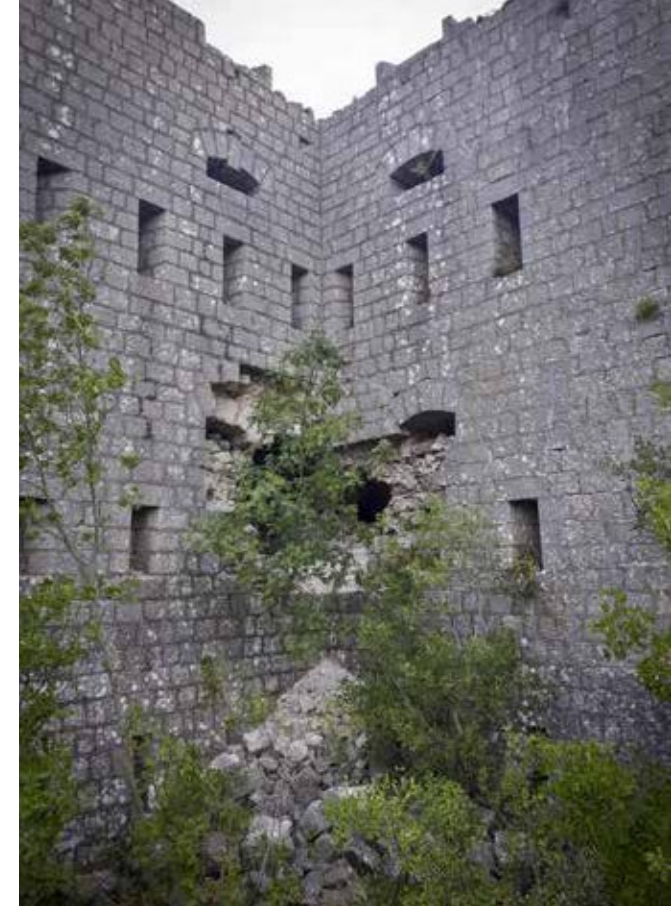
Fig. 201 (bottom left): Fort Kosmač, 2020  
Corner where the eastern barracks wall meets the southern  
wing (seen from the inside)  
Credits: Ivan Vratnica

Fig. 202: Fort Kosmač, 2020  
Corner where the eastern barracks wall meets the southern  
wing (The biggest hole in the barracks walls with a small tree  
growing out of it)  
Credits: Ivan Vratnica

biggest chimney was demolished for bricks. Judging by its location and size, it needs to be stabilized and closed with the restoration of the middle wall. The other two are small and would take less effort to repair. After the holes are secured, the structure would be

stable enough for further conservation measures. They would include the repairing of the vaults and securing the only remaining part left of the gun terrace walls in the southern wing. Afterwards, the temporary roof over the whole barracks would be required to prevent the damage from rain and snow.

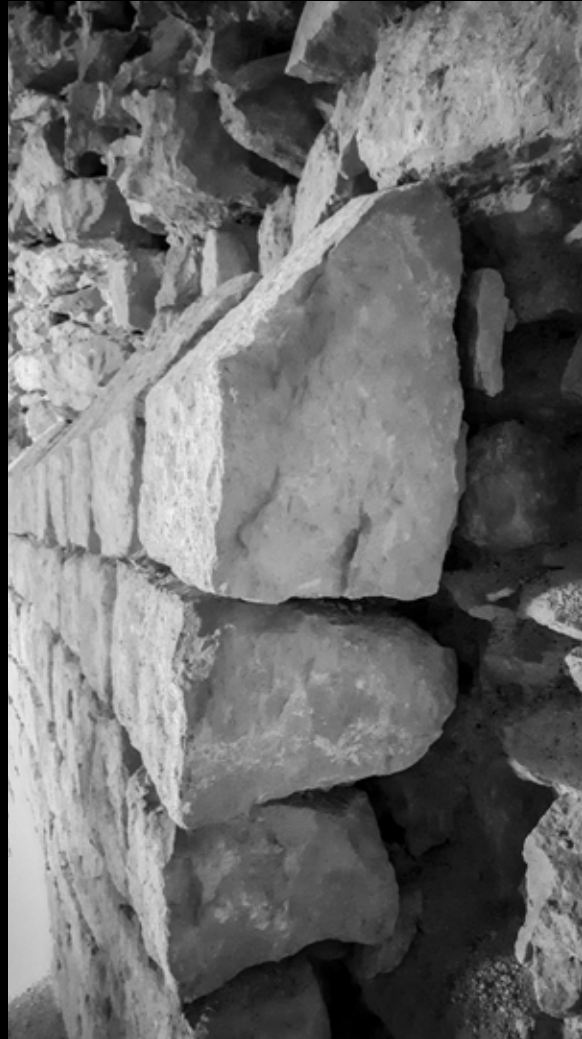
Fig. 203: Fort Kosmač, 2020  
 Slanted stone layer on which the vaults were leaned  
 Credits: Ivan Vratnica

Fig. 203: Fort Kosmač, 2020 - Slanted stone layer on which the vaults were leaned  
Credits: Ivan Vratnica

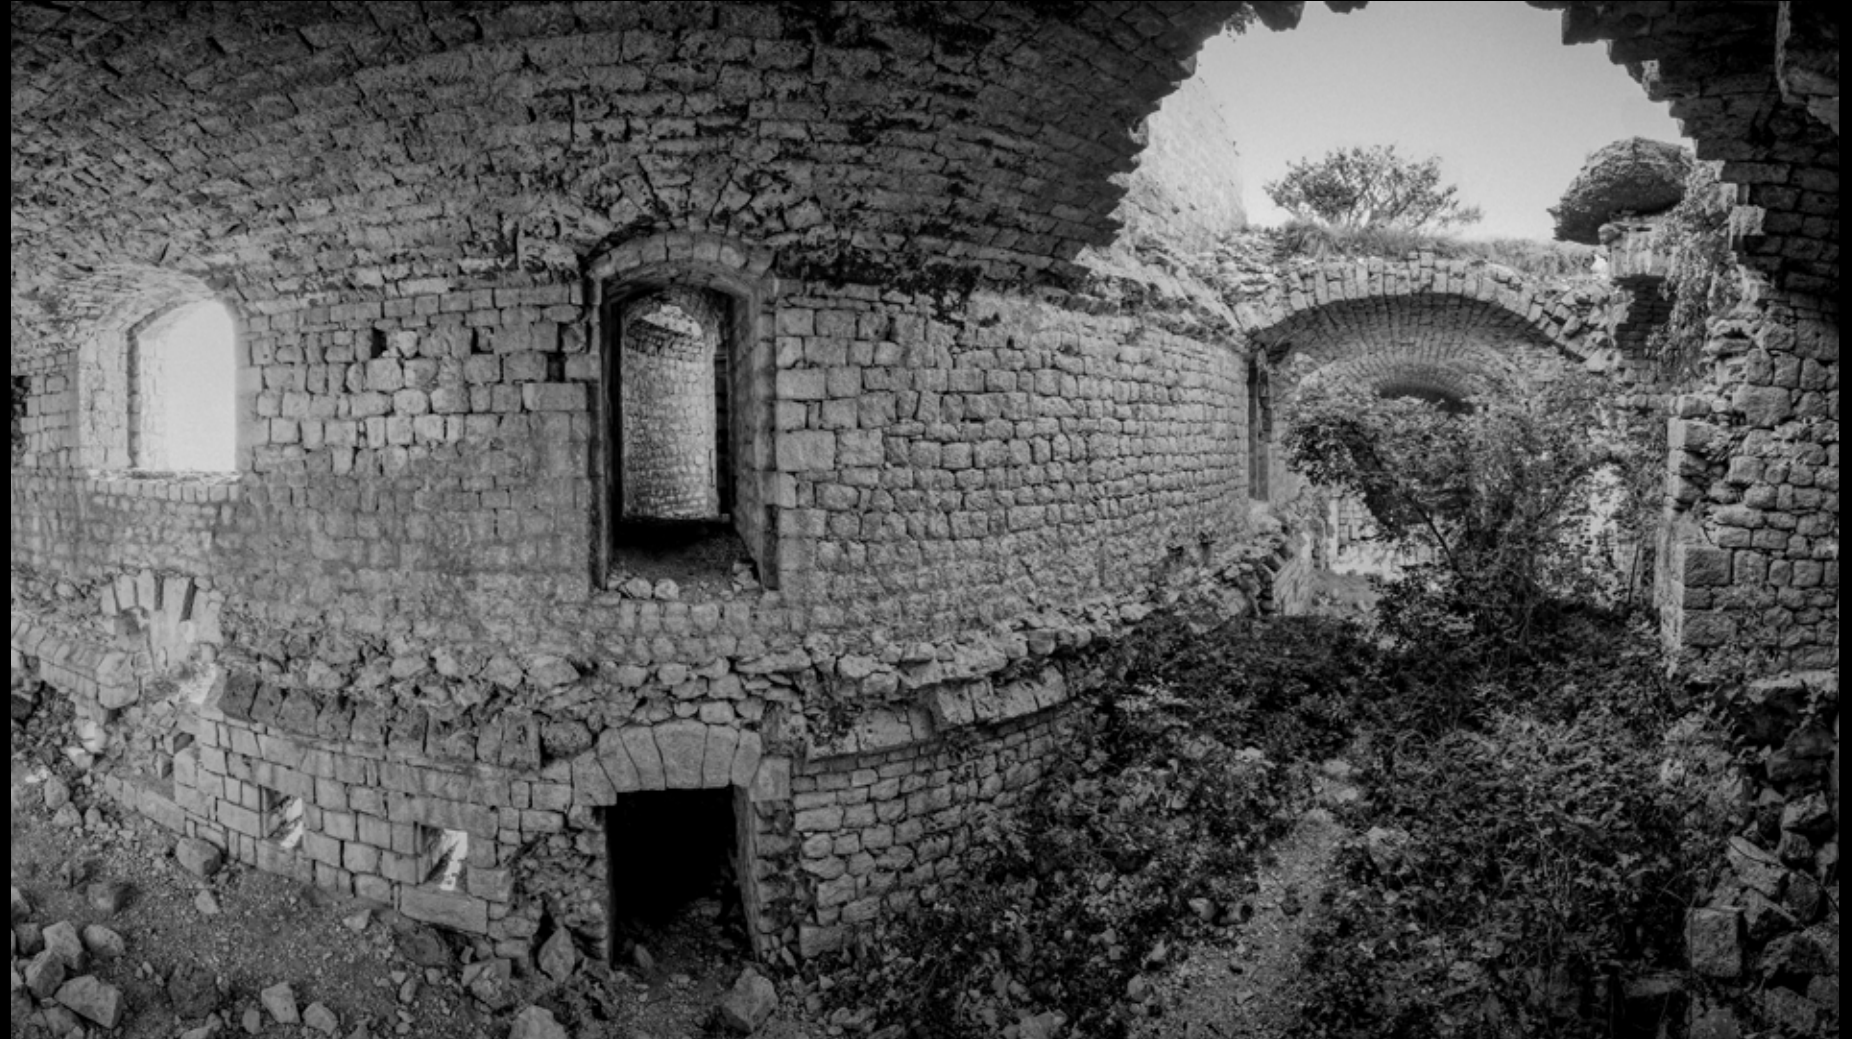
Fig. 204: Fort Kosmač, 2020  
 Middle of the barracks main tract (the vaults above collapsed and piled up in the round floor, filling it up, pushing against the outer wall)  
 Credits: Ivan Vratnica

Fig. 204: Fort Kosmač, 2020 - Middle of the barracks main tract  
(the vaults above collapsed and piled up in the round floor, filling it up, pushing against the outer wall)  
Credits: Ivan Vratnica

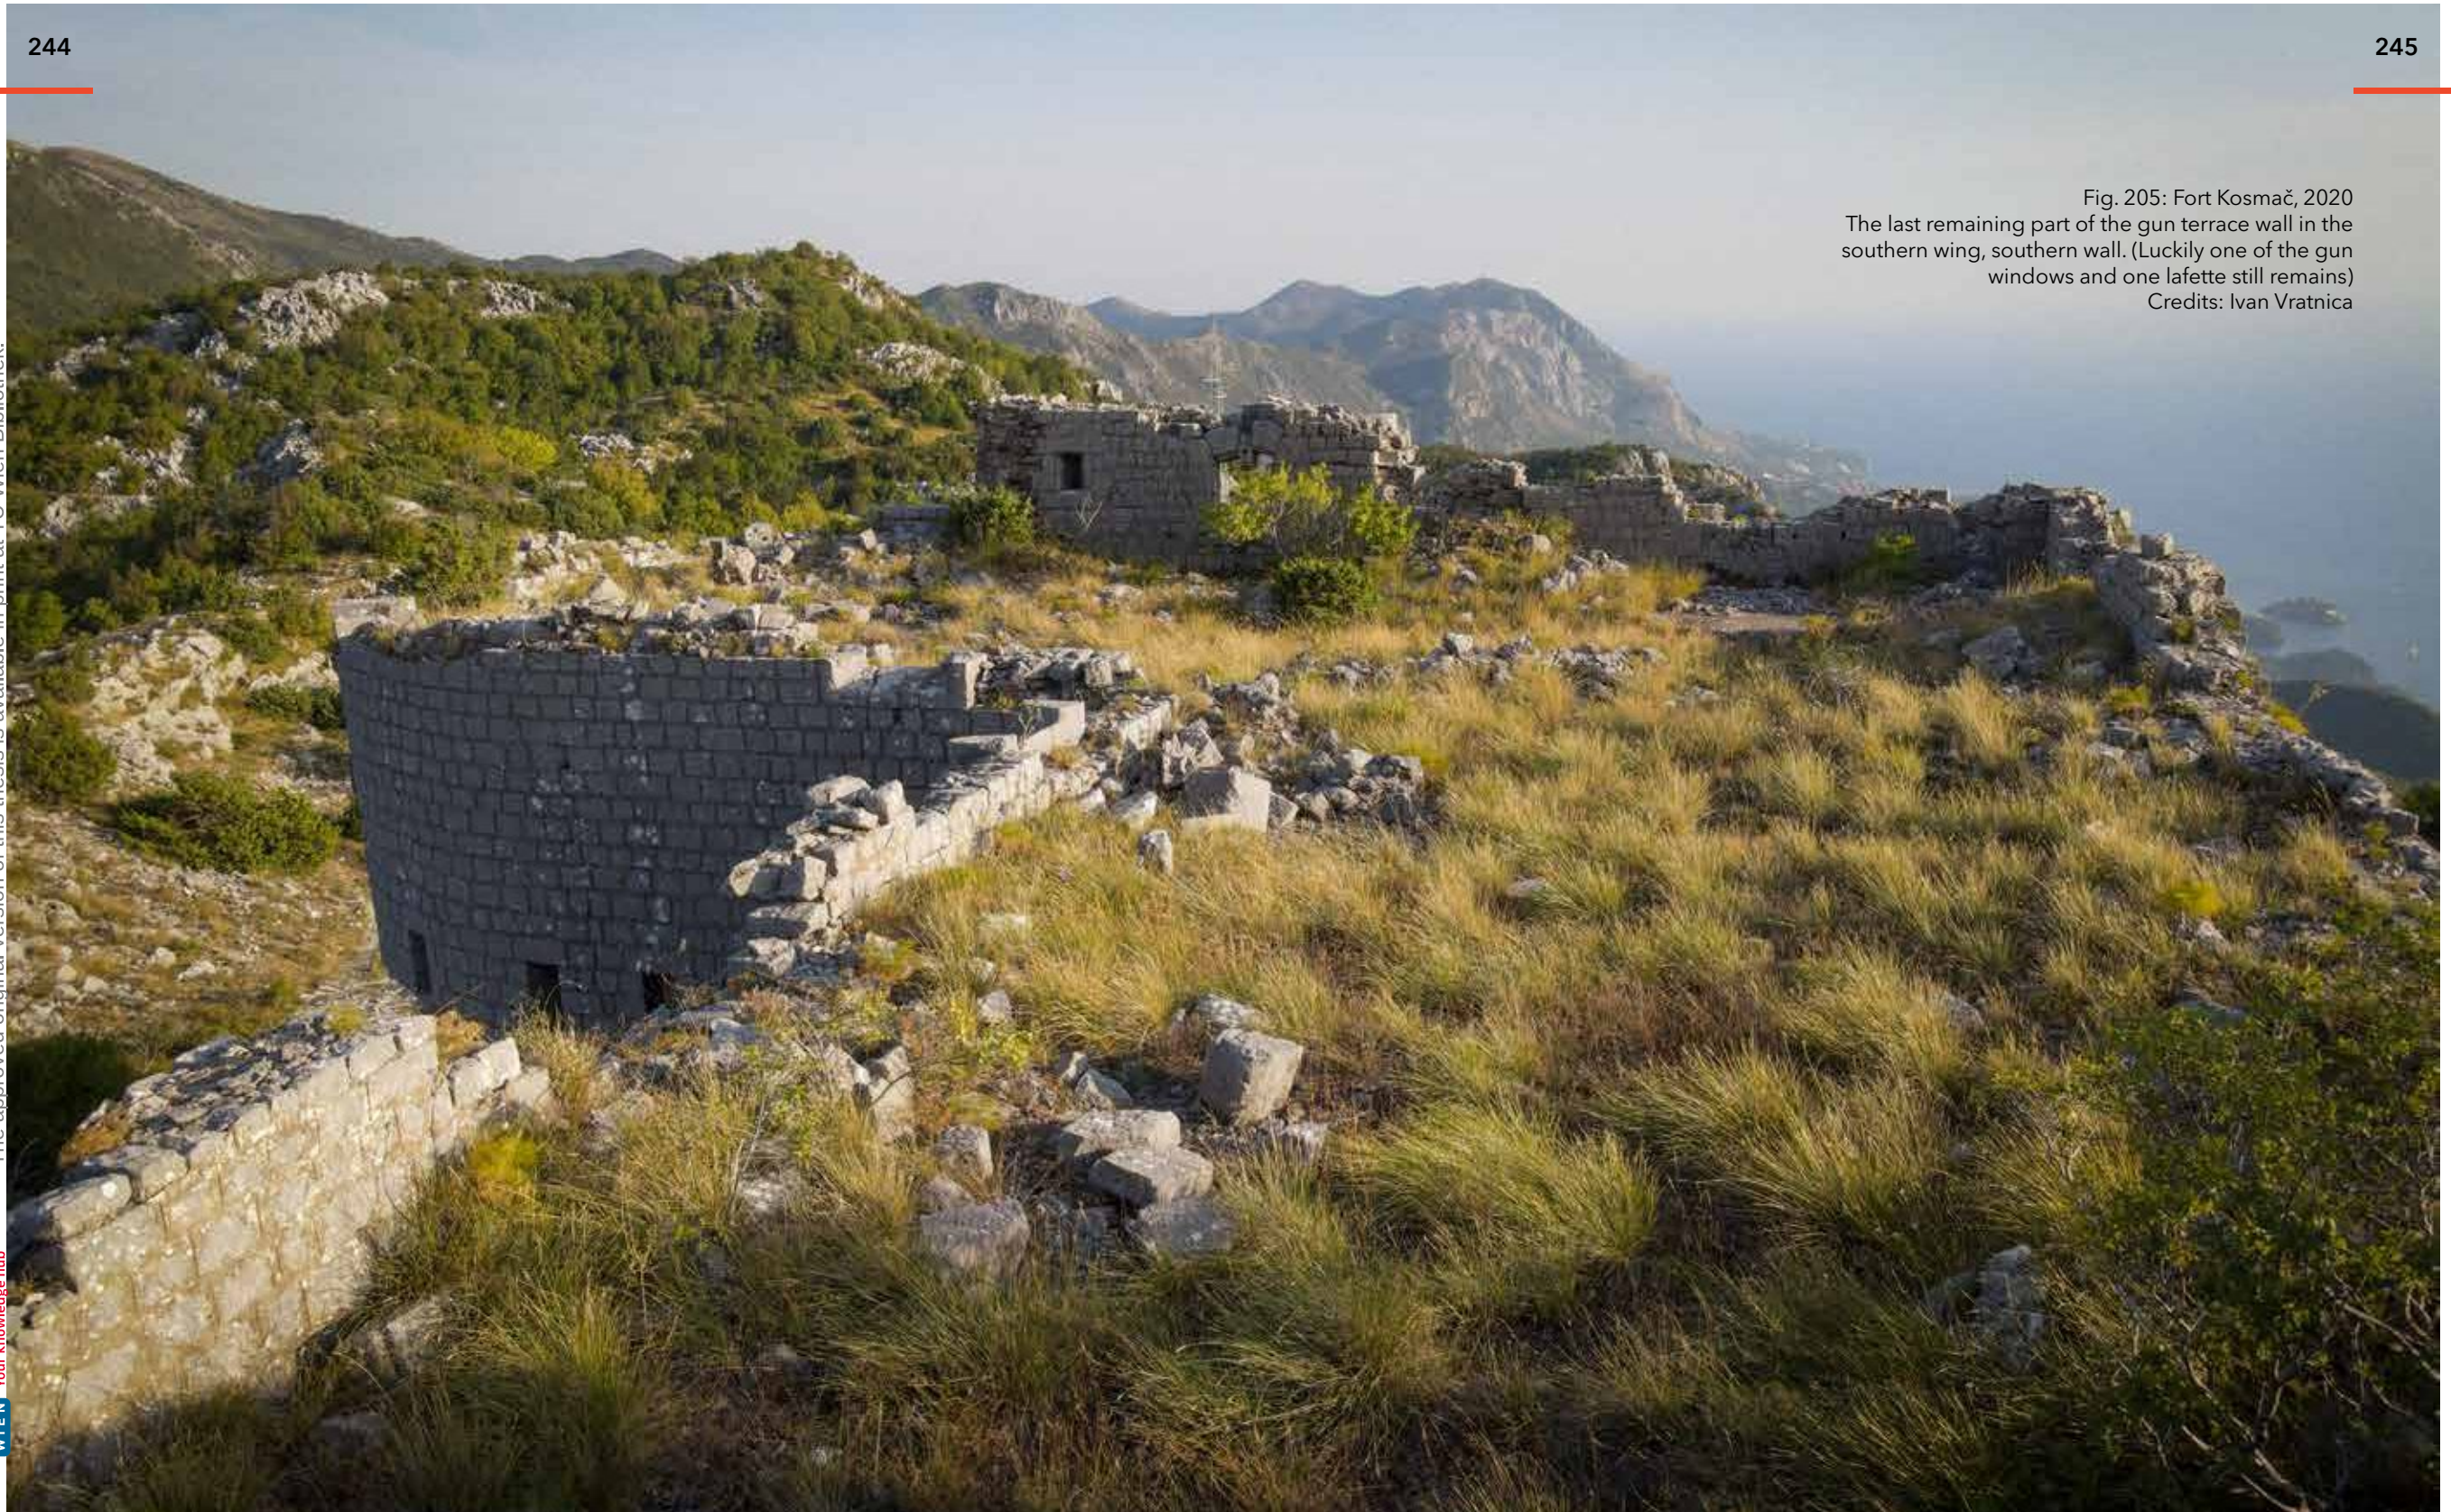
Fig. 205: Fort Kosmač, 2020  
The last remaining part of the gun terrace wall in the southern wing, southern wall. (Luckily one of the gun windows and one lafette still remains)  
Credits: Ivan Vratnica

Fig. 205: Fort Kosmač, 2020 The last remaining part of the gun terrace wall in the southern wing, southern wall. (Luckily one of the gun windows and one lafette still remains)  
Credits: Ivan Vratnica

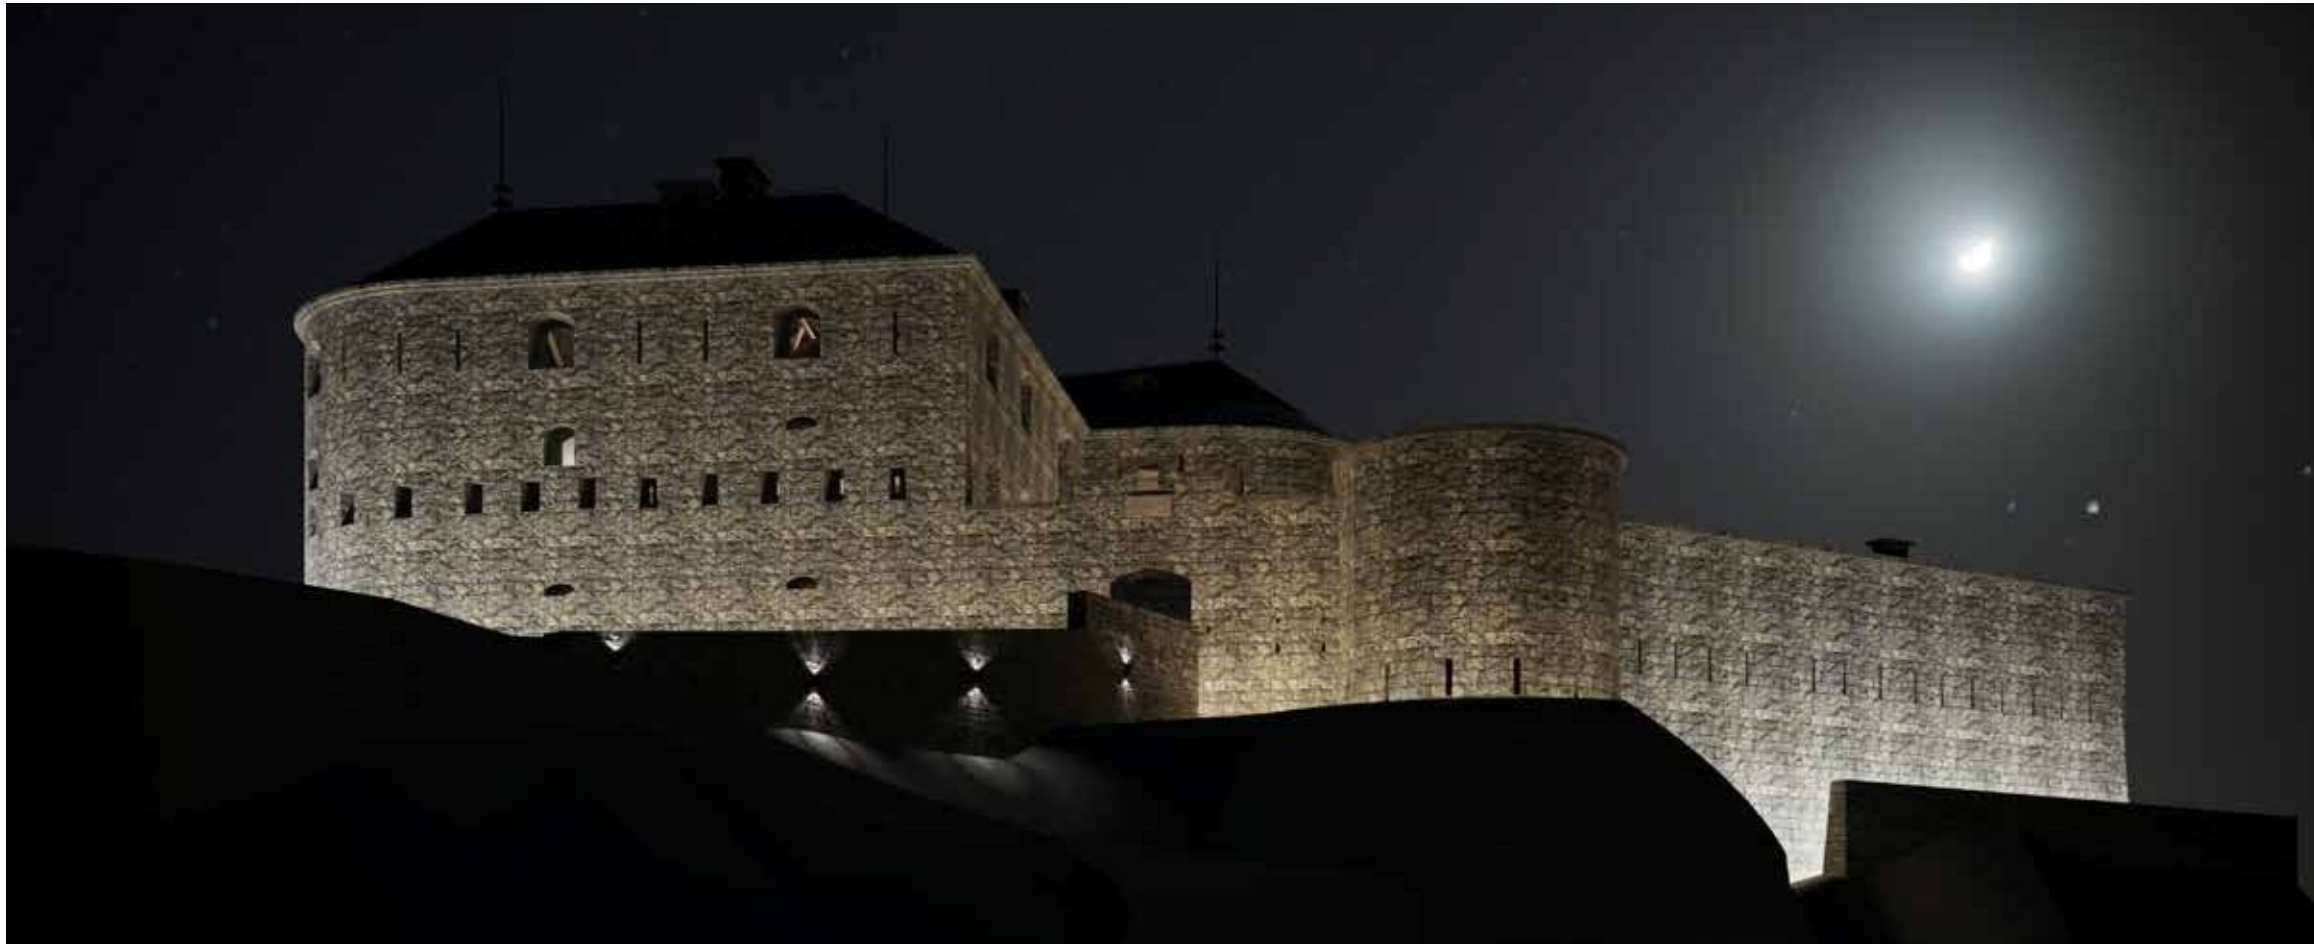
Fig. 219: Fort Kosmač - rehabilitated  
Lighting at night  
Credits: Ivan Vratnica

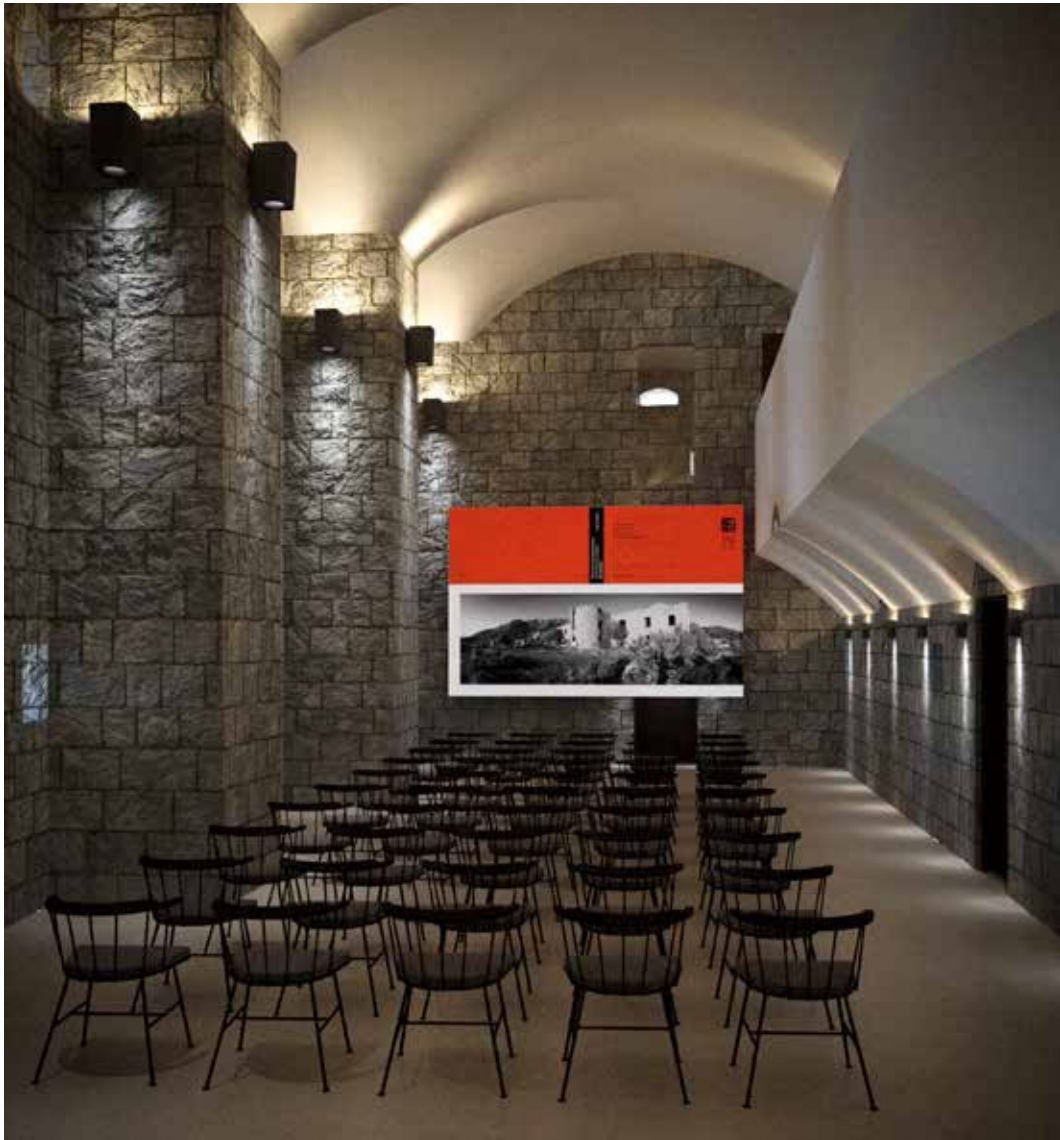
Fig. 223: Main hall  
Presentation disposition  
Credits: Ivan Vratnica

The L-galleries underneath the floor, accessed from the corners in the hall will be used as technical rooms, for electrical installations and hidden air intake. The northern L-gallery can be used as a storage for the bar in the small catering bar in the corner as well. Inside the main hall there are still two chimneys, damaged but repairable, which will be used for fireplaces to ennobel the old atmosphere of the hall and the other rooms inside. The

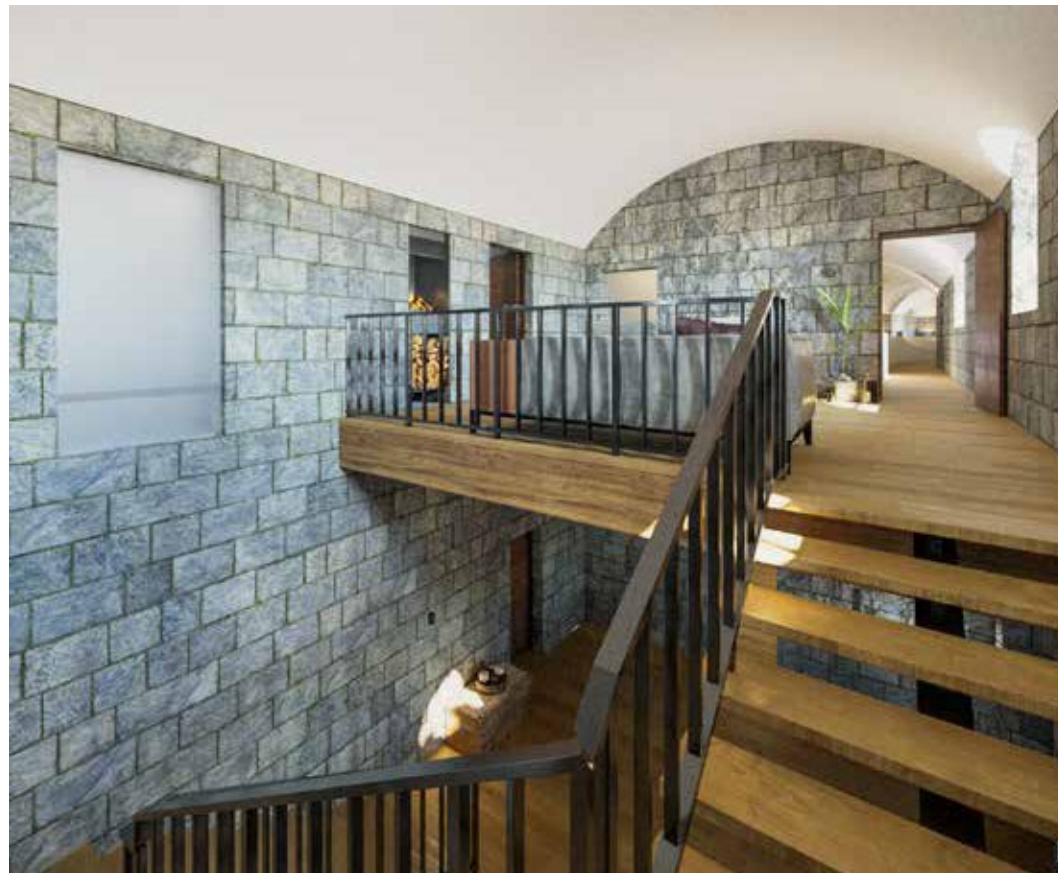
Fig. 226: Floor detail in the northern wing

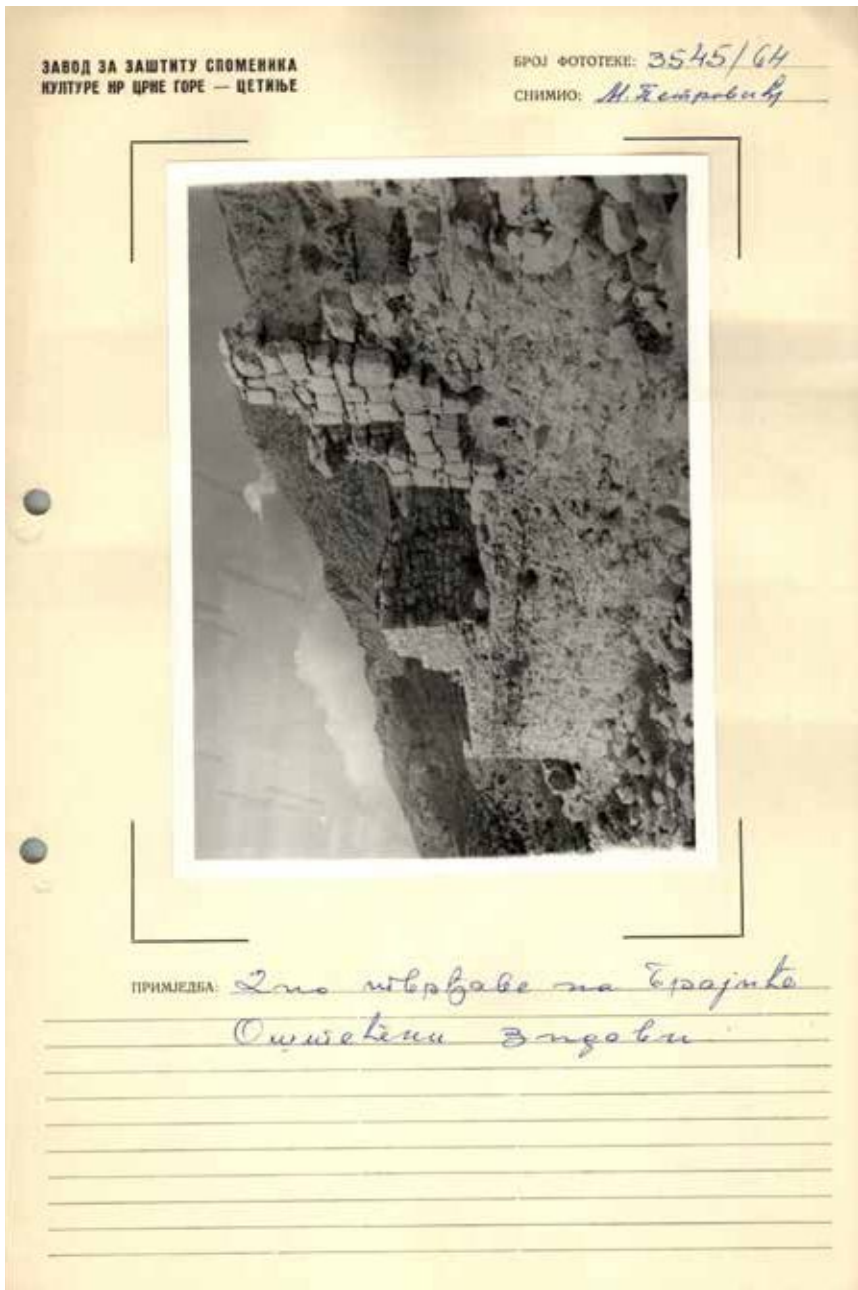
Fort Kosmač 1964  
(Southern side of the courtyard wall)  
Author: M. Petrović  
Credits: Administration for the Protection of Cultural Properties
