FLAMINGO NATURE PARK

Revitalisation and adaptive re-use of Salina
in Ulcinj, Montenegro

MASTER-/DIPLOMARBEIT

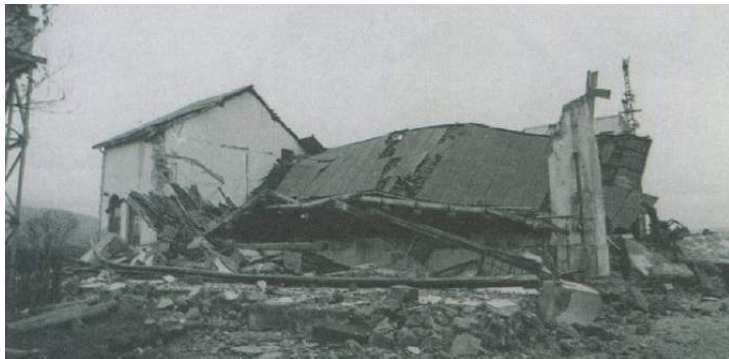
Fig.19 Earthquake in 1979

On the 15th of April 1979, an earthquake of 9.2 Mercalli Intensity Scale hit Montenegro. The consequences were catastrophic; 101 dead, with 32 being only in Ulcinj. The total damage cost around 4,5 billion dollars. Ulcinj Salina also experienced fatal losses; electrical central, part of the warehouse, administrative building, pump facilities, etc. What also caused a lot of damage is the appearance of sweet water in salt pools.²³ The test phase of the new thermos-compression facility has started in 1983. Unfortunately, it did not go as expected and faced many problems and issues; it wasn't even completely finished and the enterprise's debt was only growing bigger and bigger.²⁴ The end of the 1980s and the 90s characterized a very unstable political climate in the region. The breakdown of Yugoslavia, war, and hyperinflation shook the whole country. Serbia and Montenegro together made the new Yugoslavia and faced terrible economic sanctions from the UN. While the whole country suffered because of it, it was opposite for the Ulcinj Salina; the salt shortage on the market and the salt became once again the „white gold“, especially on the black market. The suspension of the sanctions came on the 17th of November 1995-after the signing of the Dayton Agreement and ending of the War in Bosnia and Herzegovina. The inflation was so enormous which could be best shown on the prices of groceries; on December 22nd 1993 one liter of milk costed 9 500 000 dinars, and they could vary a lot in course of just one day. Because of this inflation state, the salaries in the Salina were not made in dinars, but in groceries such as flour, oil, sugar, etc. The production was also heavily influenced by the country's state. The transformation of the establishment was discussed in the April of 1995, and it was thought that if the Saline could not stay public property. It should become a form of simple joint-stock property. The year 1995 and 1996 characterized a rapid drop in salt production, employers, and salaries. In the June of 1998, there was a meeting called which got over 30 experts to discuss new solutions and methods; participants agreed that Salina was a

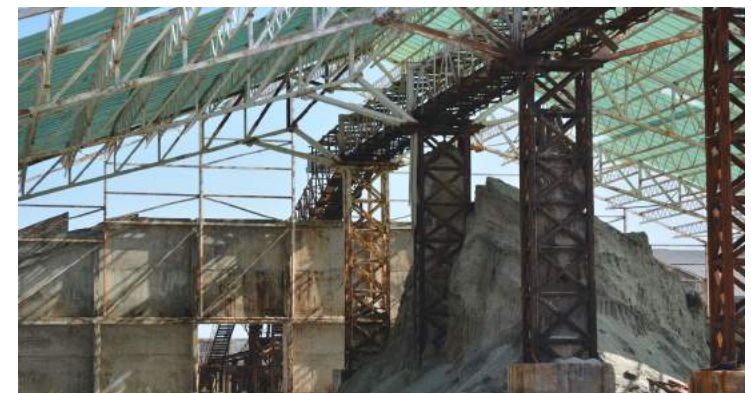
Fig.35 Decaying sat warehouse

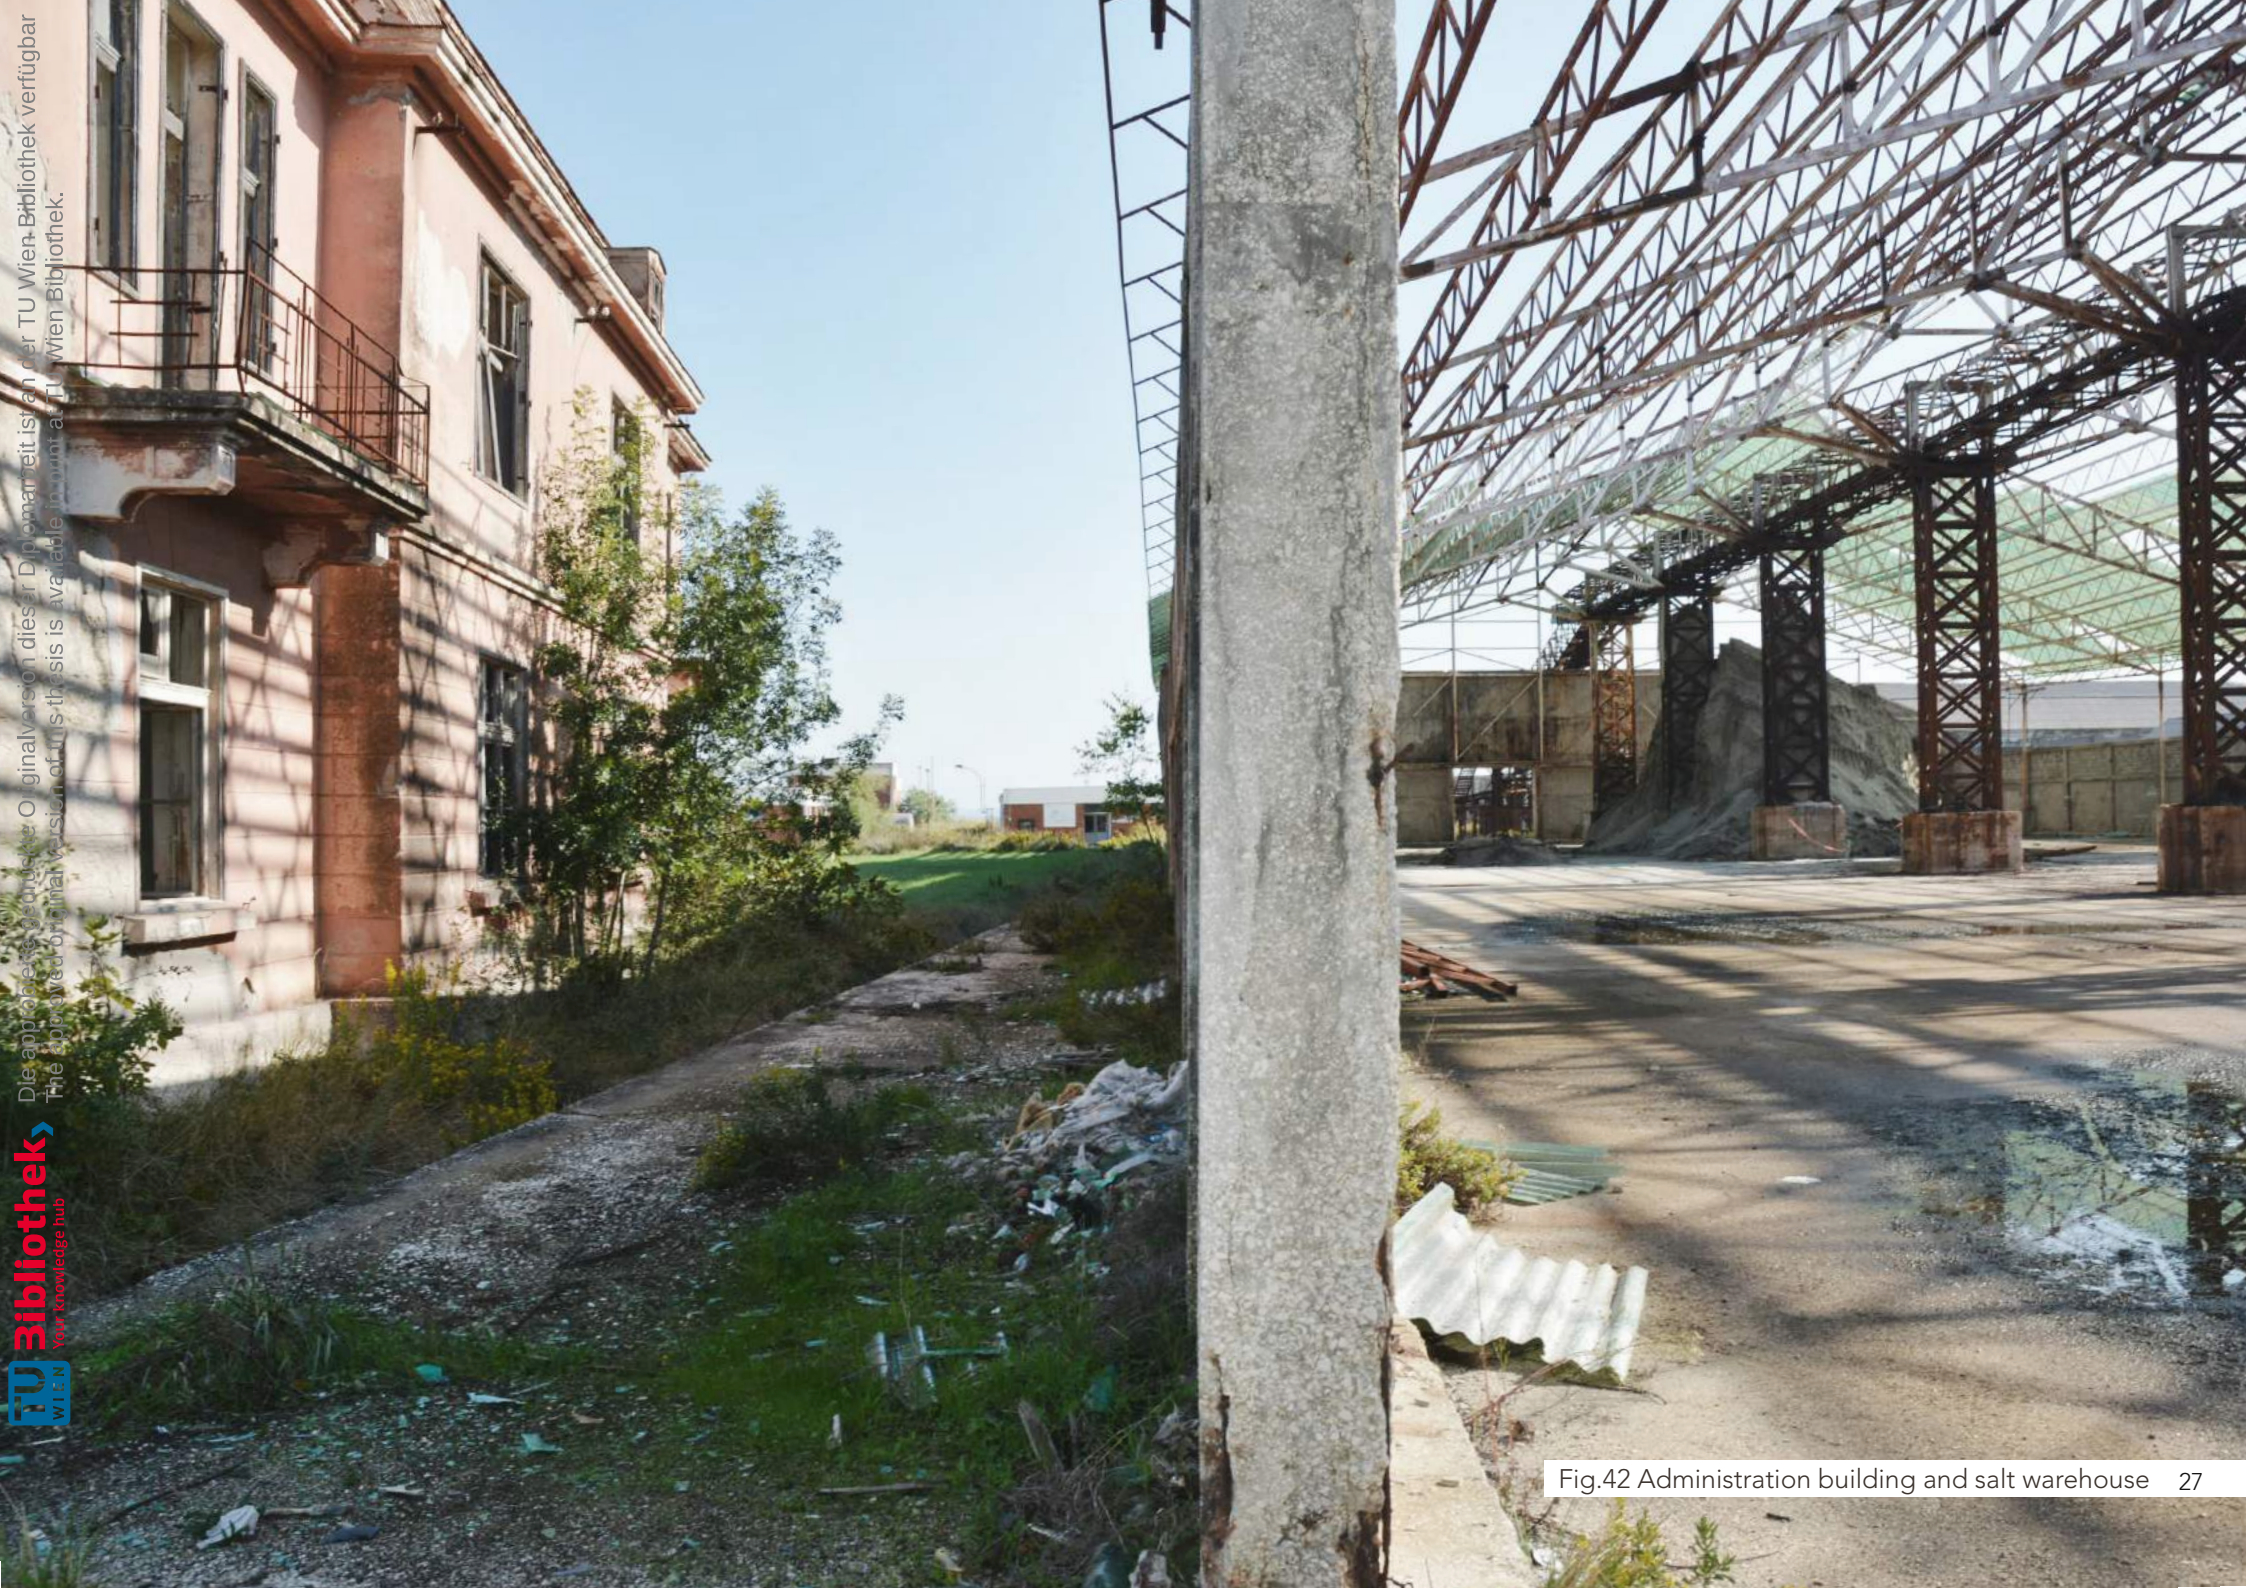
Fig.42 Administration building and salt warehouse 27

The most important building—the Administration building appears as soon as the gate is passed. This building was built in 1934 and was the first building in Ulcinj. It has suffered a great deal of damage and breakage throughout time; especially because of the strong earthquake that hit Ulcinj in 1979 after which it wasn't used anymore due to the enormous damage. The Administration building has elements of Secession; it has a very simple and symmetrical form and is consisted of the ground level, first level, and attic. The thick foundation can be read from the external image of this building. The window openings could be seen on every side of this building construction and follow a constant rhythm of the façade. Both external doors and windows could be noticed to have a skylight and are the old double wooden windows; they were all painted white. The front façade is facing north and has two slits that are pulled inside and look like small atriums that have the front side opened; the middle part of the façade pops out in the front like a kind of tower where the building's main and only stairway is located.

The Administration building has been abandoned for several decades; it suffered major damages after the earthquake in 1979 and hasn't been used since then which is very noticeable. The general state of the building interior is pretty bad and probably not completely safe. The whole external state of the administration building is not in an ideal shape as the part of the façade has fallen out and has cracks in some parts. Some of the doors and windows are missing as well as the rain gutter.

The surface layers of the walls have almost completely peeled off; both exterior and interior walls have often significant cracks and holes which bring into question the building's load capacity. The glass on the windows is almost completely gone, and the wooden window and door frames are either torn down or destroyed by the weather and time. The floors in certain rooms are gone or also not stable and the ceiling has holes in it or has completely broken down in some areas. A lot of the former building inventory is to be seen in the rooms; chairs, books, tires, and old fire extinguishers fill out the empty rooms. The roof is also in a bad condition and the core can be seen in many places; the wooden roof construction has also suffered a great deal of damage due to weathering.

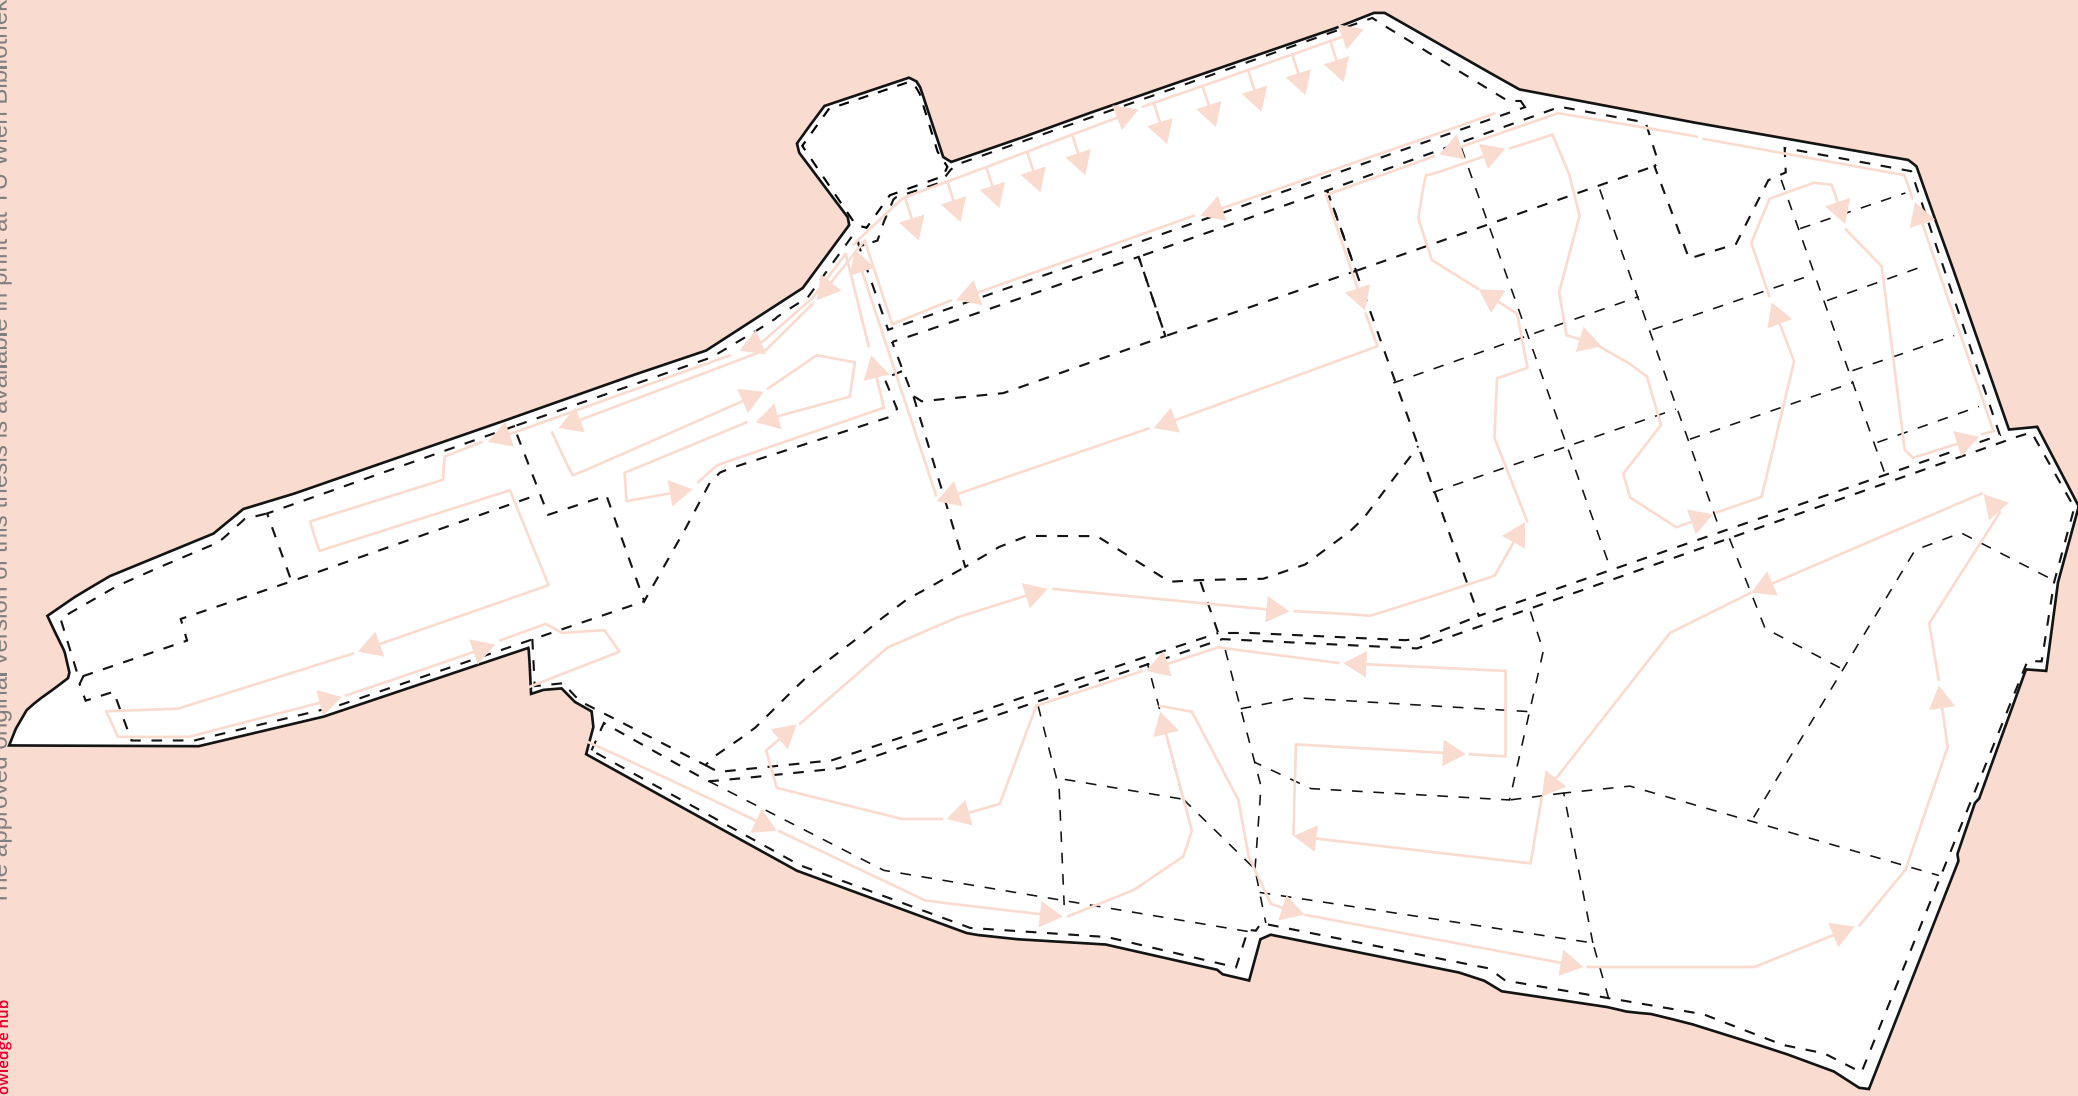
Fig.50 Water direction in the basins 37

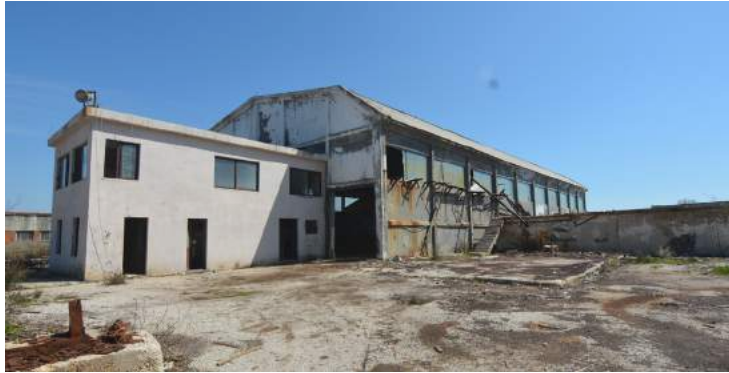
Fig.66 Unit for drying, packaging and shipping of salt

The cloakroom unit is used as a bird museum with an idea to activate the area, and is opened from time to time. Behind it, there is yet another larger unit that has suffered decay and was originally used for drying, packaging, and shipping of salt and (11). The group of units on the western part of the Salina's industrial complex were mainly technical ones. So next to the laboratory there is a unit for unloading of heating oil as well as its storage and transport (14); next to it a boiler room (15). Behind the boiler room, there is a warehouse for spare parts (16) and three more units which were used as an air compressor station (17), maintenance workshop (18) and a substation (19). The buildings are in a generally bad state as they have been almost totally abandoned for years. In order to be revitalized, they have either have to be back in the production process or be re-purposed. They are all connected via paths that can be reached by foot or by car.

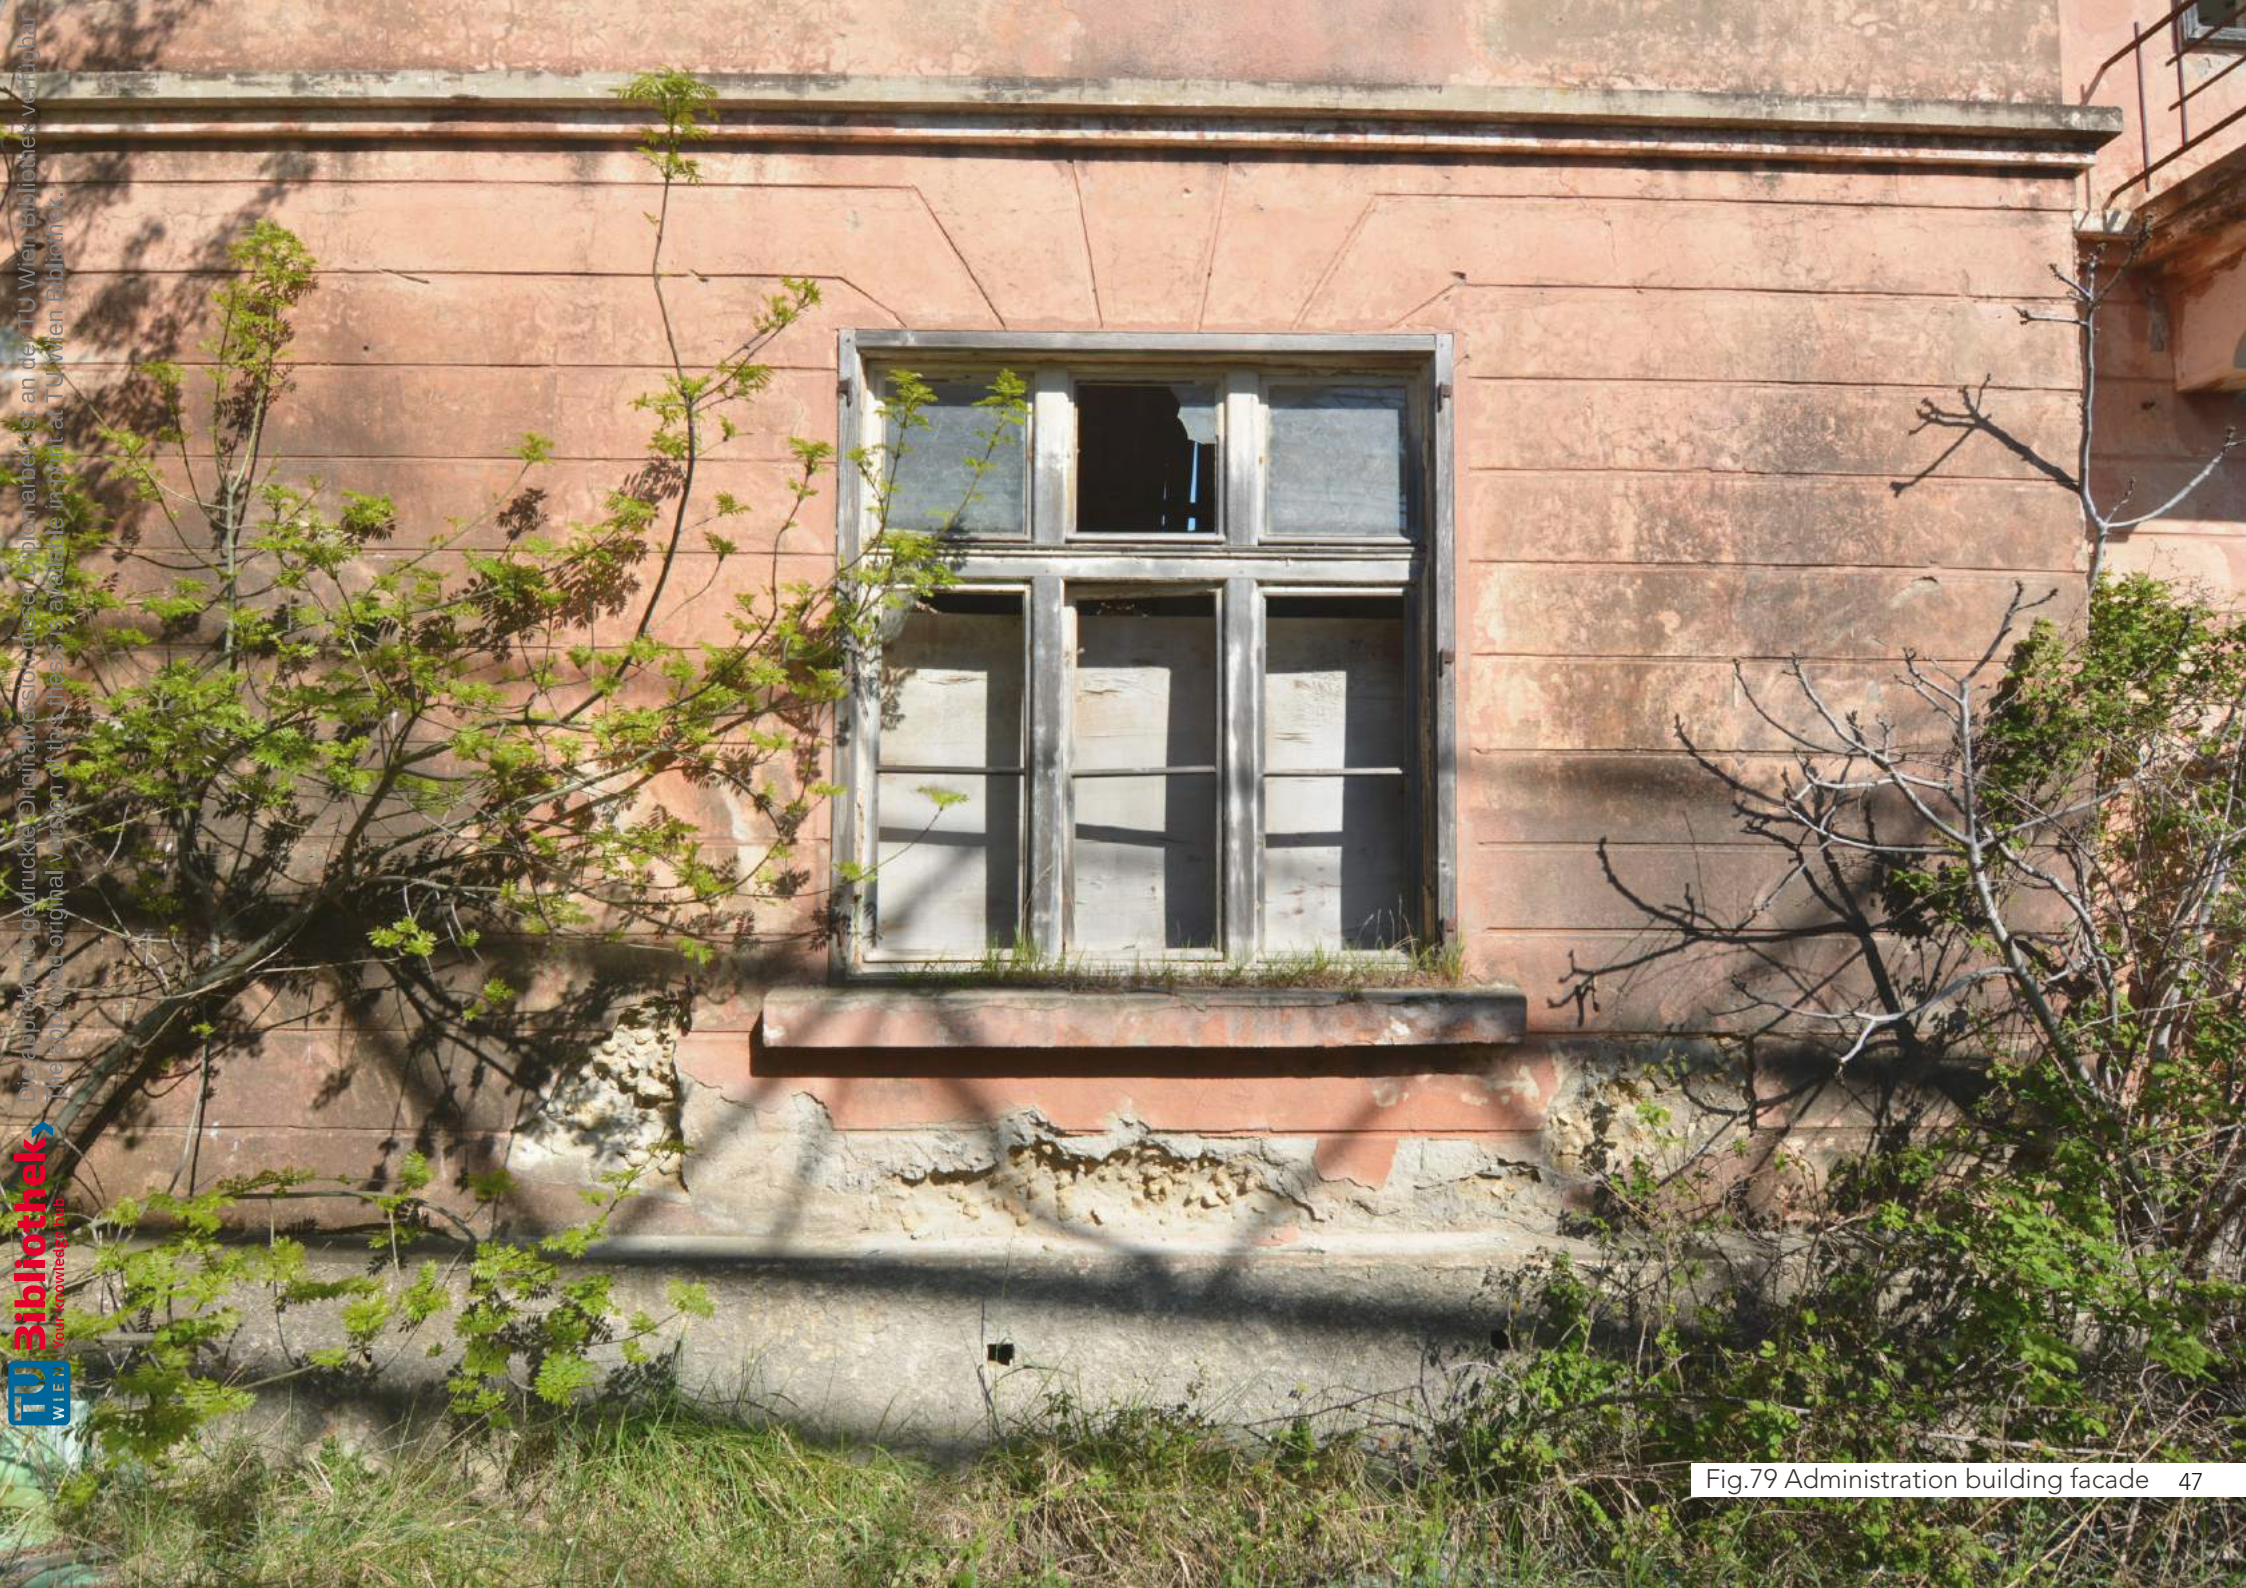
Fig.80 Administration building - Original floor plan

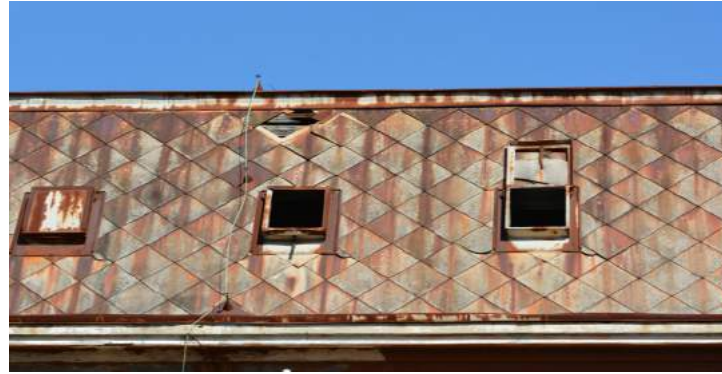
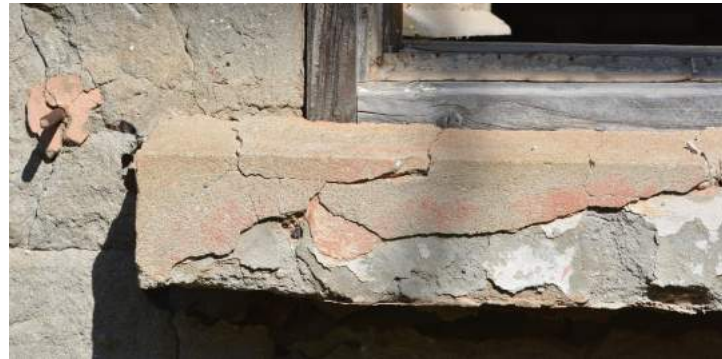
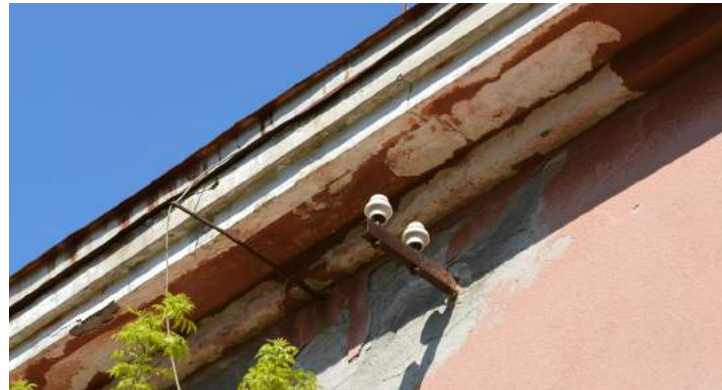
Fig.85, 86, 87 Administration building details

The stairway tower has the main entrance on the ground level, a large window between the ground and first floor, and a window in the attic. Two side entrances could be seen from each side of the main entrance which is accessible via stairs and a small landing; beside the doors, there are windows next to each side entrance. The inner parts of the two façade slits have both symmetrical windows which are toilet/bathroom openings. The main façade has on the ground level from each side identical windows; the same ones were integrated into the east and west ground floor façade with each side having a pair of windows. The south side has not been constructed to be completely flat. It has a small façade jump in the middle part with two slightly bigger windows and one from each side that resembles the ones on the north, east and west side. The façade of the ground level is emphasized with horizontal fugues that end with façade profile which accentuates the end of the ground and beginning of the first level. The whole building is painted in a bright rose colour, but it is not known if this resembles the original façade colour. The first storey of this unite quite resembles the previous one; except the first storey is enriched with balconies which are held by wreath ornaments and with wrought iron railing. On the main façade, the balconies are noticeable in the same place where the side entrances could be seen on the ground floor; the doors and windows are identical to the ones under them. The windows on the left and right side of the façade slit are slightly smaller in dimension than the ones located on the ground floor. The east and the west side are the same when looking from outside. The back, the south side looks the same in the middle part; but the left and right parts have two windows and a door that leads to the balcony with the same iron railing on each side. The last floor is visually separated from the two lower via façade profile which has been constructed slightly deeper than the one that separates the ground from the first level. All main attic windows are gabled dormer windows and have been placed in one line with the lower ones; few smaller ones are constructed as diagonal roof windows. The roof is darker coloured with visible rhomboid fugues pattern.

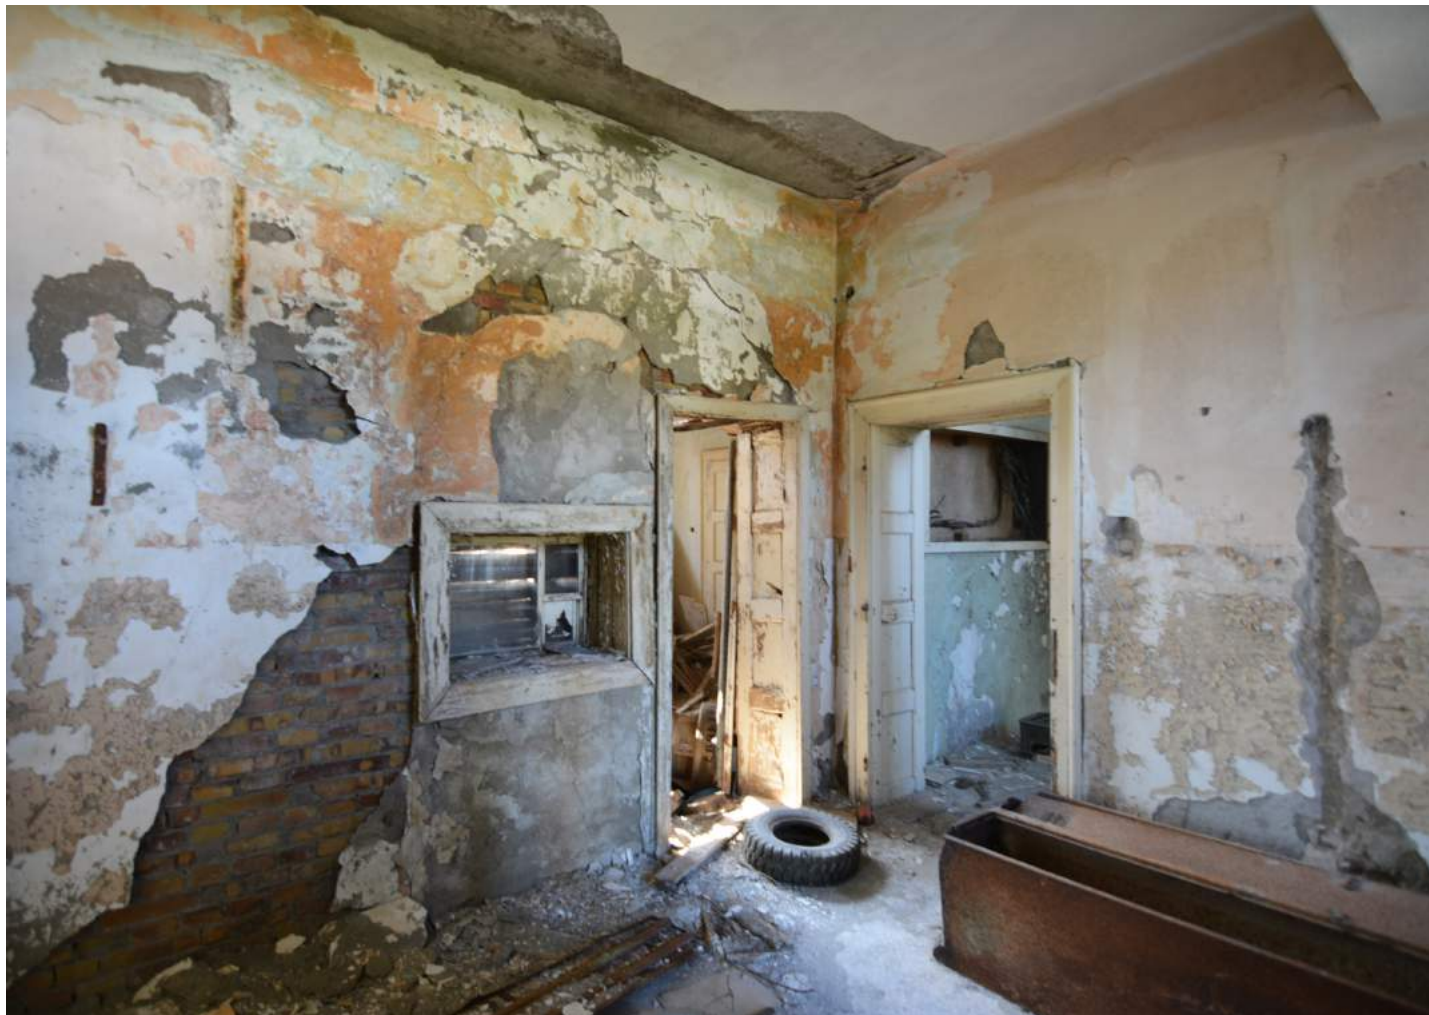
Fig.89 Current hall situation

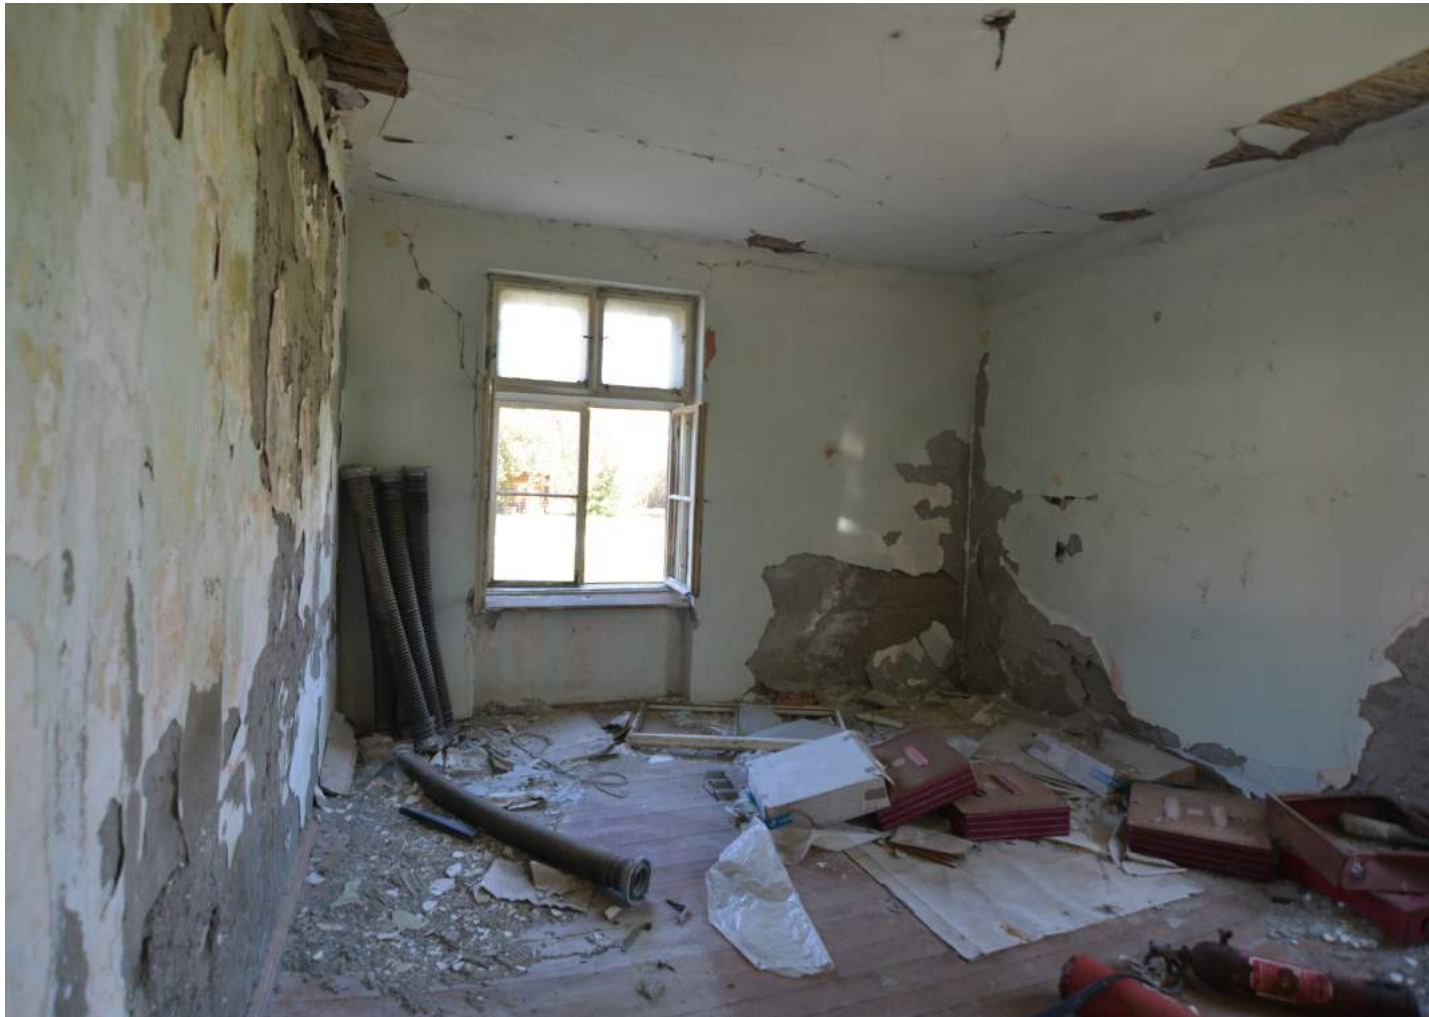
Fig.90 Current room situation

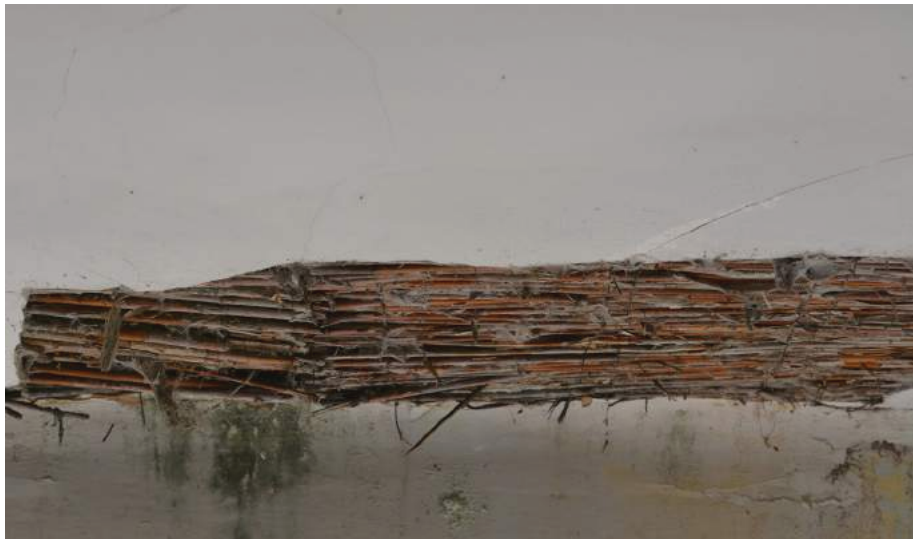
Fig.113 Ceiling detail

The external walls are made of crushed stone in the mortar with a thickness of 50 centimetres and the façade surface is a plaster one. The inner walls are a full-brick construction and plaster surface. The flooring in the rooms is wooden, and floors in the toilets, halls, and balconies are made of terrazzo. The doors and windows are made of fir or spruce wood, as well as their frames. The railings on the balconies are made of iron and have a unique appearance. The ceiling is a combination of concrete slab with wooden construction, reed, and lime mortar; with a sound attenuator layer. The flooring is wood and terrazzo. The main core, the stairs, are made out of prefabricated stone elements. The roof is a wooden construction finished with asbestos cement boards/eternity in diagonal raster.

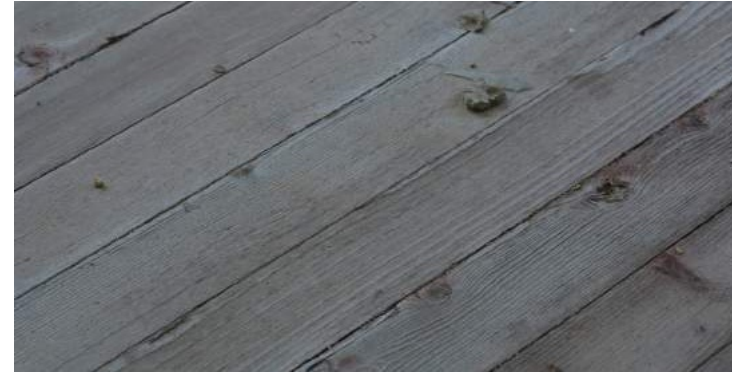
Fig.114 Wooden floor

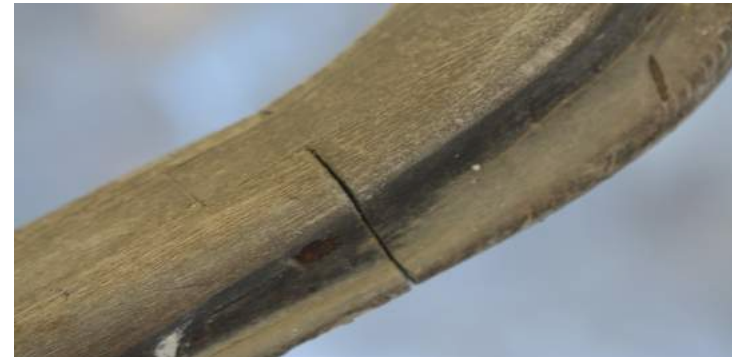
Fig.115 Handrail detail

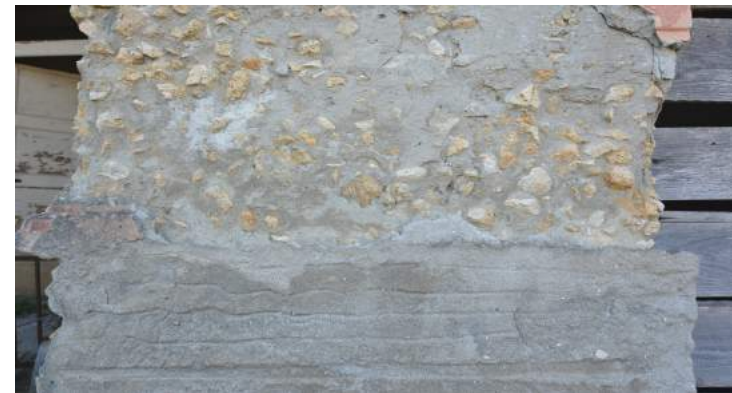
Fig.116 External wall

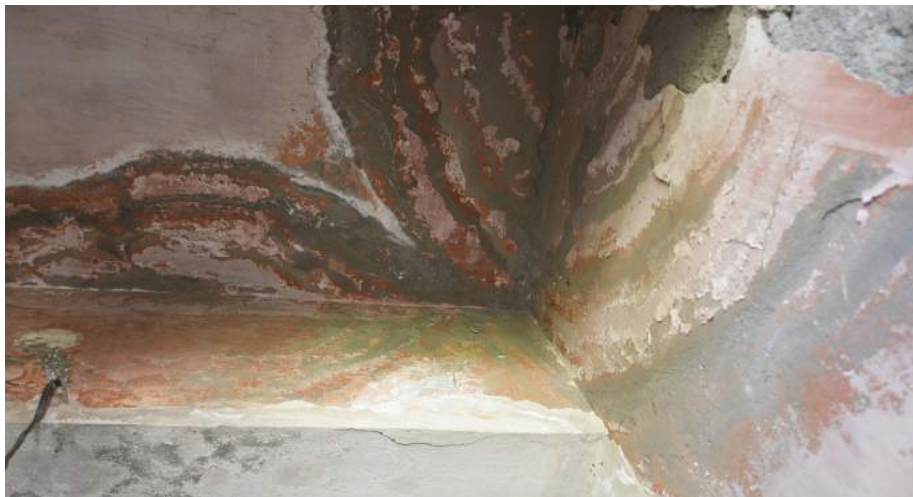
Fig.138 Mould and moisture damage on interior walls and ceiling

Materials from which historic buildings are made often consist of some porous material and absorb water in various degrees (e.g. brick, stone, mortar), so moisture is a regular occurrence. Very often it is accompanied by harmful salts that are primarily responsible for construction damages. A proper moisture reduction should be reduced to those occasions when there is a potential risk to the object or its users. All measures that are to be used must be based on the least possible intervention with the greatest possible reversibility to protect the historic objects themselves. The measures for moisture reduction are extremely complex building physics-chemical processes; they are to be

determined only individually and object-specifically. Moisture can never be eliminated. Because the measures often turn out to be technically and economically unattainable it is very important that before each operation there is a detailed professional assessment of all relevant aspects. Moisture reduction measures do not always have positive effects; they can often affect the structural components such as building settlements through the digging of drainage channels, surface damages due to death; that is why an examination of load-bearing structure is necessary before any realisation. Moisture reduction goal is not the maximum achievable moisture reduction, but the lowering of moisture concentration according to the appropriate building physics parameters. The primary goal is the clearing of maintenance defects and to restore or improve the original state and properties such as drainage of roof and surface water, winter protection measures for streets and roads, etc. The administration building has moisture damages that noticeable from both inside and outside; some of the wall areas are particularly struck by it. Larger interventions may be needed in order to restore the state of the building where it can be used again. In fighting moisture damages, two basic concepts are to be followed; moisture-lowering (maintenance measures, dehumidification ditches, and electrophysical processes) and moisture barrier systems (injection methods, wall separations, wall replacements). The simplest measures could often be the most effective; controlling the roof drainage system, maintenance of existing building drainage system, removing ineffective moisture barriers. Not rarely is a moisture problem actually a problem of harmful salts; a rational replacement or repair of plaster combined with salt reduction measures and regular maintenance of the plinth area could maybe be the solution. A dehumidification ditch is basically a drainage ditch that lied directly on the building; it should reduce the wall moisture by reducing the entry of moisture. For this measure, the primary analysis must be done because it cannot be applied in any case; it be must be done properly otherwise it could cause lasting negative impacts on the existing building. If done correctly, dehumidification ditch

can bring long-term freedom of moisture damages. Direct application of barrier layers on the outer surface of the masonry is to be avoided for both diffusion and reversibility reasons. One of the favourite moisture-lowering systems is the drainage ditch; it enables the lowering of capillary humidity. It can also be combined with a dehumidification ditch. Another method is the exchange of the floor substructure which also leads to the lowering of capillary moisture. Changing floor substructure is not an insignificant method, especially with structures that are in contact with the ground. This method must be carefully planned both with the concept itself as well as with the implementation; if done properly it can be very useful. Injection method is based on filling out or „clogging“ the pore volume. Advantage of this method that there are no structural side effects; the disadvantage is that the clogging substance is not easy to apply and cannot be carried out with 100% certainty. Wall separation method is used to separate components from moistened elements; it is usually done using a wire cutting machine. Its advantage is that is highly efficient for dehumidification; its disadvantages are that is often not accepted in the field of monument preservation. With implementation, it should be done below the ground level and structural side effects must be taken into account. The core drill process could be very useful as a horizontal moisture barrier system with stone ore mixed masonry. The benefit of this method is that there is a systematic division being made between moistened components with very low structural side effects; unfortunately, with this process there is a risk of introducing harmful salts through the mortar. Wall replacement and underpinning are very useful methods in fighting moisture damages; they represent massive interventions in the historical object. A complete wall replacement is not a desirable method from the monument protection point of view and should only be applied if there is no other solution. Soil improvement could also be considered as it is a very helpful solution; it improves the soil through cement and strengthen its structure. It can be very successful when done correctly as it reduces moisture transport to soil and it doesn't have any structural side effects.

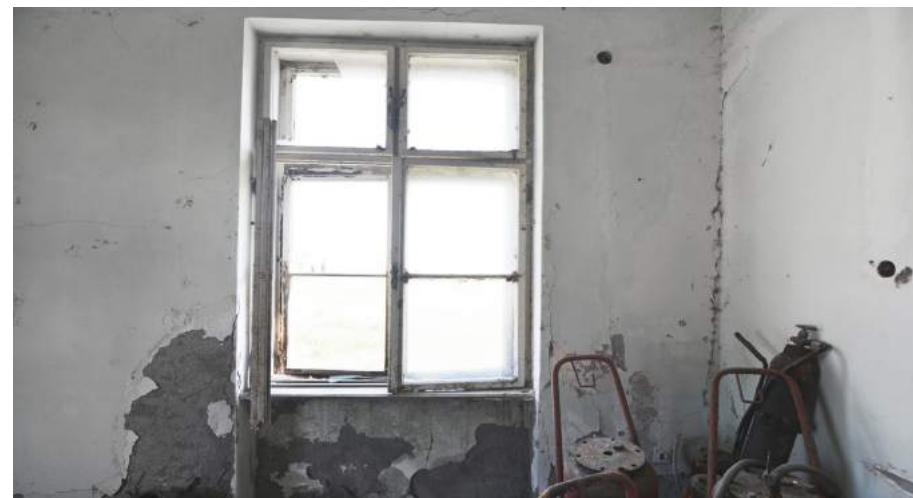
Fig.139 All radiators have been removed

Every building's interior has an indoor climate of its own; it is mostly determined by size, room function, location inside the building, and material and technics used for construction. However, it happens that over a longer period, indoor climate conditions change negatively and cause damages to space and its interior; this is often the case in the field of monument preservation. The administration building has no visible heating system left in it. However, there are niches under every window ledge so it is almost certain that heaters were placed under it and were removed after the building was abandoned. For the ventilation system, a large number of windows were used. When doing the concept for new heating and ventilation system, the original system must be

considered as well as an air conditioning solution since summer temperatures in Ulcinj are often very high. When working on improving indoor climate on a historic object, a method with minimal interference must be chosen; preference should be given to the passive (usage behaviour) over the active (air conditioning) process. Alongside usage behaviour, great attention should be given to the building's heating system; it is to be organised in such a way where temperature stability is guaranteed. Passive climate stabilization can be achieved through the combination of manual or mechanical controlled air exchange, controlled humidity, and passive solar and thermal protection. Monument protection favours passive methods that include ventilation that is adapted to the local climate conditions, water- and windproof membrane systems on doors and windows, appropriate insulation that is object-specific, temperature control measures on building envelope, and others. Active methods for ventilation and dehumidification are dehumidifiers, and air conditioners that are electronically controlled. They include heating systems-air heating and temperature control system.⁶³

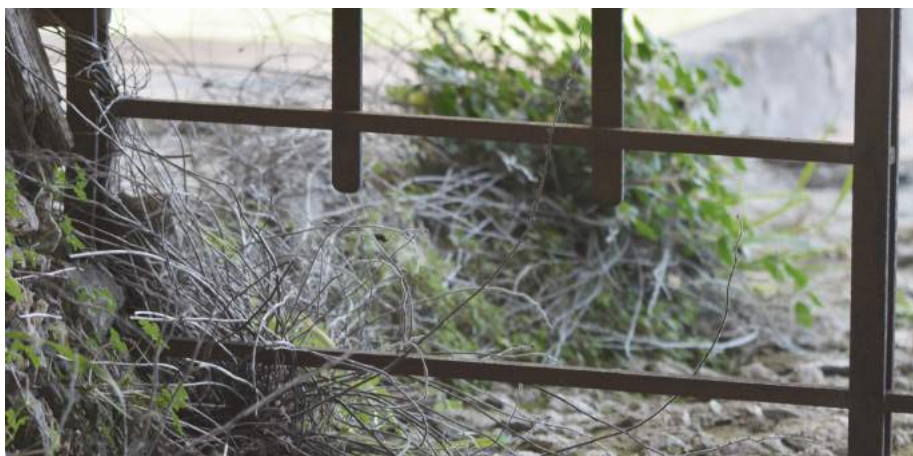
Fig.140 Vegetation overtaking the construction

Not only do physical and chemical environmental influences cause damage to architectural objects, but also biological organisms. Organic materials are often attacked by pest infestation, but inorganic as well. Damage processes can be triggered by infestation, in term of health, aesthetic and material aspects. The monument protection field aims to treat and remove the infestation through the concept of appropriate measures that preserves the historic structure as well; it includes monitoring, prevention and control (IPM-Integrated Pest Management). Insect infestation often happens in isolated areas (wasp nest in the attic) or it can be a direct infestation (parquet beetles, woodworms). Wood pest infestation is related to changes in the indoor climate, temperature and humidity; majority of these insects prefer moist and warm environments. Combating insects with biocides represents a short-term solution; establishment of appropriate ventilation and air circulation as well as temperature control, appropriate humidity are vital as long-term concepts. From a monument protection point of view, methods like hot-air process, humidity-regulated warm air and microwave process; high-frequency process and IR-radiation are rarely used. The fumigation process also represents a successful method, but substances like ethylene oxide, formaldehyde and ozone are not allowed in the field of monument preservation. IPM is an essential part of pest control as it incorporates care, maintenance and monitoring concepts; it must be carefully planned. Plants can also be a burden for historic objects; especially through their roots. It is not always regarded as harmful although its removal is often necessary. Sustainable prevention measures for plants are mostly achieved through herbicides and biocides; but manual removal and maintenance are also needed. Microbiological infestation (mold, algae) are hazardous for both human health and historic surfaces. Biocides are the most effective method as they are UV and pH stable and are non-toxic for humans and environment. Biocides must be chosen carefully and object-specified. Mold and fungus growth is deal in areas with high humidity and nutrients supply. Fighting them

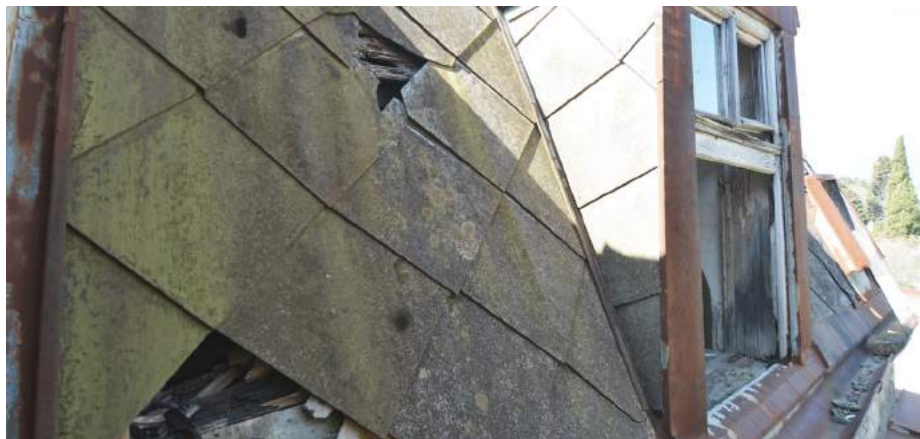
Fig.141 Roof covering
