FLAMINGO NATURE PARK

Revitalisation and adaptive re-use of Salina
in Ulcinj, Montenegro

MASTER-/DIPLOMARBEIT

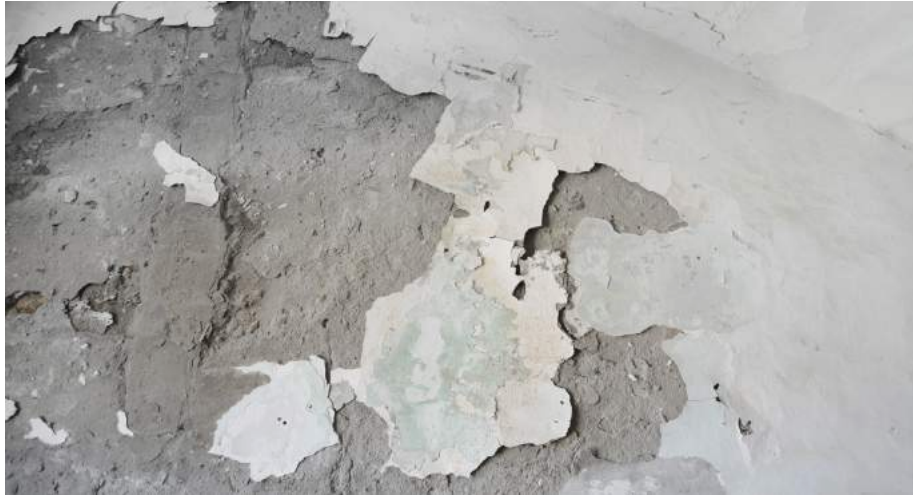
Fig.142 Interior wall decaying

The focus should be on the preservation of the plastering if it's possible and to repair it so the traditional appearance is kept. From the point of monument preservation, it is allowed to apply changes like removing the old plaster and renewing if there are technical and historical reasons in favour. The concept of measures must be well-thought applies solely for the administration building; maintenance measures are preferred to the massive restoration measures. The irreparable damages can be removed after they have been properly marked on the existing structure. The planned added plaster must correspond to the existing one as much as possible in terms of composition (colour, grain size, binding), strength, and elasticity. Parts with cracks and flaws must be repaired and matched to the surrounding materials. Because of the overall state of plaster and mortar on the administration building, it could be said that larger additions and repairs are unavoidable. In that case, all the newly added plaster and mortar is to be carried out using traditional craftsmanship. The supplementary mortar must be identical in the grain type, grain size, grading curve and colour, binding substances, hydraulic components as well as surface, tool marks and really often traditional multi-layer mortar application with a trowel. For the purpose of better matching, supplementary mortars are often mixed on-site. With newly added materials, it is important to see to what extent the added elements should be a replica of historical material, or if it should be a reinterpretation of the material with regard to the context itself. Possible salt reduction measures and water repellent methods (hydrophobization) should only be done in correspondence with the monument preservation. There is also a possibility of antigraffiti coatings for the surfaces in order to protect them on another level.⁶⁷

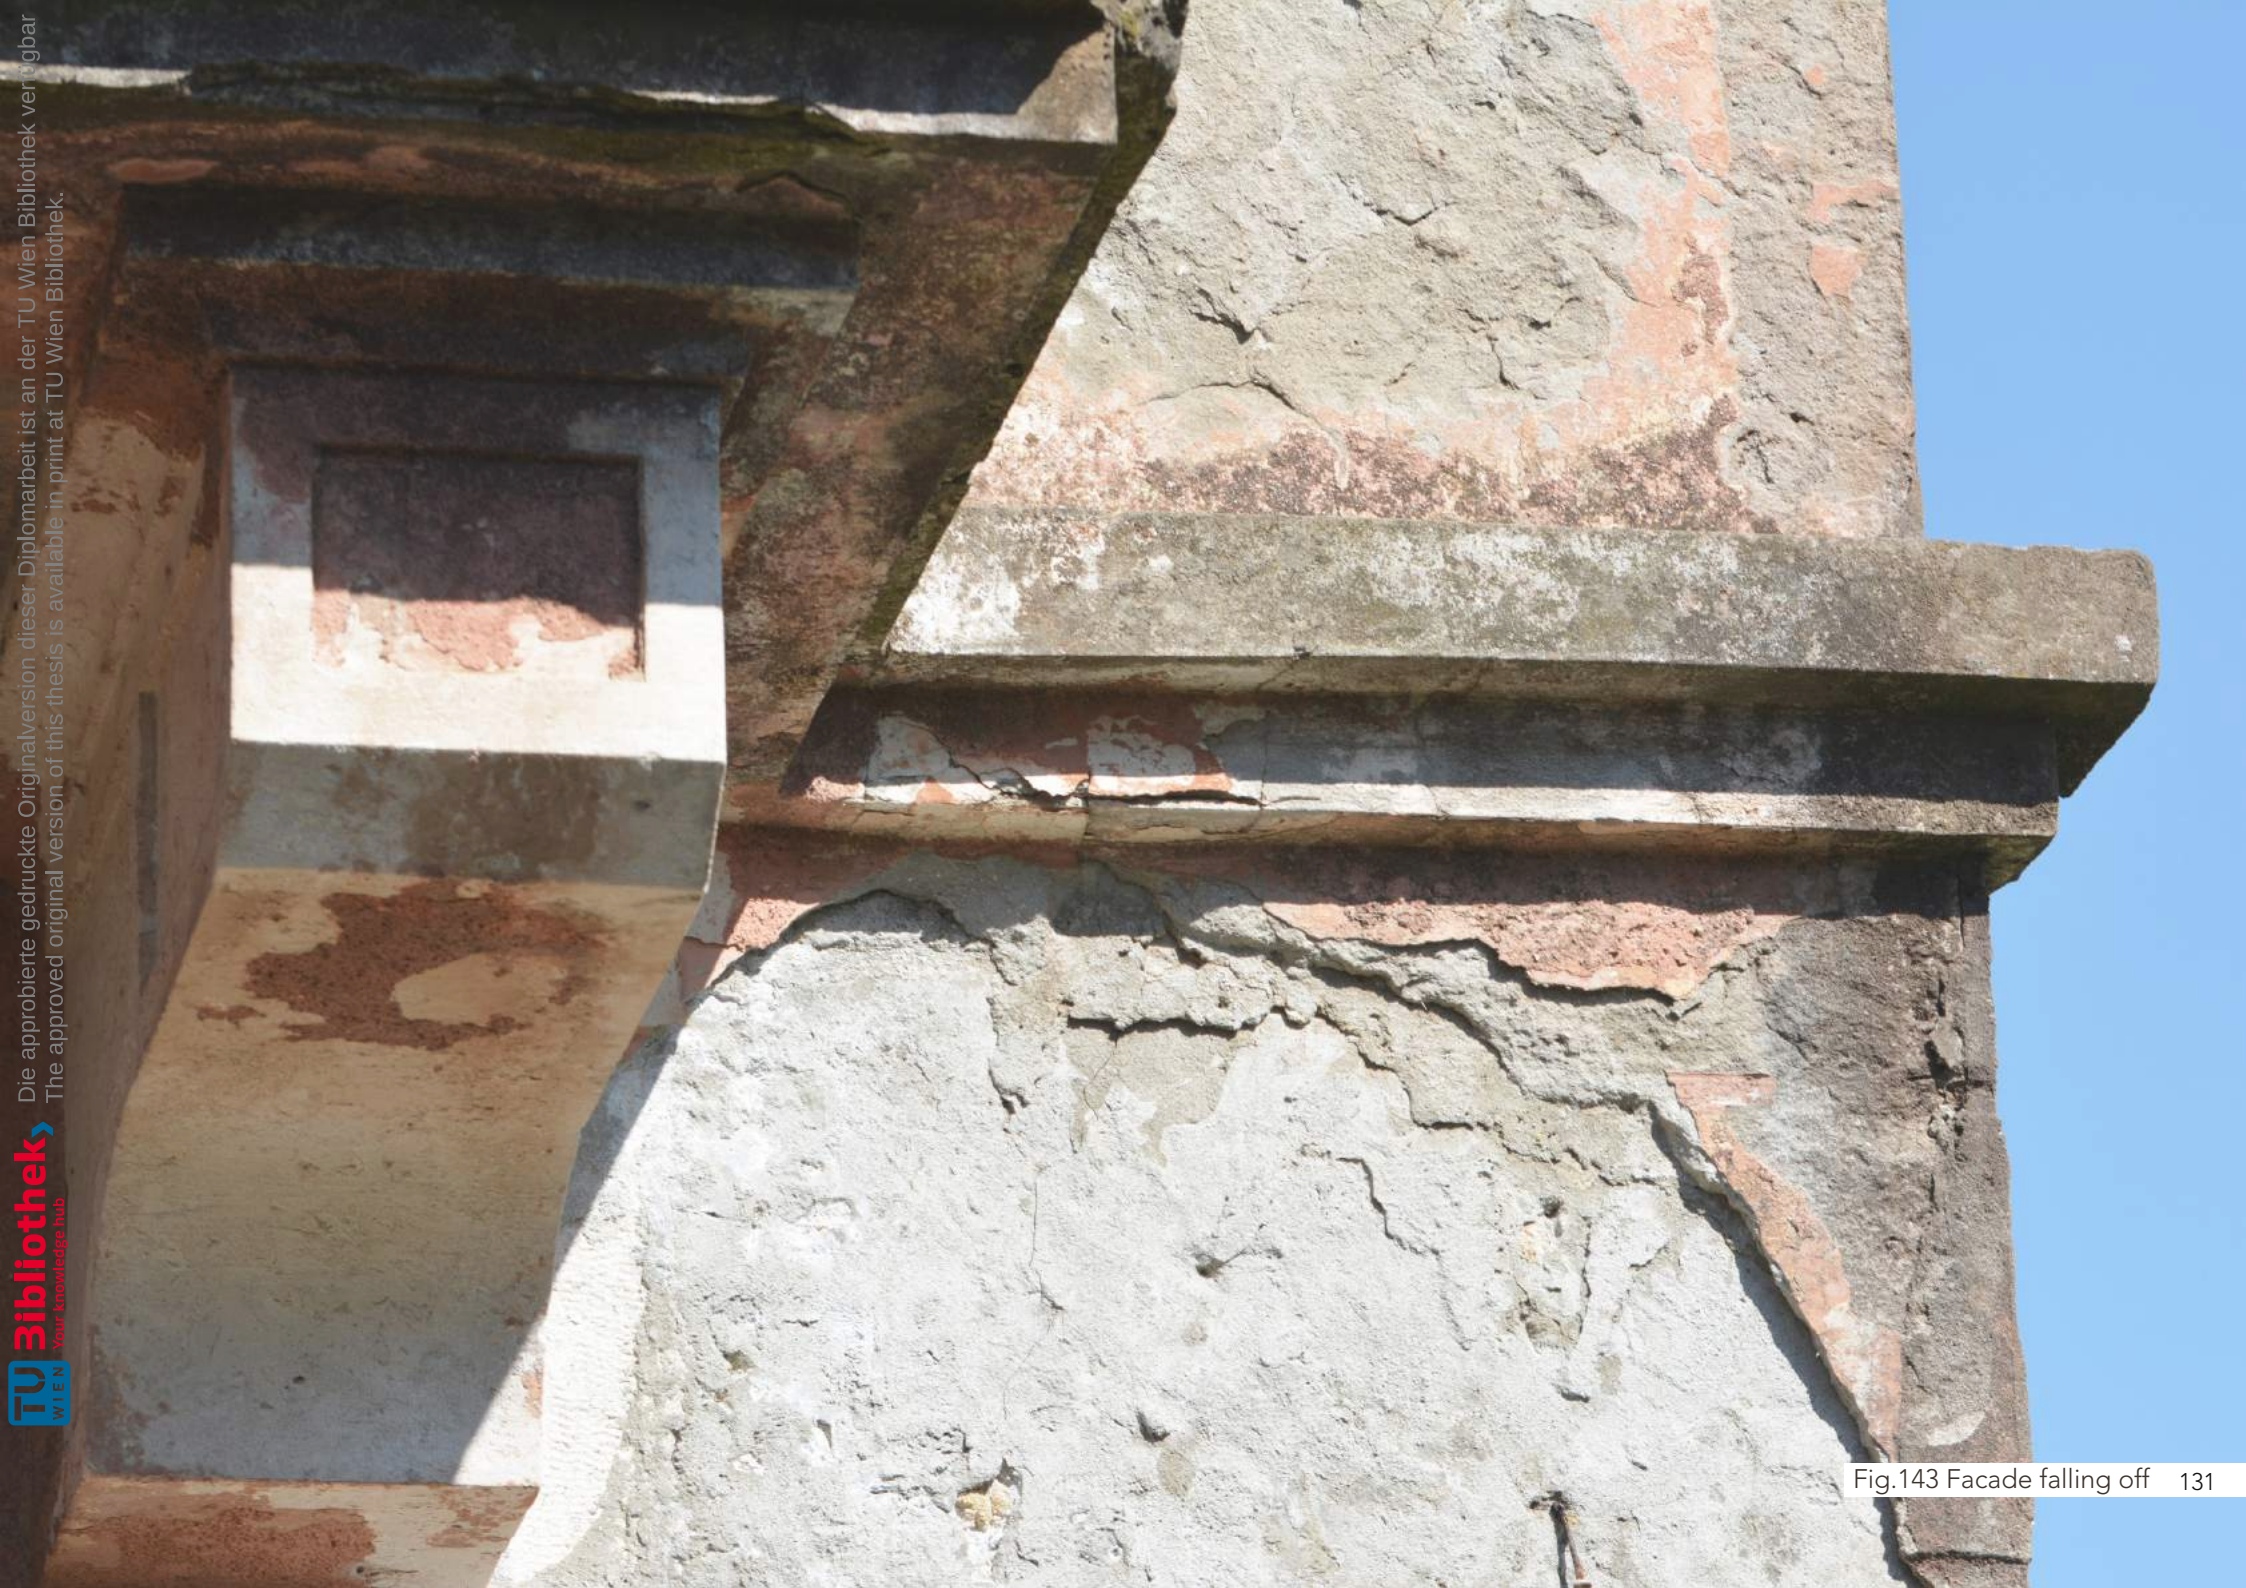
Fig.143 Facade falling off 131

separates the ground and the first floor and also the first and second/attic floor. Decoration wreaths underneath balconies are also designed in the same manner. The overall state is not the best one, but it seems that the structure itself is maintained. There are moisture damages in some areas, as well as the plastering that has fallen off from the surface. The stucco elements of the administration building are important and must be preserved as they form the building's appearance. Qualified specialists like restorers and plasterers should be in charge of the consolidation and restoration of stucco decorations. The consolidation itself should be done with materials that correspond to the existing materials and their characteristics like elasticity, structural robustness, and binding components; cracks and edges are also to be carried out in harmony with the surrounding structure. If there are any visible cracks, they are to be checked for static causes of damage. The stucco support structure should remain flexible for it to be able to absorb movements of the structure and avoid the creation of cracks and cavities. The original stucco technique in material, structure, and execution should be used. The mortar used for stucco should be preferably mixed directly on the site so that the most possible resemblance is achieved. It should be looked after that the adjusted mortar has similarities in the grain size, grading curve, colour of the sand, binder substances, additives, surface structure, and tool marks and traditional application.⁶⁸

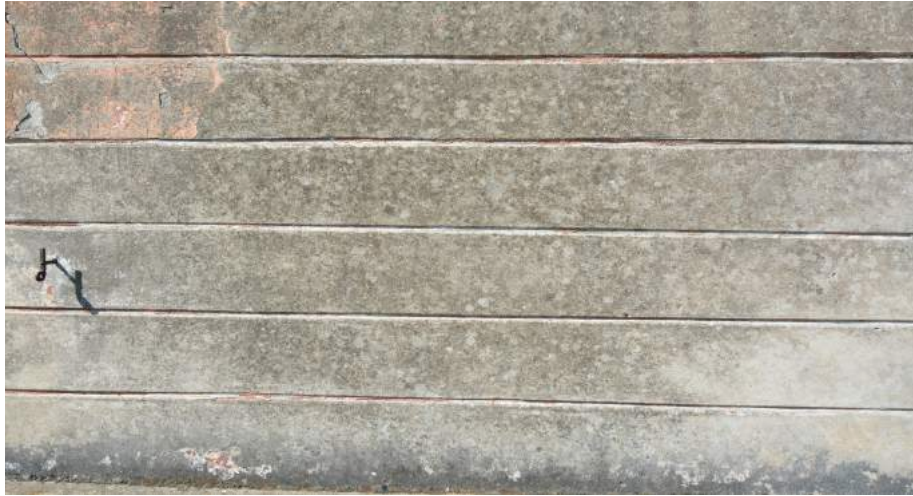
Fig.144 Damaged facade

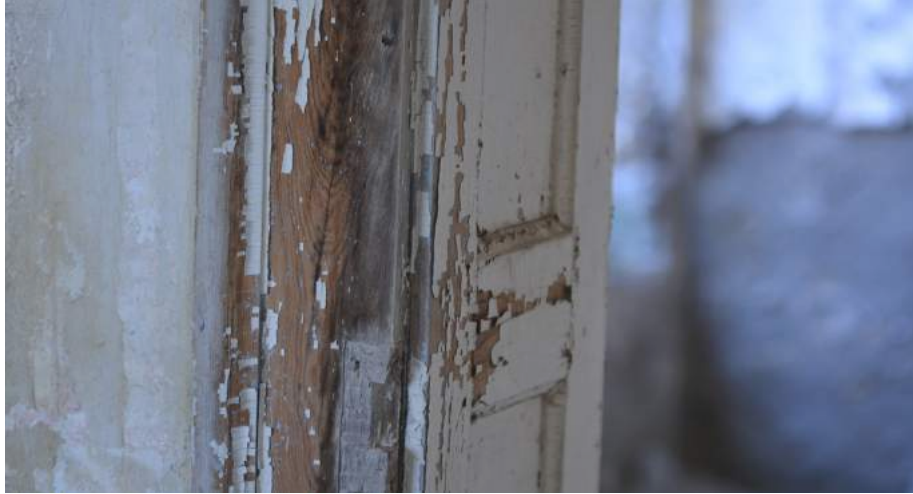
Fig.146 Wooden door detail

One of the most important building materials that affect the image of a certain construction is definitely wood; it gives a unique look to both exterior and the interior. It is often used as an elementary structural part for elements like roof trusses, framing, between-ceiling construction, and others; it is also used as the basic material for elements like doors, windows, stairs, etc. The measures for preserving wooden elements vary from simple maintenance, and small repairs to well-thought conservation and restoration strategies. The foreground of restoration of structural timber elements are issues like pest and microbiological infestation, room climate, and water protection. The acquired repair concepts and maintenance and supplementary measures are to be individually determined. The most significant wooden elements on the administration building are windows and doors that give it a special look. The flooring in all the bigger rooms is wooden and the roof truss is a timber construction. Unfortunately, the major part of all these elements is in a really bad state and they would have to be completely renewed or exchanged. When exchanging old and broken parts,

it is crucial that the static requirements are considered and it is to be done by specialists. A very large part of timber construction preservation is pest control; the pest type is to be determined, level of damage, determination and elimination of cause, fight and maintenance concept as well as monitoring strategy. These actions mustn't harm the wooden structures that can be preserved.

In the case of replacing damaged parts, the added parts are to be made of the same type of wood and have the same staining pattern so the original appearance could be maintained.⁶⁹

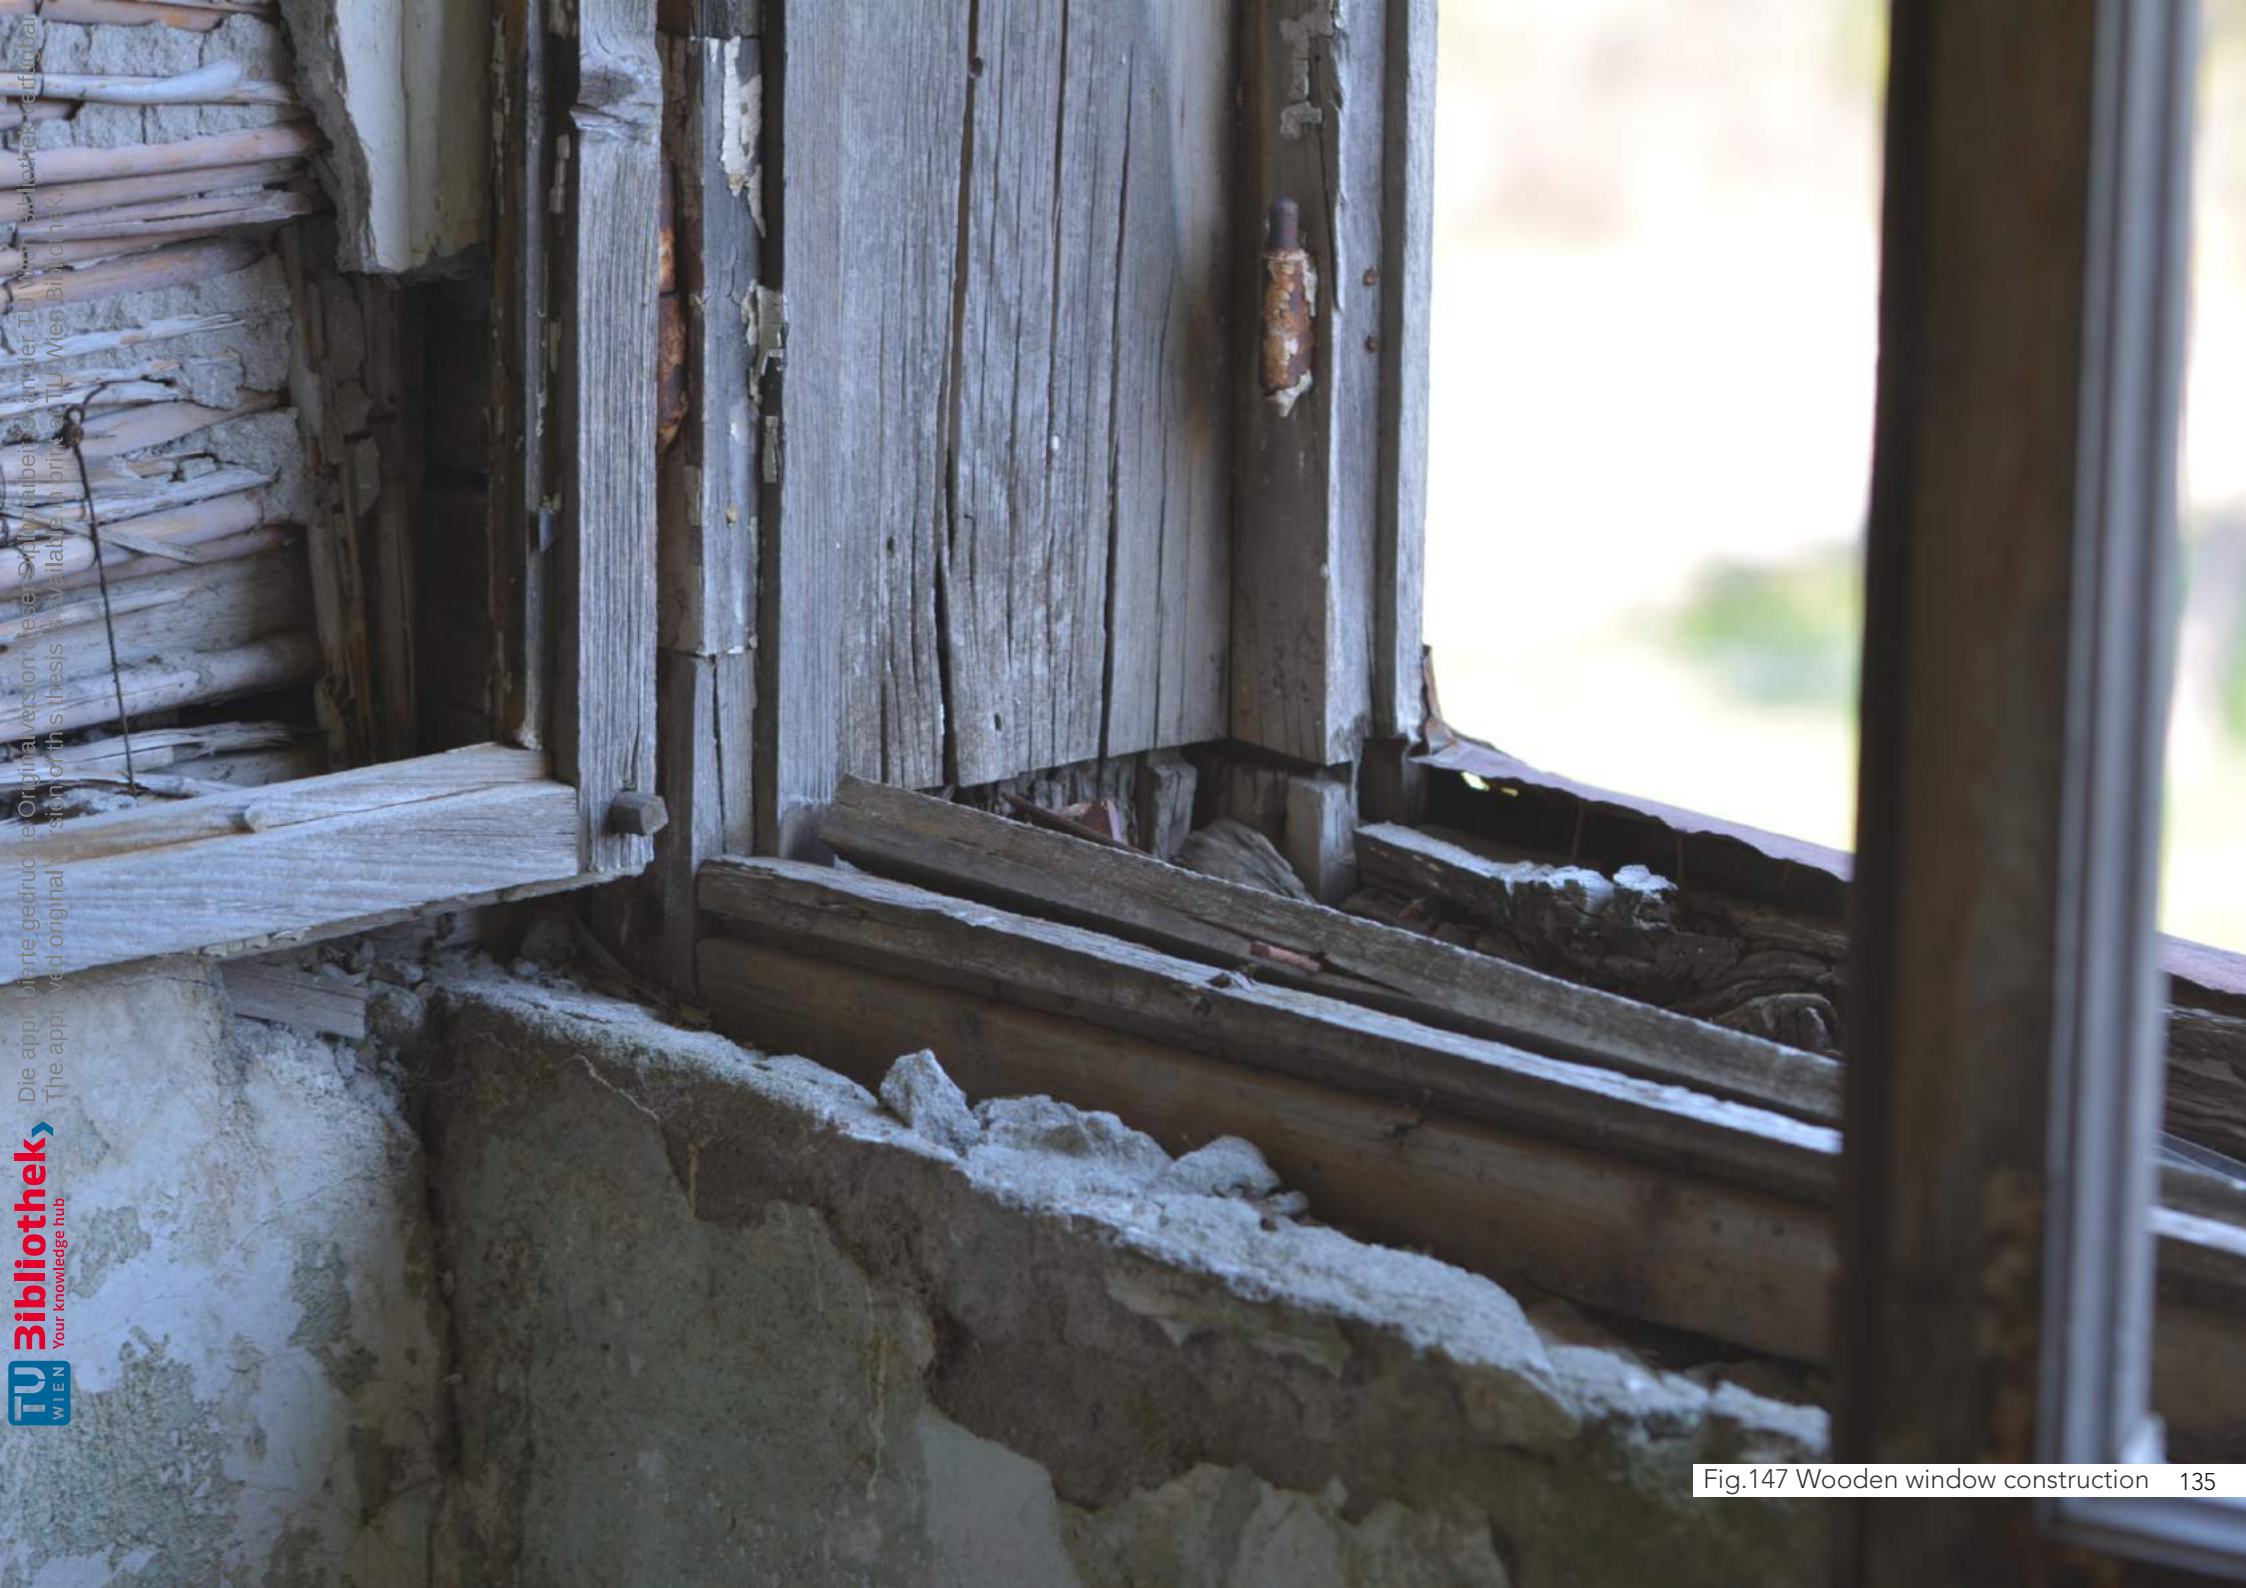
Fig.147 Wooden window construction 135

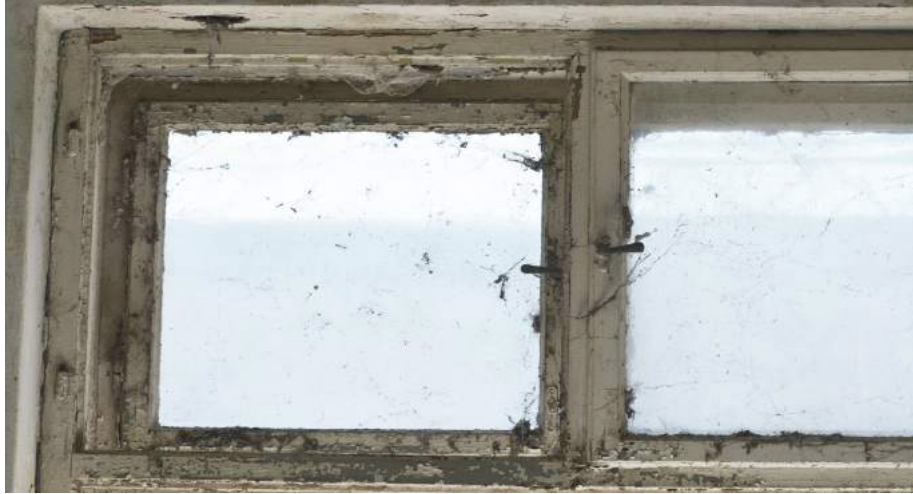
Fig.148 Spider web overtaking the window surface

The type of glass that is often mentioned in monument protection is the window glass; they are usually part of the window construction or sometimes they represent an independent element. Various shapes and designs mostly tell about the structural and artistic development and history of the existing object. The measures of the rehabilitation are to be developed object-specifically and in the context of existing subject. The existing state of the glass surfaces on the administration building is not ideal; due to the weathering and many years that have passed by, a lot of glasses did break or they have been removed. From the window glass that is still standing in its position, we can notice that it is the standard transparent window glass. It has not been known that the window glass on the administration building has any special specifics and a great historic value. Because of it, it is possible that the renewal would not be as complex as the one with historic important glass. The window frames on the building are wooden; they have been heavily struck by weathering so they should be exchanged together with the glass surfaces. The main role of the window glass is its

technical function, especially as protection from the outside effects and weather. Building physics elements of glass should also be taken into account, as well as the condensation, original construction, room climate, room usage, and room function; especially if a new use is planned. With the planning of adding new elements, the material thickness, surface structure, and colour effect is to be considered. The usage of proper fire protection glasses is also a very important characteristic especially if the future building function is going to have a public character. In the case of adding insulating glasses, a bigger change is to be expected because of the required frame profiles and it can affect the appearance greatly.⁷⁰

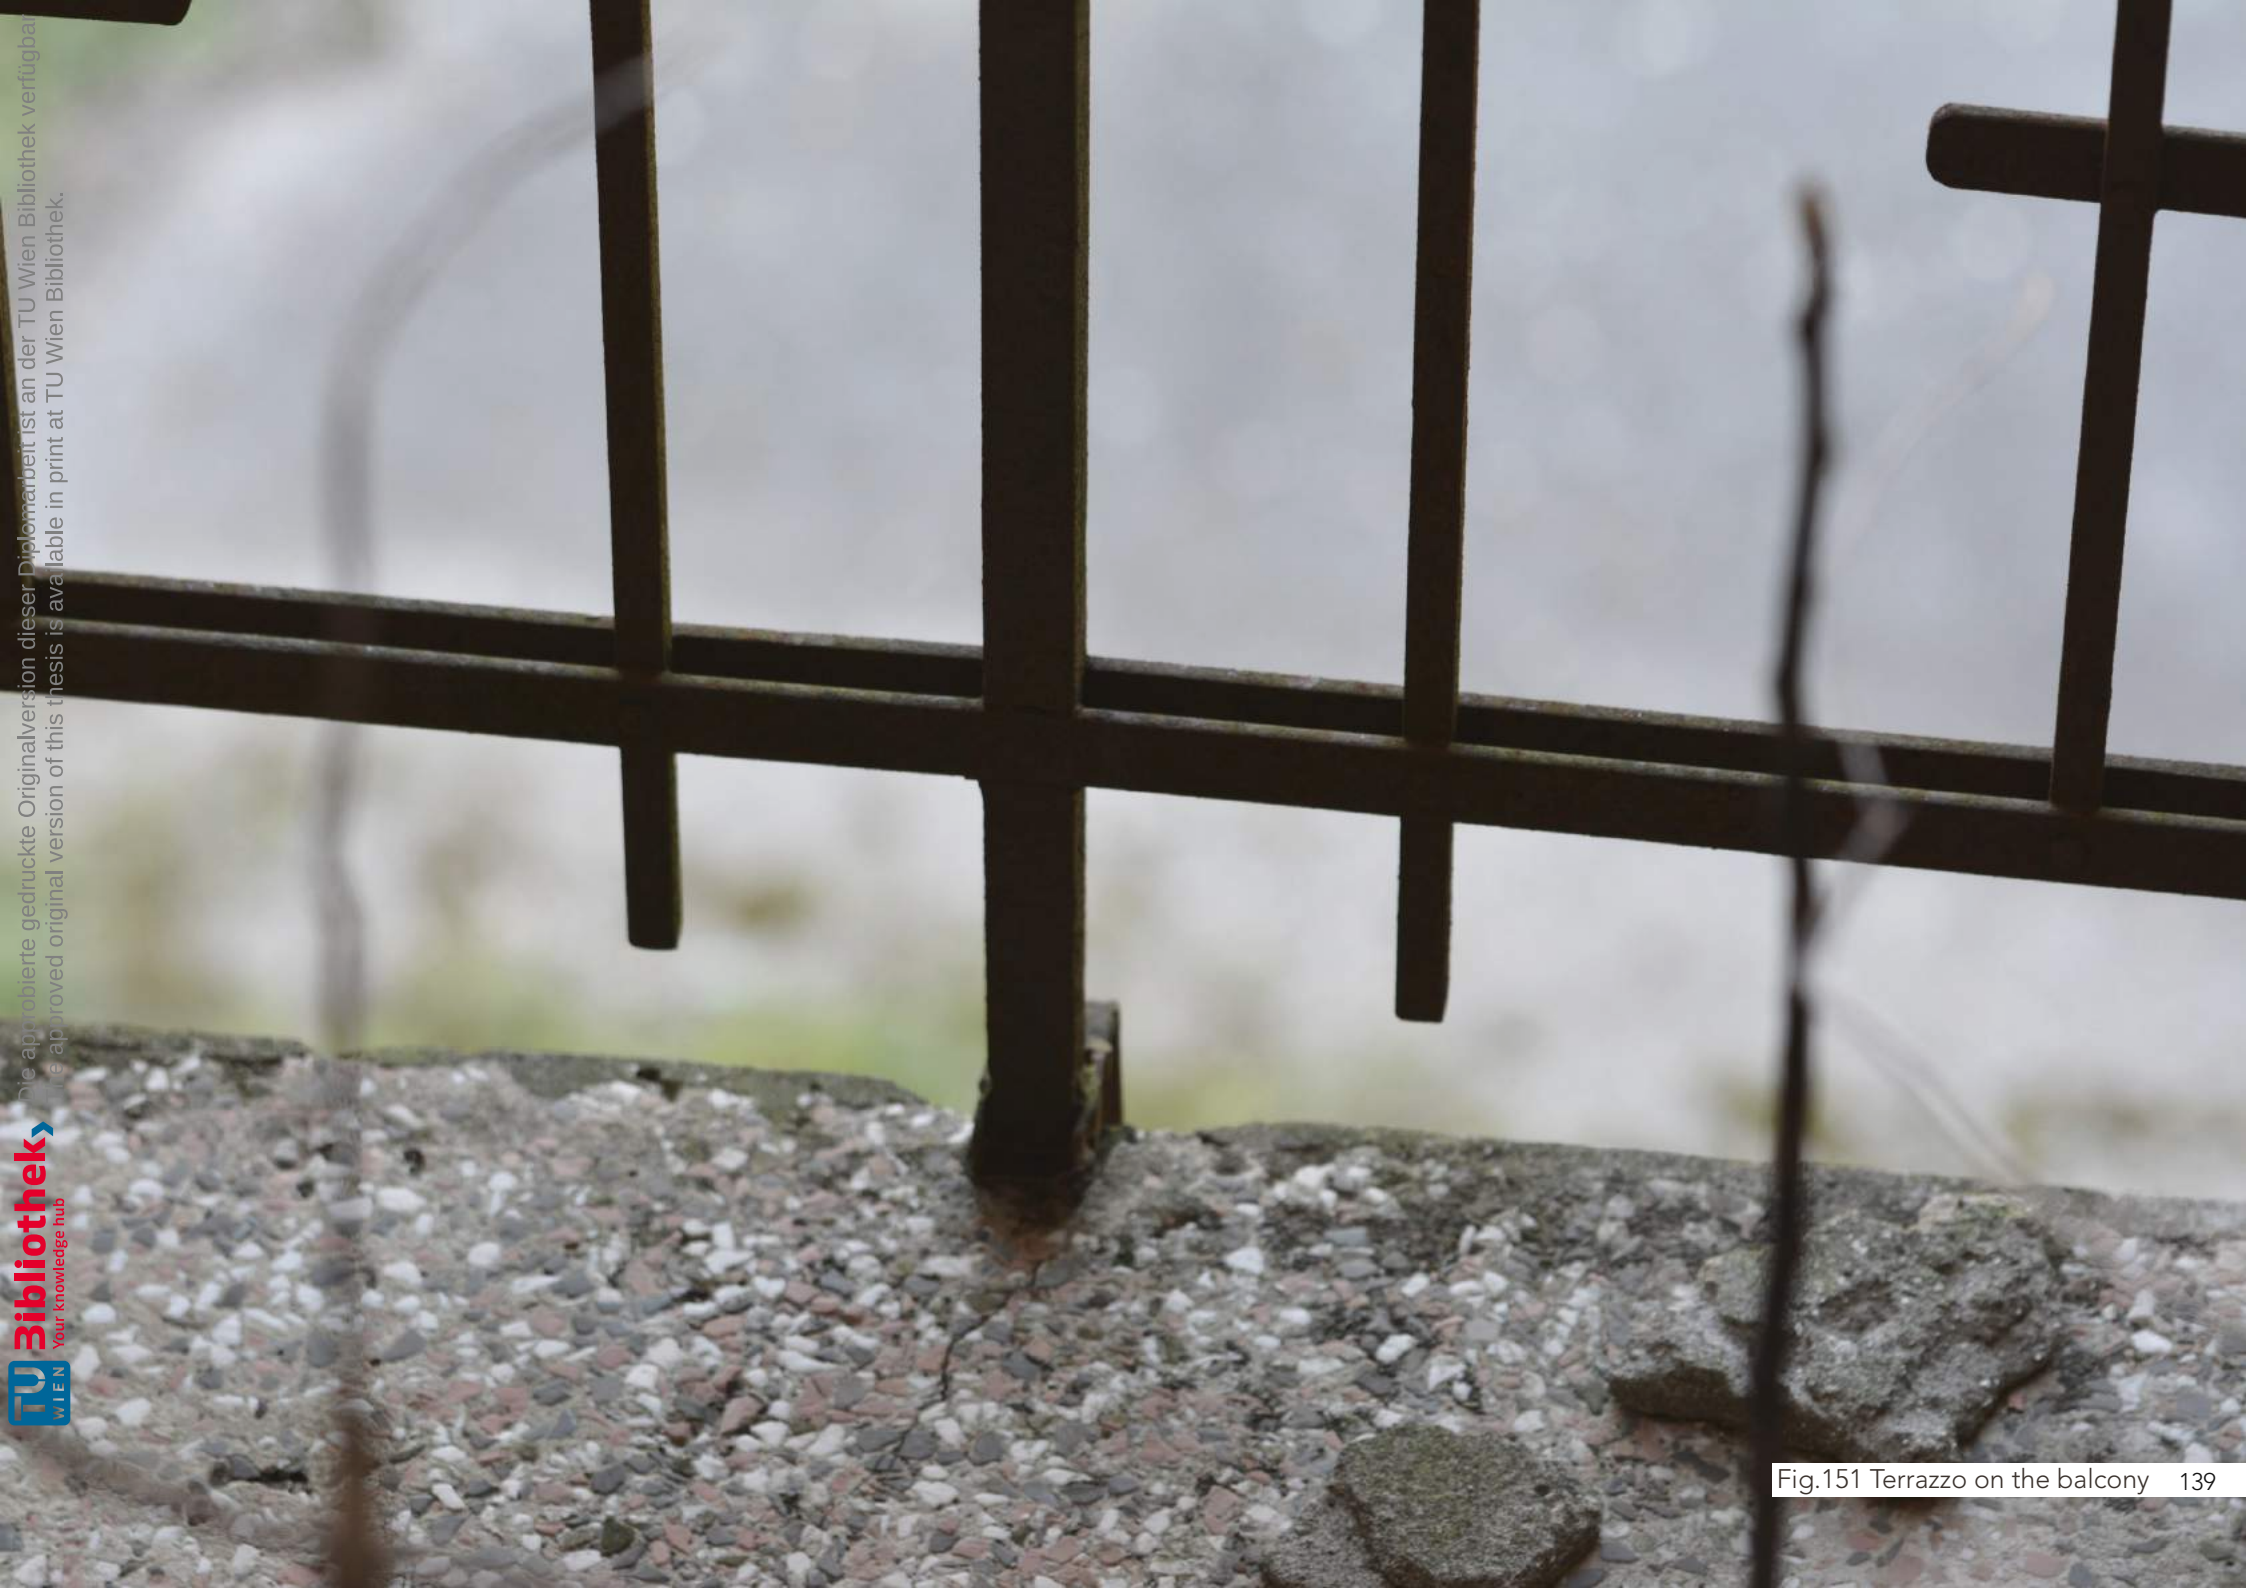
Fig.151 Terrazzo on the balcony 139

Terrazzo elements are one of the essential, often high-quality components of a historic structure and their different appearances, colour and structure influence historic interiors greatly. Preservation of historic floor surfaces is in the foreground of every restoration. The field of monument preservation justifies the addition of new floor structures, installations, and coverings only if the existing ones are secured or they cannot be repaired in any way. When restoring floor surfaces, a proper analysis of its specifics like room climate and insulation, material-technical requirements are to be considered. The sub-layer and the cover layer is to be observed as one thing and their building physics qualities are to be incorporated into the restoration. The continuity of material is always to be aimed for. The administration building has terrazzo floors in its halls, toilets and on its balconies. Luckily, the general state of these floors is good and it doesn't seem it has any severe damages. However, all the rooms are quite full with the old inventory so a great deal of surfaces is covered with it. It is very important to remove all the waste material at first, so the surface can be approached and then

If there are any cavities, flaws and cracks, they are to be repaired with materials that correspond to the existing one; the traditional application technique must also be carried out. With terrazzo, the additions must be carefully chosen because of its surface structure and pattern, colour and design; the appearance of the existing structure must be aimed for. A thought-out concept of maintenance is essential for reviving the material's old glory.⁷¹

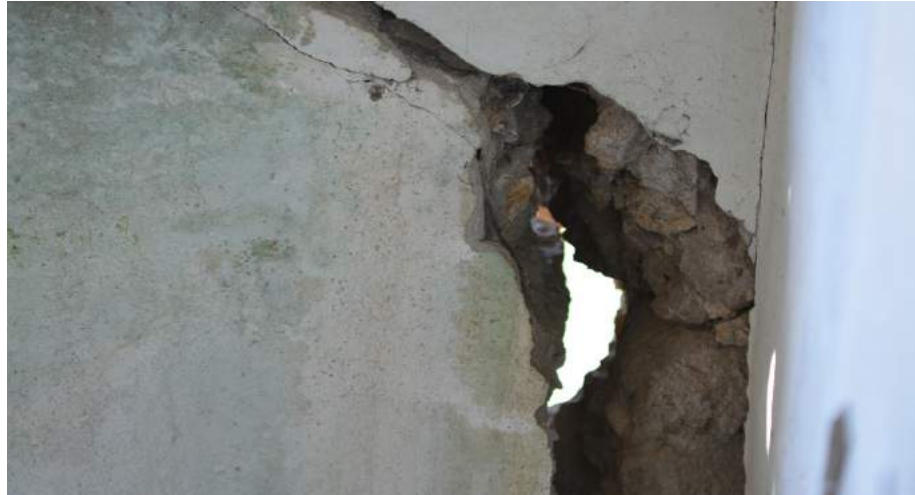
Fig.152 Interior wall cavity

by civil engineers and qualified are strongly needed; especially by earthquake specialists. Almost every wall has a crack or holes in it and the inner structure is often exposed. Some parts of walls may be completely exchanged to retrain the building's full load capacity and to fulfill today's building norms and standards. In order for the load-bearing capacity to be stabilized and increased, cavity and gap injections, needling, and anchoring are often used today; with porous materials like stone and brick, it should be paid attention to vapor diffusion compatibility of the cavities. During this process, holes and cavities should be drilled as dry as possible and with the least vibration. Changes like the lining of imperfections, lining of breakthroughs and openings, support reinforcement, etc., should be done in correspondence to the existing structure; if that is not possible in any way, it is important to mark and identify it as such. Laying out new technical installations in the existing wall structures is to be avoided; if it is not possible to use the existing pipeline routes, a maintenance-friendly solution is to be found without interfering with the historic structure.⁷³

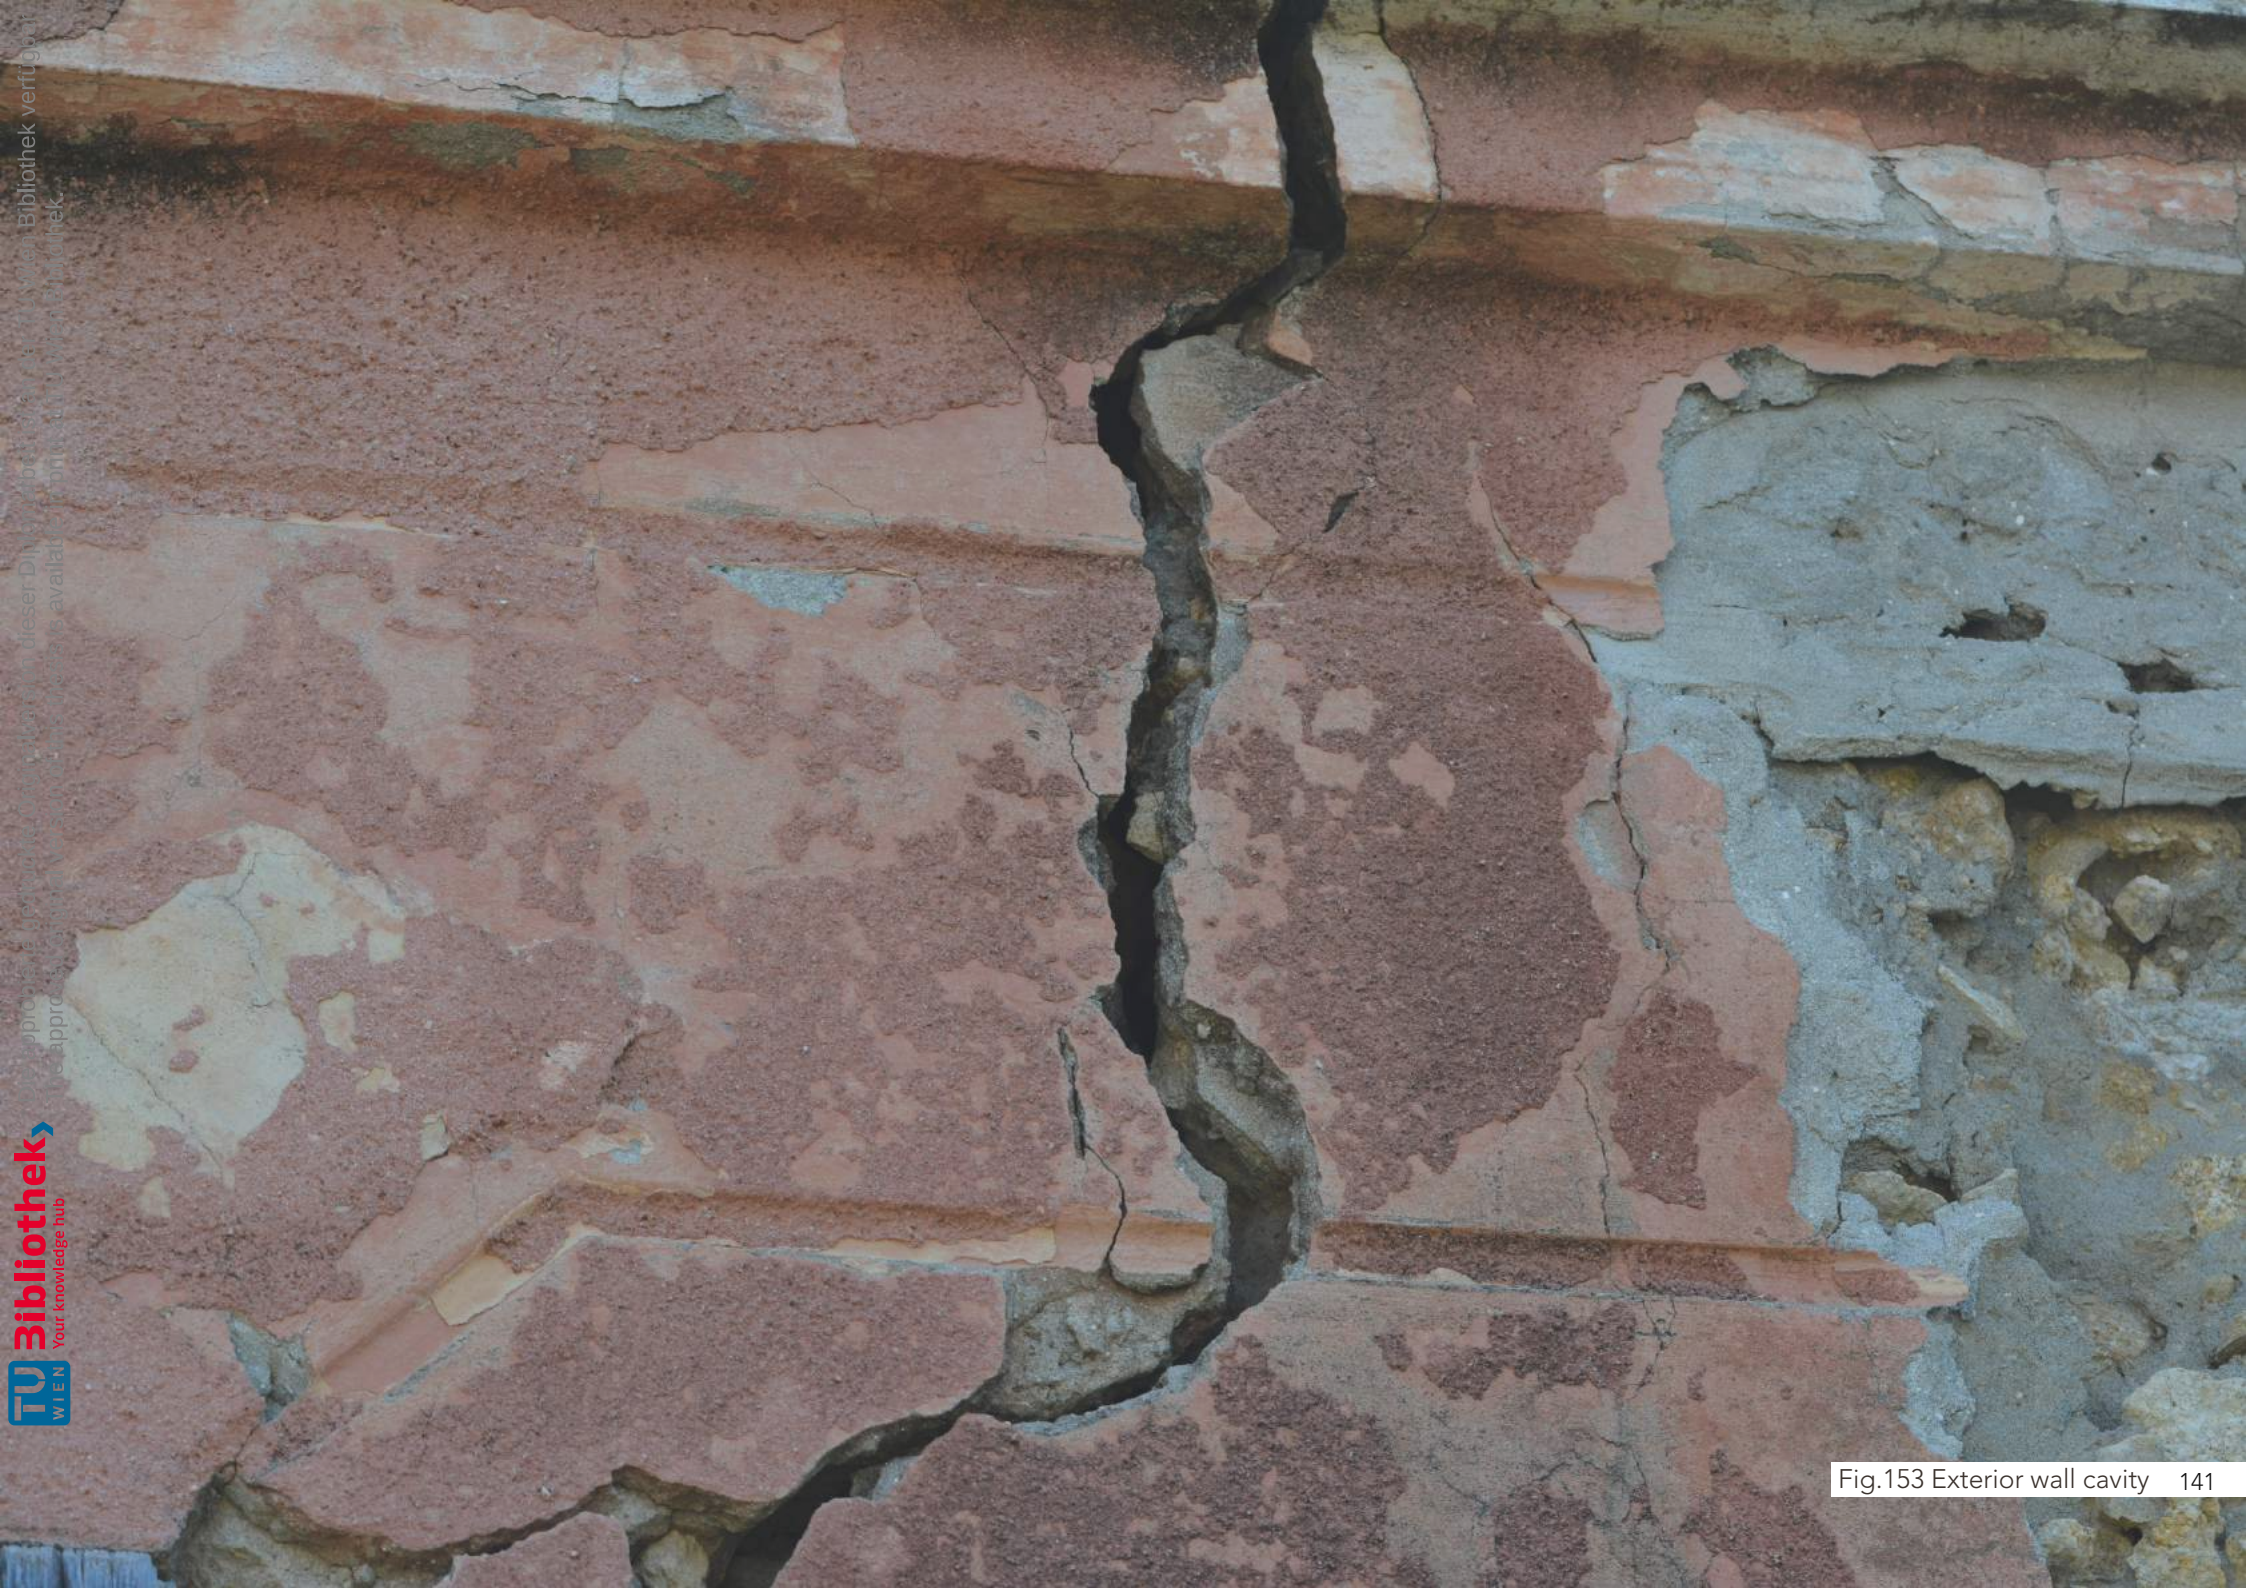
Fig.153 Exterior wall cavity 141

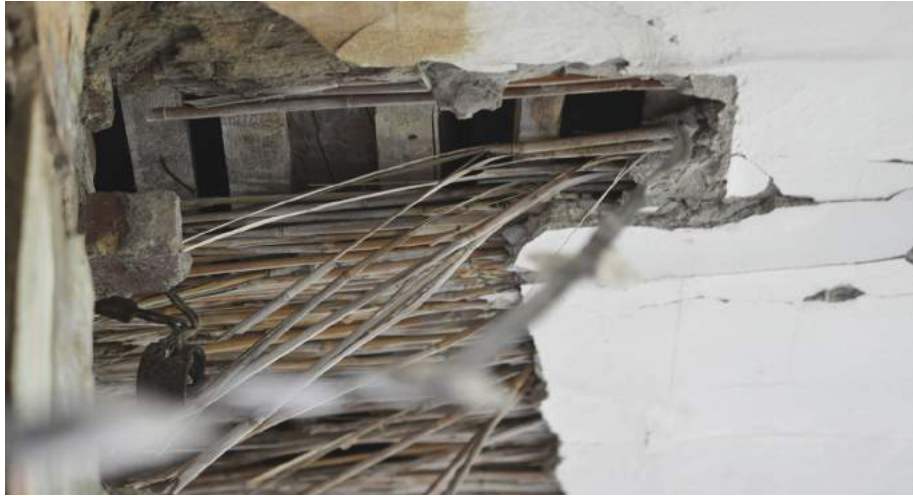
Fig.154 Exposed ceiling construction

Besides being an important structural element, ceiling constructions also have great historical value in monument preservation as they testify about the structural and material technologies of their time. If there is no reason for improving the load capacity, constructive changes on historic ceiling elements are not desirable in the field of monument preservation. Any additions or changes to the existing ceilings, such as repair of cavities or imperfections, structural and support reinforcements, corrosion protection it must be matched to the existing elements. If there is a substantial renovation planned, interventions like structural, thermal insulation, or pipeline installations changes, it all must stay true to the previous and existing construction. The state of the ceiling constructions in the administration building is partially in an extremely bad state; in one room the ceiling completely broke down and in a large number of other rooms it is not safe to walk on the floor construction. A big percentage of the ceiling surface has a number of cavities and holes in it so the inner construction is visible. The wooden beam structure which is the in-between ceiling construction here is

often exposed and the damages are visible; the thermal-acoustic reed layer is also very often visible together with it. It is clear that almost a number of these structures need a heavy or total set of repairs. For the supplementary or repair options, it could be chosen from a replacement, partial replacement, additional elements, and reinforcing materials. When there is a case of necessary structural repairs and reinforcements, there should be invested enough time in coming up with a proper solution that is individual and object-specified; whether or not to choose between system-compliant, material-appropriate upgrading of the existing load-bearing system or to introduce a parallel constructive system. All of these decisions must be made by specialists and in correspondence with the process of restoration. Putting through pipes and other technical installation through historical ceiling structures is not desirable from the monument protection point of view; existing installation openings and maintenance-friendly new constructions like suspended ceilings are to be used for it.⁷⁴
