FLAMINGO NATURE PARK

Revitalisation and adaptive re-use of Salina
in Ulcinj, Montenegro

MASTER-/DIPLOMARBEIT

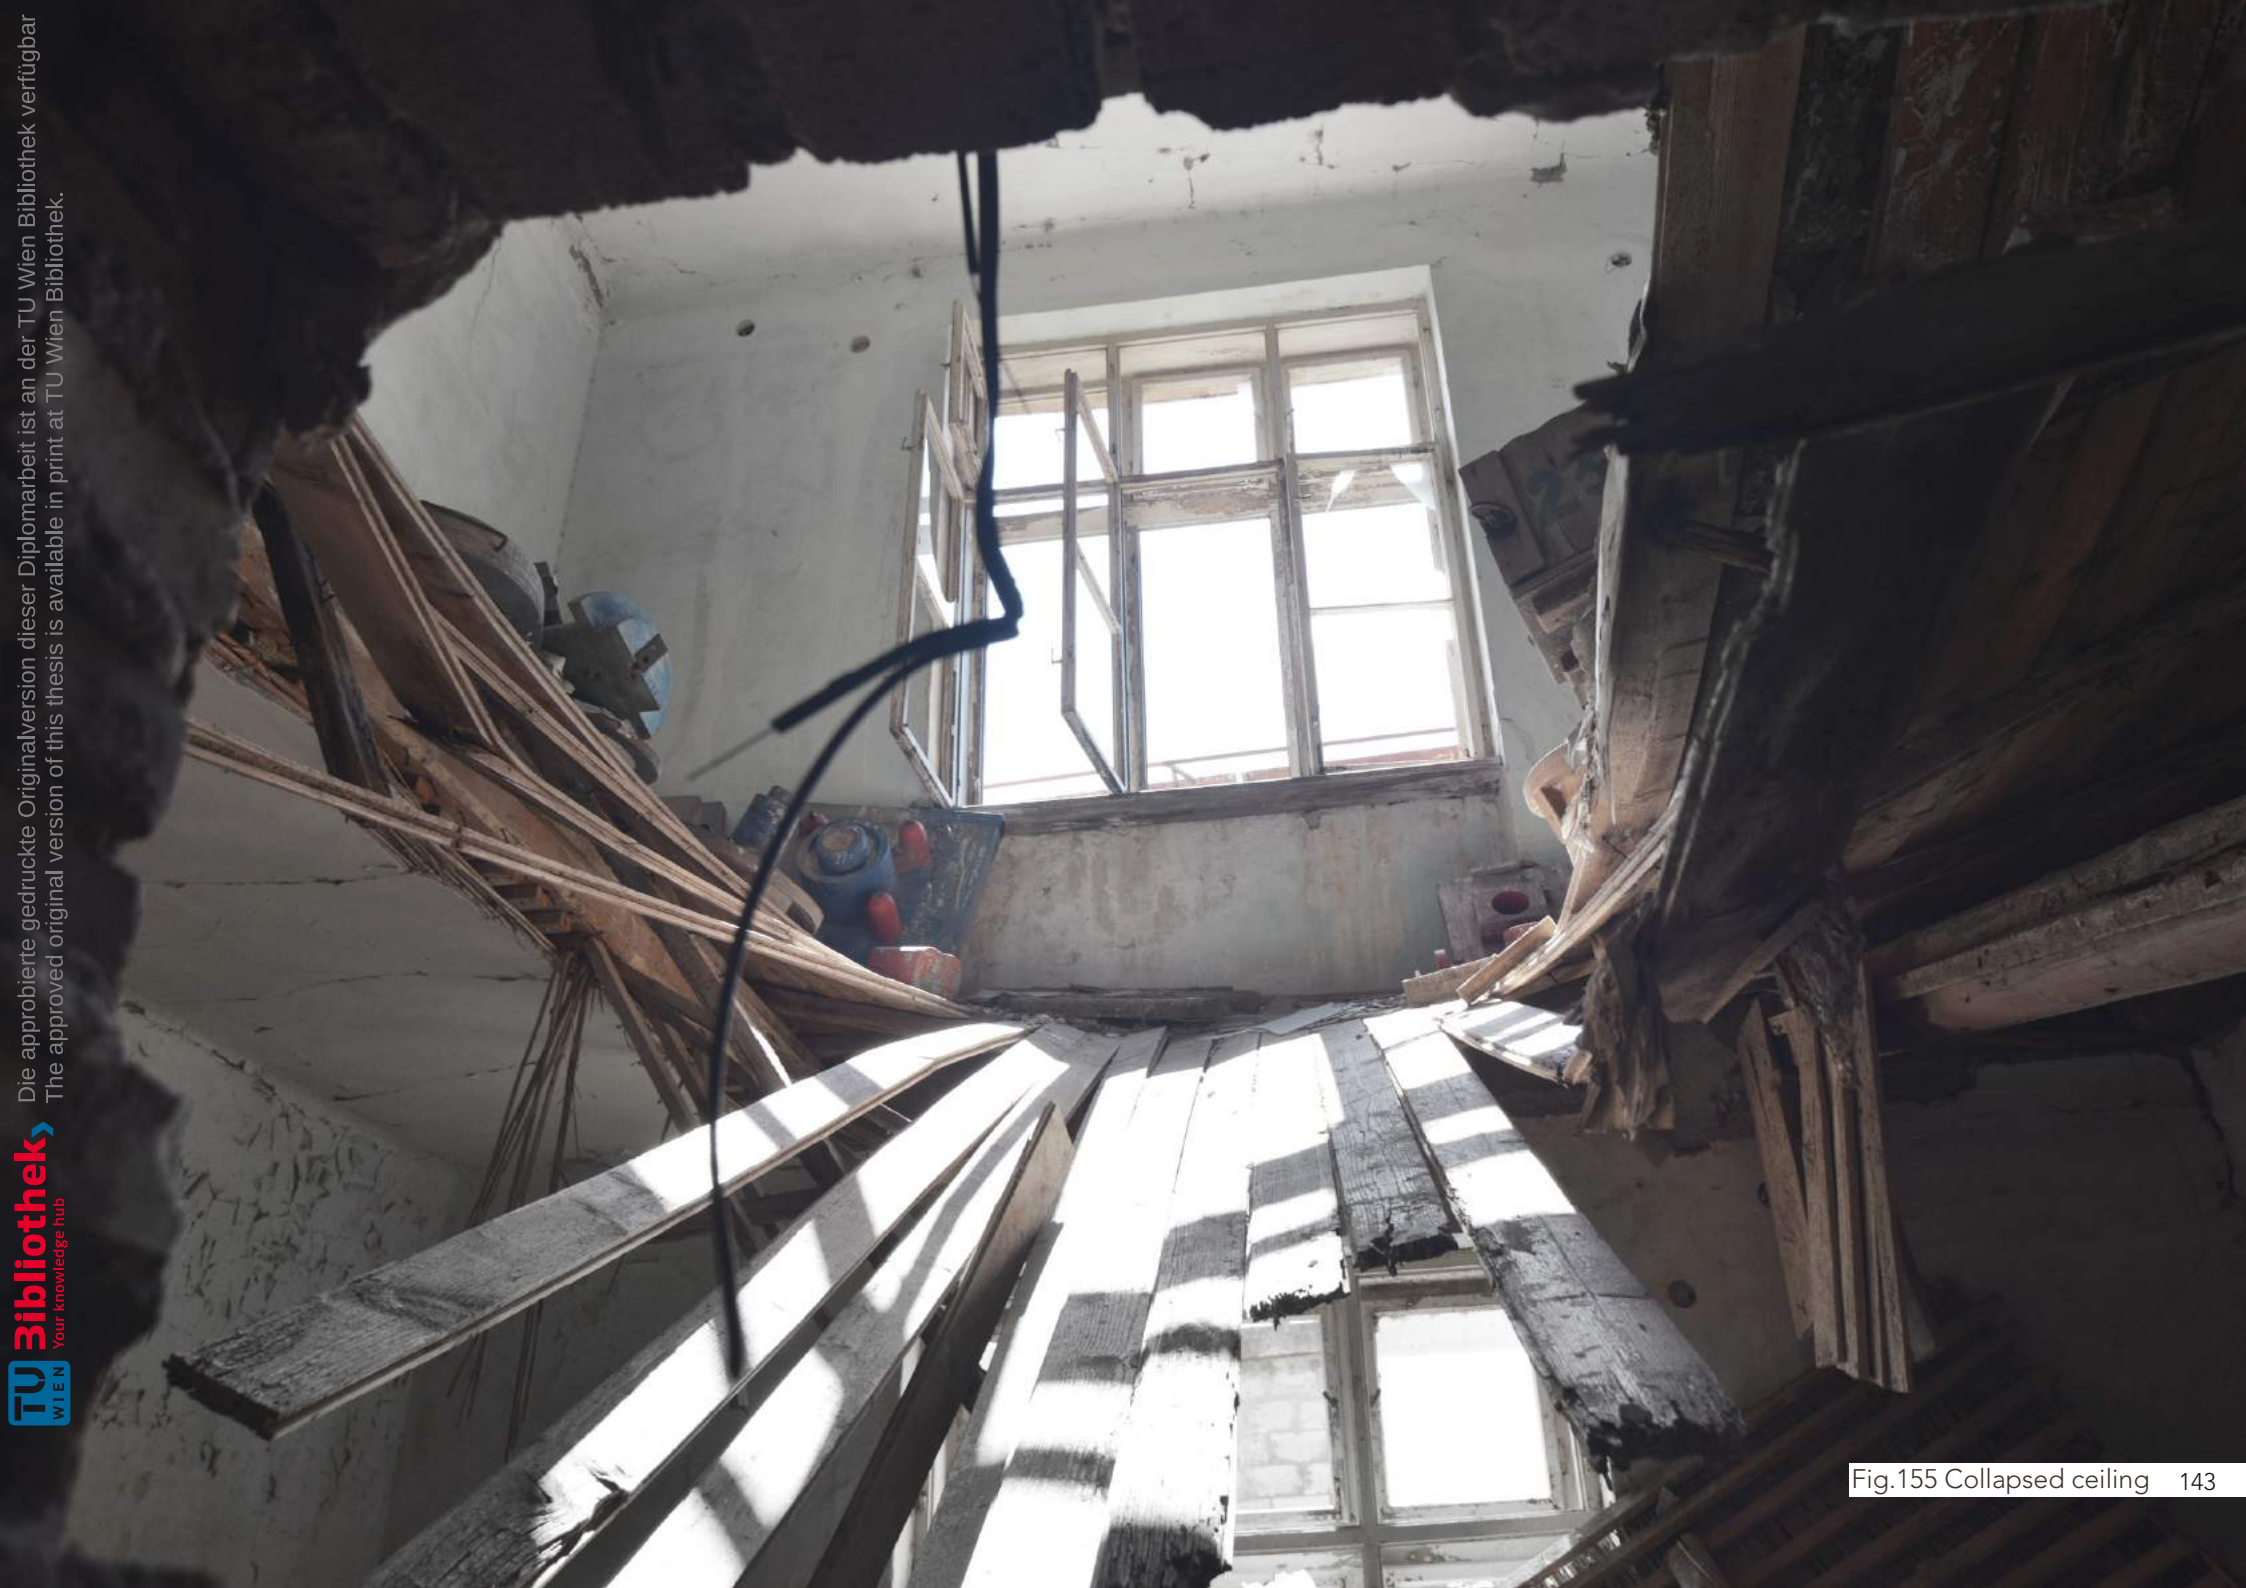
Fig.155 Collapsed ceiling 143

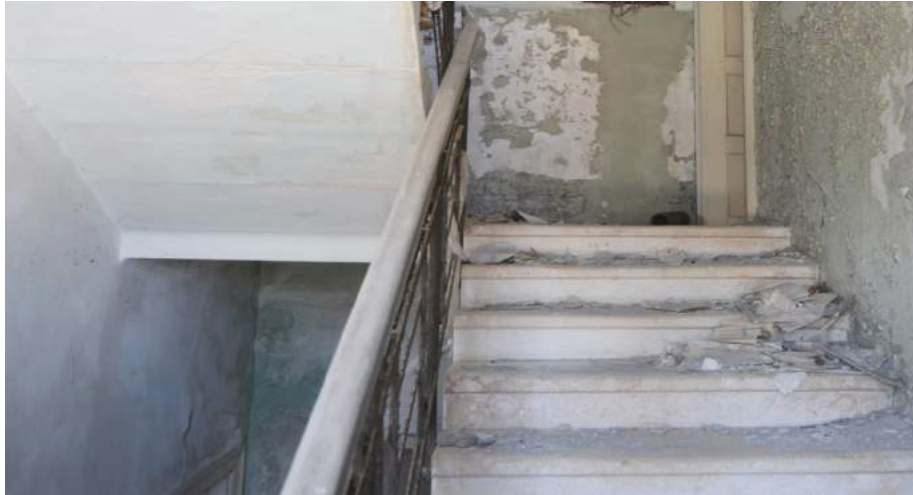
Fig.156 Staircase

Staircase and balconies have always made an important part of an architectural object and have had many different appearances throughout history. Like with other structures and elements, from the monument preservation point of view, neither staircases nor balconies should be strongly modified without any good reason. Unlike with other elements, the technical specifications and building norms have not changed so drastically like with stairs, especially with fire protection regulations and users security. Because of the new norms and requirements, it can happen that the staircase must be adjusted to new standards, but everything in the frame of monument preservation of course. Since that can't always function, sometimes situations like these are solved in a way where the historic building is going to be preserved, but the new function is going to be relocated (new external fire escape). The state of the staircase in the administration building is from pre-fabricated stone elements. It is in fairly good shape; still, maintenance concept must be created in order for it to preserve its original shape and look. At the moment the whole staircase is covered in the old inventory and it needs

to be removed. The surface of the stairs could have minimal surface damage, so an appropriate surface treatment and cavities correction is needed. Administration building adorns balconies on the front and on the back. Because of the mentioned earthquakes, there are some structural damages on the floors; it could be possible that the existing load-bearing structure must be strengthened. A possible supplementary and repair option would be a replacement or partial replacement, additional beams or using reinforcing materials; all of this is to be done according to monument preservation standards and within the historical context. It is also clear there is some microbiological infestation present as well as vegetation so the proper measured for removing it need to be done; there are also serious moisture damages visible that need to be eliminated.⁷⁵

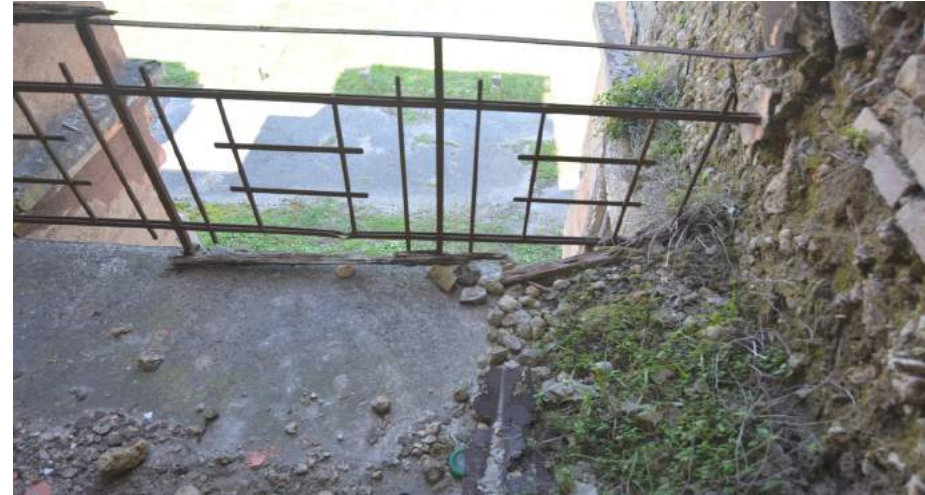
Fig.157 Balcony

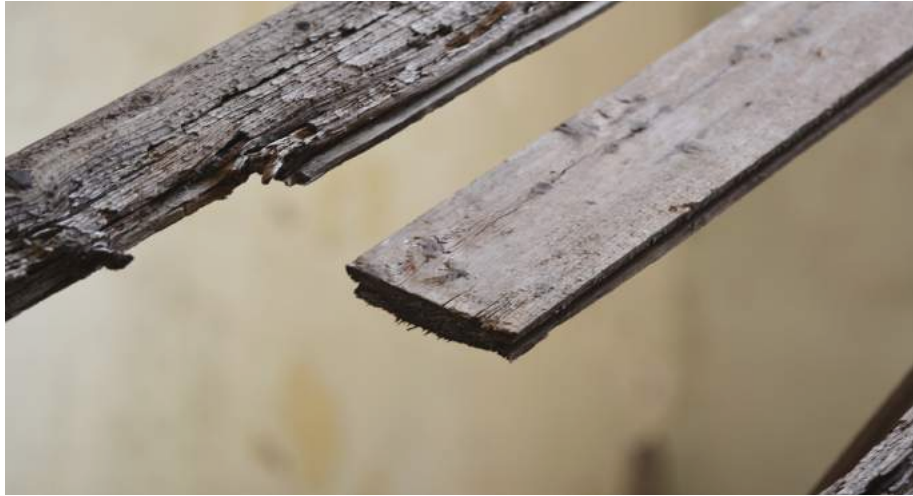
Fig.159 Timber

Roof structures and trusses are highly appreciated in the field of monument protection because of both their aesthetical as well as functional and structural values. They can be often hidden underneath the cladding so an additional intervention could be necessary in order to determine the existing state of the construction. The roof truss of the administration building is visible in some of the rooms second floor where the ceiling has fallen of the truss can be observed; it is almost completely present but the state of the timber is not great. The concept of measures for wood protection should be applied if the estimation analysis says it is going to be sufficient. In another case, unrepairable parts need to be replaced; it should be chosen between introducing a parallel constructive system and upgrading the existing load-bearing structure with the help of additions that are adapted to the existing system. Usually, any additions that are made should be recognizable, but the monument protection analysis chooses to which extent. Any changes and upgrades made must be as identical as possible regarding building technologies and materials. Changing the roof structure

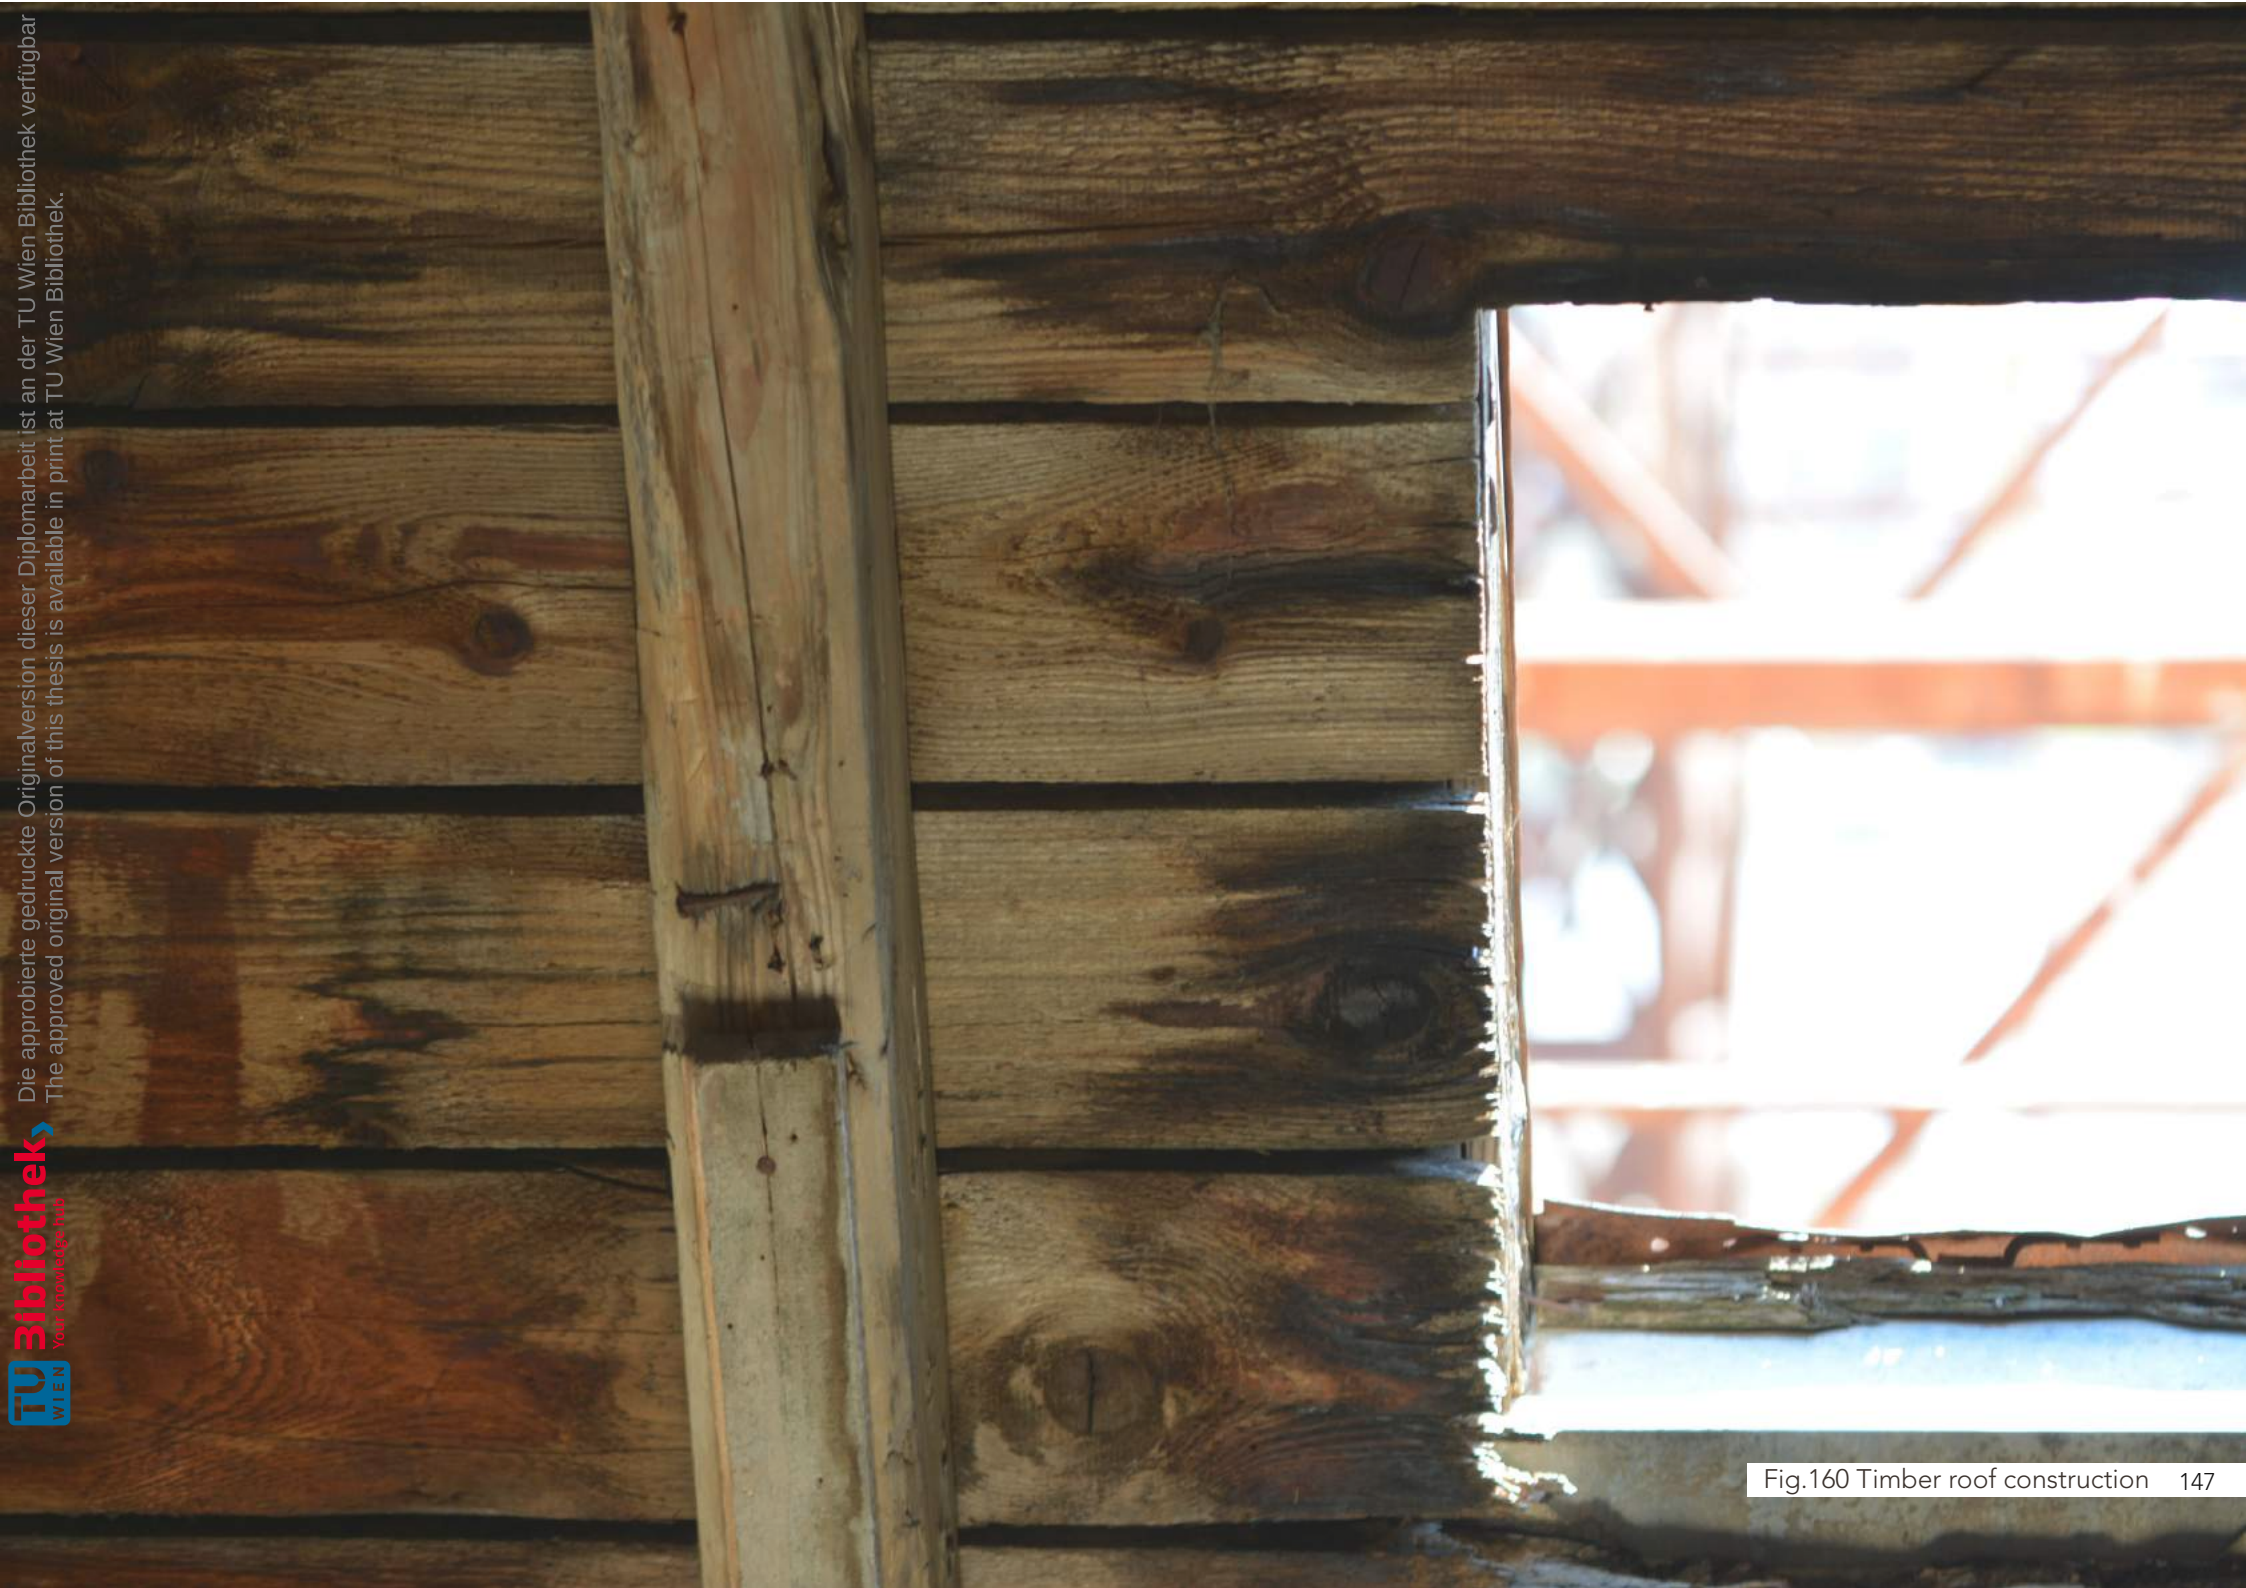
Fig.160 Timber roof construction 147

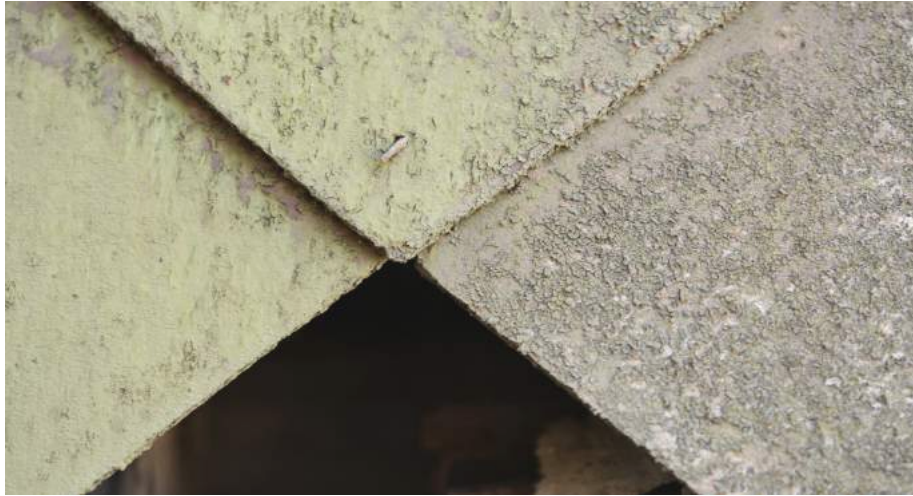
Fig.161 Roof tiles

The roof and its covering make an important part of the external image of the building; it is also a façade of its own. The object's region determines which materials have been used as well as which building technique; climate and hazard aspects are also a big influence on the choice of the roof construction and covering. Aside from the type of construction, the roof aesthetic must be maintained and remain as unchanged as possible or upgrade with new technologies that correspond to the existing structure. The roofing of the administration building is made of rhomboid asbestos plates. Since the general state of the roof is not in a good state and has experienced weathering damages and because of the general hazardous status of asbestos, the whole roof construction should be replaced. There are also numerous holes on the surface and sheet metal constructions on the roof are completely rusted. Fiber cement panels have often replaced wood and stone coverings because of their availability as well as low eight and small formats. Small fiber cement panels as roof coverings should generally not be completely taken down and covered because of the risk of panel

breaking and the general asbestos exposure; both small- and large-format panels can be partially renewed. When covering and replacing the existing panels of the administration building's roof, it must be carefully decided which material is going to be used; it has to be a complement in the appearance, surface, colour, pattern, and design. The current roof and gable landscape must be preserved because without it, the original appearance will be lost; the regional characteristics must also be considered as the roof decking is constantly exposed to the weather conditions so its building physics characteristics must be considered as well.⁷⁷

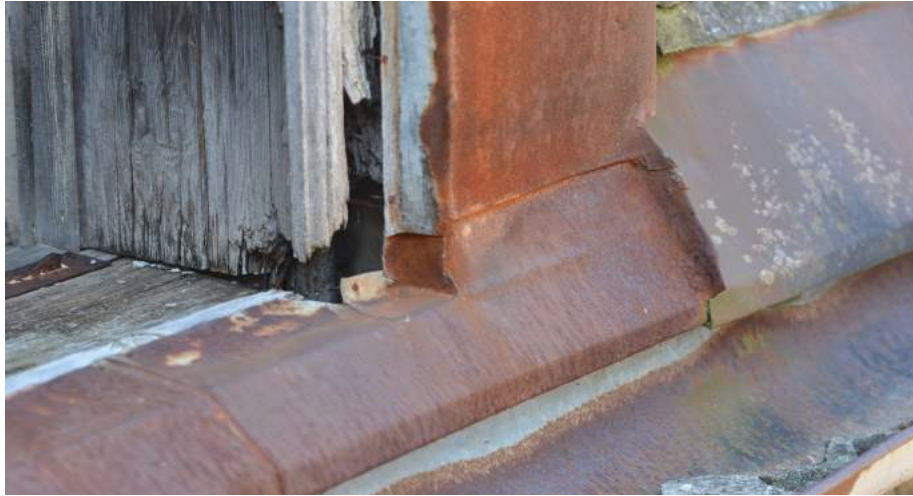
Fig.163 External metal framing and rain gutter

bent; large parts of downpipes are missing on the façade. Existing historical inventory and material, regional conditions, and current technical standards and requirements must be considered. The shape, dimensions, and attachments like gutter hooks must be respected and keep the existing route on the roof structure and eaves when adding any new elements. Technical characteristics like water volume and inclination must also be read from the existing historical structure when planning on adding new systems.⁷⁸

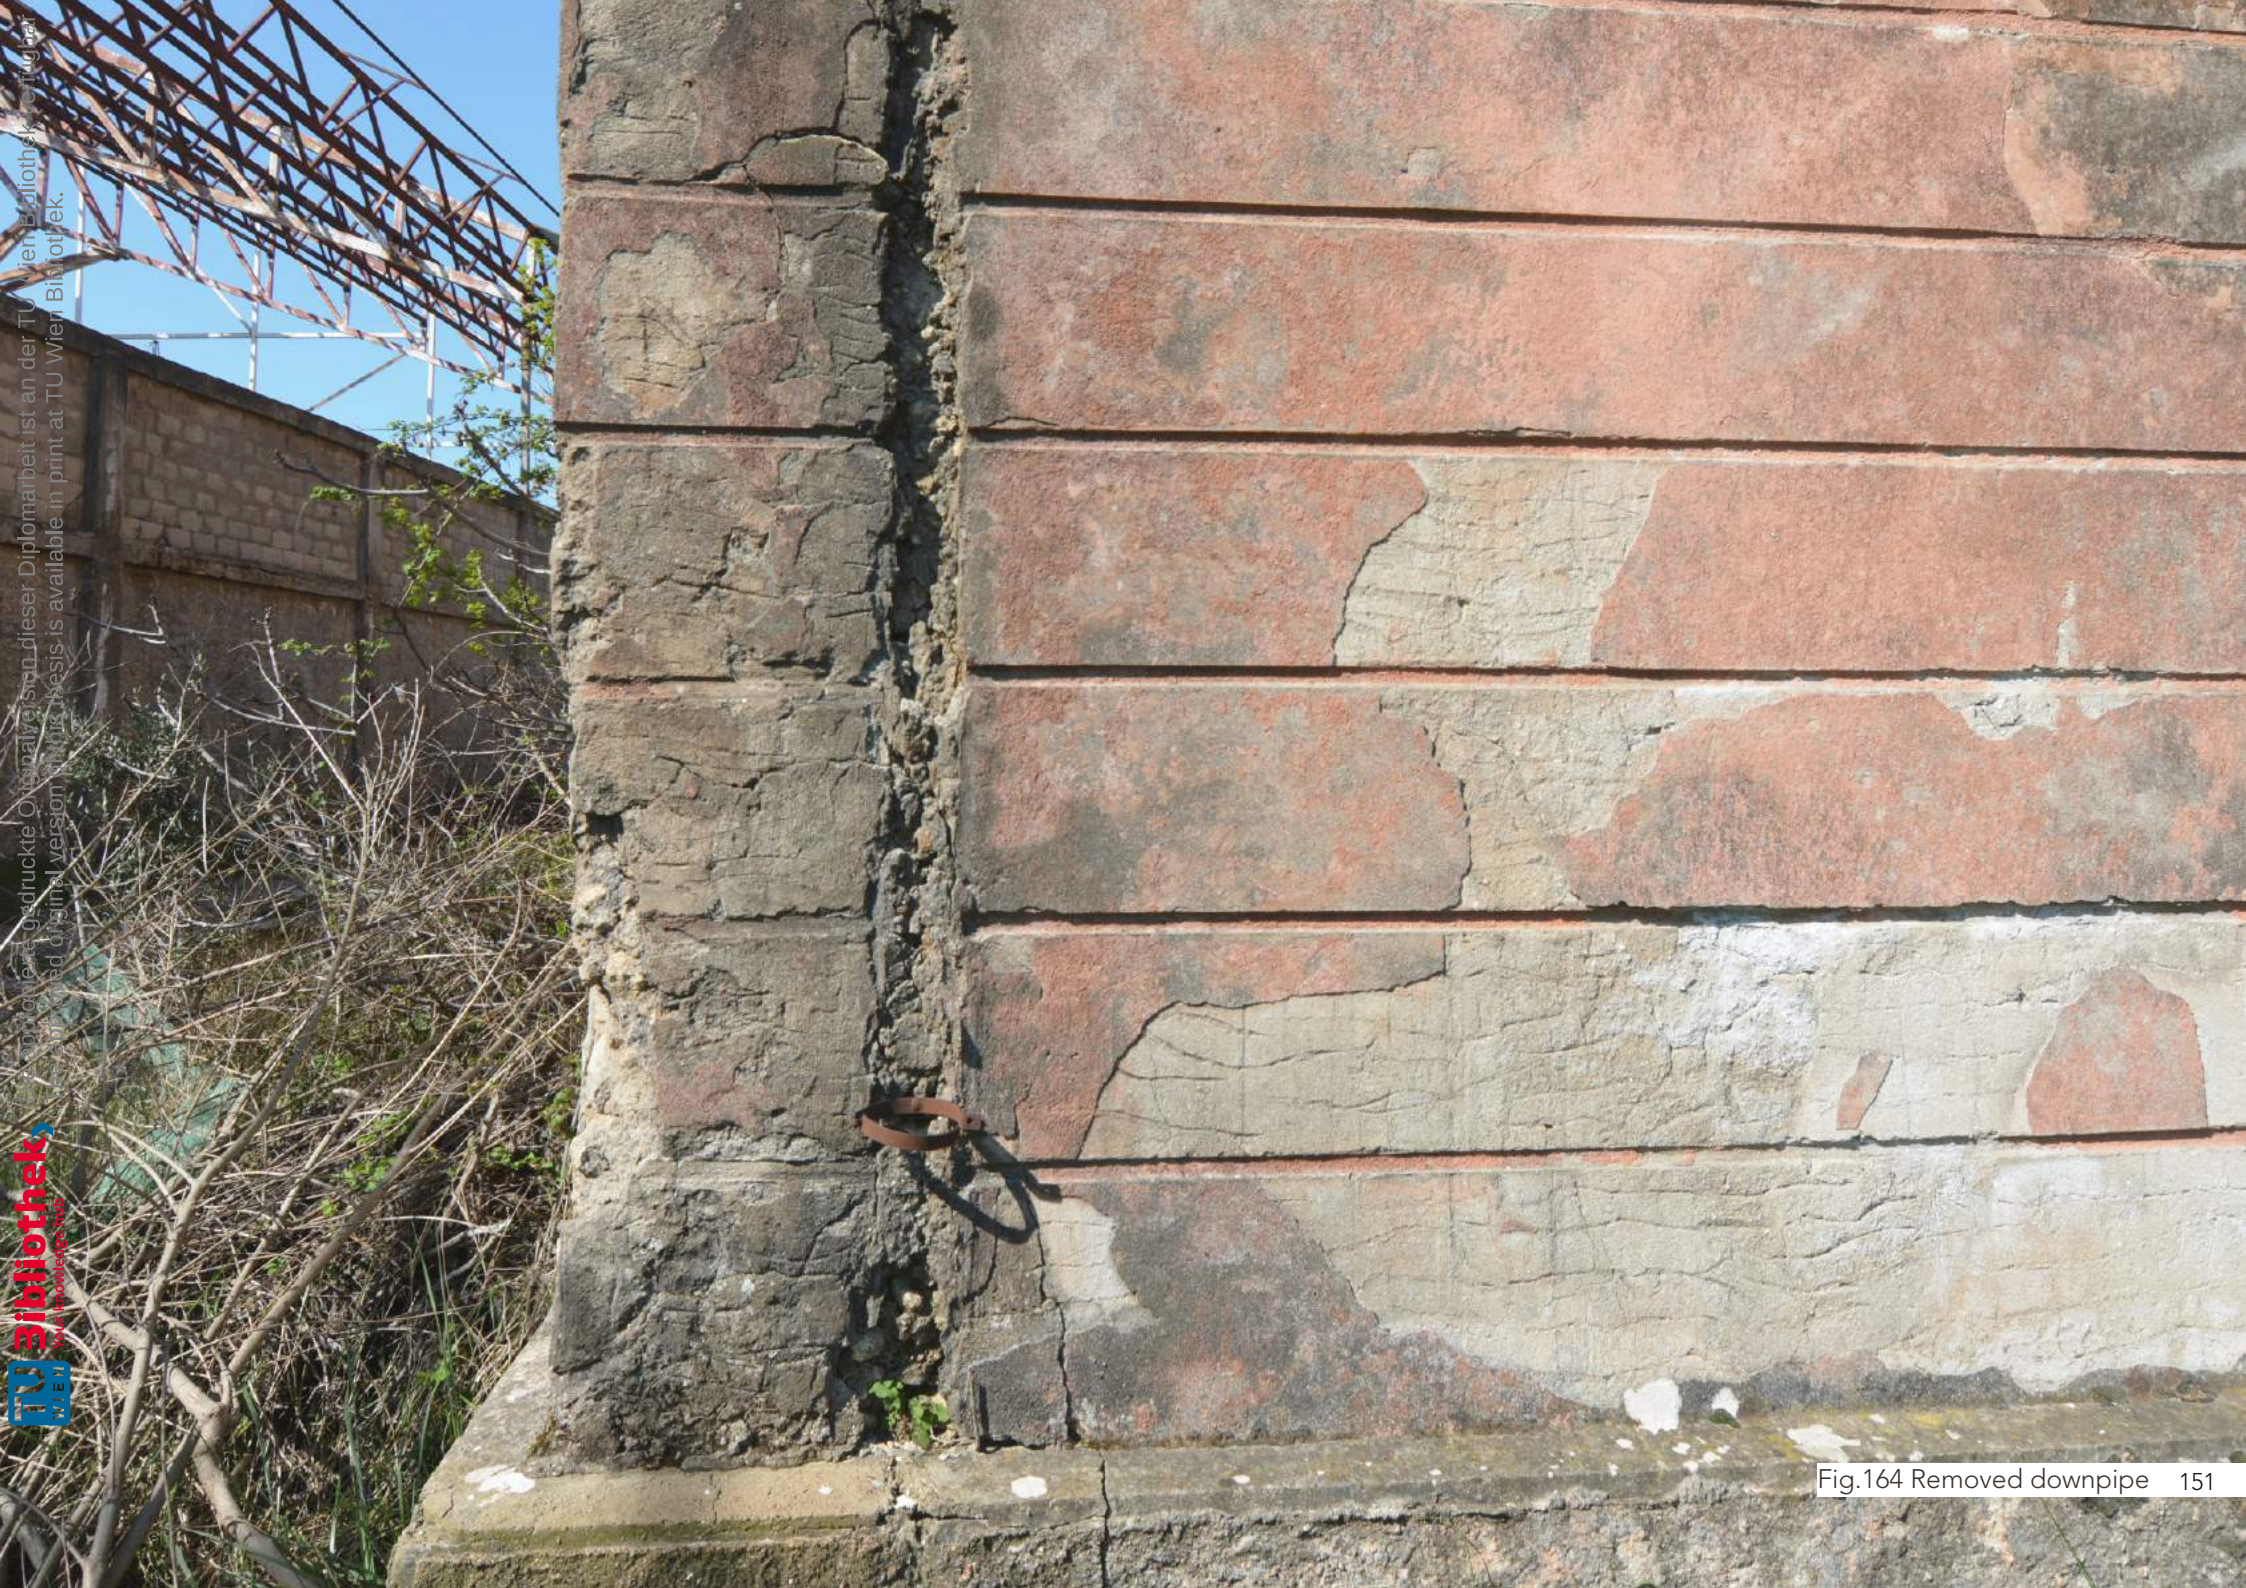
Fig.164 Removed downpipe 151

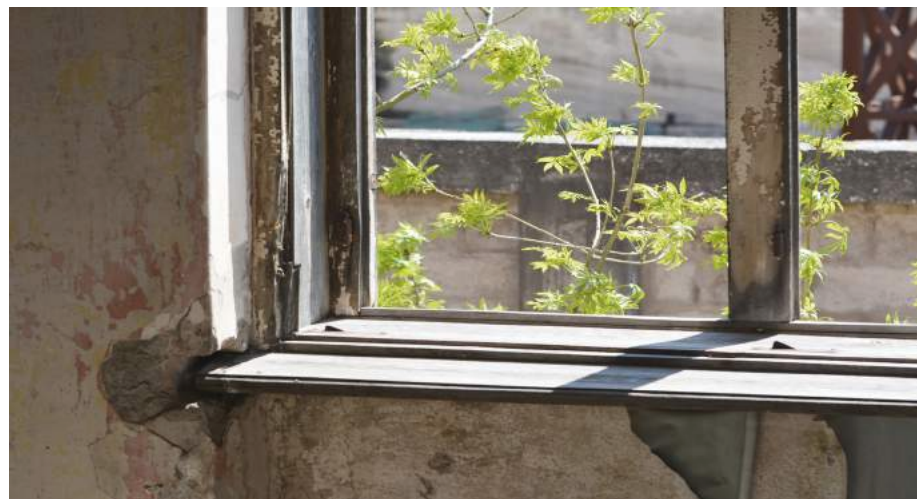
Fig.165 Window sill

and marks should be kept if there is a possibility. Another big part of preserving openings such as windows are the technical requirements; whether it is the preserved historical elements or a replica, windows need to fulfill building regulations and norms, especially in the terms of fire protection. Energetic characteristics must be taken seriously, as well as the room and future building usage, room climate, and regional weather conditions. In order to improve some of these specifics, there are solutions like subsequent seals or changing the coated single glass; important is that the solution is developed for this individual case. Before any addition is being made, a detailed analysis of the existing windows must be made. Detailed drawing must be made according to an individual case, and working with samples is also a very important part. Material continuity, type of construction, functionality, dimensions, profiles, etc., must be respected; especially if a complete renewal is planned. If there are no reasons against it, the functionality of the windows openings such as ventilation function or opening directions should be maintained in order to keep the identity. If the historic window elements are managed to be preserved, a maintenance concept is to be made in order for them to keep their function and recognition.⁷⁹

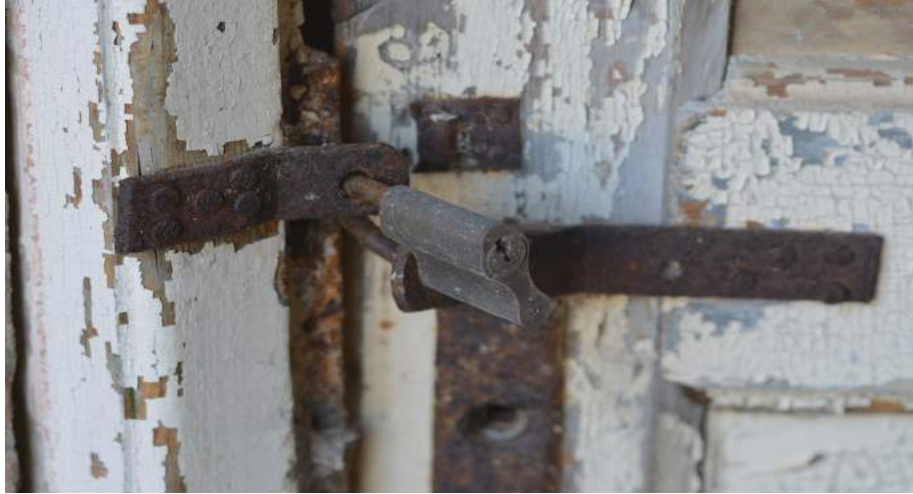
Fig.167 Door detail

construction, functionality, dimensions, profiles, etc. It is important to work with sampling in order to find the best replica; detailed analysis and drawings must be made so that the best possible solution is being found. Special attention must be brought to the possible public usage of the historic object and all the building requirements and standards that need to go along with it; especially fire protection and safety regulations. Energetic characteristics need to be assessed in terms of room/regional climate, future function, and building physics aspects.⁸⁰

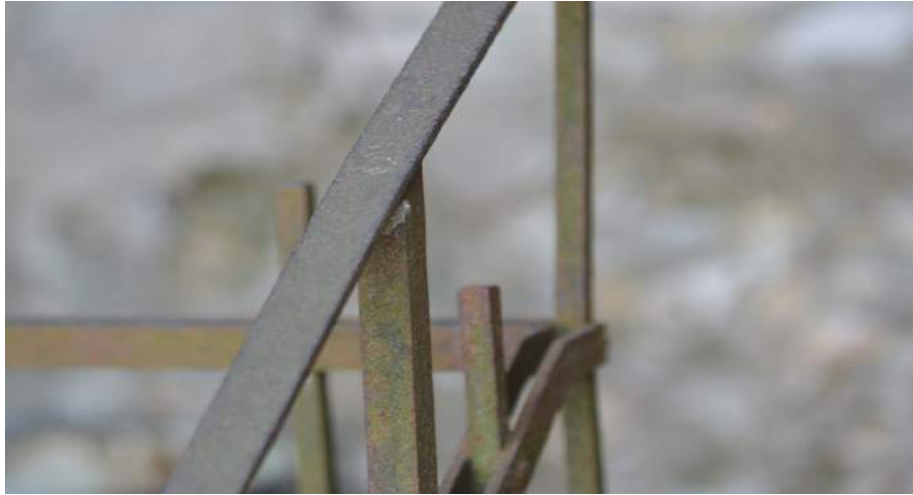
Fig.169 Railing detail

Whether it is a staircase or balcony railing, it has often merged the safety and aesthetical function. Throughout history, different types of materials and construction railing methods have been used on monument objects and it was always the reflection of the historical values and it was always in the interest of monument protection to preserve it. The preservation measures can range from simple cleaning and maintenance or surface treatments to the complete replacement of the railing if nothing else can be done. The railing on the administration building is made out of iron and has a unique design; the same pattern can be noticed on both balcony and staircase railing. It is completely present which helped with maintaining the building character. However, it is not in great shape. Severe surface treatment is necessary (e.g. setting in oil paint, corrosion protection by burning with linseed oil, minimal covering layers, etc.), as well as repairing or adding the top part since it has been distorted in some places or the wooden hand railing is missing. Another thing that should be considered is the current building norm of 1-meter height for railing for the buildings with a height lower of

12 meters; the current railing does not seem to complete this norm so an appropriate solution should be found. The top part for the hand railing could be added to the level of the required height. The space between the individual bars and underneath them must also be checked for safety norms. If it is decided that the railing should be completely replaced, a technical and material continuity must be obtained; the traditional craftsmanship should be aimed for.⁸¹

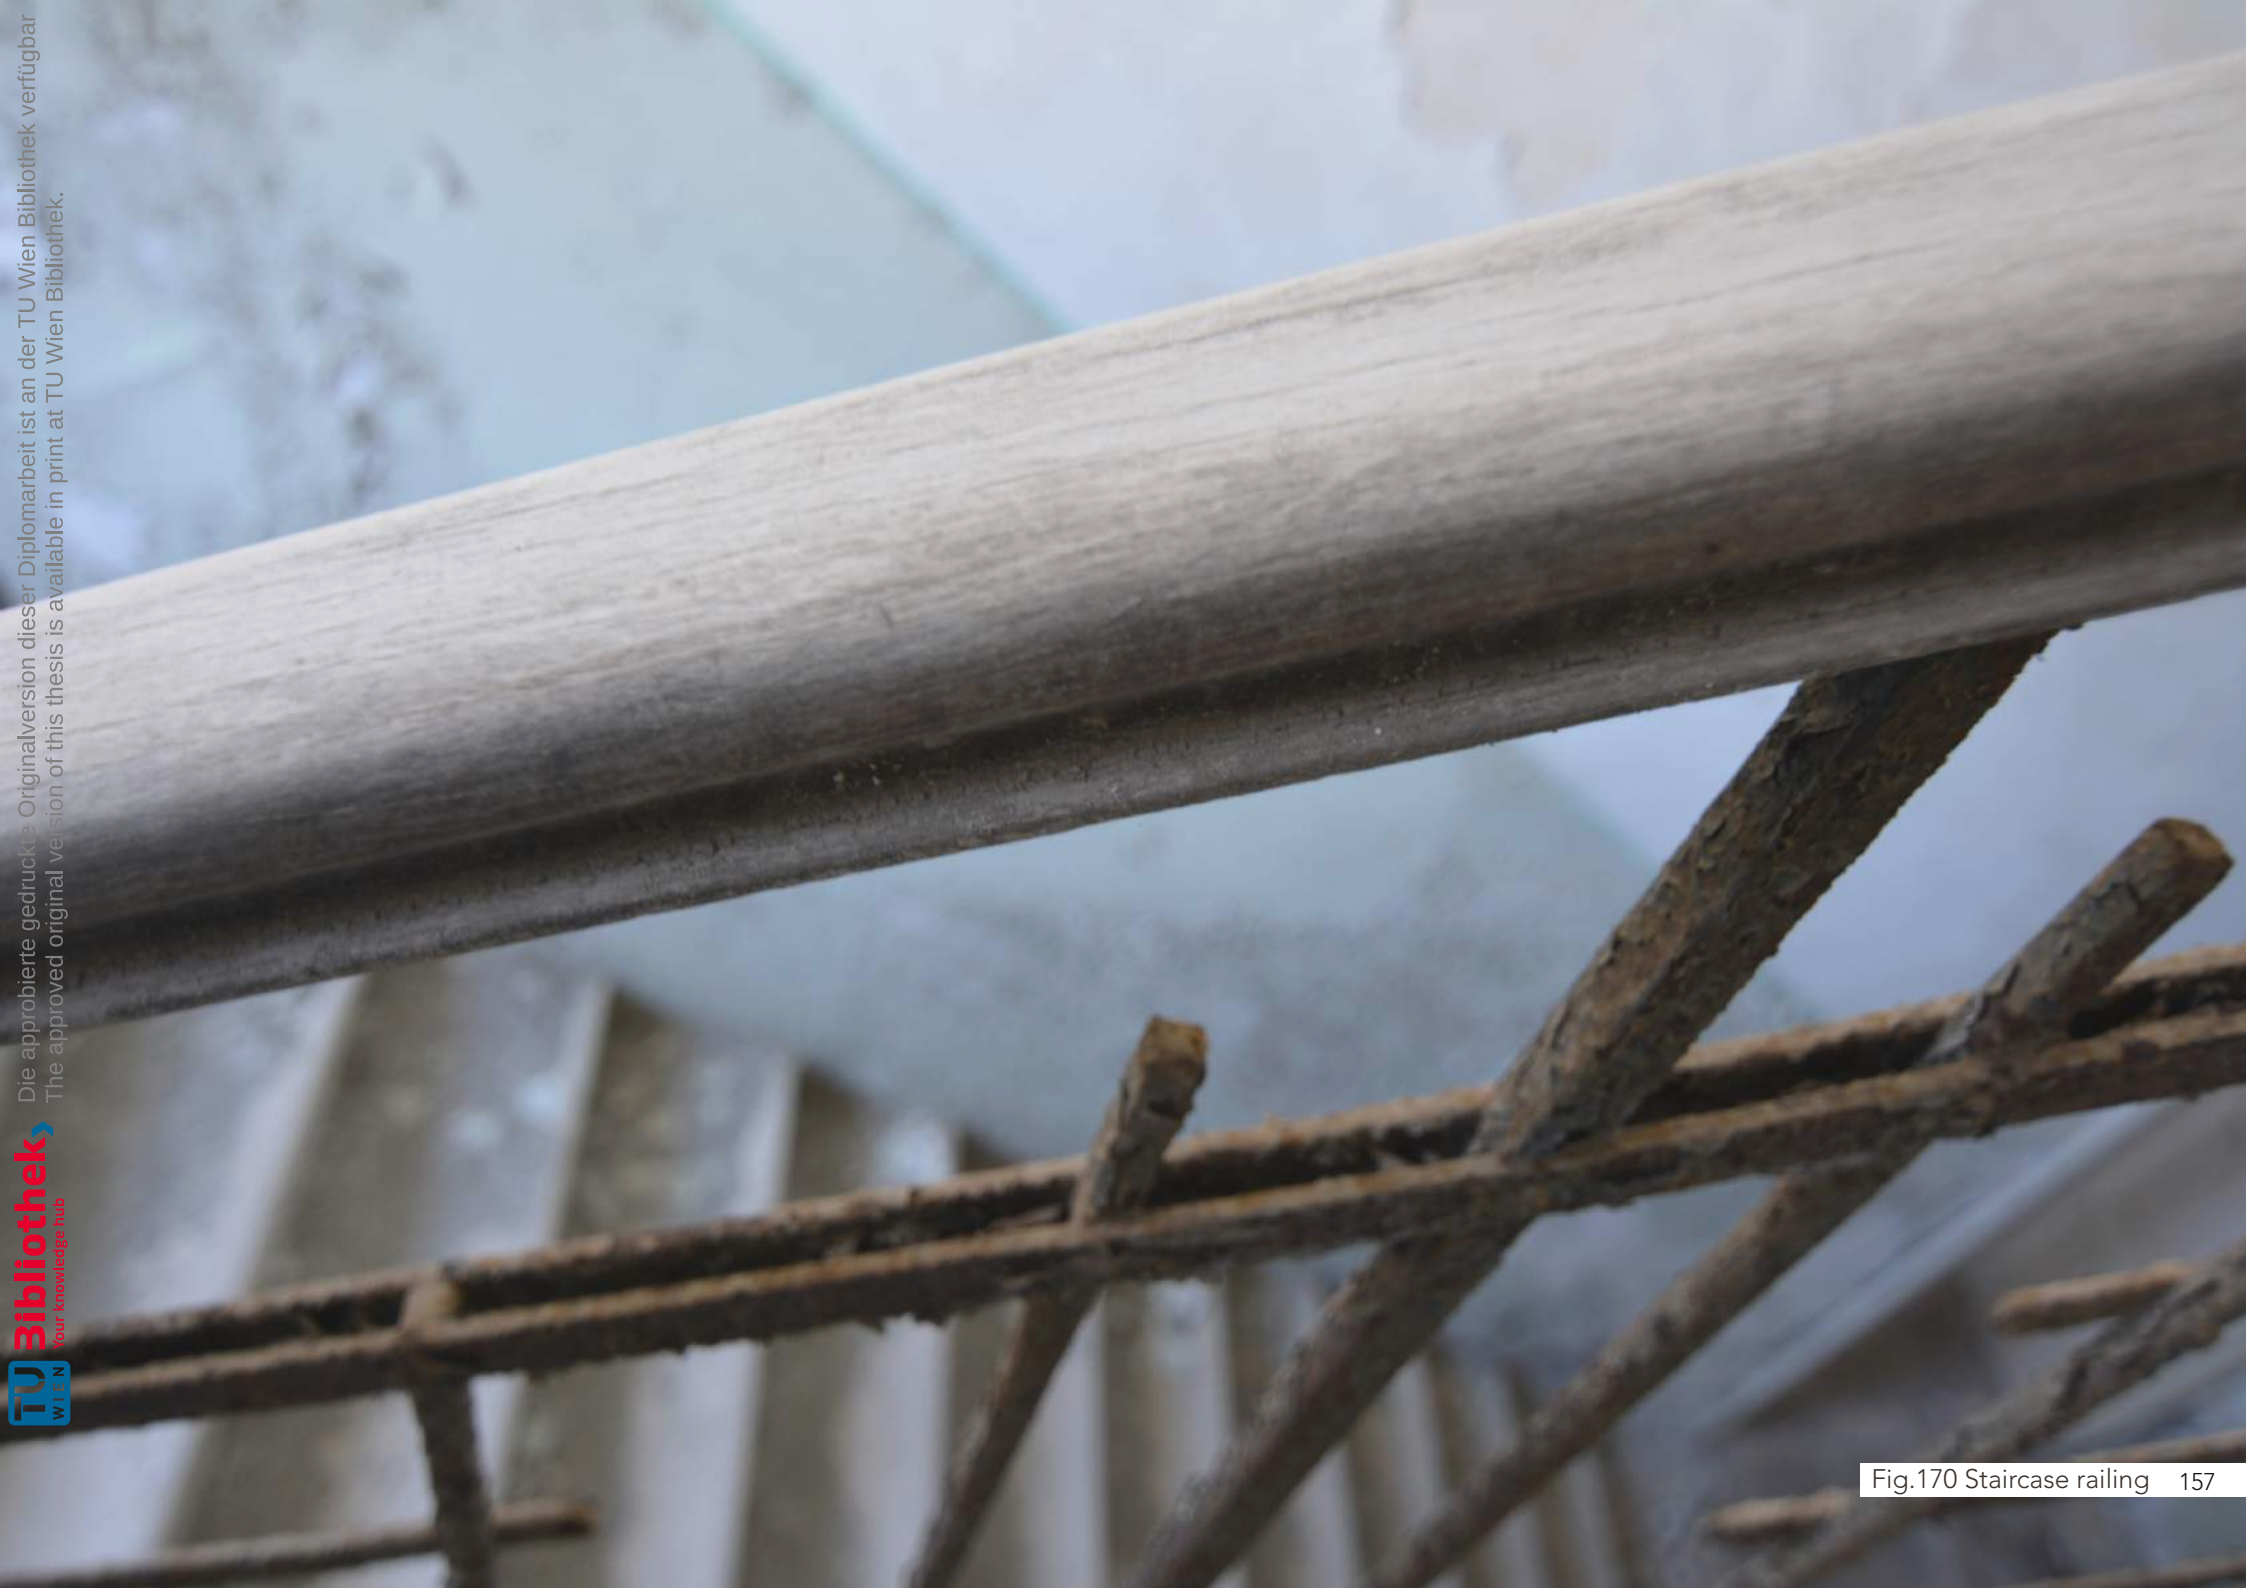
Fig.170 Staircase railing 157

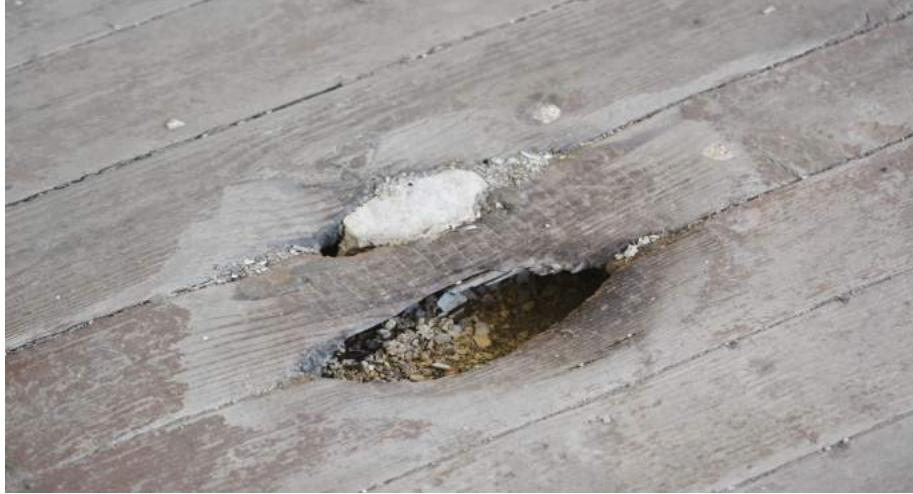
Fig.171 Floor cavity

The structural and artistic developments could be observed through different materials, construction methods, and surface treatments that have been used for flooring during various eras; the appearance of the floors was almost equalized with its function. Since floors can also be heavily struck by time and weather, the measured for conservation can range from cleaning and simple maintenance to repairing or special kind of preservation measures to complete replacement. The individual case must be thoroughly analysed and the right solution must be made within the context of the existing structure. The flooring in the administration building is wooden boards in all the bigger rooms; toilets, halls, and balconies have terrazzo floors. A lot of the old building inventory lays on the floor so it should first be removed in order to determine the real state of the surface. Terrazzo floors have mainly stayed without any bigger damages, which could not be said for the wooden floors. In some of the rooms, wooden boards have been removed and the load-bearing structure is unstable and unsafe. In other parts of the building, the wood has stayed which is very important because there are enough examples for possible future additions. The room-long wooden boards give special character and atmosphere to space. In one room the complete floor and ceiling construction has broken down; in others, there are a lot of holes and cavities. It is possible that most of the flooring should be completely replaced or heavily repaired.

In some rooms it could be possible for the floor surface to be saved and preserved; original and new floors must both be marked so it is known what has been added. Alongside the surface, the substructure must be examined and repaired as well to secure the load-bearing component; if it is going to be rebuilt, it must follow the original structure and be optimized in terms of structural parameters. With additions, the material and technical execution continuity must be respected; building physics parameters must be considered; new structures should be constructed to be damage-tolerant also improve the existing parameters with components such as floor heating and insulation- but it all has to be in correspondence with the historic structure.⁸²
