FLAMINGO NATURE PARK

Revitalisation and adaptive re-use of Salina
in Ulcinj, Montenegro

MASTER-/DIPLOMARBEIT

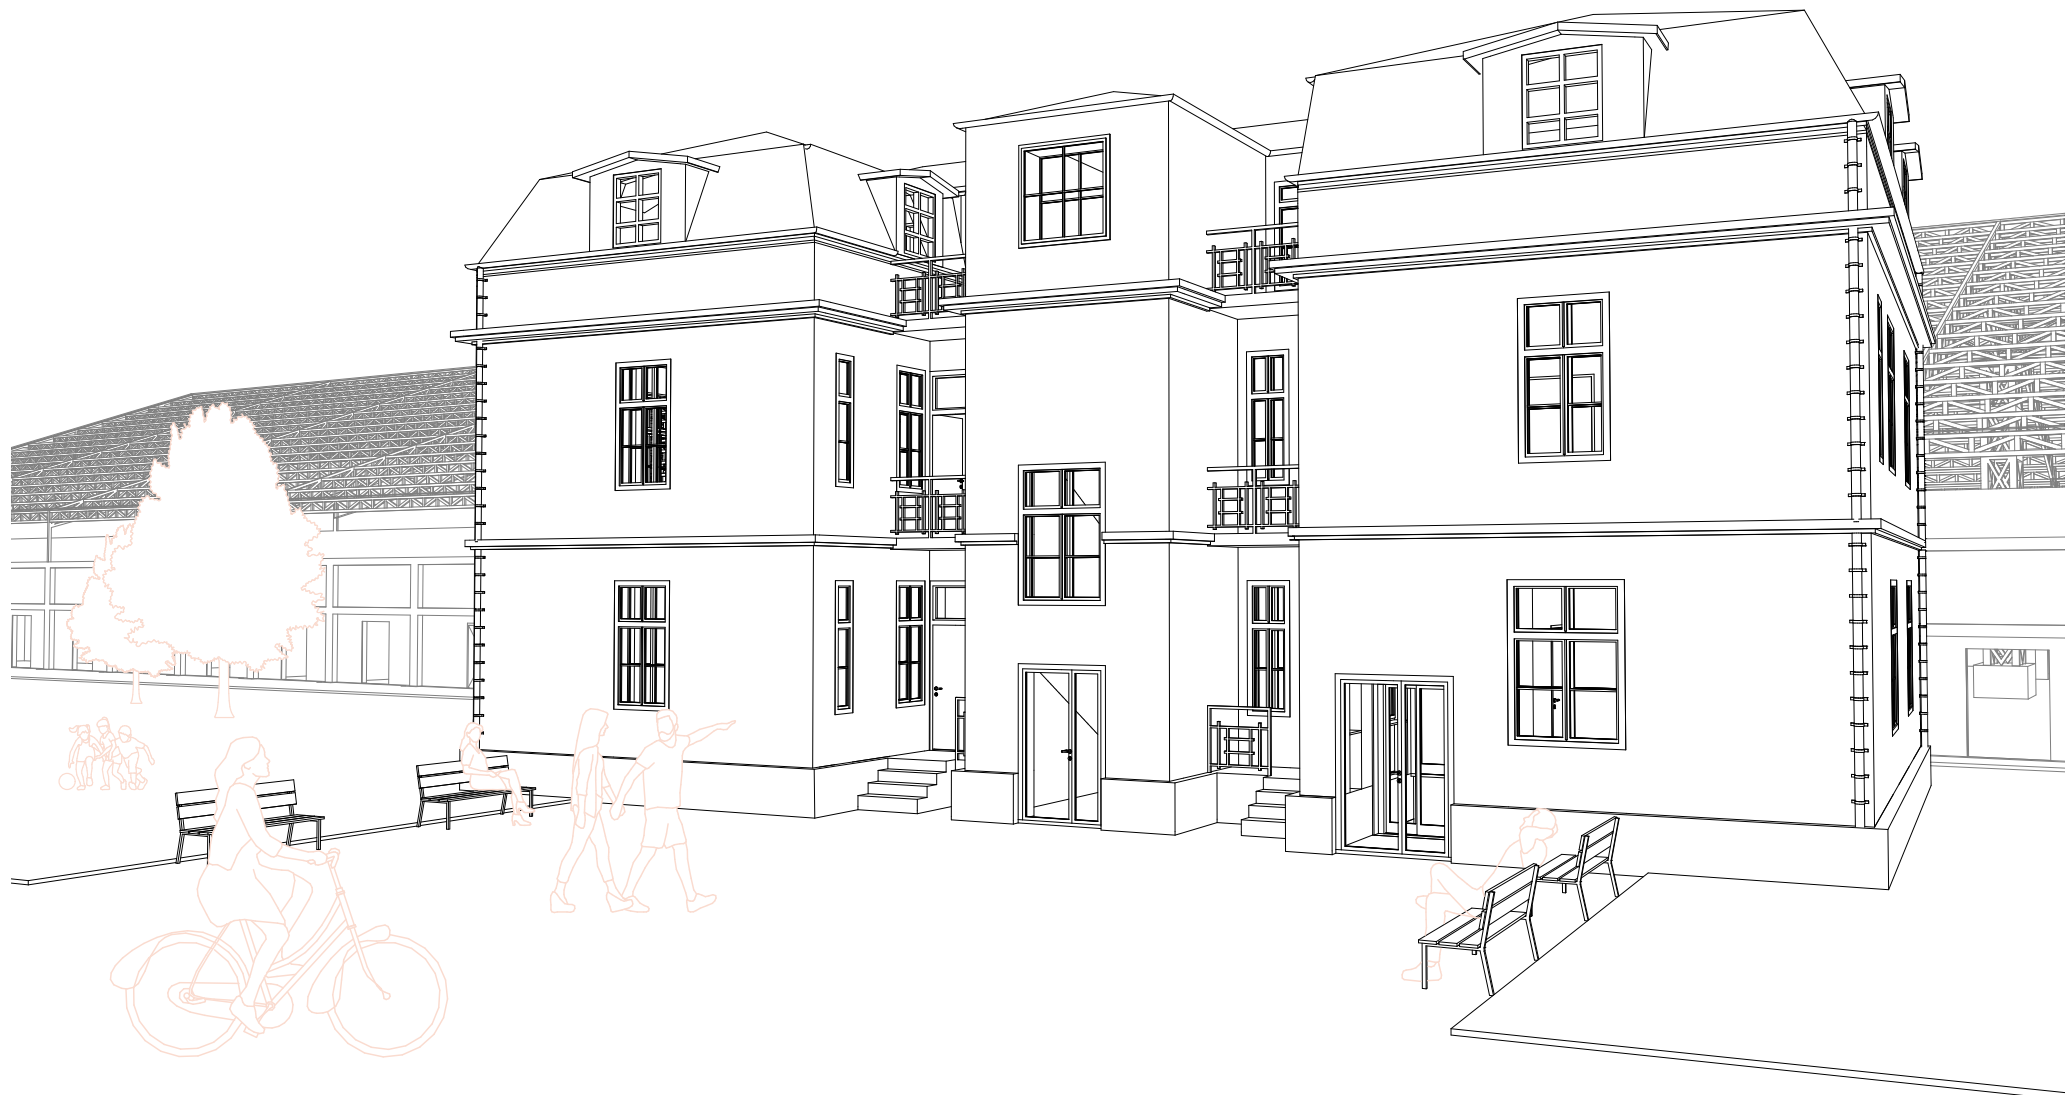
Fig.174 Outside perspective museum 165

For the general design of the museum, the original image of the administration building was kept; wooden double windows have been reconstructed as well as doors and the railing. Since the administration building has no basement cellar, the whole technical elements and storage have been put into the opposite building-the learning center that has no issues with space storage.

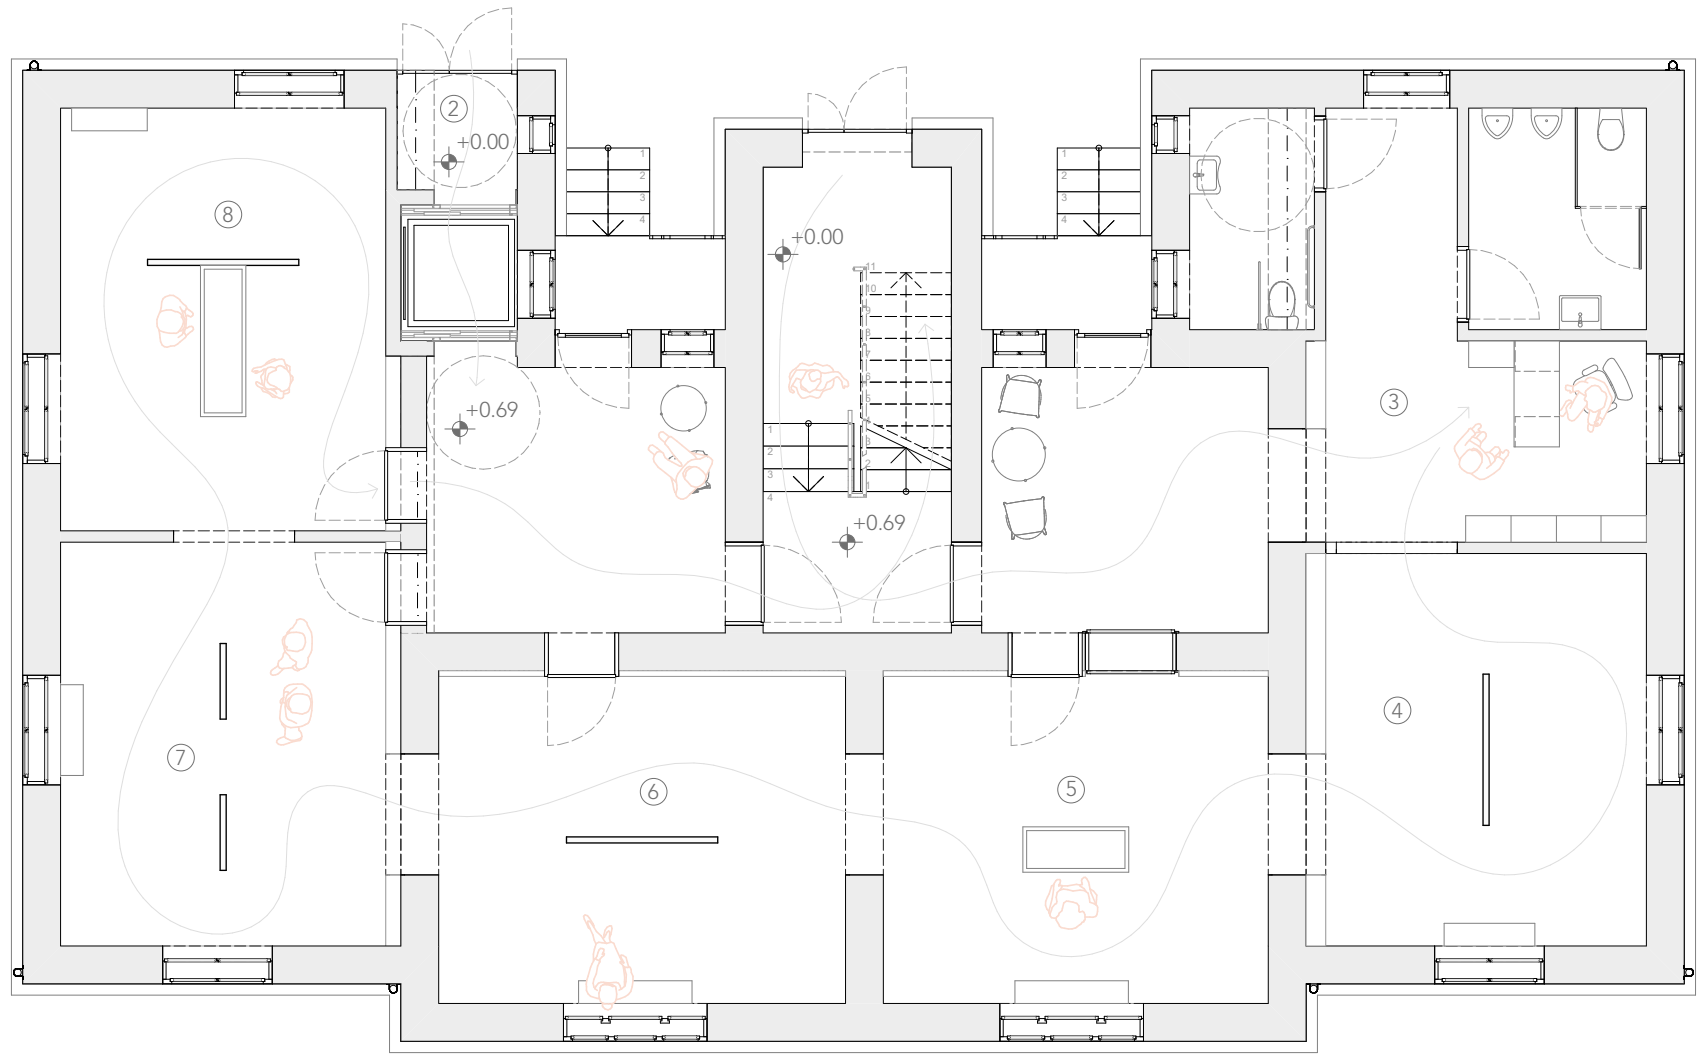
166 Fig.175 Ground Floor Plan Alterations, 1:100

- ① Main entrance
- ② Wheelchair accessible entrance
- ③ Tickets/Cloakroom
- ④-⑧ Exhibition rooms
