Dissertation

On the formation of stratified surface layers associated to fatigue cracks on rail wheels

submitted at TU Wien
Faculty of Mechanical and Industrial Engineering

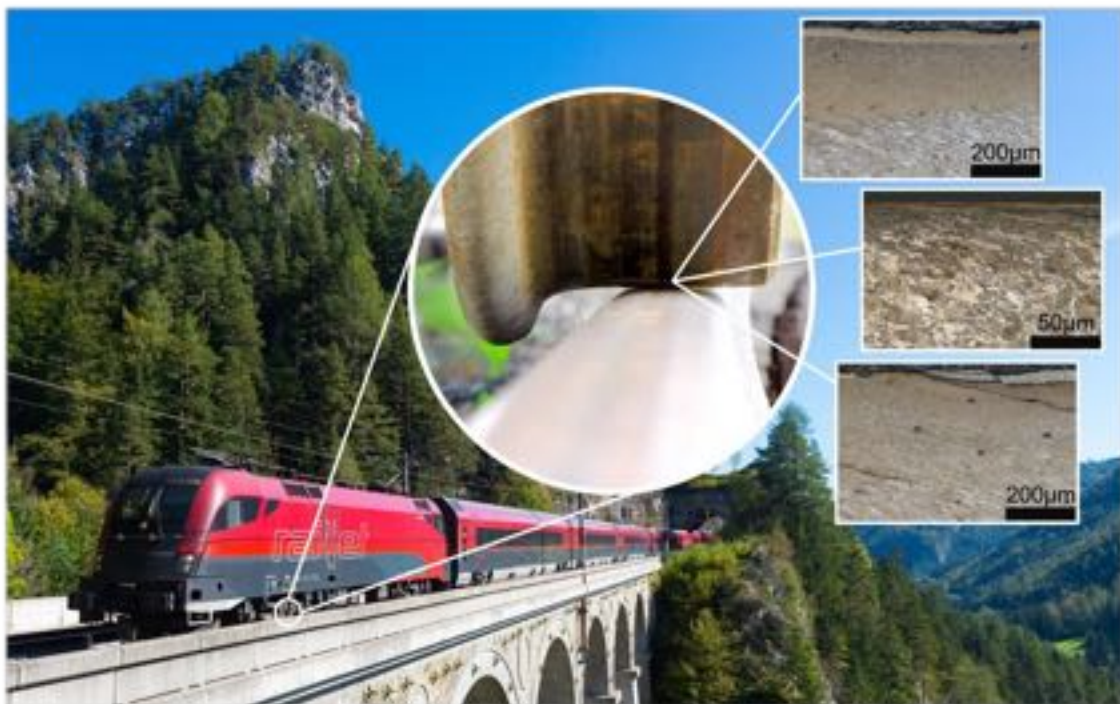
Figure 1: Several tons of wheel load and an open system tribology within $\sim 1 \text{ cm}^2$ of contact zone, the outstanding complexity of the wheel-rail contact results in a wide variety of evolving near-surface microstructures during service. [58], [59]

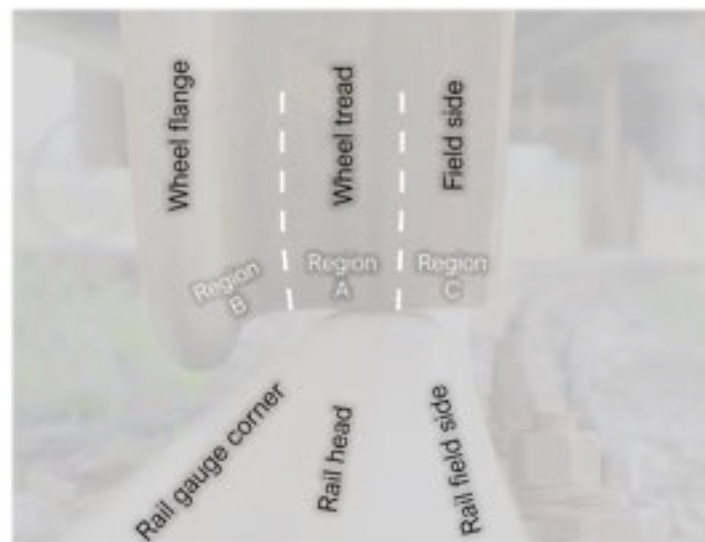
Figure 2: Different possible regions of the wheel-rail contact (image adapted from [59])

Region A represents the main contact region – most common for straight or large curved tracks – revealing low contact stresses. Longitudinal creep forces are larger in comparison to side creep forces. When the wheel-rail contact occurs in region B, the contact zone is smaller coming up with high contact stresses. This can lead to significant fatigue of the inner side of the rail and wear at the wheel flange. The latter can lead to changing contact mode, a two-point contact is possible (Wheel tread and flange – Rail gauge corner). Lubrication can reduce the wear rate in this region. Contact situated in region C is quite rare, but if this case occurs induced contact stresses are high with significant tangential forces toward the wheel tread. [3], [11], [61]

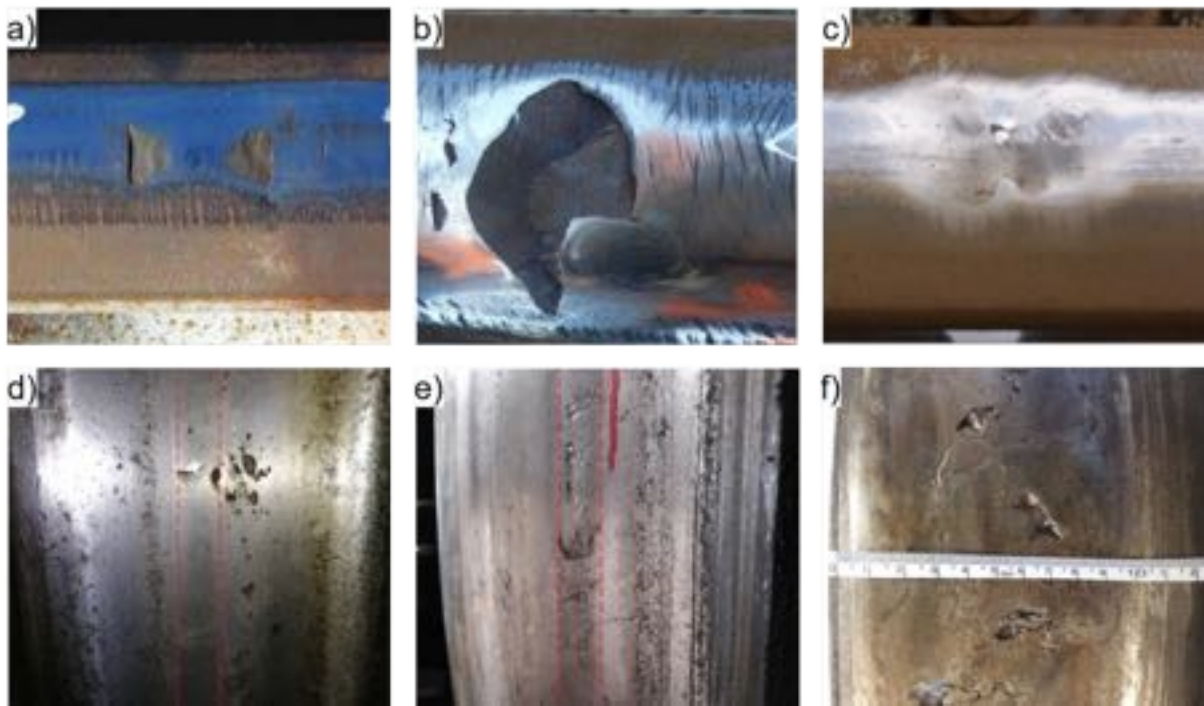
Figure 5: Exemplary RCF-related material defect on rails: a) severe squat formation [119], b) spalled-out stud defect [35], c) squat defect [115], and wheels: tread surface after d) ~40,000 km and e) 140,000 km [120], f) RCF cluster [110]

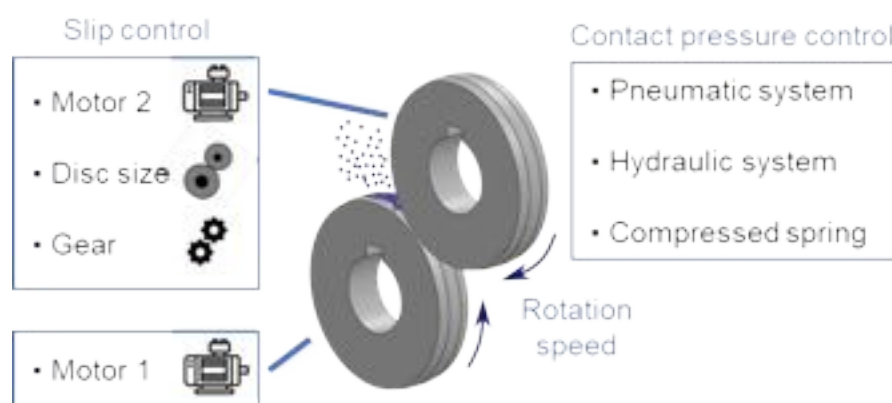
Figure 6: Fundamental principle of a twin disc configuration (Image adapted from [121])

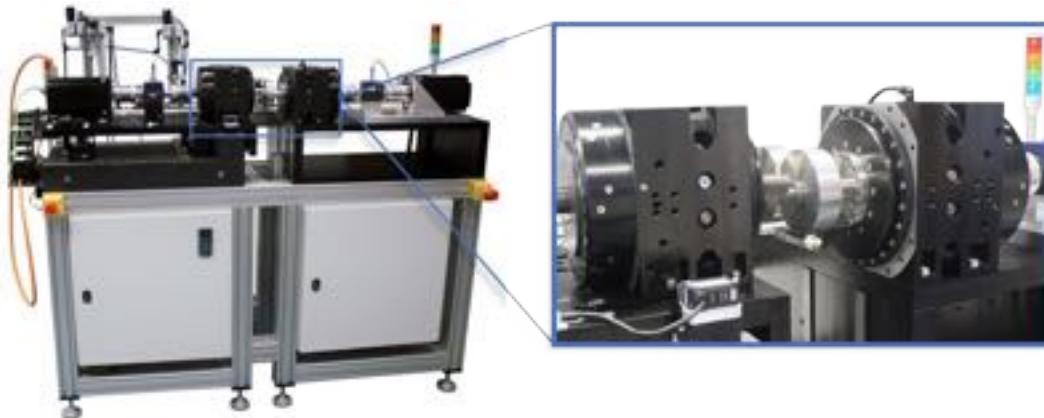
Figure 7: Self-constructed twin disc tribometer at AC2T research GmbH.

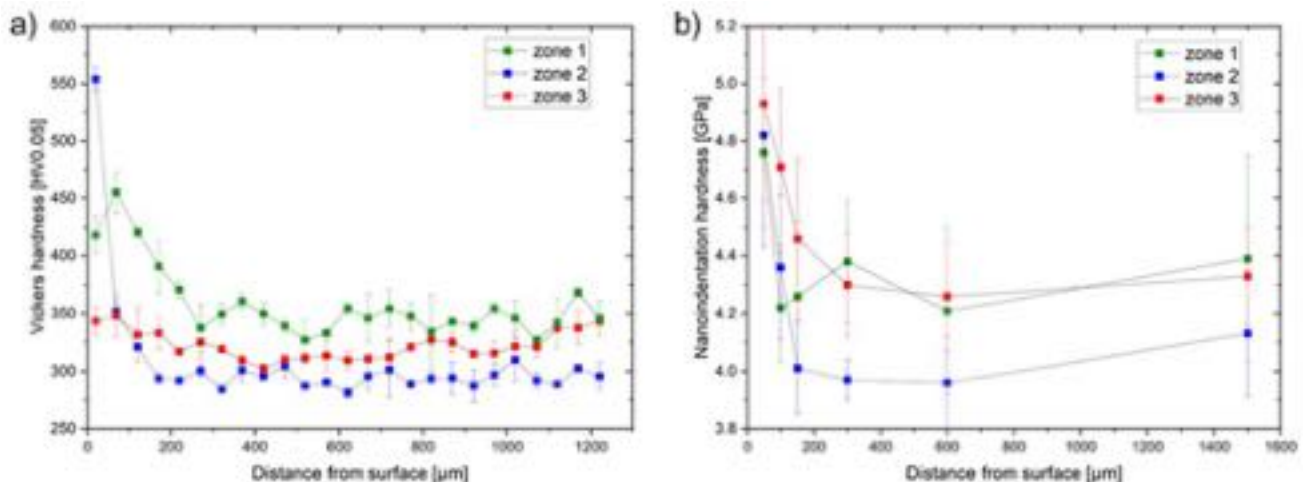
Fig. 6 Low-load Vickers hardness measurements (a) and nanoindentation hardness (b) graphs for the different zones

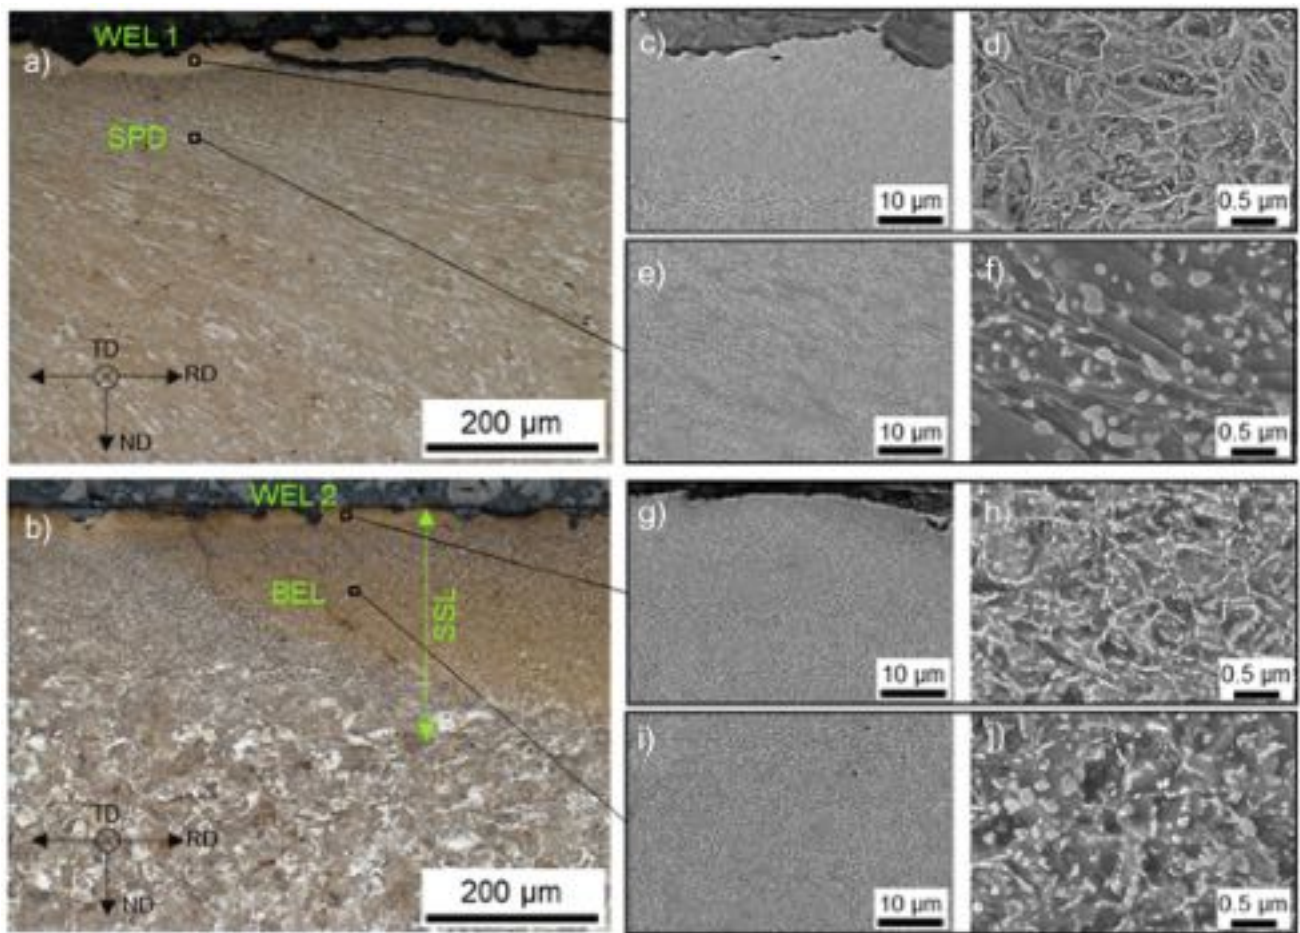
Fig. 7 (a) and (b) show overview micrographs of the investigated WEL-like microstructures. Detailed SEM investigations of the regions marked in (a) and (b) are presented in (c–j) with different

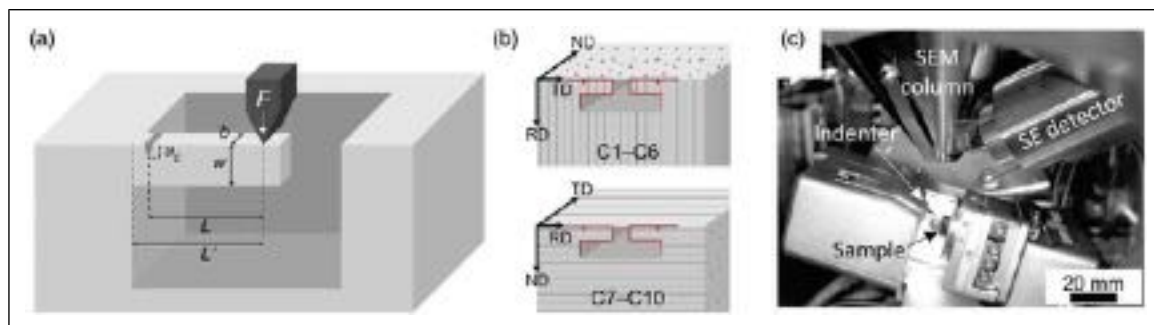
Figure 1. The schematic overview of the *in-situ* micro-bending method conducted on the wheel microstructures (a) shows the geometrical parameters and the point of loading. The arrangement of the cantilevers with different notch direction on two cubic samples extracted from the rail wheel is schematically shown in (b). The set-up in the SEM chamber is given in (c).

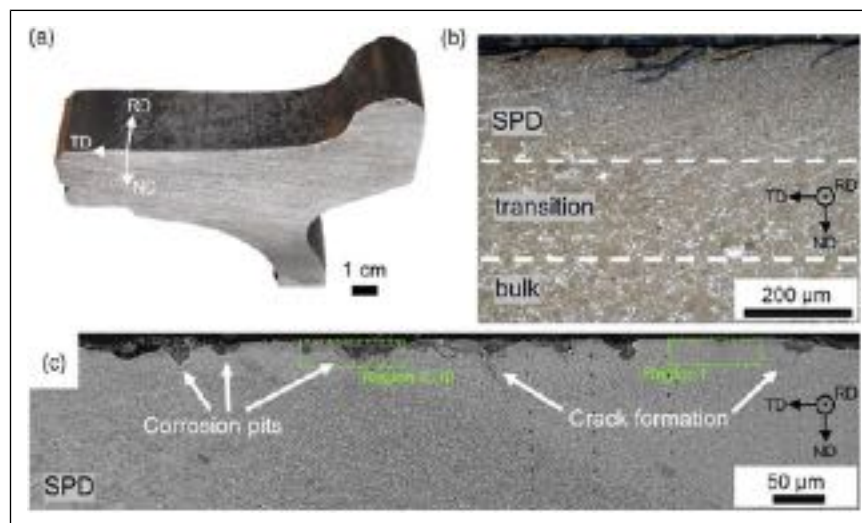
Figure 2. The cut slice of the ER7 wheel after $\sim 200,000 \text{ km}$ in service (a) shows a corrosion affected tread surface. The cross-sectional cut in rolling direction (RD) (b) reveals an SPD zone with numerous cracks, followed by a transition zone and a bulk microstructure. SEM investigations (c) show the corrosion pits along the surface of the wheel, with cracks initiated at some pits. The regions I, II and III where the cantilevers for the micro-bending were prepared are indicated. Within region I, cantilevers with notch orientation in rolling direction (RD) and cantilevers with notch orientation normal to the rolling direction (ND) are prepared.

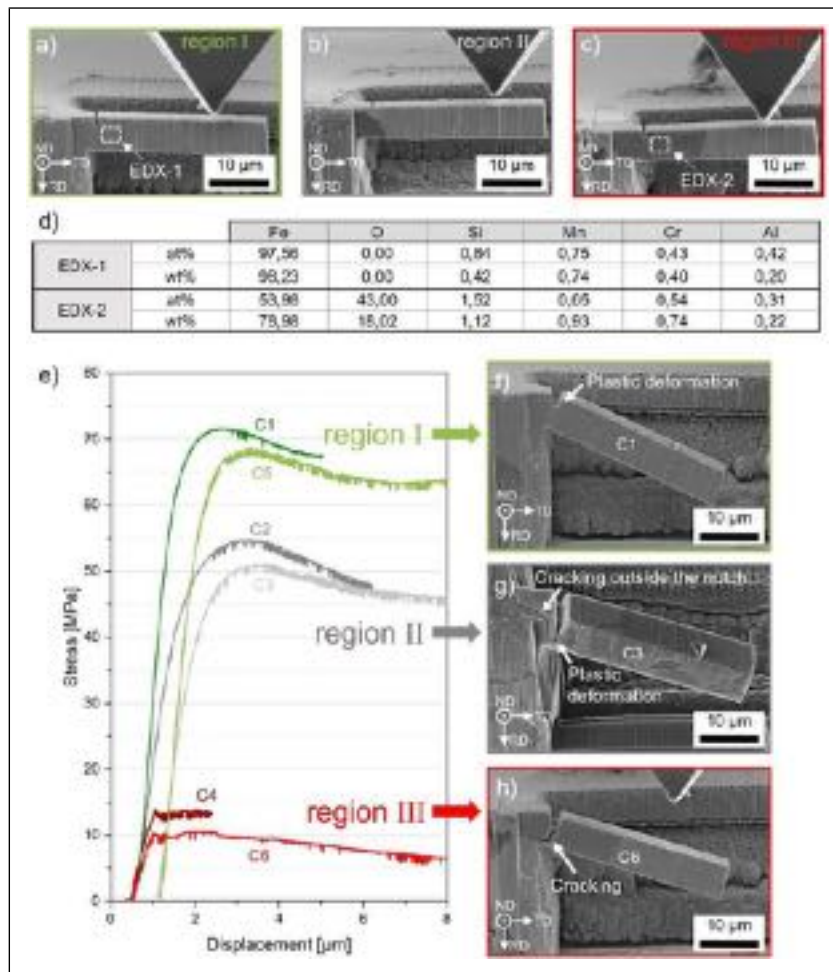
Figure 3. Representative micro-cantilevers before and after the micro-bending are shown: region I ((a), (f)) is the corrosion unaffected SPD microstructure, region II ((b), (g)) represents a mixture of corrosion influence and SPD microstructure, and region III ((c), (h)) represents cantilevers with the artificial notch located within corrosion affected microstructures. The chemical differences of “region I” and region III is given by EDX analysis in (d). Stress-displacement graphs of all cantilevers prepared with notch direction in rolling direction (C1–C6) are plotted in (e), where significant differences for each region can be seen.

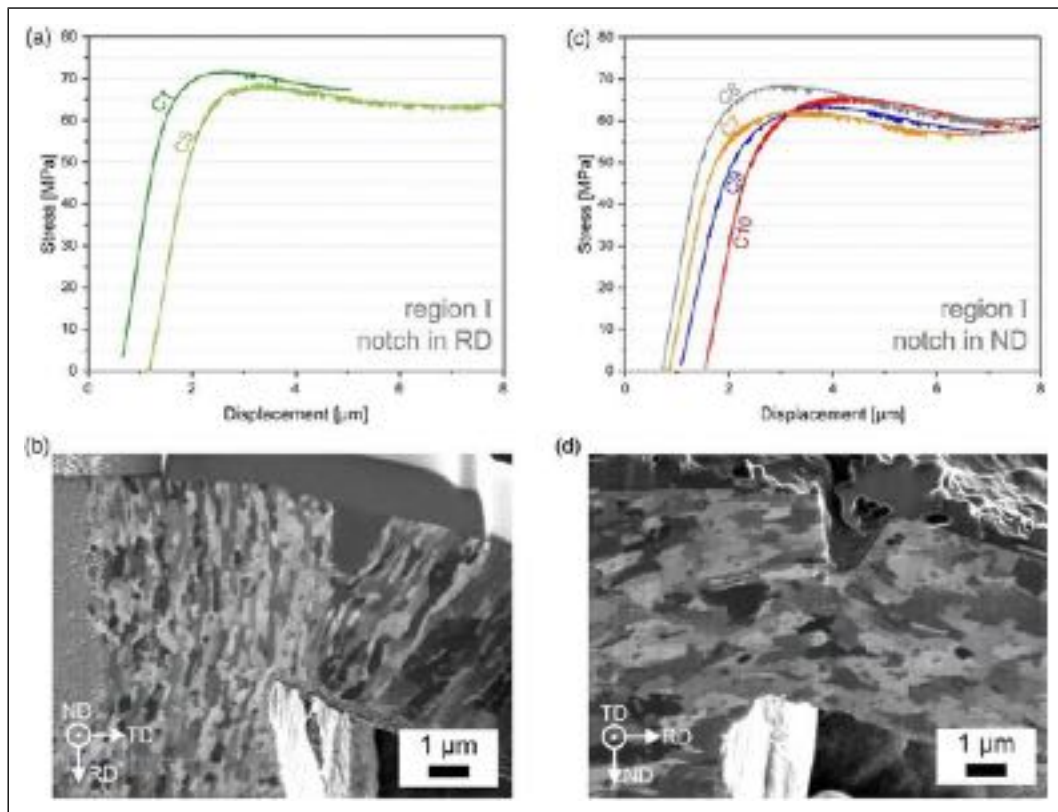
Figure 4. The stress-displacement graphs of the micro-bending investigations in the SPD microstructure with different directions of the artificial notch: Notch normal to the rolling direction is given in (a), a representative ICC image showing the alignment of the grains and the plastic material behavior can be seen in (c). Stress-displacement curves and ICC image of the cantilevers with the notch orientation in rolling direction are given in (b) and (d).

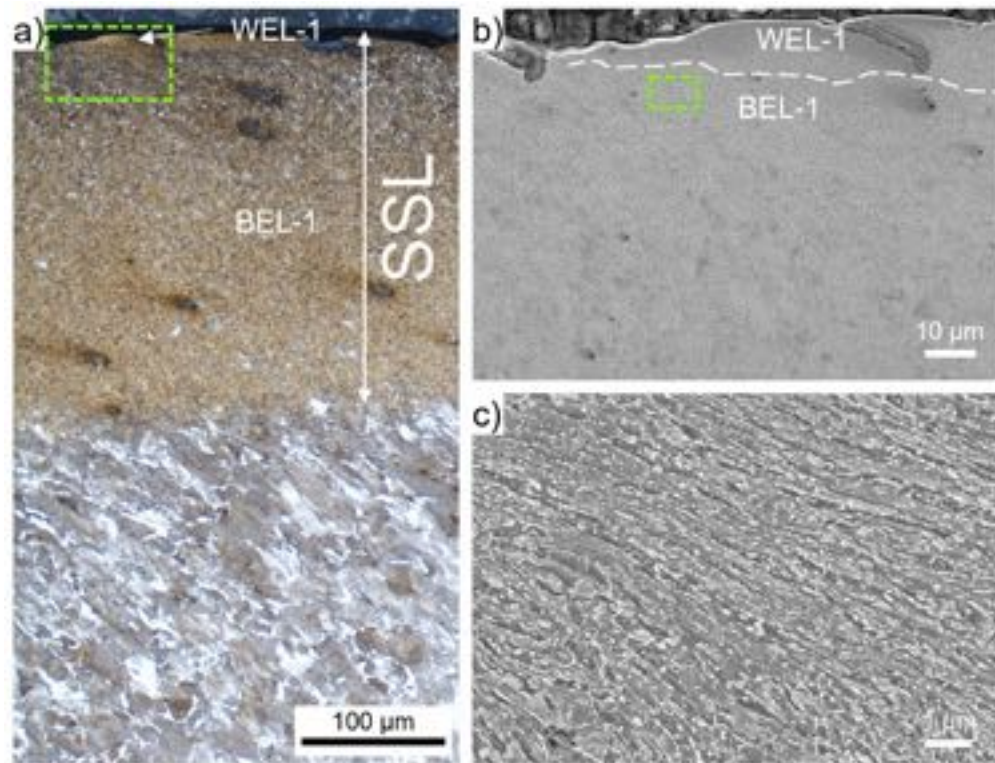
Figure 2. (a) shows the evolved microstructure within ROI-1 (see Figure 1b, c) consisting of a thin white etching layer (WEL) at the top, a $\sim 250 \mu\text{m}$ thick brown etching layer (BEL) underneath, segueing into a deformed ER7 microstructure. (b) presents a scanning electron microscope (SEM) image of the WEL and BEL area framed in (a). A higher magnification SEM image of the BEL-1 microstructure is given in (c).

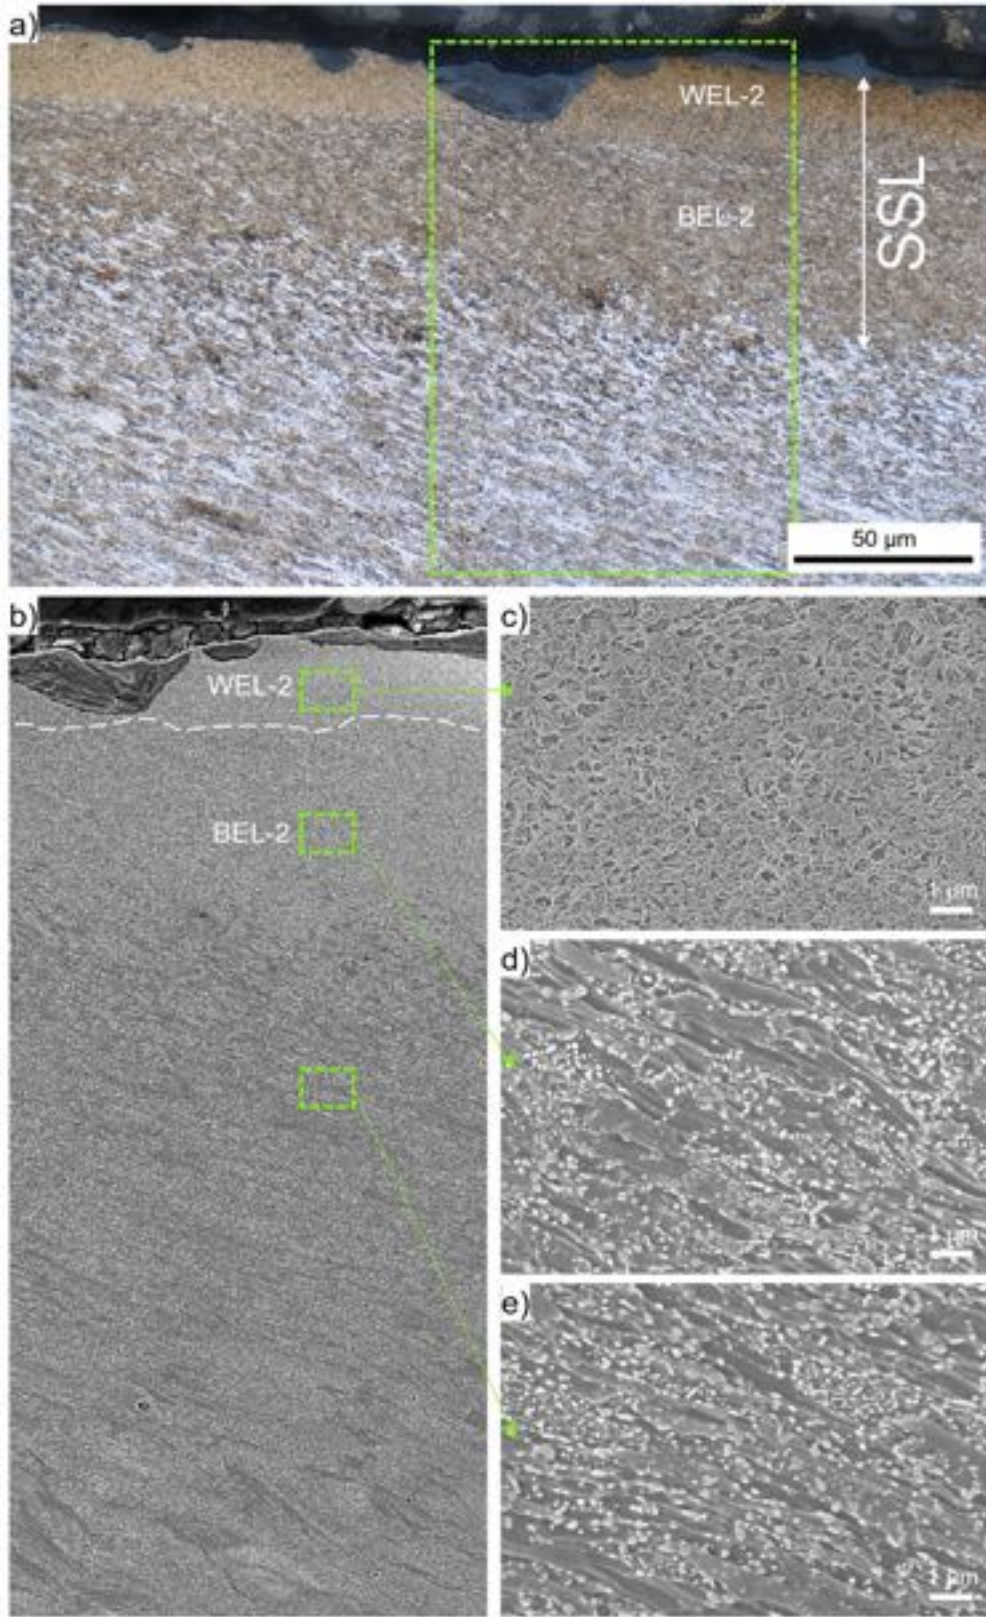
Figure 3. (a) shows the stratified surface layer (SSL) (white etching layer-2 (WEL-2) and brown etching layer-2 (BEL-2) within ROI-2 (see Figure 1b, d). (b) presents a scanning electron (SEM) image of the region framed in (a). For more details, higher magnification SEM images of certain locations are given: WEL-2 (c), BEL-2 (d), and the underlying deformed ER7 microstructure (e).

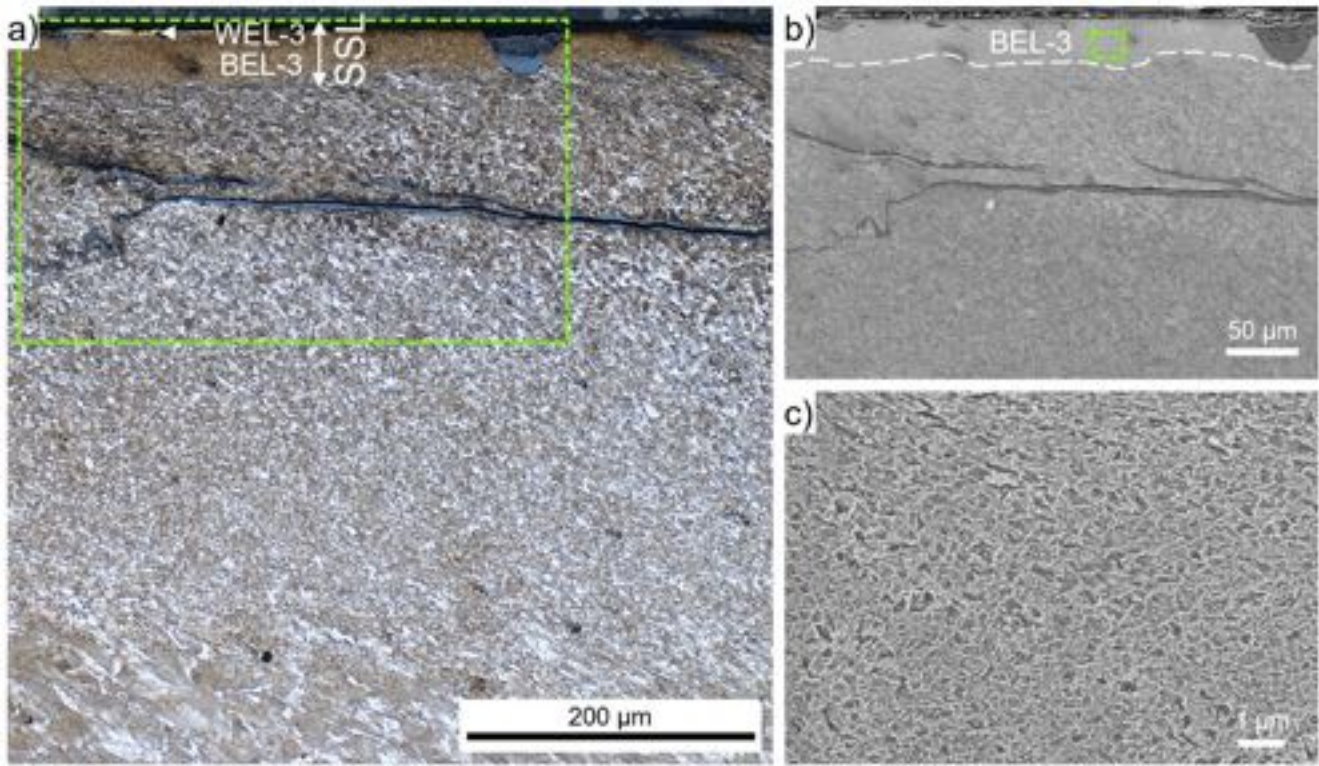
Figure 4. (a) shows the evolved microstructure within ROI-3 (see Figure 1b, e), where a very thin white etching layer (WEL) is on top of a brown etching layer (BEL) with a thickness of $\sim 50 \mu\text{m}$ (BEL-3). This layer is situated on a severely plastically deformed (SPD) microstructure accompanied by severe cracking. (b) presents a scanning electron microscope (SEM) image of the WEL and BEL area framed in (a). A higher magnification SEM image of the BEL-3 microstructure is given in (c).

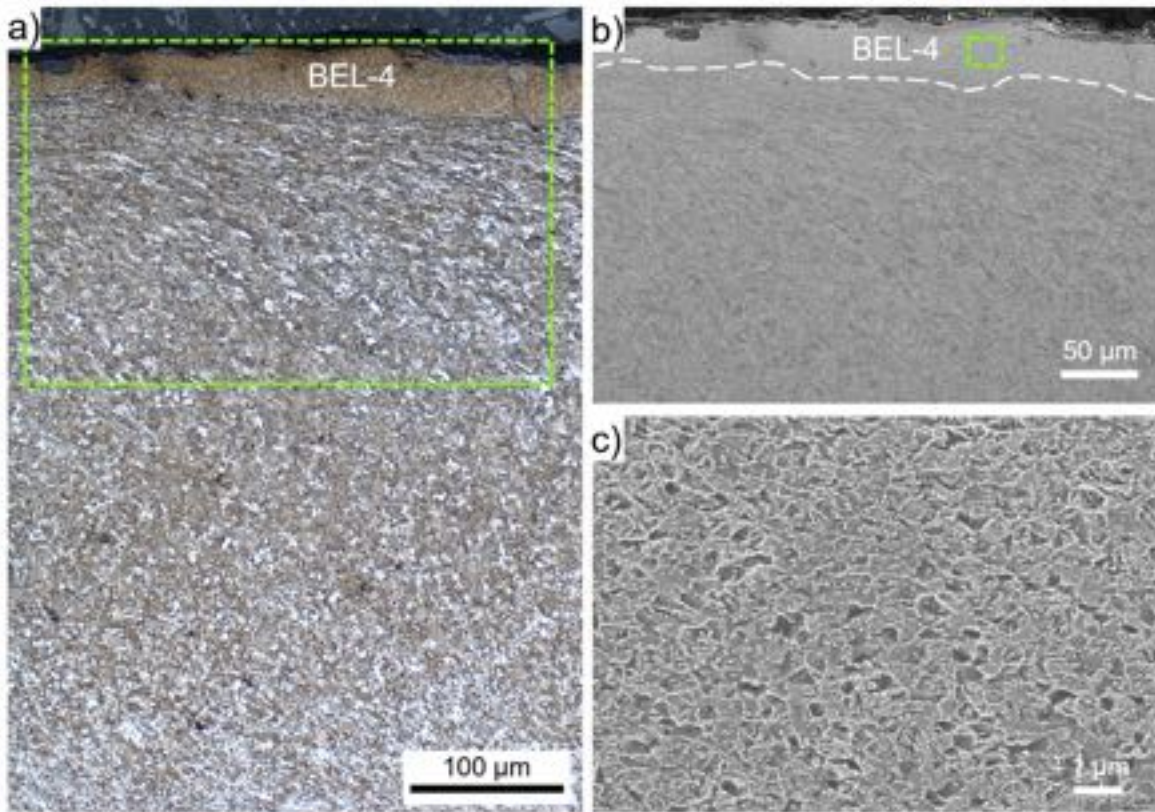
Figure 5. (a) shows the microstructure within ROI-4 (see Figure 1b, f), where a brown etching layer (BEL) with a thickness of $\sim 50 \mu\text{m}$ (BEL-4), is situated on an severely plastically deformed microstructure. (b) presents a scanning electron microscope (SEM) image of the WEL area framed in (a). A higher magnification SEM image of the WEL-4 microstructure is given in (c).

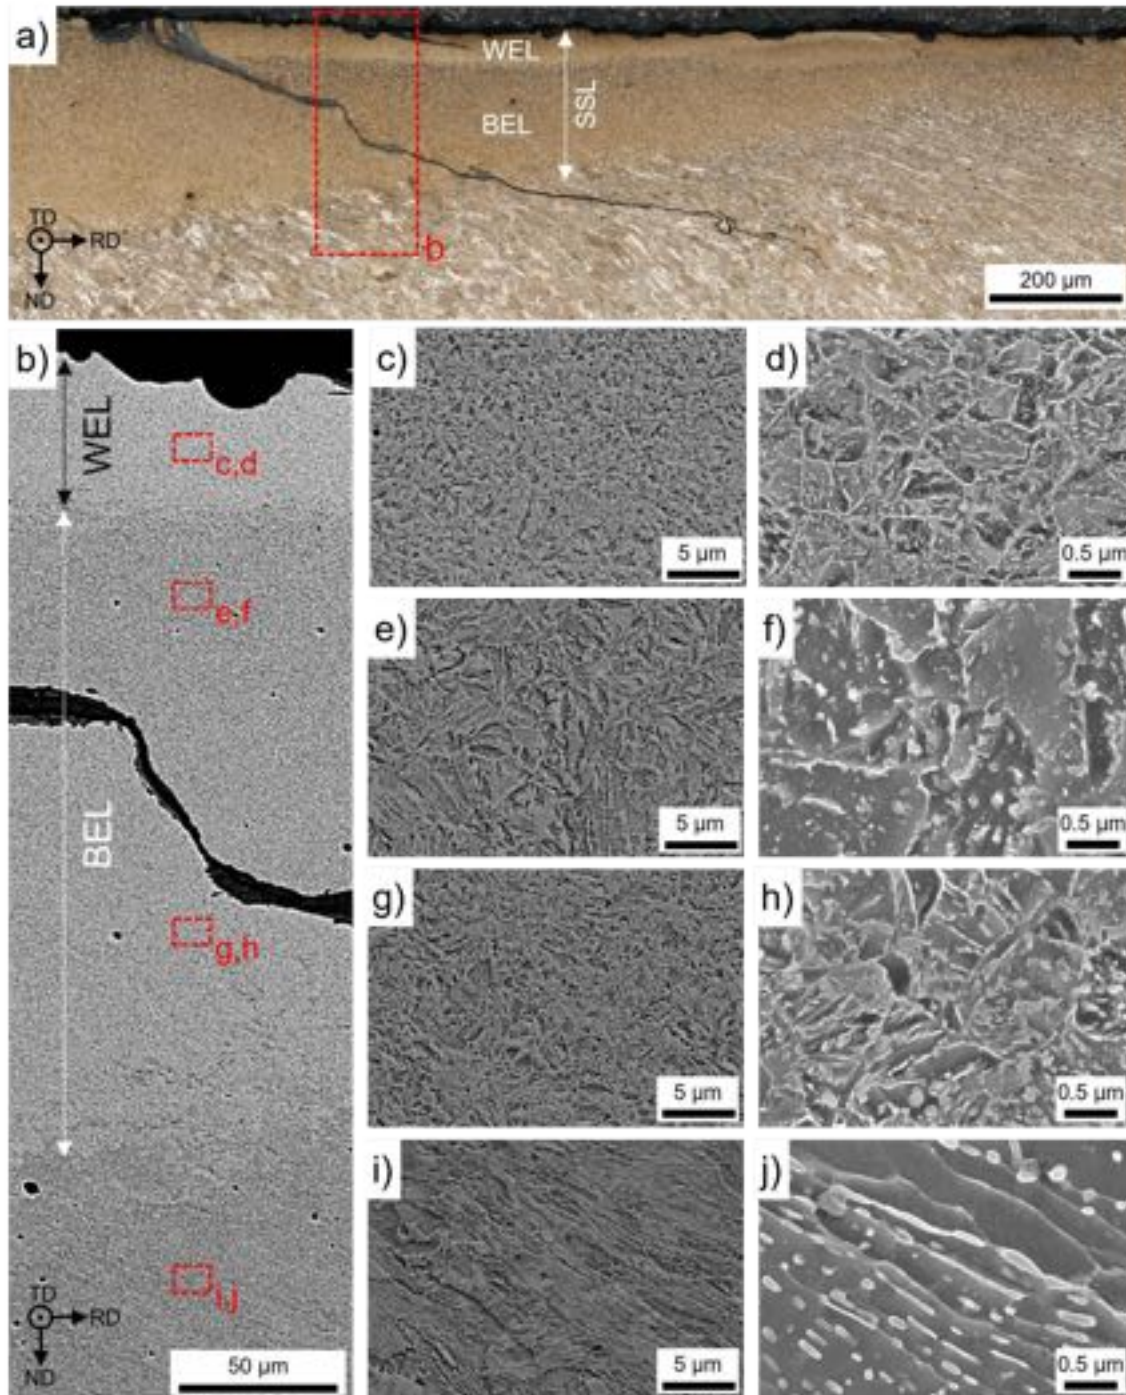
Figure 2: (a) LOM image of the investigated SSL in the middle of the tread surface of the rail wheel from service, where a microstructural gradient within the BEL is observed in the region of the fatigue crack. (b) SEM image (BE mode) of the area indicated in (a). Detailed SEM analysis is done at different distances from the surface: (c) and (d) represents the WEL microstructure, (e) and (f) the BEL just underneath the WEL-BEL transition, (g) and (h) the lower part of the BEL, and (i) and (j) the underlying plastically deformed ferritic-pearlitic rail

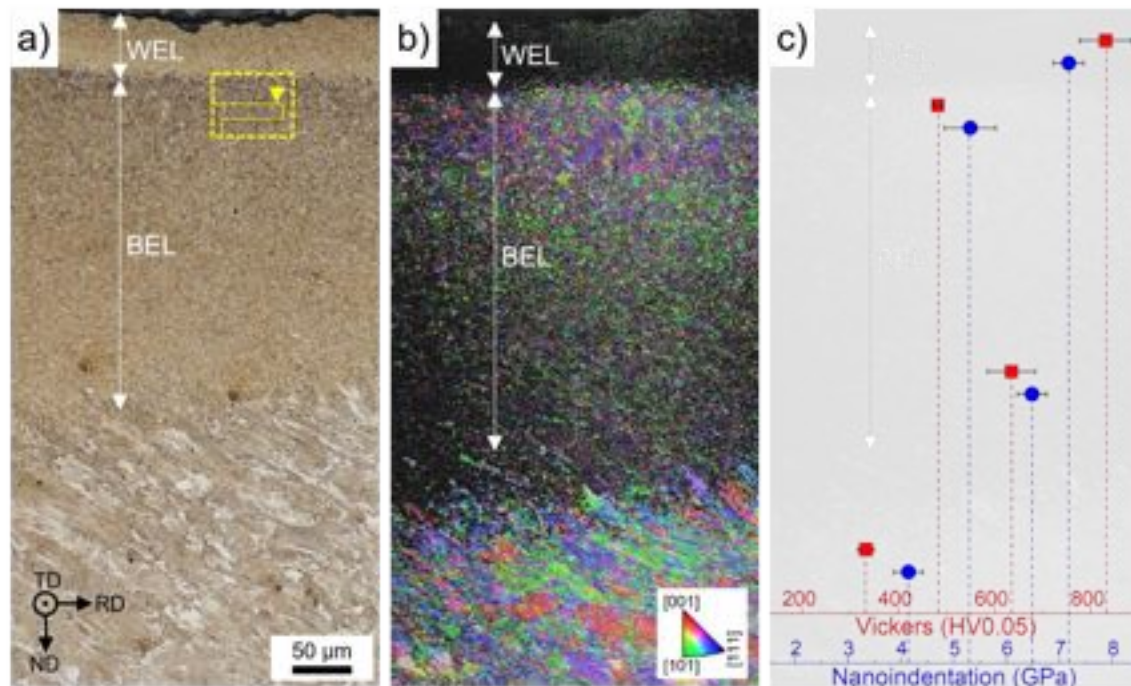
Figure 3: (a) shows the SSL consisting of WEL and BEL, whereat the microstructural gradient within the BEL can be seen. The dashed yellow line rectangular gives the region for further TEM and micro-bending studies. (b) IPFX image shows low quality due to fine grain size within the WEL and the lower part of the BEL. The grain size gradient within the BEL is clearly demonstrated. (c) gives the Vickers hardness and nanoindentation results of distinctive regions within the SSL and the underlying microstructure.

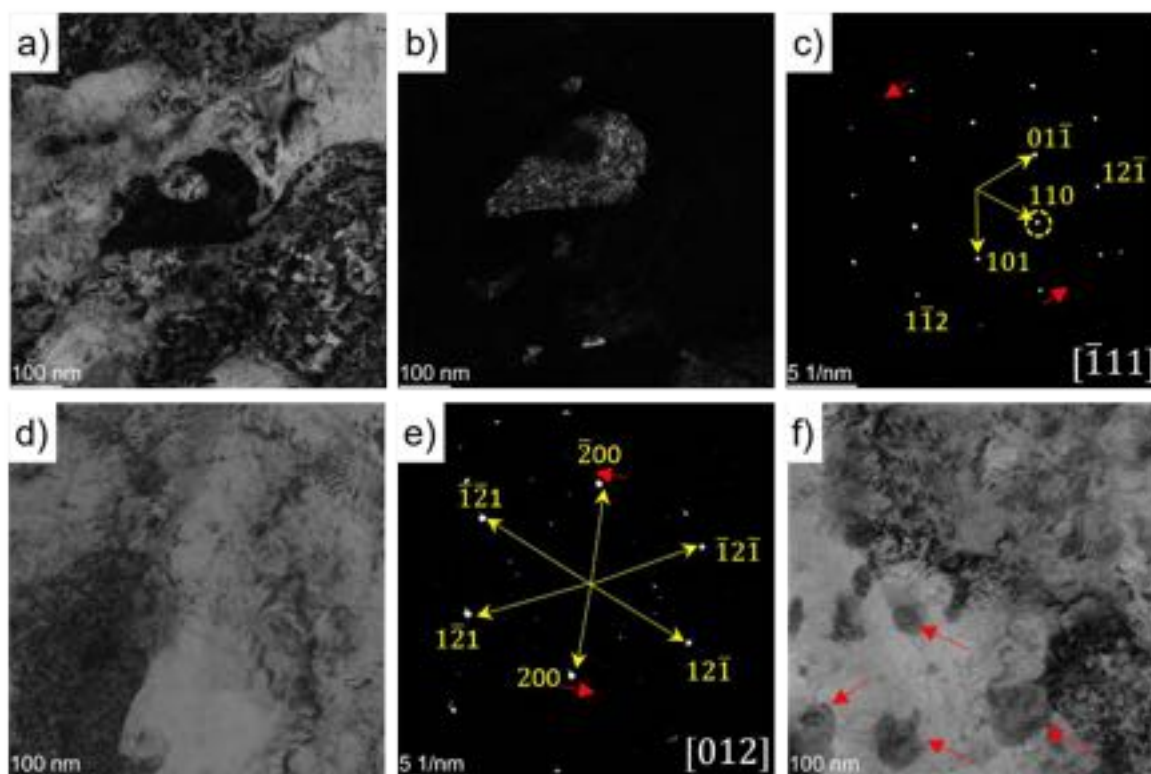
Figure 4: TEM imaging within the BEL region just underneath the WEL-BEL transition: (a) BF and (b) DF image with corresponding SAED pattern (c) show the fine-grained, polycrystalline, distorted bcc microstructure. Further, the BF image presented in (d) shows regions with high dislocation density, while the corresponding SAED pattern (e) represents a distorted bcc lattice in the $[012]$ direction. In addition, in some areas, globular particles are detected (f).

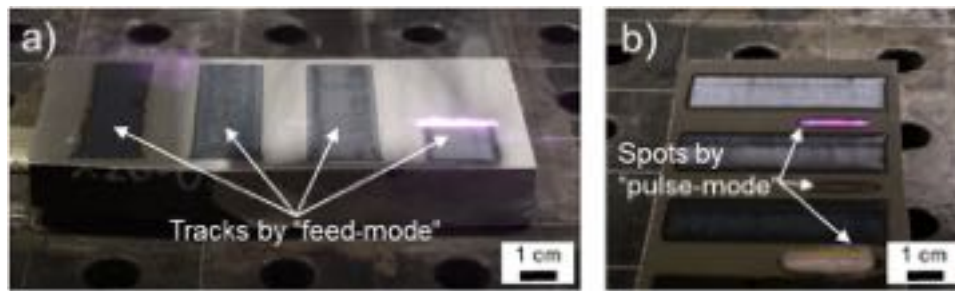
Fig. 1. The images show the sample with the undeformed initial microstructure on a welding table: (a) Tracks created by “feed-mode” (constant laser spot travel speed of 12 mm/s), (b) Spots created by the “pulse-mode” (no movement of the laser spot) treatments.

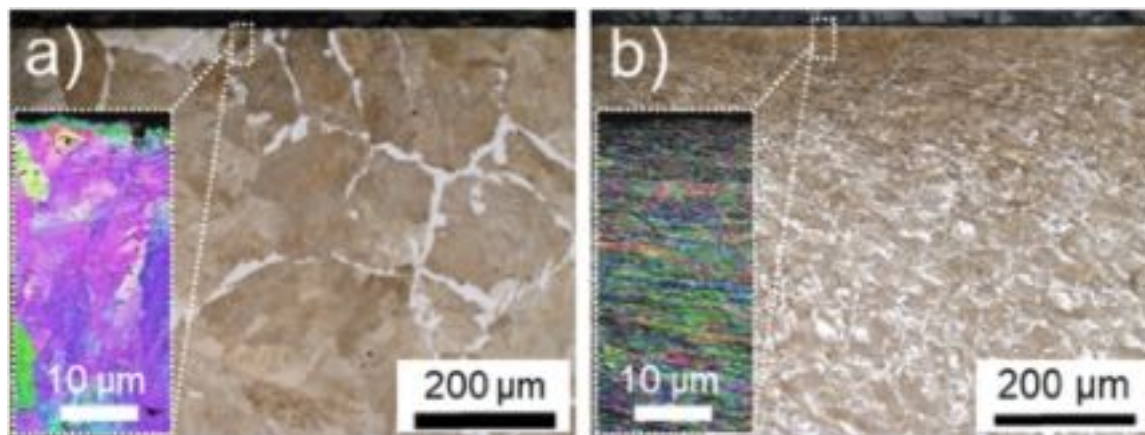
**Fig. 3.** Initial microstructure of the ER7 material of an ex-service wheel before the laser treatment experiments: (a) undeformed ER7 (ER7-u) from regions at least 1 cm below the tread surface, (b) deformed ER7 (ER7-d) from regions directly below the tread surface.

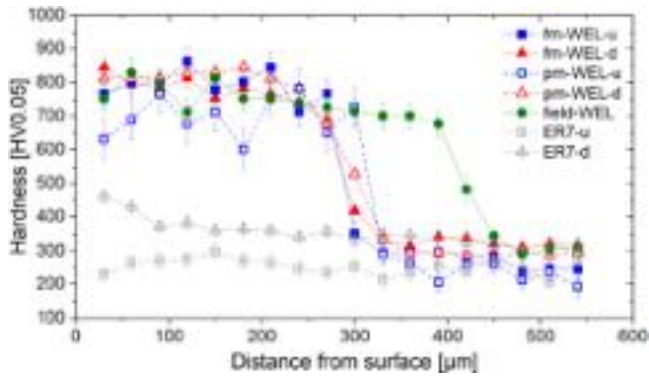
Fig. 4. Vickers hardness depth profiles across the WELs prepared with the laser in feed-mode and pulse-mode on an undeformed and deformed ER7 steel (fm-WEL-u, fm-WEL-d, pm-WEL-u, pm-WEL-d). For comparison, the hardness depth profiles of the undeformed and deformed ER7 steel without laser treatment (ER7-u, ER7-d) as well as of a sample taken from the tread surface of an ex-service ER7 rail wheel with a WEL (field-WEL) are shown.

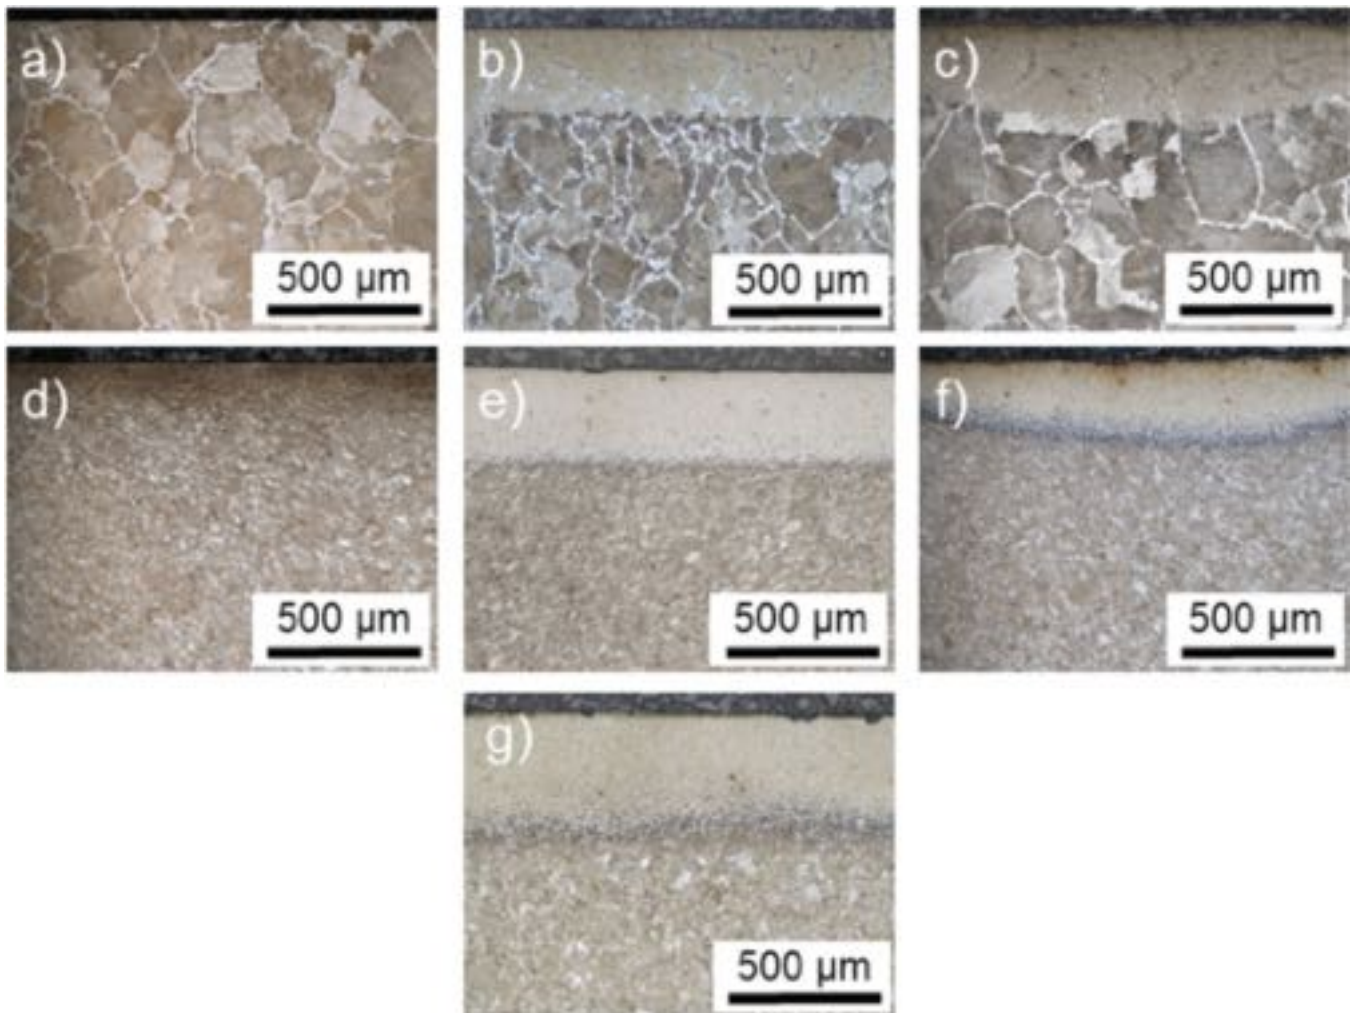
Fig. 5. LOM images: Microstructure of (a) the undeformed sample and its change (b) after the feed-mode laser treatment ($T_{\text{pre-set}}=840$ $^{\circ}\text{C}$) and (c) after the pulse-mode laser treatment ($T_{\text{pre-set}}=840$ $^{\circ}\text{C}$); Microstructure of (d) the deformed sample and its change (e) after feed-mode laser treatment ($T_{\text{pre-set}}=840$ $^{\circ}\text{C}$) and (f) after pulse-mode laser treatment ($T_{\text{pre-set}}=840$ $^{\circ}\text{C}$). The field-WEL is shown in (g).

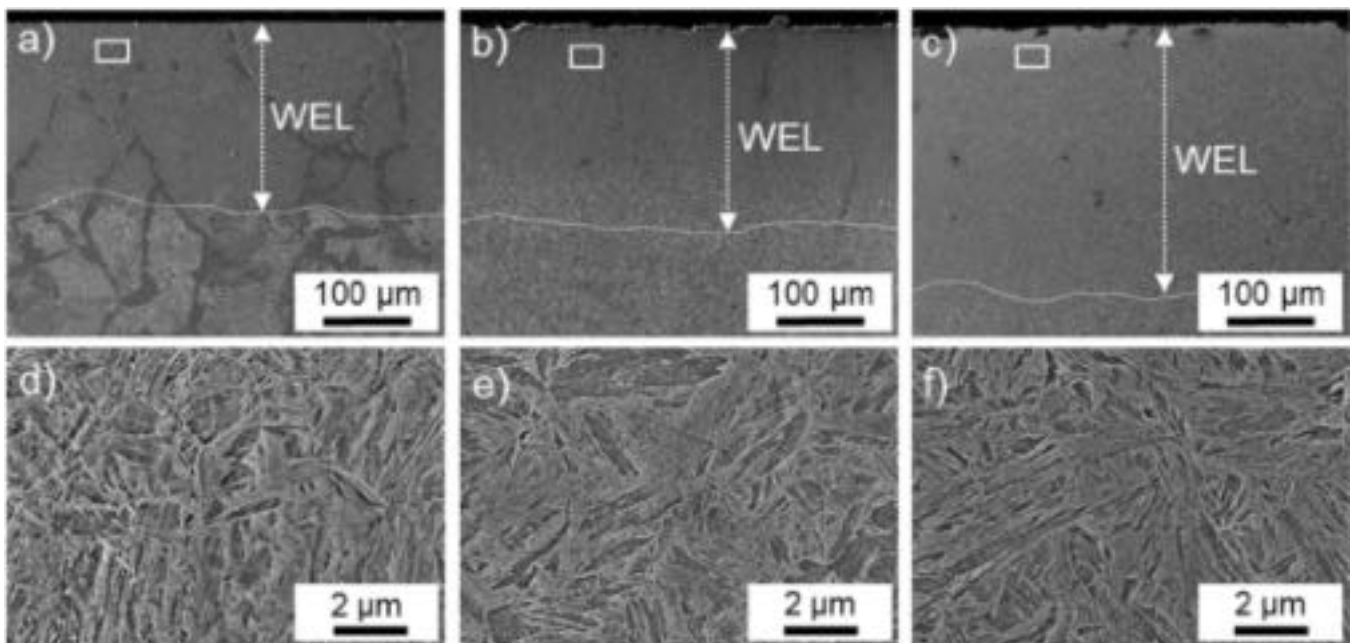
Fig. 6. SEM images with different magnifications of the microstructure of the (a),(d) fm-WEL-u and (b),(e) fm-WEL-d. The WEL on both samples was created by a feed-mode laser treatment ($T_{\text{pre-set}}=840^\circ\text{C}$). The field-WEL is shown in (c),(f). The WEL regions are indicated, although there is no distinctive boundary but more of a gradual transition to the underlying material for the fm-WEL-d and the field-WEL.

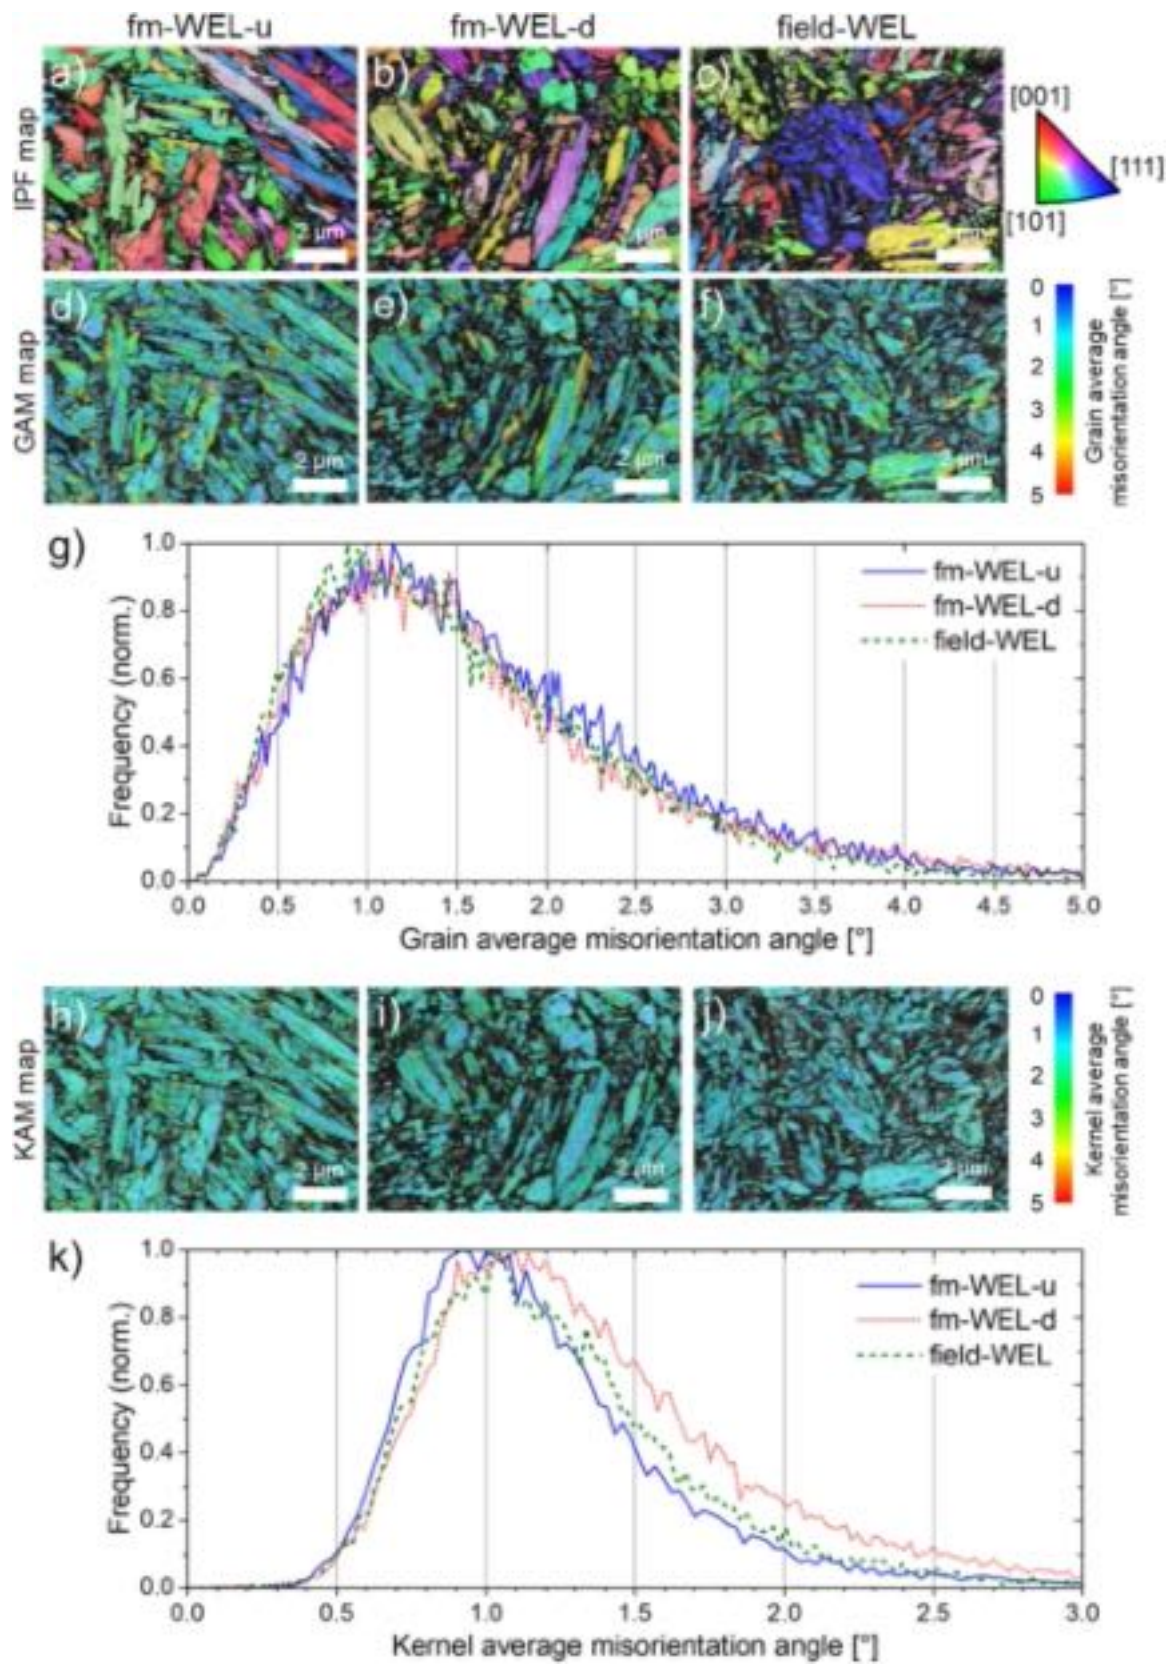
Fig. 8. EBSD measurements at a depth of 100 μm from the surface. The first row shows the inverse pole figure (IPF) maps for (a) fm-WEL-u, (b) fm-WEL-d, and (c) field-WEL. In the second row, panels (d), (e), and (f) show the related grain average misorientation (GAM) maps. The plot of the GAM angle distribution is shown in (g). Corresponding kernel average misorientation (KAM) maps for fm-WEL-u, fm-WEL-d, and field-WEL are presented in (h), (i), and (j). The KAM angle distribution is shown in (k).
