Dissertation

On the formation of stratified surface layers associated to fatigue cracks on rail wheels

submitted at TU Wien
Faculty of Mechanical and Industrial Engineering

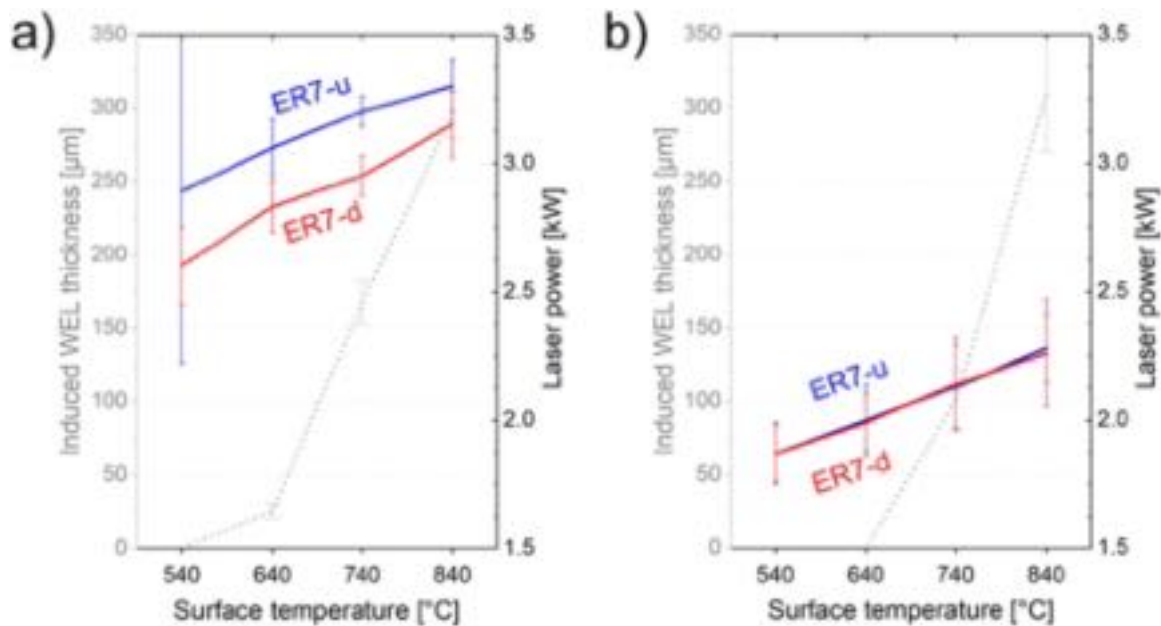
Fig. 9. Dotted lines show the average thicknesses of the laser-WELs on ER7-u and ER7-d produced in (a) feed-mode, and (b) pulse-mode for defined pre-set surface temperatures. The colored lines represent the necessary laser power to reach the defined surface temperatures (blue lines refer to the initial undeformed microstructure (ER7-u), red lines to the initial deformed microstructure (ER7-d)).

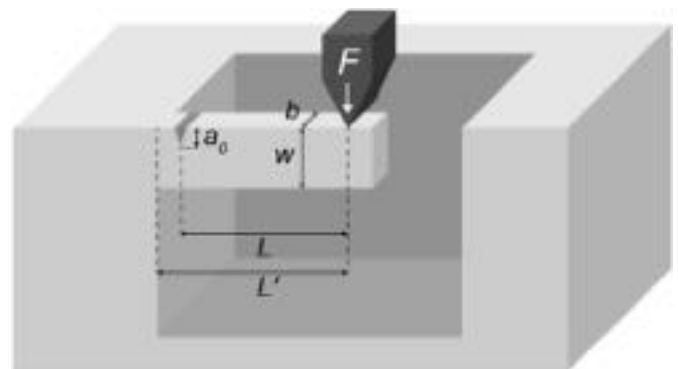
Fig. 1. Schematic overview of the micro-cantilever prepared by FIB milling with the diamond wedge applying the load at a distance L from the notch.

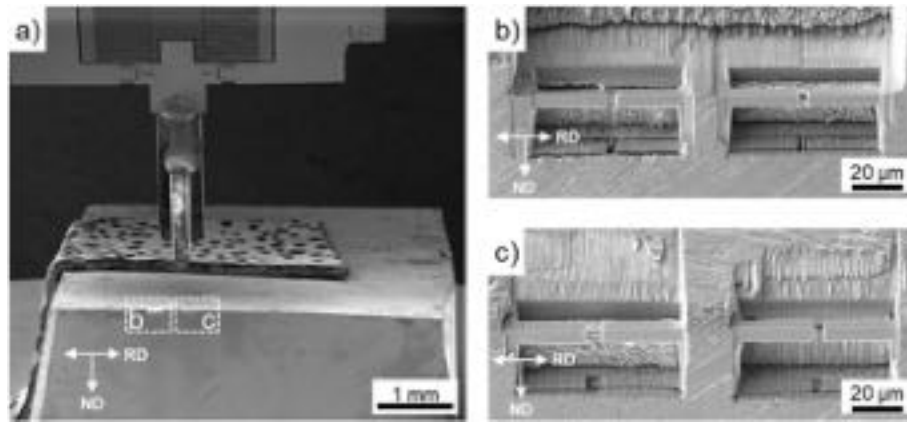
Fig. 2. (a) Cube cut-out of the laser-treated steel surface as placed inside the SEM chamber, with the diamond wedge of the nanoindentation system approaching from the top. Details of the FIB milled cantilevers – marked in (a) with rectangles – are shown in (b) and (c) before testing.

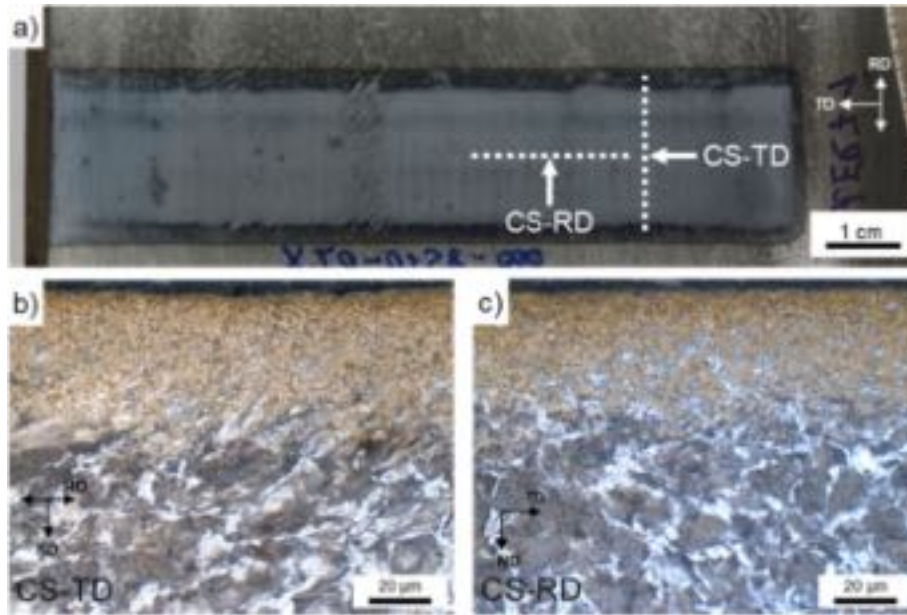
Fig. 3. (a) Top-view of the rail wheel tread surface with the track of the laser surface treatment. LOM images of the cross-sectional cut in transversal direction (CS-TD, (b)) and in rolling direction (CS-RD, (c)) picture the martensitic WEL, the transition zone, and the ferritic-pearlitic underlying microstructure. CS-TD shows a weak alignment of the deformed microstructure.

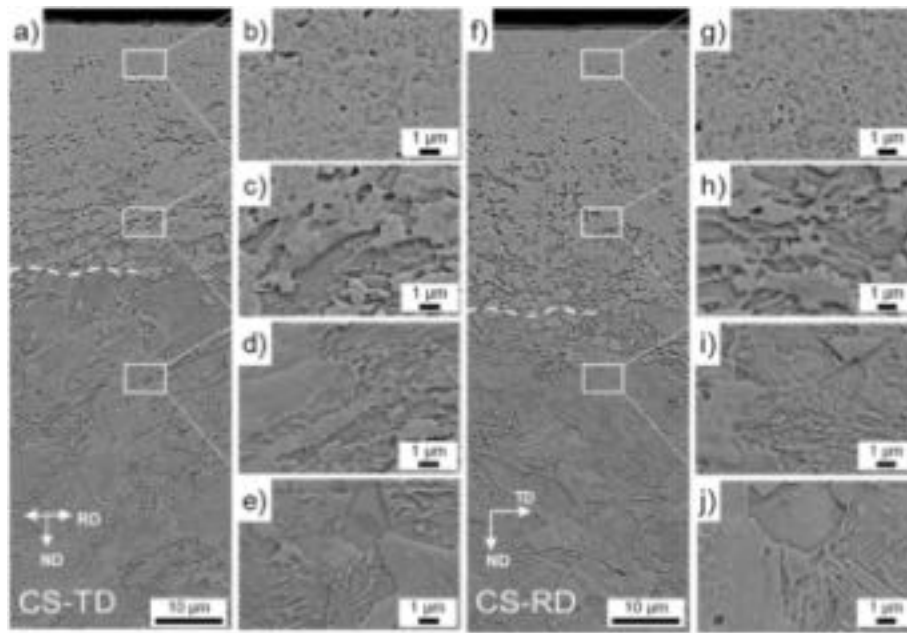
Fig. 4. Electron backscattered images representing the cross-sectional cut in transversal direction (CS-TD, (a)) and rolling direction (CS-RD, (f)). Insets with higher magnification images show the WEL (b, g), the transition zone (c, h), the underlying deformed microstructure (d, i), and the undeformed bulk microstructure (e, j).

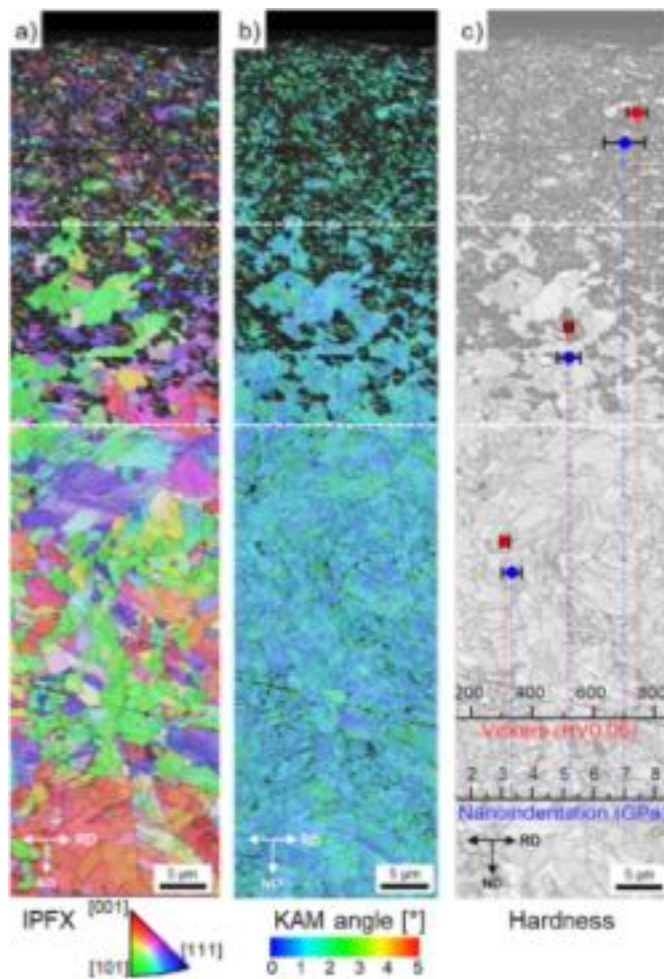
Fig. 5. The EBSD measurements are performed on the cross-sectional cut in transversal direction (CS-TD) and include the WEL with low pattern quality and a high fraction of zero-solutions, the transition zone, and the underlying deformed hypoeutectoid steel. The inverse pole figure (IPFX) map (a) and the Kernel average misorientation (KAM) angle map (b) is shown. In (c), the hardness values within the three zones evaluated by the low-load Vickers technique and nanoindentation are presented.

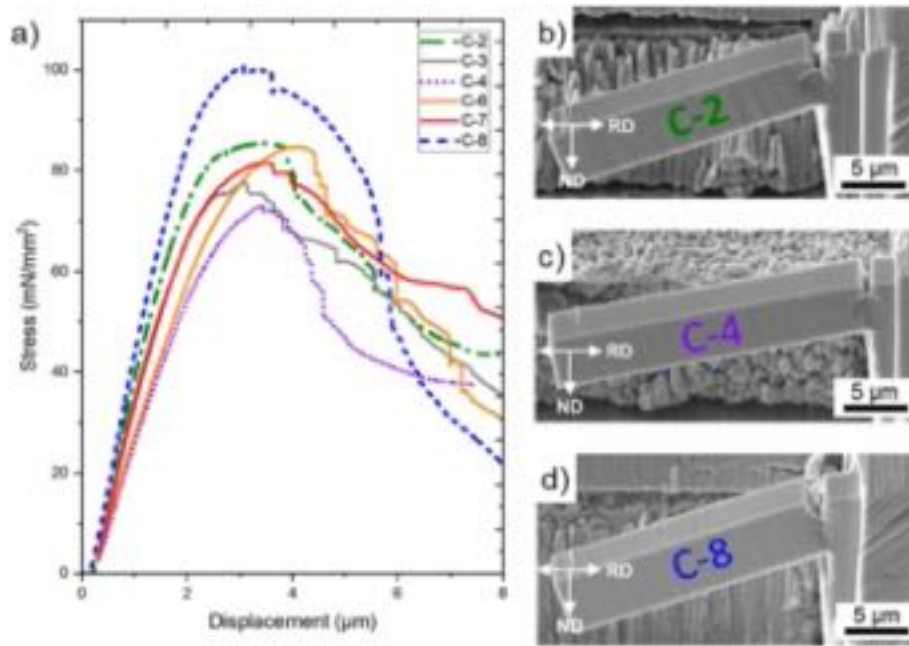
Fig. 6. (a) Stress-displacement curves for all seven valid tested micro-cantilevers show elastic deformation at the beginning, followed by plastic deformation, crack initiation, and propagation. SEM images of representative cantilevers prove this after testing, where cantilever C-2 (b) shows maximum stress of $\sim 85 \text{ N/mm}^2$, cantilever C-4 (c) with the lowest ($\sim 72 \text{ N/mm}^2$), and cantilever C-8 (d) reveals the highest maximum stress of $\sim 100 \text{ N/mm}^2$.

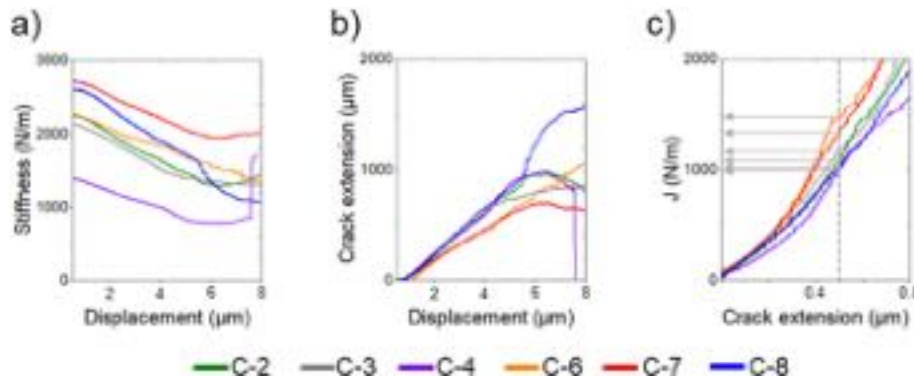
Fig. 7. Based on each cantilever's stiffness change (a), the crack extension is calculated (b). To determine the J -integral, the crack resistance curve (c) is plotted where J_Q is determined at a crack extension of $0.5 \mu\text{m}$.

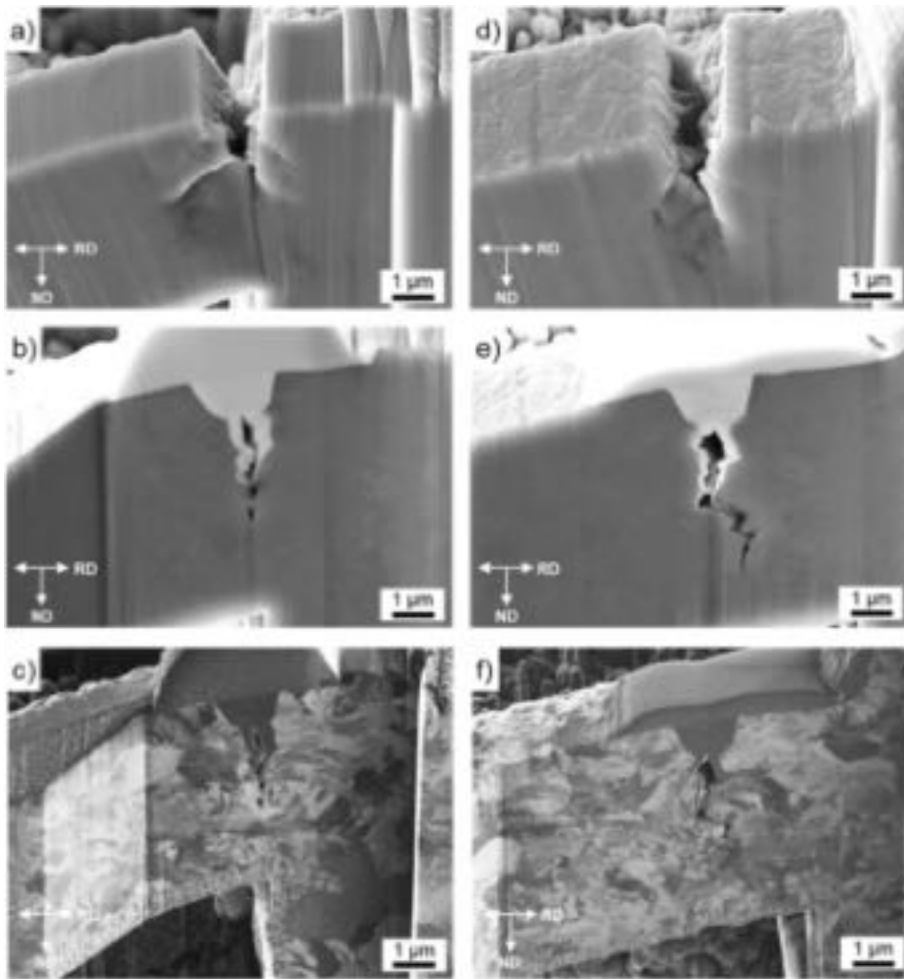
Fig. 8. In the first row, secondary electron (SE) images of the fractured cantilever C-2 (a) and C-6 (d) are presented. The cantilevers reveal the same stress level during bending but different J_Q values. After depositing tungsten onto the notch region to protect the cantilever, FIB milling is done to prepare a cross-section in the middle of the cantilever, displayed in the second row (b, e). Ion channeling contrast images are shown additionally (c, f) to highlight the crack evolution within the microstructure.

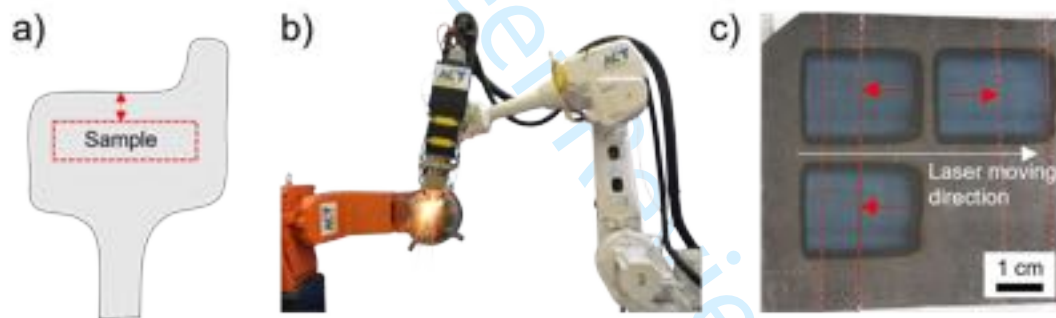
Figure 1: (a) The samples for the laser treatment are cut out from wheels ~1 cm below the tread surface followed by uniform heat treatment. (b) shows the laser system which is used for applying thermal loads. (c) gives an exemplary wheel plate sample after three laser surface treatments are conducted. Red dotted lines and arrows show the cross-sectional cuts which are analysed by light optical microscopy.

Laser surface treatments are conducted by using a Direct Diode Laser System (HighLight 8000D, Coherent, U.S.). To ensure a careful positioning and movement, the laser system is mounted on a 6-axis robot arm (IRB 4600-60/2.05, ABB, Austria) controlled via the teach-pedant of the controller system of the IRC5 (ABB, Austria), see [Figure 1b](#). A rectangular laser spot with 3 mm in the moving direction (x) and 24 mm in the lateral

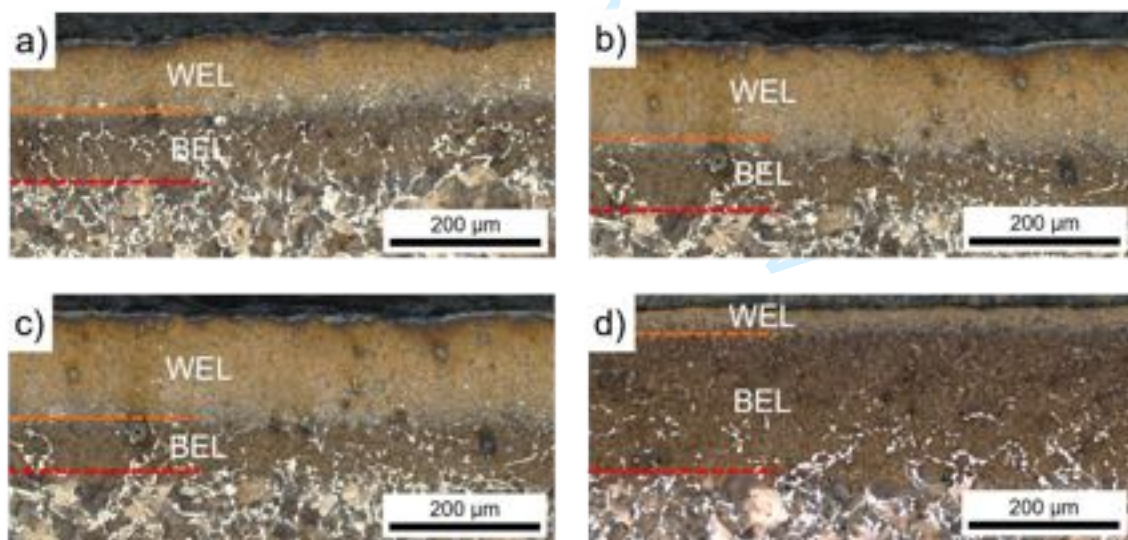
Figure 3: Influence of thermal loading parameters on SSL formation (ER7 railway wheel steel): An increase of laser power leads to increased SSL thickness: (a) $P_{\text{Laser},1} = 2.3 \text{ kW}$ and $P_{\text{Laser},2} = 1.7 \text{ kW}$, (b) $P_{\text{Laser},1} = 2.4 \text{ kW}$ and $P_{\text{Laser},2} = 1.8 \text{ kW}$. By varying the laser power difference between the first and second thermal loading (ΔP_{Laser}) the ratio of WEL and BEL is changing: (c) $\Delta P_{\text{Laser}} = 0.6 \text{ kW}$, (d) $\Delta P_{\text{Laser}} = 0.8 \text{ kW}$.

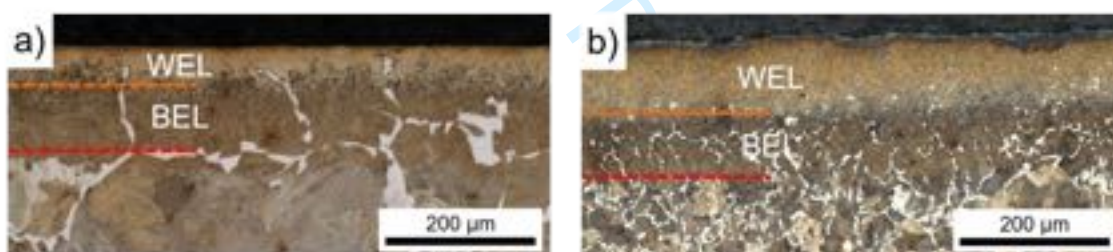
Figure 4: Influence of the initial microstructure of ER7 railway wheel steel on SSL formation: (a) Coarse grain size leads to smaller SSL compared to (b) a fine-grained initial microstructure, with same thermal loadings ($P_{\text{Laser},1} = 2.3 \text{ kW}$, $P_{\text{Laser},2} = 1.7 \text{ kW}$).

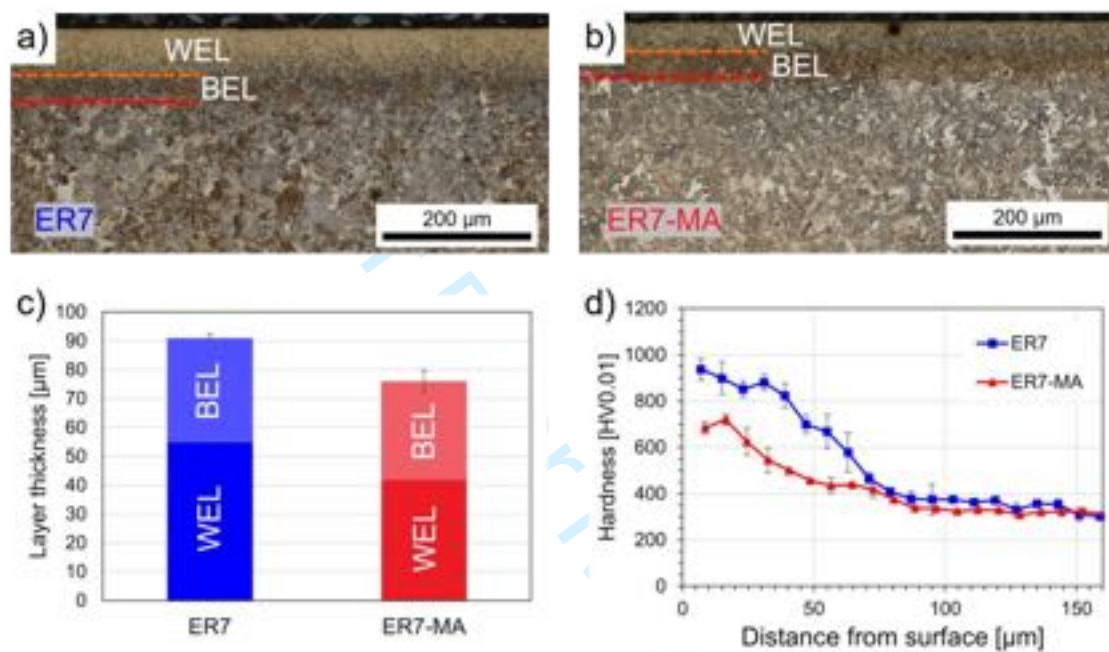
Figure 5: Influence of the chemical composition is shown by SSL formed (PLaser,1 = 2.0 kW and PLaser,2 = 1.6 kW) on (c) ER7 compared to (d) ER7-MA with decreased SSL thickness. (e) Layer thickness plot and (f) hardness measurement graphs of the different wheel steel grades.

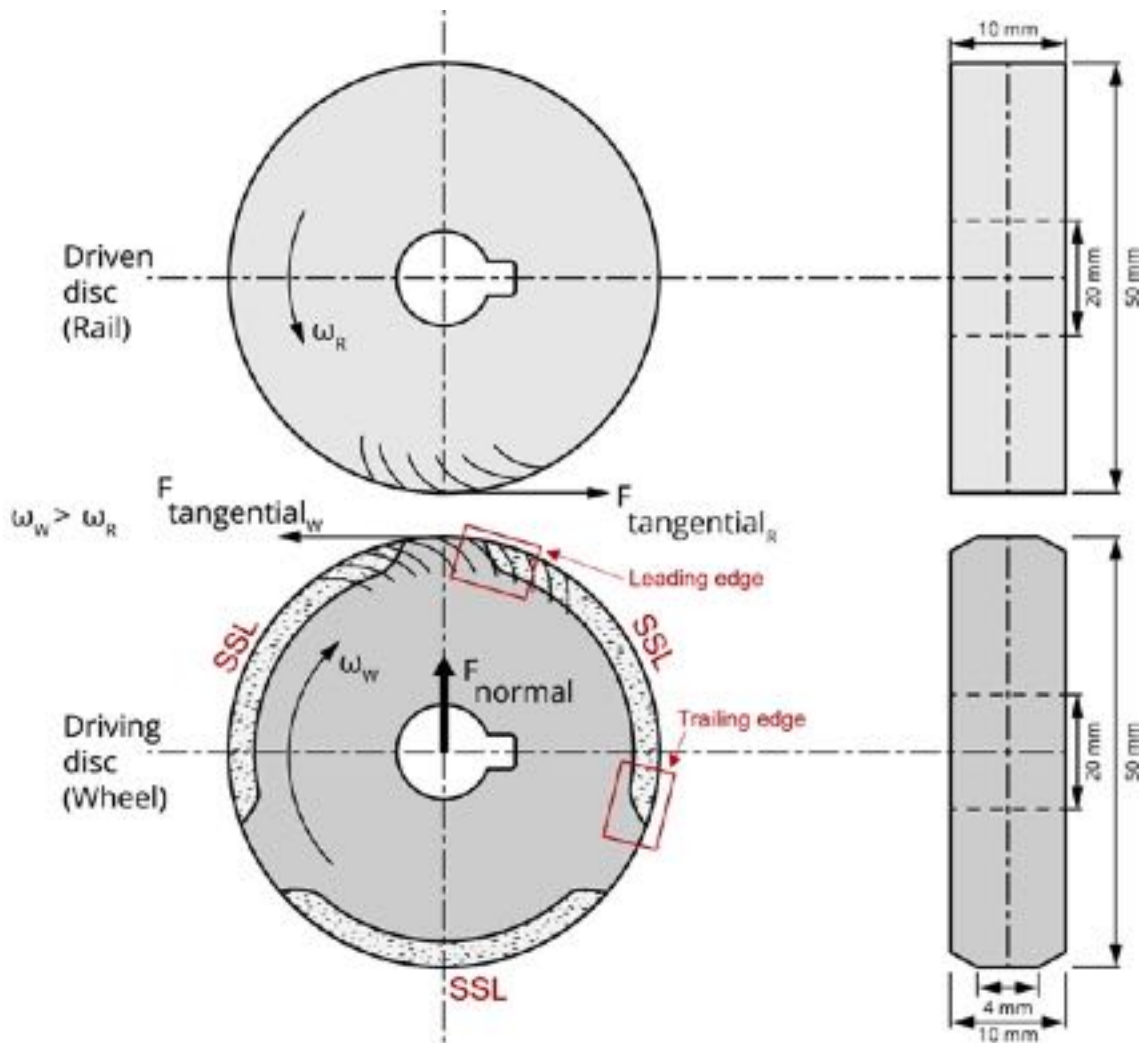
Figure 1: The configuration of the twin disc tribometer used for the initial mechanical loading before the thermal loadings, and for the fatigue testing of the created SSLs. The driving disc (wheel material, grade ER7/ER9) is pressed with a normal load F_{normal} towards the driven disc (rail material, grade R260). The wheel samples for the fatigue testing feature three SSL sections, whereby the leading edge of the SSL is named side A and the trailing edge side B.
