The Wieselburg Bridge collapse—Analysis of the shear capacity based on forensic data

This paper describes the structural aspects of the Wieselburg Bridge collapse in Austria. The original design and reinforcing details for this integral concrete bridge are discussed. The collapse of the bridge is re-constructed based on forensic documentation of the failure. The results of structural analysis carried out using material properties obtained after failure are compared to the shear capacity obtained from various models and from test results from literature. The results are used to explain the cause of failure of the integral bridge under dead load.

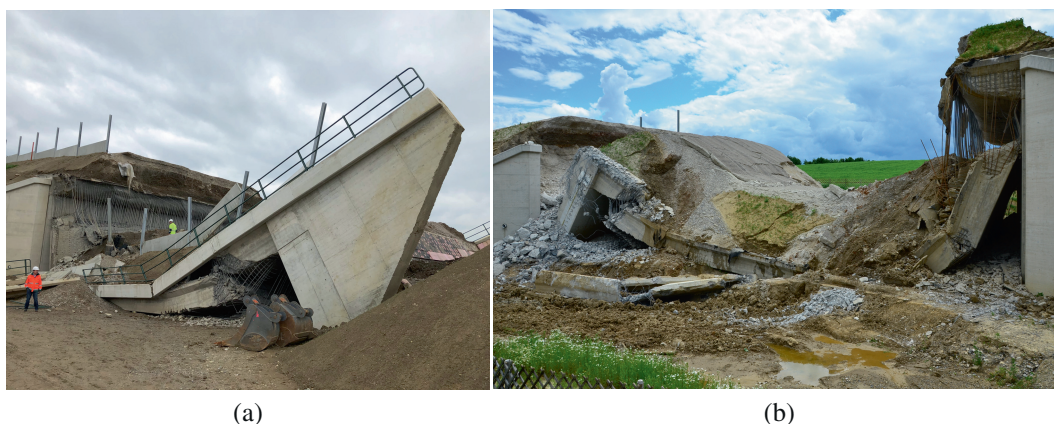
**FIGURE 3** Collapsed Wieselburg Bridge: (a) from the south-west; (b) from the north-east.

The deck slab had been cast on August 1, 2019. At the time of the collapse, the concrete was, therefore, around 10 months old. Figure 3 shows the collapsed bridge from the south-west and the north-east sides.

The failure sequence of the bridge was re-constructed based on the location and the measured lengths of the individual deck slab fragments (Figure 3) and is shown in Figure 6. Figure 6a illustrates the situation before the collapse of the bridge. It is assumed that flexural cracks close to the abutments and in the center region of the span must have formed because the calculated longitudinal stresses in the concrete at these locations were higher than the concrete's tensile strength, which was calculated as $f_{ctm} = 0.3 \cdot (f_{cm})^{2/3}$ as stipulated in Eurocode 2 (EC 2),⁷ yielding $f_{ctm} = 3.97 \text{ N/mm}^2$. Flexural cracks are shown qualitatively in regions where a tensile stress exceeding f_{ctm} was calculated from the results of the static analysis presented in Section 4.1 of this paper. A wide crack is shown in Figure 6a at a distance of 3.10 m from axis 10. At this location, the area of the top longitudinal reinforcement dropped from 8252 to 3540 mm²/m (see Figure 2). It is important to note, that the same decrease in longitudinal reinforcement occurs at a distance of 3.65 m from axis 20; however, this location is located in the uncracked region at the beginning of the failure sequence.

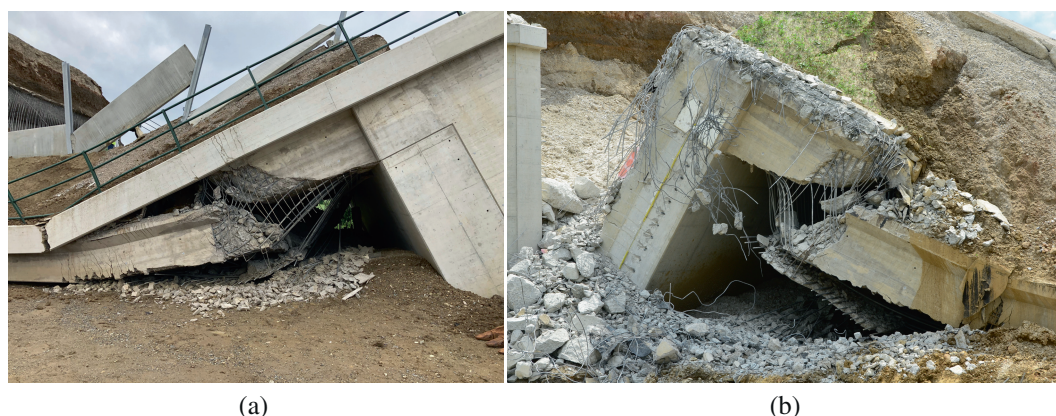
FIGURE 5 Tilted abutment 20 with shear crack: (a) from the south-west; (b) from the north-east.

top part of the failure plane. An analysis of the shear capacity of the deck slab at this location is presented in Section 4 of this paper. Figure 5 shows the tilted abutment at axis 20, with shear failure in the deck slab.

Figure 6e. As a consequence of the leftward movement of the right part of the bridge and the contact of the tip of the cantilever with the abutment wall in axis 10, an upward movement of the tip occurred. This movement led to the buckling of the bottom longitudinal reinforcement, as can be seen in Figure 4. In both the right and left parts of the bridge, the top and bottom longitudinal reinforcement crossing the flexural shear crack close to axis 20 were still connecting the individual pieces of the collapsed bridge (see also Figure 5).
