TRIGA
CENTER
Atominstitut

DIPLOMARBEIT

Identification, extraction, and analysis of Cs-bearing microparticles from Fukushima

Wien, 18. Dezember 2024

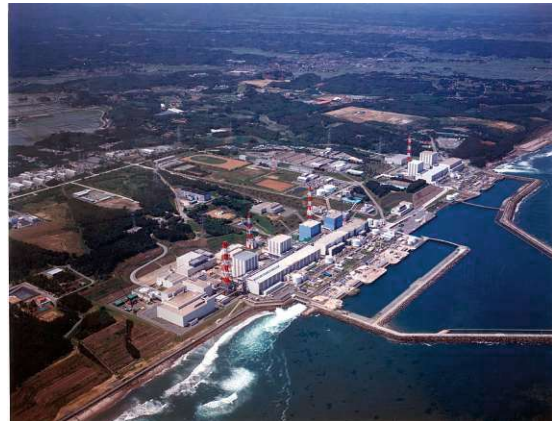
(b) Photo of the FDNPP site in February 2007. **Source:** [2]

Figure 1: Overview of all nuclear power plants in Japan shortly before the accident as well as a photo of FDNPP in the years prior to the nuclear accident.

As of January 2011, the Fukushima Daiichi Nuclear Power Plant was one of 21 nuclear power stations in Japan with a country-wide total of 54 reactors. It is situated approximately 220 km north-east of the capital Tokyo on Japan's Pacific east coast. A photo of the power plant years before the accident can be seen in figure 1b with the two distinct reactor complexes on the left and right hand sides. Numbered from left to right, Units 4 - 1 are in the left complex and Units 5 and 6 are in the right complex. The six cubical reactor buildings can be seen just behind their respective turbine buildings. Also clearly visible are the red and white stacks next to some of the units.

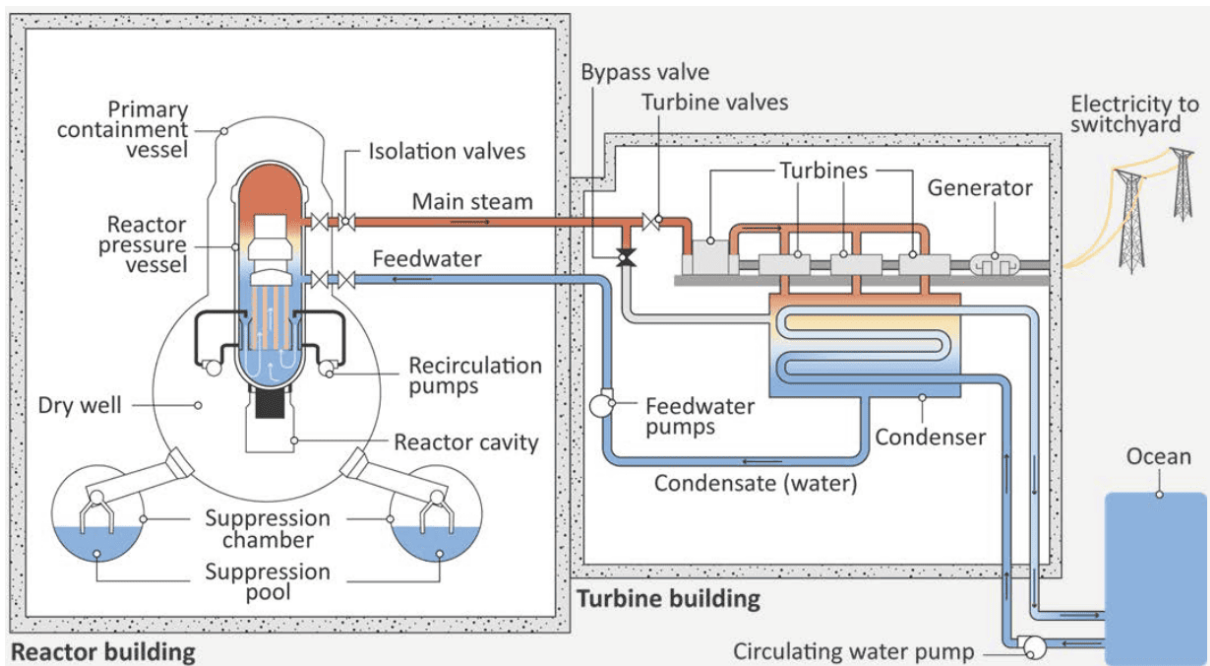
Figure 2: Simplified schematic diagram of the working principle of a BWR type nuclear power plant with access to ocean water like FDNPP. **Source:** [1]

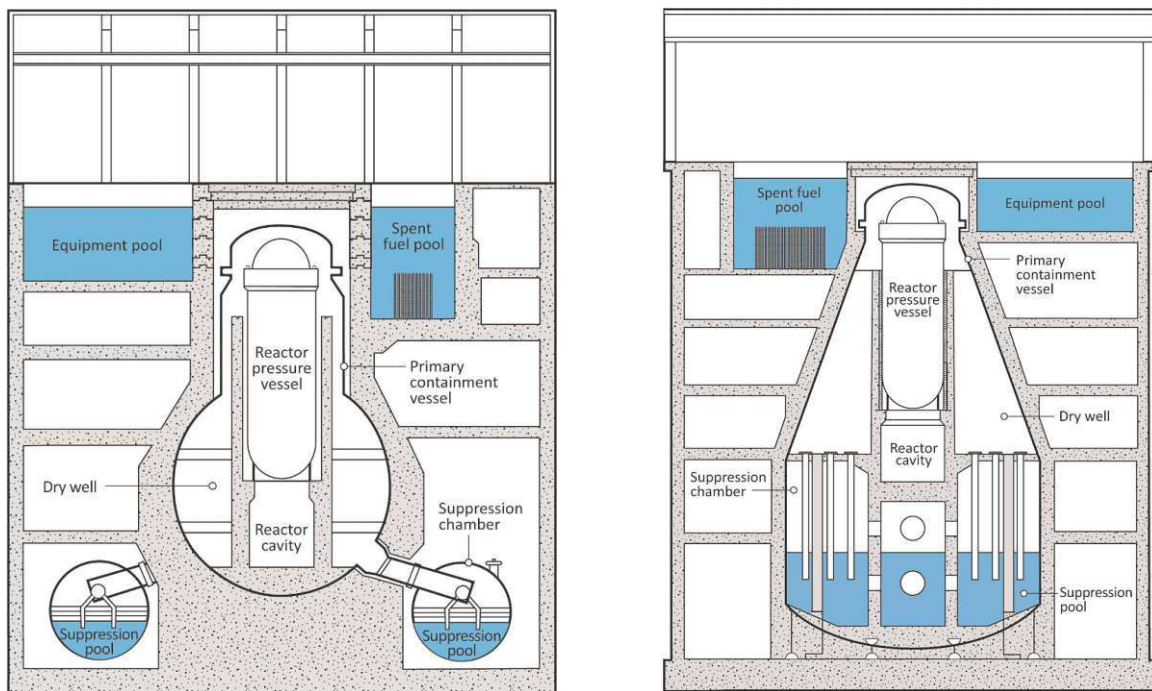
(a) Simplified representation of the Mark-I containment configuration like in the GE BWR-3 reactor of Unit 1. The GE BWR-4 reactors of Units 2 - 5 featured the same configuration with only minor differences.

The containment systems for the GE BWRs at FDNPP were also different between the newer and older models. Units 1 - 5 had the so-called Mark-I containment and the newest unit, Unit 6, already had a Mark-II containment. In general, both designs had two fission product barriers and a common pressure suppression system to relieve pressure in the primary containment vessel (PCV) by condensing the steam in case of too high pressure in the containment vessel. The fission product barriers were twofold: there was the primary containment, i.e., the primary containment vessel (PCV), and the secondary containment, i.e., the reactor building (RB) [1].

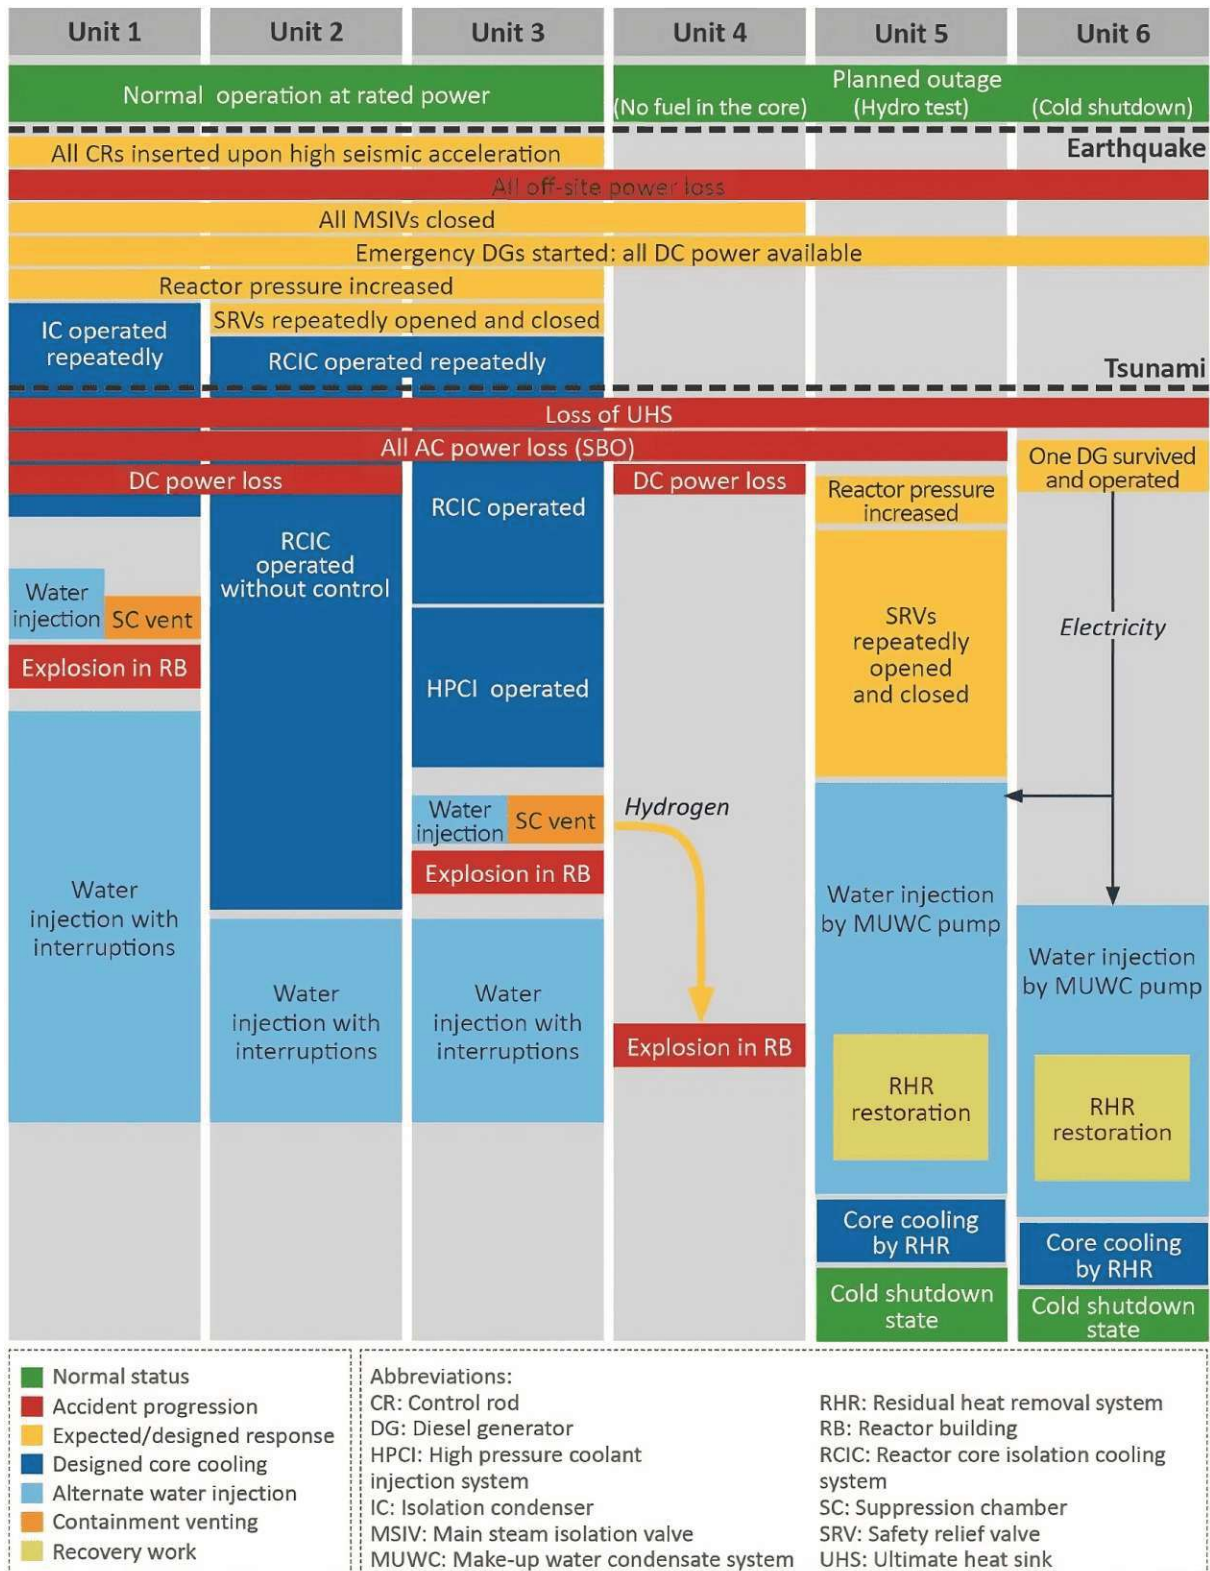
Figure 4: Overview of the main sequence of events at FDNPP shortly before and after the earthquake and tsunami hit the site. Source: [1]

On March 11, 2011, one of the world's most severe nuclear accidents in history would unfold. After one of the largest earthquakes ever recorded, a tsunami would overwhelm the seawalls at the Fukushima Daiichi Nuclear Power Plant (FDNPP) and flood the primary and backup power systems, leading to the total loss of power at the site. The main shock lasted for more than 2 minutes with a magnitude of M 9.0. Due to the damage sustained, an extended SBO would lead to the total loss of four of the six units, with three of those lost due to the complete loss of plant cooling, resulting in the fuel overheating and melting. This in turn would result in the release of radionuclides into the atmosphere. In this section, a chronological sequence of the events that took place on this day will be described. Again, most of the information will be summarized from the Fukushima Daiichi accident report [1]. All timestamps are cited in the respective local time, i.e., Japan Standard Time (JST) (UTC +09:00). For quick reference, an overview of the main event sequence is shown in figure 4.

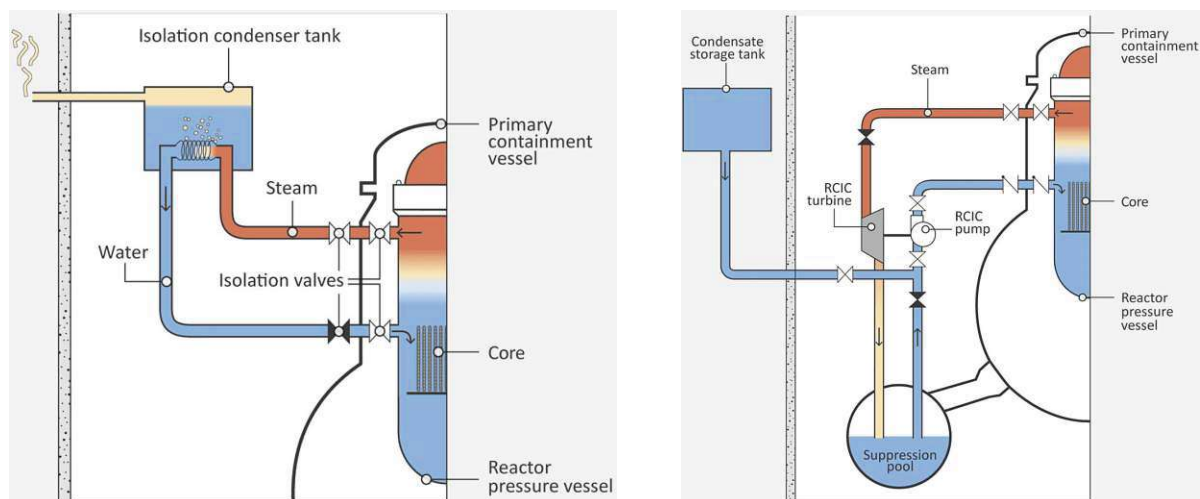
(a) Working principle of the isolation cooler (IC) in the design of Unit 1.

Another automatic safety measure after the initial earthquake was the isolation of the reactors from the turbine systems by closing the **MSIVs**. This naturally lead to an increase in core temperature and thus increased core pressure. In order to cool the reactors when they are isolated, there were mainly two systems in place that are shown in figure 5. The **isolation cooler (IC)** (Fig. 5a) is a trivial system that uses cold water tanks (isolation condenser pools) outside of the **PCV** to cool down and condensate the steam from the reactor. The water inside the tank would eventually boil away and be released to the atmosphere, thereby acting as the heatsink. This naturally works completely without the need for power by the use of gravity and was sufficient for 8 h of operation before needing to be replenished. The **reactor core isolation cooling (RCIC)** (Fig. 5b) works by using the **SC** together with a condensate storage tank as a heatsink. The steam from the reactor drove a small turbine that in turn ran a pump that injected water back in the reactor at a high pressure. The water lost from the reactor was restored by the storage tank. This formed a closed loop cycle that was designed to run for at least 4 h. All the

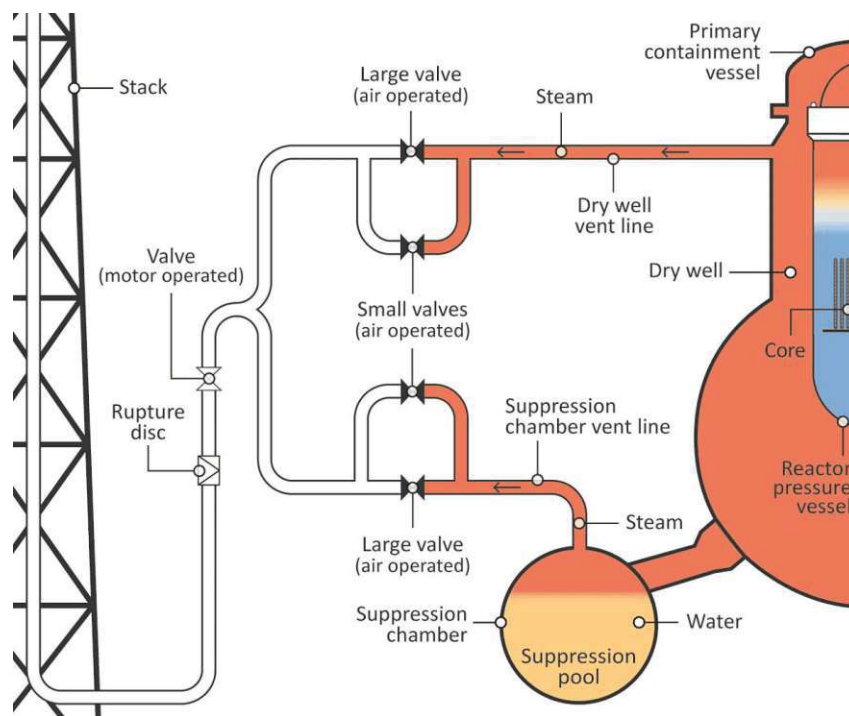
Figure 6: Schematic of the containment venting system with thick-walled discharge piping from the DW and the SC to a single stack. It was used to prevent a breach of the PCV's integrity by overpressurization. Venting through the SC was preferred due to radioisotope scrubbing. At FDNPP the vent line contained an additional rupture disk. **Source:** [1]

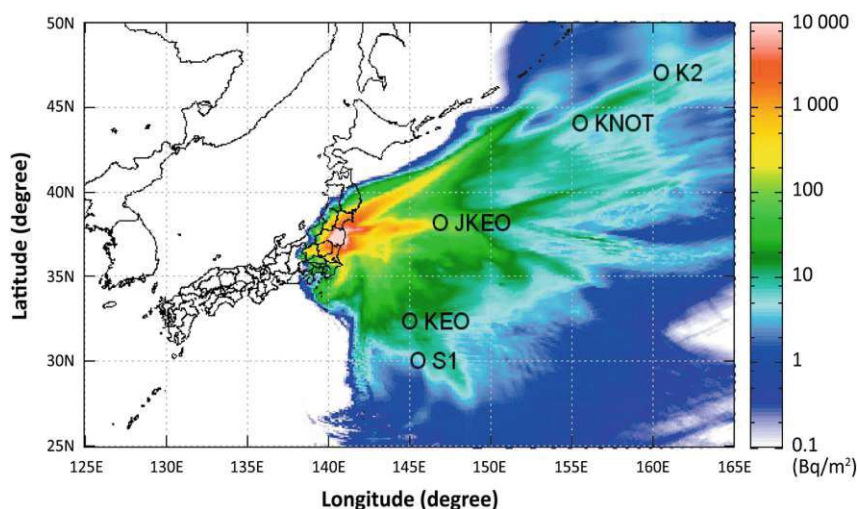
Figure 8: Modeled cumulative ^{137}Cs aeolian input through 1 April 2011. Deposition density in Bq/m^2 . **Source:** [8]

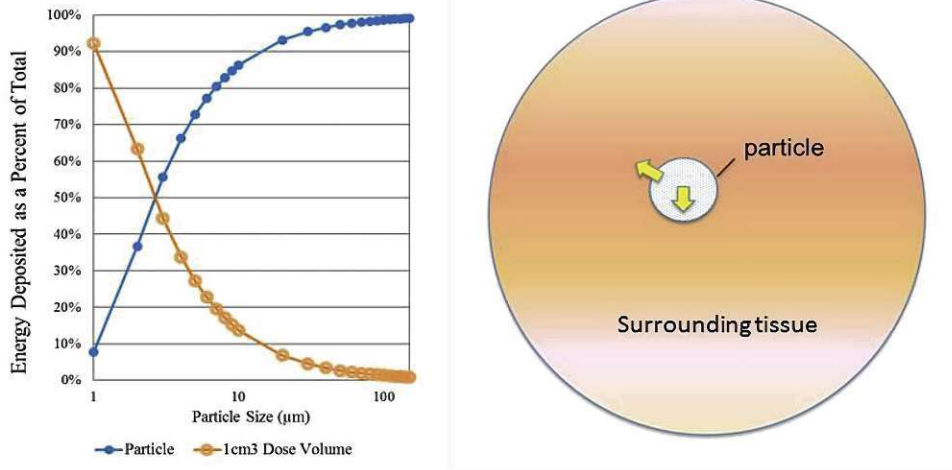
Figure 9: Model data indicating, for a range of particle sizes, the relative fraction (%) of alpha emission energy that is deposited within a Pu-containing particle (blue symbols) versus that deposited in surrounding tissue (orange symbols). The Pu was assumed to be homogeneously distributed within a spherical particle. **Source:** [25], adapted from [29]

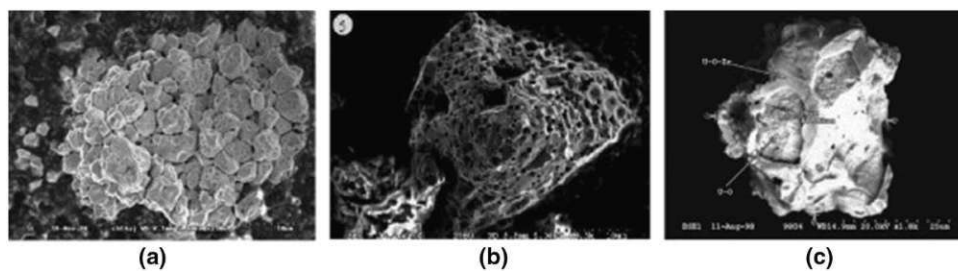
Figure 10: SEM images of fuel particles found in Chernobyl's Red Forest: **a)** UO_2 fuel particle; **b)** oxidized UO_{2+x} fuel particles; **c)** ZrU_yO_x fuel particles. **Source:** [24], originally taken from [35]

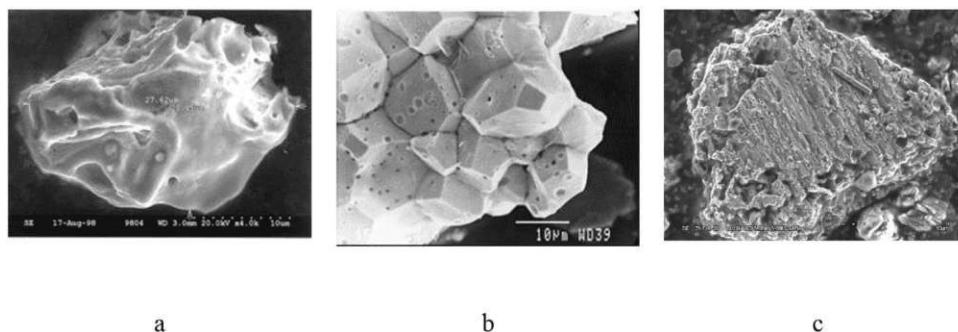
Figure 11: SEM images of fuel particles: **a)** ZrU_yO_x fuel particles; **b)** UO_2 fuel particles; **c)** UO_{2+x} fuel particles. **Source:** [36]

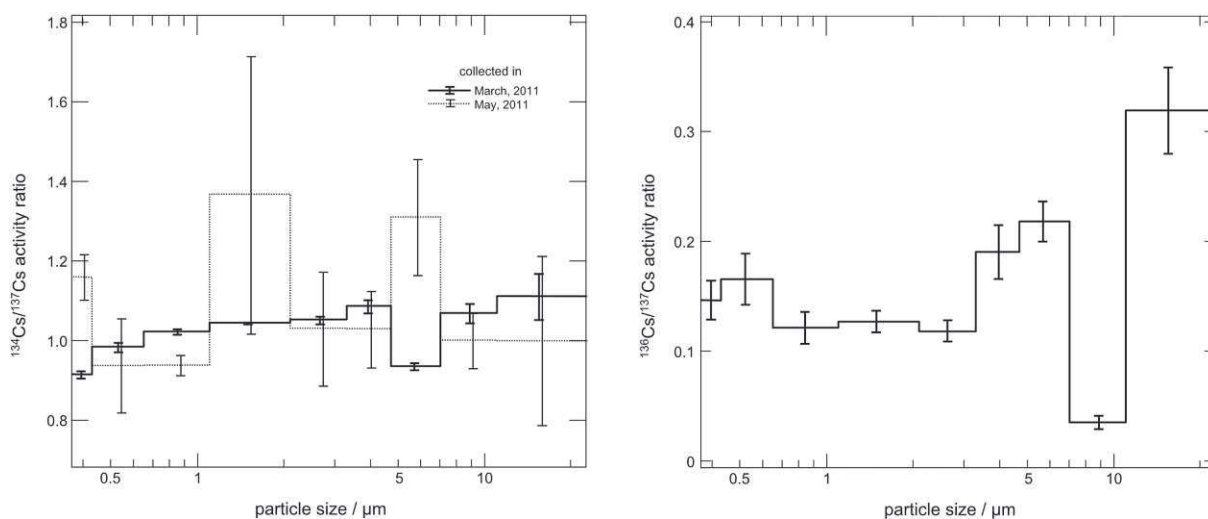
(a) Variation of $^{134}\text{Cs} / ^{137}\text{Cs}$ activity ratio with particle size. The solid lines show the variation for the samples collected in the period of March 17 - April 1, 2011, and the dotted lines show those collected in the period of May 9 - 13, 2011.

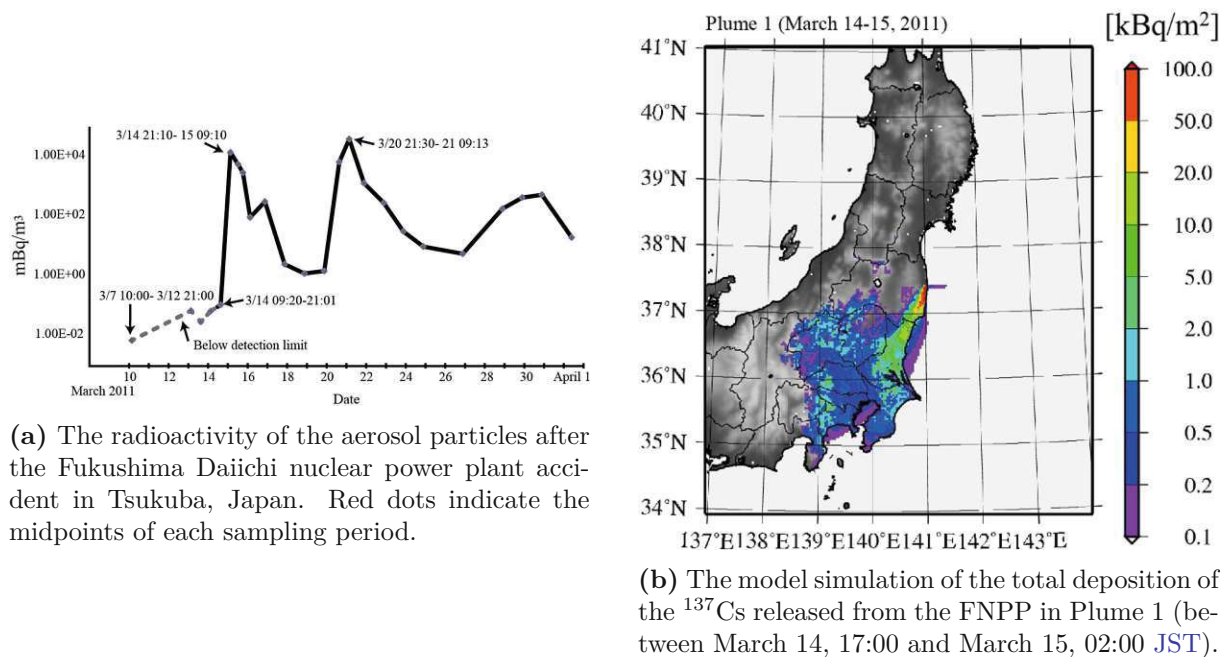
(a) The radioactivity of the aerosol particles after the Fukushima Daiichi nuclear power plant accident in Tsukuba, Japan. Red dots indicate the midpoints of each sampling period.

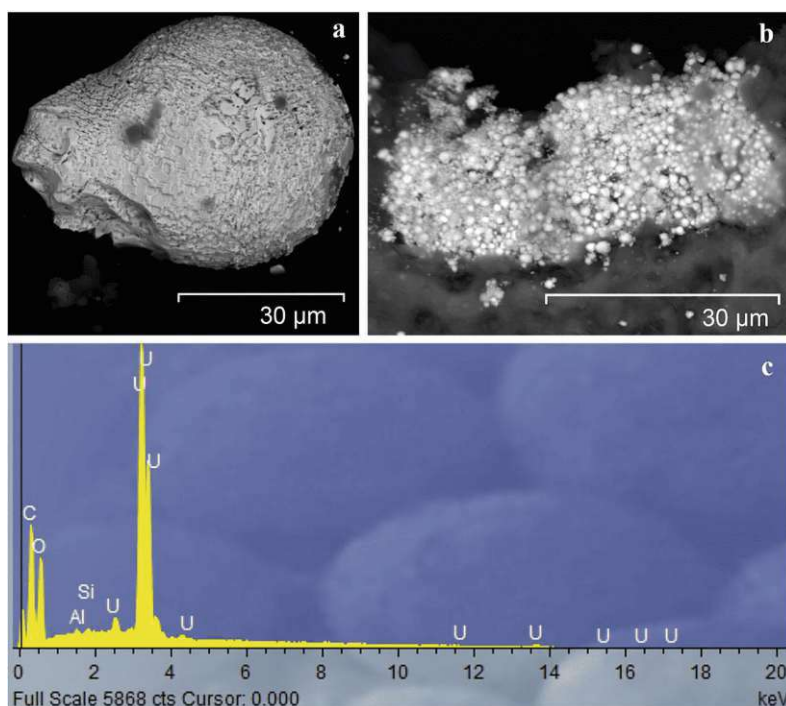
Figure 14: SEM images of some of the typical Yenisei fuel particles that were investigated: (a) an individual particle; (b) a conglomerate of particles; (c) a typical X-ray spectrum of fuel particles. **Source:** [43]

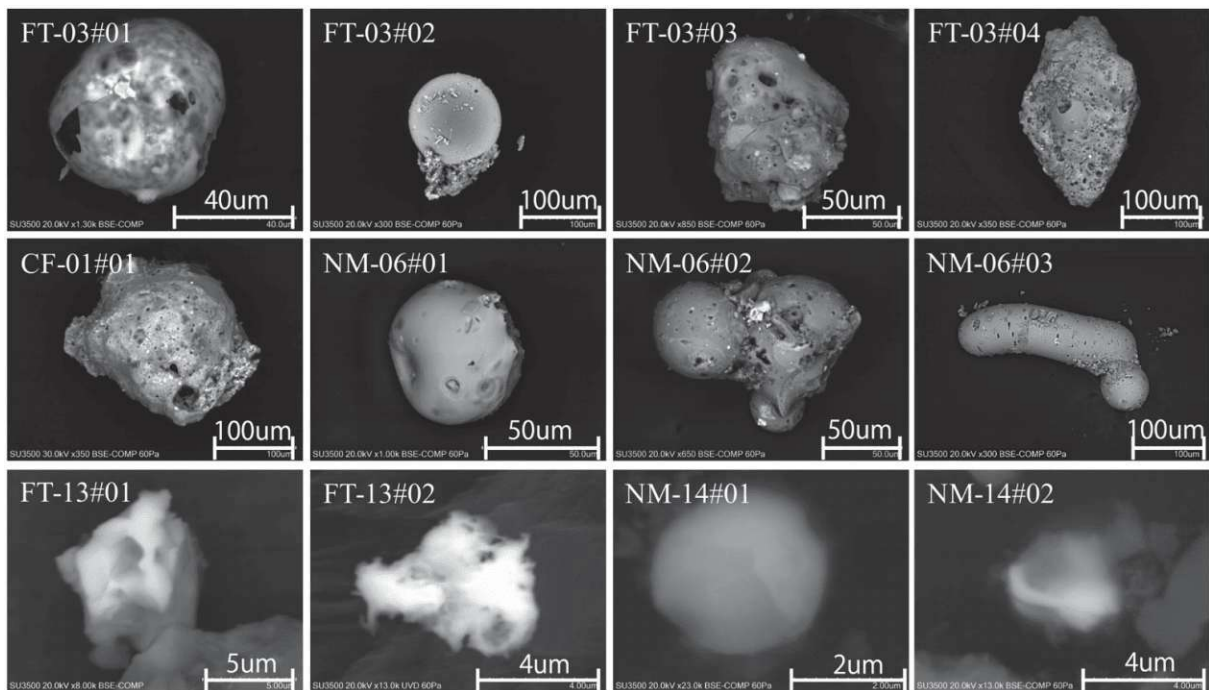
Figure 15: Backscatter electron images of representative radioactive CsMPs from environmental samples collected around FDNPP. **Source:** [49]

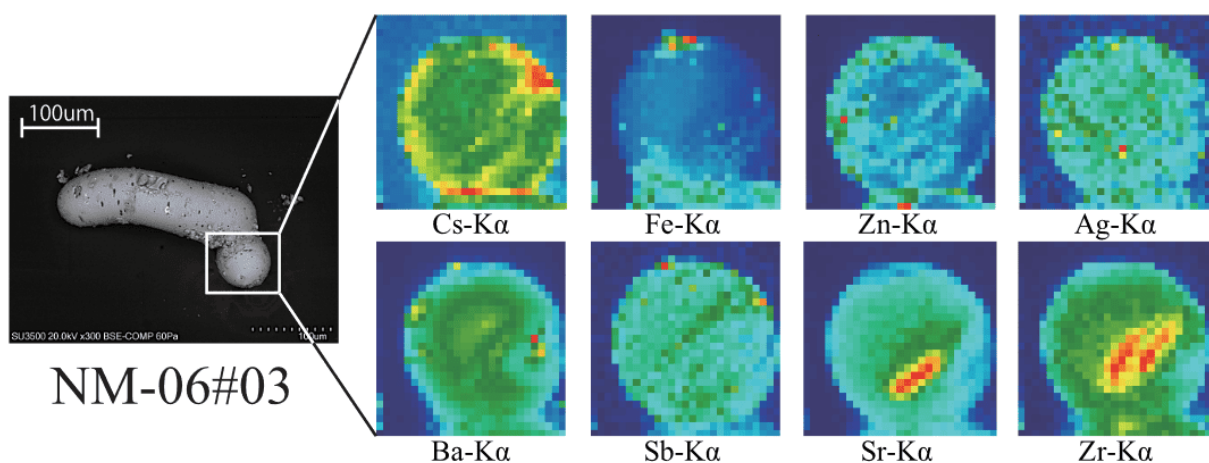
Figure 16: Micro-beam maps of elemental distributions on a CsMP, showing uneven patterns across its surface. **Source:** [49], with data reconstructed from [47]

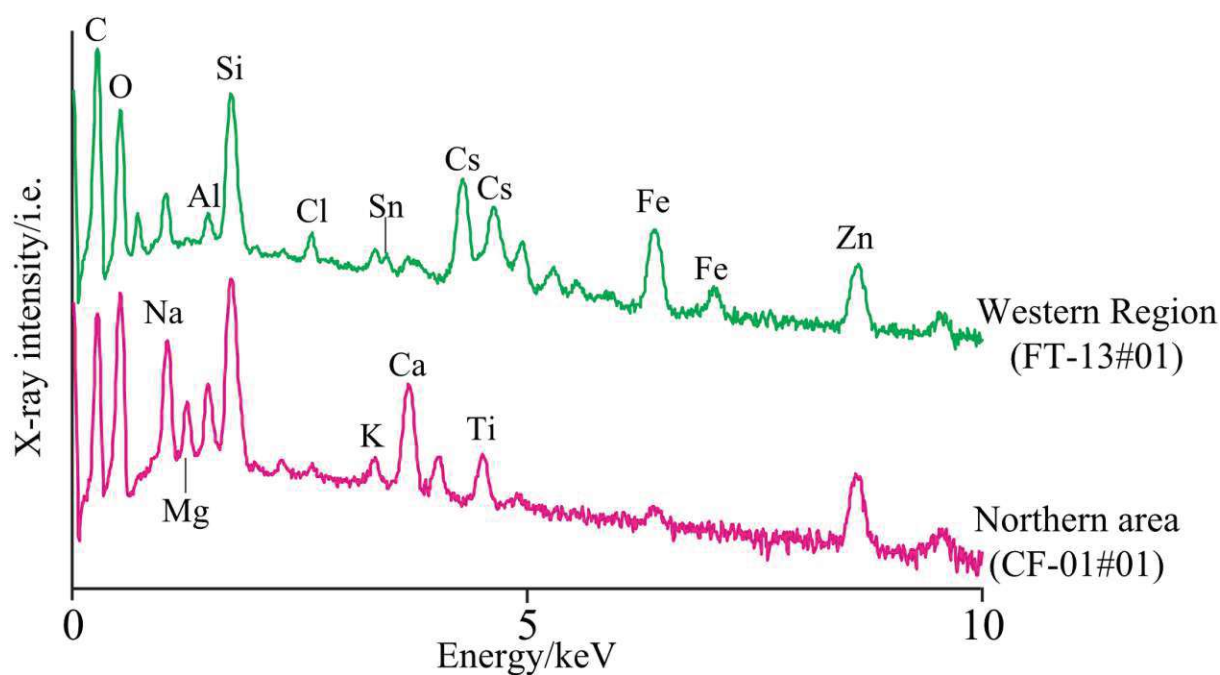
Figure 17: Elemental dispersive X-ray spectra (EDX) of two representative particles in figure 15. Note the absence of Cs peaks in the Type B particles. **Source:** [49]

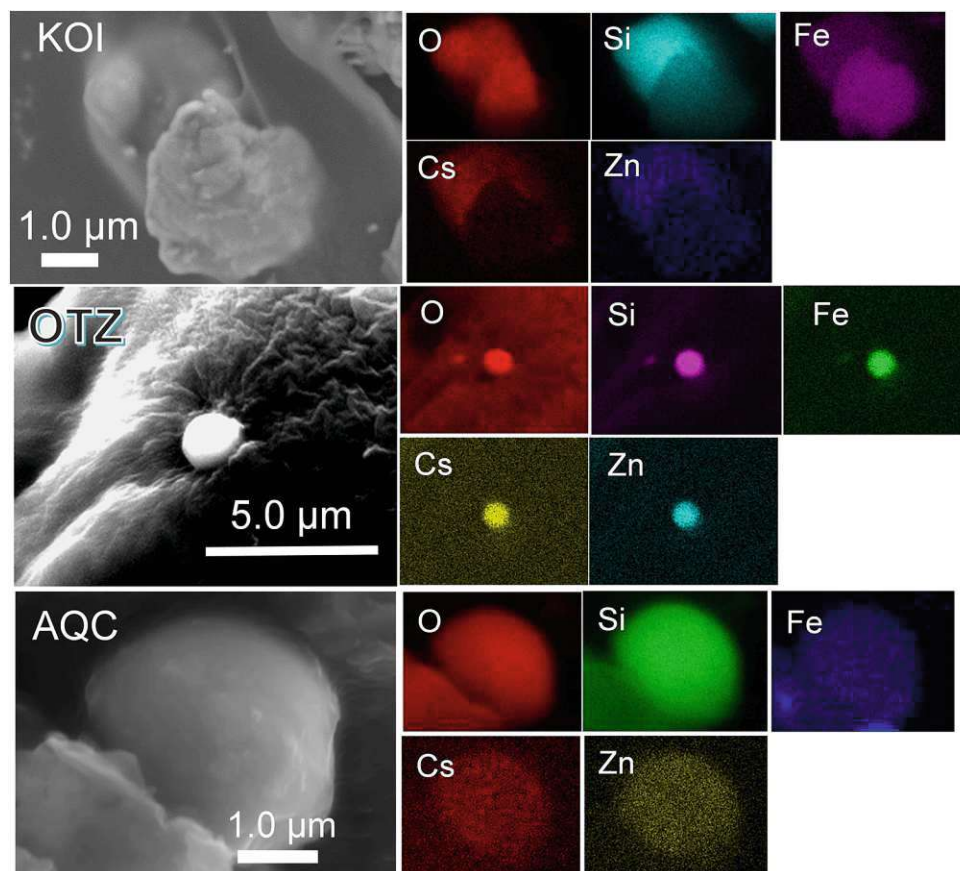
Figure 18: Secondary electron images of three CsMPs: *KOI*, *OTZ*, and *AQC*, associated with the energy dispersive X-ray spectrum (EDX) maps of the major constituents. **Source:** [53]

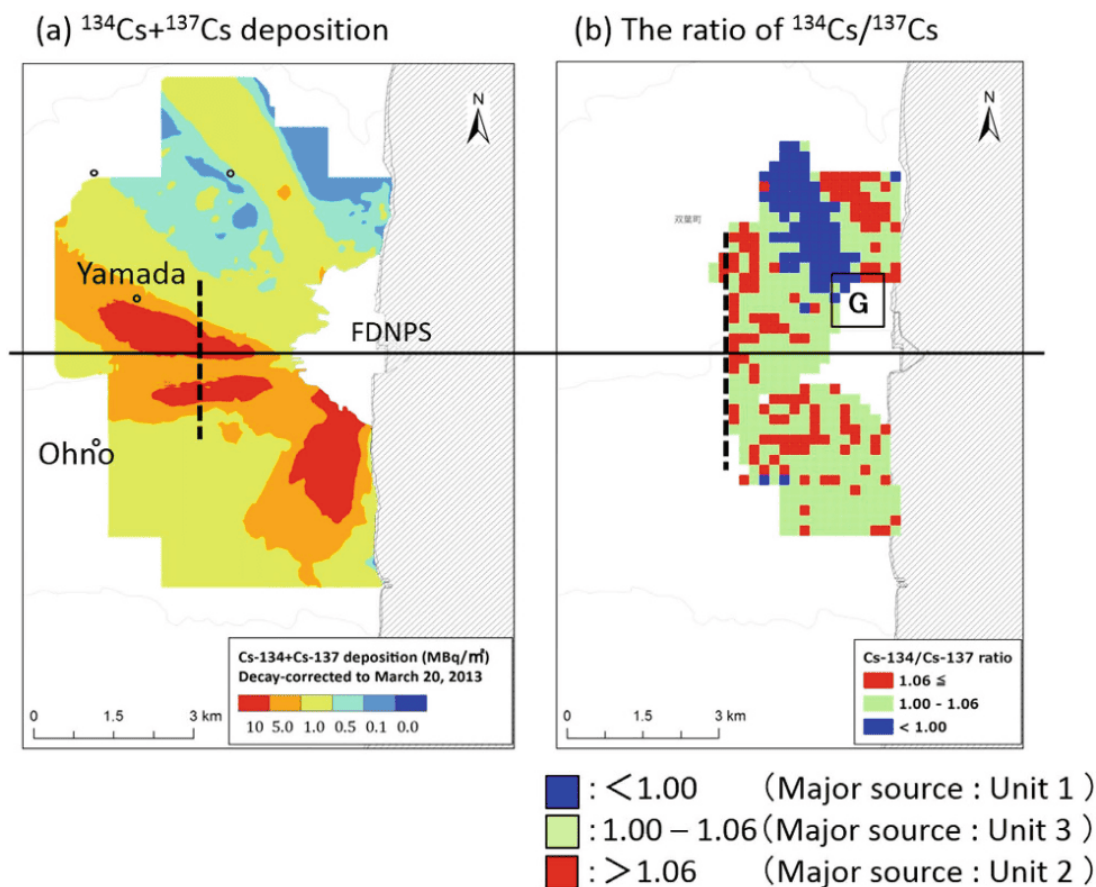
Figure 20: Autonomous unmanned helicopter (AUH) survey; spatial maps of (a) $^{134}\text{Cs}+^{137}\text{Cs}$ deposition over the 5-km area of FDNPP [55], and (b) the $^{134}\text{Cs}/^{137}\text{Cs}$ ratio over the 3-km area. Source: [40]

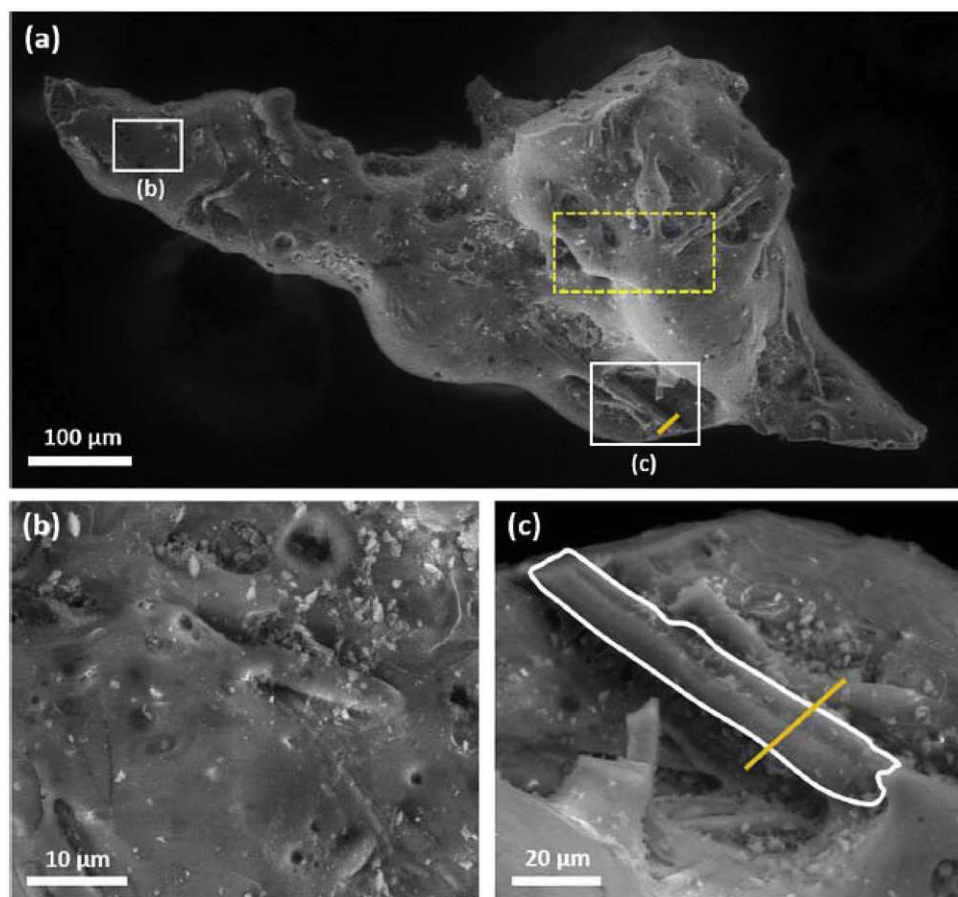
Figure 21: (a) SEM image of a Type-B CsMP; (c) shows a fibrous surface feature. Source: [46], originally reported in [49]

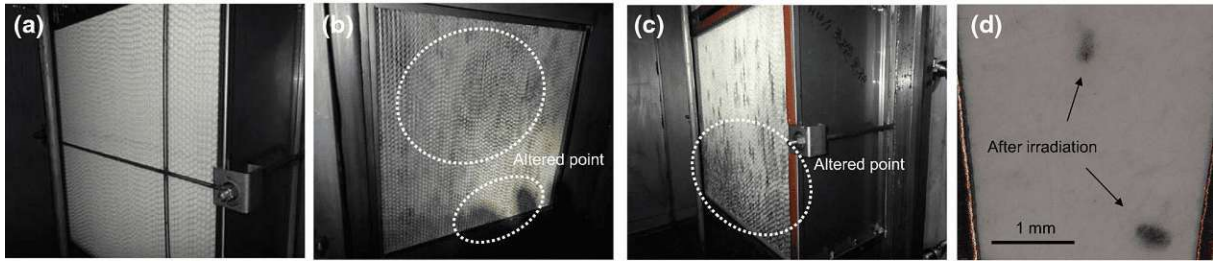
Figure 22: Images of HEPA filters and prefilters. (a) HEPA filter (No.1 in the B system) at the Unit 3 outlet after the accident; (b) Prefilter (in the B system) at the Unit 3 inlet after the accident; (c) HEPA filter (No.3 in the B system) at the Unit 3 inlet after the accident; (d) Magnified HEPA filter after irradiation in a laboratory experiment. **Source:** [57], modified from [58]

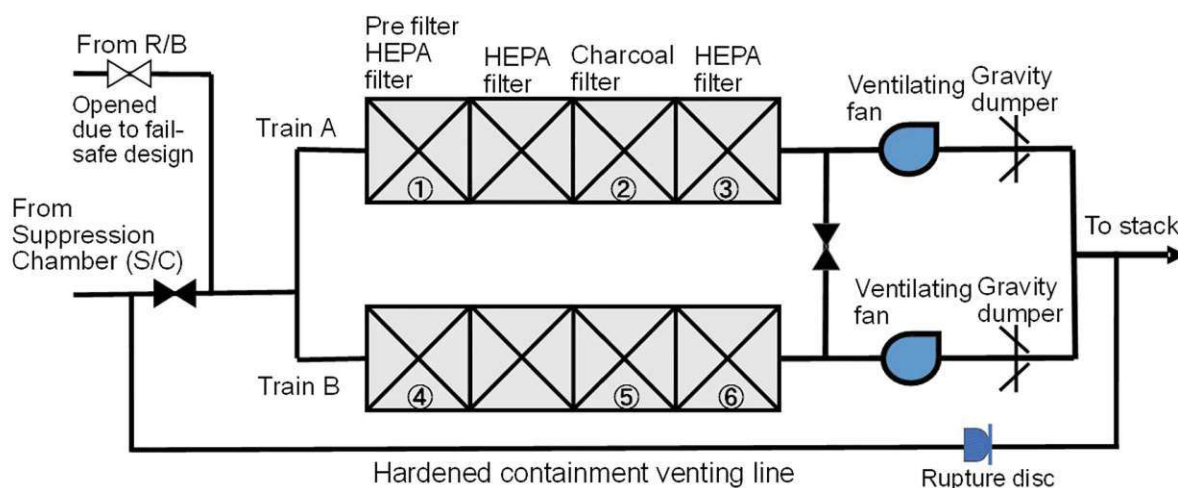
Figure 24: Setup of the HEPA filters in both lines of the SGTS at FDNPP. Source: [45], removed dose rate measurements from figure

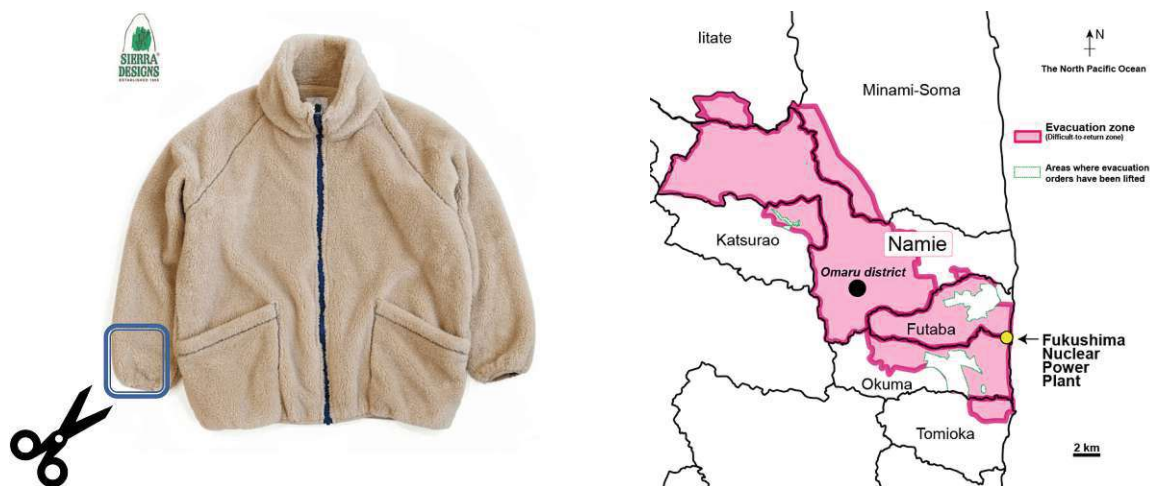
(a) Symbolic illustration of the sample extraction on a similar-looking fleece jacket.

(b) Location of the residential building inside Omaru district, Namie-town, Fukushima Prefecture.

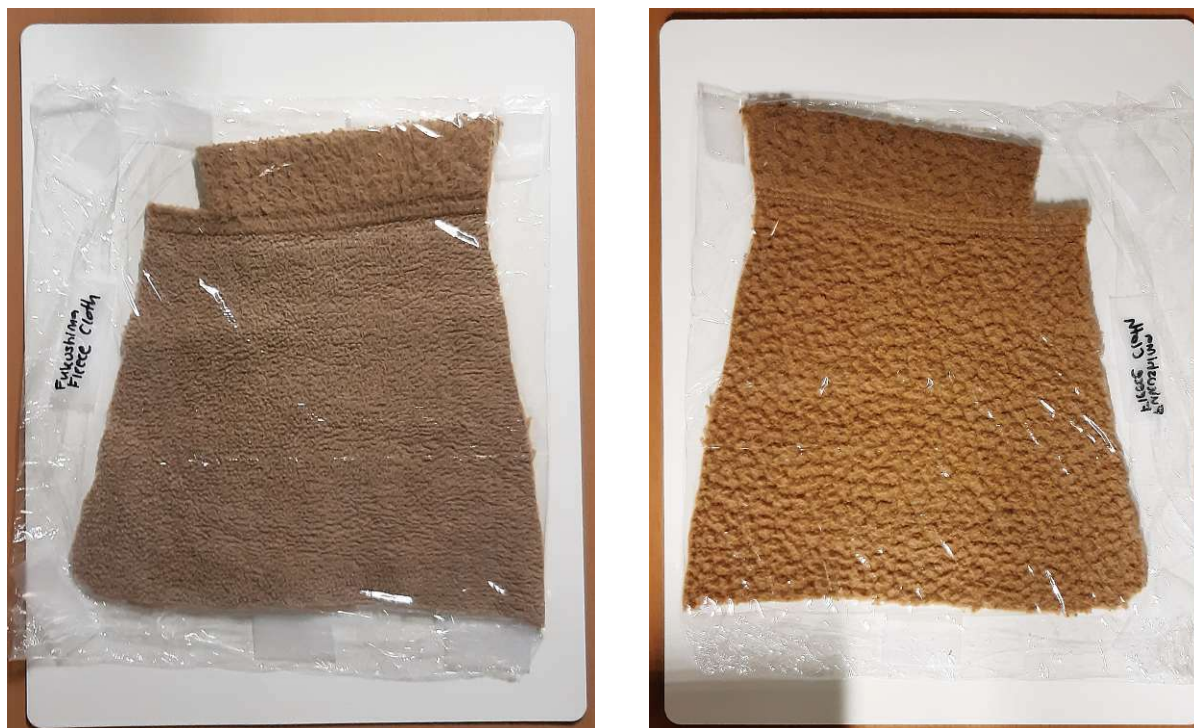
(a) *Top* side of the fleece coat sample.

(b) *Bottom* side of the fleece coat sample.

Next, the fleece coat sample was put on an AIP for radiography. Both top and bottom sides were exposed and an area of interest was identified that was easy to isolate and contained a large number of hotspots on the exposed image. It was subsequently cut from the bulk fleece sample and put on the AIP for exposure according to the work flow. The top and bottom side exposures of the fleece coat sample are shown in figure 37. These are not the original exposures that were done initially, though, recognizable by the missing top left corner. Due to a lack of large-enough image plates, the initial exposure was done with an AIP that would not fit the entirety of the sample, cutting off at the edges. For this reason, the radiography was repeated at a later point with an AIP of adequate size. In the resultant image, there is a clear difference between the top and bottom sides of the fleece, which is expected since one of the sides must have been the outer surface of the original fleece coat. Furthermore, as expected, the radioactivity is distributed very discretely in visible hotspots all over the two sides. The intensity of these spots randomly differs a lot over a broad range. On top of this, in some cases, self-absorption can be seen quite well,

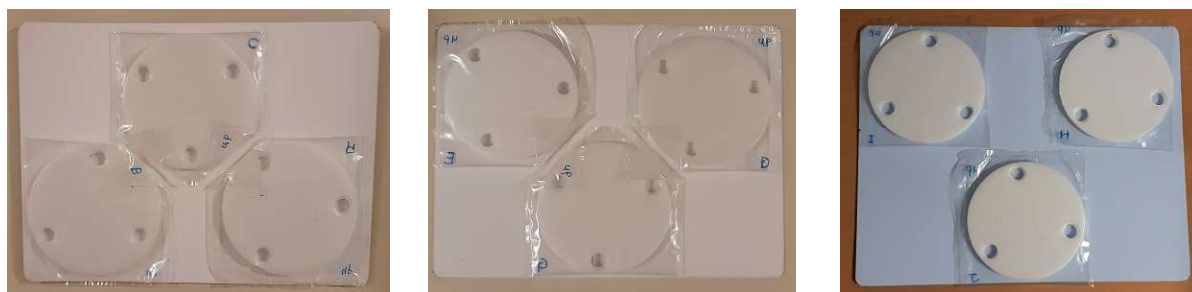
(a) Passive sampler disks A, B, and C.

(b) Passive sampler disks D, E, and G.

Figure 29: Photos of all nine provided passive sampler disks on autoradiography plates that have been investigated for this thesis.

For the research reported here, nine sampler disks labeled A - J (excluding F) that have been

exposed to resuspended radioactive aerosols of the FDNPP fallout were provided. The three groups of three disks are shown in figure 29. They have been recovered from a passive sampler set up in a forest at the coordinates N37.412312, E141.025941, which is only about 1 km from the Unit 1 RB. A photo from the sampling location amongst the thick forest vegetation is shown in figure 30, as well as the fact that PUF disks A - J were mounted from the top to bottom in this case. The unit was placed there on July 14, 2022 and was left to sample the ambient air until October 24, 2022, i.e., for a period of a good three months. Notably, the air dose rate at the sampler location was measured to be around 19 $\mu\text{Sv/h}$.

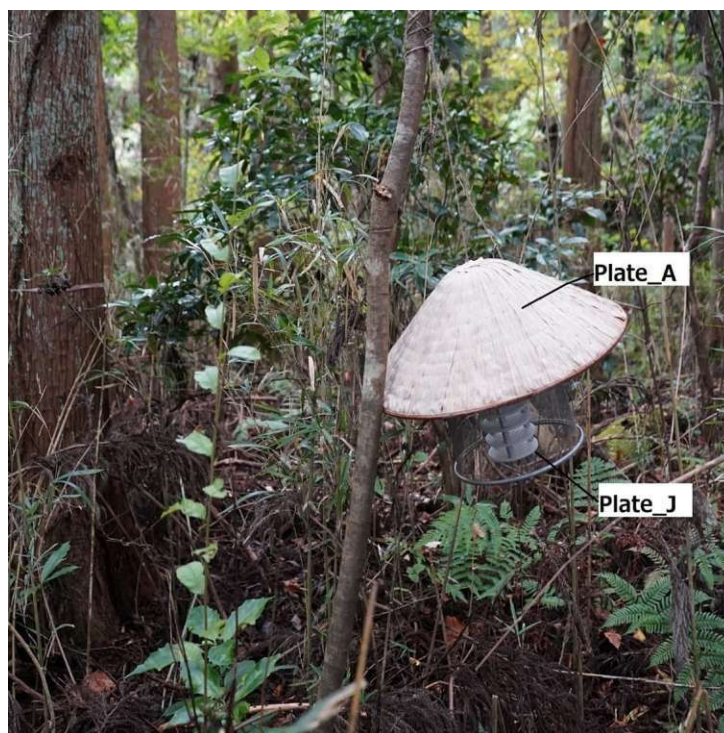
Figure 30: Photo of the sampling location amongst the forest vegetation with the passive sampler set up around 1 km from the Unit 1 RB at FDNPP for a good 3 months. **Source:** Katsumi Shozugawa, University of Tokyo

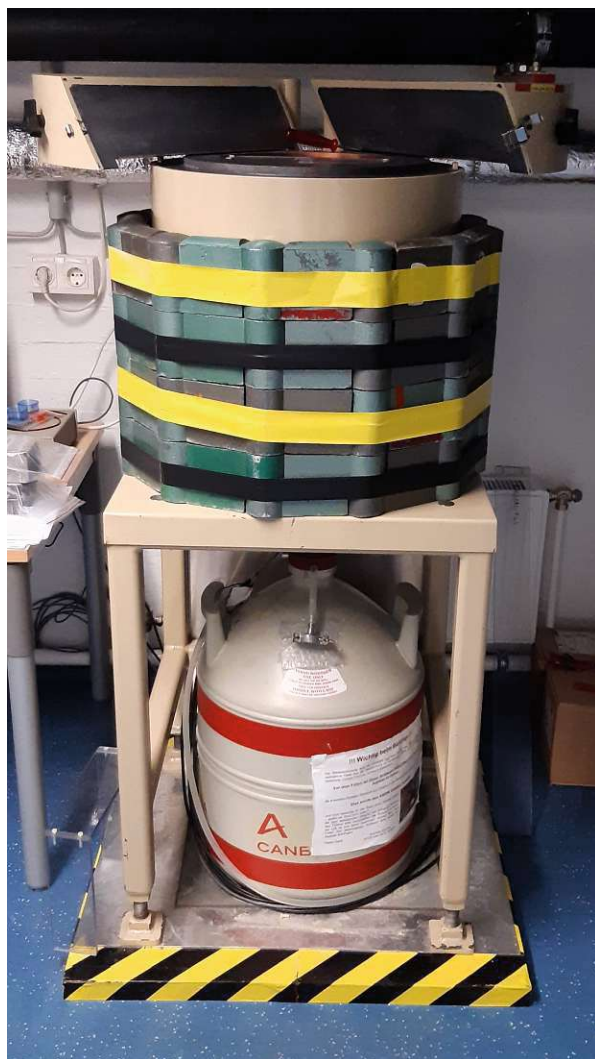
(a) Photo of the low-level gamma spectrometry setup used extensively at the ATI for this thesis. The top shielding consists of the original factory shielding for this setup with an additional layer of lead bricks around that. The nitrogen dewar sits below the detector platform.

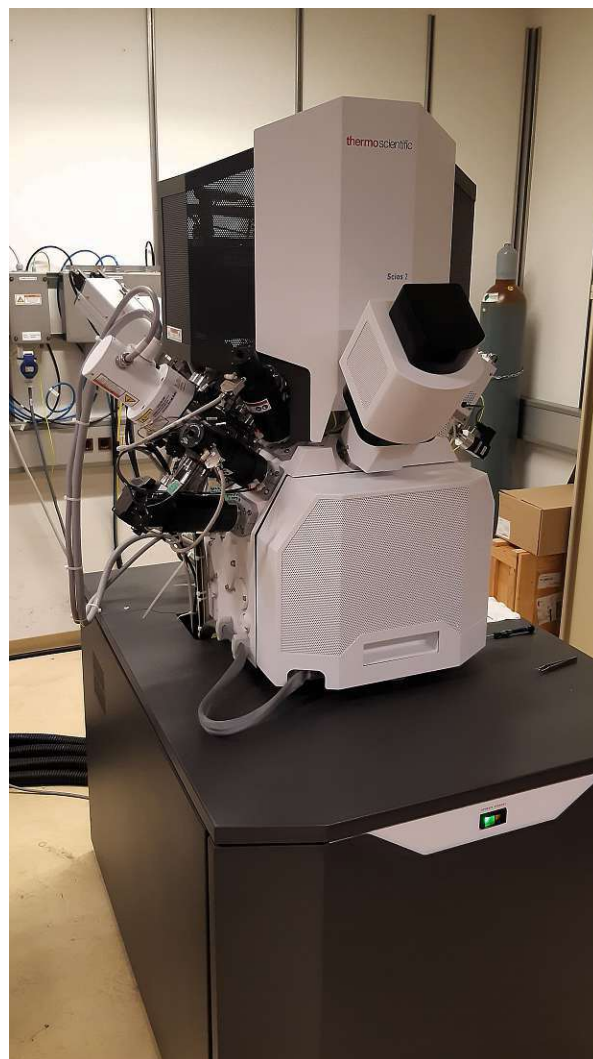
(b) Photo of the Scios 2 DualBeam FIB SEM setup used at the USTEM to do micro-surgery on the samples to extract potential hot particle candidates.

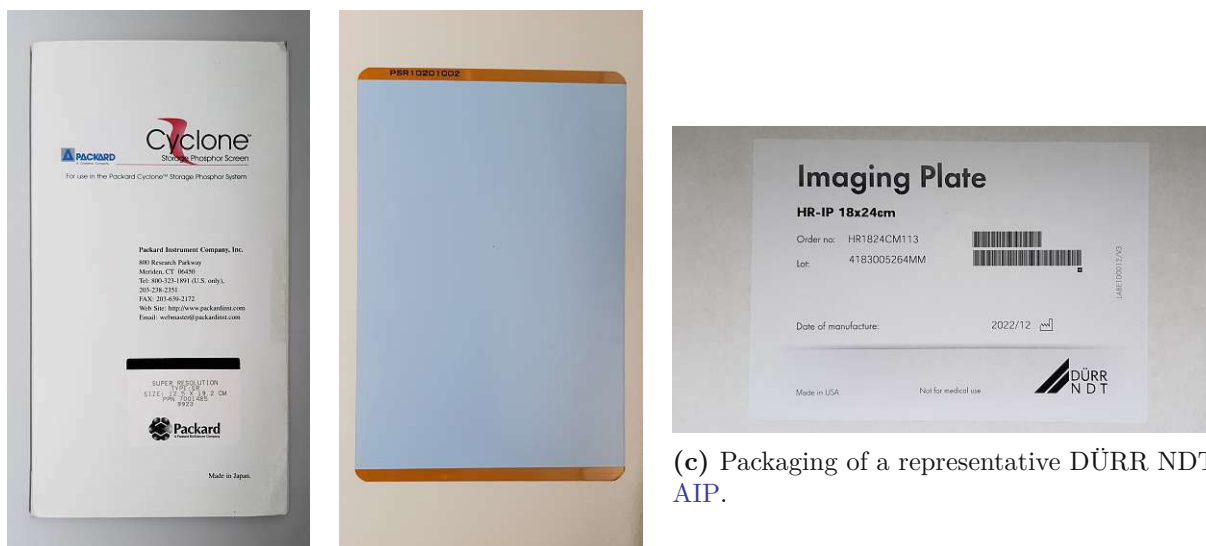
(a) Packaging of the Packard Inst. Co. AIP. (b) The Packard Inst. Co. AIP itself.

(c) Packaging of a representative DÜRR NDT AIP.

The *autoradiographic imaging plates (AIPs)* are designed specifically for their use in computed radiography, which is a compromise between the old-fashioned film and the modern fully digital autoradiography. They are passive devices, meaning they do not require any power and cannot be read out live. However, when it comes to evaluating the results, it is as easy as scanning the image plates with a special scanner to get the digital data – no chemicals required, in contrast to old-fashioned film. A representative selection of image plates and their packaging with detailed model numbers is shown in figure 32.

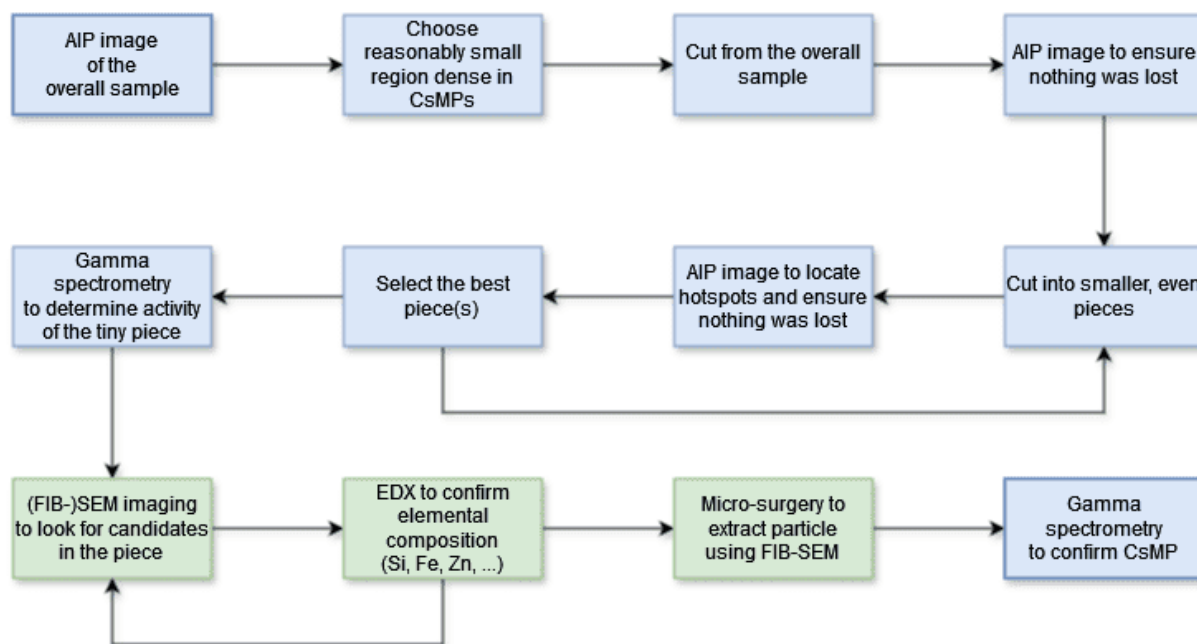
Figure 33: Schematic of the experimental procedure to find and extract CsMPs from a larger sample. Colored blue are all the steps that are performed in-house at the ATI, green are steps that had to be done at the USTEM. The looped parts are repeated until a satisfactory results is achieved or the sample is depleted.

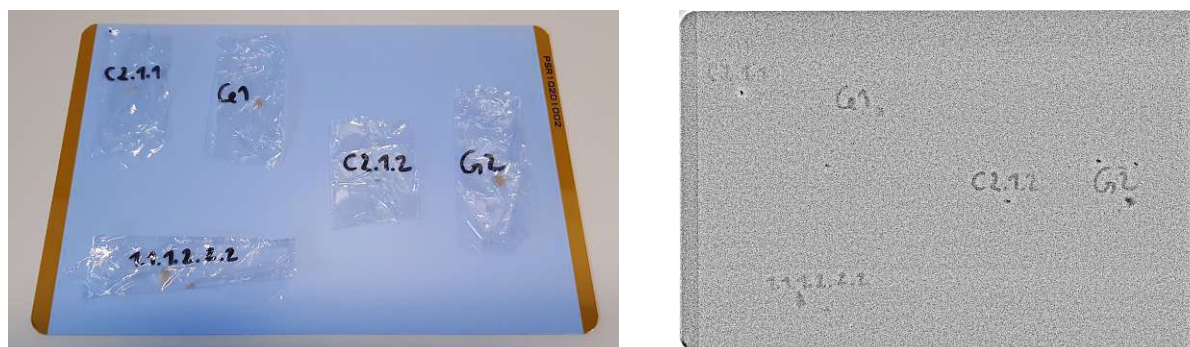
(a) The AIP setup with all of the packaged samples lying on top of the imaging plate.
