TRIGA
CENTER
Atominstitut

DIPLOMARBEIT

Identification, extraction, and analysis of Cs-bearing microparticles from Fukushima

Wien, 18. Dezember 2024

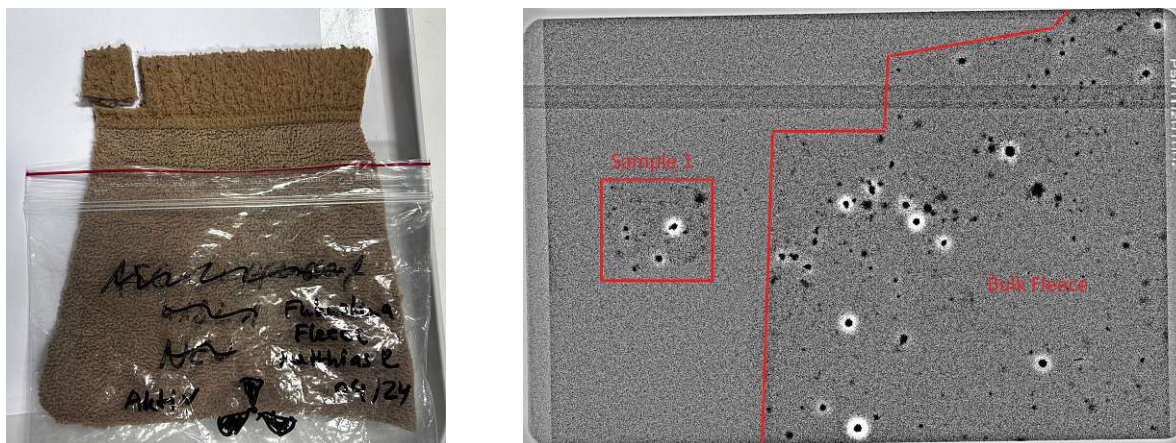
(a) Photo of the bulk fleece with the cut corner.

(b) AIP image of the bulk fleece with the clearly missing corner and the piece of fleece that was further investigated.

Figure 38: The starting point of the fractionation process for the fleece sample was this corner material that was cut from the bulk sample. The AIP was exposed for ≈ 6 days.

The corner that was cut from the sample and its AIP image can be seen in figure 38. This was a good starting point for the following fractionation process. It contained a large number of smaller hotspots and one of special interest near the middle. The rest of the fleece was left untouched and might be used in future studies of CsMPs. Figure 38b shows a comparison of the corner piece with the rest of the bulk fleece. The horizontal line near the top of the image is a readout artifact from the evaluation and does not otherwise affect the image results.

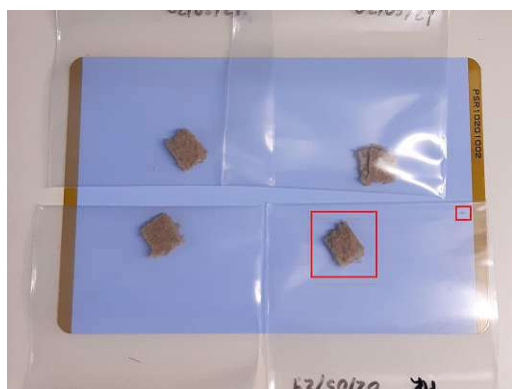
(a) Photo of the quartered corner piece during the very first fractionation cycle. The main sample and the tiny, detached fiber bundle are highlighted in red.

The new corner sample underwent the fractionation process for a few of months, during which the workflow was tested, fine-tuned (e.g., gamma spectrometer vs. AIP, exposure times, etc.), and complications (e.g., contaminations, loss of particles, etc.) were dealt with. At this point, it cannot be stressed enough that it is important to use AIPs regularly if not during the entire process as it was the case for this thesis. During the very first iteration of the fractionation cycle, where the corner piece was quartered, a tiny bunch of fleece fibers flaked off of the main sample and was only found during the evaluation of the AIP exposure. This is shown in figure

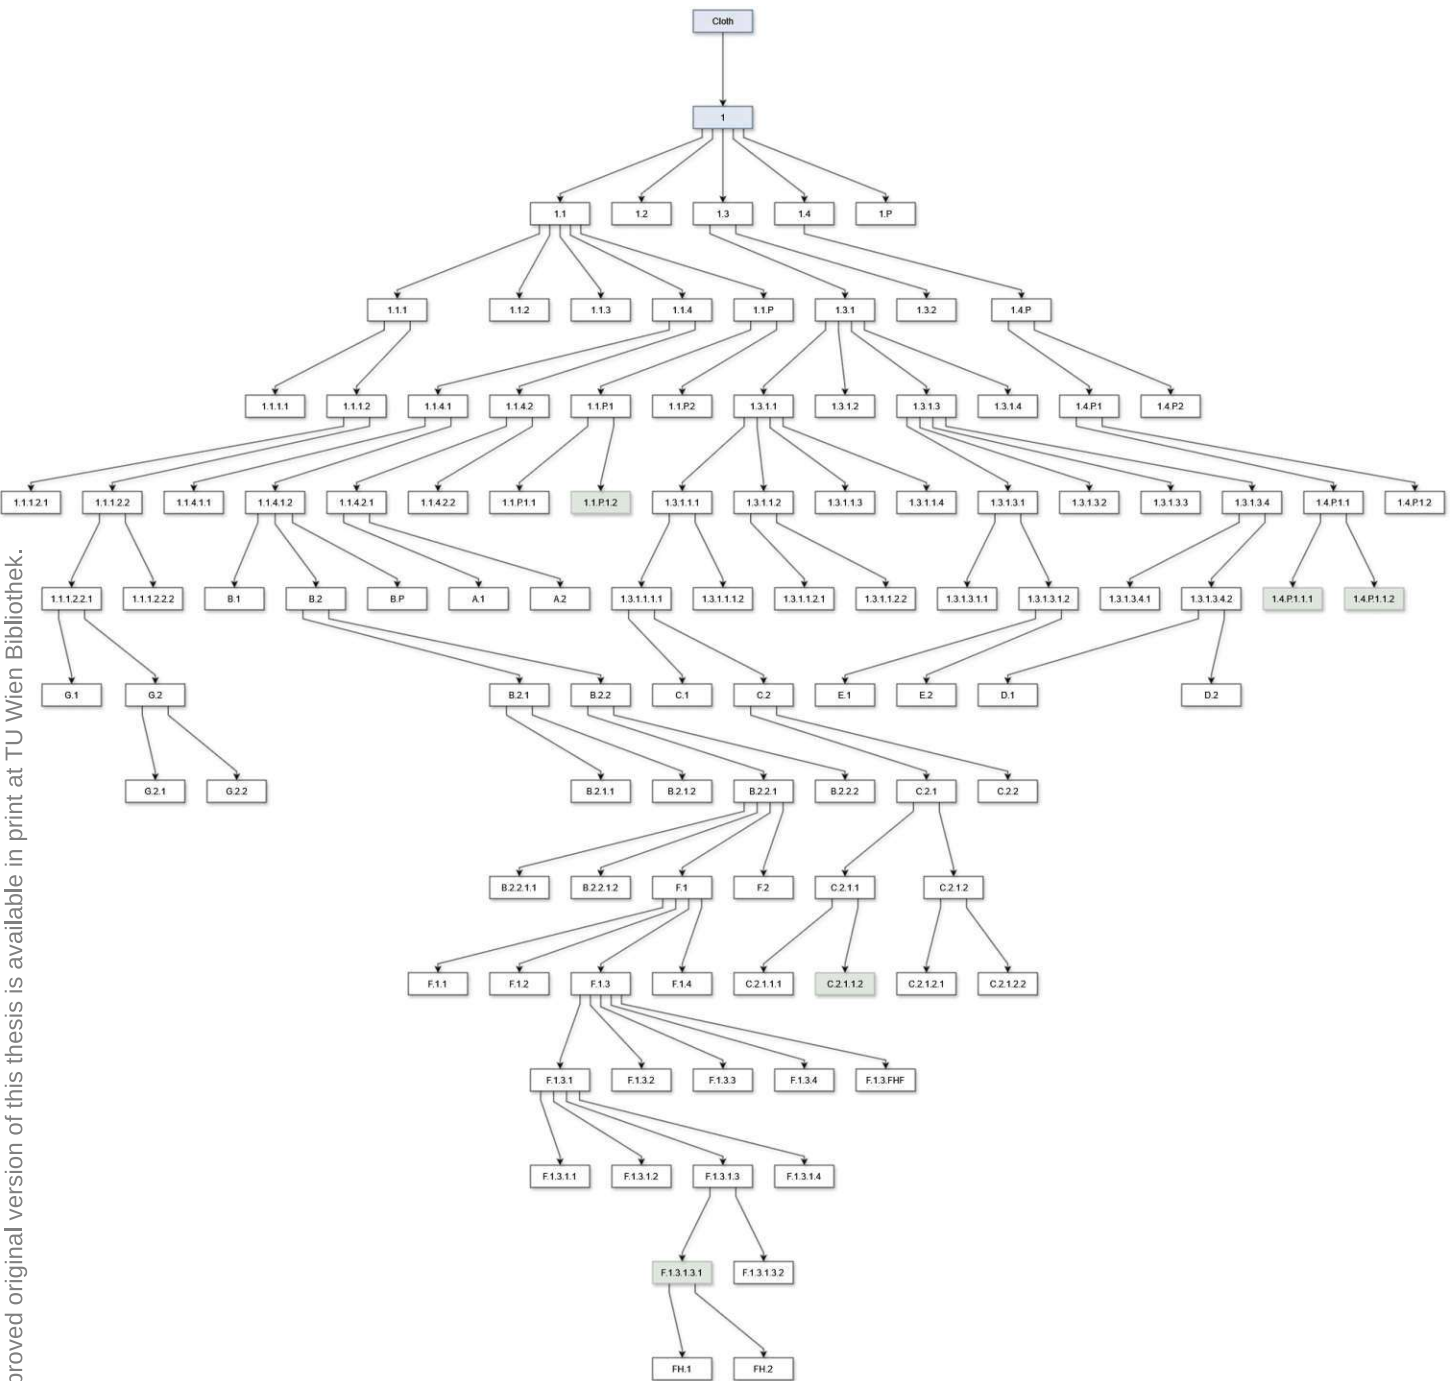
Figure 40: Hierarchical tree diagram of all the investigated samples of the Namie fleece coat sample. The blue color represents the starting point of the entire sample chain with the first sample piece cut from the bulk fleece. The green colored samples represent those that were examined at the **USTEM** using **SEM** imaging (5). In total 106 samples were produced from a small section of the bulk fleece.

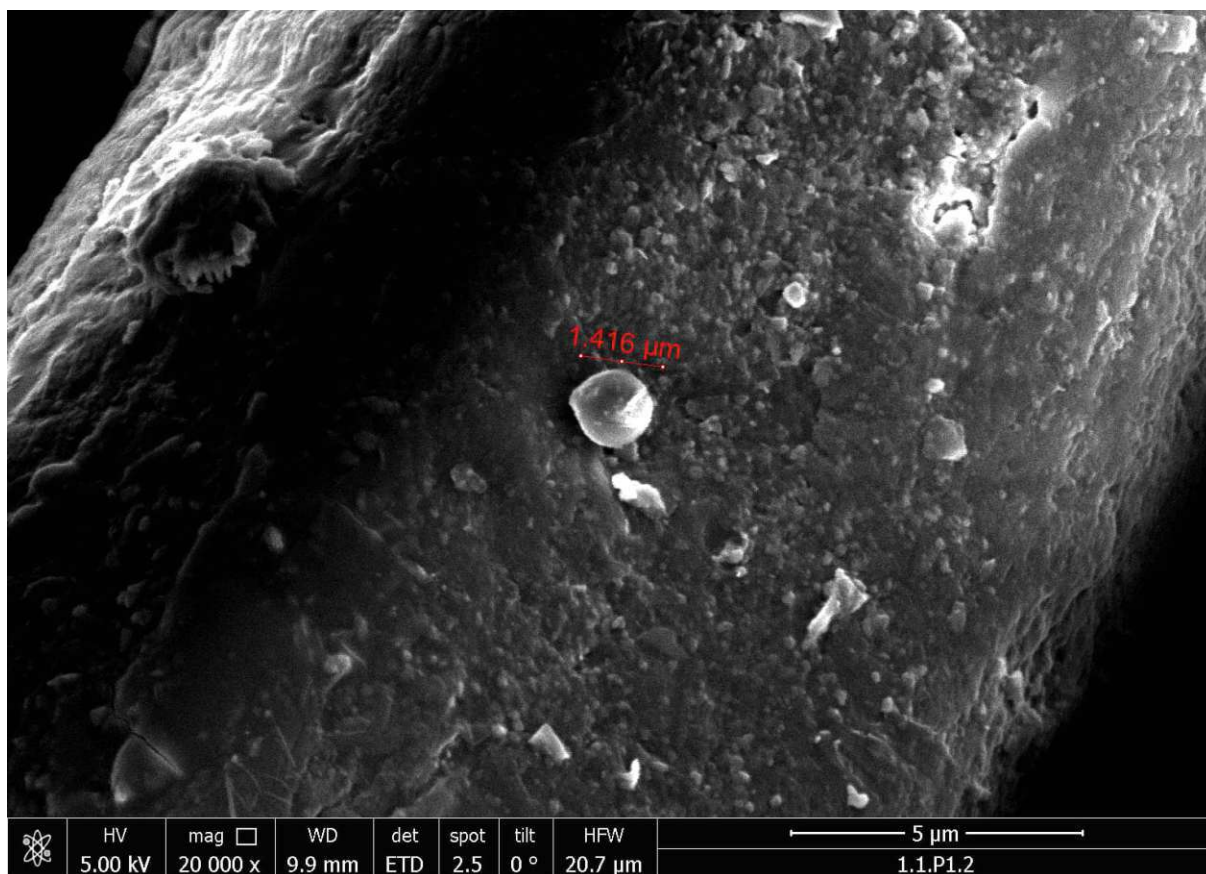
Figure 42: Image of the spherical particle that was brightly visible in EDX mode. This approximately 1.4 μm large particle was a potential CsMP-candidate. A possible crack can be seen to the right of the particle, this portion introduced charge issues.

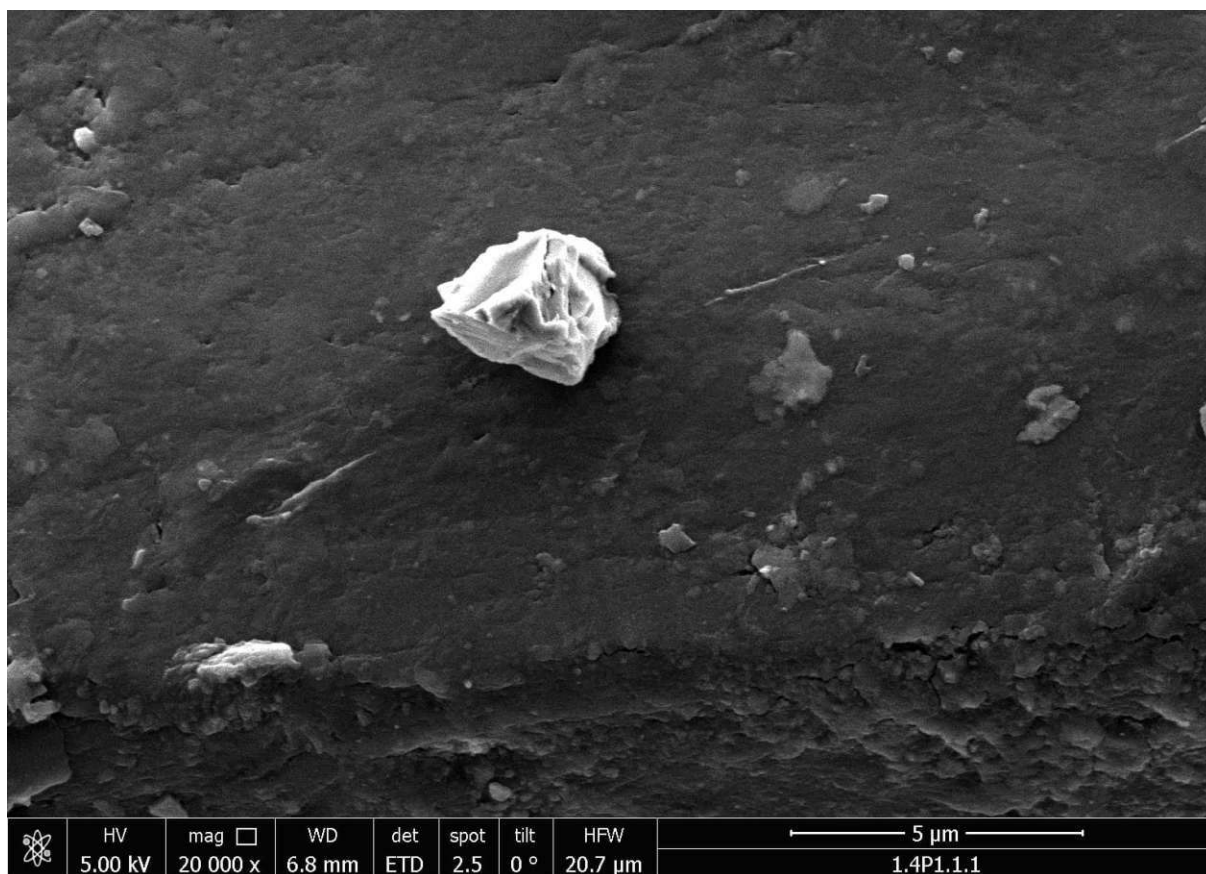
Figure 46: Image of the angular particle that was brightly visible in EDX mode. This approximately 2.4 μm large particle was a potential CsMP-candidate.

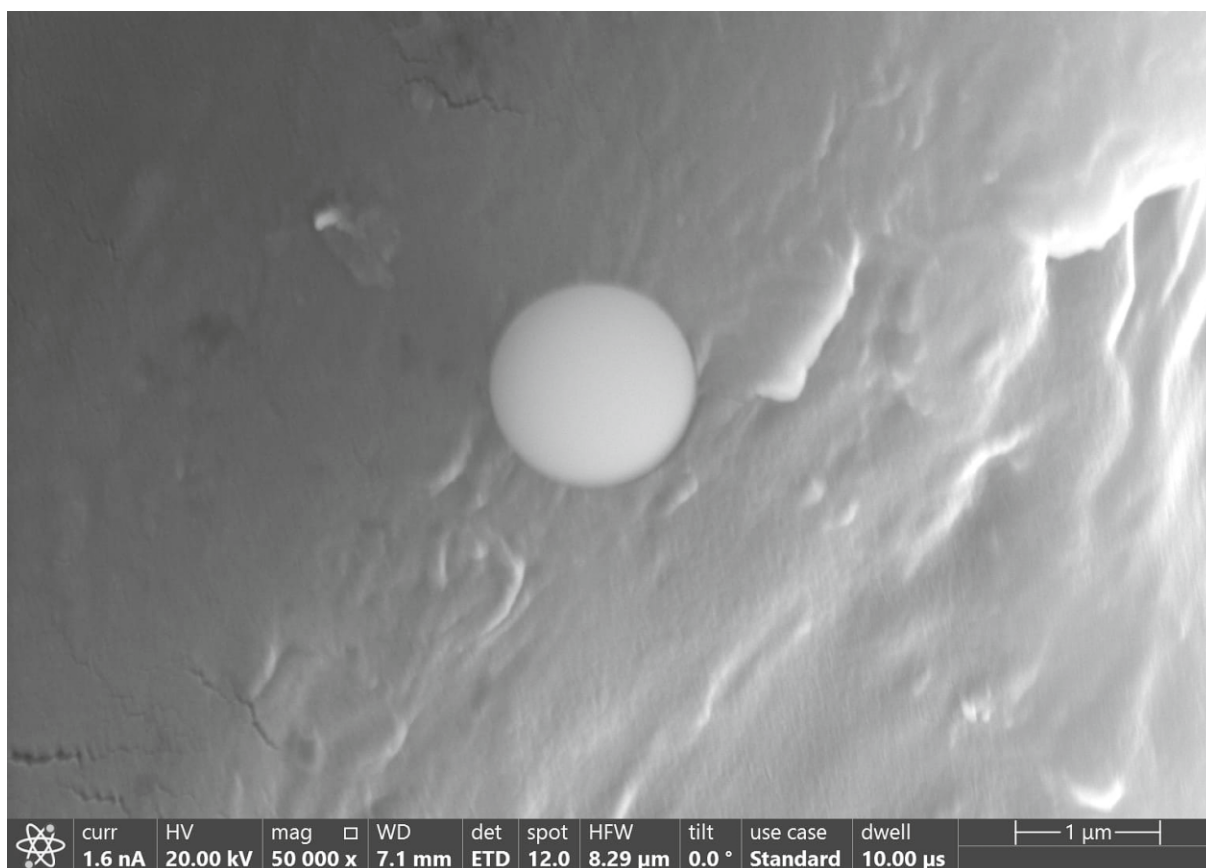
Figure 50: Image of the perfectly spherical particle that was found on a fleece fiber. This approximately 1.4 μm large particle was a potential CsMP-candidate due to its shape, size, and elemental composition.

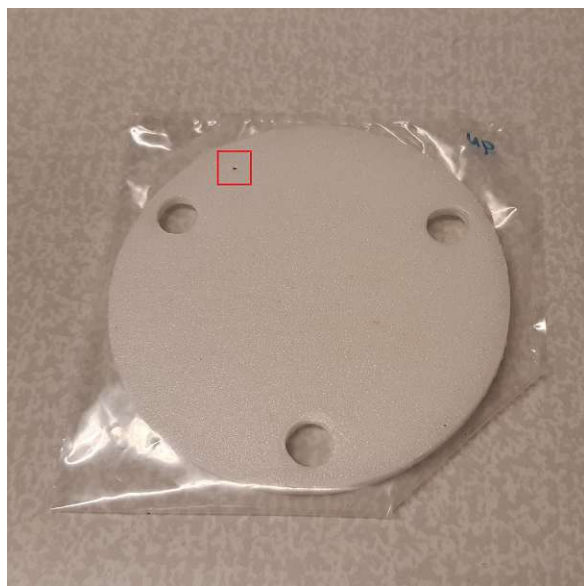
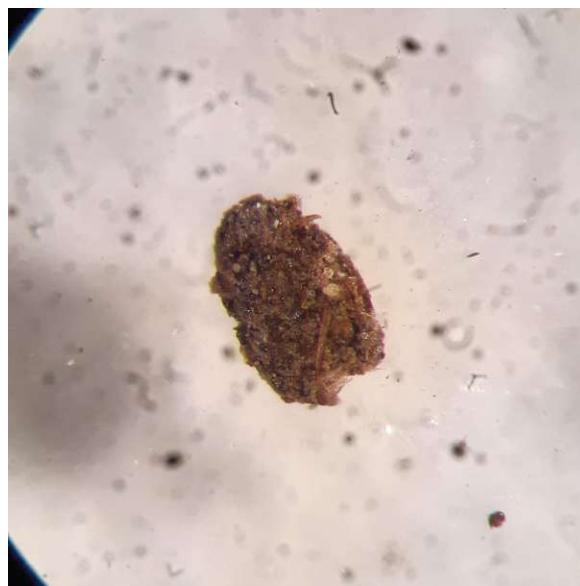
(a) Photo of the passive sampler disk with the particle inside the AIP hotspot region highlighted in red.

(b) Photo of the large particle through an optical microscope at low magnification.

Figure 56: Photos of the large particle that was found directly on the surface of passive air sampler PUF disk B, registering significantly on the AIP.

This sample was a large particle that was found directly on the surface of passive sampler disk B inside the region of the hotspot on the AIP image. It was therefore in accordance with the naming scheme used for the Namie coat samples labeled "Passive Sampler B Particle 1". The particle could then be simply picked up from the surface using tweezers, photos of it are shown in figure 56. It resembles a small grain of dirt or similar material. An additional AIP exposure of the particle only confirmed that this was indeed the origin of the bright hotspot. Before taking it to the USTEM, gamma spectrometric measurements of the particle were made. 0.151 ± 0.018 Bq of ^{137}Cs were detected, calculated back to the time of the accident (24 h measurement period, 1.960σ).

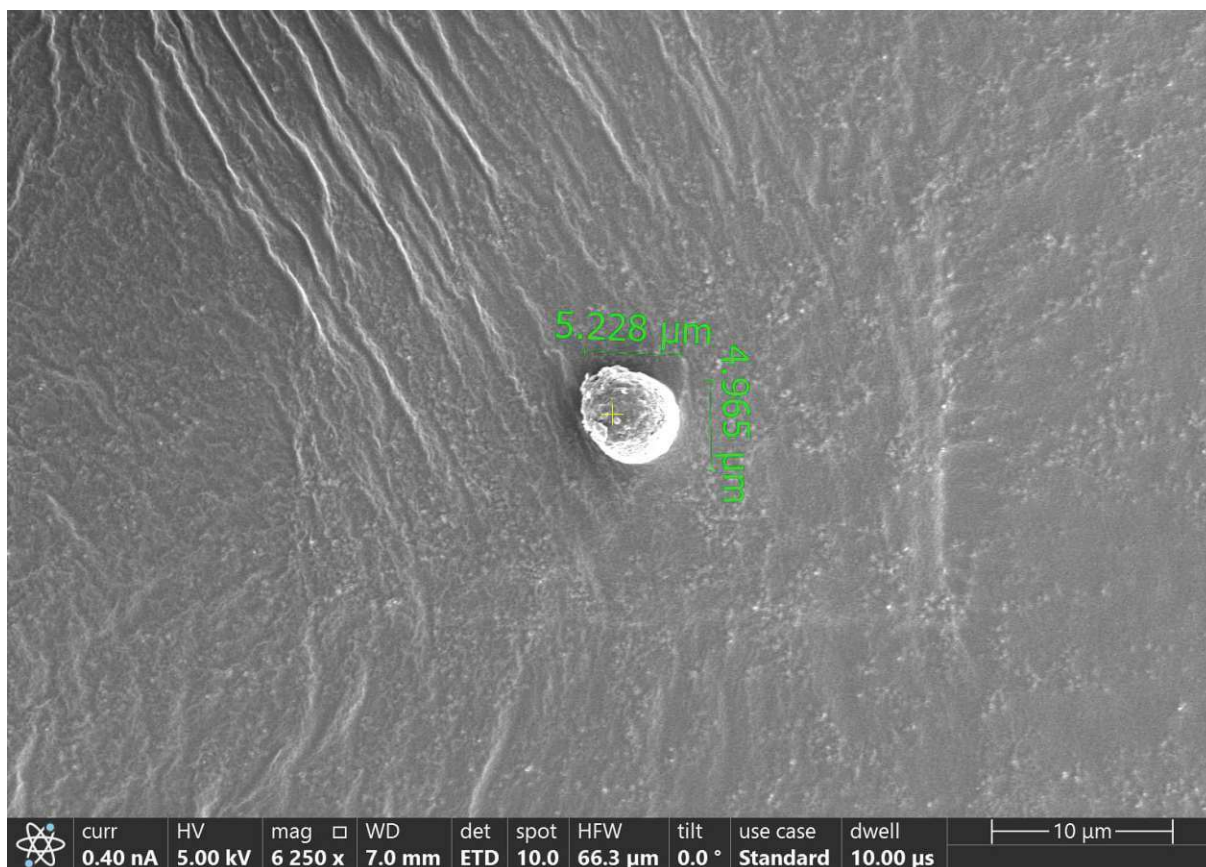
Figure 58: Image of the first spherical particle that was found in the dirt particle debris. This approximately 5 μm large particle was a potential CsMP-candidate due to its shape, size, and elemental composition.

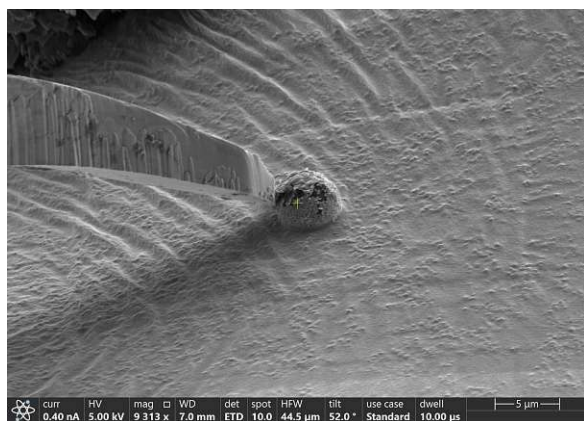
(a) Particle with extraction needle before welding (W deposition).

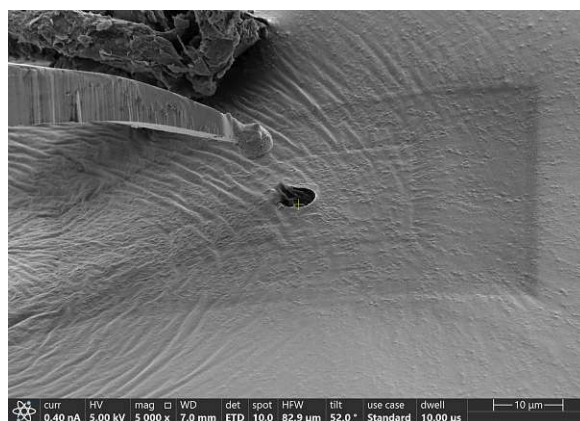
(d) Needle and particle have lifted off and are now able to move freely.

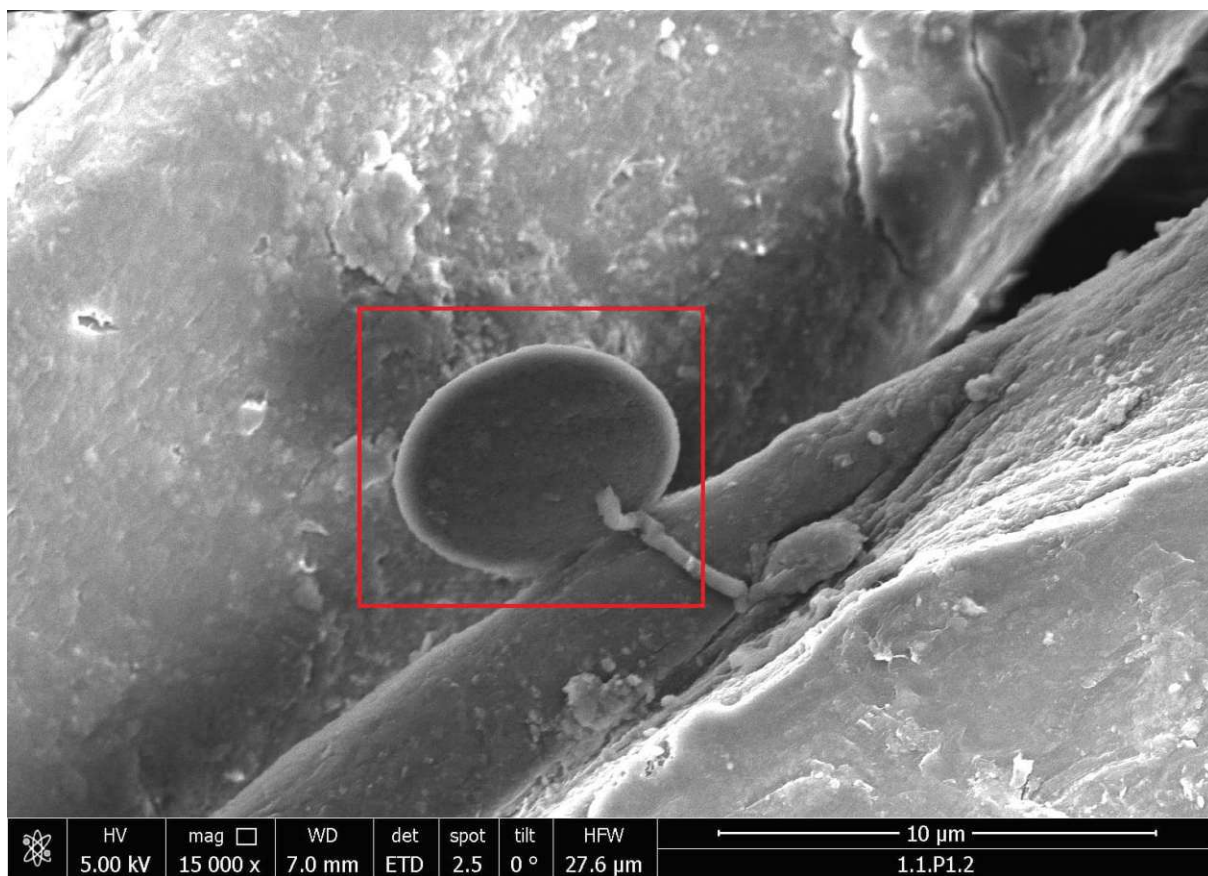
Figure 62: Image of a large oval-shaped structure attached to the side of one of the fleece fibers. The red section was scanned using EDX to determine the elemental composition.

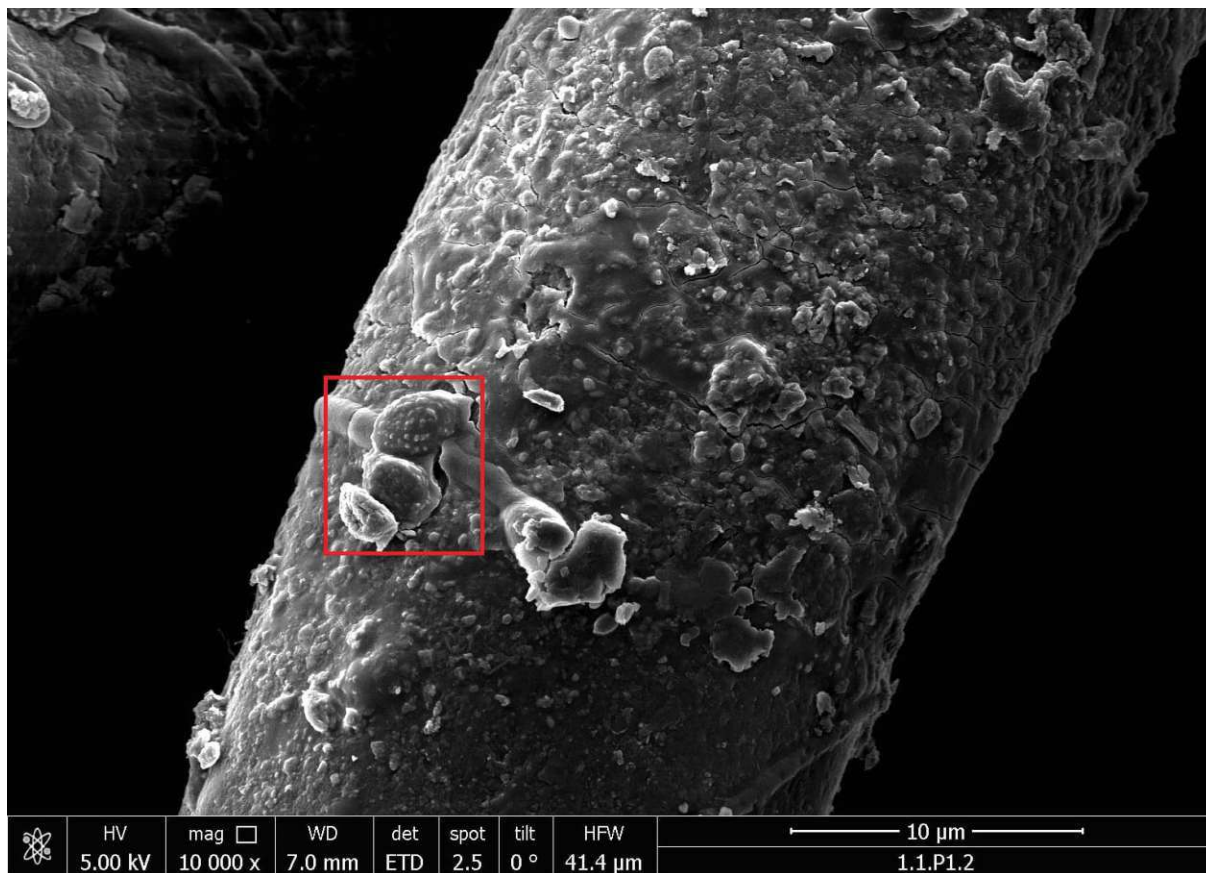
Figure 63: Image of multiple round structures with fibrous parts attached to the side of one of the fleece fibers. The red section was scanned using EDX to determine the elemental composition.

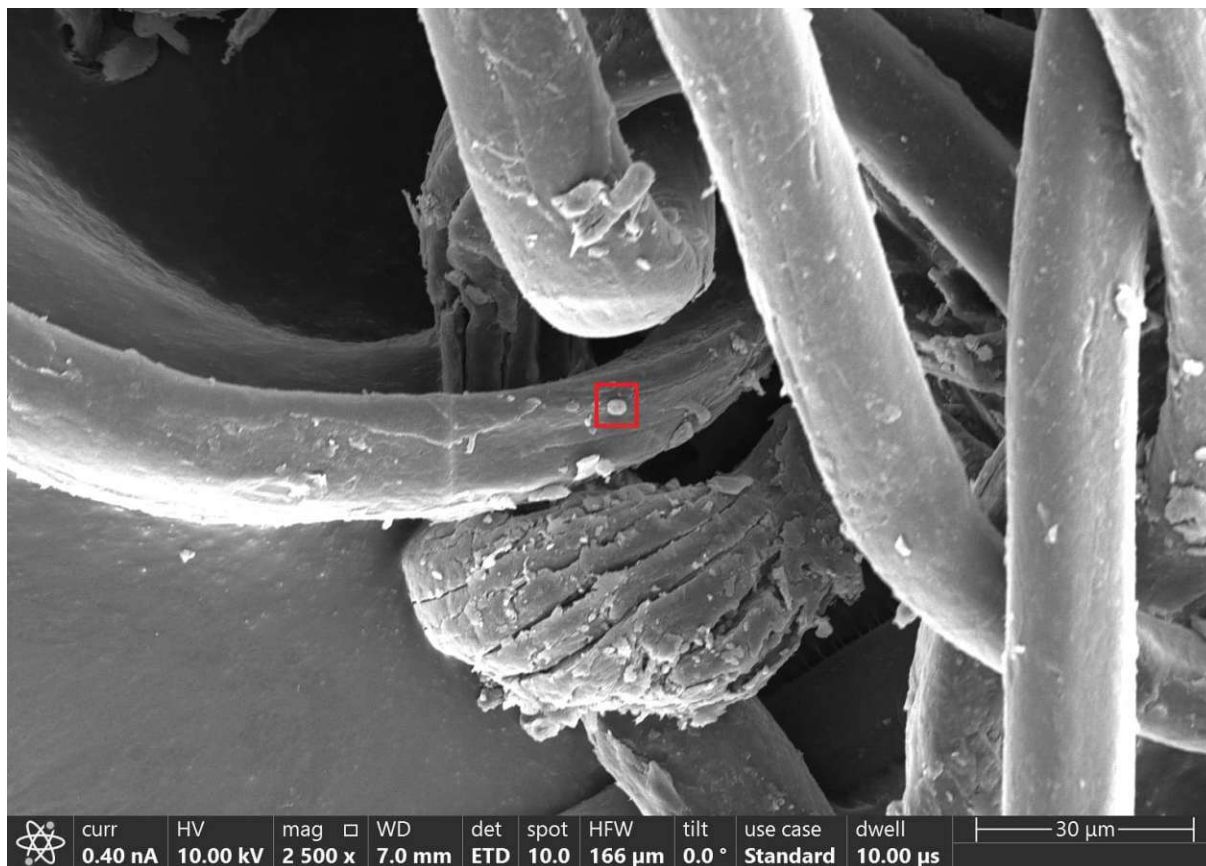
Figure 64: Image of a spherical microparticle on one of the fleece fibers. The red section was scanned using EDX to determine the elemental composition.

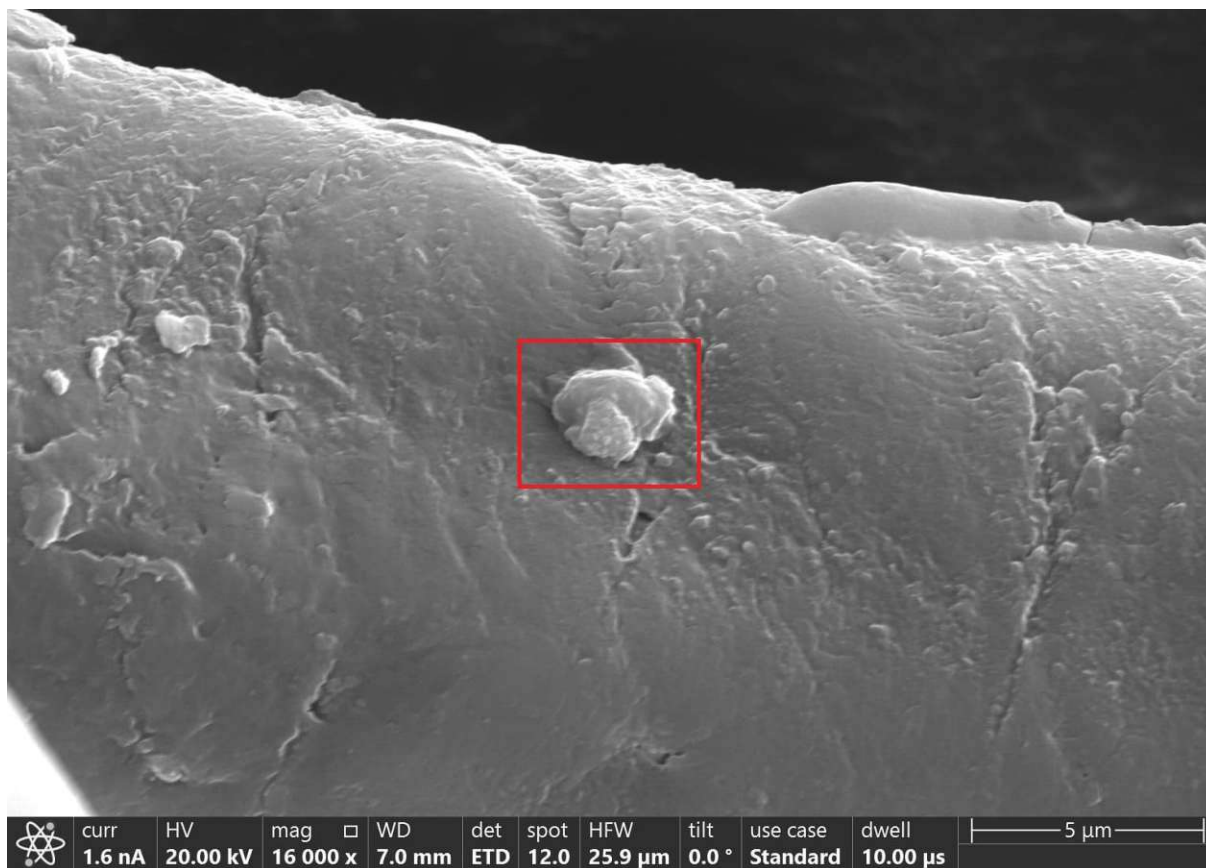
Figure 65: Image of an irregularly rounded structure on one of the fleece fibers. The red section was scanned using EDX to determine the elemental composition.

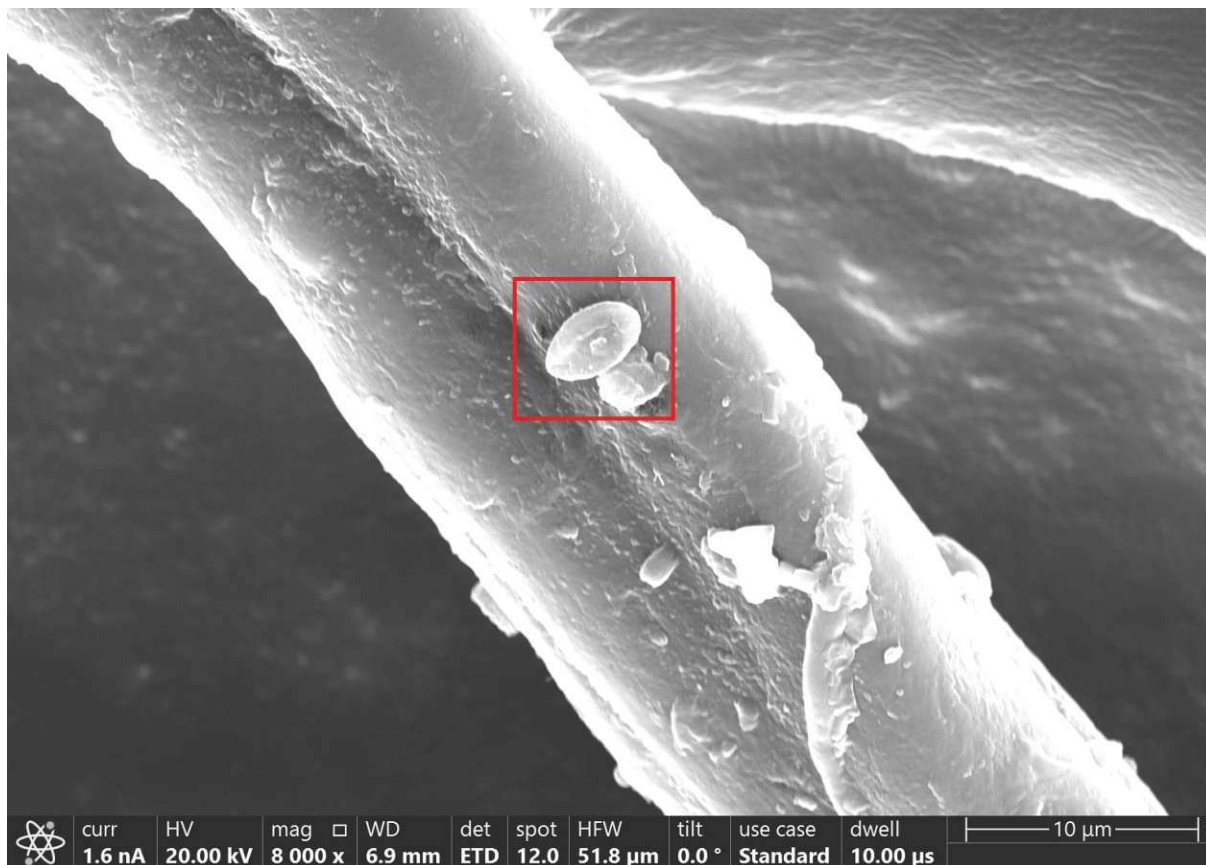
Figure 66: Image of an ellipsoidal microparticle on one of the fleece fibers. The red section was scanned using EDX to determine the elemental composition.

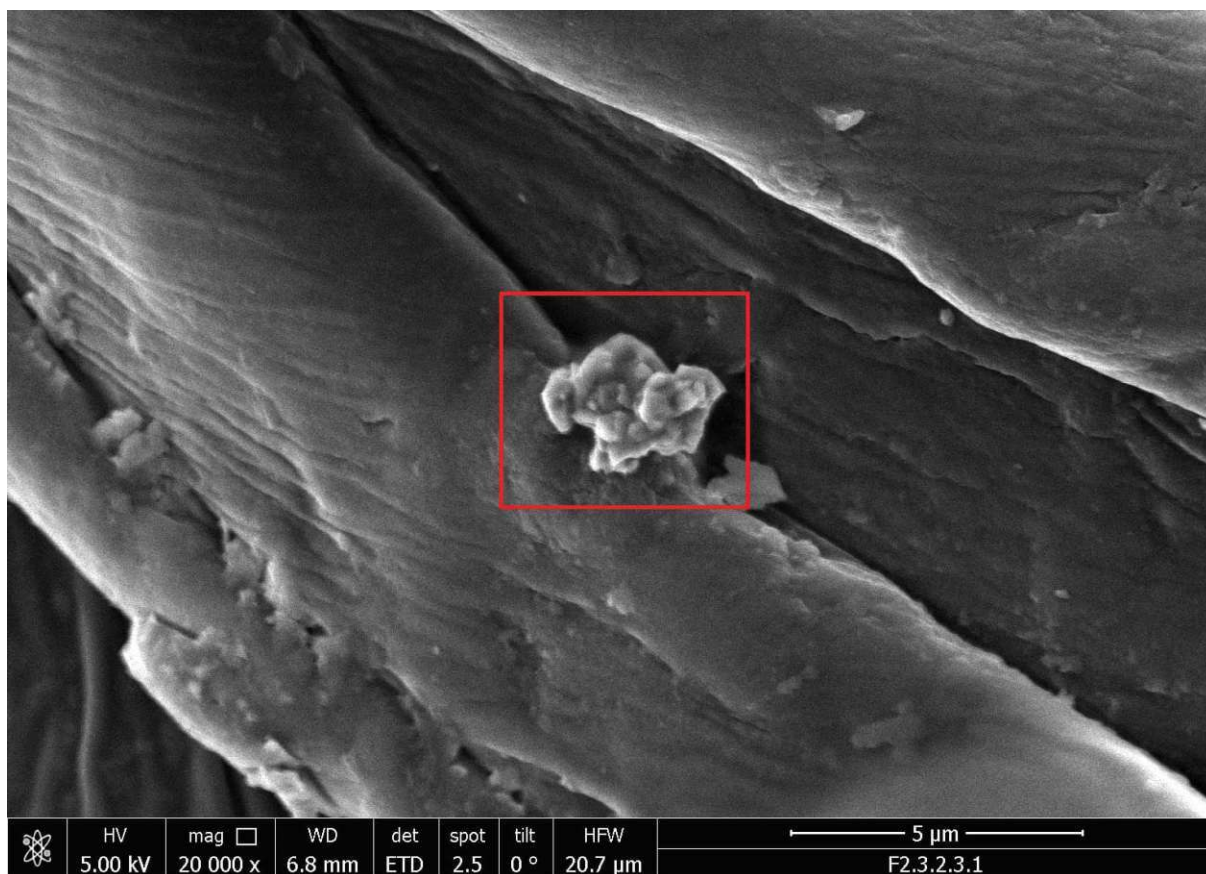
Figure 67: Image of a largely irregular, jagged microparticle on a fleece fiber. The red section was scanned using EDX to determine the elemental composition.

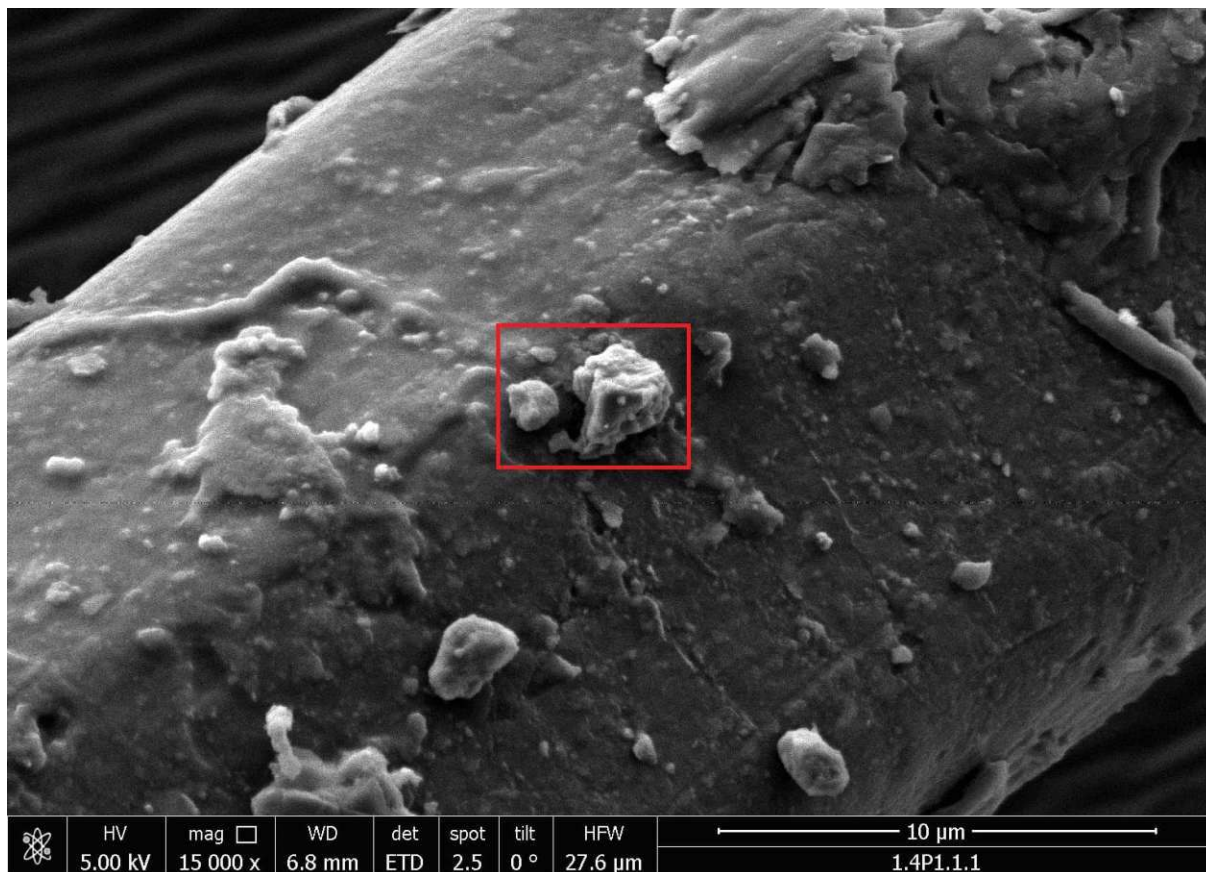
Figure 69: Image of a couple of irregular microparticles, some are rounded, on a fleece fiber with one fairly large prominent particle in the middle. The red section was scanned using EDX to determine the elemental composition.

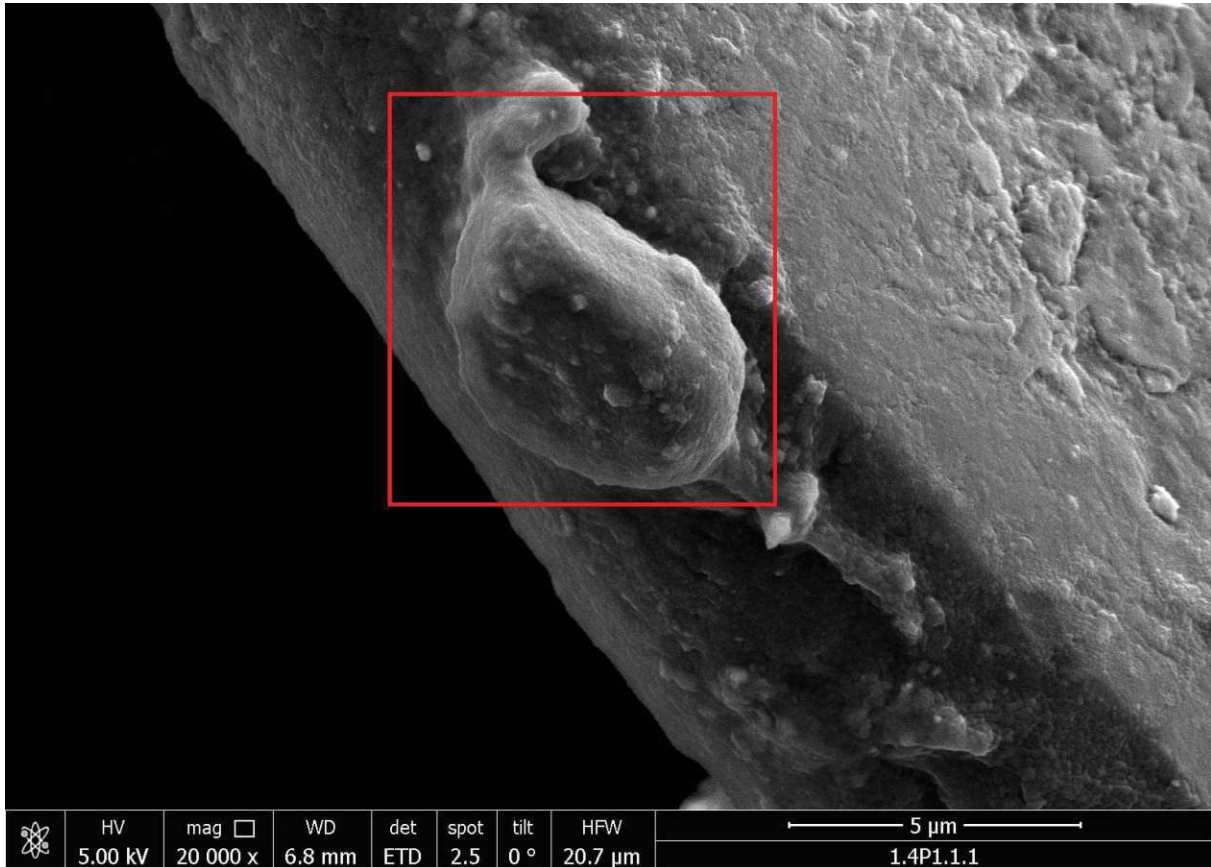
Figure 70: Image of a rounded particulate structure that is fused to the fleece fiber. The red section was scanned using EDX to determine the elemental composition, however, the measurement was not completed or no EDX data was saved to save on time. In that case, the outcome was clearly visible to not be part of a CsMP.

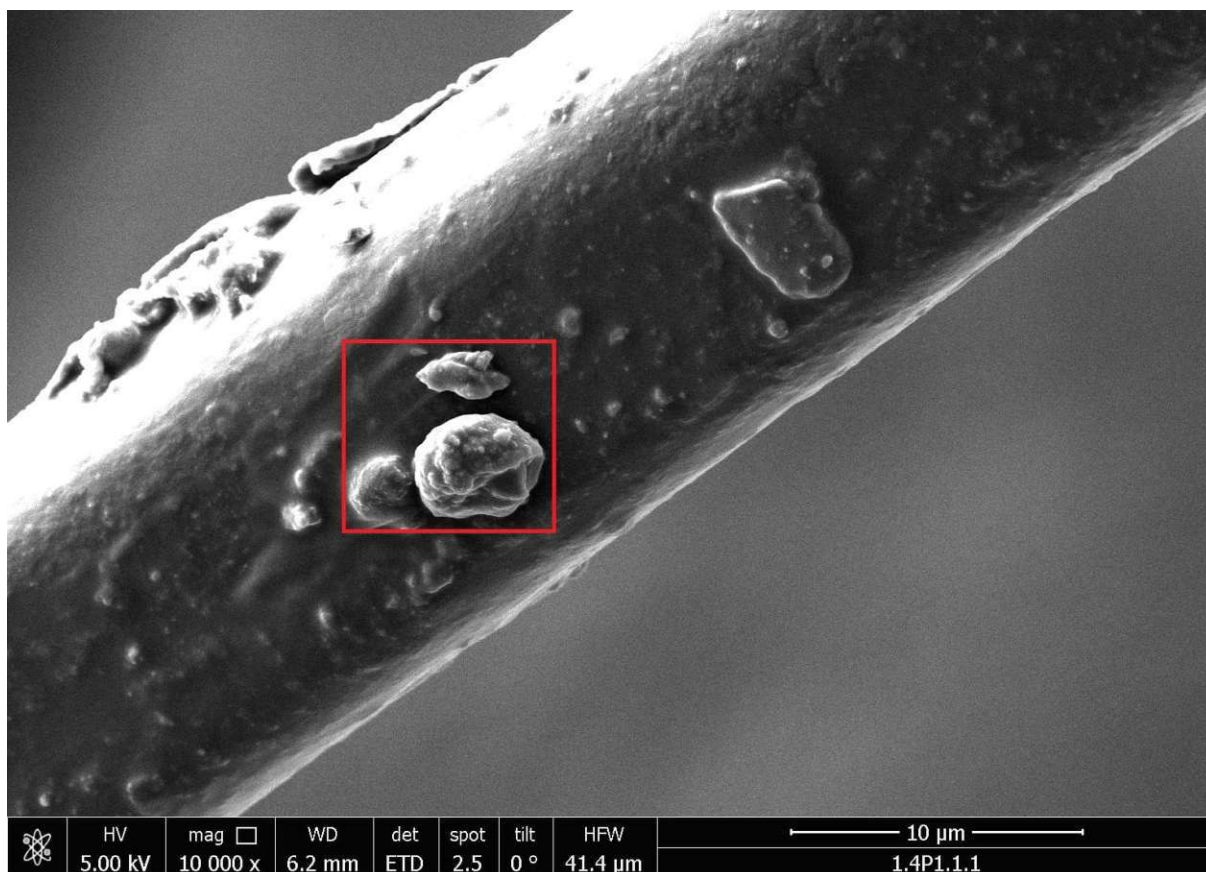
Figure 71: Image of a couple of irregular microparticles, with one prominent rounded particle sitting next to much smaller ones. The red section was scanned using [EDX](#) to determine the elemental composition, however, the measurement was not completed or no EDX data was saved to save on time. In that case, the outcome was clearly visible to not be part of a [CsMP](#).

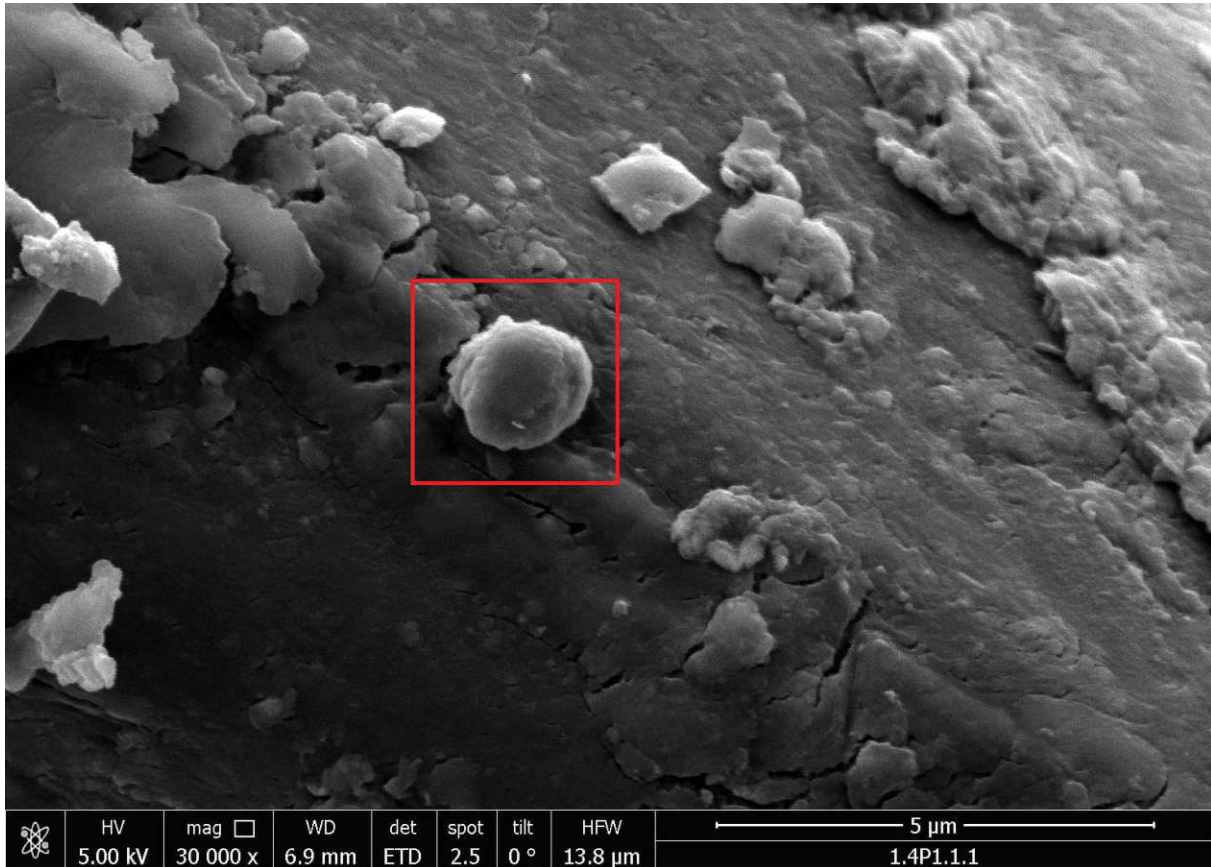
Figure 72: Image of a single fairly spherical microparticle that has been found amongst a field of flakes on the fiber. The red section was scanned using EDX to determine the elemental composition, however, the measurement was not completed or no EDX data was saved to save on time. In that case, the outcome was clearly visible to not be part of a CsMP.

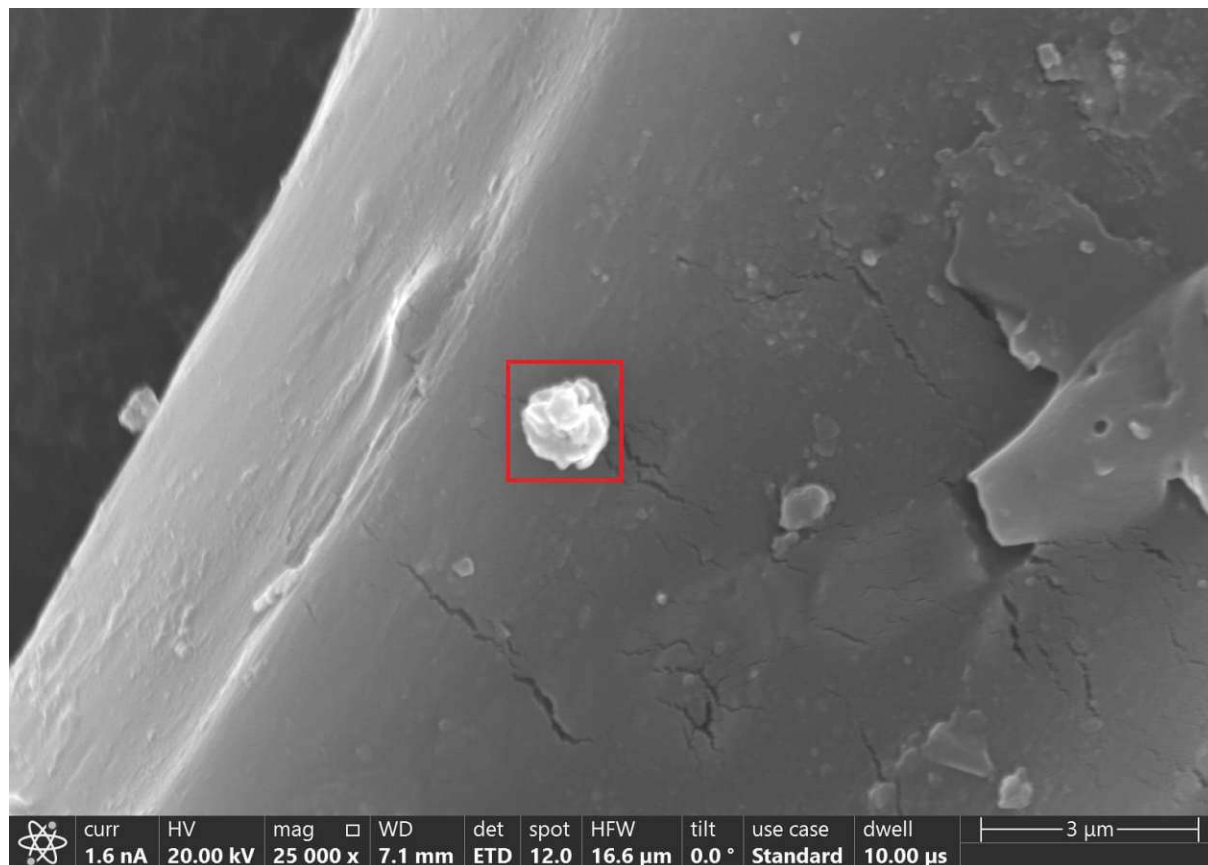
Figure 73: Image of a single irregular microparticle that stands out easily from the rest of its surroundings. The red section was scanned using EDX to determine the elemental composition.

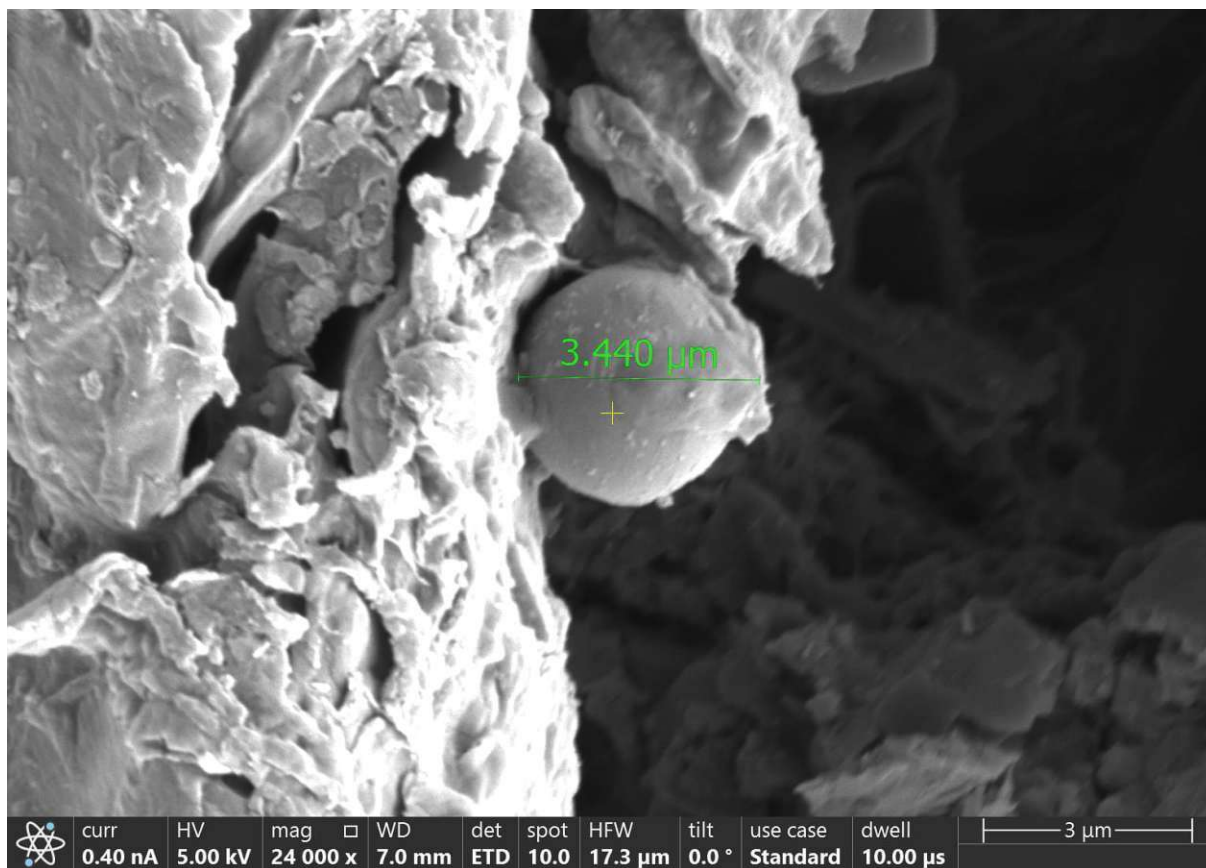
Figure 78: Image of a promising spherical microparticle, it seems to be fused or stuck to the other debris around it. Morphologically speaking, this particle would be another candidate for a CsMP.
