DIPLOMARBEIT

Repair Solutions for PV Modules with Cracked Backsheets

ausgeführt am Institut für Angewandte Physik (IAP)
der Fakultät für Physik der Technischen Universität Wien
in Zusammenarbeit mit dem Österreichisches Forschungsinstitut für Chemie und Technik (OFI)

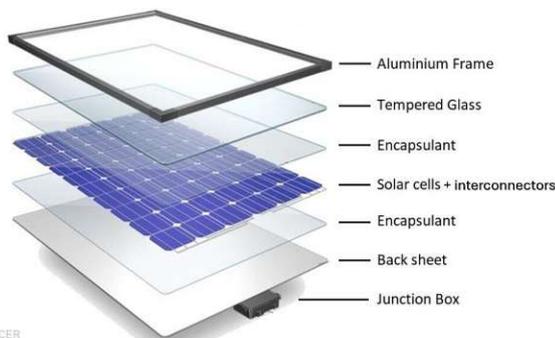
Understanding the construction/design of a PV module is essential for identifying potential failure points and developing effective repair solutions. As illustrated in Figure 1.1a, a typical glass/backsheet PV module consists of several layers, each playing a crucial role:

(a) Typical layer structure of a glass-backsheet module [49].

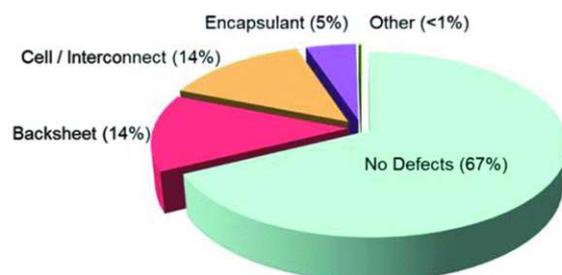
(b) Distribution of defects in PV modules, high-lighting backsheet failures [53].

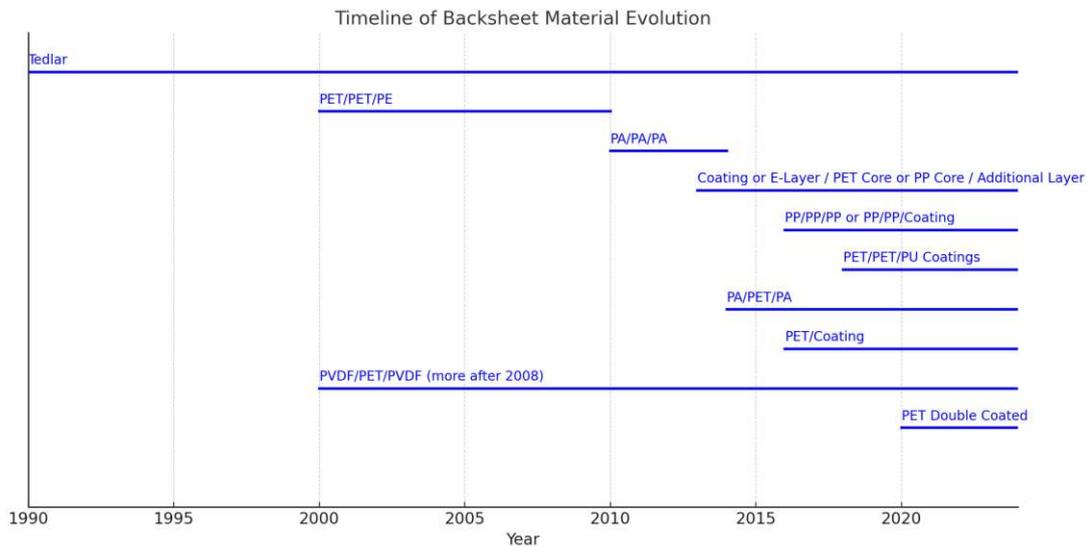
Figure 1.2: Timeline of backsheet material evolution in photovoltaic modules according to Markus Feichtner, Dr. Gabriele Eder and Dr. Gernot Oreski (personal communication at the PVSEC (European Photovoltaic Solar Energy Conference and Exhibition), September 2024). The nomenclature (e.g., PA/PA/PA) represents multilayer structures, where each material separated by a slash (/) corresponds to a distinct layer in the backsheet composition.

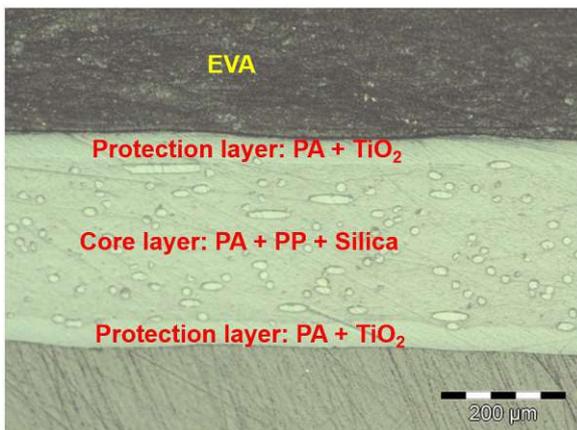
(a) Light microscopy image of the Cross-section of a co-extruded polyamid-backsheet [12]

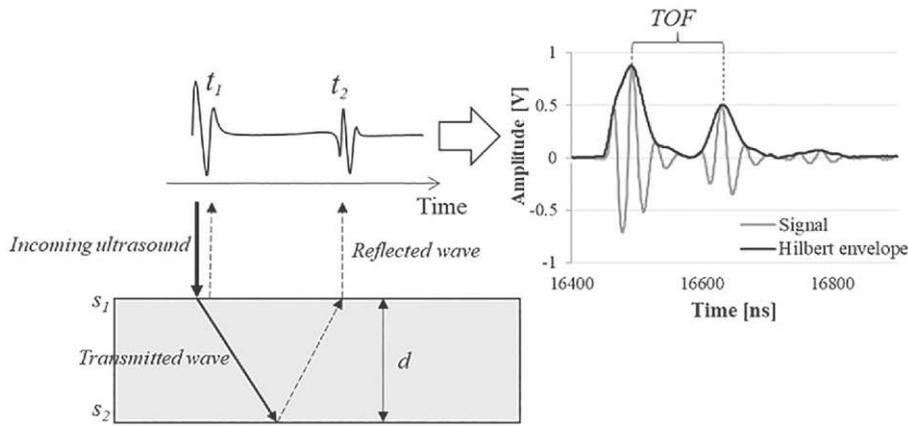
Figure 3.1: Measurement principle of the scanning acoustic microscopy in reflection mode [37]

The primary physical principle underlying SAM is the interaction of *ultrasonic waves* with the material interfaces. When an ultrasonic wave encounters an interface between two materials with different *acoustic impedance*, part of the wave is reflected, and part is transmitted.

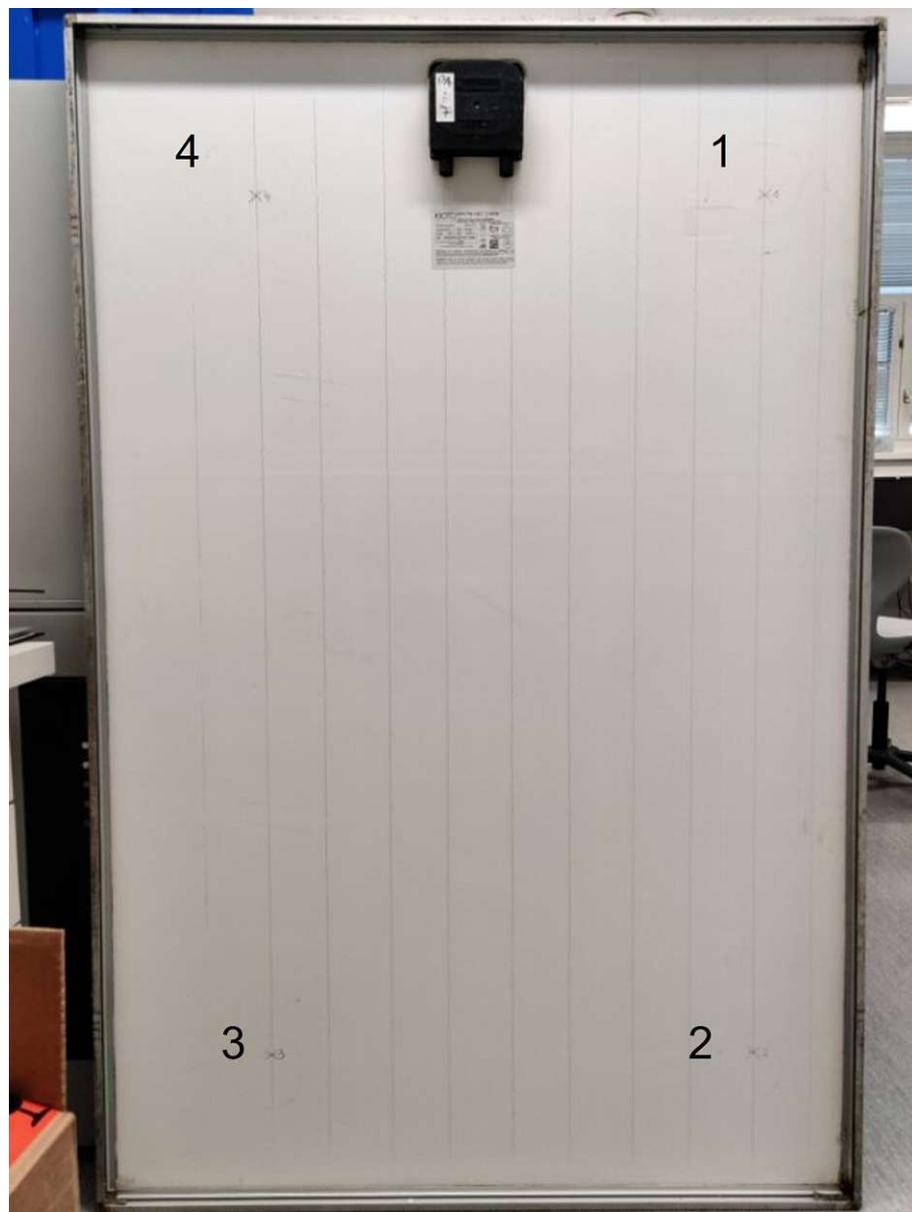
Figure 4.1: Overview of the Kioto 235Wp PV module with cracked BS. The numbers refer to the sample areas where the four repair materials were applied

PV-modules with coextruded PA-based 3-layer backsheets were found to develop very distinct failure modes after several years of operation in the field [24, 23, 35]. Cracks in the backsheet, shown later in Figures 4.1 and 4.2, often form above the bus bars due to localized mechanical stress in these areas. The PA backsheet itself successfully passed all aging tests, indicating that the primary issue lies within the multi-material composite structure of the PV module. Due to the varying coefficients of thermal expansion among the different materials, mechanical stresses develop within the module. Since the PA backsheet is fixed within the module structure, it cannot expand freely in the x- and y-directions in response to temperature fluctuations, ultimately leading to crack formation [12].

A PV module (see Figures 4.1 and 4.2), featuring an aged polyamide BS in a degraded state was used for the experiment.

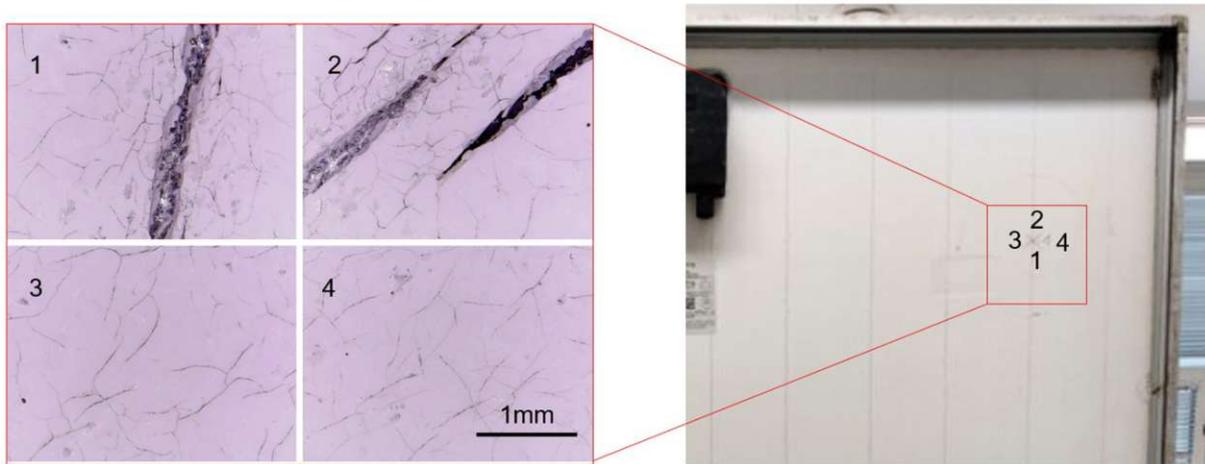
Figure 4.2: LM images taken with the handheld USB microscope (left) of one of the sample areas shown in Figure 4.1.

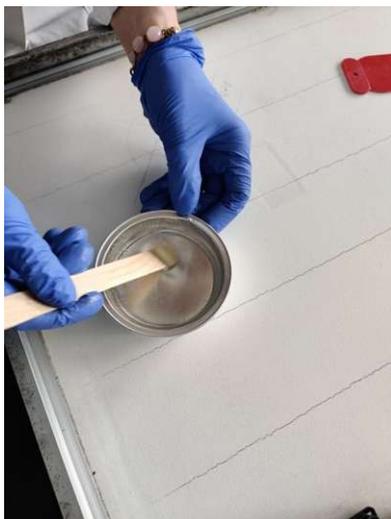
(a) Crack filler mixing and application process

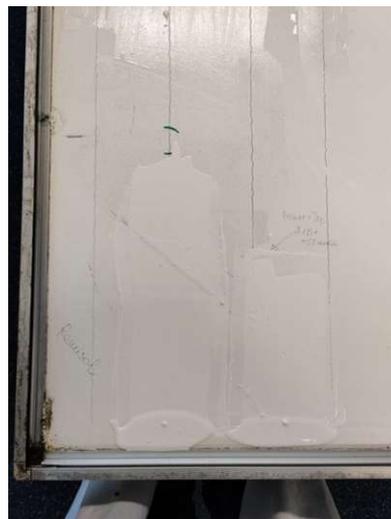
(b) Cover coating application with coating knife

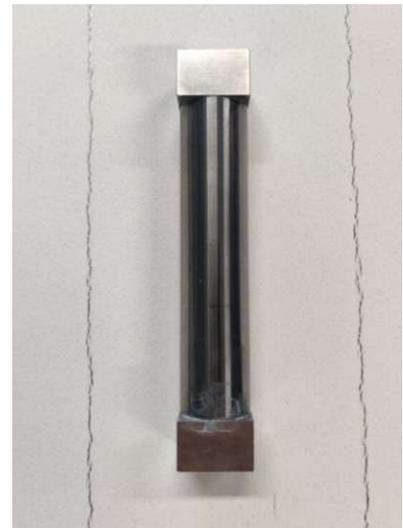
(c) Coating knife used for applying coating with specific layer thickness

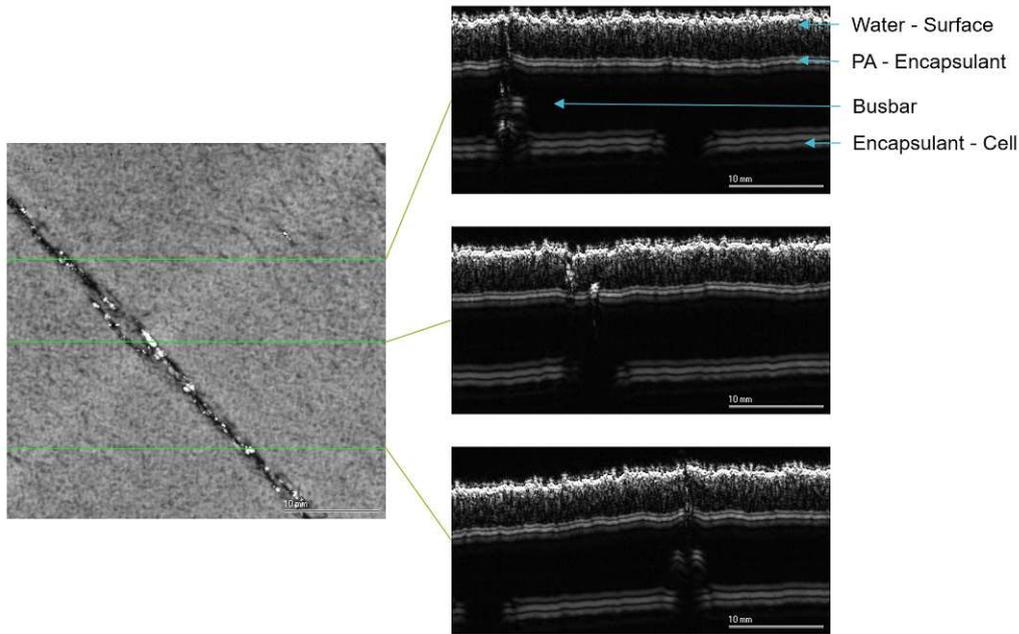
Figure 4.4: SAM images of the uncoated BS: On the left, the image of the area scan of the surface layer; On the right, the cross sectional scans of the BS.

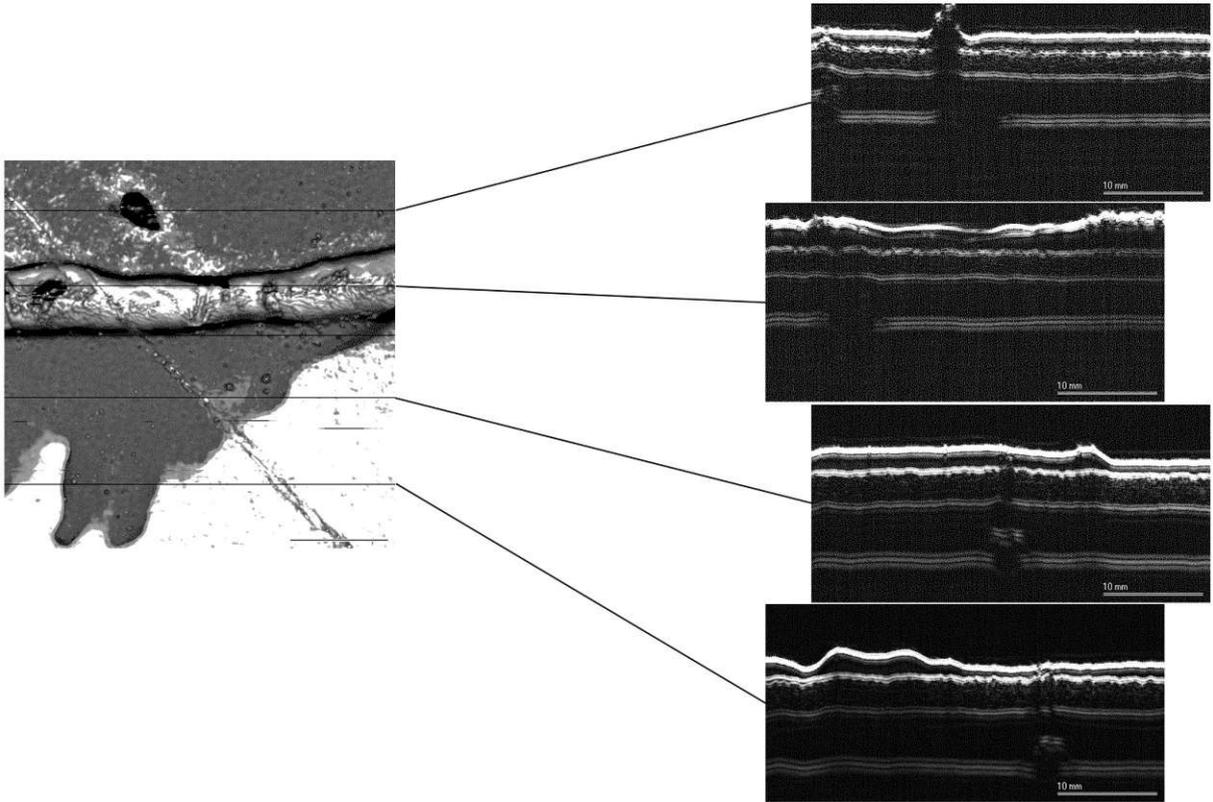
Figure 4.5: SAM image of the BS coated with PU: On the left, the image of the area scan of the surface layer; On the right, the cross sectional scans of the BS.

Following the discussion of the SAM results on the uncoated BS, we proceeded to analyze the first coated corner, which uses the PU coating shown in Figure 4.5. The imaging setup

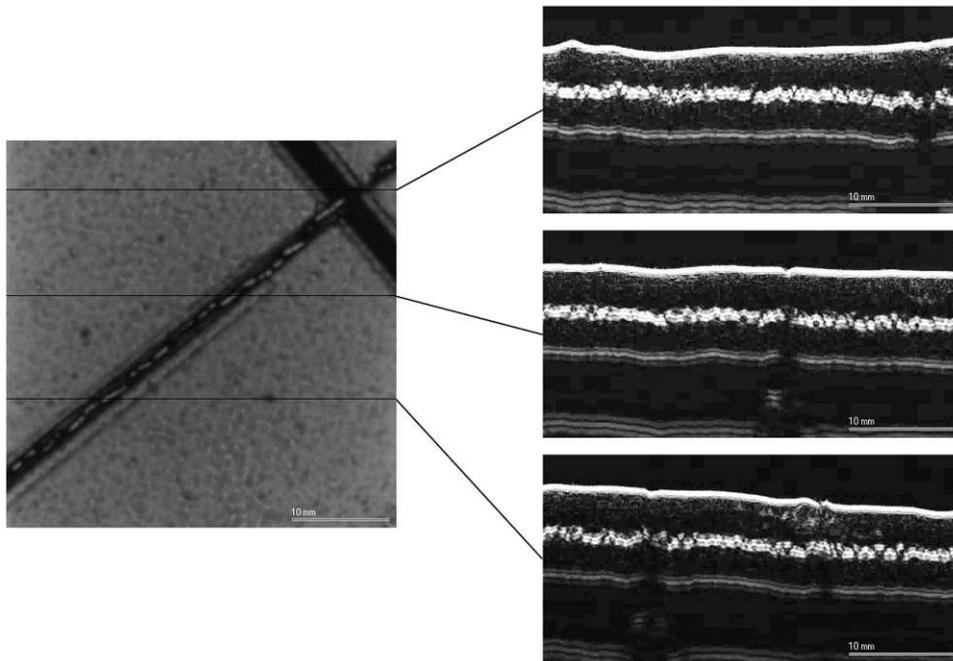
Figure 4.7: SAM images of the BS coated with silicone (DOWSil): On the left, the image of the area scan of the solar cell layer; On the right, the cross sectional scans of the BS.

In Figure 4.7, the SAM images of the cracked backsheet with a silicone layer applied are shown. The results are similar to those observed with the PU coating. The interfaces visible in the cross-sectional scans are, from top to bottom: the silicone surface, the silicone-BS interface, the BS-encapsulant interface, the bus bar embedded in the encapsulant above the intercell gap, and finally the encapsulant-cell interface. The image on the left shows an areal scan of the

encapsulant-cell interface, which displays the interface in the plane.

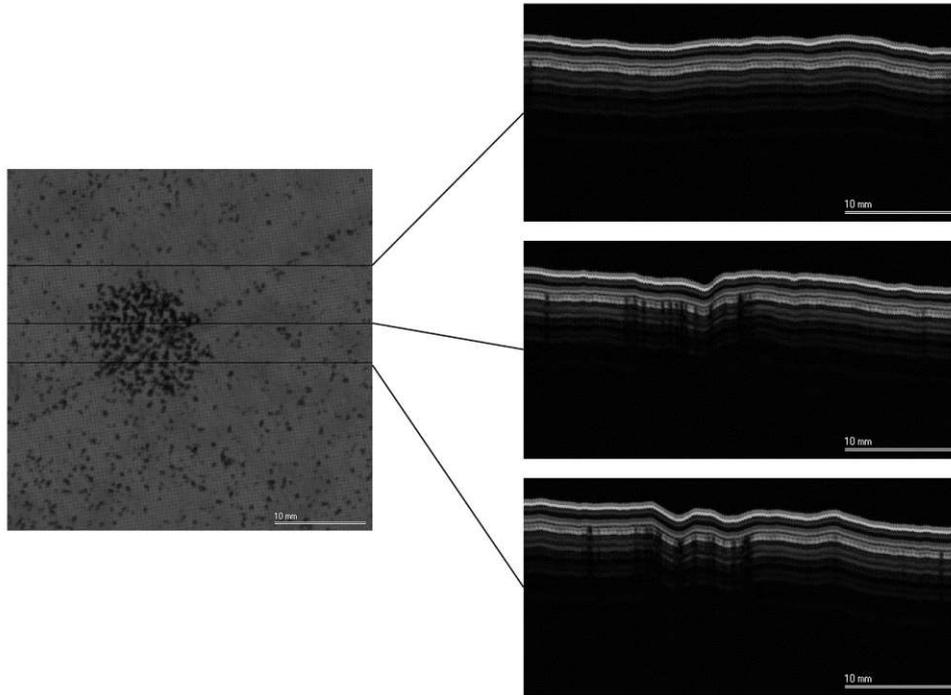
Figure 4.6: SAM image of the BS with tape (3M 1080): On the left, the image of the area scan of the surface layer; On the right, the cross sectional scans of the BS.

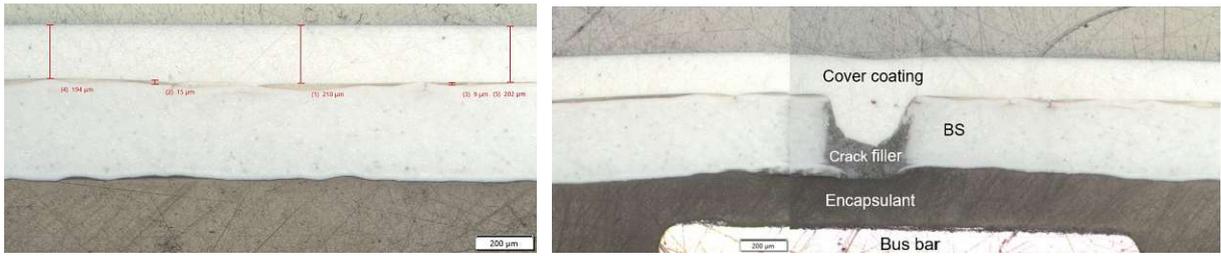
(a) The Remisol coating with measured layer thicknesses of around 10 μm for the crack filler and around 200 μm for the cover coating.

Figure 4.8: Light microscope images of cross-sections of the coated BS.

The light microscopic images of the cross-sections of the backsheet with the PU coating are shown in Figure 4.8. The image on the right reveals a successfully filled deep BS crack. However, due to the high solvent content, the crack filler exhibits significant shrinkage during the curing process, leaving the deep crack only partially filled. The much thicker cover coating compensates for this, providing an insulating layer that protects against mechanical stressors and enhances the electrical insulation of the BS. In the ATR-IR image shown in Figure 4.9 it can be confirmed that the crack filler (layer 1) was successful in filling not only the deep crack but also the much smaller micro cracks (shown on the image in the bottom right of Figure 4.9.)

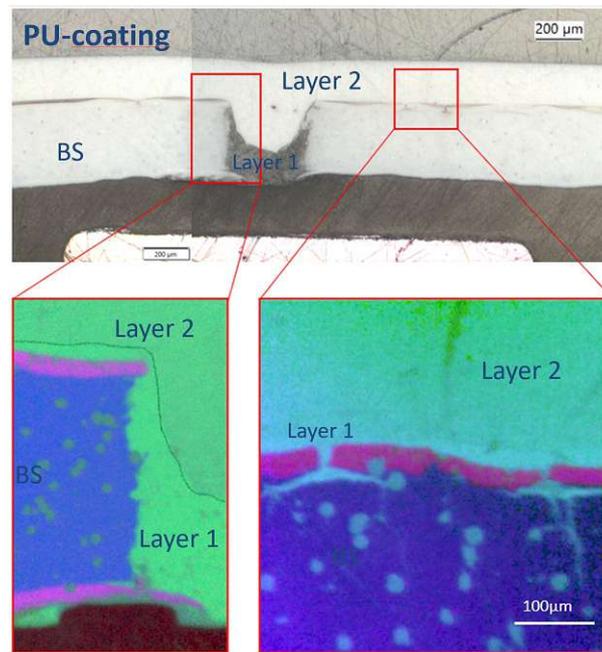
Figure 4.9: LM image (top) and ATR-IR image (bottom) of the BS coated with Remisol

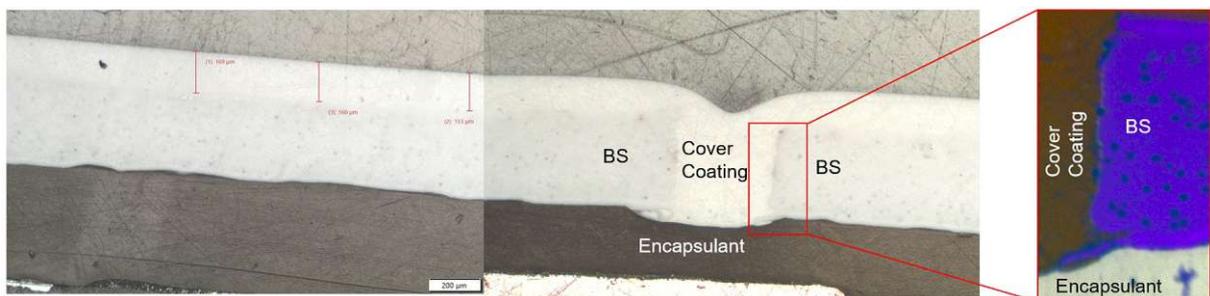
Figure 4.10: Light microscopy image and ATR-IR image of the BS coated with Remisol cover coating without the crack filler. The coating is around 160 μm thick.

In an attempt of reducing the time and labor requirement for the repair process, the crack filler was omitted to see if the cover coating alone was sufficient in filling cracks. From the results in Figure 4.10 the Cover Coating on its own seems to fill the cracks sufficiently. The shrinkage of the coating in the deep crack, however, is much more notable compared to the two layer process above.

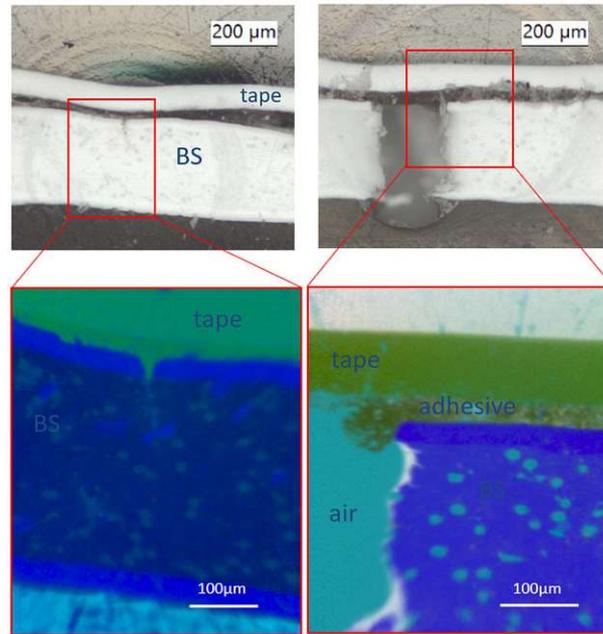
Figure 4.11: Light microscopy image and ATR-IR image of the BS repaired with tape

In Figure 4.11 the light-microscopic images and ATR-IR-images of the cross-section taken from the BS after repair using the 3M tape are given. While the acrylic adhesive of the tape appears to successfully fill microcracks (as shown in the images on the left), the deep crack remains largely unfilled, with air occupying most of the cavity. This is attributed to the insufficient amount of adhesive present on the tape to fill the larger void.

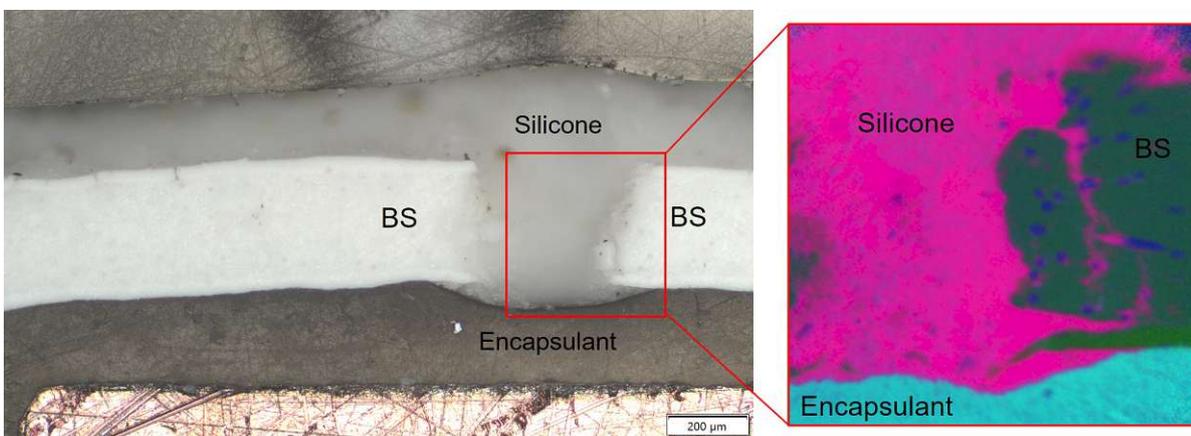
Figure 4.12: Light microscopy image and ATR-IR image of the BS coated with silicone

The silicone coating effectively filled the deep crack in the backsheet as shown in Figure 4.12. The pink coloration in the ATR-IR image on the right indicates that the silicone was able to penetrate even the smaller cavities of the torn BS without leaving air gaps. Furthermore, since silicone does not contain any solvent, no shrinkage occurs during the curing process.

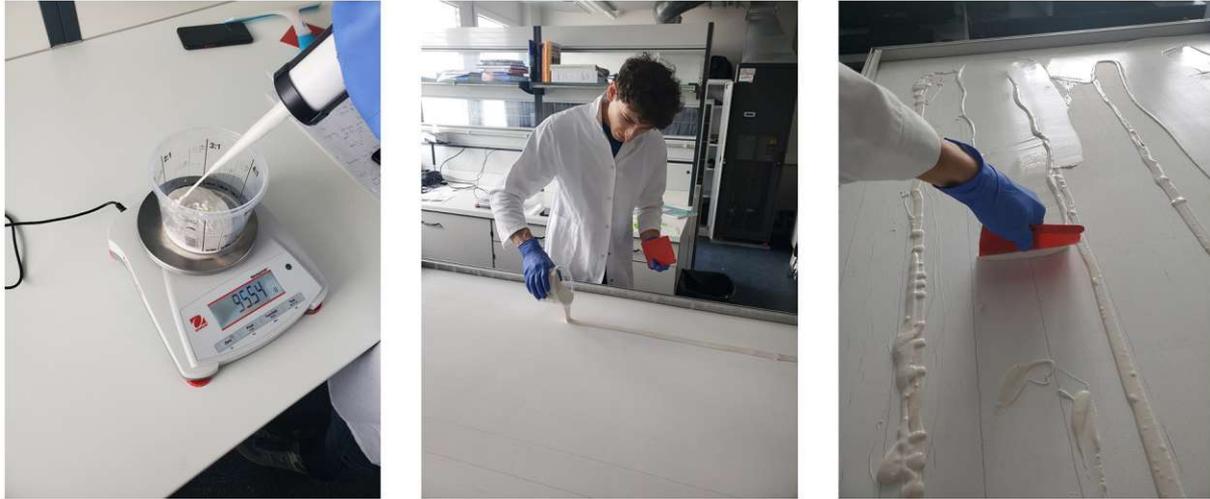
Figure 4.13: First steps of the silicone coating process

After cleaning the BS of Module M1, silicone is pressed into the cracks as thoroughly as possible using a spatula, ensuring maximum filling of the damaged areas (see Figure 4.13).

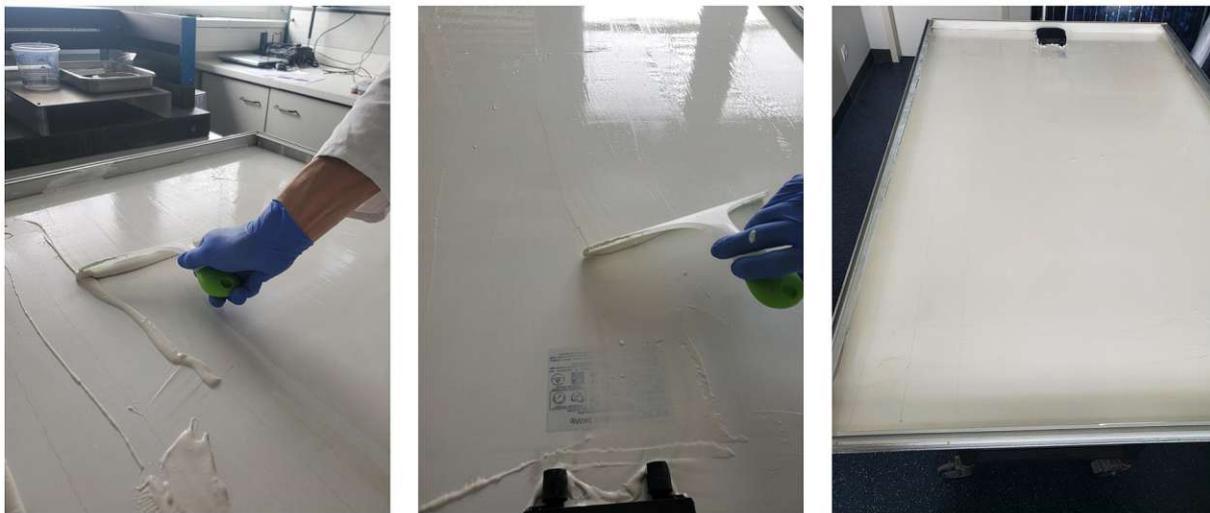
Figure 4.14: Further steps of the silicone coating process

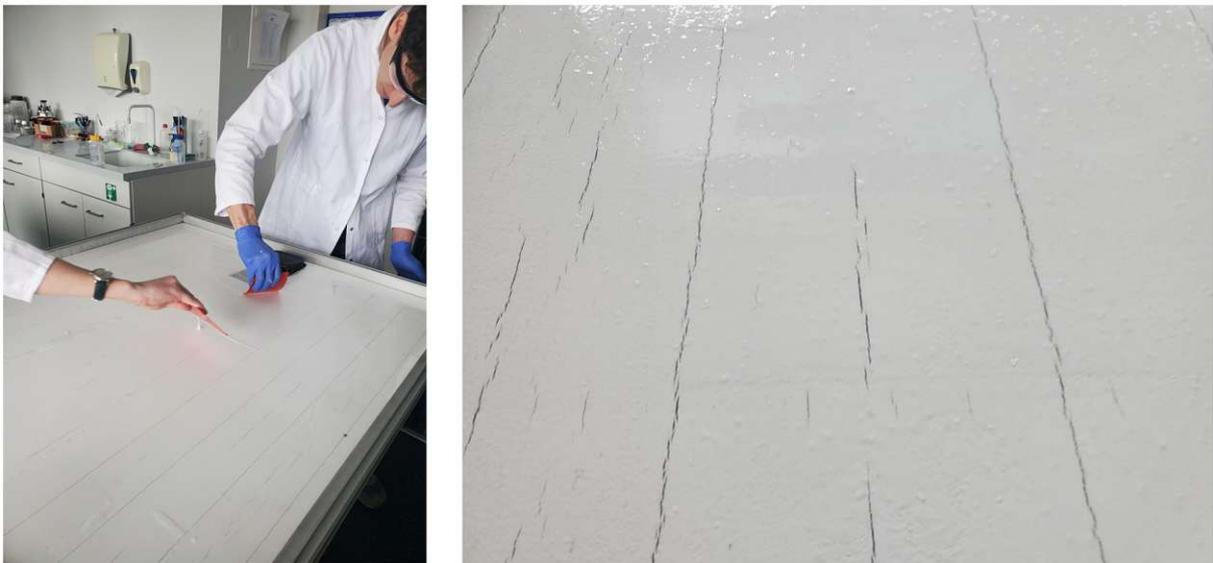
Figure 4.15: Application of the crack filler in the Remisol coating process

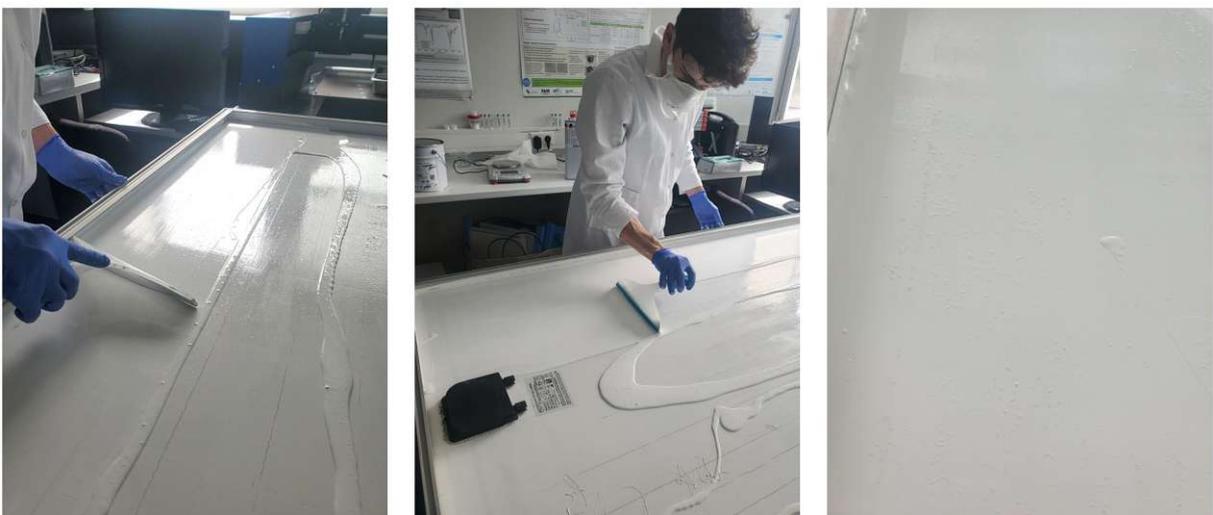
Figure 4.16: Application of the cover coating in the Remisol coating process

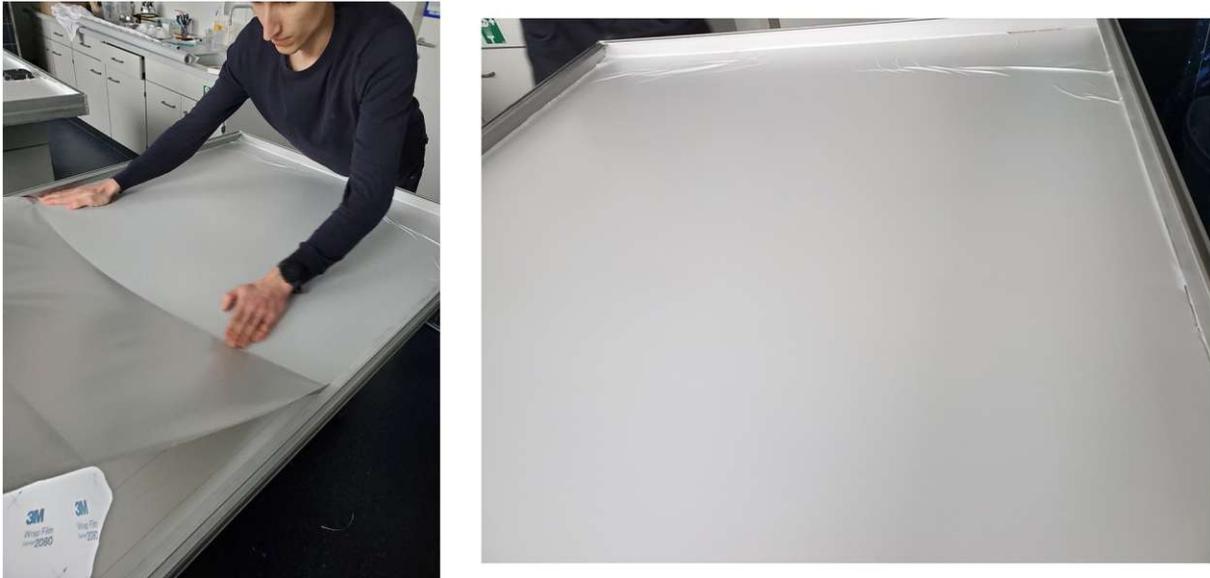
Figure 4.17: Application of the 3M PVC foil

The application process of the PVC foil from 3M onto Module M4 was more time-consuming than anticipated due to the difficulty of achieving a bubble-free application. The process involved three people. As shown in the right image of Figure 4.17, a few bubbles could not be avoided despite the efforts to minimize them.

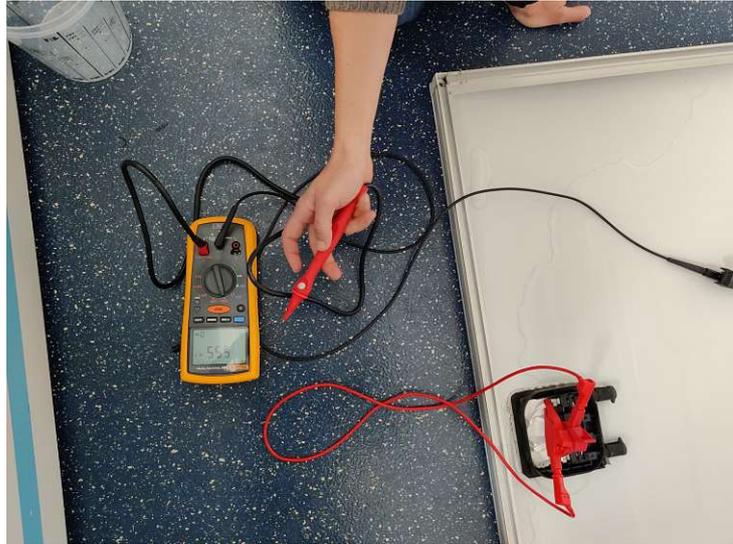
Figure 4.18: Test-setup for wet leakage test

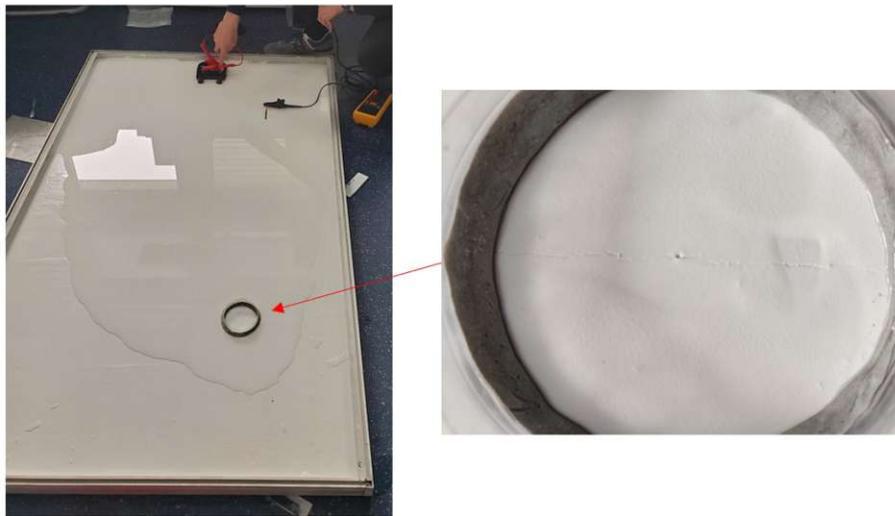
Figure 4.19: Isolation of the hole in the Remisol coating

After measuring a R_{iso} of only $0.2 \text{ M}\Omega$ for module M3, further investigation was conducted to identify the cause of the failure. Initially, no apparent defects were visible in the coating. However, a small hole was eventually discovered in the coating (see Figure 4.19), likely caused by a bubble or contamination during application. To address this issue, the affected area of the BS was isolated using plasticine to prevent water from reaching the hole. After this modification, the resistance improved significantly to $250 \text{ M}\Omega$ to $260 \text{ M}\Omega$. This demonstrates that even a small, barely visible defect in the coating can compromise the repair's effectiveness, leading to an unsuccessful BS restoration.

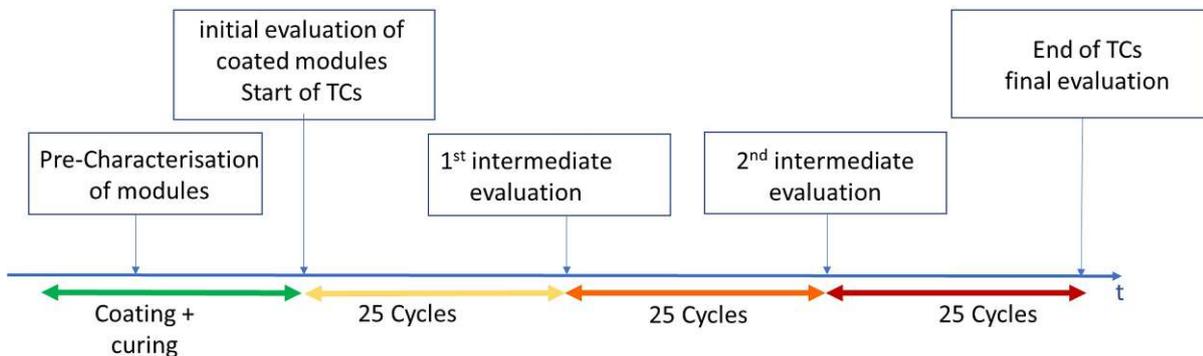
Figure 4.20: Timeline of weathering experiment

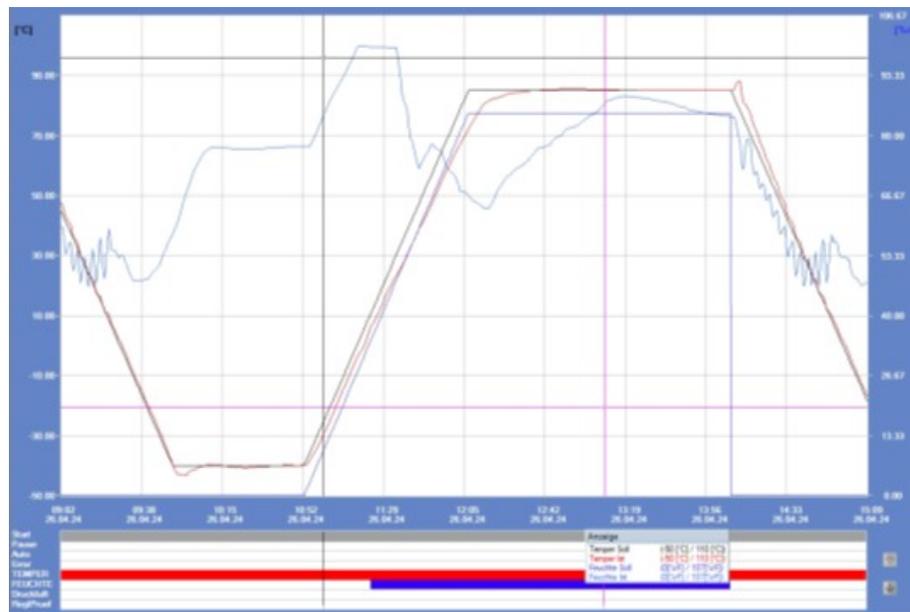
Figure 4.22: Comparison of programmed (black for temperature and dark blue for humidity) and measured (red for temperature and light blue for humidity) temperature cycles

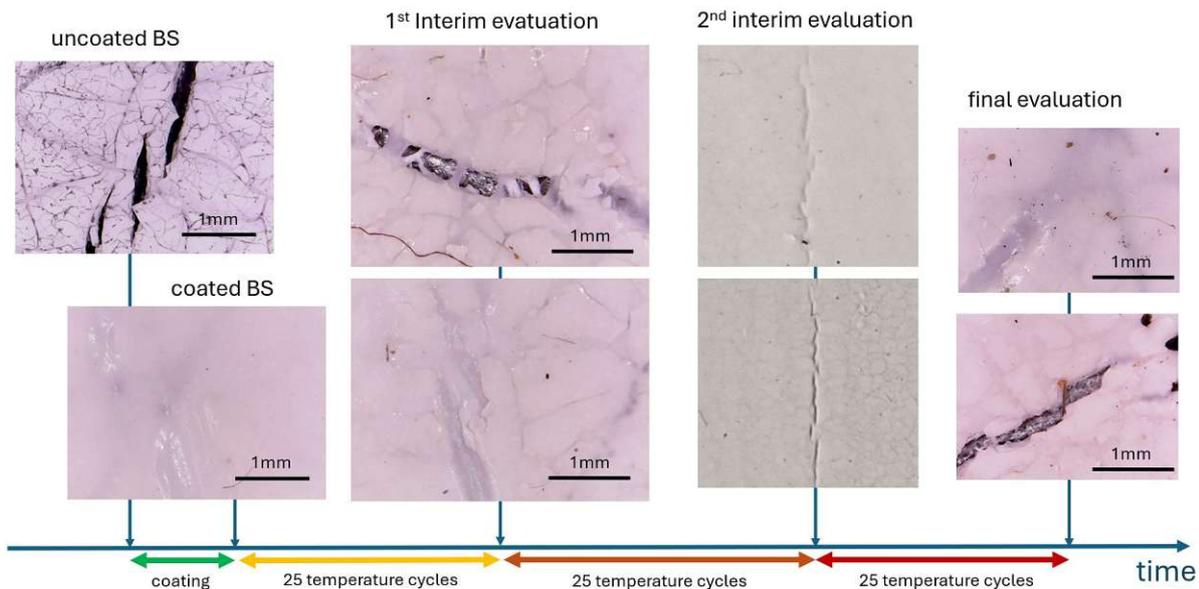
Figure 4.23: Overview of the accelerated aging results for the silicone coating on the backsheet

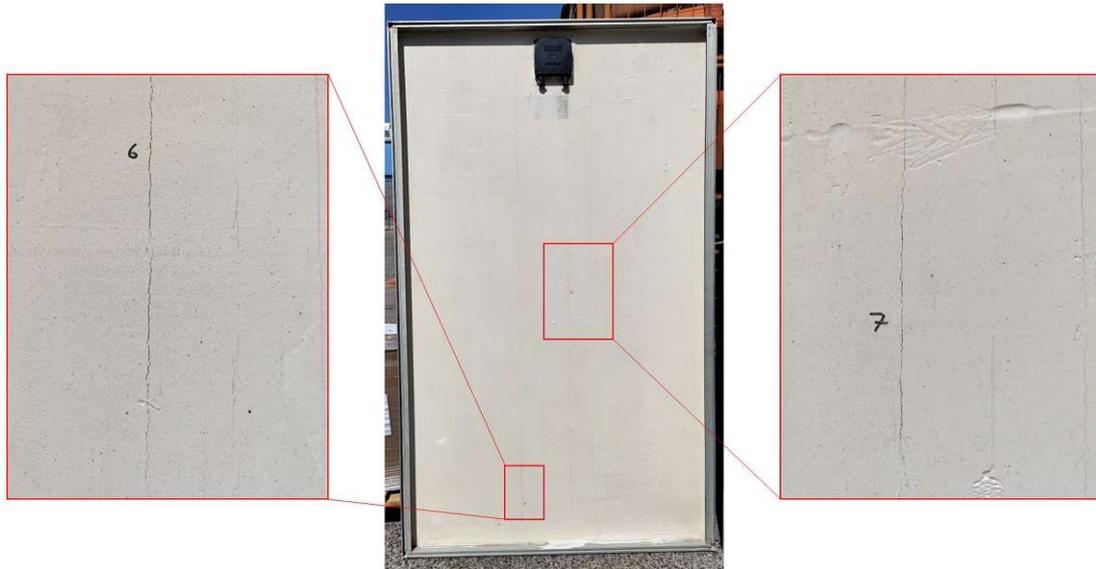
Figure 4.24: Artificially aged silicone coating showing few surface near cracks

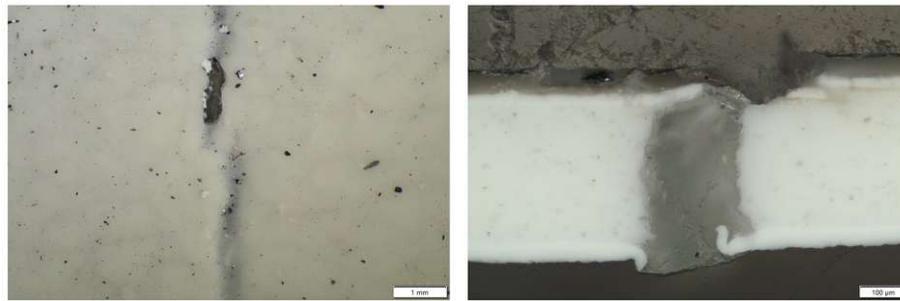
Figure 4.25: Light microscopy images of cracked coating after 75 temperature cycles

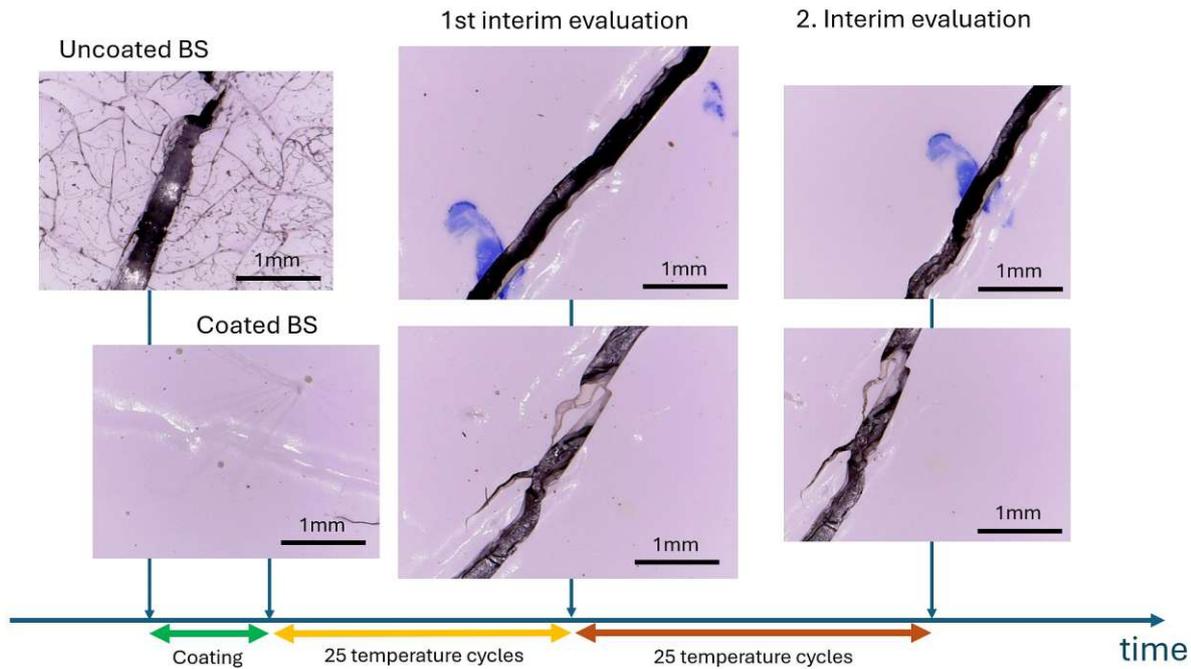
Figure 4.26: Overview of the accelerated aging results for the PU coating (Remisol) on Module M2

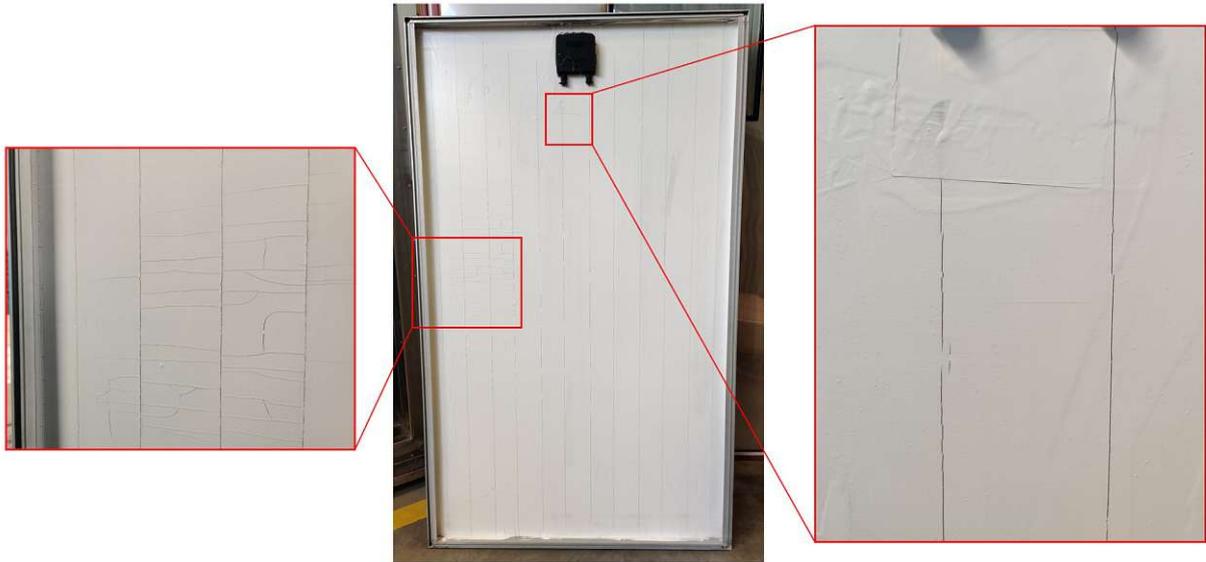
Figure 4.27: Artificially aged PU coating showing severe cracking

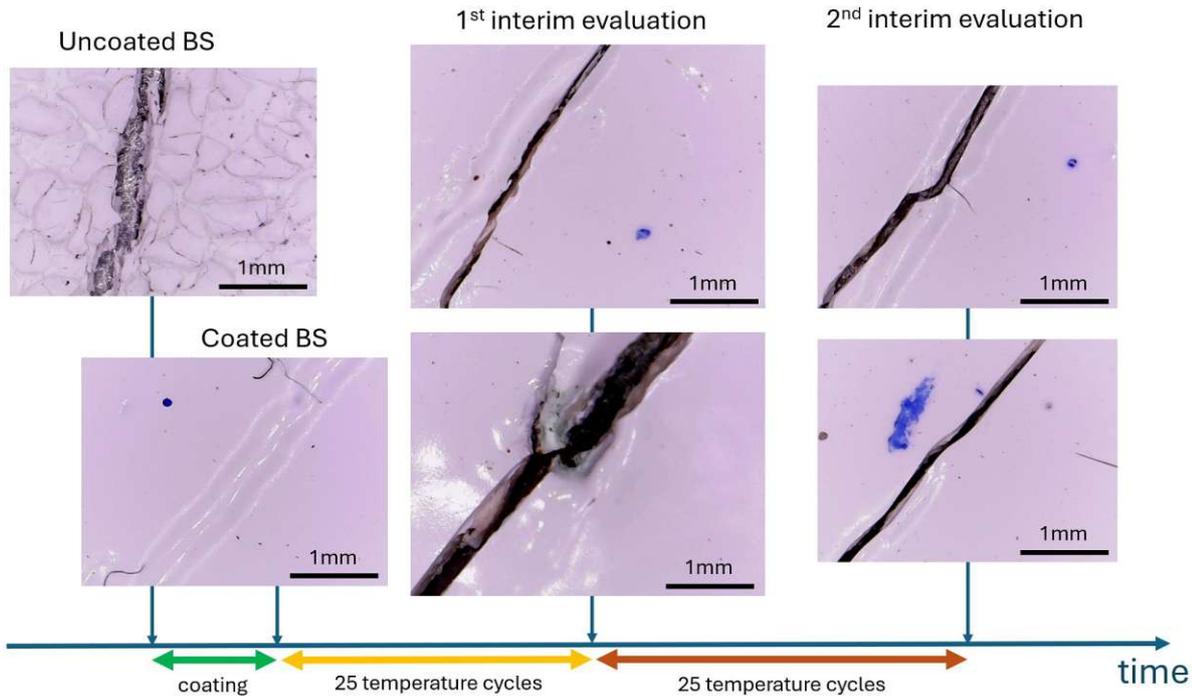
Figure 4.28: Overview of the accelerated aging results for the PU cover coating on Module M3

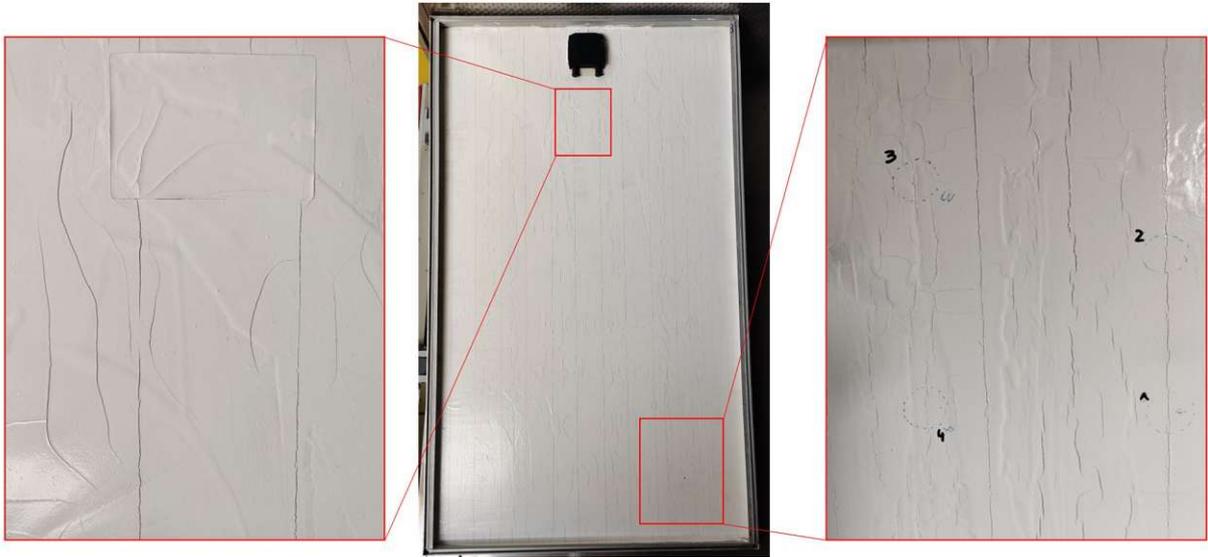
Figure 4.29: Artificially aged PU coating showing severe cracking

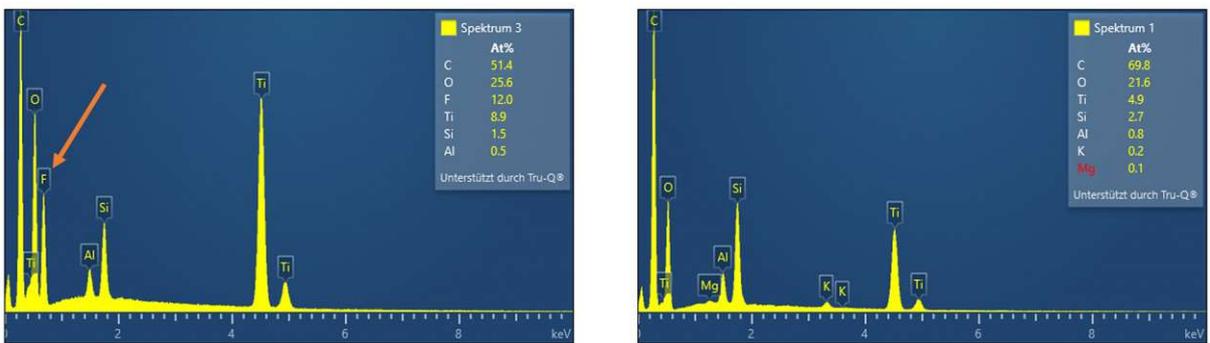
Figure 4.30: Comparison of the Energy-dispersive X-ray spectroscopy results of the original (left) and the new (right) PU cover coating

1. The absence of fluorine in this coating was confirmed through energy-dispersive X-ray spectroscopy (EDX), as shown in Figure 4.30.
2. To evaluate the elasticity and mechanical properties, as well as the material identity the

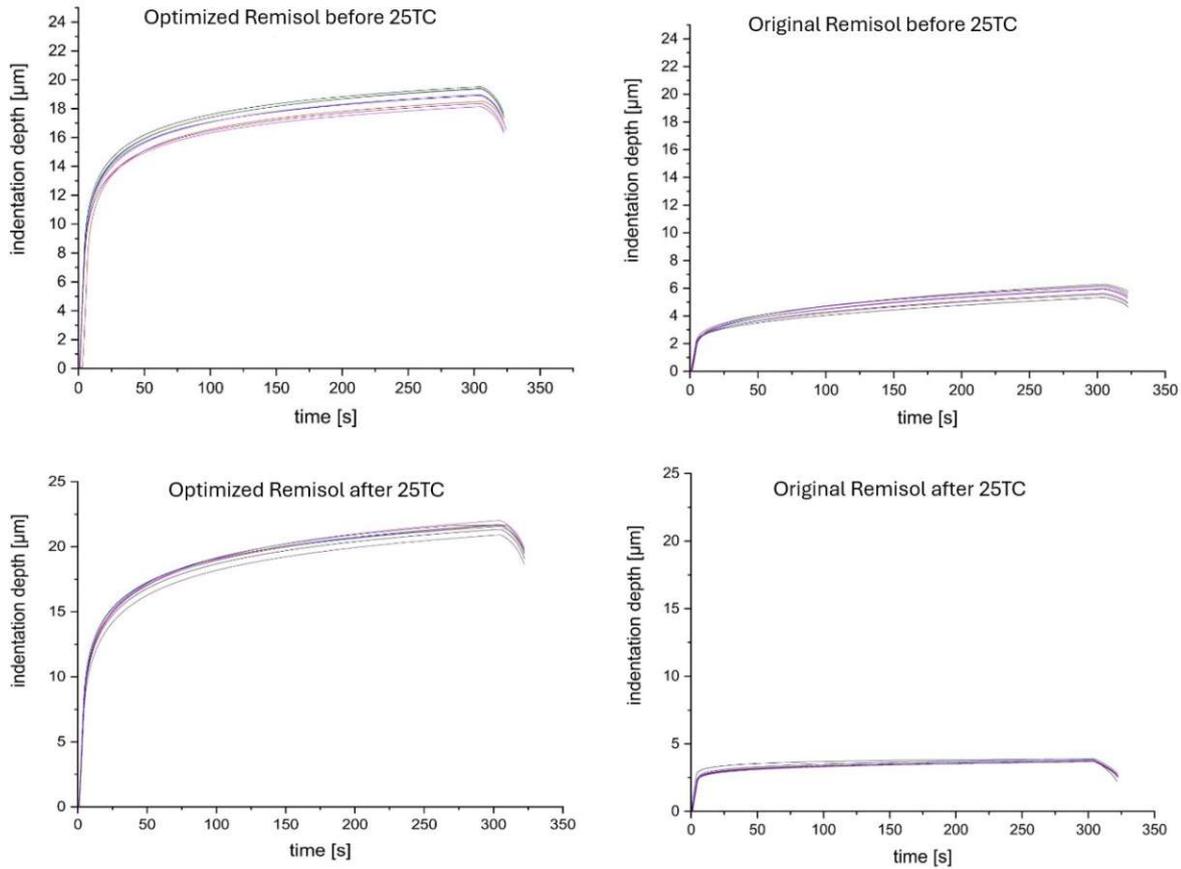
Figure 4.31: The nano-indentation results for the the PU coating before and after 25 TC

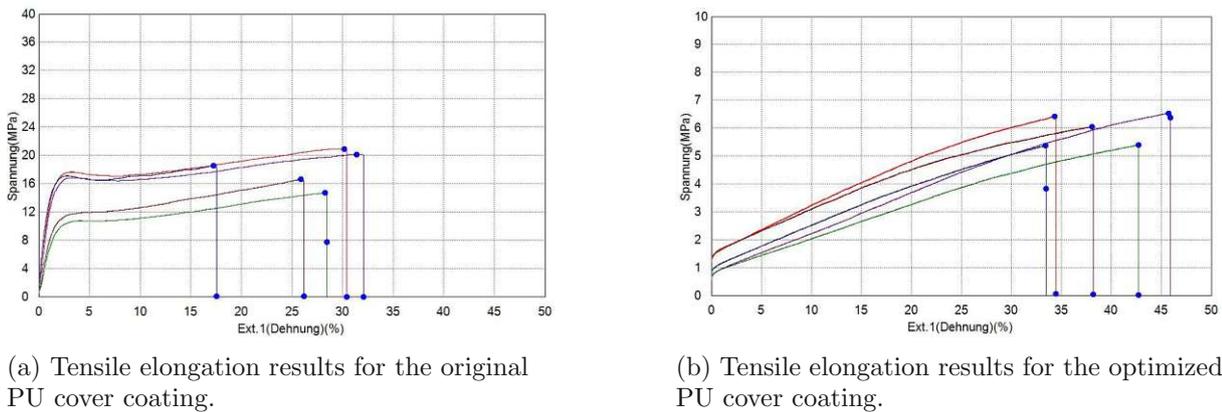
(a) Tensile elongation results for the original PU cover coating. (b) Tensile elongation results for the optimized PU cover coating.
