DIPLOMARBEIT

Repair Solutions for PV Modules with Cracked Backsheets

ausgeführt am Institut für Angewandte Physik (IAP)
der Fakultät für Physik der Technischen Universität Wien
in Zusammenarbeit mit dem Österreichisches Forschungsinstitut für Chemie und Technik (OFI)

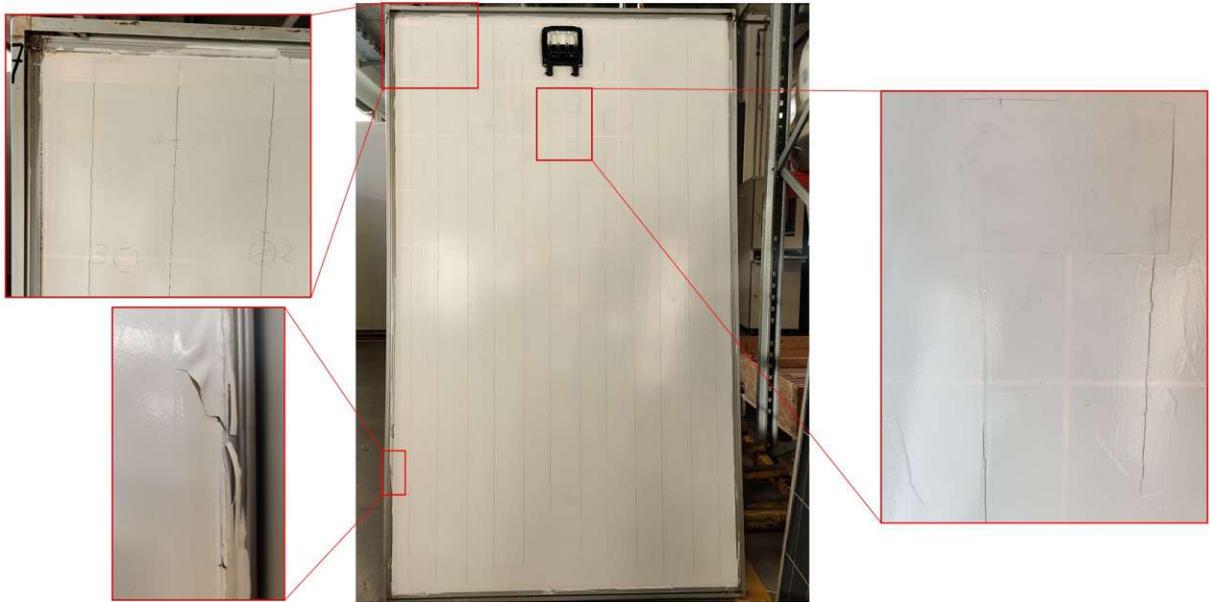
Figure 4.33: The original PU coating on Module M7 after 25 TC with the modified application and test parameters

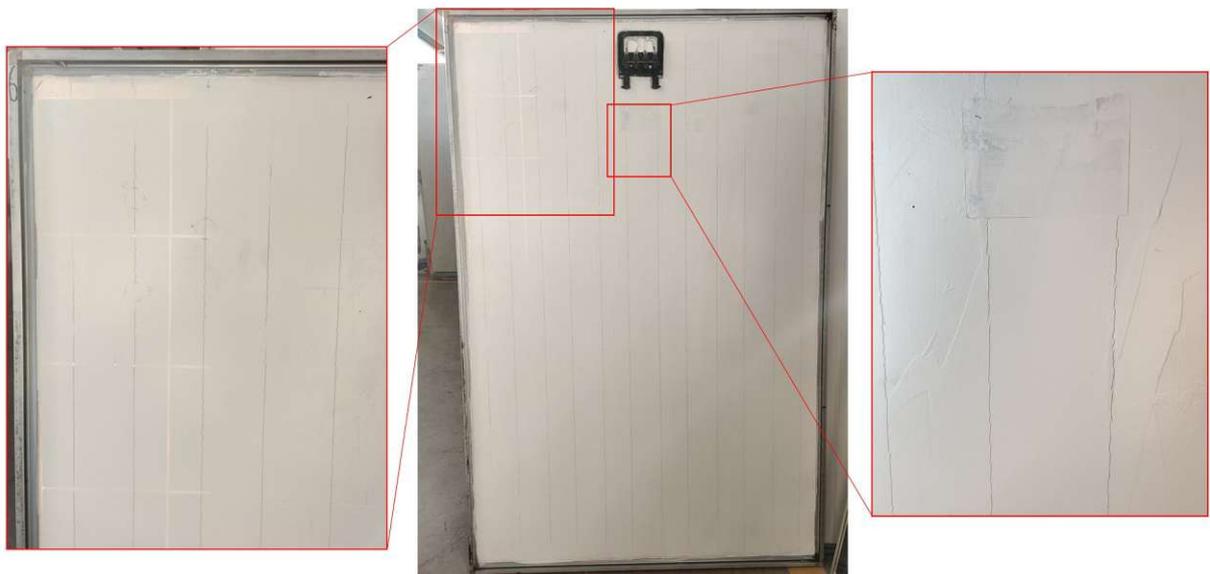
Figure 4.34: The optimized PU coating on Module M6 after 25 TC with the modified application and test parameters

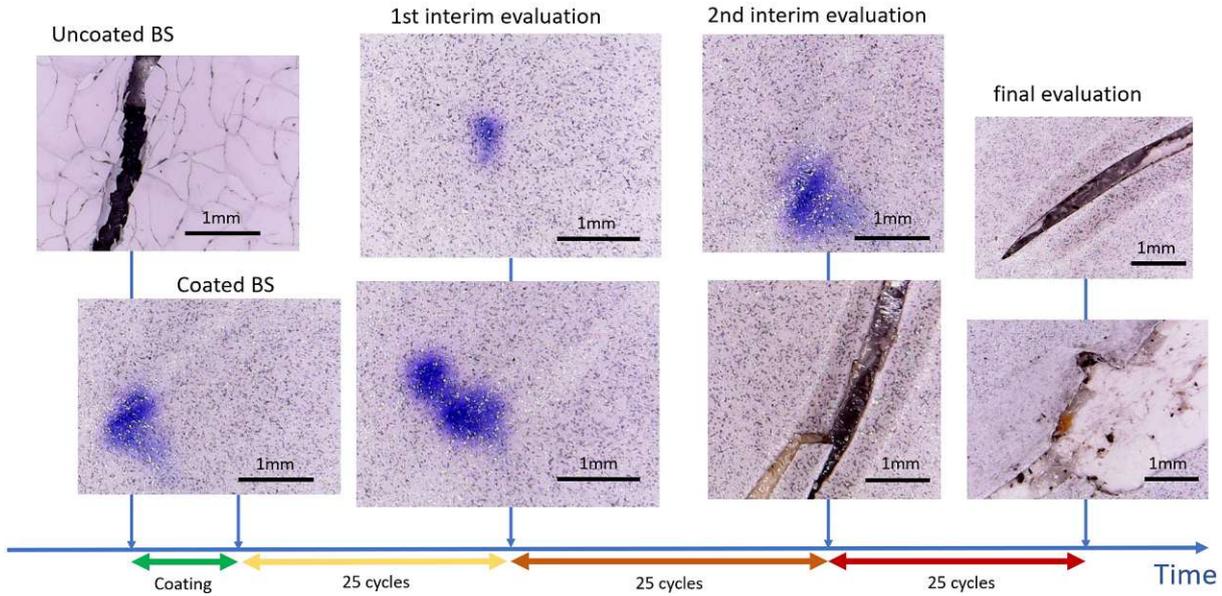
Figure 4.35: Overview of the accelerated aging results for the 3M Wrap Tape (The blue spots are color markings and not caused by or linked to degradation)

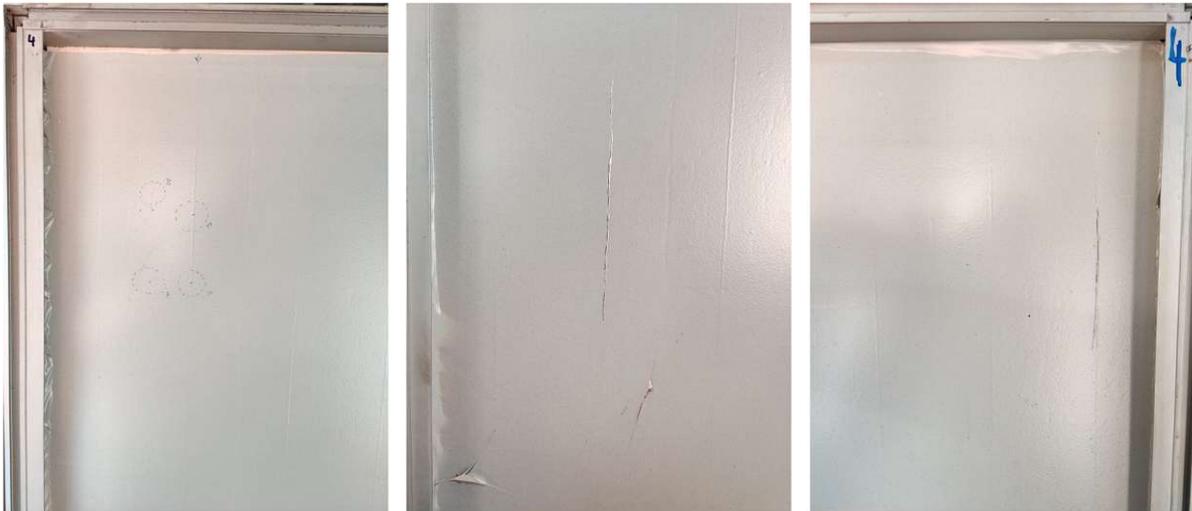
Figure 4.36: Ripped Tape after 75 cycles

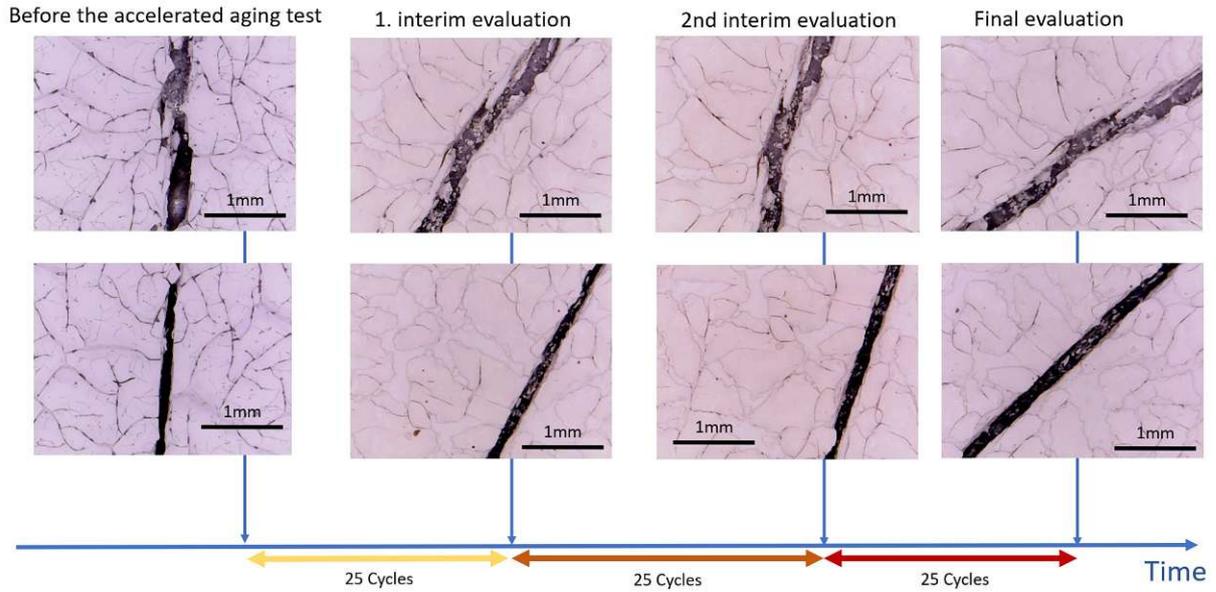
Figure 4.37: Overview of the accelerated aging results for the uncoated reference module

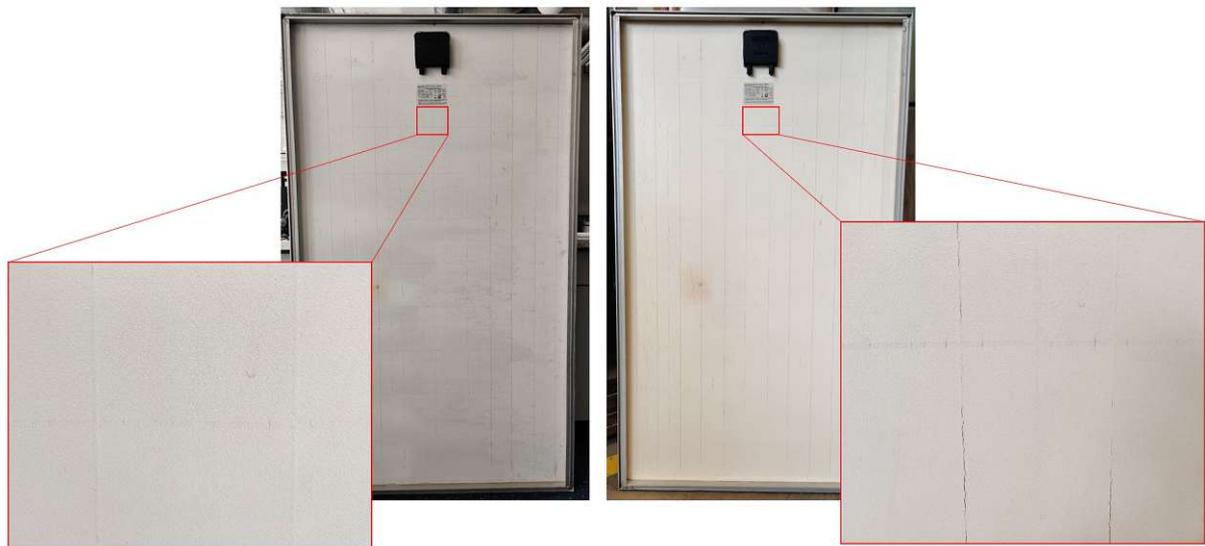
Figure 4.38: Comparison between uncoated reference module before and after 25 temperature cycles

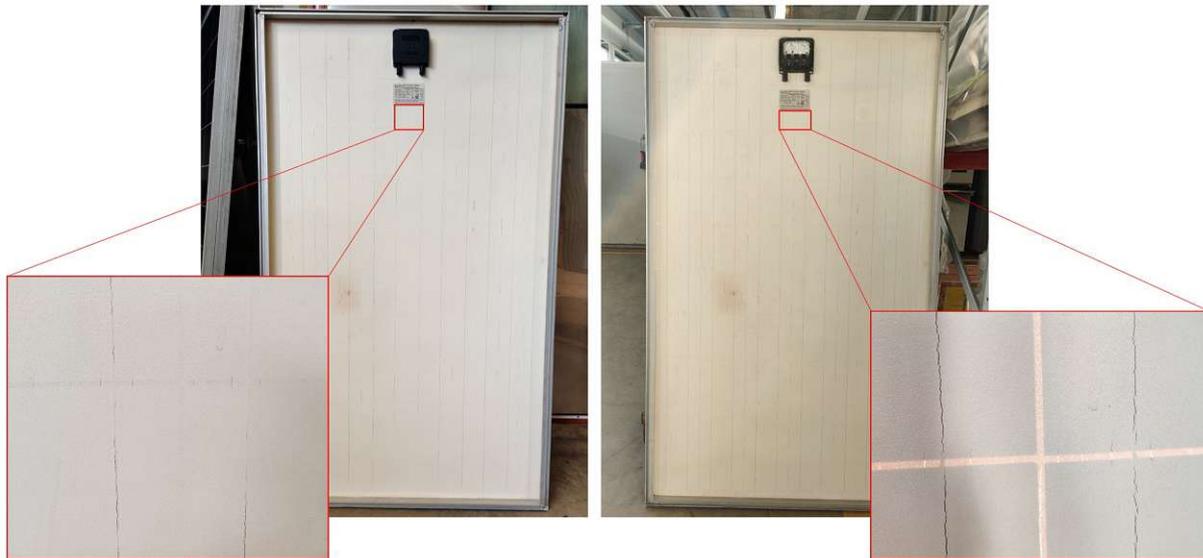
Figure 4.39: Comparison between uncoated reference module after 50 and 75 temperature cycles

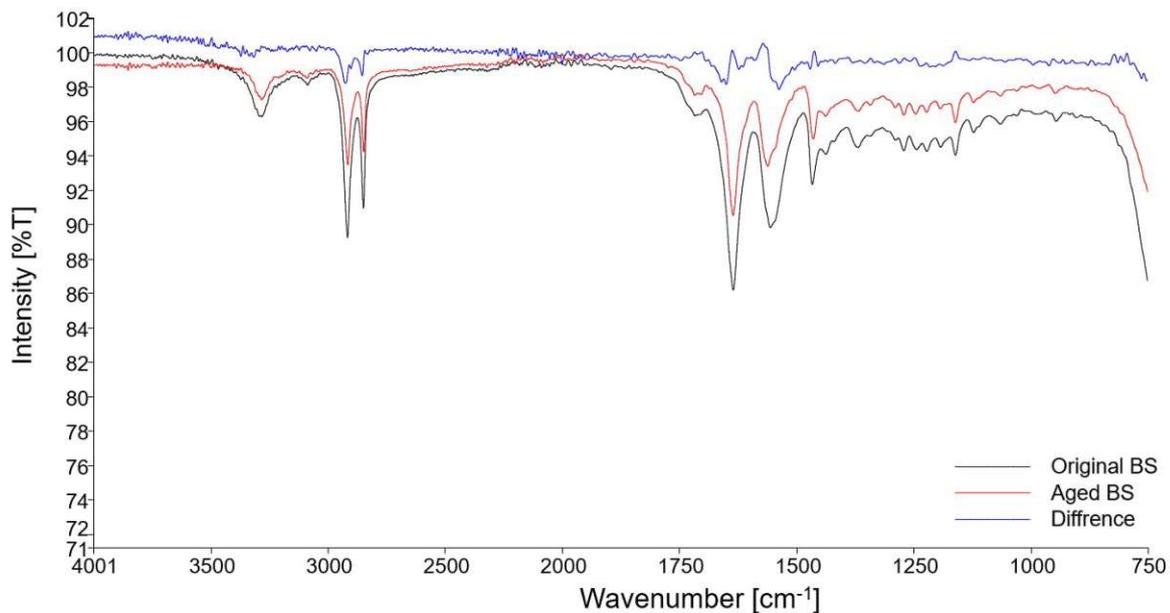
Figure 4.40: Comparison between IR spectra of the backsheet of the uncoated reference module before and after the 75 temperature cycles

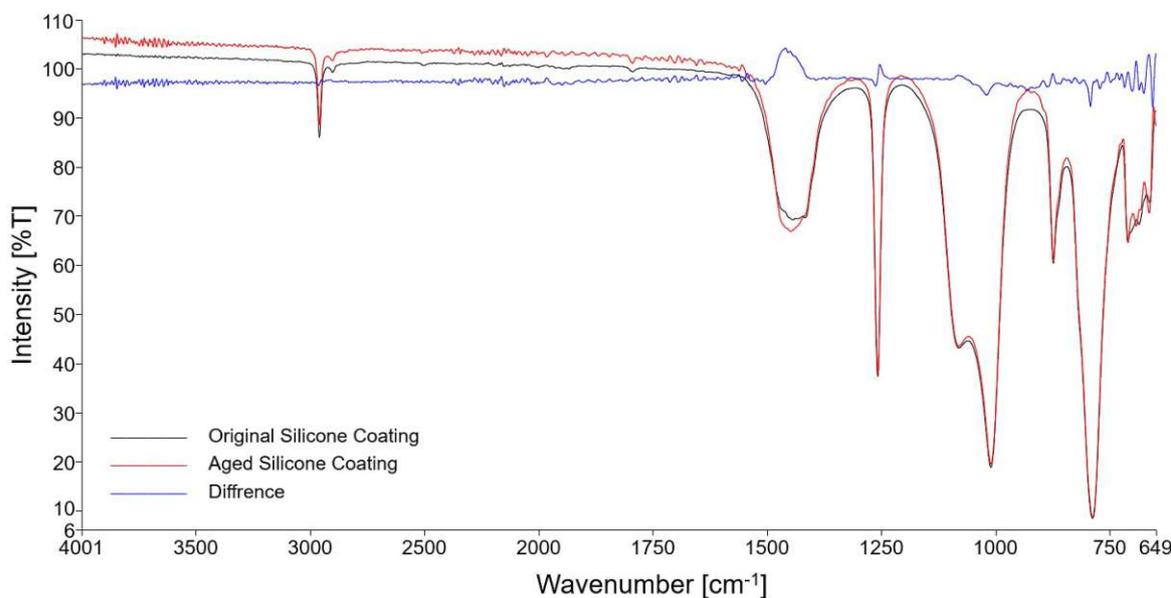
Figure 4.41: Comparison of the IR spectra of the silicone coating before and after the 75 temperature cycles

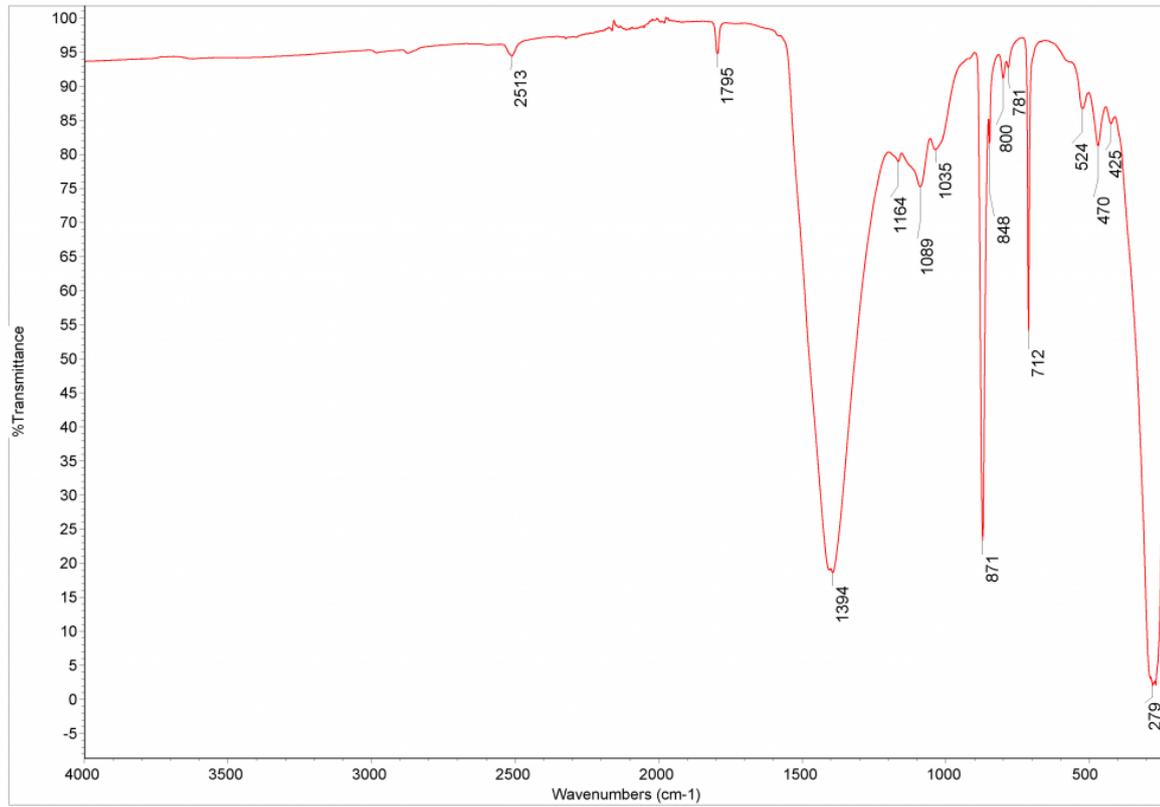
Figure 4.42: The IR spectra of chalk from [54]

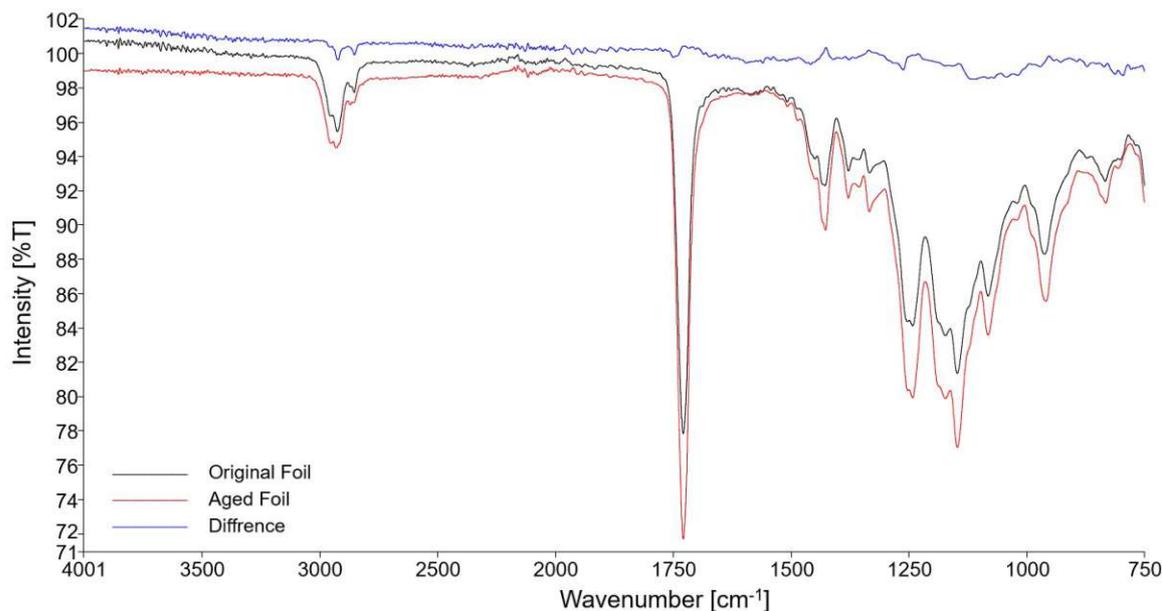
Figure 4.43: Comparison between the IR spectra of the 3M PVC Foil before and after the 75 temperature cycles

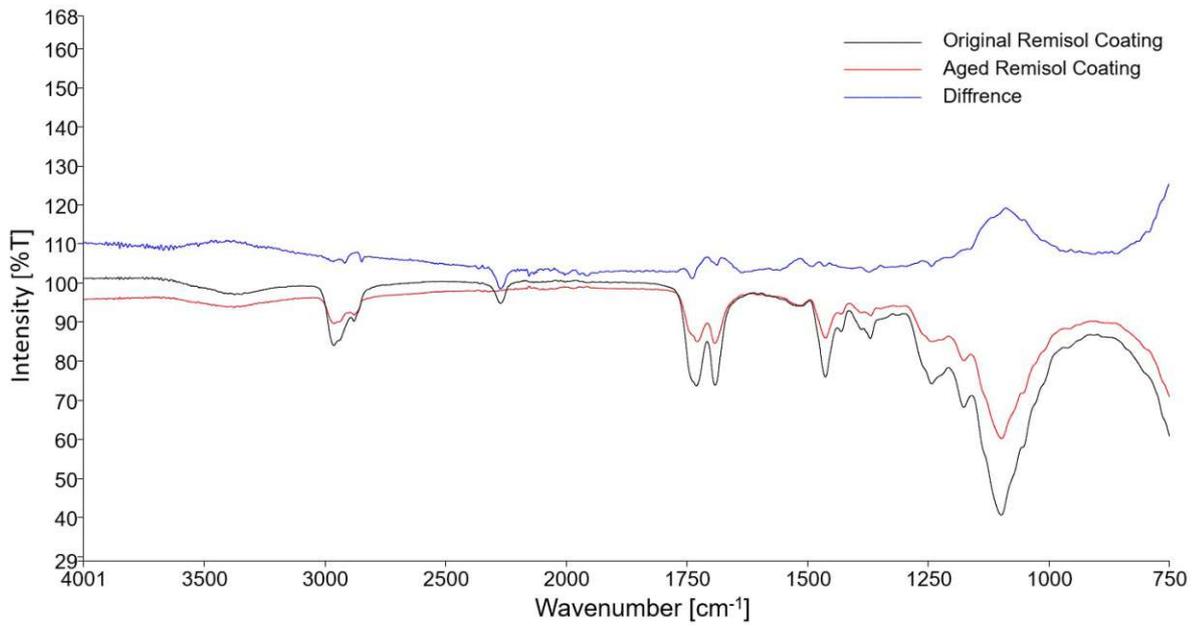
Figure 4.44: Comparison of the IR spectra of the Remisol coating before and after 50 temperature cycles

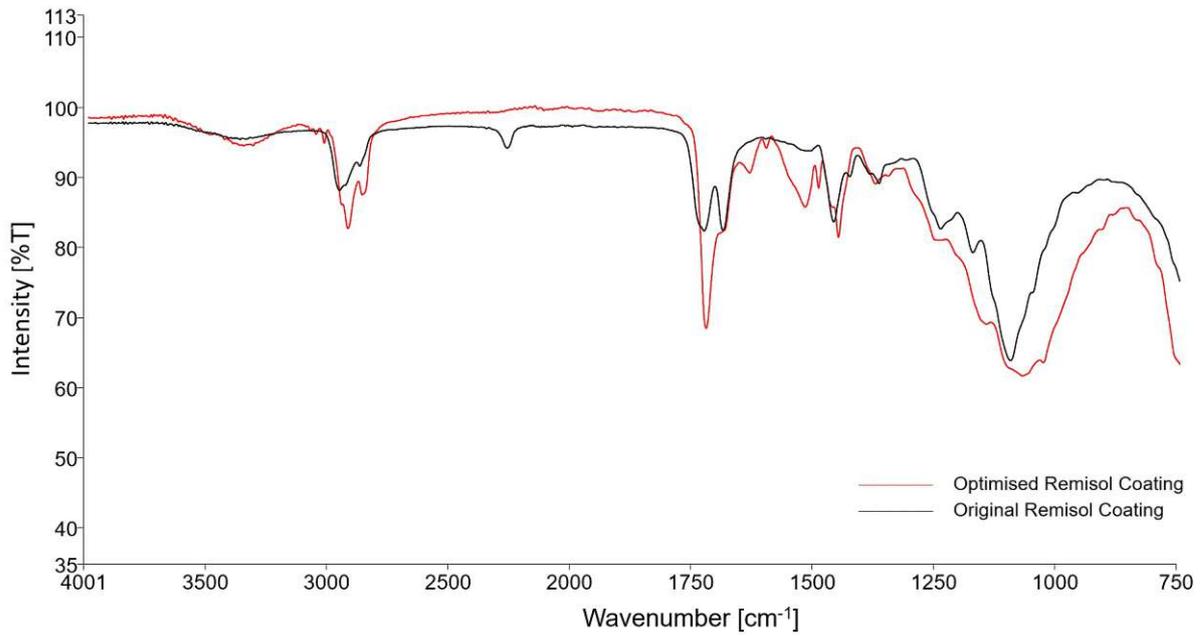
Figure 4.45: Comparison of the IR spectra of the original and the optimized PU cover coating (before the accelerated aging test)

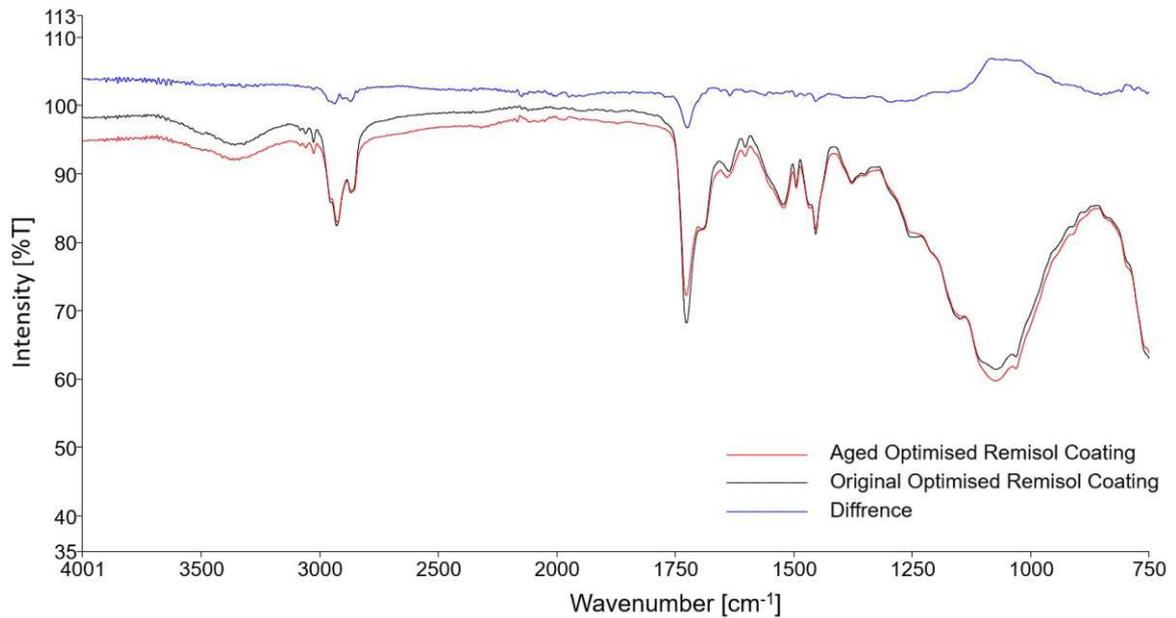
Figure 4.46: Comparison of the IR spectra of the optimized PU cover coating before and after 25 temperature cycles

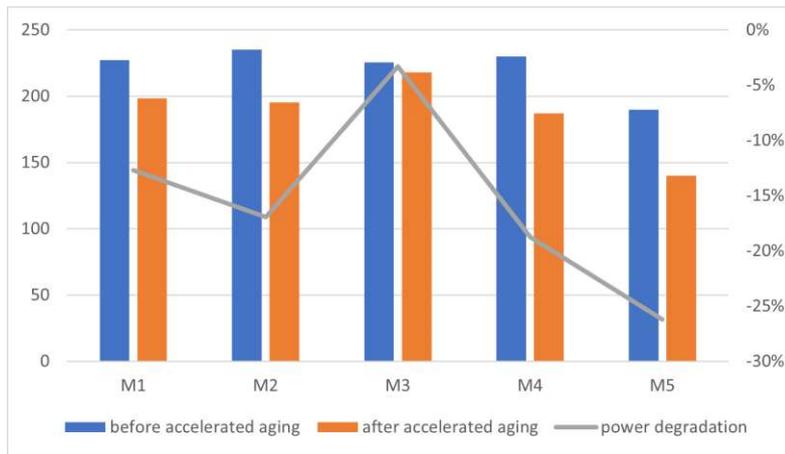
Figure 4.47: Calculated P_{\max} for standard conditions before and after the temperature cycles and the power degradation in percent. The modules are rated for a peak power of 240 W
