TECHNISCHE  
UNIVERSITÄT  
WIEN

DIPLOMARBEIT

**Evaluation of the impact sound insulation of an existing and  
refurbished wooden beam floor construction**

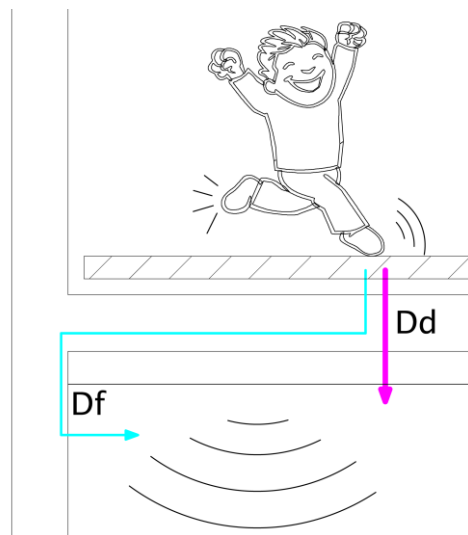
Figure 2. Footfall noise produced by a jumping child on a floor. Arrows show the impact sound transmission; direct transmission (path Dd) and flanking transmission (path Df)

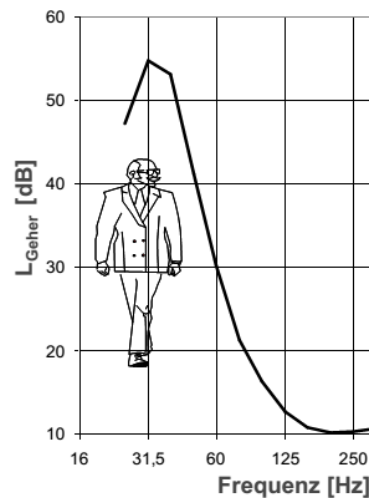
Figure 4. Frequency dependent illustration of the impact sound transmission by walking on a floor (Rabold.A, "Trittschalldämmung richtig bewerten", p. 4, 2011)

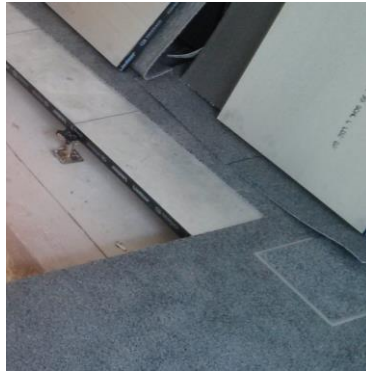
Figure 7. The picture shows an opening of a raised floor system, Palais von Foerster

Around 1990 the whole building was refurbished and its use turned to that of a bank. For office buildings it was a common technique at that time to construct raised floor systems. They have the advantages of easy and fast montage and offer enough space in the void to route mechanical services and cables, wiring and electrical supply (Figure 7).

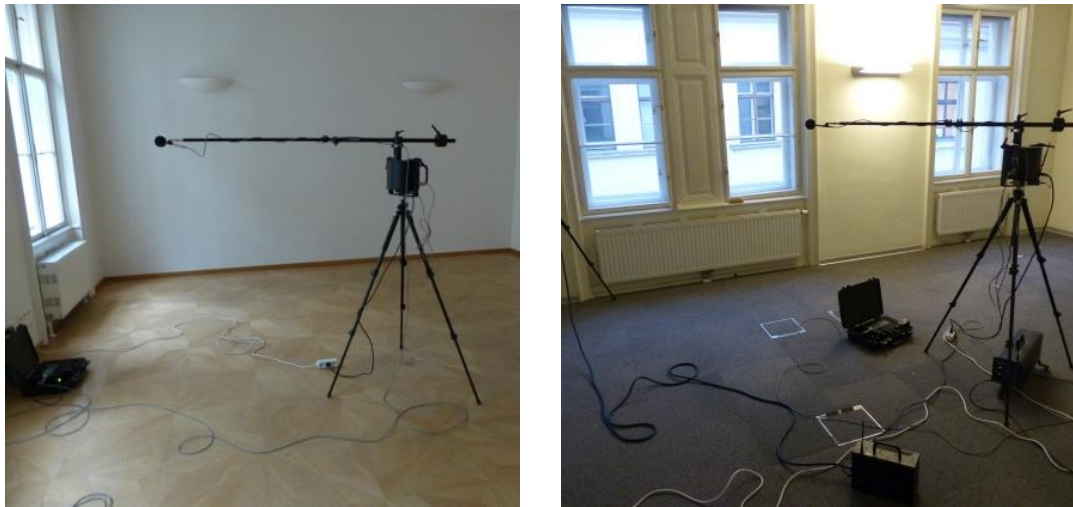
In Figure 10 the source room with the non-refurbished wooden beam floor construction (a) separating the 3<sup>rd</sup> and 4<sup>th</sup> level (Figure 11) and the receiving room with the non-refurbished wooden beam floor construction (b) separating the 2<sup>nd</sup> and 3<sup>rd</sup> level (Figure 12) can be seen.

Figure 10. Receiving room (left);Source room (right)

According to the EN ISO 16283-2 the distance of the tapping machine and the edges of the floor has to be at least 0.5 m. In case of the wooden beam floor (inhomogeneous floor construction) the hammer connecting line was orientated at 45° to the direction of the beams. In every impact sound test both source and receiving room were unfurnished and unoccupied; hence the operator of the sound analyzer was always outside the rooms. Only the microphone, which was mounted on a Tripod, was in the receiving room (Figure 10, left).

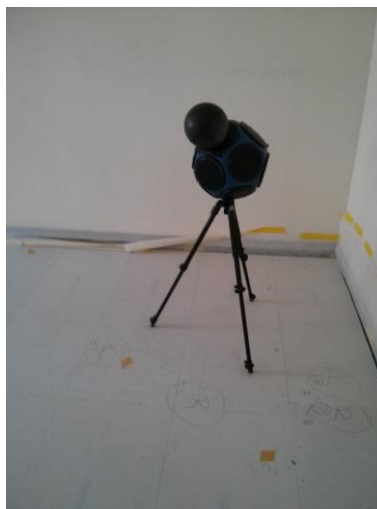
Figure 16. Impact ball positioned in a height of  $100 \pm 1$  cm above the surface of the floor

The impact ball was dropped vertically (see Figure 16) in a free fall from a height  $100 \pm 1$  cm measured from the bottom of the rubber ball to the surface of the floor under test. In order to avoid positional or structural effects during data collection, the rubber ball was left to fall from ten positions, where at least one position was above the beam and one in the middle of the floor. For each excitation by the rubber ball in the source room floor, the microphone was positioned at a random place in the receiving room. There the energy-average maximum impact sound pressure level  $L_{i,Fmax}$  was recorded with the Nor140 sound analyzer in one third octave bands with at least the following center frequencies (50, 63, 80, 100, 125, 160, 200, 250, 315, 400, 500, 630). For each ball position three microphone positions were used and their impact sound pressure levels were logarithmically averaged according to (equation (11)).

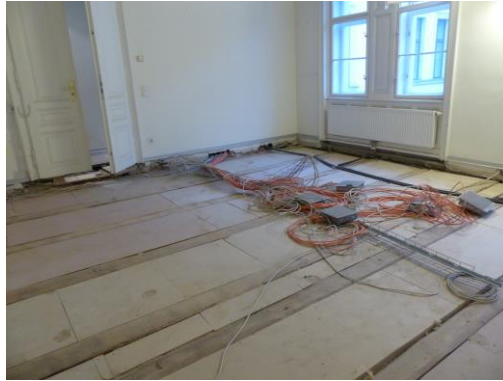
*Figure 17. Level 4, floor after removing the layers on top of the wooden beam construction*

For the refurbishment of the wooden beam floor, as a first step the layers on top of the wooden beam construction were removed (see Figure 17) and a possible rehabilitation solution was schemed.

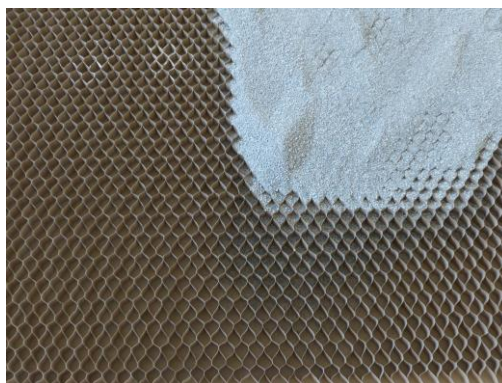
Figure 18. Fermacell Honeycomb acoustic system

The FERMACELL®Honeycomb acoustic system consists of a Honeycomb insulation board (1500x1000x30 mm, “l x w x h”) which is laid wall to wall on top of the resilient layer and then filled with the special FERMACELL Acoustic infill (loose weight 1500kg/m<sup>3</sup>, graded 1-4 mm). This technique allows the application of a softer resilient layer, such as the GetznerWerkstoffe Construction Mat with a dynamic stiffness  $s' < 13 \text{ MN/m}^3$ , which has a very high proportion of recycled PU (Polyurethan), shows very good impact sound insulation and has a high load bearing capacity. First, on top of the resilient layer one layered gypsum fibreboard is positioned to serve as a screwing ground for any installation tubes (heating, cables etc.) needed. Afterwards, the Honeycomb acoustic system is positioned. It is used as the installation plane for heating tubes and other cable (see Figure 19). The whole proposed refurbishment design with an area related mass of 145,22 kg/m<sup>2</sup> (see Table 6) and the position of the remaining layers can be seen in Figure 20. The height thickness is kept in that way under the required 130mm.

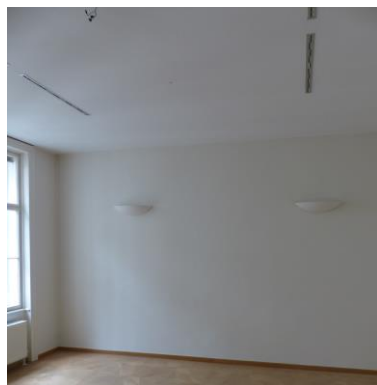
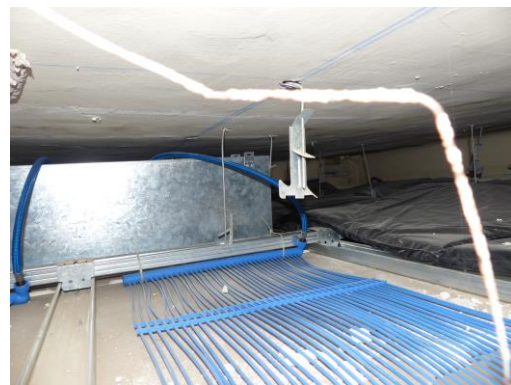
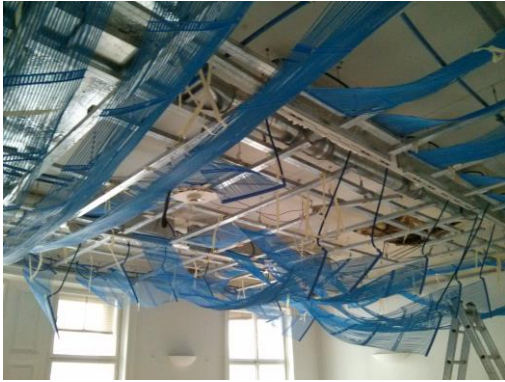
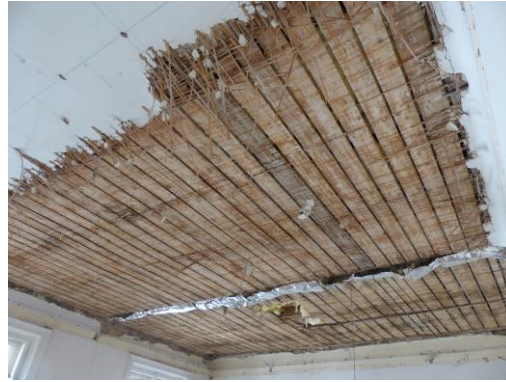
a.) Gypsum cardboard suspended ceiling

b.) Into the void

c.) After removal of gypsum cardboards

d.) Removing the last parts of the reed mats layer

Figure 21. Removing the suspended ceiling, mechanical equipment and the reed mats layer

As a second step, the whole suspended ceiling (see Figure 21) with all the mechanical equipment in the cavity, as well as the layer of reed mats with plaster was removed (Figure 22). This prelim step was done for two reasons: First, in order to investigate the influence of mass removal from the underside of the floor on the impact sound insulation. And second to prepare the construction for the next variant.

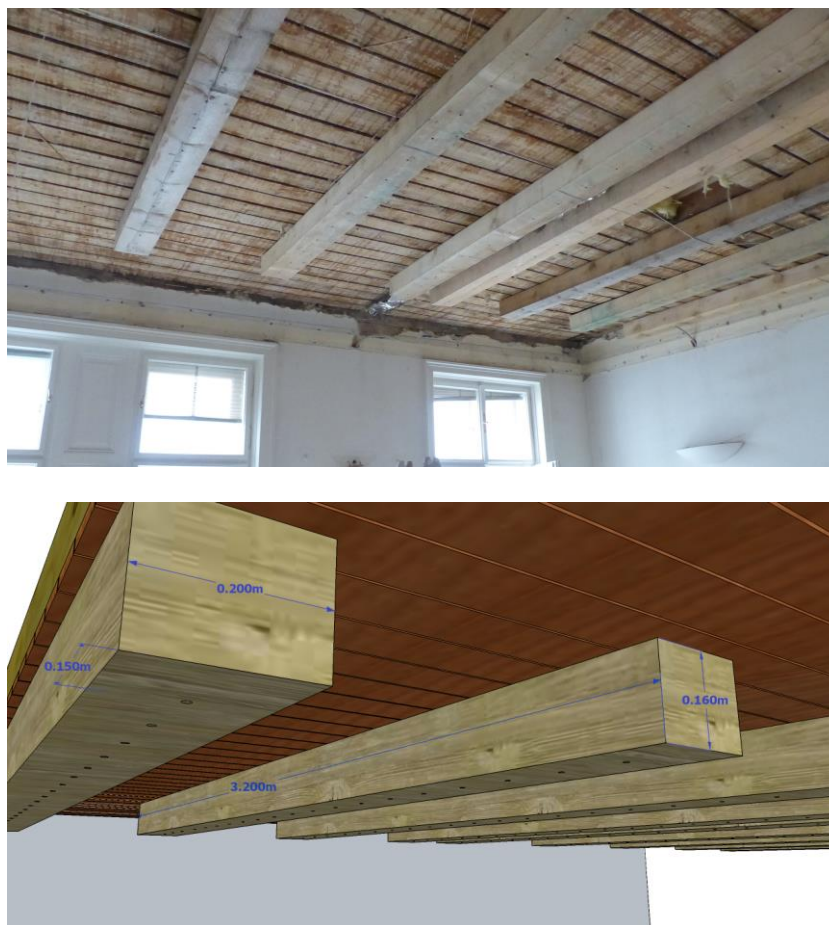
Figure 23. Third refurbished construction (e), wooden beam “stiffeners” bolted on the original wooden beam structure with 200x6 mm bolts every 150 mm.

floor construction would become more rigid and as a result enhance the performance of the resilient layer (construction) in the low frequency spectrum.

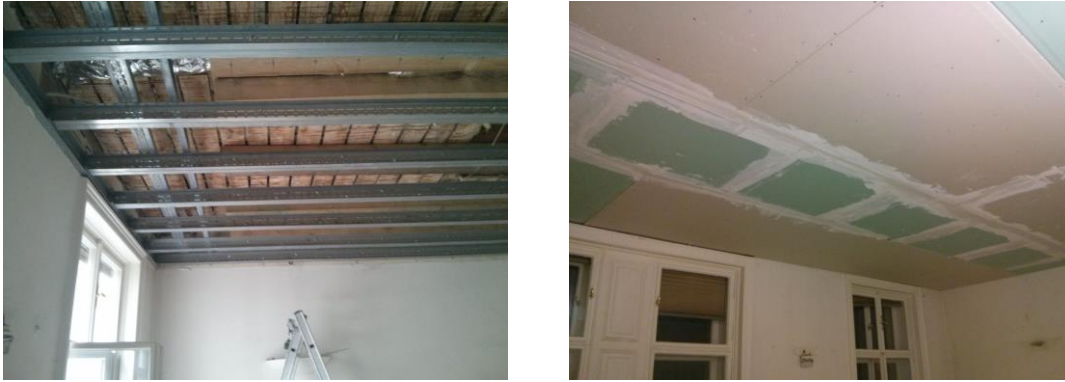
Figure 24. Constructing the fully self-supported decoupled ceiling (left: mounting the U-steel profiles resiliently on the walls); (right: finished underside with double gypsum layer)

Successively, a second layer of gypsum plaster board (12,5mm) was mounted on the first gypsum layer giving us the final wooden beam floor construction. With this method, the underside construction acts as a second ceiling which does not have any contact with the main floor construction. Thereby it is expected to enhance the impact sound insulation several fold, especially in the low frequency by the cavity mineral wool insulation.

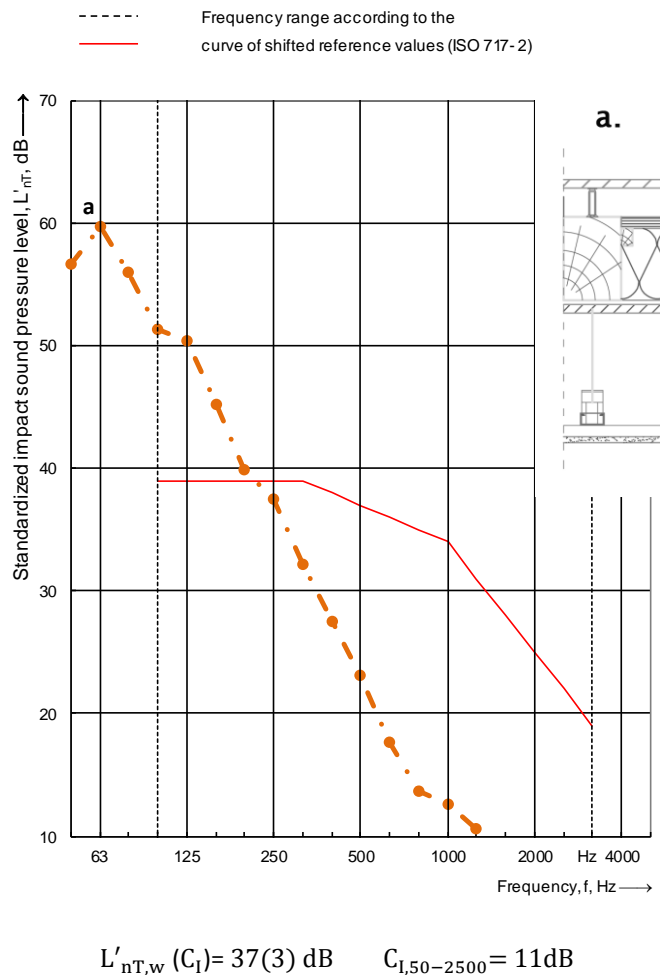
Frequency f [Hz]	$L'_{nT}$ 1/3 octave [dB]
50	56,6
63	59,7
80	55,9
100	51,3
125	50,4
160	45,2
200	39,9
250	37,5
315	32,1
400	27,5
500	23,1
630	17,6
800	13,7
1000	12,6
1250	10,6
1600	7,6
2000	2,3
2500	2,6
3150	1,0
4000	0,8
5000	1,4

Figure 27. Standardized impact sound pressure level  $L'_{nT}$ ; (a). Non-refurbished construction; raised floor system, suspended ceiling

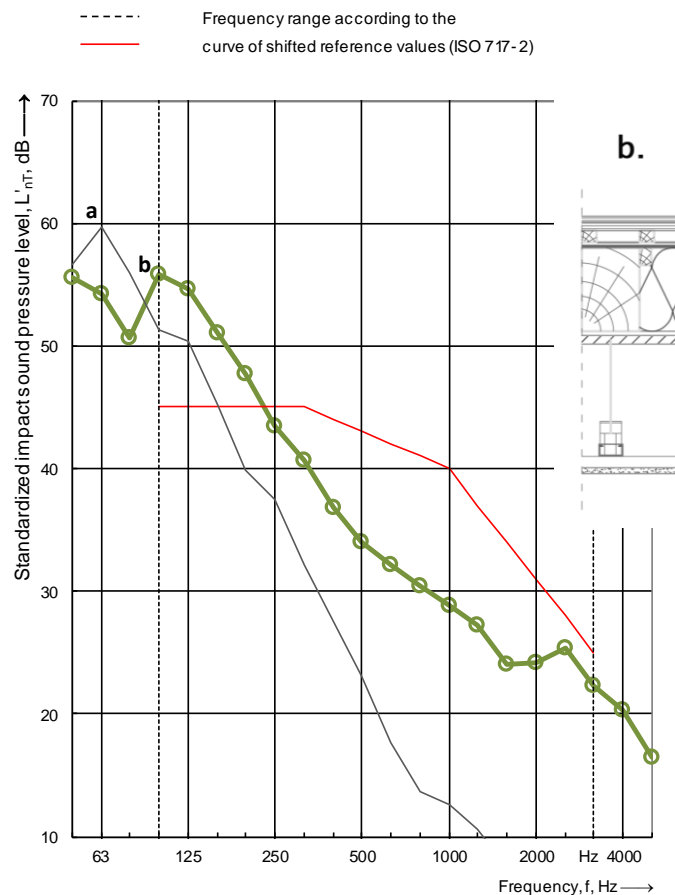
Frequency f [Hz]	$L'_{nT}$ 1/3 octave [dB]
50	55,5
63	54,2
80	50,6
100	55,8
125	54,7
160	51,0
200	47,7
250	43,5
315	40,6
400	36,8
500	34,0
630	32,2
800	30,4
1000	28,8
1250	27,2
1600	24,0
2000	24,2
2500	25,4
3150	22,3
4000	20,3
5000	16,5

$$L'_{nT,w} (C_1) = 43(2) \text{ dB} \quad C_{1,50-2500} = 4 \text{ dB}$$

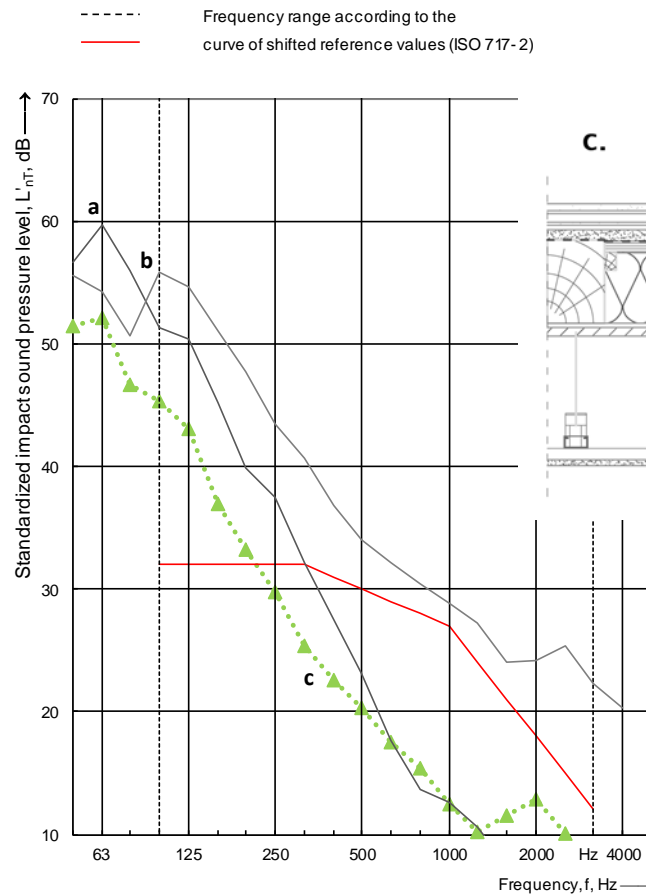
Frequency f [Hz]	$L'_{nT}$ 1/3 octave [dB]
50	51,4
63	52,1
80	46,6
100	45,3
125	43,0
160	37,0
200	33,2
250	29,7
315	25,4
400	22,6
500	20,3
630	17,5
800	15,4
1000	12,4
1250	10,2
1600	11,5
2000	12,8
2500	10,1
3150	2,3
4000	-0,7
5000	-0,5

$$L'_{nT,w}(C_1) = 30(3) \text{ dB} \quad C_{I,50-2500} = 11 \text{ dB}$$

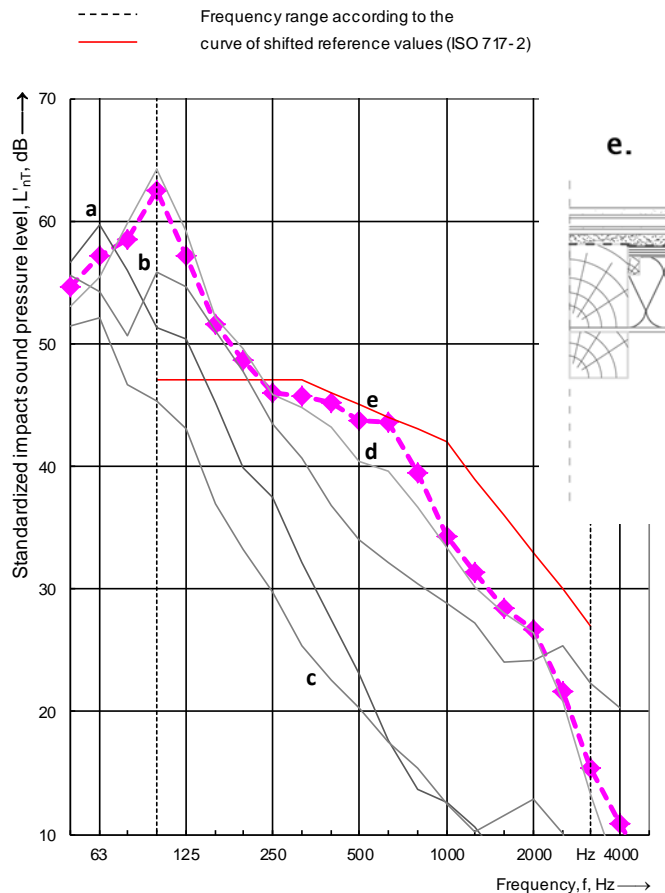
Frequency f [Hz]	$L'_{nT}$ 1/3 octave [dB]
50	54,7
63	57,2
80	58,5
100	62,5
125	57,2
160	51,6
200	48,6
250	46,0
315	45,7
400	45,2
500	43,7
630	43,6
800	39,5
1000	34,3
1250	31,3
1600	28,4
2000	26,7
2500	21,7
3150	15,4
4000	10,8
5000	6,8

$$L'_{nT,w} (C_I) = 45 (4) \text{ dB} \quad C_{I,50-2500} = 6 \text{ dB}$$

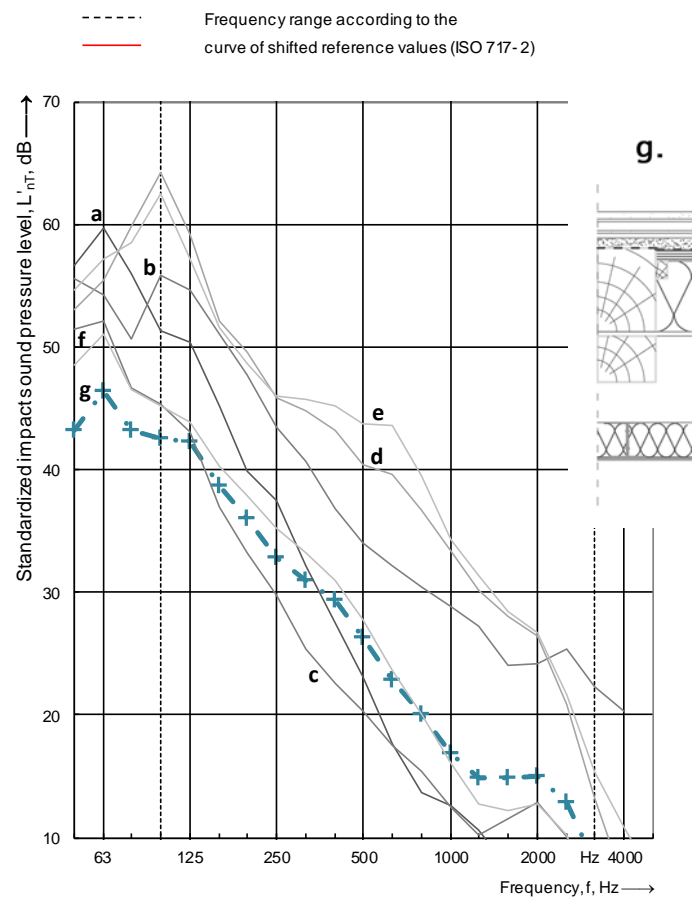
Frequency f [Hz]	$L'_{nT}$ 1/3 octave [dB]
50	43,2
63	46,4
80	43,2
100	42,5
125	42,2
160	38,7
200	36,0
250	32,8
315	31,0
400	29,3
500	26,3
630	22,8
800	20,0
1000	16,8
1250	14,9
1600	14,8
2000	15,0
2500	12,9
3150	8,0
4000	4,5
5000	2,7

$$L'_{nT,w} (C_I) = 31 (1) \text{ dB} \quad C_{I,50-2500} = 5 \text{ dB}$$

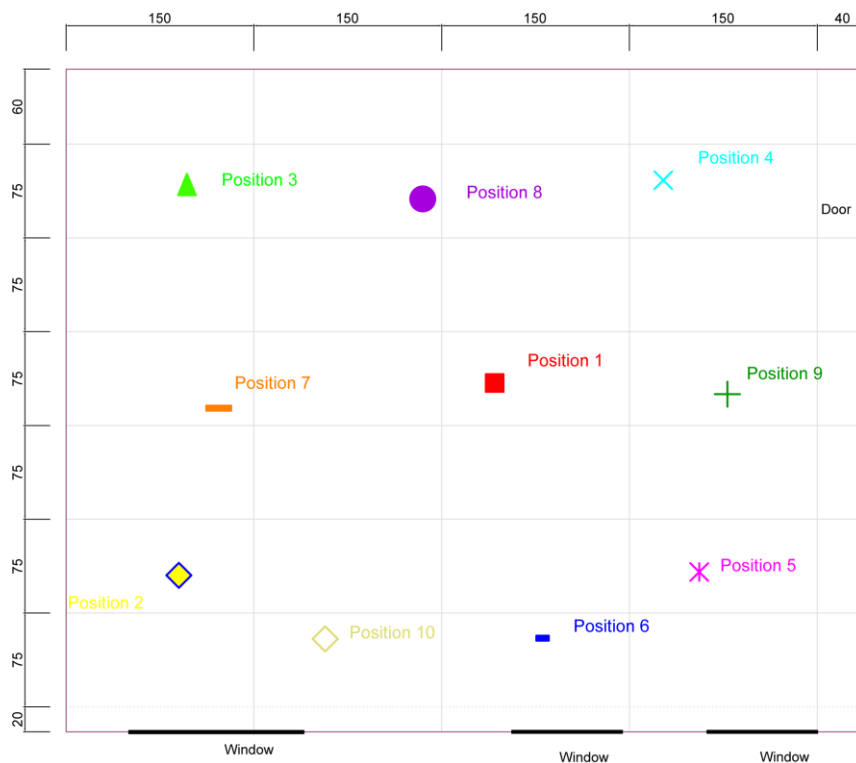
Figure 34. Sketch of the approximate impact ball positions

On 5<sup>th</sup> March 2014 a first attempt to carry out an impact sound measurement, according to the alternative method, using an impact ball to excite the floor took place. As described in the methodology (see section 2.3.2) the impact ball was left from a height of  $100 \pm 1$  cm above the floor surface on a free fall to excite the construction. This was repeated for ten positions (3 times per position). A sketch of the approximate positions can be found in Figure 34 and the results of the impact sound pressure levels in Figure 35. As illustrated in Figure 35 the peak of the maximum impact sound pressure level is for most of the positions at 63 Hz. Only positions P1, P3, P4 and P5 show a rather inconsistent curve progression with their highest peaks at and supposedly below 50 Hz. In the middle range frequencies all positions show many fluctuations and a rather inconsistent progression. The highest  $L'_{i,Fmax,V,T}$  difference between the positions is about 20 dB.

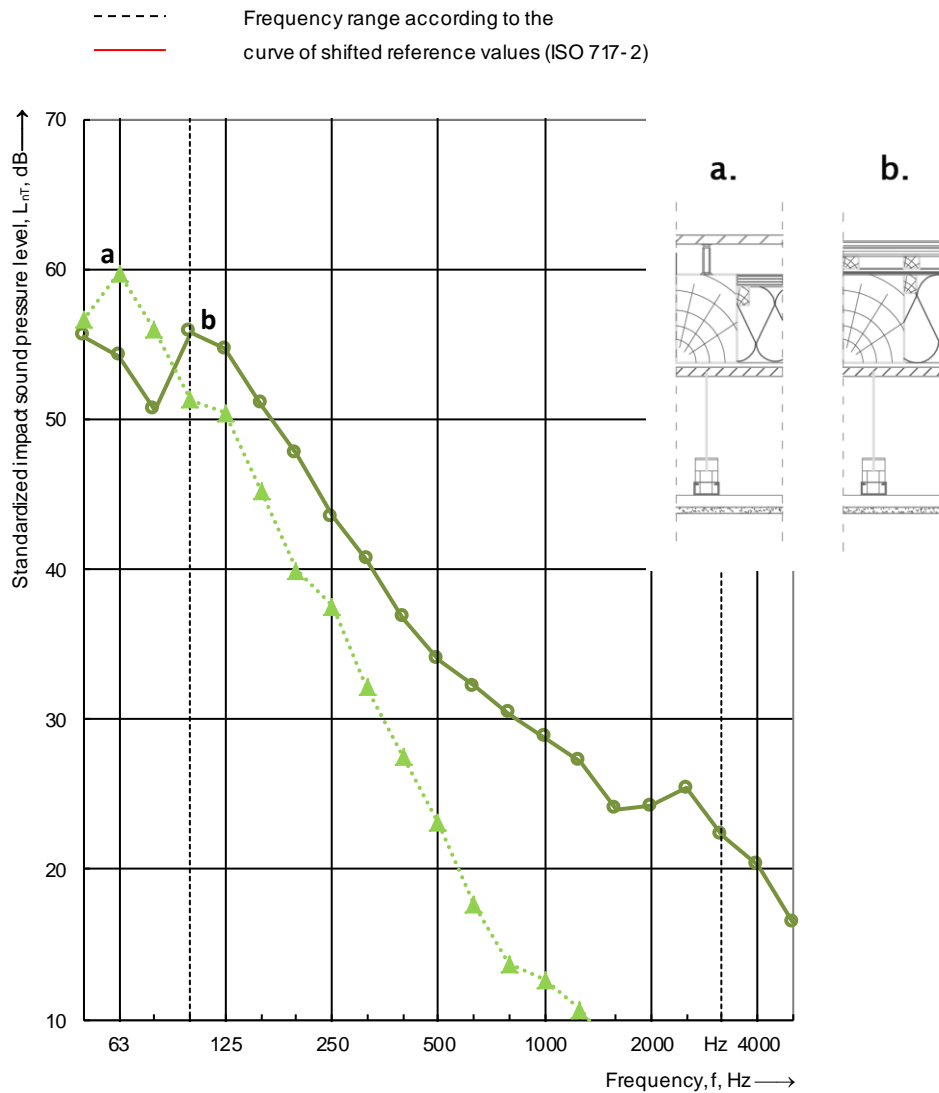
Figure 37. Standardized impact sound pressure level  $L'_{nT}$  for non-refurbished wooden beam floors
