Diploma Thesis

Aging of reinforced thermoplastic pipes under extreme environmental conditions

carried out for the purpose of obtaining the degree of Dipl.-Ing. submitted at the Institute of Materials Science and Technology at Vienna University of Technology

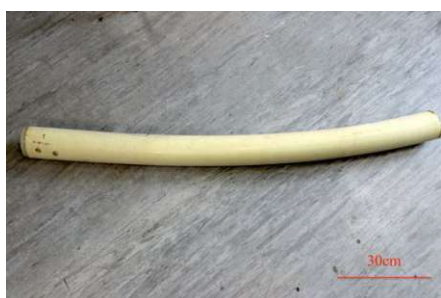
Figure 1.1: Pipe 1

The materials to be tested are high-pressure pipes for the oil industry. Four ends of the coiled-up pipes were available to investigate and were numbered from 1-4. The pipe sections with a length of approximately 130cm are shown in figure [1.1](#) - [1.4](#).

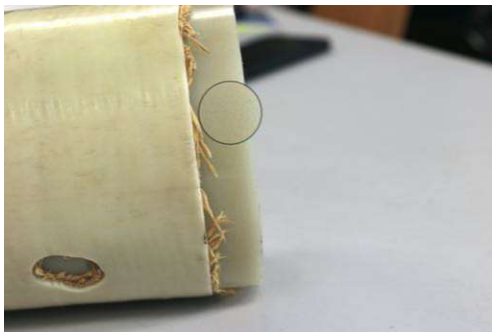
Figure 1.7: End of pipe 1

The liner has the function of taking the main load. It consists of $\approx 6,6\text{mm}$ thick, extruded PA. It can be observed on each of the four pipes, that in a small area on the very end of the pipe section where the liner is not covered with reinforcement and jacket, the liner is brittle and covered with cracks. Thus it can be concluded, that the liner is aged in this area. This can be seen in figure 1.7 - 1.10. The sample 1R, which acted as a representative sample for the aged area of all four pipes, was taken from the uncovered area of pipe 1, shown in figure 1.7.

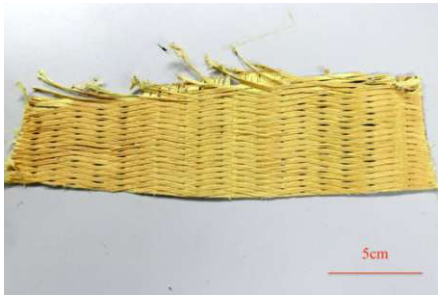
Figure 1.11: Reinforcement outside

The reinforcement consists of two components, both made of PPTA yarn. The first one is the longitudinal yarn which is only put lengthwise on the liner but not woven. It can be seen in figure 1.14. It does not enclose the tube over the circumference as shown in figure 1.12. The second component is the braided yarn. As it can be seen in figure 1.13, three parallel yarns are cross-woven for the fabric. It is woven over the liner with the applied longitudinal yarn. The longitudinal and braided yarn are not interwoven. It can be observed, that the inside of the reinforcement has another colour than the outside.

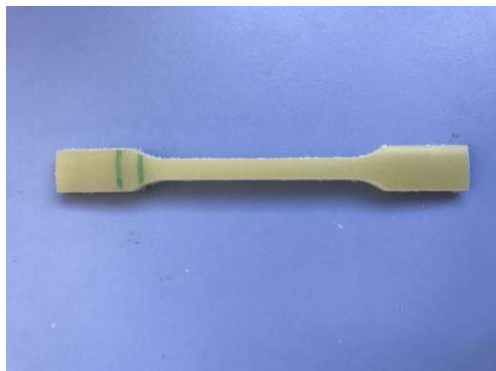
Figure 2.10: ISO 527-1 1B specimen

In figure [2.10](#) and figure [2.11](#) a standard specification specimen according to ISO 527-1 1B can be seen. The bend which can be observed in figure [2.11](#) comes from the reel, the pipes were coiled up.

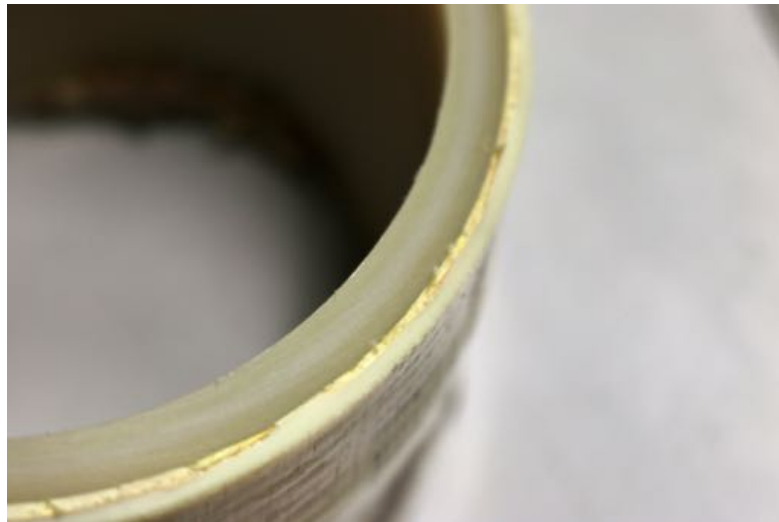
Figure 3.6: Cross section

A cross sectional view of the lining material shows three different layers, which can be seen in figure [3.6](#). The inner and outer layers of the liner are darker than the brighter middle layer. The initial idea was that the variation of the colours was caused by the production process of the liner and it might be a variation of the crystallinity. For further assessment, the composition of the material had to be first analysed.

It was expected, that in the supposedly three different layers of the liner which are discernible by different colours, displayed in figure 3.6 show various crystalline structures. An increase in the intensity of the absorbance of the above- mentioned peaks would mean a higher amount of the peak belonging phase. As in figure 3.25 diagrammed, the peak at 1124 cm^{-1} representing the amorphous δ - phase, does not show any correlation to the position where it was taken from. There is a variation in the absorbance over the cross-section as it can be seen in figure 3.26 but it does not give any reasons for the different colourings.

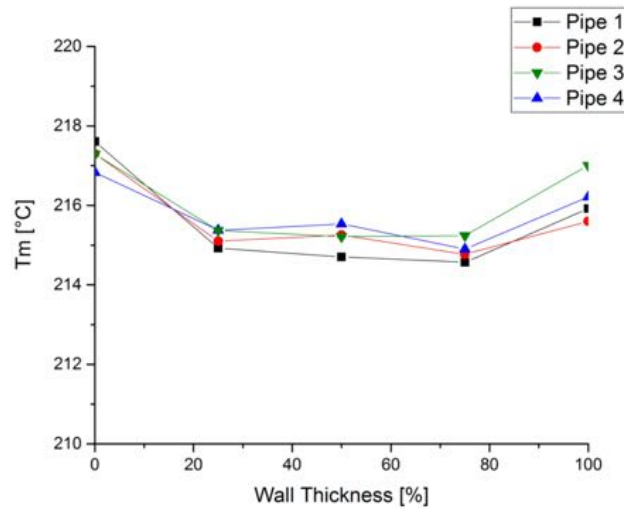
Figure 3.7: Melting temperatures

Figure 3.7 illustrates the behaviour of the melting temperature T_m of the liner material over the wall thickness of the liner. It can be seen that the melting temperature on the inside (measuring point A) of the pipe is approximately at a value of $T_m=217^\circ\text{C}$. At the three inner measuring points (B, C, D) the temperature of melting is sinking to $T_m=215^\circ\text{C}$. On the outside (E) it is $T_m=217^\circ\text{C}$ again.

This confirms that the liner of the RTP consists of PA6. Dominghaus [9] gives a melting temperature for PA6 of $T_m=220^\circ\text{C}$ which correlates quite well to the values of the DSC analysis. The difference in the melting temperature of the inside and the outside of the liner can be either caused by the various crystalline structures of PA6. This is the α - and γ - phase and the amorphous δ - phase. Another possibility are the diverse reactions of the PA6 to the environmental conditions. It is evident that the two outer layers (A, E) are forming a significant second melting peak as shown in figure 3.8. The inner layers also show this kind of behaviour but not so obviously. This second peak does not only appear at pipe 2, but at all other 3 pipes.

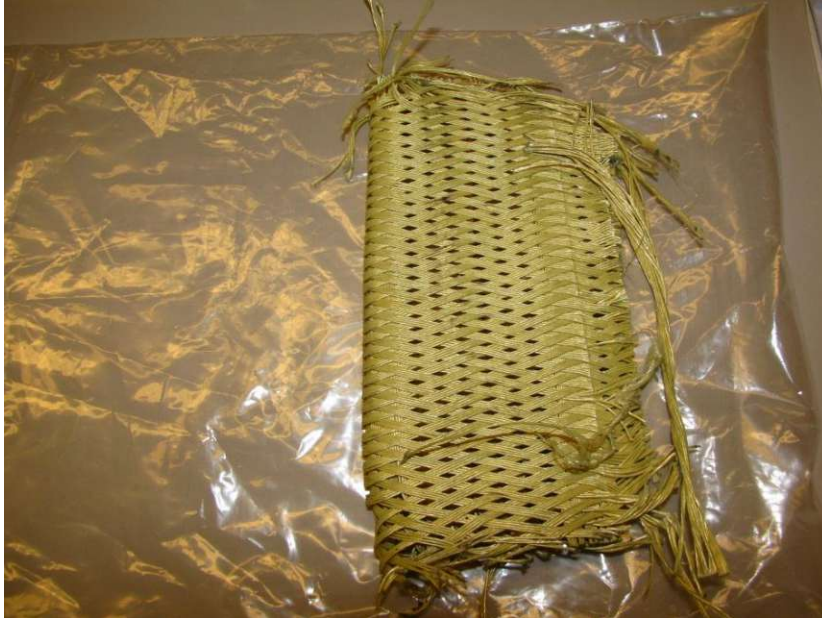
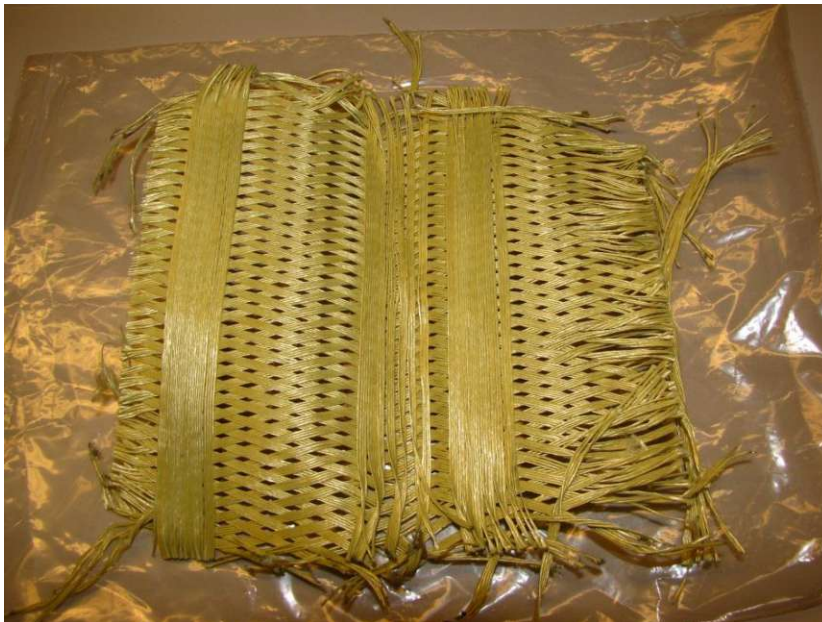
1: Braided hose sample

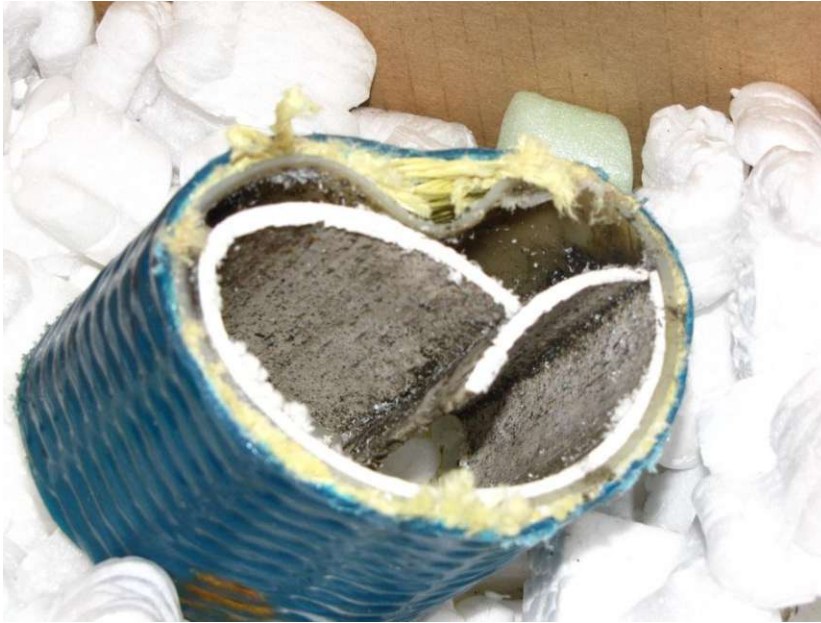
2: Field tested pipe sample after 18 months

Note: The pipe collapsed at the end of the test. The internal fluid was removed from the pipe section to be examined however it was still under external hydrostatic pressure. As a result the liner collapsed. In spite of this the braid residual strength seems to not be effected.
