DISSERTATION

SUSTAINABLE ARCHITECTURE OF FORTIFIED DWELLINGS IN THE BALKANS

KALTRINA THAÇI, MSc

Vienna, 2022

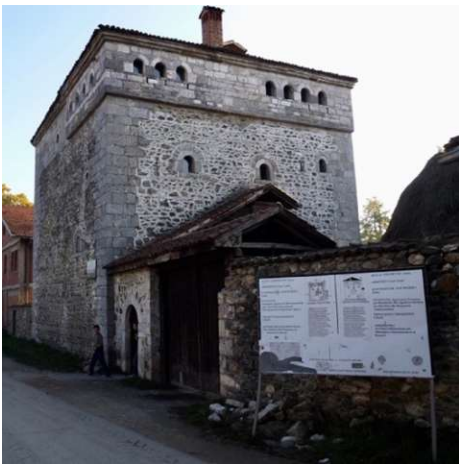
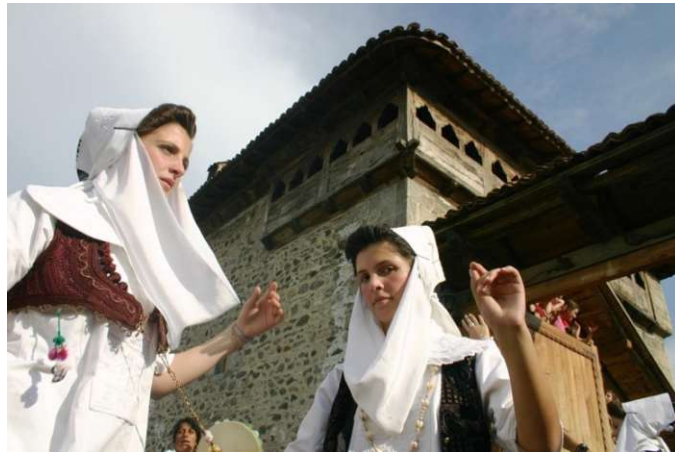
Fig. 5 Left: Kulla of Osdautaj, Isniq (Peter Moore)

- The stone gallery extends in the whole front façade of the highest floor, but also partially in one cross façade;
- The stone gallery extends on the front side of the upper floor;
- Sub-variant of the kulla which has no stone gallery at all;
- The most characteristic sub-variant of the real Albanian kulla is the one with stone gallery in the corner of the two perimeter walls.⁵²

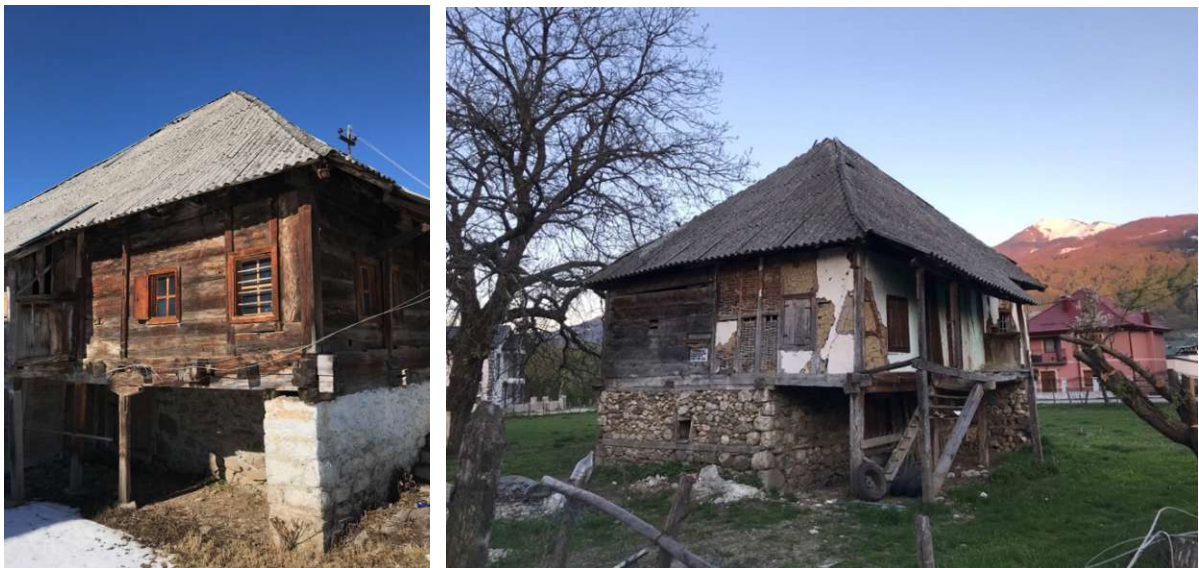
Houses with stone ground floor and timber upper floor- These houses are mainly located in the urban center of Gucia. They are characterized as low, simple buildings with square layout. The first floor is constructed by timber and horizontal timber boards in the facades, whereas the ground floor is constructed by hewn stones, which serve as a strong and durable foundation. There are cases when the upper floor protrudes beyond the planimetric contours of the ground floor, which creates a small porch below it. In some cases, we encounter some houses with timber construction, connected with straws and mortar. In this typology of houses, the timber staircase is placed outside. These constructions are covered by a hipped roof.⁵⁷

Fig. 9 Left and right: Houses with stone ground floor and timber upper floor (Labeatët, 2021)

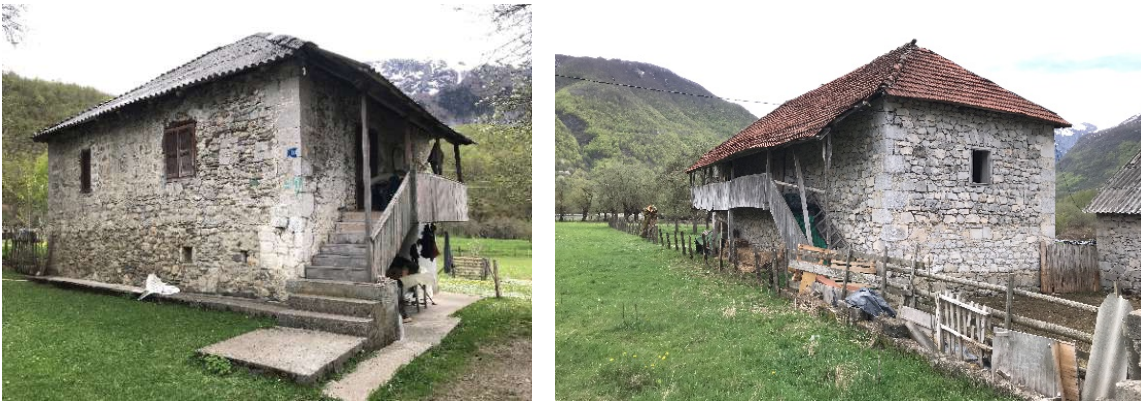
Stone houses- These houses are found more in rural areas than in urban ones. The houses have a rectangular floor plan and are built of stone, which is the main constructive material of the whole building. They are covered with a hipped roof. Stairs extend from the side of the longitudinal façade and cover almost the entire façade. There are many such constructions, that differ in shape and size. They can be found in Plava and Guci, but especially in the village of Vuthaj. Some of these buildings have “krevet”, windows and shutters painted in blue.⁵⁸

Fig. 10 Left and right: Stone houses in Vuthaj (Labeatët, 2021)

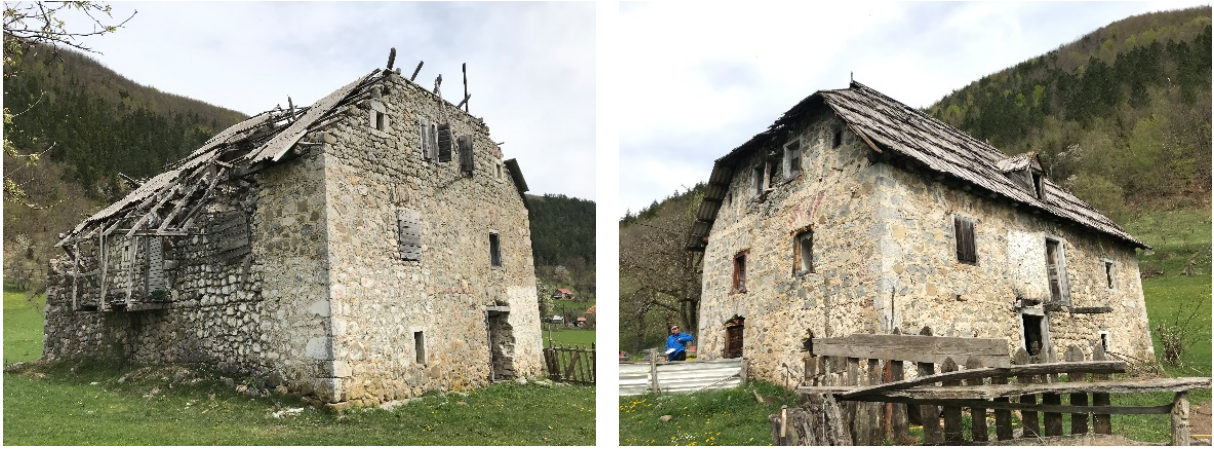
Fig. 11 Left and right: Mountain Kulla in Dol, Guci (Labeatët, 2021)

Mountain kullas- As defined by the name these constructions are built in mountainous areas. They are special constructions that stand out in terms of shape, volume, and especially in terms of their characteristic roof. The roof of these kulla is well adapted to the atmospheric conditions of mountainous areas, which is shaped in such a way as to remove snow efficiently. The hipped roof consists of two longitudinal slopes with large surfaces, while, above the cross facades the roof consists of two smaller sloping surfaces. Mostly, these kullas consist of three floors. The ground floor, as always, was used as a barn, whereas the upper floors were used by family members.⁵⁹ These buildings are usually used by two families, and are usually characterized by two separate entrances: either on opposite sides of the facades, or on two facades next to each other. These constructions are characterized by “krevet” which stands out as an integral and defining part of the main facade. This typology of kullas is usually found in the suburbs of Plava, Gucia, the suburbs of Valbona and Theth.⁶⁰

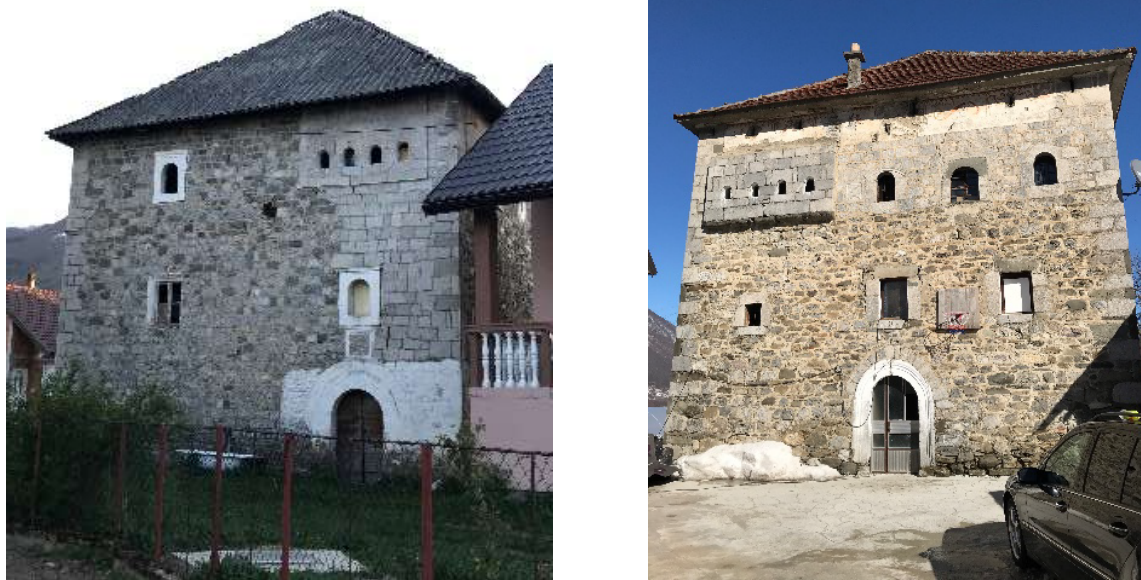
Fig. 13 Left: Kulla with stone gallery in Guci, right: Kulla with stone gallery in Vishnjeve, Guci (Labeatët, 2021)

the openings of kullas, as well as the longitudinal shooting holes in the highest part of the floor, respectively under the roof canopy. The gallery, is also an inseparable part of the structure, which appears in timber rather than in stone. The gallery is placed in various locations of kullas (always on the top floor), flat on one façade, flat on the corner of the building, protruding in one of the facades, and protruding on the corner of the building.⁶¹

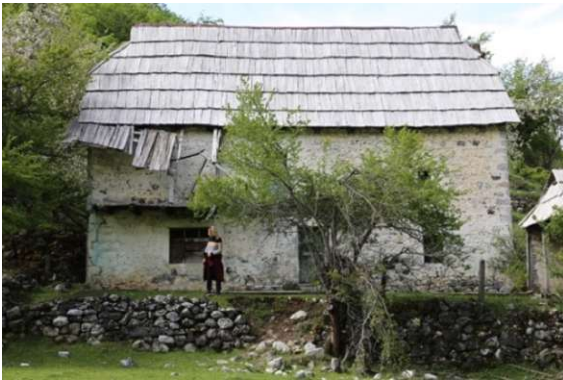
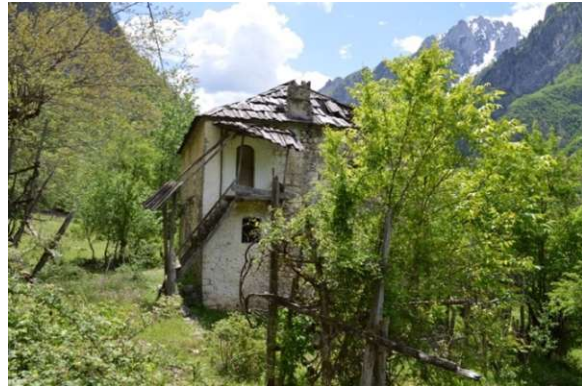
Fig. 15 Left: Rectangular dwelling, Valbona, right: Square kulla, Valbona, 2021

Square shaped dwelling- These types of kulla are the earliest and can be found in every province. They belonged mainly to the first of the area because they were limited at the floor plan but were high in verticality. The square shape in most cases is 2 to 3 stories high with a hipped or pitched roof covered by pine boards, called “*furde*”. Floor height does not reach more than 2.2m-2.6 m. Generally, when it was 3 story or more, it belonged to a wealthy family.

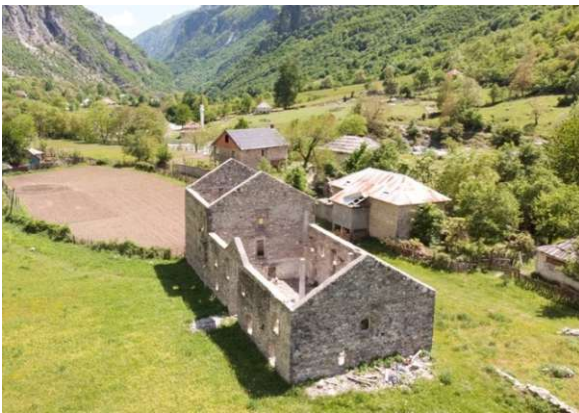
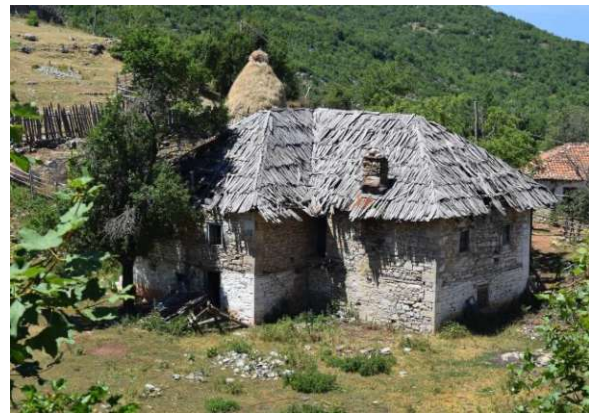
Fig. 16 Left: Semi-detached kulla in Valbona (By author, 2021), right: T-shaped kulla in Has (Go2 Albania, 2020)

T-shaped dwelling- This typology is quite seldom, usually found in Dukagjini and Malësi e Madhe.

Attached dwelling- Consisting of 2-3-4-5 kullas connected in a row mainly for the whole tribe. This typology is found more in Dibër and Mat.⁶³

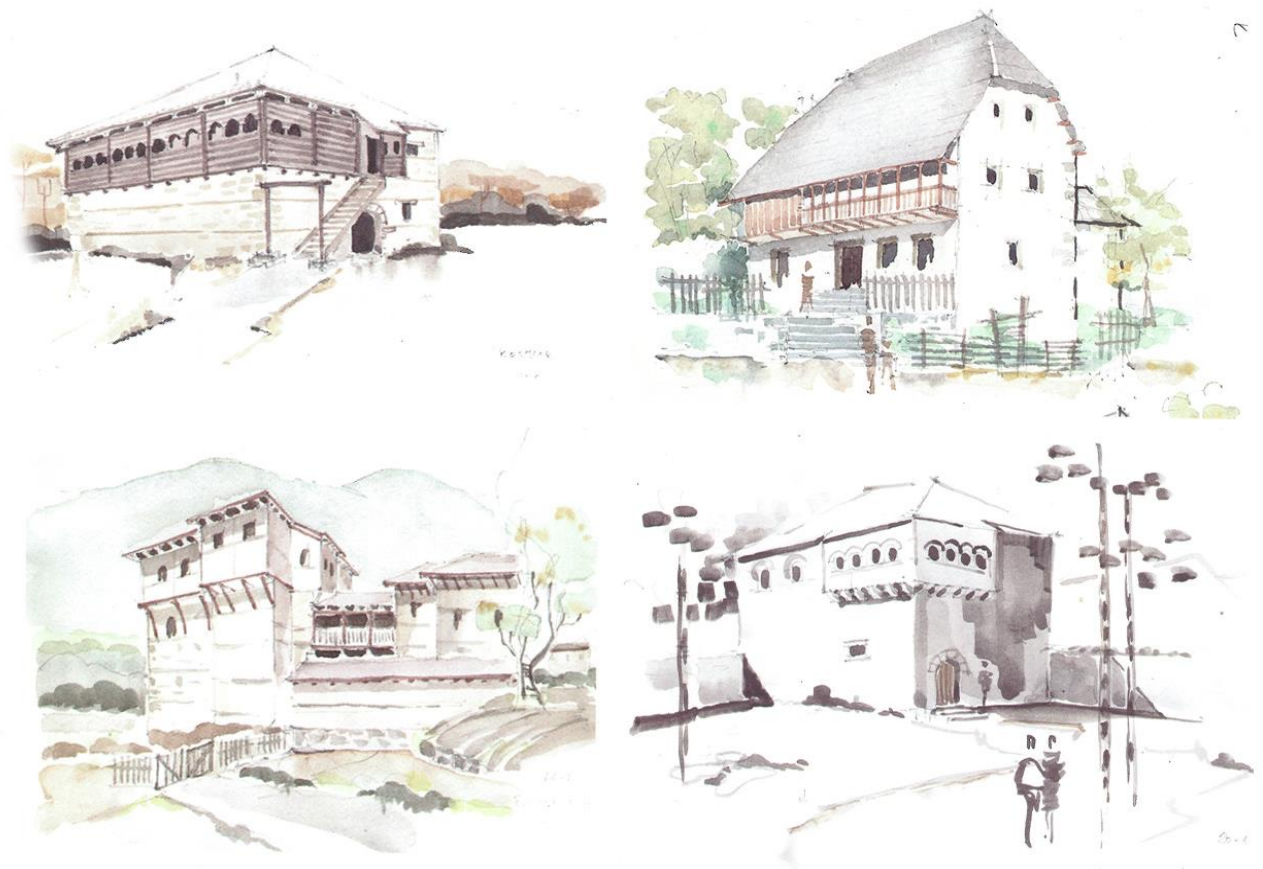
Fig. 17 Façade elements of kulla-banesa in Albania (Maksim Mitrojorgji and Joli Mitrojorgji, 2013, Forma, Permbajtja dhe Arkitektura: Udhetim ne banesen popullore Shqiptare)

The other categorization of kulla into sub typologies is according to the facade elements.

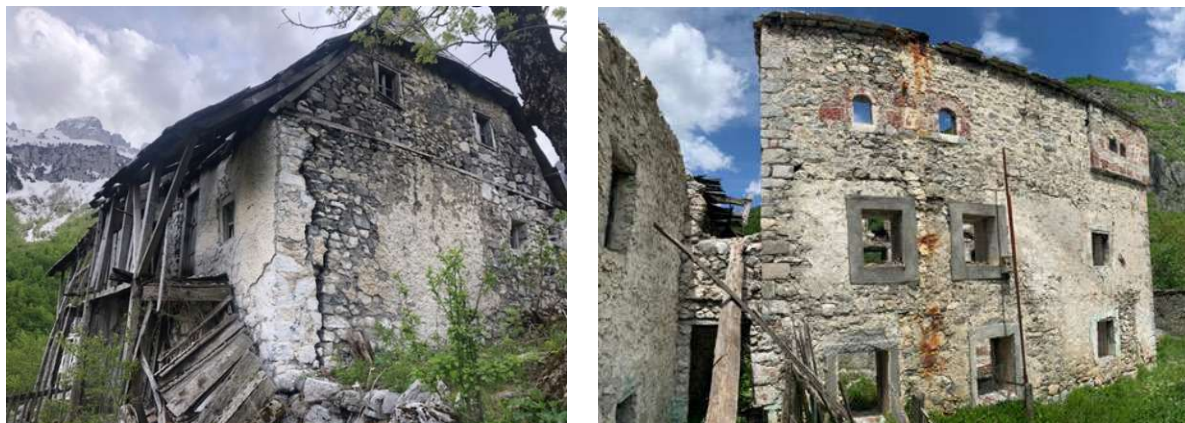
Fig. 18 Left: Kulla with krevet in Valbona, right: Kulla with çikma in Valbona, 2021

Kulla with krevet- *Krevet* or *shameshi* as the Kelmendi area calls it, is a wooden architectural element, placed on the façade, that served as the main entrance to kulla when the ground floor was used as a barn. It was placed mainly on the front facade, but also on the side ones and had mainly a function of entering the building, but it also served as a storage place for food. Usually, krevet is encountered in one story, but seldom there are cases where it is found it two stories. The width reaches 1m-1.5m and is generally built entirely of wood, but in cases where stairs are exposed to rain, it is constructed by stones.⁶⁴

on all sides of the wall and is constructed by carved stone tiles. In its front are placed two carved windows, whereas in various points are placed *frëngji*.⁶⁵

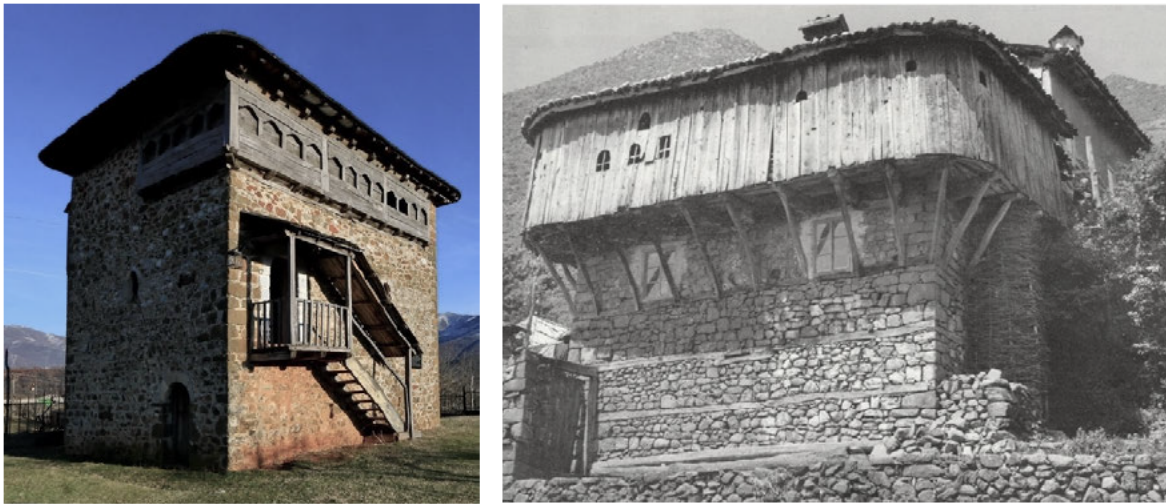
Fig. 19 Left: Kulla with dyshekllek (Irir Seci, 2018), right: Kulla with teliz in Dibra (Go2 Albania, 2021)

Kulla with *divanhane* (closed *dyshekllek*)- *divanhane* is a wide corridor in the upper floor of *kulla*, which serves as an entering hall to the *oda e burrave*. This element is placed in three facades of *kulla*, is made out of timber and is extruded about 20-25 cm from the structure. It has a dozen of windows, closed with timber covers. There are also cases where this element is built out of stones.⁶⁶

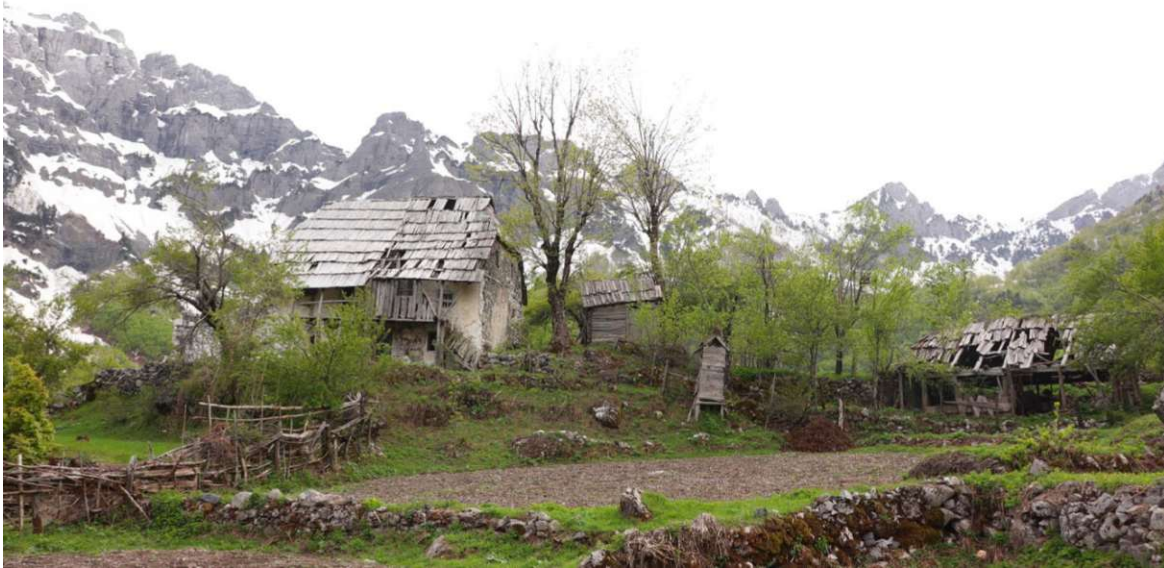
Fig. 20 The setting of kulla in Valbona, 2021

Nivokaz as there are neighborhoods.⁷⁰ The same case is in the villages of North Albania and Plavë and Guci. During the field research in Valbona, it was found out that kullas were also clustered according to family neighborhoods.

The layouts of these clusters (Alb. *mahalla*) have evolved around the first built Kulla, which is always dominant. Within a cluster, kullas are customarily placed along the main street – sharing one sidewall with the main surrounding wall of the cluster, which stretches out the entire street axis. In this context, the interaction and coordination of the overall defensive system of the cluster is achieved in terms of orientation of the two sides of Kulla with most loopholes, towards the center of the settlement.⁷¹ Thus, indicating that within such macro-defensive system of one cluster, Kullas as singular defensive units having been structurally interlinked together, create a strong fortifying wall, which protects the most vulnerable parts of the neighborhood.

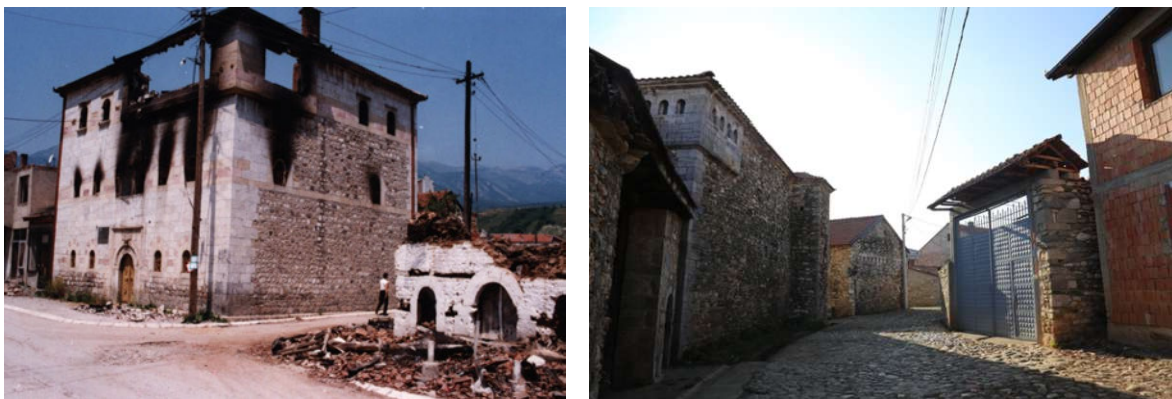
Fig. 31 Left: Kulla of Haxhi Zeka in Peja, burnt during the war (Department of Culture, JIAS-UNMIK Kosovo, 2000), Right: New developments in Mazrekaj neighborhood, Dranoc, (By author, 2021)

Kosovo became a victim of the war with Serbia during 1998- 1999. More than the war, it was an ethnic cleansing where thousands of people were killed, and millions were driven from home. Along with the people, Kosovo's cultural heritage was heavily damaged. Despite historical monuments and urban centres, traditional residential architecture that existed in the urban and rural areas was also targeted.¹⁴⁷ The aftermath of the Kosovo War, in 1999, presented a scenario of extensive destruction to its built cultural heritage, resulting in a vulnerable condition of Kullas. During the Mapping of Cultural Heritage in Kosovo project, conducted by CHwB Kosovo during 2016-2017, the field research indicated that out of 160 designated kullas, 10 of them are in a very bad condition, 19 are partially ruined and 9 are completely ruined. Nowadays, kullas are also affected by various transformations from owners, resulting in the loss of authenticity and integrity.

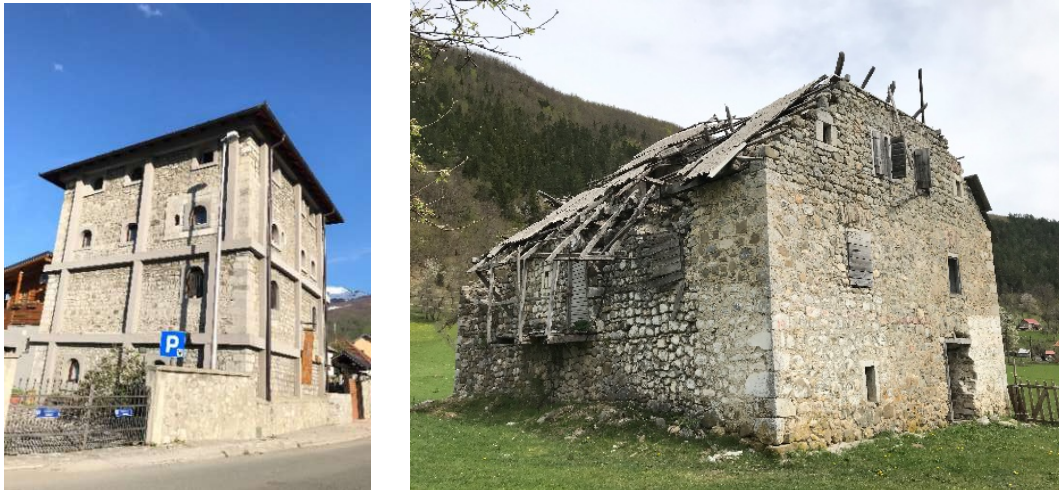
authenticity and integrity of kullas, such as the insertion of concrete columns and beams, new balconies, canopies, entrances, new constructions, often with new (not compatible) materials, and in other cases with same materials (which changes the authenticity of the building). The worst risk for kullas is their physical condition, presented by deformations, constructive cracks, wall deterioration, presence of moisture- usually by the lack of maintenance and conservation. In some cases, kullas are also destroyed by their owners, when their condition poses risk for the family members.

Fig. 32 Left: Inadequate interventions in kulla, right: Damaged kulla, Guci (Labeatët, 2021)

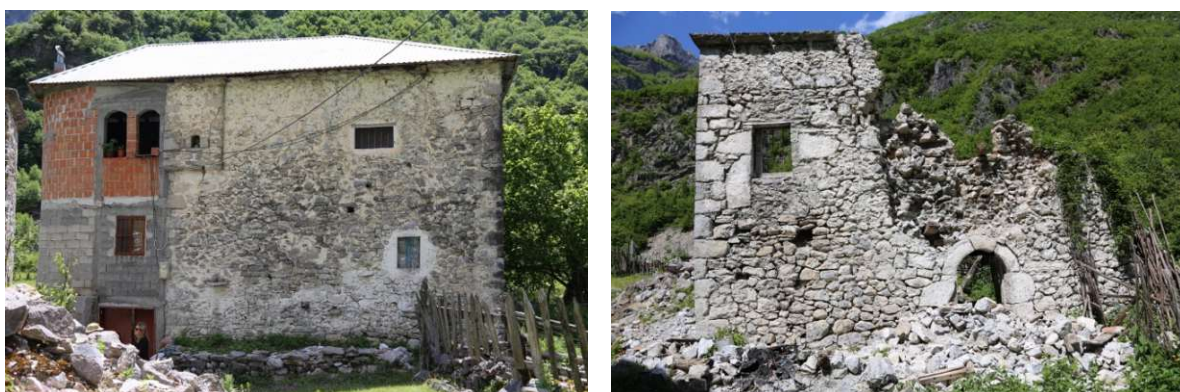
In Albania, another action, so called sanitization¹⁴⁹, aimed to remove the cattle from the ground floor of kullas and build new small stables instead. This change of function, had also contributed to the transformation of the architecture of kullas. With the change of political system in 1992, the North-Northeast Region of Albania was completely forgotten. The new state began to slowly abandon its citizens even in urban centers, which led to the acceleration of the degradation of health care, education, electricity, water, transport, etc.¹⁵⁰ Forced by these conditions, a part of the inhabitants emigrated abroad, while the rest migrated towards the cities, leaving carelessly the properties and especially their dwellings in the mountains. The degradation of kullas is an ongoing process. Those that were not destroyed, are prey to lack of maintenance, institutional protection and improper interventions, especially in the roofs, by removing the original timber layer and putting aluminum sheets instead.

Fig. 33 Left: Inadequate interventions in kulla, right: Damaged kulla, Valbona, 2021

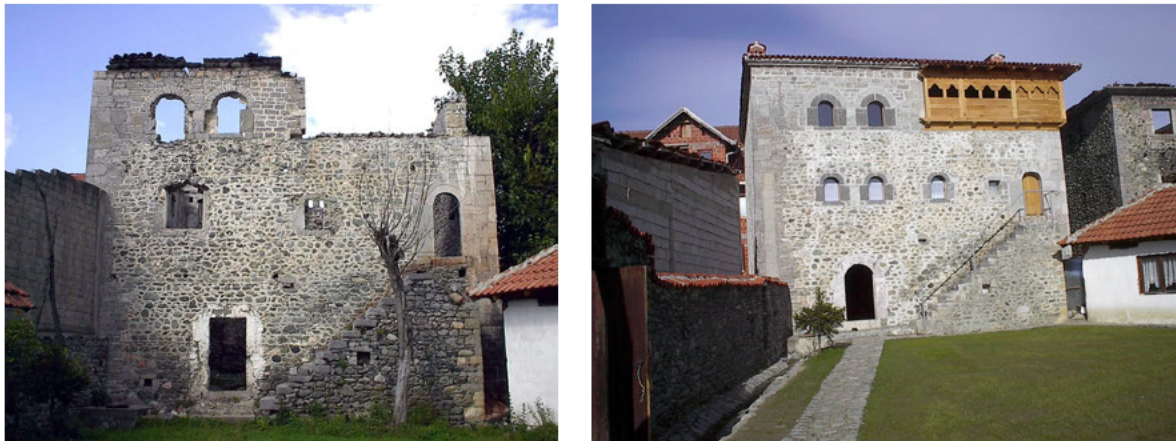
Fig. 35 Reconstruction and adaptive reuse of the Kulla Oda e Junikut during 2001-2002 as a library; Left: before intervention (CHwB Kosova, 2001), right: after intervention (CHwB Kosova, 2019)

Since 2001, CHwB Kosova enforces the conservation and adaptive reuse of several *kullas* in the Dukagjini Plain. The latest such project was the *kulla* of Isuf Mazrekaj in autumn 2017, which focused on analyzing the challenges of adaptive reuse in the local context. Professionals and students of different fields along with the community gathered, analyzed and proposed interventions. The resourceful group worked for twelve days at site and adapted the *kulla* into the guesthouse. The intervention focus lay on the improvement of the environmental performance of the *kulla* including the adaptation of its interior and yard, and the introduction of the concept of slow food and storytelling. Despite these preservation initiatives, there is a lot of work among owners of these sites and other relevant stakeholders to understand the values of *kullas* and use the possibilities for income generation with further preservation and development of these historic buildings.

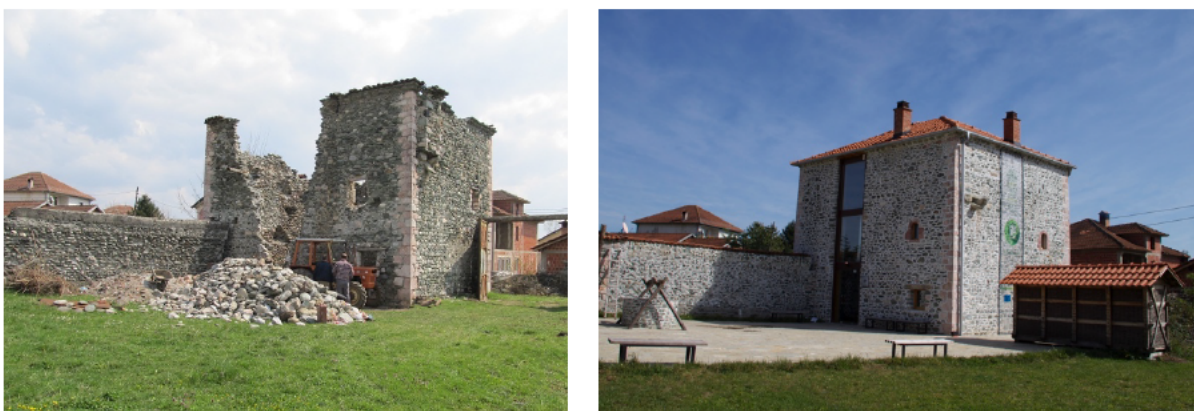
Fig. 36 Reconstruction and adaptive reuse of the Kulla Ruste Zeqiri, Junik as a Regional Tourism Center, during 2001-2002, Left: Kulla before (CHwB Kosova, 2001), right: Kulla after intervention (CHwB Kosova, 2016)

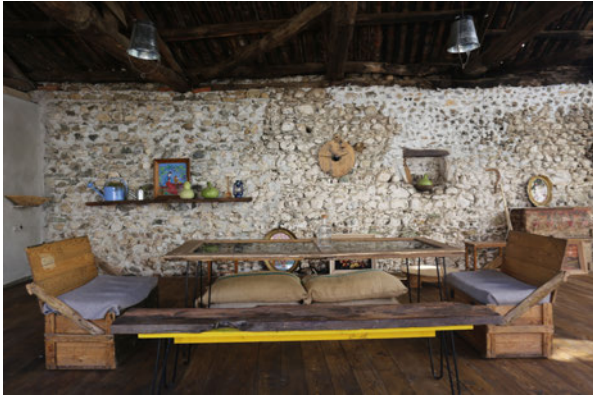
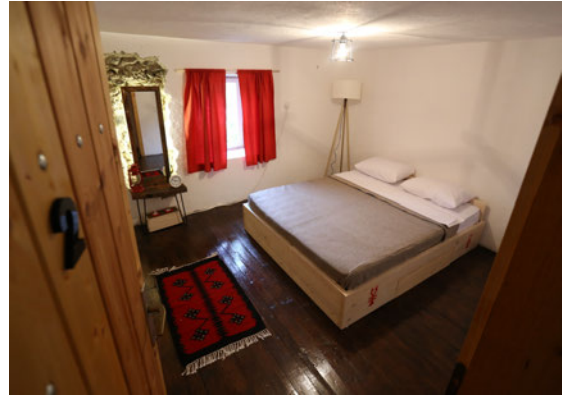
Fig. 37 Adaptive reuse of Kulla of Isuf Mazrekaj as Bed and Breakfast during 2017, part of CHwB Kosovo's Restoration Camp, 2020

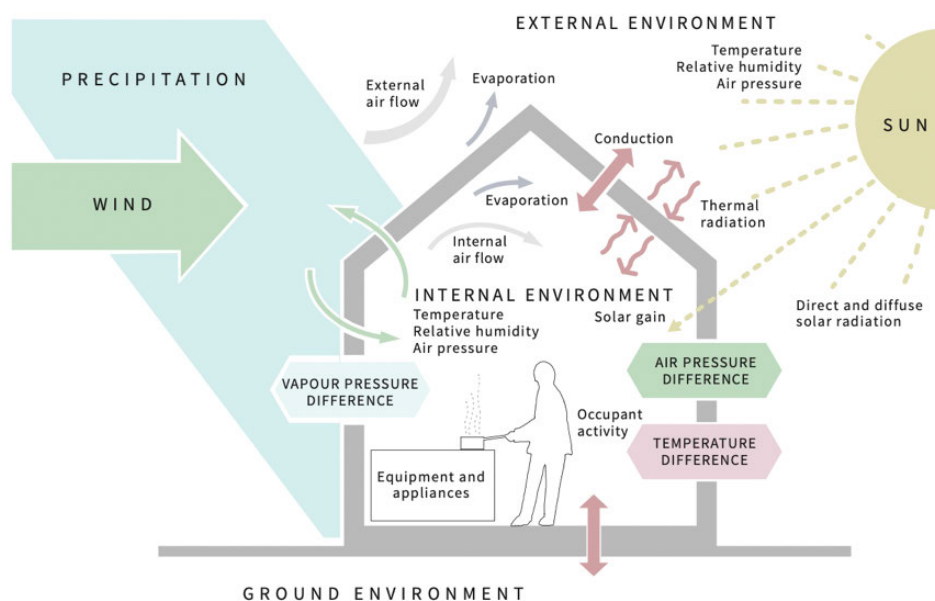
sources of heat intake and loss through radiation. Because heat and humidity are exchanged by air infiltration, the air tightness of the building has a considerable impact on climatic stability. The intrinsic stability supplied by the structure and contents has been completely depended upon in these structures. This is known as passive climate control, distinguished from active climate control, which necessitates the use of technology and energy.¹⁷⁵

Fig. 43 Interactions between the building envelope and the environment (Historic England, 2018, p.13)

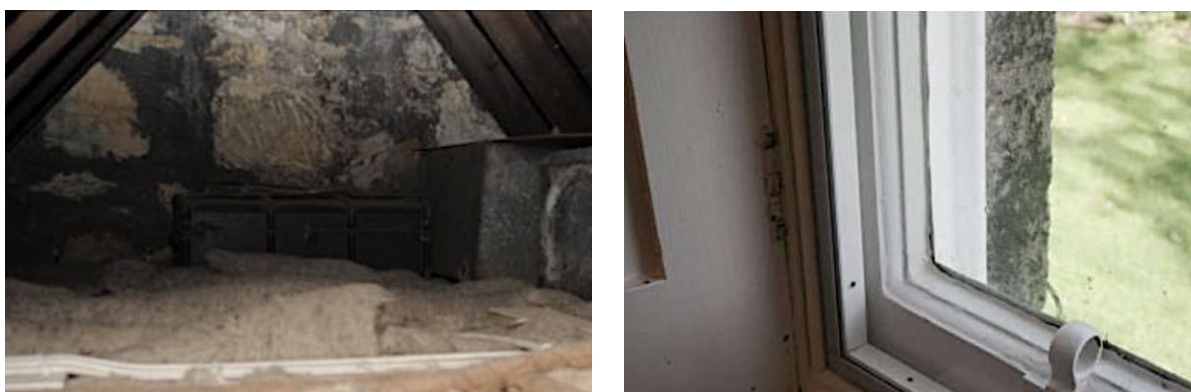
Fig. 51 Left: Sheep's wool insulation, right: Polycarbonate secondary glazing in place (Historic Scotland, 2012, p.9)

The existing windows had a traditional sash and case design and were in fine operating order. The cost of installing double glazed units into the existing sashes would have been considerable for such a little glazed space because the sashes were '6 over 6' (each sash had six panes). Because traditional secondary glazing would have been prohibitively expensive, an alternative polycarbonate system was used, which consists of a single sheet cut to size and adhered to the timber bearers within the staff beads with magnetic strips. While not up to the standards of more mainstream solutions, this glazing system allowed the shutters to function, addressed thermal heat losses and air leakage, and made a substantial impact. This intervention can be definitely applied to all case study kullas in the enlarged existing windows, but not in the original small ones.

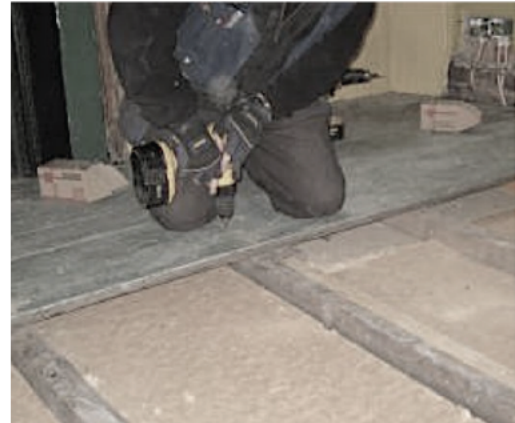
Fig. 52 Left: Detail of the floor insulation, right: Floor being fixed down over wood fibre bats (Historic Scotland, 2012, p.10-11)

Although the skirting boards were removed, the disruption was kept to a minimum by limiting the quantity of boards taken. Bats were carved from 80 mm thick proprietary wood fibreboard to fit between the joists. The bats were then put into the gap between the joists and secured with a fixed rail. After that, the floorboards were replaced. This intervention is not feasible in the case studies of kullas, since the floor is not in suspended in the first place. Moreover, the insulation of the floor of any kind is more feasible where the timber floor is damaged, so that the authenticity is not lost on purpose, but the floor improvement (and insulation) is needed.

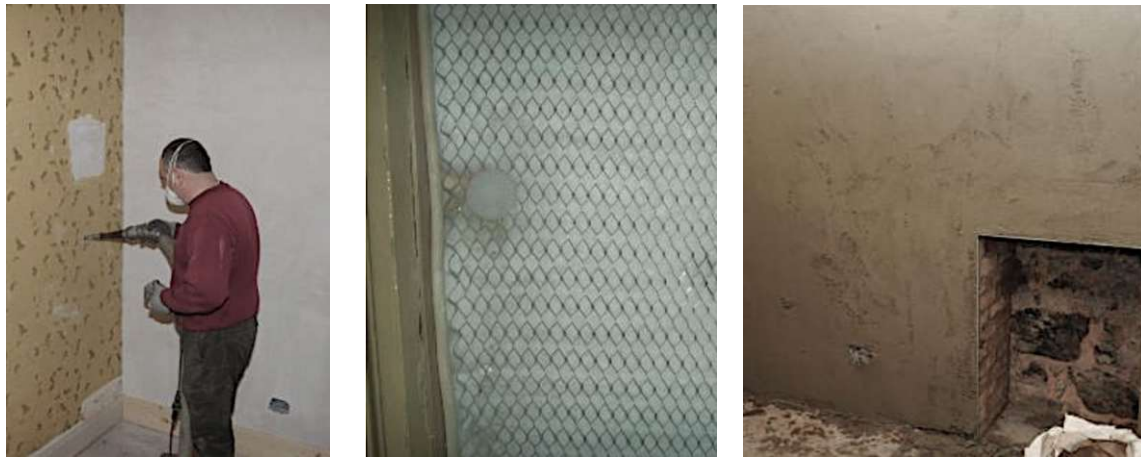
Fig. 53 Left: Blowing in the cellulose fiber, right: Aerogel blanket held behind mesh, right: First coat of plaster on top of the mesh/insulation layer (Historic Scotland, 2012, 13-14)

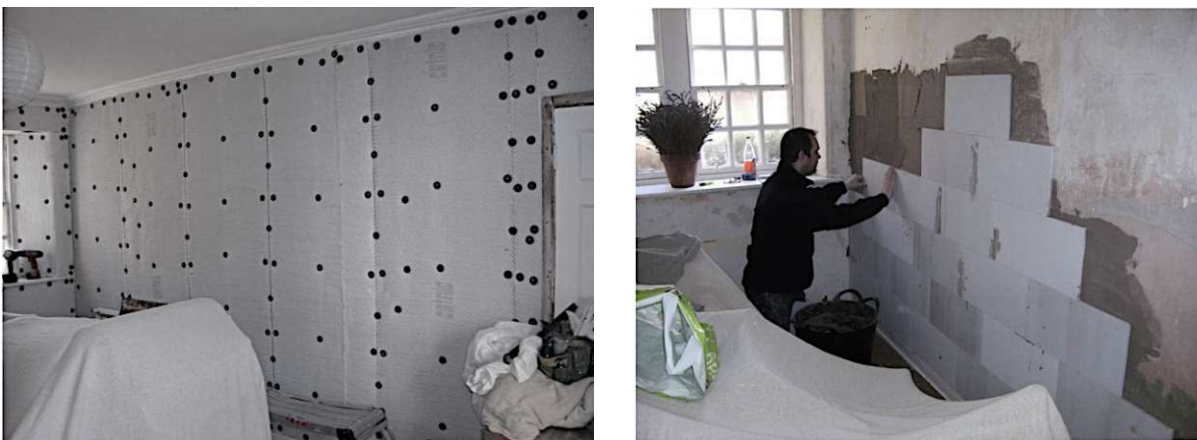
Fig. 56 Left: Aerogel insulation before applying the plaster finish, right: Calcium silicate board being applied to the masonry wall (Historic Scotland, 2012 b, p.5-10)

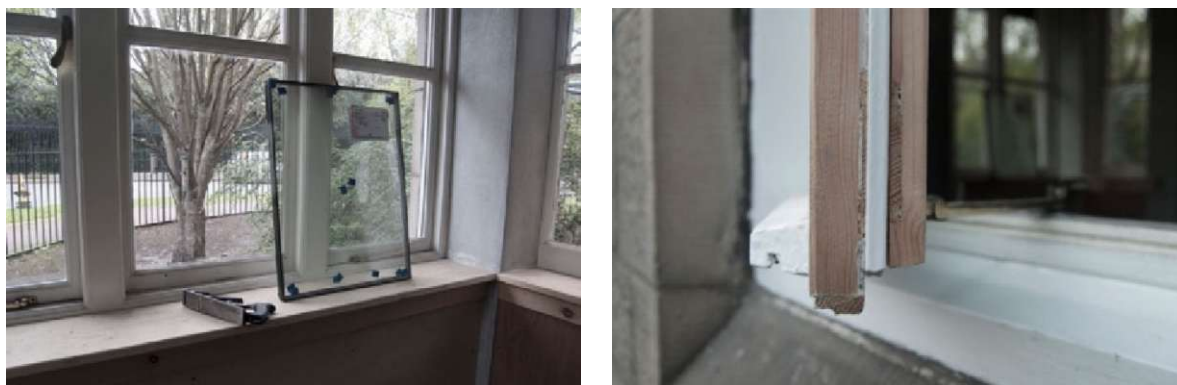
Fig. 59 Left: One of the double-glazed units before installation, right: Draught strips added to casements (Historic Building Energy Retrofit Atlas, 2019)

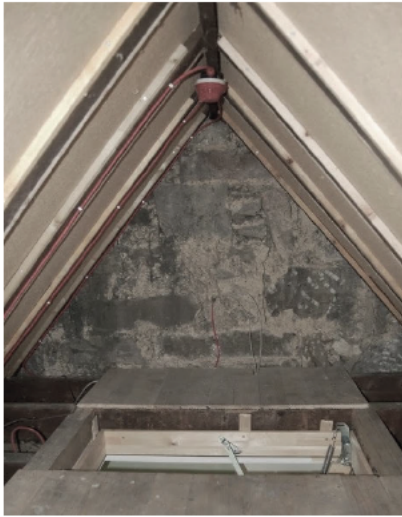
Fig. 60 Left: The warm roof with wood fiber between the rafters, right: The cold roof with wood fiber insulation between the rafters (Historic Building Energy Retrofit Atlas, 2019)

There were two roof areas in the lodge, separated by the chimney breast. Larger access hatches were installed in both attics to enable for safe working and visitation. This insulation was chosen since it buffers humidity in the roof areas and fits well with the project's natural material concept. The south facing gable of one of the roof spaces was equipped with wood fiber board fastened between the rafters to create a 'warm roof.' The other, west-facing attic, was fitted with wood fiber board between the ceiling joists, resulting in a 'cold roof.' This intervention is quite feasible for application in kullas in Kosovo, Albania and Montenegro, but first it has to be checked that wood fiber insulation is locally available, or in other case a rather more vernacular material can be used for insulation, such as hay.

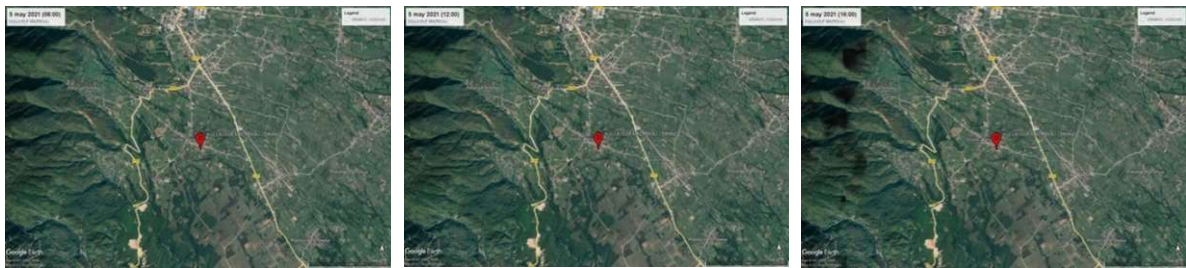
Fig. 65 Sun study of Dranoc on 5th of May 2021 (Location of Kulla of Isuf Mazrekaj in red pin), left: 08:00 o'clock, middle: 12:00 o'clock, right: 16:00 o'clock (pictures calculated from Google Earth, by the author)

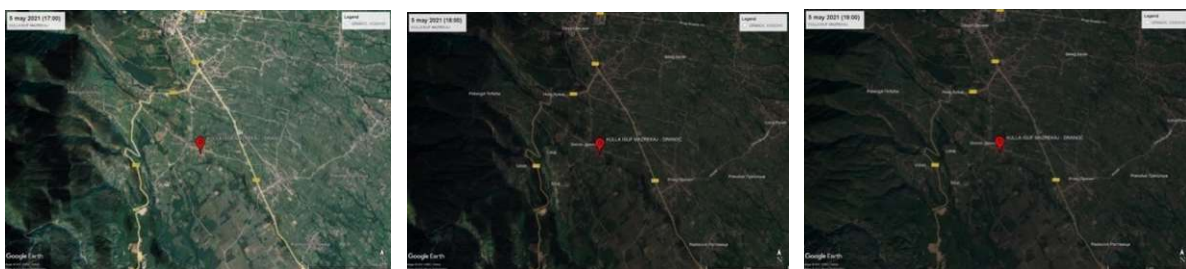
Fig. 66 Sun study of Dranoc on 5th of May 2021 (Location of Kulla of Isuf Mazrekaj in red pin), left: 17:00 o'clock, middle: 18:00 o'clock, right: 19:00 o'clock (pictures calculated from Google Earth, by the author)

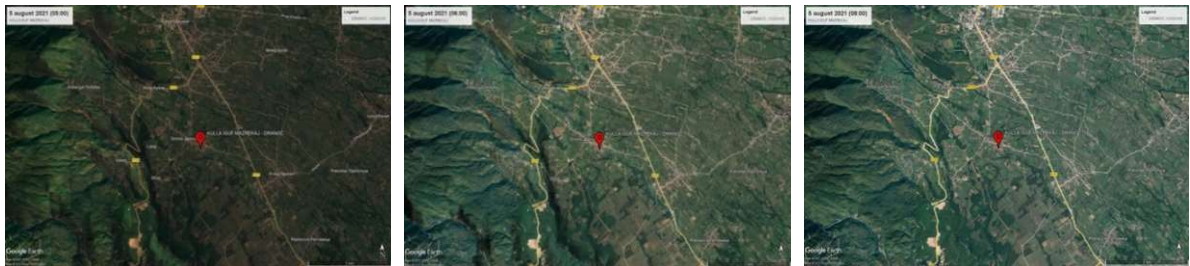
Fig. 70 Sun study of Dranoc on 5th of August 2021 (Location of Kulla of Isuf Mazrekaj in red pin), left: 05:00 o'clock, middle: 06:00 o'clock, right: 08:00 o'clock (pictures calculated from Google Earth- sun tool, by the author)

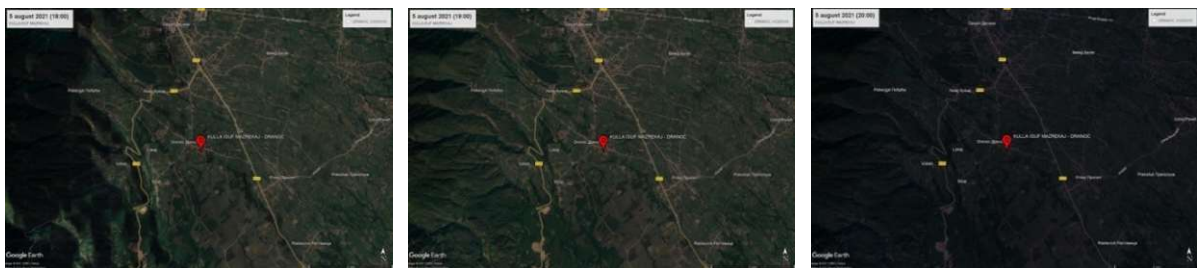
Fig. 72 Sun study of Dranoc on 5th of August 2021 (Location of Kulla of Isuf Mazrekaj in red pin), left: 18:00 o'clock, middle: 19:00 o'clock, right: 20:00 o'clock (pictures calculated from Google Earth- sun tool, by the author)

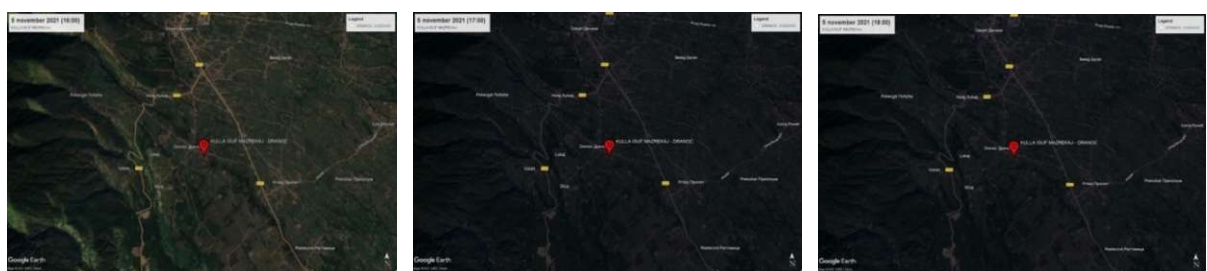
Fig. 78 Sun study of Dranoc on 5th of November 2021(Location of Kulla of Isuf Mazrekaj in red pin), left: 16:00 o'clock, middle: 17:00 o'clock, right: 18:00 o'clock (pictures calculated from Google Earth- sun tool, by the author)

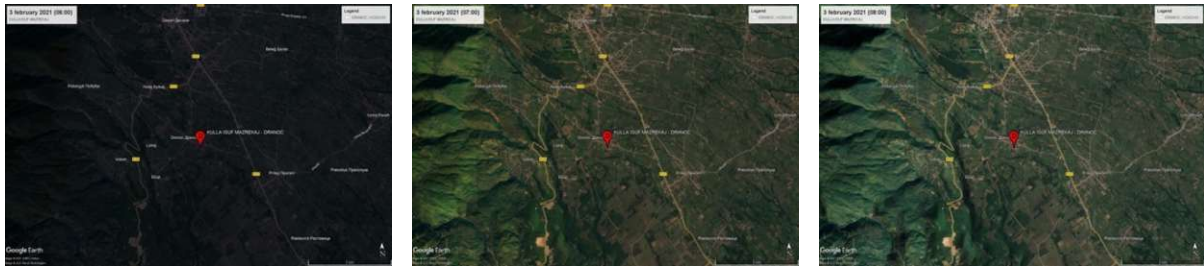
Fig. 82 Sun study of Dranoc on 3rd of February 2021 (Location of Kulla of Isuf Mazrekaj in red pin), left: 06:00 o'clock, middle: 07:00 o'clock, right: 08:00 o'clock (pictures calculated from Google Earth- sun tool, by the author)

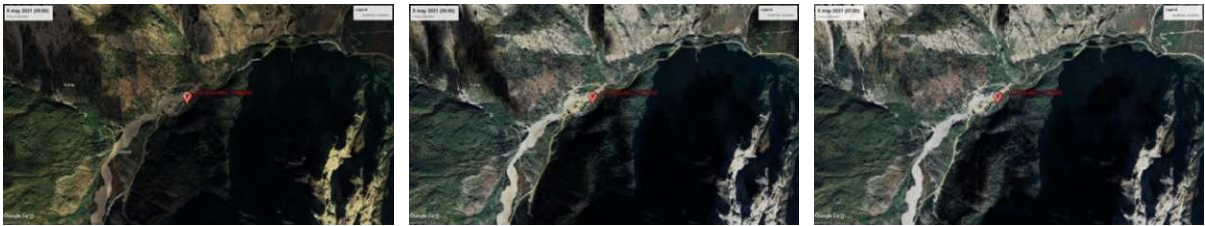
Fig. 90 Sun study of Valbona on 5th of May 2021(Location of Kulla of Selimaj family in red pin), left: 05:00 o'clock, middle: 06:00 o'clock, right: 07:00 o'clock (pictures calculated from Google Earth- sun tool, by the author)

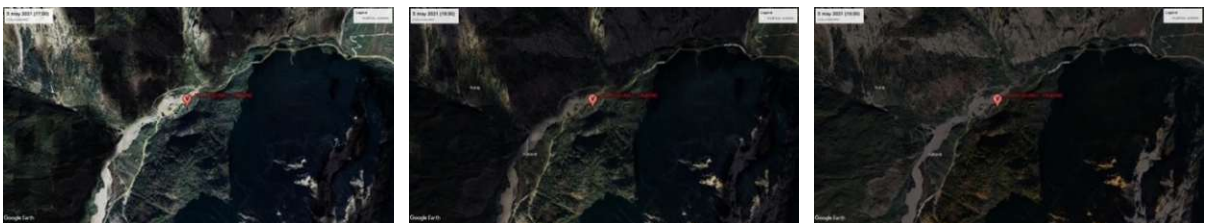
Fig. 92 Sun study of Valbona on 5th of May 2021(Location of Kulla of Selimaj family in red pin), left: 17:00 o'clock, middle: 18:00 o'clock, right: 19:00 o'clock (pictures calculated from Google Earth- sun tool, by the author)

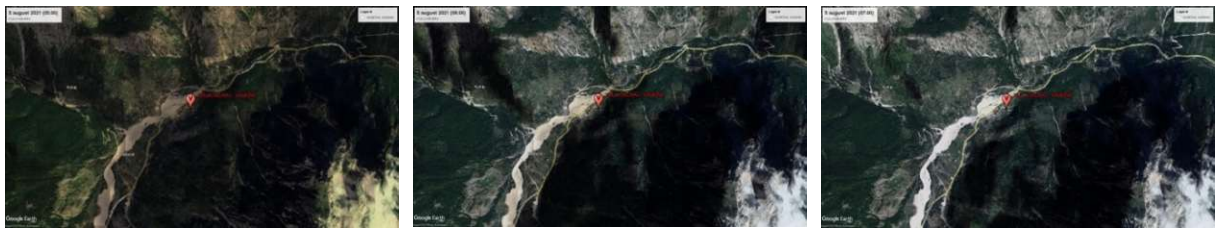
Fig. 96 Sun study of Valbona on 5th of August 2021 (Location of Kulla of Selimaj family in red pin), left: 05:00 o'clock, middle: 06:00 o'clock, right: 08:00 o'clock (pictures calculated from Google Earth- sun tool, by the author)

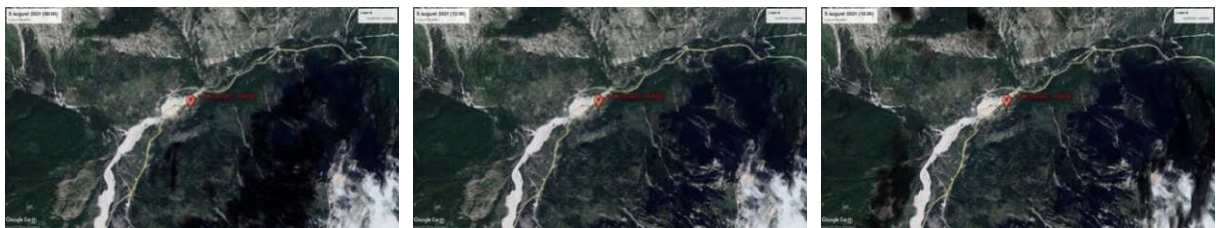
Fig. 97 Sun study of Valbona on 5th of August 2021 (Location of Kulla of Selimaj family in red pin), left: 08:00 o'clock, middle: 12:00 o'clock, right: 16:00 o'clock (pictures calculated from Google Earth- sun tool, by the author)

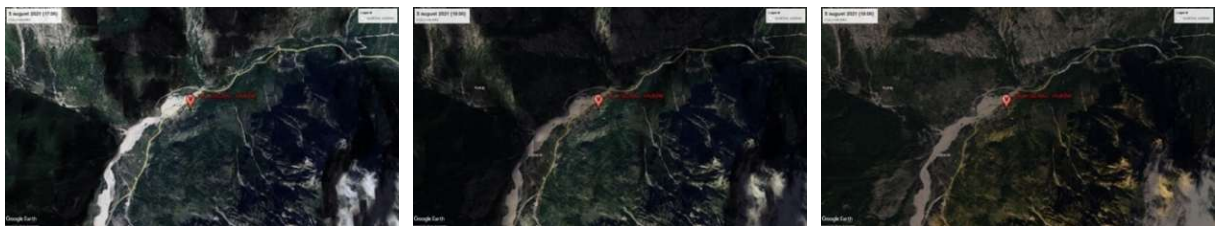
Fig. 98 Sun study of Valbona on 5th of August 2021 (Location of Kulla of Selimaj family in red pin), left: 17:00 o'clock, middle: 18:00 o'clock, right: 19:00 o'clock (pictures calculated from Google Earth- sun tool, by the author)

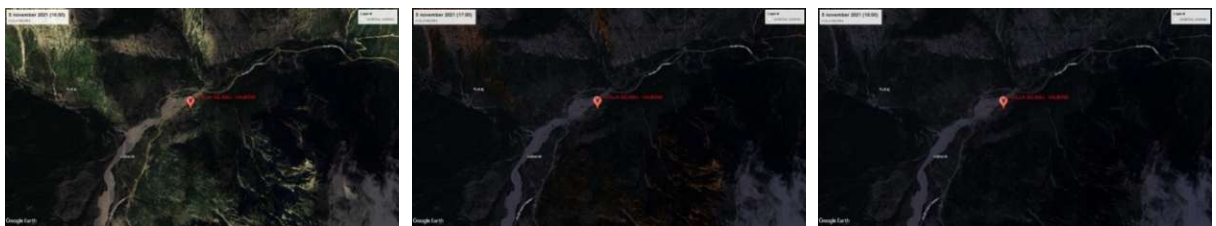
Fig. 104 Sun study of Valbona on 5th of November 2021 (Location of Kulla of Selimaj family in red pin), left: 16:00 o'clock, middle: 17:00 o'clock, right: 18:00 o'clock (pictures calculated from Google Earth- sun tool, by the author)

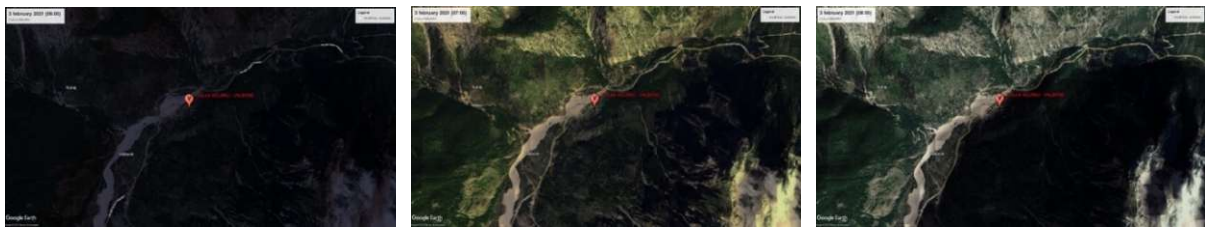
Fig. 108 Sun study of Valbona on 3rd of February 2021 (Location of Kulla of Selimaj family in red pin), left: 06:00 o'clock, middle: 07:00 o'clock, right: 08:00 o'clock (pictures calculated from Google Earth- sun tool, by the author)

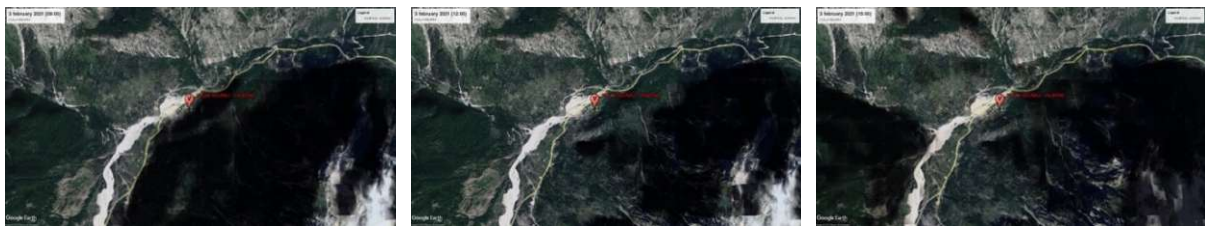
Fig. 109 Sun study of Valbona on 3rd of February 2021 (Location of Kulla of Selimaj family in red pin), left: 09:00 o'clock, middle: 12:00 o'clock, right: 17:00 o'clock (pictures calculated from Google Earth- sun tool, by the author)

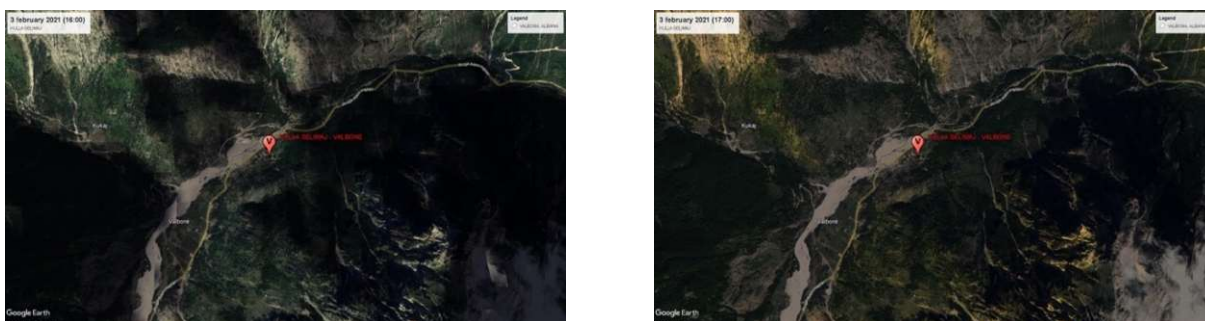
Fig. 110 Sun study of Valbona on 3rd of February 2021 (Location of Kulla of Selimaj family in red pin), left: 16:00 o'clock, right: 17:00 o'clock (pictures calculated from Google Earth- sun tool, by the author)

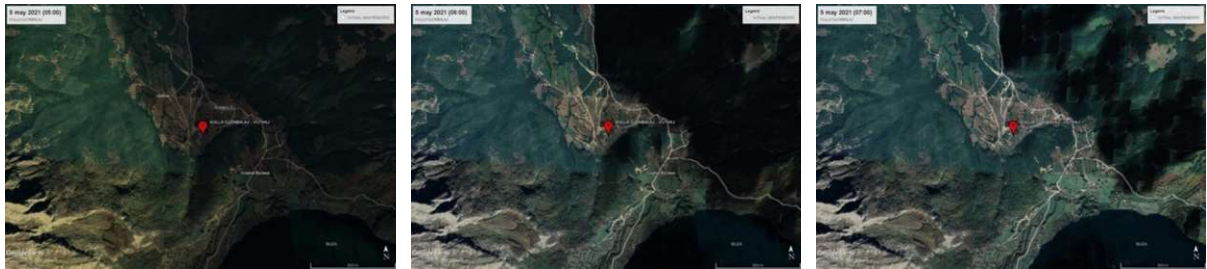
Fig. 116 Sun study of Vuthaj on 5th of May 2021 (Location of Kulla of Deli Gjonbalaj in red pin), left: 05:00 o'clock, middle: 06:00 o'clock, right: 07:00 o'clock (pictures calculated from Google Earth- sun tool, by the author)
