DISSERTATION

SUSTAINABLE ARCHITECTURE OF FORTIFIED DWELLINGS IN THE BALKANS

KALTRINA THAÇI, MSc

Vienna, 2022

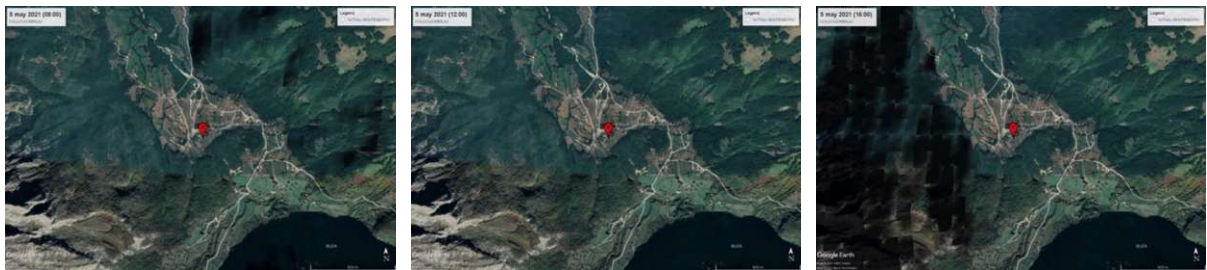
Fig. 117 Sun study of Vuthaj on 5th of May 2021 (Location of Kulla of Deli Gjonbalaj in red pin), left: 08:00 o'clock, middle: 12:00 o'clock, right: 16:00 o'clock (pictures calculated from Google Earth- sun tool, by the author)

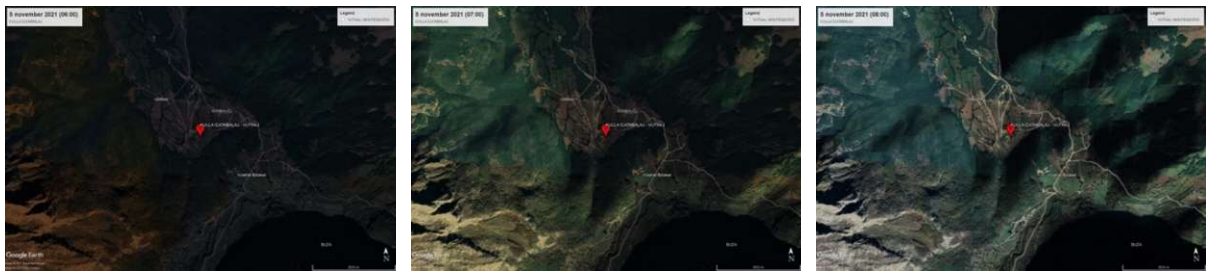
Fig. 128 Sun study of Vuthaj on 5th of November 2021 (Location of Kulla of Deli Gjonbalaj in red pin), left: 06:00 o'clock, middle: 07:00 o'clock, right: 08:00 o'clock (pictures calculated from Google Earth- sun tool, by the author)

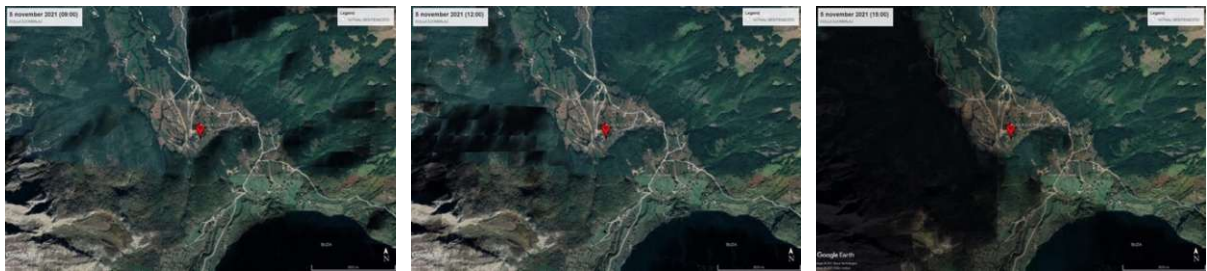
Fig. 129 Sun study of Vuthaj on 5th of November 2021 (Location of Kulla of Deli Gjonbalaj in red pin), left: 09:00 o'clock, middle: 12:00 o'clock, right: 15:00 o'clock (pictures calculated from Google Earth- sun tool, by the author)

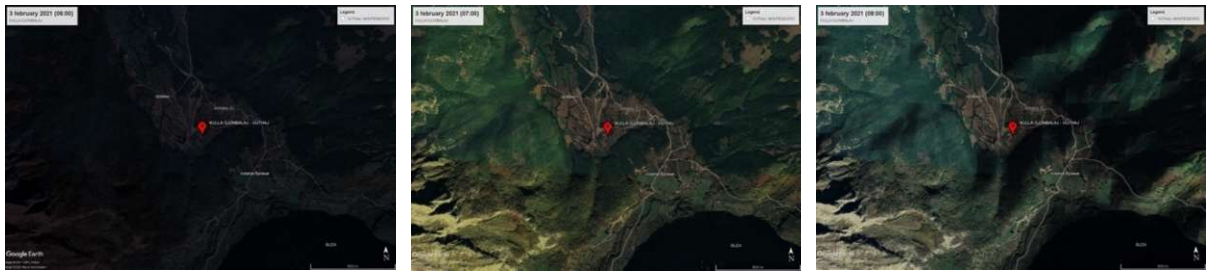
Fig. 134 Sun study of Vuthaj on 3rd of February 2021 (Location of Kulla of Deli Gjonbalaj in red pin), left: 06:00 o'clock, middle: 07:00 o'clock, right: 08:00 o'clock (pictures calculated from Google Earth- sun tool, by the author)

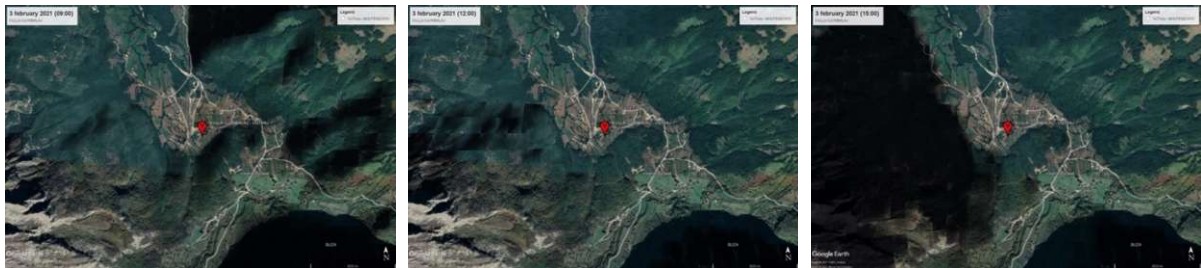
Fig. 135 Sun study of Vuthaj on 3rd of February 2021 (Location of Kulla of Deli Gjonbalaj in red pin), left: 09:00 o'clock, middle: 12:00 o'clock, right: 15:00 o'clock (pictures calculated from Google Earth- sun tool, by the author)

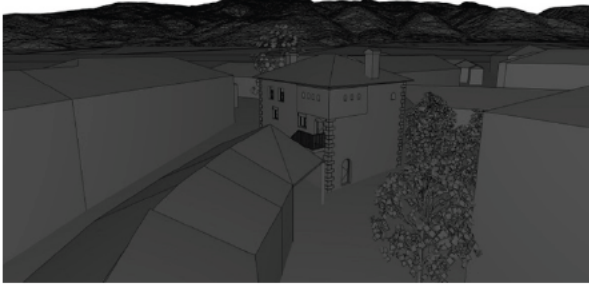
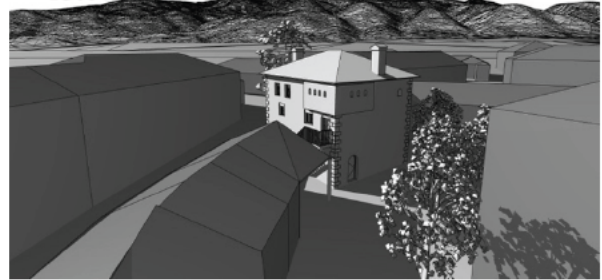
Fig. 143 Sun study of Kulla's context on the 3rd of February 2021, every hour from 06:00 until 17:00 o'clock

The sun study of the setting of Kulla during mid-Autumn, shows that the building is shadowed from sunrise until sometime after 07:00 o'clock and then from 15:00 o'clock onwards. Even during this time interval, the north-east façade is shadowed from the surrounding buildings and landscape most of the time, basically it is under sunlight only for 2 hours. So, during 3rd of February 2021, Kulla is partially under sunlight for about 8 hours.

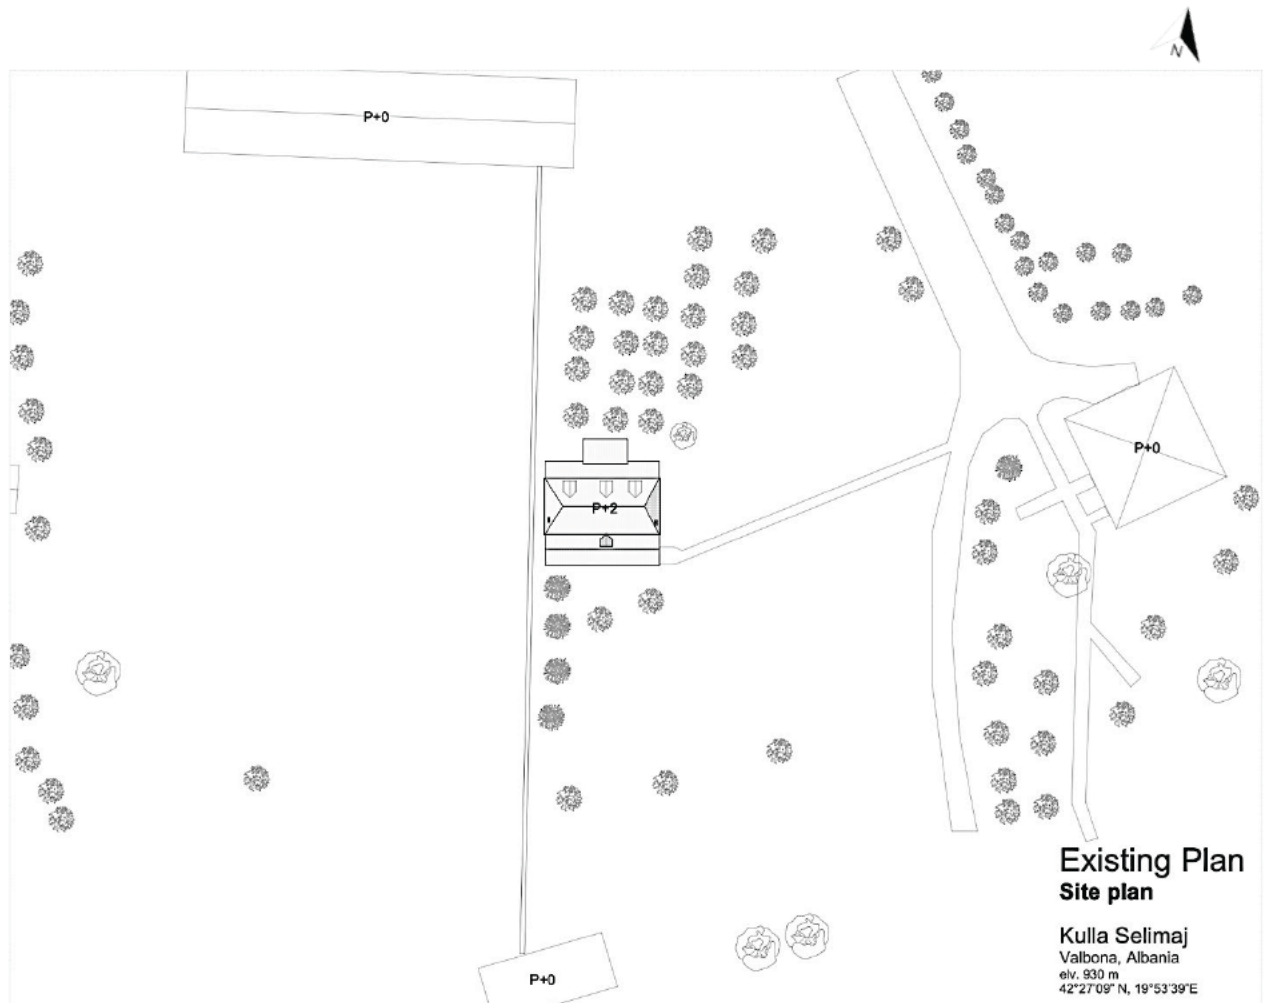
Fig. 144 Site plan of the Kulla of Selimaj family in Valbona

This building is surrounded by one story houses and other auxiliary buildings. The analysis below shows the impact that these buildings might have in kulla, in terms of sunlight exposure and shadowing.

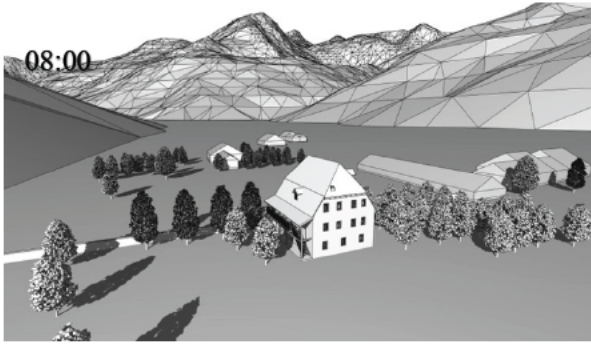
Fig. 146 Sun study of Kulla's context on the 5th of August 2021, every hour from 06:00 until 19:00 o'clock

The sun study of the setting of Kulla during mid-Summer, shows that the building is shadowed from sunrise until 07:00 o'clock and then from sometime after 18:00 onwards. The shadows come from the mountains and there is little to no impact from the surrounding buildings. So, during 5th of August 2021, Kulla is under sunlight for about 11 hours.

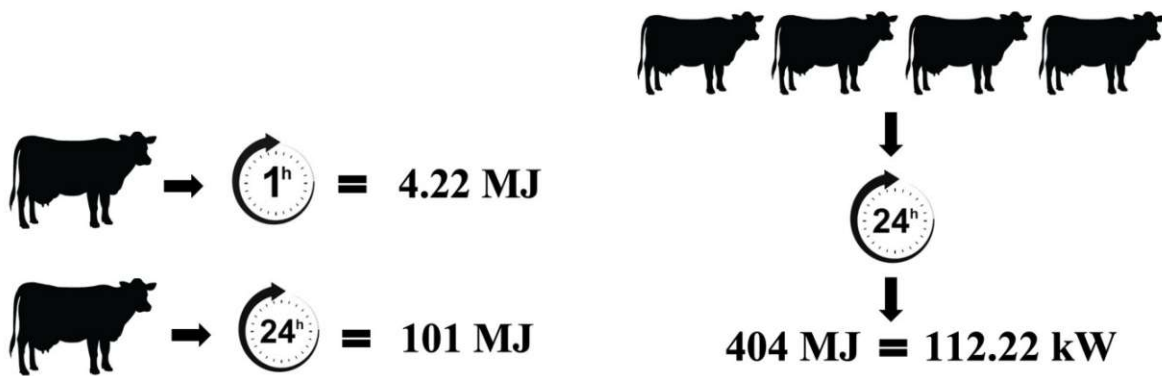
Fig. 180 Heat emission of cows for 1h and 1 day

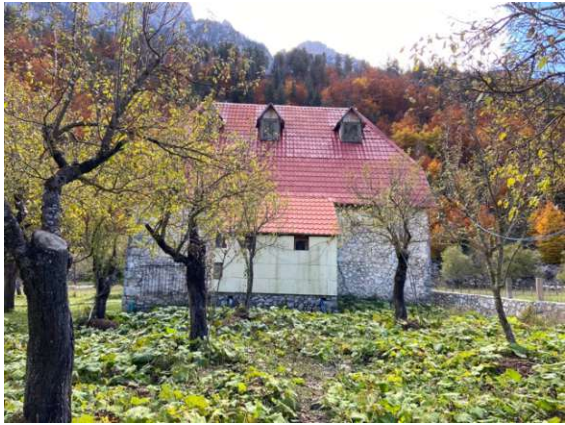
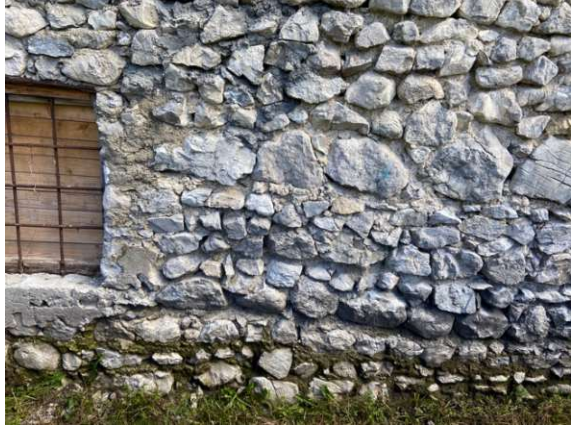
Fig. 195 Left: New annex added in the north facade, 2021, right: Rising damp in the west facade, 2021

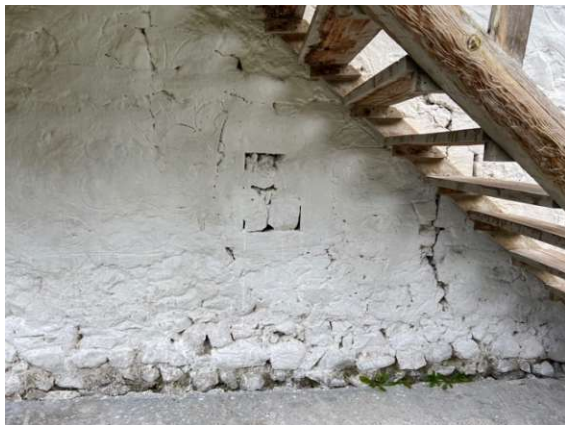
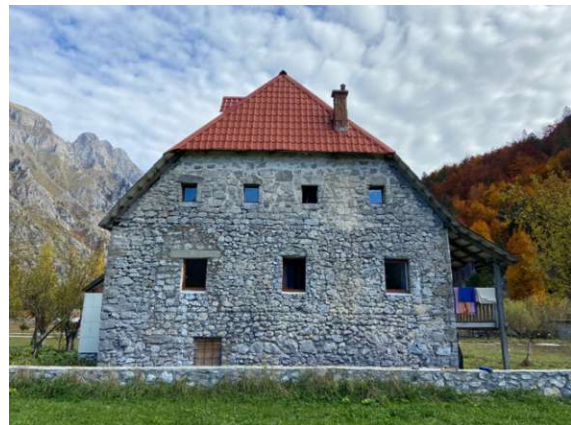
Fig. 196 Left: A closed opening and a crack in south facade, 2021, right: Cement mortar and new windows, 2021

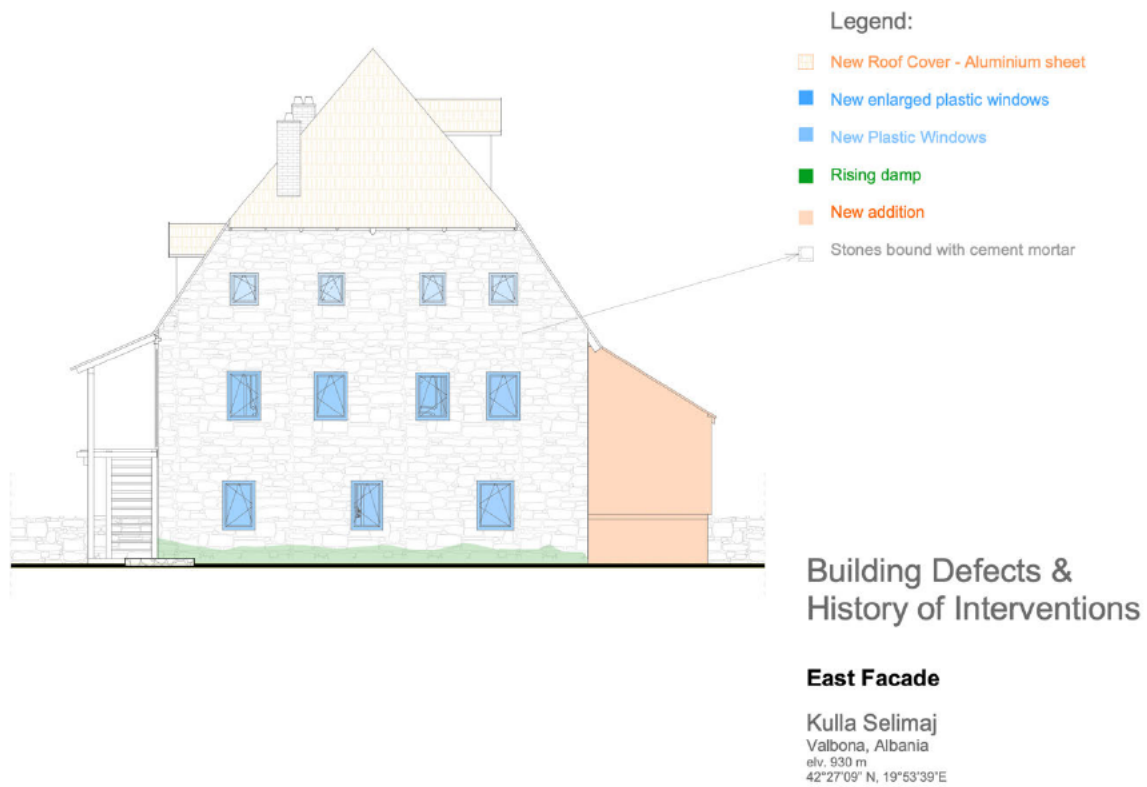
Fig. 200 Building defects and history of interventions in the East façade of the building

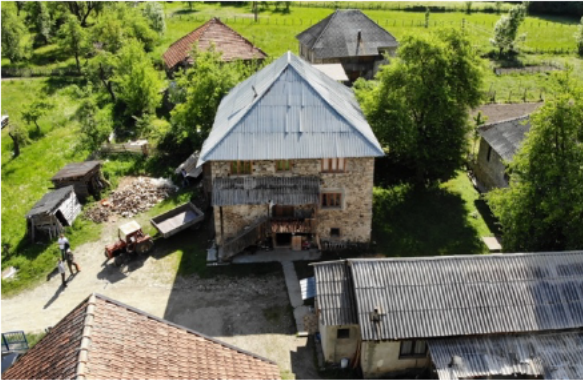
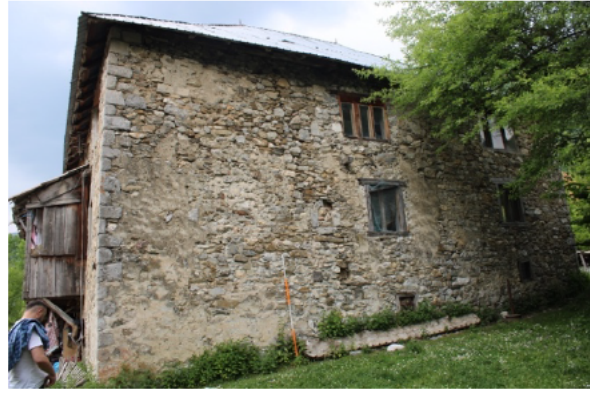
Fig. 207 Left: The damaged roof cover of the building, 2021, right: Cement mortar and enlarged windows, 2021

In terms of the building's condition, it was determined during the field survey that the structure is in poor condition. First, water has invaded the building due to the damaged new roof cover, causing damage to the ceiling. Then there are indicators of rising damp inside the structure due to the lack of guttering and French pipes. Finally, the structure has been substantially distorted by bulges developed in the external walls and constructive cracks forming in the building fabric as a result of multiple "inappropriate" transformations and a lack of maintenance and repair.

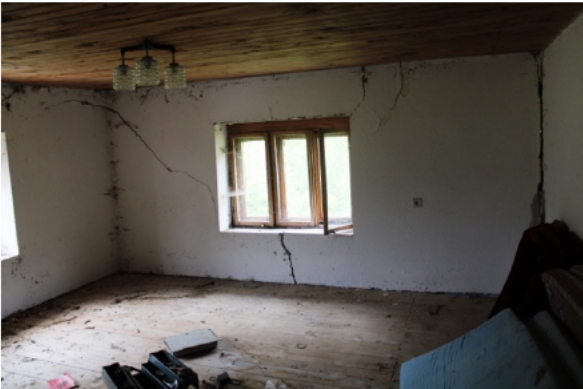
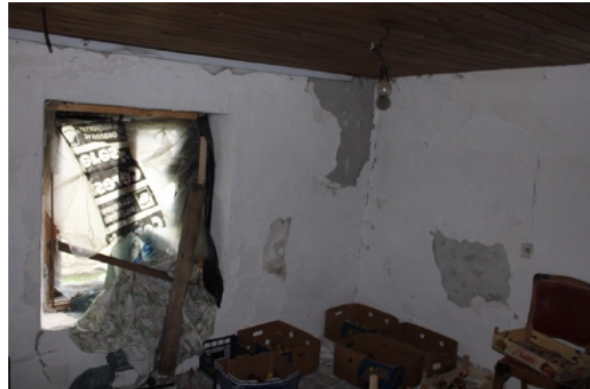
Fig. 208 Left: Constructive cracks in the abandoned part, 2021, right: Damaged plaster and window, 2021

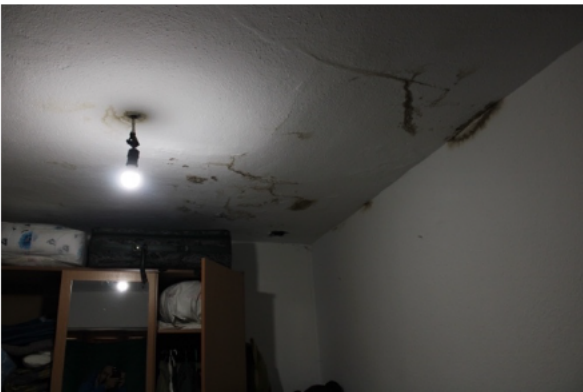
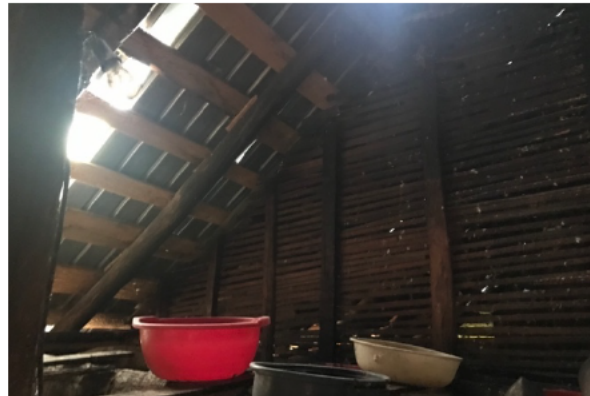
Fig. 209 Left: Damp in the ceiling of a used bedroom, 2021, right: Holes in the roof and baskets for water, 2021
