TECHNISCHE  
UNIVERSITÄT  
WIEN

DIPLOMARBEIT

# Monitoring of electrical performance and material stability of PV modules with repaired/coated backsheets

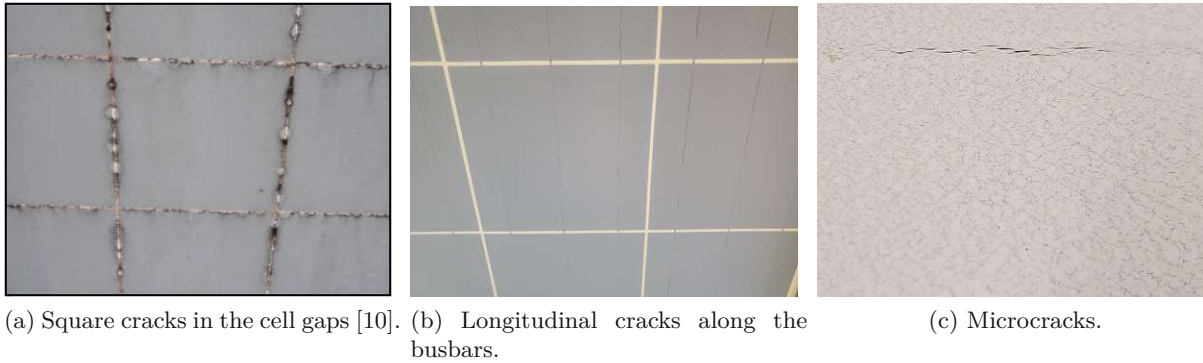
Figure 1.2: Different crack types in polyamide (PA) backsheets.

Even though cracks can develop in various backsheet materials, polyamide is affected the most. Therefore, several investigations and research had focussed on this material. A detailed error analysis [10] revealed that several effects, happening at outdoor weathering, play together to result in the backsheet cracks. In the field, a module is exposed to daily and seasonal temperature changes. As the different materials in the module layers have varying thermal expansion coefficients this results in internal thermo-mechanical stress. As the busbars have a height of  $200\ \mu\text{m}$ , additional stress is induced there by this height difference. Therefore, deep longitudinal cracks develop in the PA backsheet along the busbars. They start from the airside and can develop so deep that only the encapsulant is left to protect the cells from the airside. In contrast, the square cracks in the cell gaps grow from the inside, i.e. the interface between encapsulant-backsheet. They are less common and only happen if special EVA types are used. Due to solar irradiation, this EVA degrades, forming acetic acid. This acid is degrading the PA material from inside which results in the squared cracks. Microcracks only affect the utmost PA-layer and develop randomly from higher stress levels [10].

Which problems do such backsheet cracks create? The longitudinal cracks along the busbars and the squared cracks in the cell gaps can grow through the whole backsheet. In this way, moisture can enter through the backsheet and only the encapsulant is left to protect the cells from the outside. This leads to degradations like corrosion of solder joints and metallisation, degradation or delamination of the encapsulant, or polymer hydrolysis. All this leads to a faster decrease in the module's electrical performance. On the other hand, the backsheet fails to protect the surrounding of the power generated in the solar cells. Due to the cracks it no longer acts as an electrical insulator and leakage currents can occur. Therefore, affected modules present a safety risk for people and animals. This can result in automatic disconnections of strings of affected modules by the inverter, which may lead to larger production losses in a solar park [12, 15].

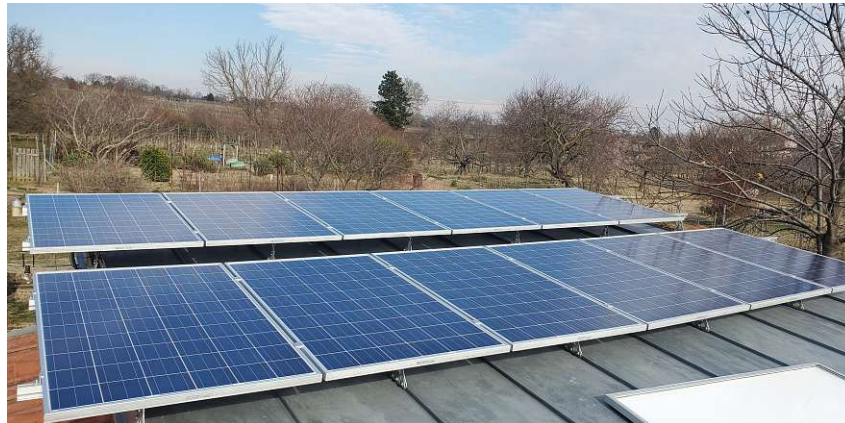
Figure 3.1: PV test site with the twelve coated modules mounted on the roof.

The modules were coated in the beginning of July 2021 and mounted on the roof shortly afterwards. Figure 3.1 shows a picture of the test site mounted on the roof. Furthermore, Figure 3.2 outlines the module assignment, their respective coating as well as the place of the pyranometer (P) and the temperature sensors (which will be described in Section 4.1).

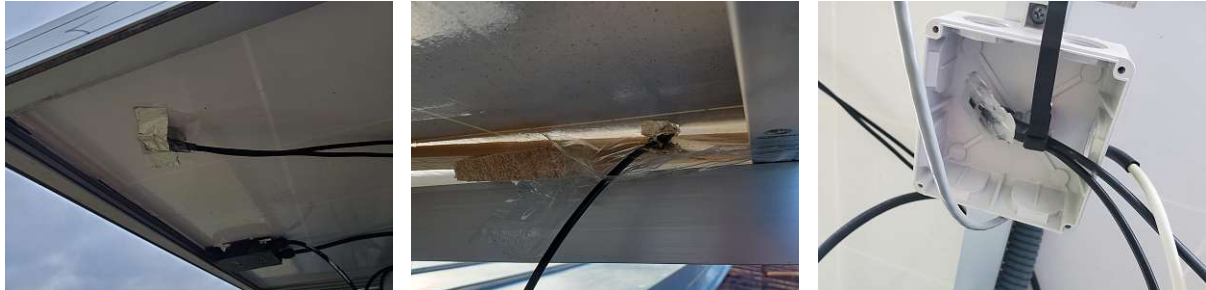
(a) Sensor 4 mounted on the corner of Module 1 (Remsolar). (b) Sensor 1 mounted on the corner of Module 7 (Dowsil). (c) Sensor 5 measuring the ambient temperature.

Figure 4.2 shows the sensors mounted on Module 1 and Module 7 for the module temperature and Sensor 5 for the ambient temperature. As adhesive tape is not sticking on silicone wooden sticks press the sensors against the coated backsheet of Module 7.

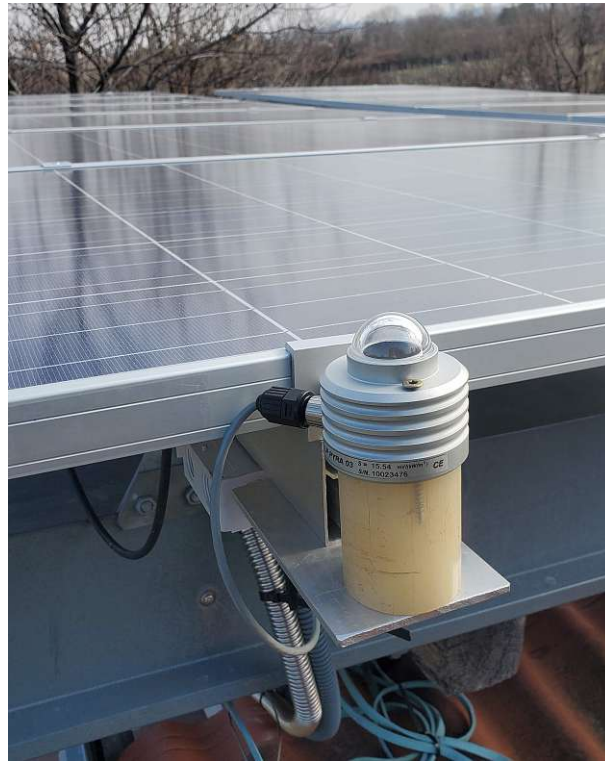
Figure 4.4: LP PYRA 03 pyranometer mounted next to Module 1, parallel to the module plane (plane-of-array irradiance), with the test site in the background.

The pyranometer has a measuring range of 0 - 2000  $\text{W/m}^2$  and a spectral range between 300 and 2800 nm. According to ISO 9060:2018 it is inside the spectral flat class C [50].

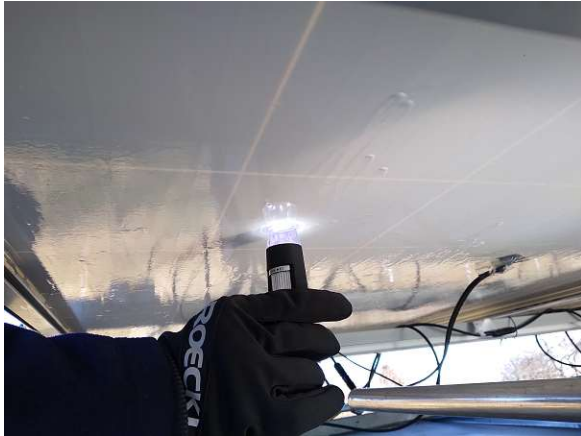
(a) Measurement with the light microscope on the Remsolar-coated backsheet of Module 1.

Figure 4.9: Measurement devices at the test site

When visiting the test site, the first step was a visual examination of the coated backsides of the modules with the naked eye. Pictures were taken with a camera to record changes in the surface morphology of the coating over time. To investigate the surface in more detail, pictures were also taken with a portable light microscope. Here a PCE-MM 800 digital microscope was used (see Fig. 4.9a). It is directly connected to a laptop via the USB-port and pictures can be taken with the associated software *Measurement*. The microscope can be used with a 20× or 200× magnification. For most pictures, the smaller magnification (20×) was used. Table 4.1 gives an overview of the sample measurements.

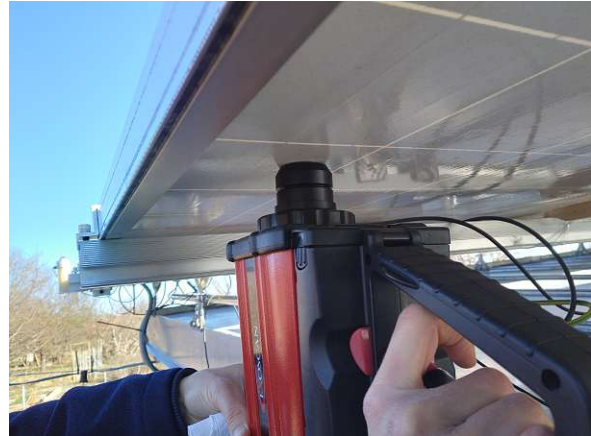
(b) Measurement with the EXOSCAN FTIR-spectrometer on the Dowsil-coated backsheet of Module 7.

The infrared measurements were done with a handheld Fourier transform infrared (FTIR) spectrometer, A<sub>2</sub> Technologies EXOSCAN [57] (see Fig. 4.9b). A diamond ATR-crystal is brought in direct contact with the sample surface (in this case the backsheet or the coating). The ATR (attenuated total reflection) technique is a surface sensitive method, where only the top 1.5-2.5  $\mu\text{m}$  of the sample are investigated. As a detector a DTSD is used. All techniques are explained in Section 2.2.2.

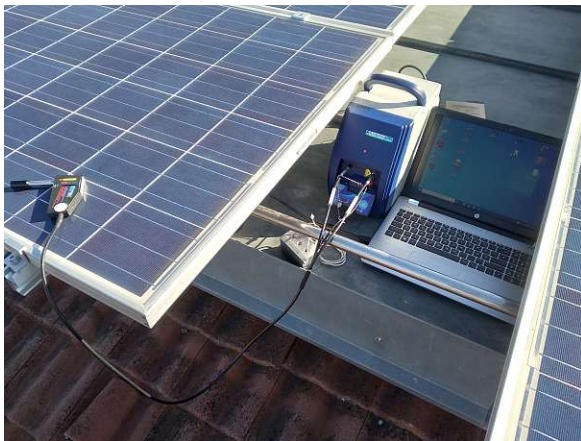
(a) Raman laser and laptop running the measurement software BWSpec.

Figure 4.10: Measurement with the Raman laser at the test site.

The Raman spectroscopic measurements were done with a portable **B&W**TEK i-Raman Plus [58]. The model BWS465-532S excites the Raman signal with a laser at 532 nm. The spectrometer range is 65 - 4200  $\text{cm}^{-1}$  with a resolution of 4  $\text{cm}^{-1}$  at 614 nm. As a detector, a high quantum efficiency CCD array is used. Figure 4.10 shows the probe connected to the laser with a specific fibre-optic cable. Hence, the Raman device can be 1-2 m away from the sample. In contrast to the ATR technique of the FTIR (which needs direct contact), the maximum Raman signal occurs in the focal point of the laser probe ( $\sim 1$  cm distance to sample surface). So when different spacers are used, also layers beneath transparent material can be measured. For example, the encapsulant of the PV module under the front glass can be inspected, as shown in Figure 4.10b.

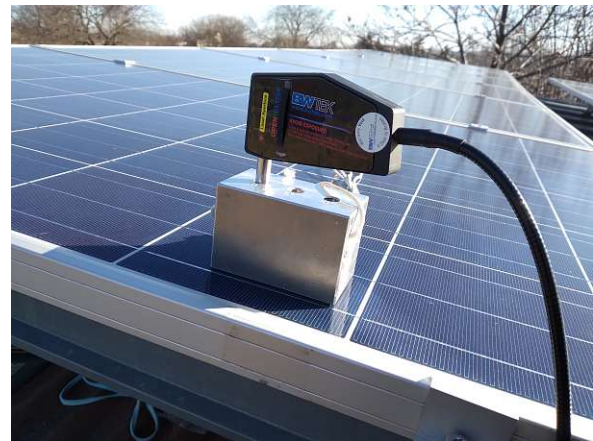
(b) Laser probe measuring the encapsulant of the modules using a specially designed spacer.

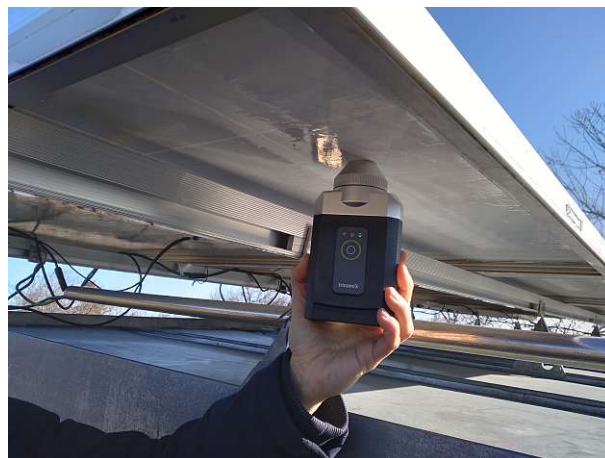
Figure 4.11: Measurement with the NIR-spectrometer on the Remsolar-coated Module 1.

The NIR spectroscopic analysis of the coating was performed using a trinamiX near-infrared (NIR) spectrometer (Model SYS-IR-R-P) [59]. Figure 4.11 shows that the device is rather small and measuring in the field is convenient. The spectral range is 1400 - 2500 nm which corresponds to  $4000 - 7143 \text{ cm}^{-1}$ , the resolution is 1% of the wavelength. An especially by trinamiX created miniaturised infrared detector Herzstück<sup>TM</sup> detects the reflected light, which is then transformed into an electrical signal. Because of the long wavelengths involved, not only surface material can be inspected but the light can enter the material deeper until it is reflected by opaque material e.g. the Si-cell. For additional comparison, spectra were therefore taken of the EVA encapsulant of the modules.

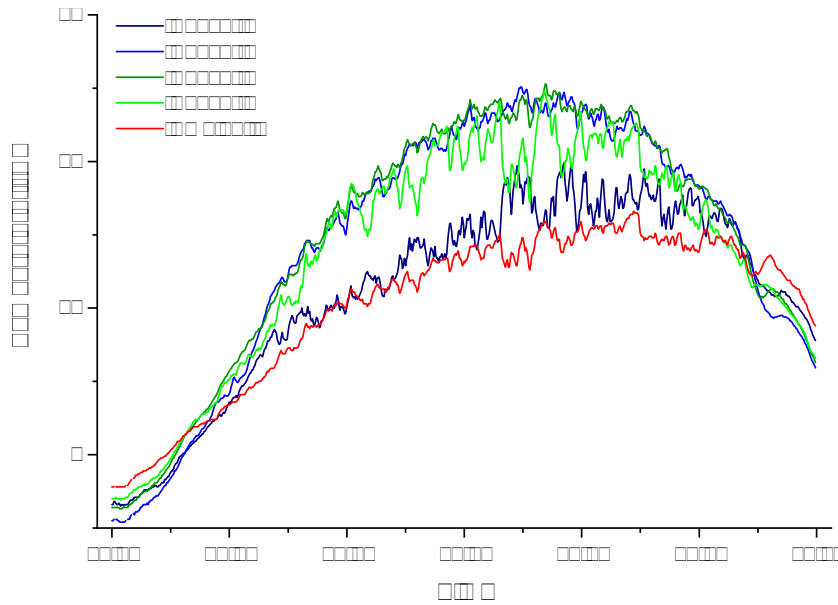
Figure 5.2: Temperature profile of all five temperature sensors (Sensor 1 and 2 on Module 7; Sensor 3 and 4 on Module 1) on 21.03.2022.

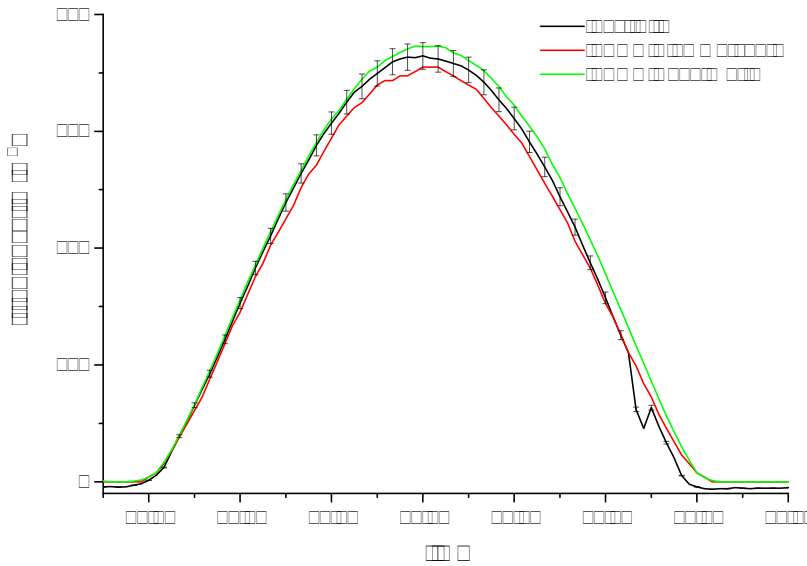
Figure 5.3: Irradiance at the test site in comparison to two ZAMG monitoring stations on 21.03.2022.

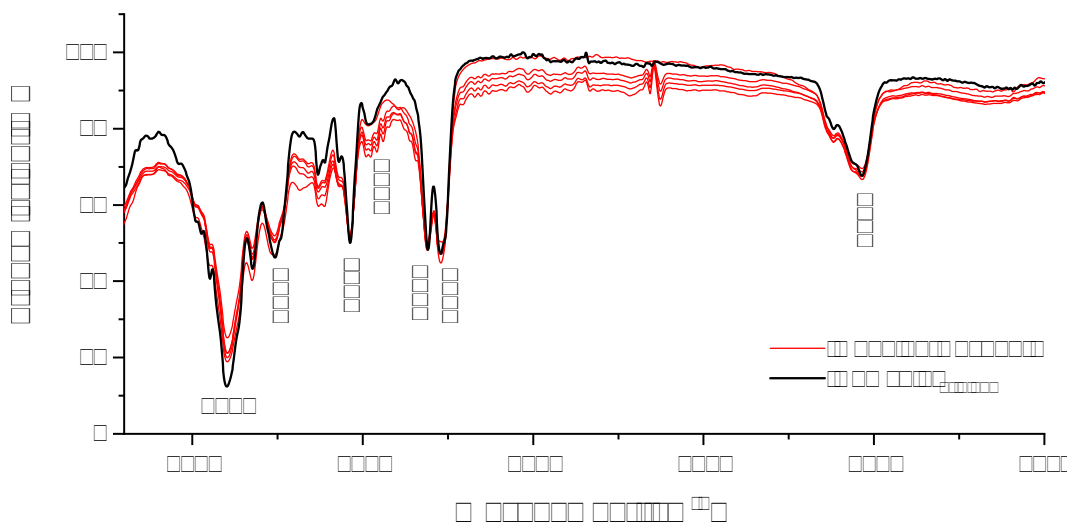
Figure 5.17: Comparison of five IR spectra (a-e) recorded on various measurement areas on the coated backsheet of Module 1 in November 2021 (red) and the original coating on an aluminium foil (black).
