Hidden Architecture
The timber roof structure of the dome of Vercelli
Inspection-Diagnostics- Interventions

A Master's thesis submitted for the degree of
"Master of Science"

DI Pia Therese Panosch
0126769

Milan, 05.02.2010

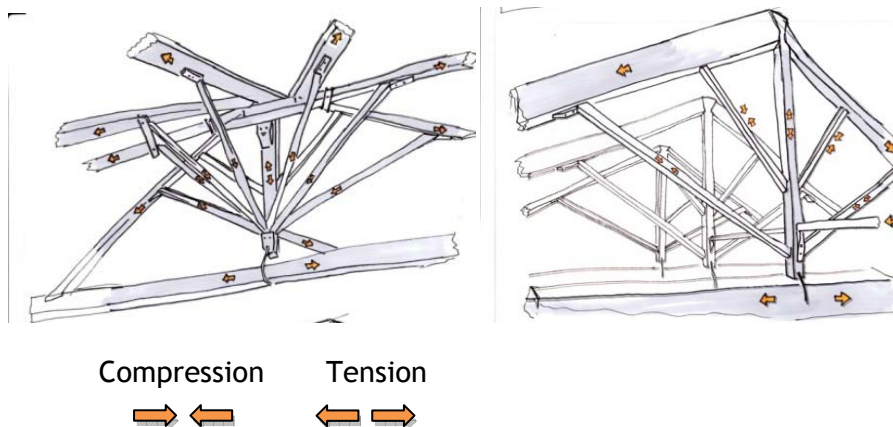
sketch 11

The ridge beam of the structure is missing. This means that all the little beams (third order) on top of the rafters have to transmit the loads in the longitudinal direction of the choir.

over beams connecting the king posts. It is likely that these loads originally have been contributed over all 8 trusses, now some of these connecting elements are missing and only the first 5 trusses are connected. These forces caused high deformations. This umbrella construction is extremely interesting, because on the kingpost (truss apses) are arriving 9 struts, which is very uncommon!

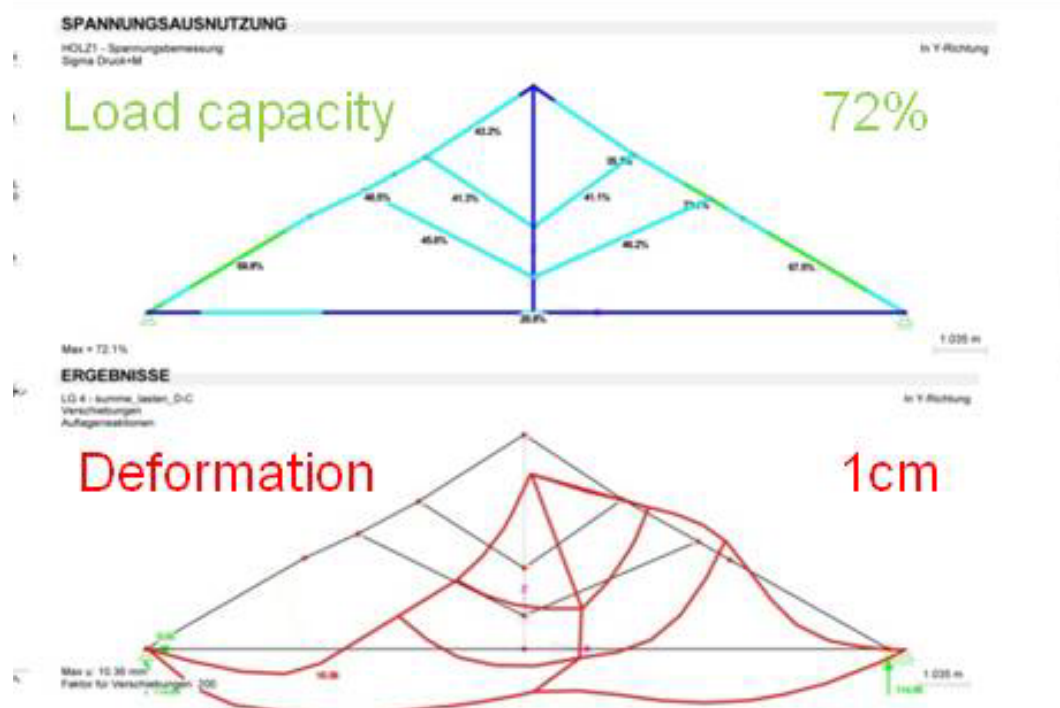
If the truss has no damaged areas at all, it is more than sufficient. The load capacity lies by 72% and the Deformation is 1 cm. considering that the truss has a span length of about 15.50m this is nearly no deformation. The element which has the highest load to carry is the rafter.

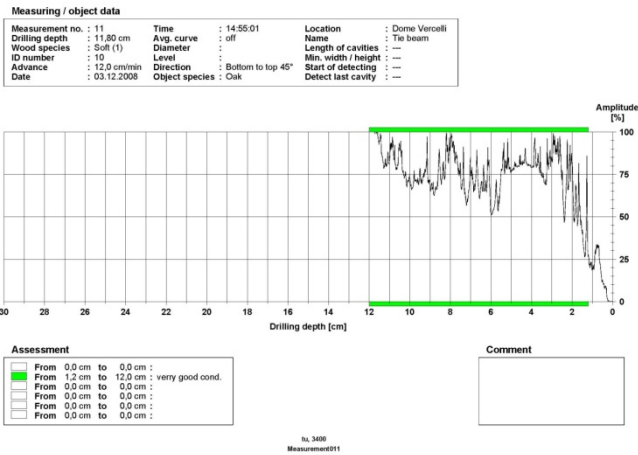
3.12.08	R 11	front end north side	underside to top side inclination 45° (ref. exterior wall)	- Drill 11 (executed on soft timber): the test was taken on the truss 8.
---------	------	-------------------------------	---	--

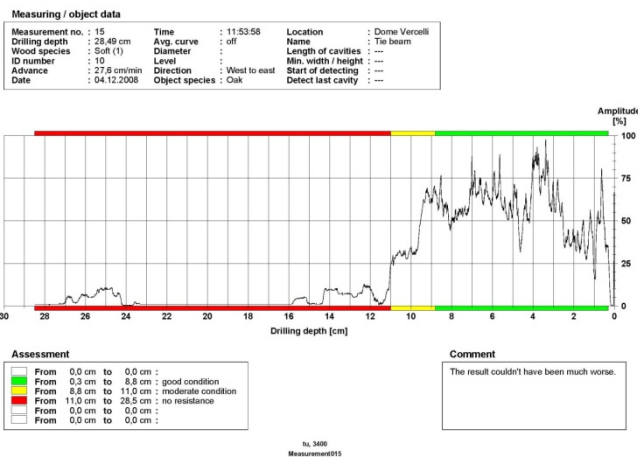
3.12.08	R 15	front end south side	perpendicular to grain	Drill 15 (executed on soft timber): the test has been taken perpendicular to grain on the tie beam. There are only 6cm of good timber, after that there is nearly no resistance. <u>The result couldn't have been much worse.</u>
---------	------	-------------------------------	---------------------------	---

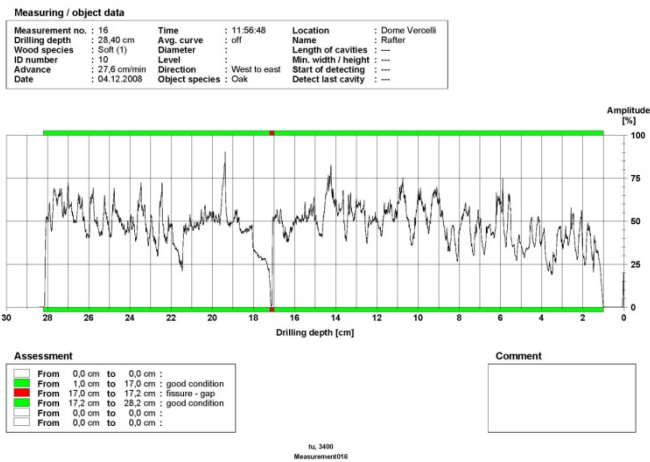
Twist			
Wooden species	Oak			
Humidity	According to the surrounding air about 16%			
Average dimensions of the element	26 x 29 cm			
	Section	Rectangular		
	Geometric peculiarity	Wane	Nothing visible	
Deformations				
Other characteristics	The beam is in a moderate condition. A single knot is visible.			
Resistographic profiles				
Data	Profile N°	from	Direction	Observations
3.12.08	R 16	front end south side	perpendicular to grain	Drill 16 (executed on soft timber): the test has been taken in perpendicular direction on the rafter next to the joint tie beam-rafter. The graph falls at a point due to a crack.

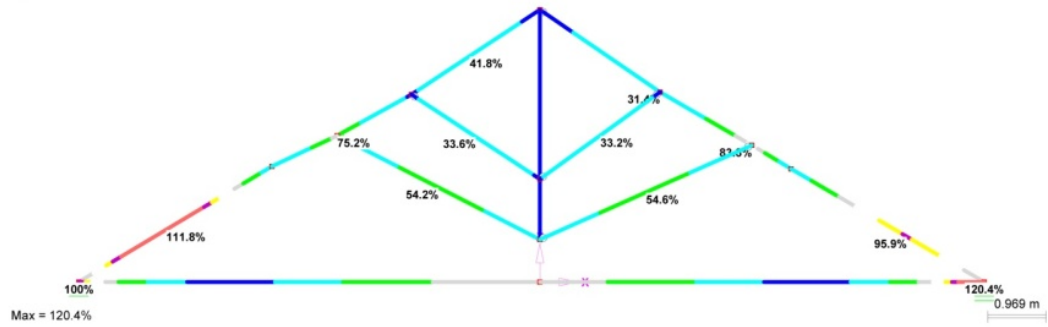
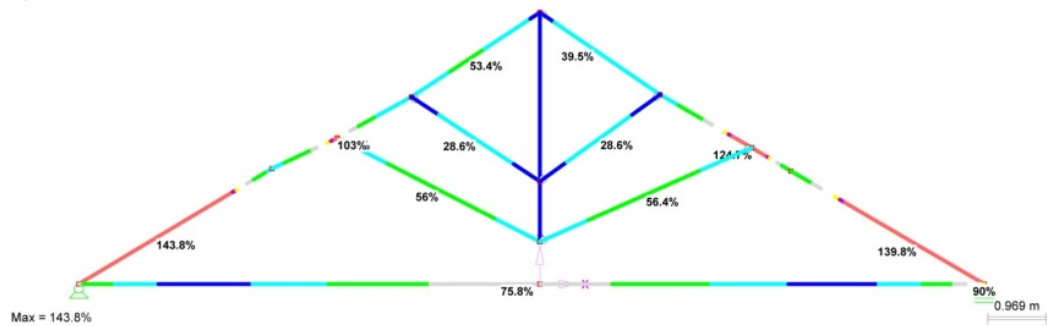
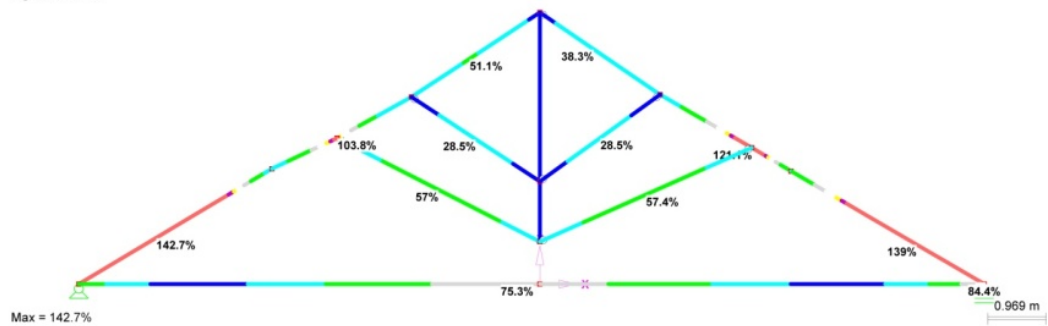
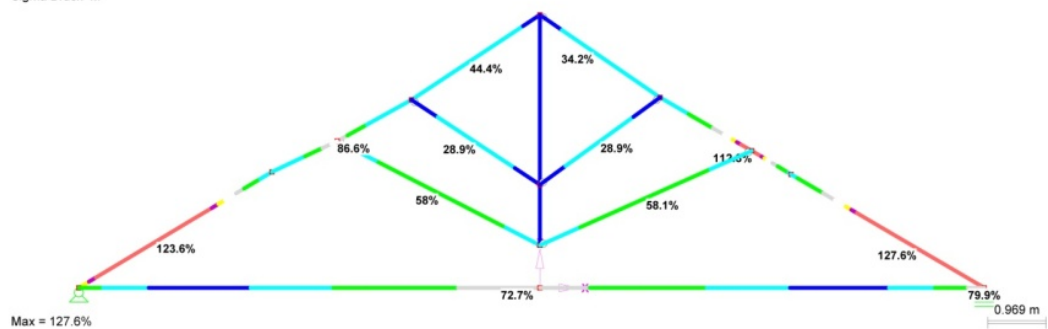
The stress in the lower part of the rafters is generally too high (Values between 110%-175% of the load capacity). Further results can be found in the attachment.

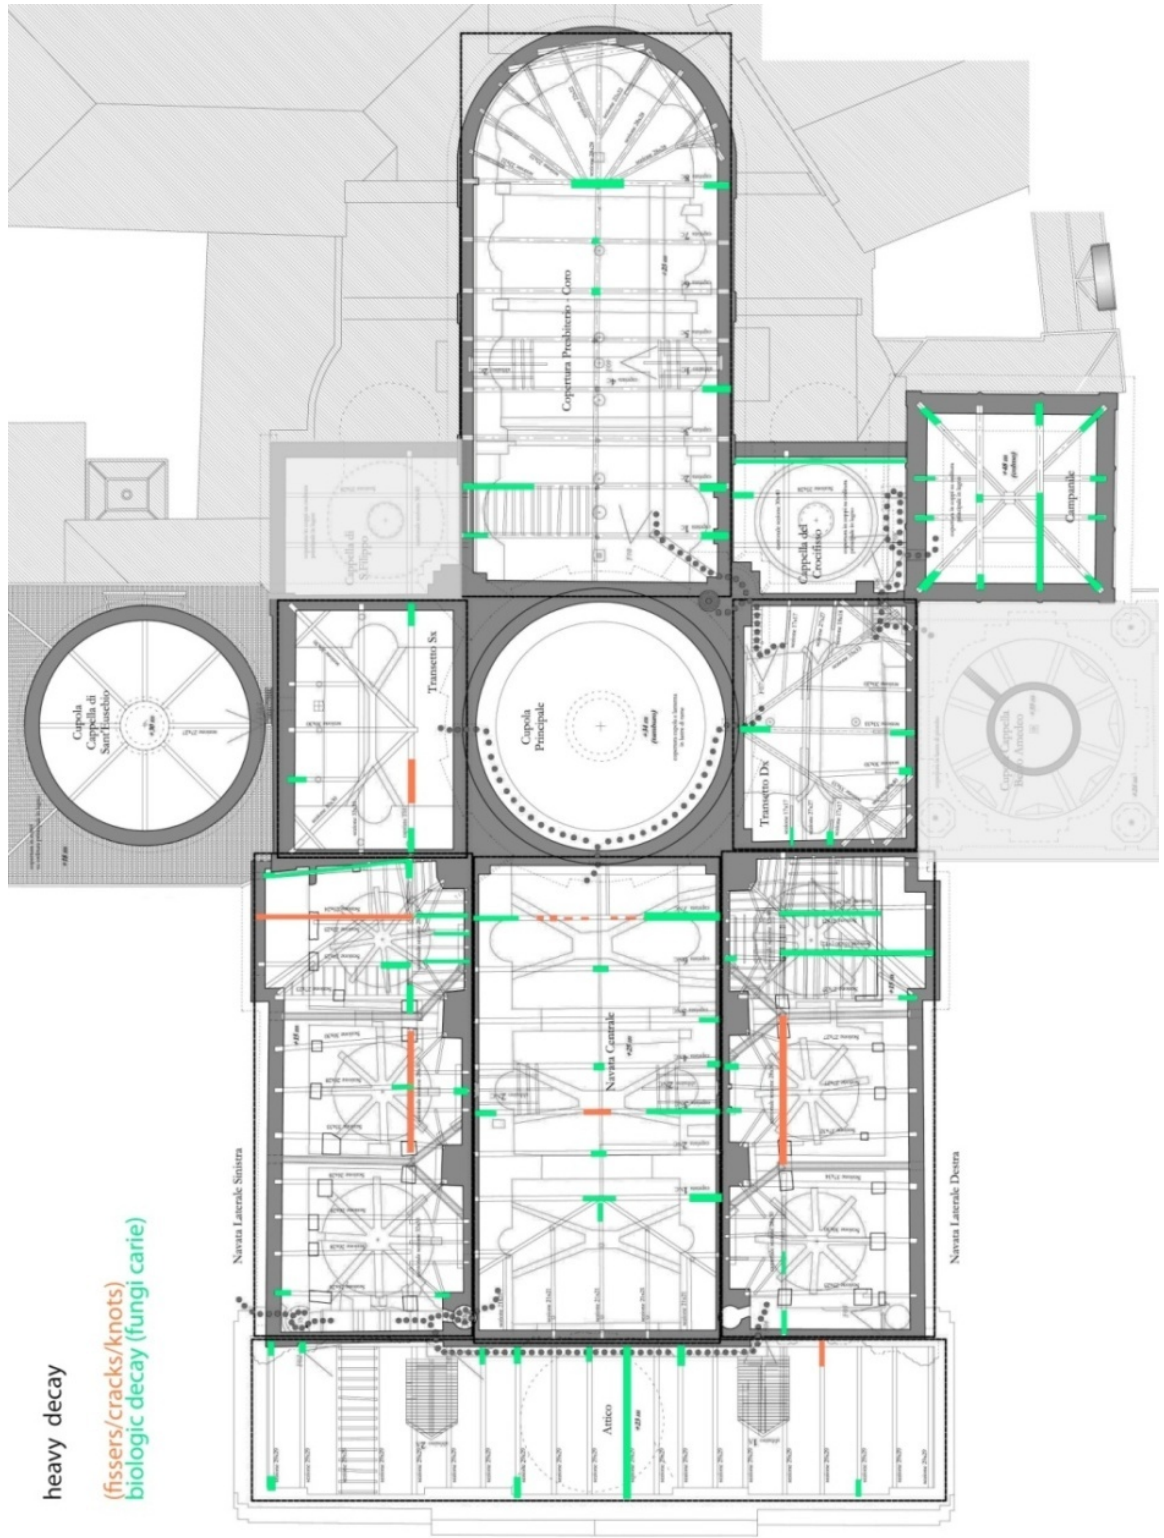
Plan 3

The following plan shows the areas where the structure has suffered most. The signed points are in a dangerous condition. It has to be considered, that most of the bearings of the structure have been covered (stones /dirt and in some cases also concrete). Therefore it is difficult be certain, that all damaged areas have been discovered. It is recommended to have a closer look at the elements, when they are freed.

heavy decay

(fissures/cracks/knots)
biologic decay (fungi carie)

The points where the timber structure has suffered most are on the ridge and the eaves of the roof. These points are difficult to get dense and where water can penetrate the structure it gets easily damaged.

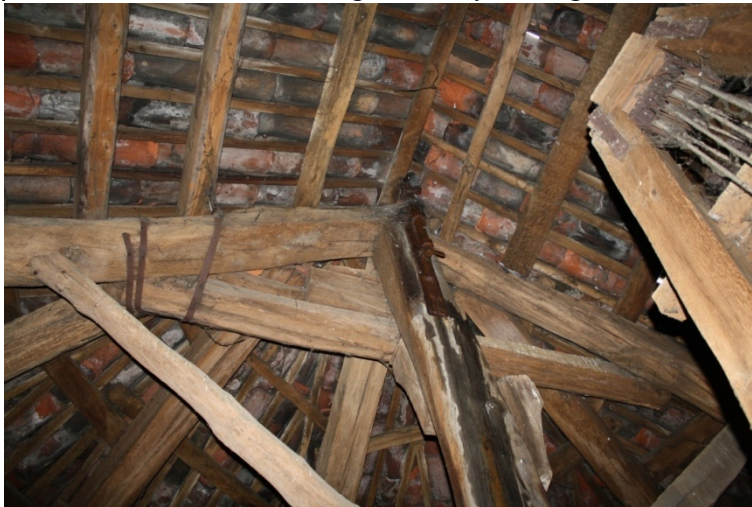
Illustration 40 Water infiltrations on the peak

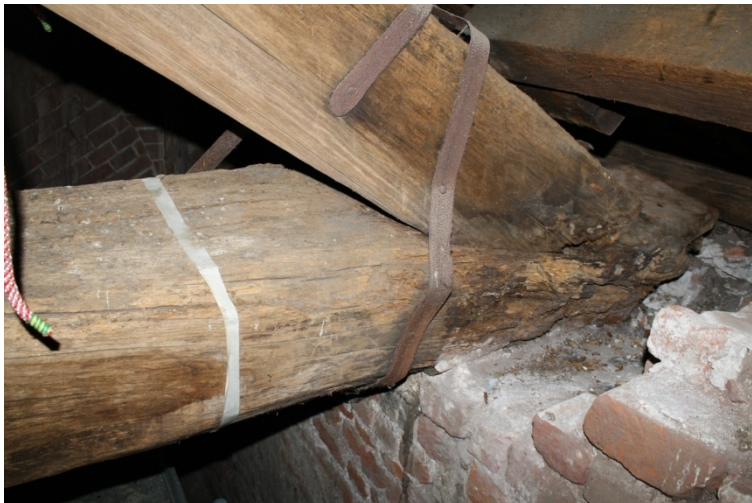
Illustration 41 Damaged tie beam

Some joints of the trusses bearing on the external walls are heavily degraded (see pic. damaged tie beam) Especially the heads of the tie-beams seem to be problematical in some points. The unreliable components should be replaced or reinforced.

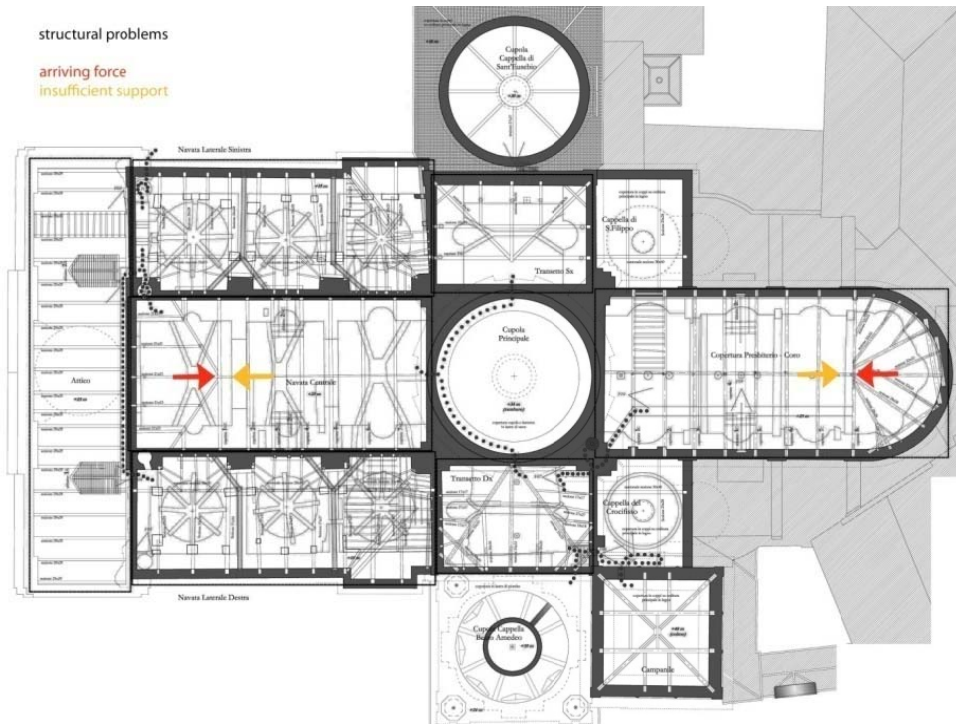
Plan 4

structural problems

arriving force
insufficient support

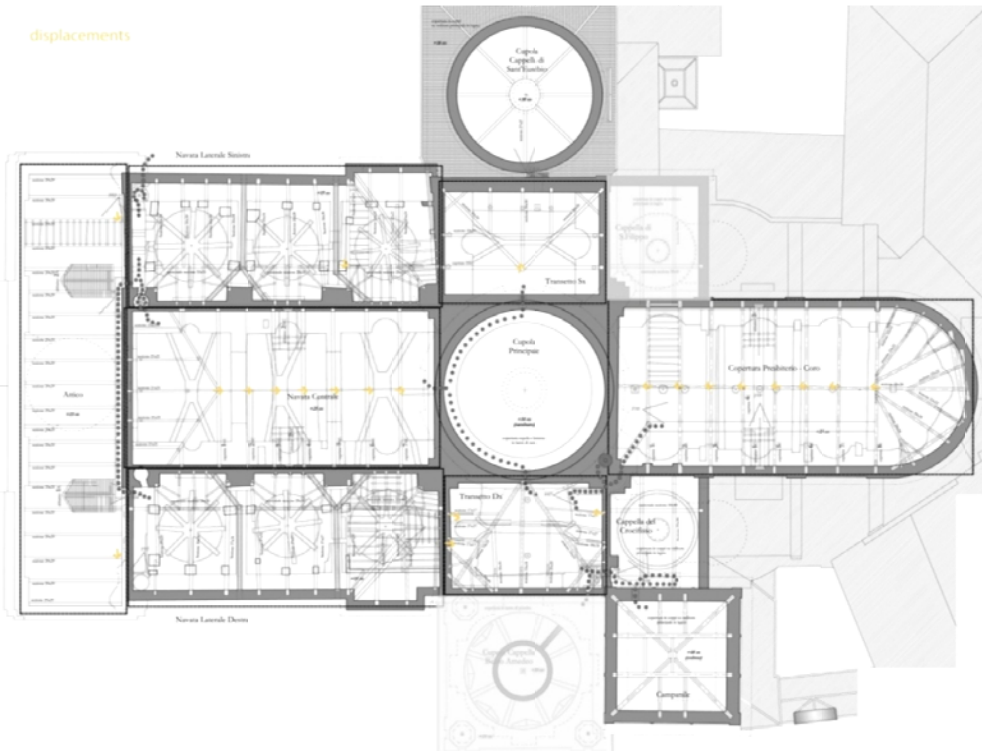
Plan 5

displacements

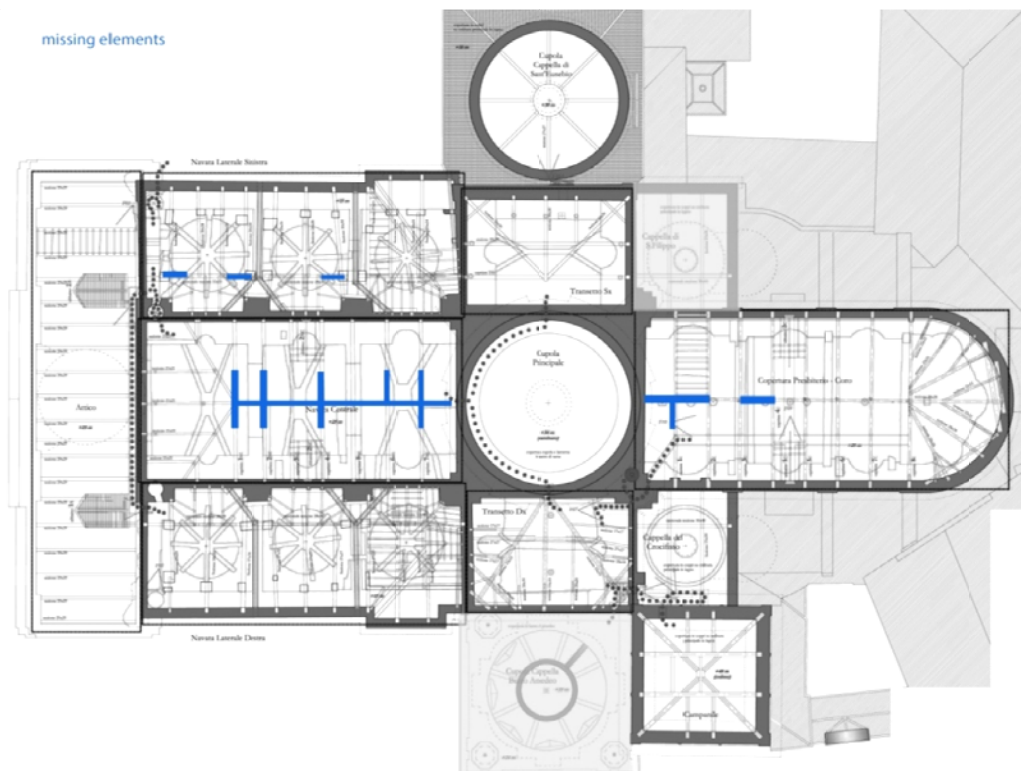
Plan 6

Illustration 43 Missing elements

Some elements are missing completely it is unlikely that the structure has been designed non symmetrical therefore these elements must have been removed because of their weak condition.

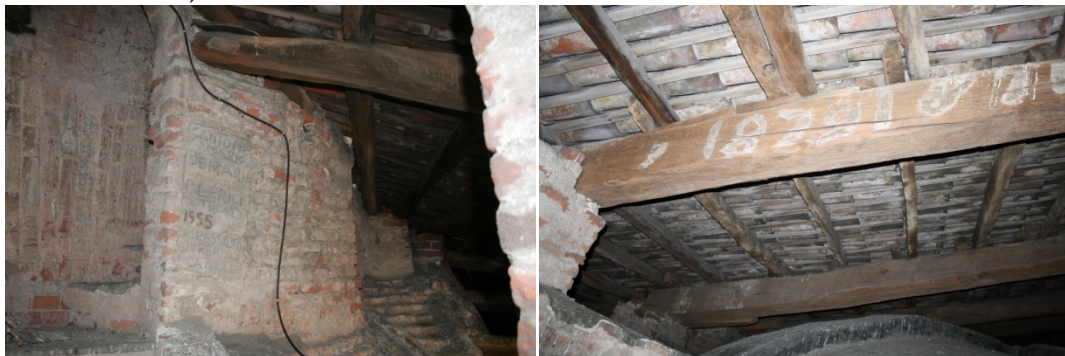
Illustration 47 Former refurbishment

The roof of the cathedral has been restored various times. Some of these refurbishments are documented on the beams or exterior walls. (see pic. Former refurbishment)

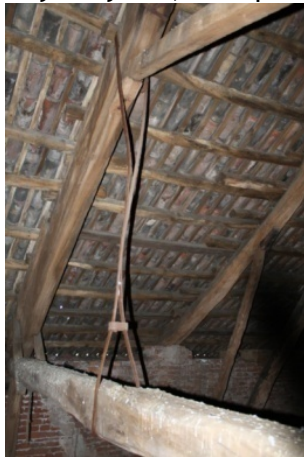
Support tie beam

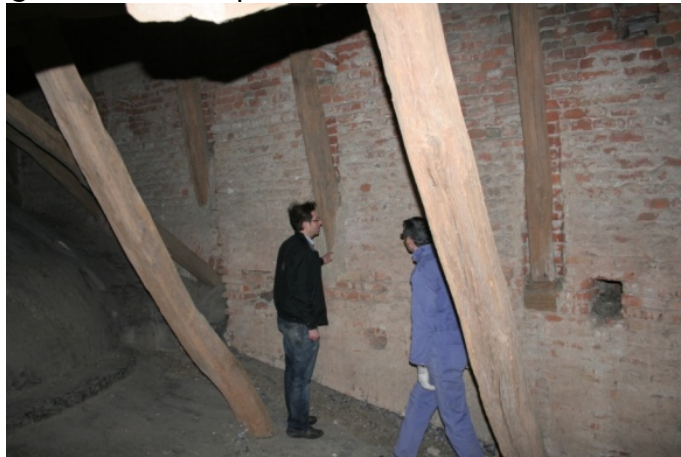
original bearings and bearings which have been closed with concrete

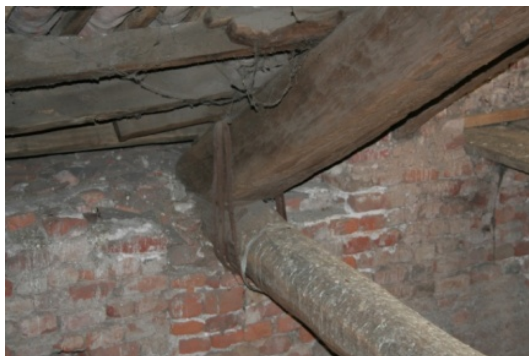
Closed bearing truss

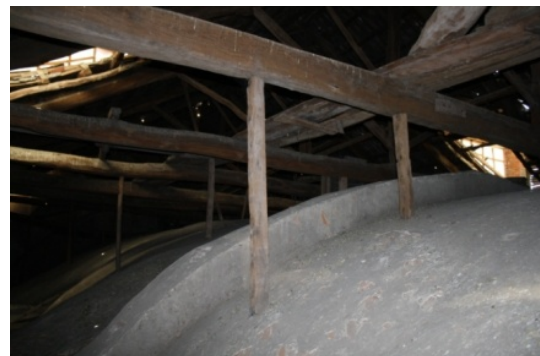
support tie beam (struts bearing on the vault)

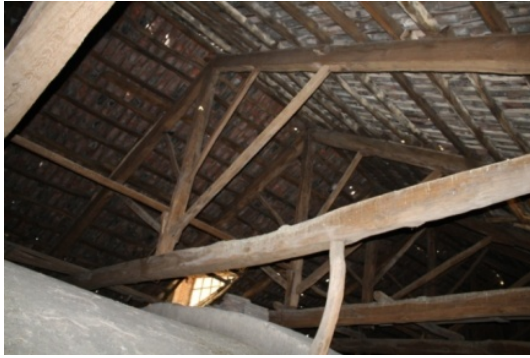
Strut bearing on vault

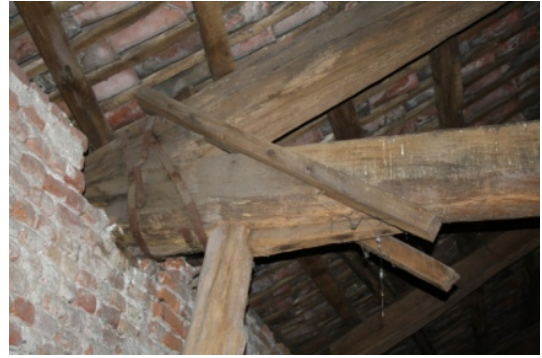
connection rafter tie beam

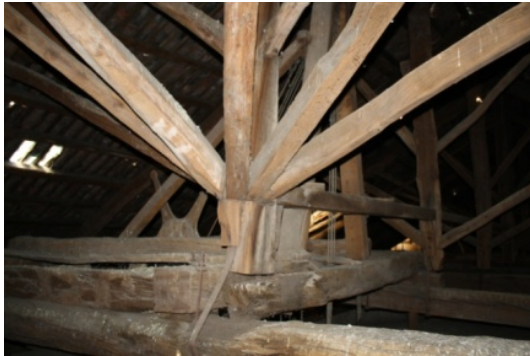
Support king post

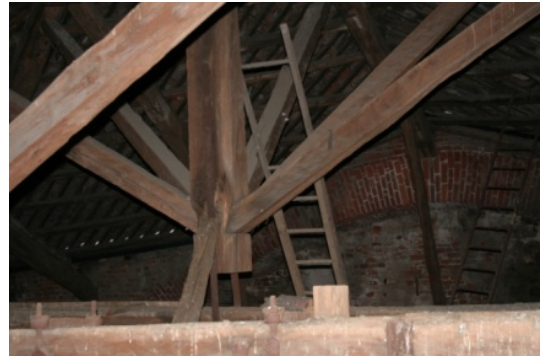
The most extreme case is a post in the main aisle, which overtakes all forces coming from west. It is placed directly after the umbrella construction on the west end and substitutes the connection which most likely once connected all trusses till the wall on the east side of the aisle. The forces coming from west may have caused the displacements of the king posts of the trusses (which are also visible on the choir). It is likely that this post bearing on the vault has been added to get rid of the forces perpendicular to the truss systems and therefore the movements of the king posts.

strut to overtake the forces coming from the umbrella structure (bearing on the vault)

It is difficult to decide what to do with such interventions, as it is very complicated to ascertain how the structure actually works. It is always very risky to remove former interventions; therefore I would recommend leaving them the way they are, or replacing them with adequate secure modern interventions.

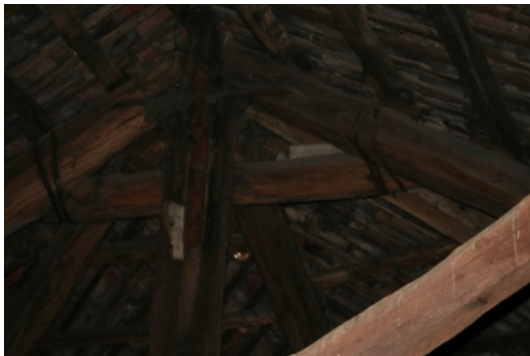
Support connection of the truss on the peak

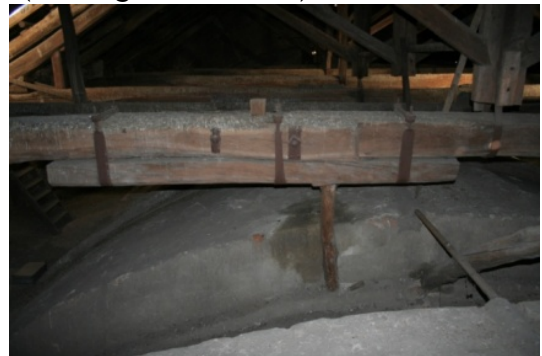
support tie beam

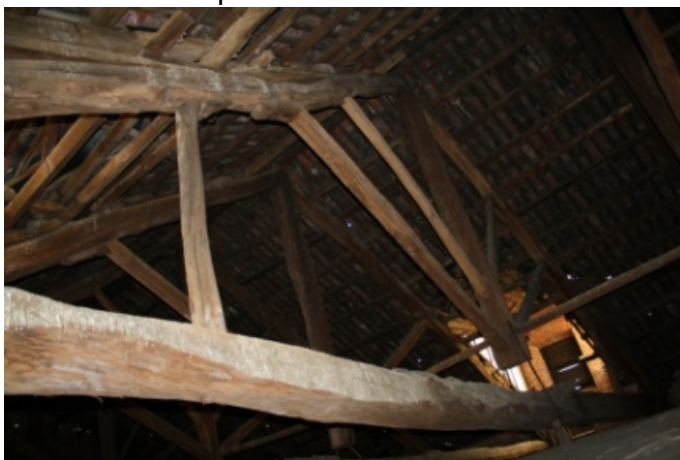
Strut supporting rafter

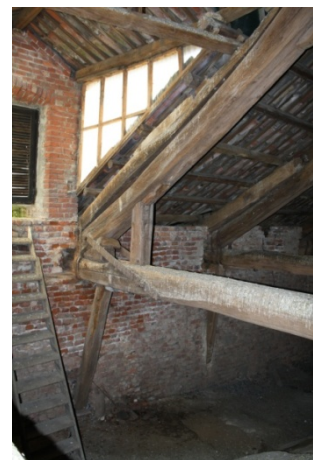
connection rafter - tie beam

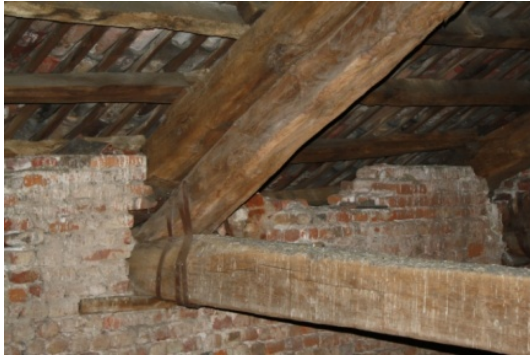
timber element to ensure the inclination of the roof

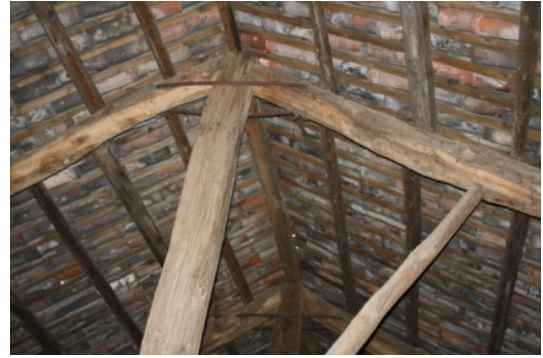
Metal elements connection king post - rafters

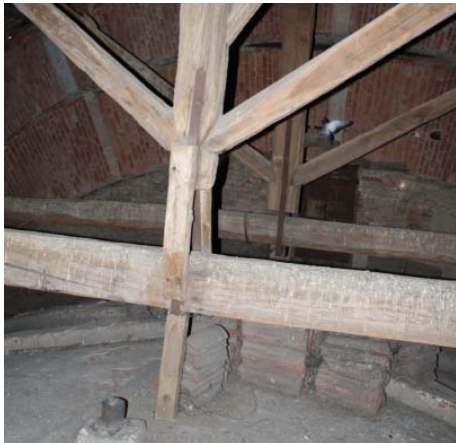
Timber element to avoid displacements

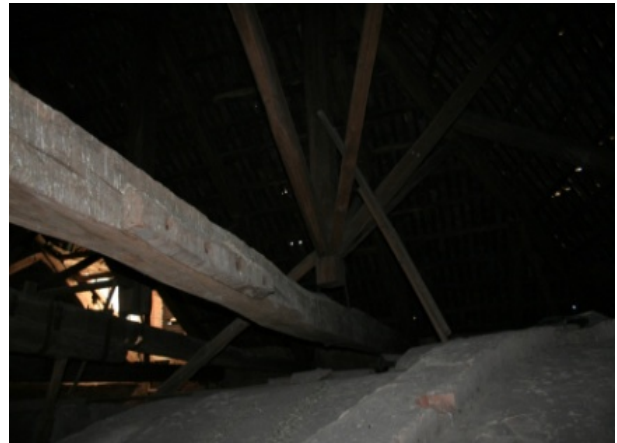
strut to overtake the forces coming from the umbrella structure

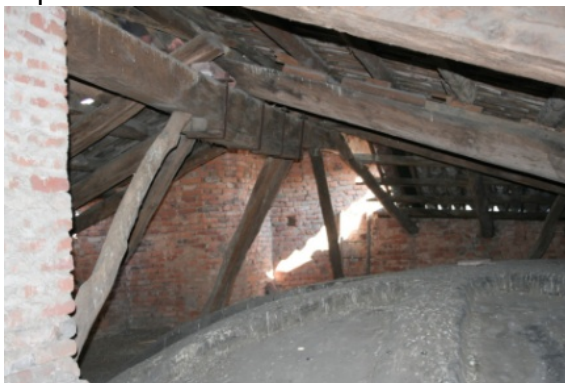
Illustration 48 Former refurbishments

Support joist (doubled)

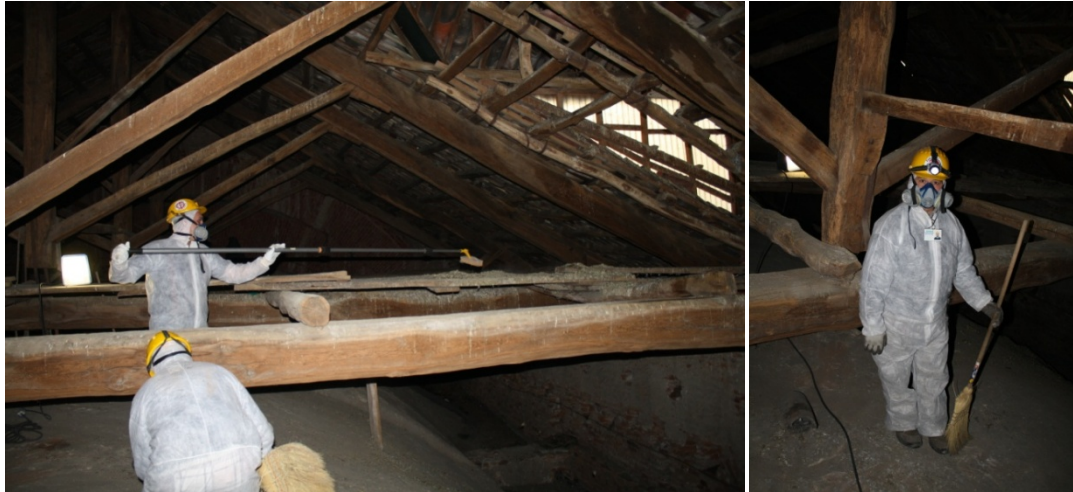
Illustration 52 Company Ecologica cleaning the roof

To be able to work in hygienic conditions and to evaluate the real state of the structure the whole attic of the dome of Vercelli has to be cleaned. This preliminary cleaning has been done with conventional brooms and brushes. Not even a week after the cleaning took place the whole workshop has been full of dove dirt again. Therefore it is necessary to protect the roof against animals entering and soiling the whole attic.

In a later phase, before the interventions on the timber elements will take place (connecting new timber elements with old ones and the treatment with chemical products to augment the resistance against outer influences) a sandblasting with a controlled pressure or a further brushing too remove the dirt is foreseen.

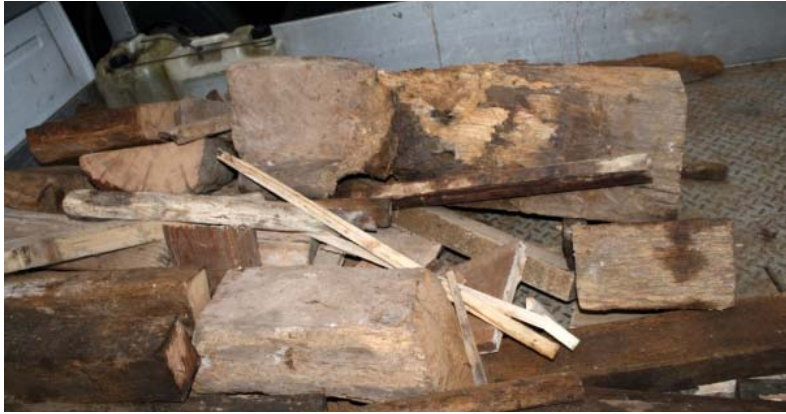
Illustration 56 Element, which had been substituted

Truss one, which has been in the weakest condition:

The heads of the tie beam have been substituted completely. The beam got two prostheses, which are fixed with two metal plates, one on each side. To ensure the connection between tie beam and it has been fixed with two screws at the end (position where two nails connected the original structure) and a metal tie. Additionally to the screws, the two timber elements have been glued (MAPE wood primer 100 / MAPE wood gel 120 and MAPE wood paste 140).

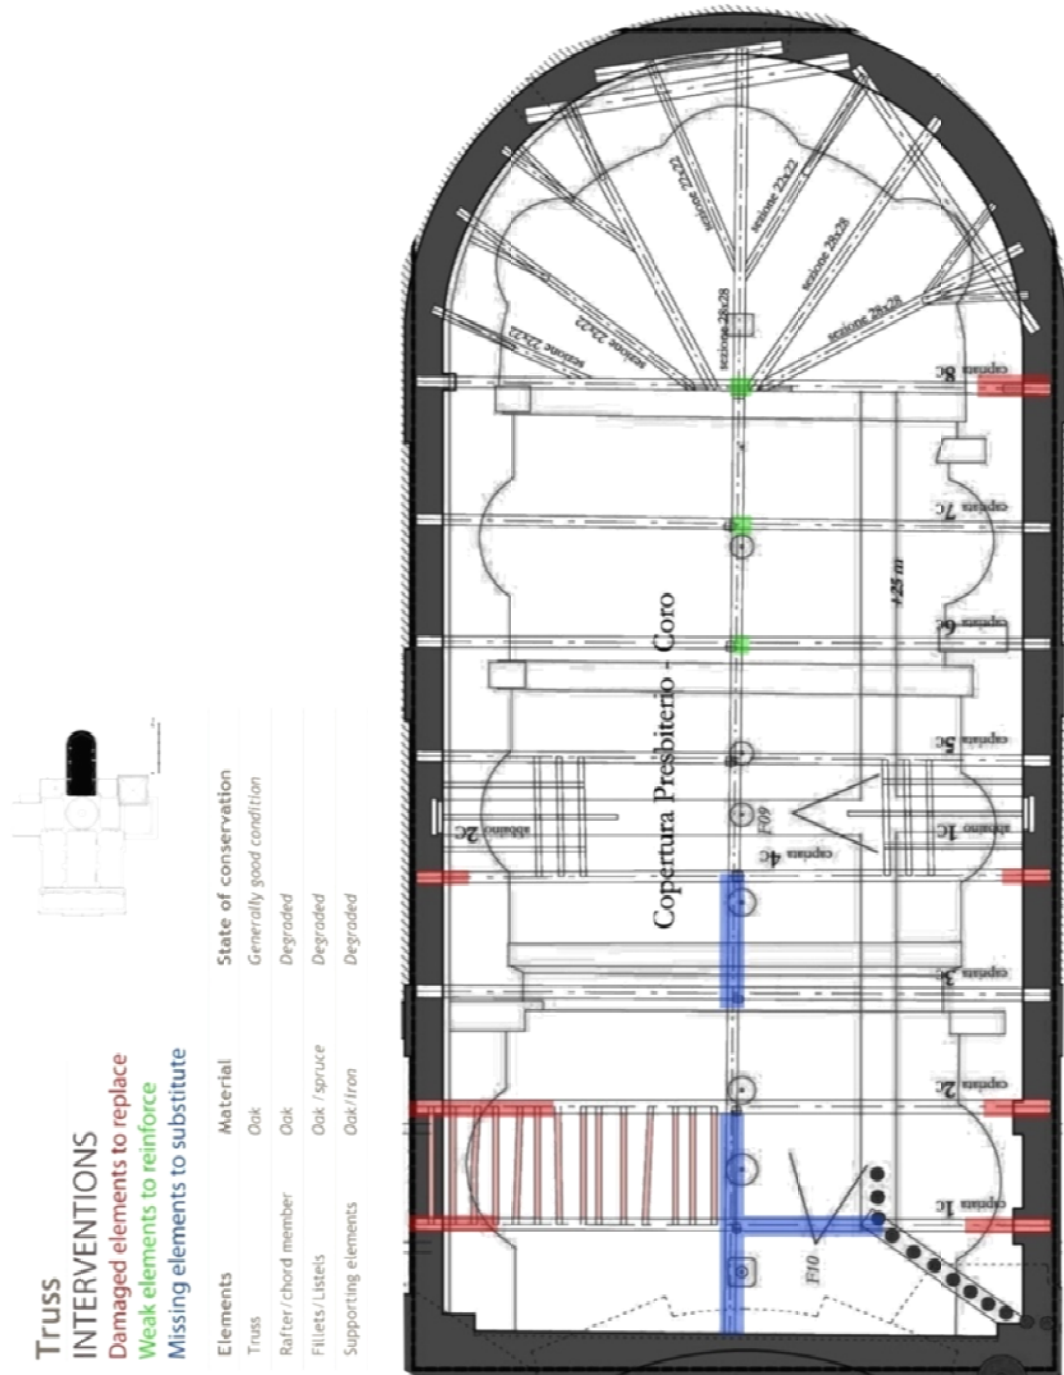
Plan 7

Elements	Material	State of conservation
Truss	Oak	Generally good condition
Rafter/chord member	Oak	Degraded
Fillets/Listels	Oak / spruce	Degraded
Supporting elements	Oak / iron	Degraded

Truss
INTERVENTIONS
 Damaged elements to replace
 Weak elements to reinforce
 Missing elements to substitute

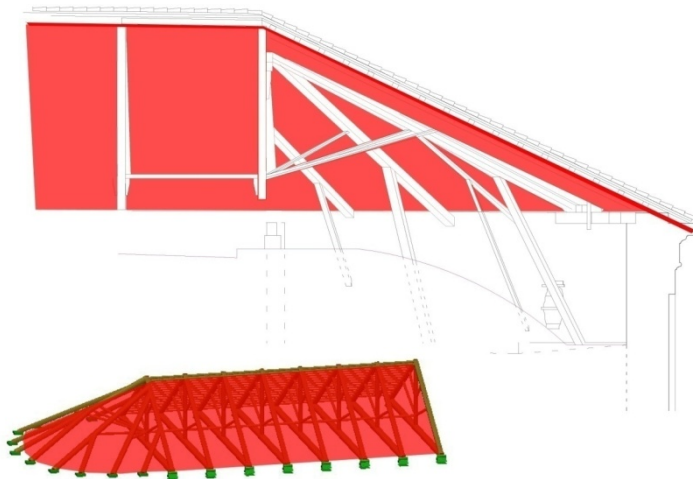
Plan 17

Red: added timber panels nailed on the beams

It would be a good idea to cover the whole roof under the tiles with timber plates (plywood or LVL boards) to achieve a higher over all stiffness of the structure. In general changing the rigidity of a structure is risky it can lead to overloads in points which haven't been designed to take forces as high as they may occur after the intervention, but in this case the load is distributed over the whole structure and shouldn't lead to any further damage. Furthermore the plates are not as heavy as the foreseen tiles.

In every case (Version De Luca or timber panels) load will be added to the structure and the structure will have to be calculated again.

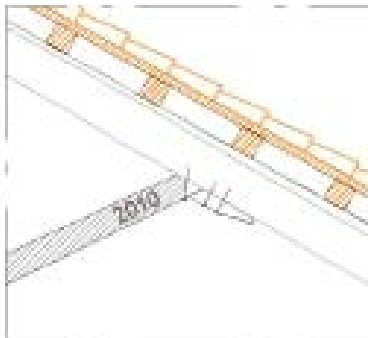
Plan 19

The trusses in the main aisle and the choir, but also the timber frames in the left and right aisle have been designed symmetrically. Now some elements are missing. They should be substitute. Oak wood should be used and the joints should be the same once like the once of the original structure. It is important to mark these elements to make it clear for later restorations that they have been added later. To avoid problems of shrinkage and deformations, the new timber element

should have the same moisture content as the rest of the original structure (Timber roof Vercelli about 16%). The element should be connected in the same way as the original one has been (In the case of the detail above nailed).

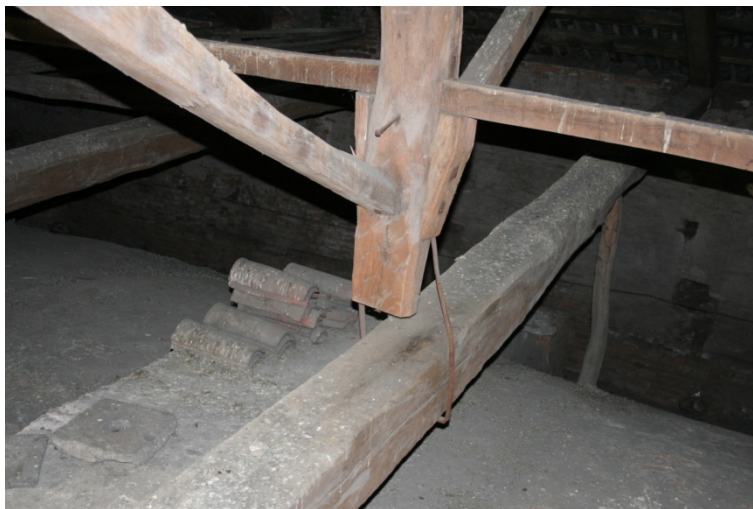
Plan 25

Many of the metal elements do not work anymore, mainly because of the elastic characteristics of metal. The elements got bigger and cannot overtake loads anymore. These elements have to be substituted. It would be preferable to choose a system which can be readjusted, to avoid such problems in future.

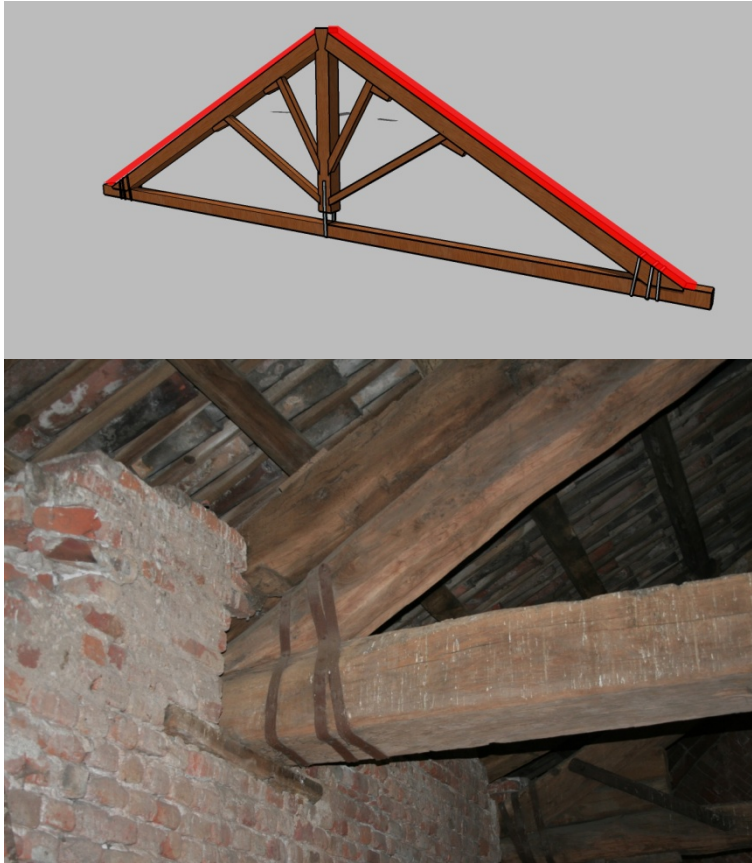
Illustration 70 doubled beam

The problem of the elements which are unable to carry the loads can be resolved in various ways.

The simplest way is often the best one. Therefore, in the case where the elements have above themselves already different little timber elements to change the inclination, I would recommend adding a timber piece on top and connecting the two elements (double the beam).

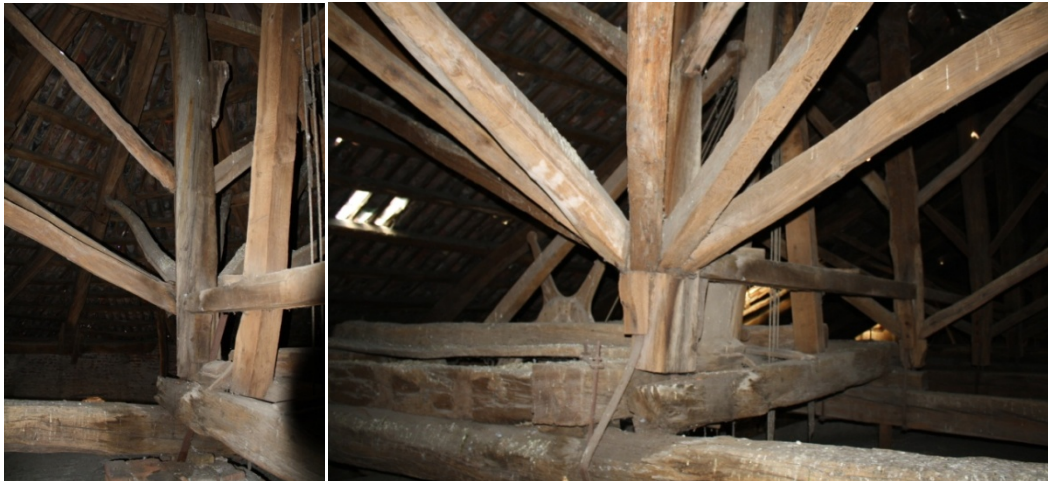
Illustration 71 umbrella structure

The most difficult point to resolve is the situation in the choir and the main aisle, where the umbrella construction intersects with the king post. Either the original situation could be reconstructed (The beam connecting the trusses proceeds up to the inner wall), or a metal element can be added to the truss to overtake the too high forces.

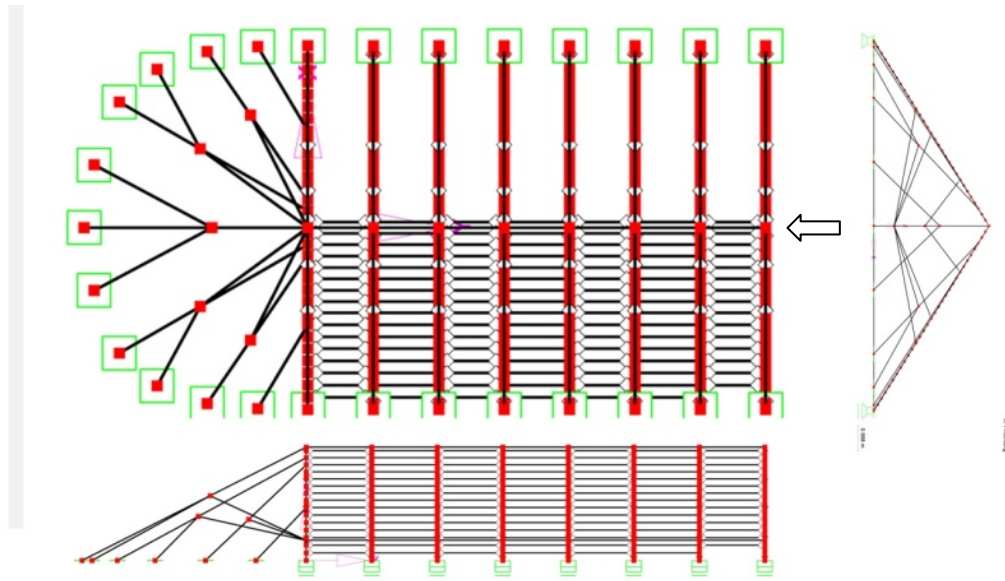
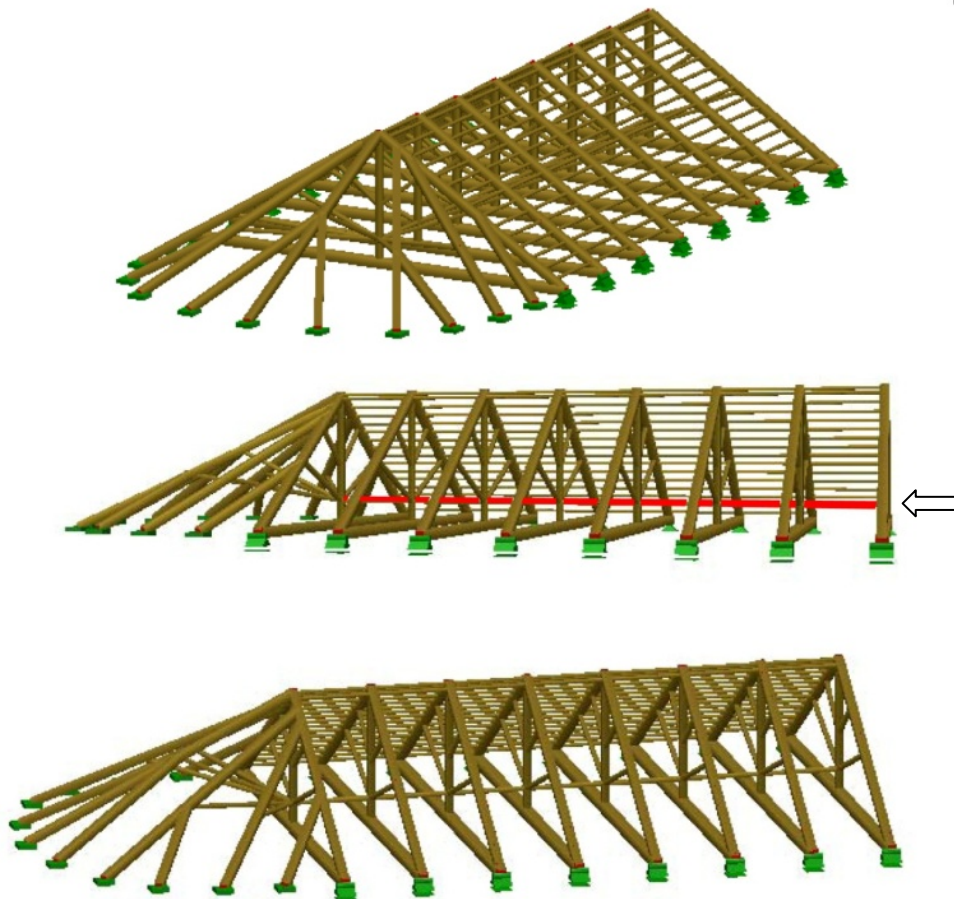
sketch 18

The problem with the first method (original structure) is that it is not perfectly clear, that the structure once really looked like this and that it will work without problems.

Pic: Original version (inserting the missing horizontal elements connecting the trusses)

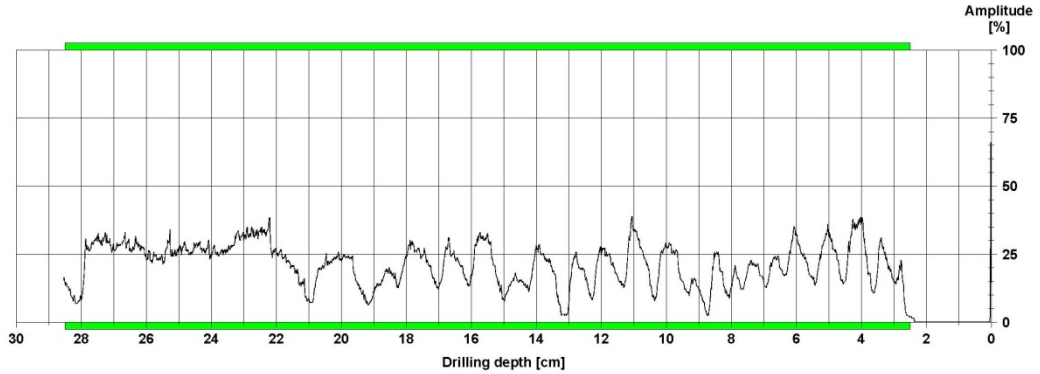
Truss	N. 1		Choir	
Tie-beam				
Biological decay	From fungi	Fungi is present. It interests the superficial part of the element for about 1cm depth on each side.		
	From insects	Absent		
Defects	Joints	Weak (intervention necessary)		
	Ring-shakes	No signs (absent)		
	Twist	deviation of the fibre direction		
Wooden species	Oak			
Moisture content	18 % Water infiltration visible N and S side			
Average dimensions of the element	30 x 30 cm			
	Section	Rectangular		
	Geometric peculiarity	Wane	Wane and deviation of the fibre direction	
Deformations		Slightly deformed		
Other characteristics	The state of the truss is critical, because the joint (bottom chord - top chord) doesn't work anymore. Water infiltrations provoked grow of fungi (Xilofagi), which caused a heavy degrade at the final part of the bottom chord (point of support on the wall). The bottom chord (tie beam) enters on both sides (N and S) 75cm into the wall.

From 0,0 cm to 0,0 cm :
From 2,5 cm to 28,5 cm : good condition
From 0,0 cm to 0,0 cm :
From 0,0 cm to 0,0 cm :
From 0,0 cm to 0,0 cm :
From 0,0 cm to 0,0 cm :

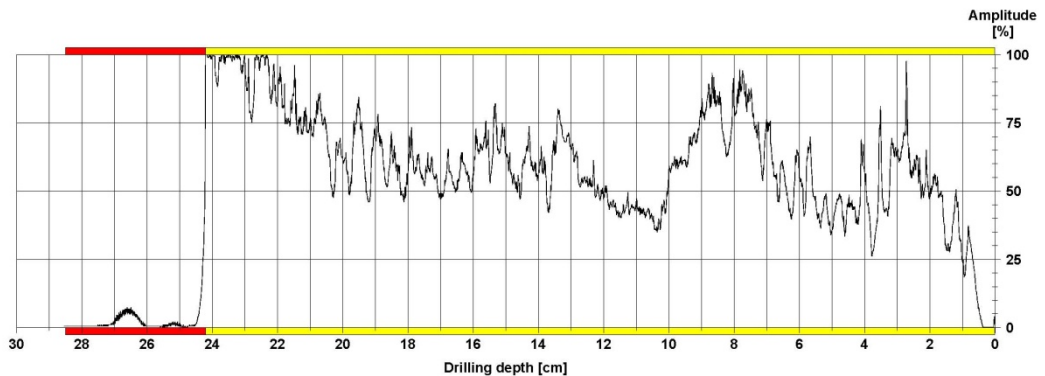
3.12.08	R 25	front end south side	underside to top side Inclination 45° (ref. exterior wall)	The test was executed on soft timber on the truss 1. The drill shows the moderate condition of the structural element in the first phase and the low load bearing capacity of the structural element in the second phase. It has to be considered that the structural element is drenched with water.
---------	------	-------------------------------	--	---

From 0,0 cm to 24,2 cm : moderate condition
From 24,2 cm to 28,5 cm : poor condition
From 0,0 cm to 0,0 cm :
From 0,0 cm to 0,0 cm :
From 0,0 cm to 0,0 cm :

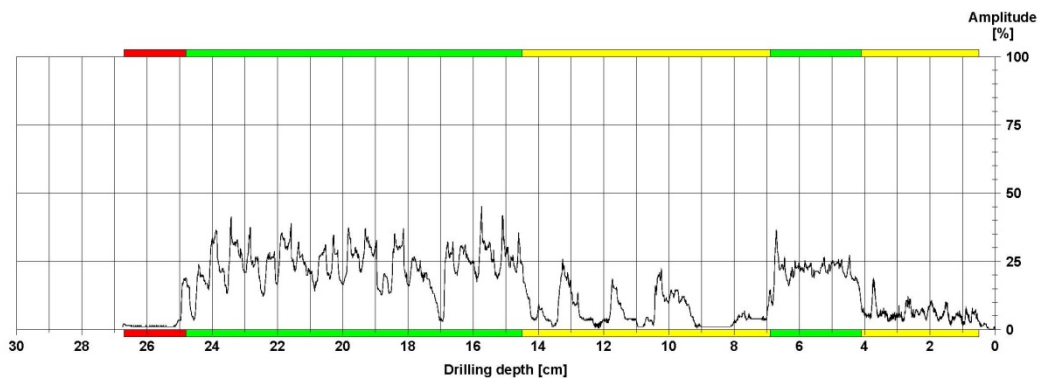
Rafter	North Side	
Biological decay	From fungi	Fungi is present in the superficial part of the element.
	From insects	Absent
Defects	Joints	Moderate (connection tie beam) Better (connection king beam)
	Ring-shakes	No signs (absent)

From 0,0 cm to 0,0 cm :	
From 0,5 cm to 4,1 cm : moderate condition	Yellow
From 4,1 cm to 6,9 cm : good condition	Green
From 6,9 cm to 14,5 cm : moderate condition	Yellow
From 14,5 cm to 24,8 cm : good condition	Green
From 24,8 cm to 26,7 cm : weak condition	Red

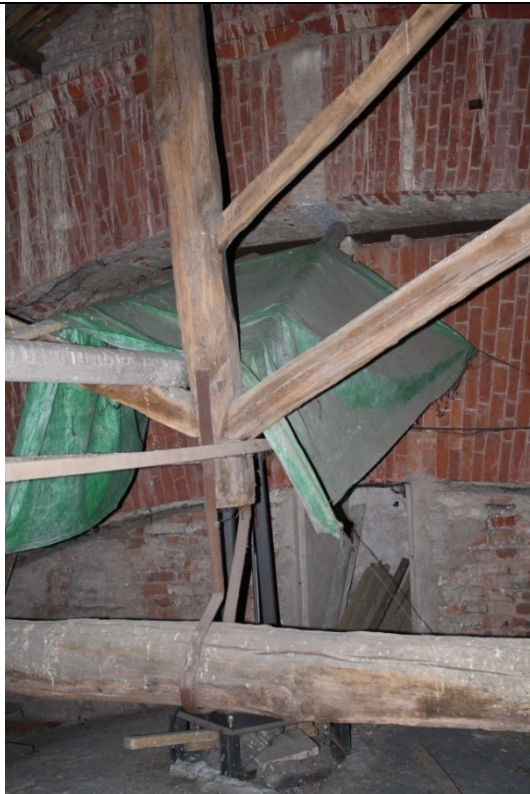
IMG_0737
Knot (king post - chord member)

Wooden species	Oak		
Moisture content	According to the surrounding air about 16%		
Average dimensions of the element	22 x 25 cm		
	Section	Rectangular	
	Geometric peculiarity	Wane	Wane
Deformations			
Other characteristics	The post is not lined up with the tie beam. The horizontal connections joining the king posts with each other caused a displacement of the timber element. Knots and wane, but generally in a moderate condition
