Hidden Architecture
The timber roof structure of the dome of Vercelli
Inspection-Diagnostics- Interventions

A Master's thesis submitted for the degree of
"Master of Science"

DI Pia Therese Panosch
0126769

Milan, 05.02.2010

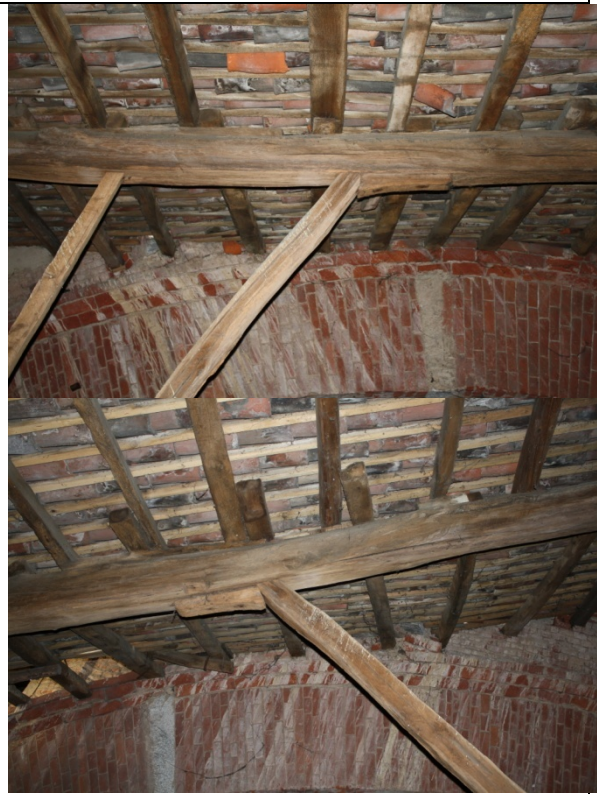
IMG_0739 / IMG_0736
Knot (rafter - chord member)

Rafter	South Side	
Biological decay	From fungi	Present in the part inside the masonry.
	From insects	Absent
Defects	Joints	Weak (connection tie beam) Better (connection king beam)
	Ring-shakes	No signs (absent)
	Twist	No signs (absent)
Wooden species	Oak	
Moisture content	16 % Water infiltration visible	
Average dimensions of the element	27 x 27 cm	
	Section	Rectangular
	Geometric peculiarity	Wane
Deformations		
Other characteristics	Wane, generally in a moderate condition	
King Post		
Biological decay	From fungi	Present in the part inside the masonry.
	From insects	Absent
Defects	Joints	The connection with the rafters seems to be in a moderate condition. The metal connection with the tie beam doesn't work anymore. The metal lengthened and doesn't support the tie beam anymore (no tension forces can be transmitted).
	Ring-shakes	No signs (absent)
	Twist	No signs (absent)

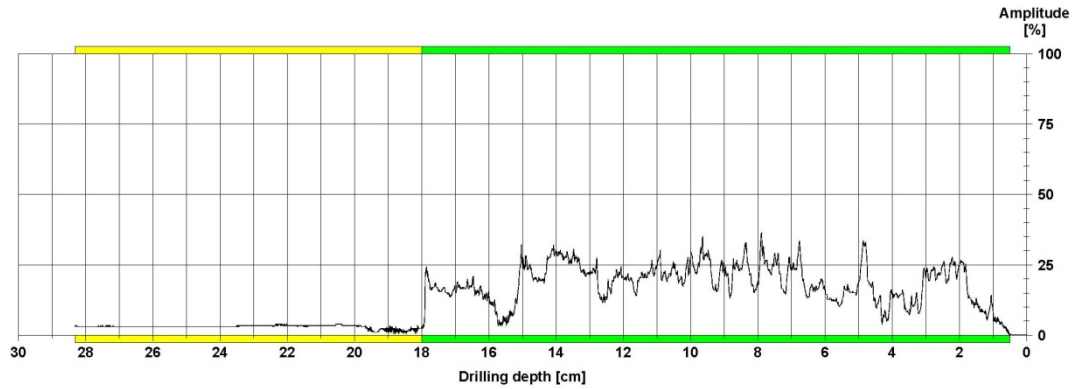
Truss	N. 2		Choir	
Tie-beam				
Biological decay	From fungi	Sapwood: fungi attack		
	From insects	Absent		
Defects	Joints	See rafter		
	Ring-shakes	Single deviation of the fibre direction		
	Twist			
Wooden species	Oak			
Moisture content	According to the surrounding air about 16%			
Average dimensions of the element	30 x 30 cm			
	Section	Rectangular		
	Geometric peculiarity	Wane	Absent	
Deformations		Absent		
Other characteristics	<p>The head (south side) of the element is twisted and shows a fracture which starts at the other end of the tie beam. The timber in this area is weakened and the sap wood is missing.</p> <p>A protection cover has been introduced at the end of the beam.</p> <p>On the topside of the bottom chord is an interior void which is covered by a timber cap.</p> <p>The bottom chord has shrinking fractures with an obligatory inclination. The timber of the chord can be classified in the 3rd category.</p>

<input type="checkbox"/>	From 0,0 cm to 0,0 cm :
<input checked="" type="checkbox"/>	From 0,5 cm to 18,0 cm : good condition
<input checked="" type="checkbox"/>	From 18,0 cm to 28,3 cm : moderate condition
<input type="checkbox"/>	From 0,0 cm to 0,0 cm :
<input type="checkbox"/>	From 0,0 cm to 0,0 cm :
<input type="checkbox"/>	From 0,0 cm to 0,0 cm :

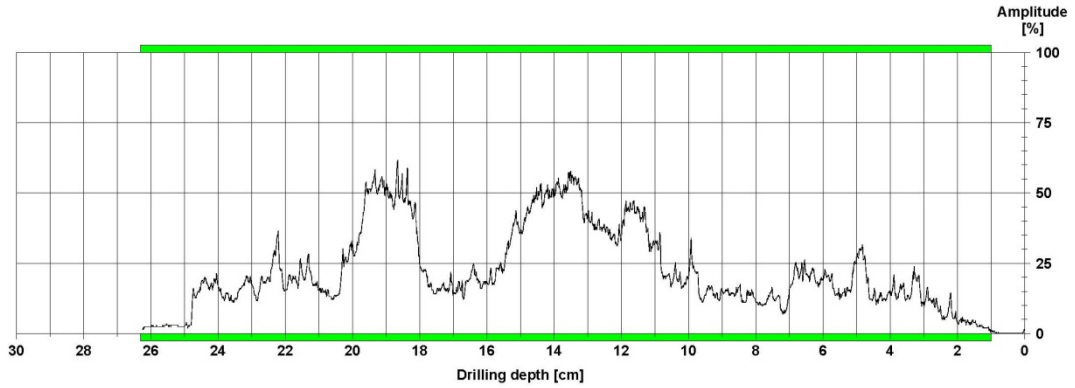
From 0,0 cm to 0,0 cm :	
From 1,0 cm to 26,3 cm :	good condition
From 0,0 cm to 0,0 cm :	
From 0,0 cm to 0,0 cm :	
From 0,0 cm to 0,0 cm :	
From 0,0 cm to 0,0 cm :

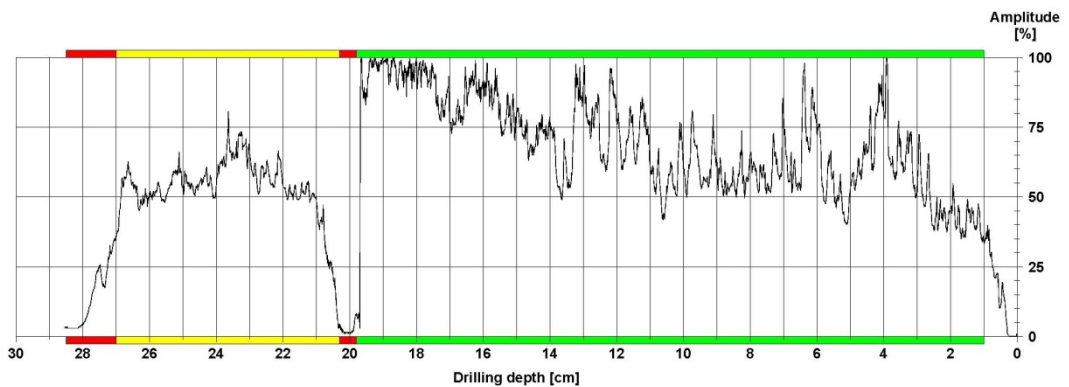
3.12.08	R 5	front end north side	underside to top side Inclination 45° (ref. exterior wall)	- Drill 5 (executed on soft timber): the test was taken on the bottom chord in distance of about 2 meters from the front end, after the timber joint (bottom chord - top chord). A fracture about the twentieth centimetre was registered.
---------	-----	-------------------------------	--	--

From 0,0 cm to 0,0 cm :	
From 1,0 cm to 19,8 cm :	good condition
From 19,8 cm to 20,3 cm :	crack
From 20,3 cm to 27,0 cm :	moderate condition
From 27,0 cm to 28,5 cm :	weak
From 0,0 cm to 0,0 cm :

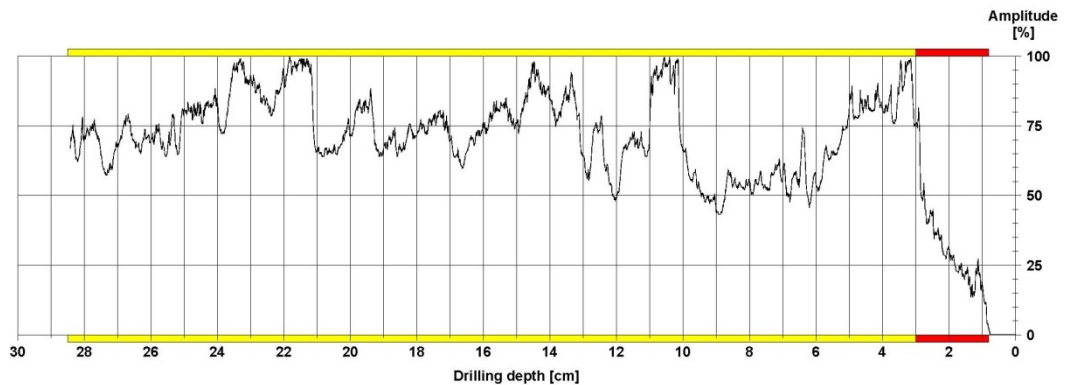
3.12.08	R 24	front end south side	underside to top side Inclination 45° (ref. exterior wall)	- Drill 24 (executed on soft timber): the test was taken on the truss 2. The drill shows the extremely bad condition of the structural element in the first part and that the condition of the beam improves in the second part.
---------	------	----------------------	--	--

From 0,0 cm to 0,8 cm :	
From 0,8 cm to 3,0 cm :	bad condition
From 3,0 cm to 28,5 cm :	moderate condition
From 0,0 cm to 0,0 cm :	
From 0,0 cm to 0,0 cm :	
From 0,0 cm to 0,0 cm :

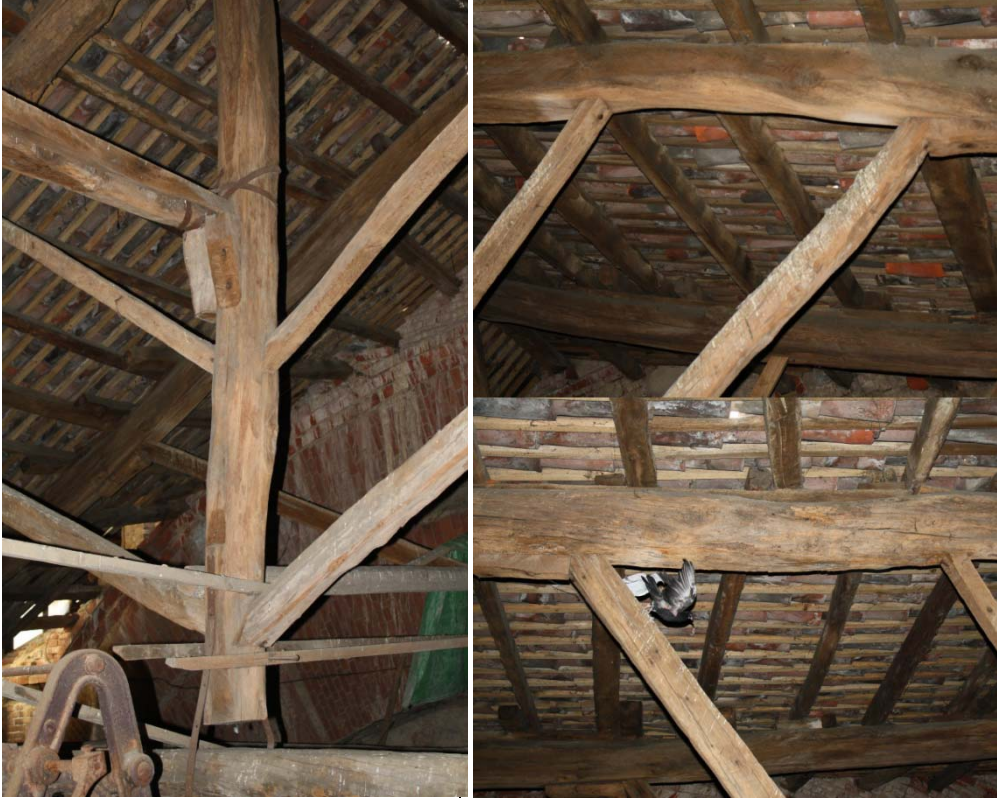
n. Photo	IMG_0729 Knot (king post - chord member)

Biological decay	From fungi	Present in the part inside the masonry.	
	From insects	Absent	
Defects	Joists	The connection with the rafters seems to be in a good condition. The metal connection with the tie beam doesn't work anymore. The metal lengthened and doesn't support the tie beam anymore (no tension forces can be transmitted).	
	Ring-shakes		
	Twist		
Wooden species	Oak		
Moisture content	According to the surrounding air about 16%		
Average dimensions of the element	22 x 23 cm		
	Section	Rectangular	
	Geometric peculiarity	Wane	Knot and wane
Deformations			
Other characteristics	The post is not lined up with the tie beam. The horizontal connections joining the king posts with each other caused a displacement of the timber element. The presence of the tenon in the connection with the tie-beam is evident in profiles 36a and 38a. From the profiles are not visible particular decay signs.

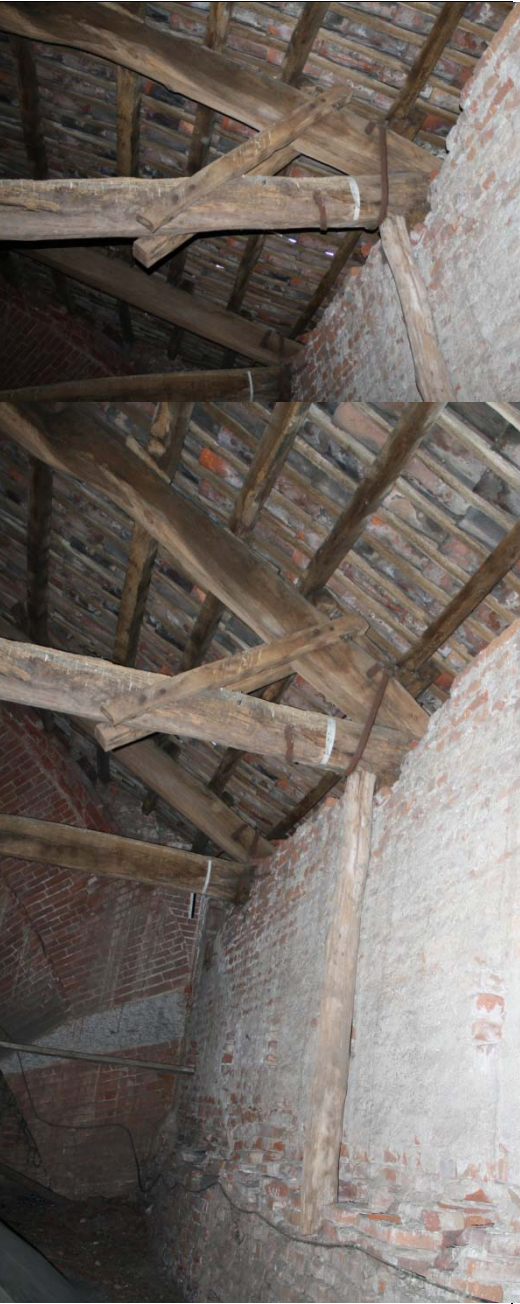
n. Photo	IMG_0649 / IMG_0650/ IMG_0728/ IMG_0679 Knot (rafter - tie beam) South side	IMG_0678/ IMG_0677 Knot (rafter - tie beam) Nord side

Rafter		North Side	
Biological decay	From fungi	Present in the part inside the masonry.	
	From insects	Absent	
Defects	Joints	The joint of the truss on the north side (bottom cord - top chord) has a double connection with nailed timber elements in an angle of circa 25-28 ° compared to the horizontal direction of the bottom truss. The joint (bottom cord - top chord) on north side is supported by a wooden "barotto" placed vertically and next to the external wall.	
	Ring-shakes		
	Twist		
Wooden species	Oak		
Moisture content	According to the surrounding air about 16%		
Average dimensions of the element	28 x 28 cm		
	Section	Rectangular	
	Geometric peculiarity	Wane	Nothing to observe.
Deformations			
Other characteristics	Single deviation of the fibre direction		
Rafter		South Side	
Biological decay	From fungi	Present in the part inside the masonry.	
	From insects	Absent	
Defects	Joints	The whole sapwood on the joint (bottom cord - top chord) is degraded by fungi. The joint of the south side (bottom cord - top chord) shows a transversal fracture provoked by a load cutting parallel to the fibre of the bottom chord.

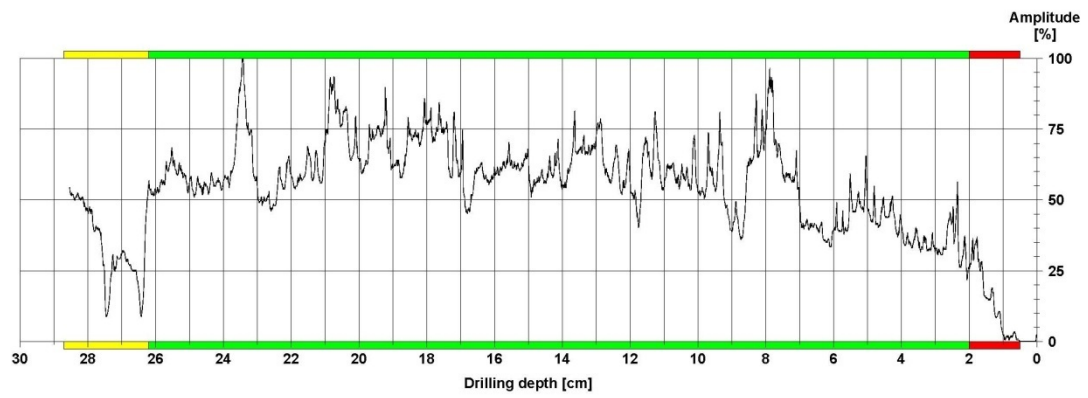
Defects	Joints	See rafter	
	Ring-shakes	Nothing observed	
	Twist		
Wooden species	Oak		
Moisture content	15% N side		
Average dimensions of the element	30 x 30 cm		
	Section	Rectangular	
	Geometric peculiarity	Wane	Absent
Deformations		Absent	
Other characteristics	The state of the beam is moderate. A single knot is visible.

From 0,0 cm to 0,0 cm :	
From 0,5 cm to 2,0 cm : bad condition	Red
From 2,0 cm to 26,2 cm : good condition	Green
From 26,2 cm to 28,7 cm : moderate condition	Yellow
From 0,0 cm to 0,0 cm :	
From 0,0 cm to 0,0 cm :

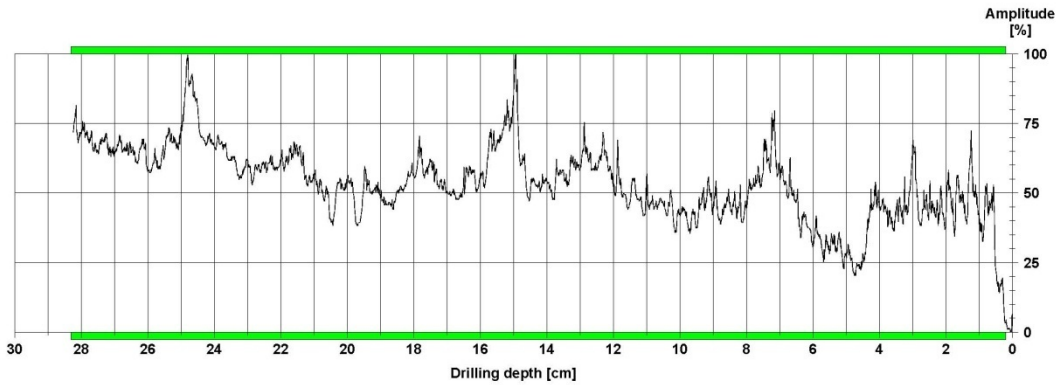
3.12.08	R 23	front end south side	underside to top side Inclination 45° (ref. exterior wall)	- Drill 23 (executed on soft timber): the test was taken on the truss 3. The drill shows the good condition of the structural element.
---------	------	----------------------	--	--

<input type="checkbox"/>	From 0,0 cm to 0,2 cm :
<input checked="" type="checkbox"/>	From 0,2 cm to 28,3 cm : good condition
<input type="checkbox"/>	From 0,0 cm to 0,0 cm :
<input type="checkbox"/>	From 0,0 cm to 0,0 cm :
<input type="checkbox"/>	From 0,0 cm to 0,0 cm :
<input type="checkbox"/>	From 0,0 cm to 0,0 cm :

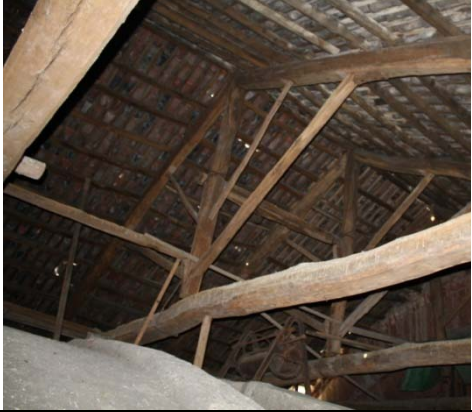
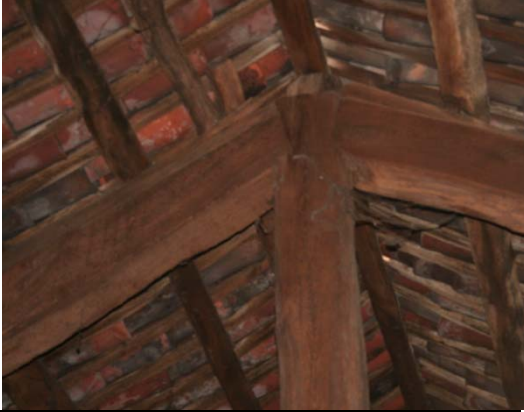
n. Photo	IMG_0688 Truss 3	IMG_7058 Knot (king post - rafter)
PHOTO

Deformations	
Other characteristics	Injuries on the living tree are visible. The rafter is in a moderate condition.		
King Post			
Biological decay	From fungi	Nothing observed	
	From insects	Absent	
Defects	Joints	The connection with the rafters seems to be in a good condition. The metal connection with the tie beam doesn't work anymore. The metal lengthened and doesn't support the tie beam anymore (no tension forces can be transmitted).	
	Ring-shakes

Twist	
Wooden species	Oak	
Moisture content	According to the surrounding air about 16%	
Average dimensions of the element	26 x 20 cm	
	Section	Rectangular
	Geometric peculiarity	Wane
Deformations		
Other characteristics	The post is not lined up with the tie beam. The horizontal connections joining the king posts with each other caused a displacement of the timber element. The king post is in a moderate condition.	
PHOTO

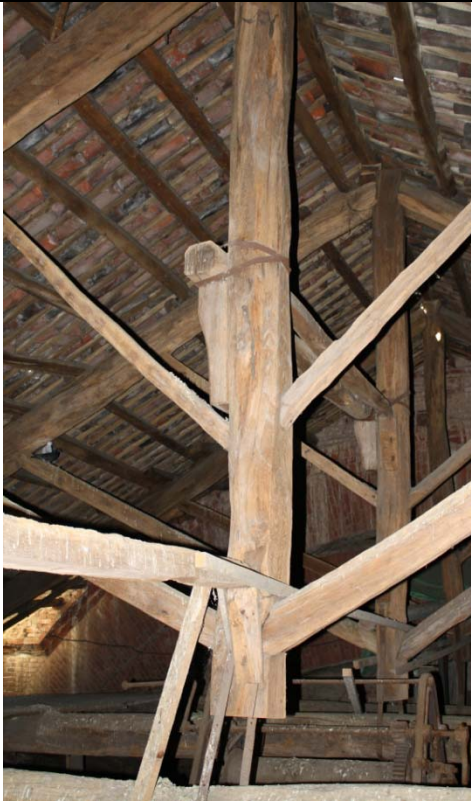
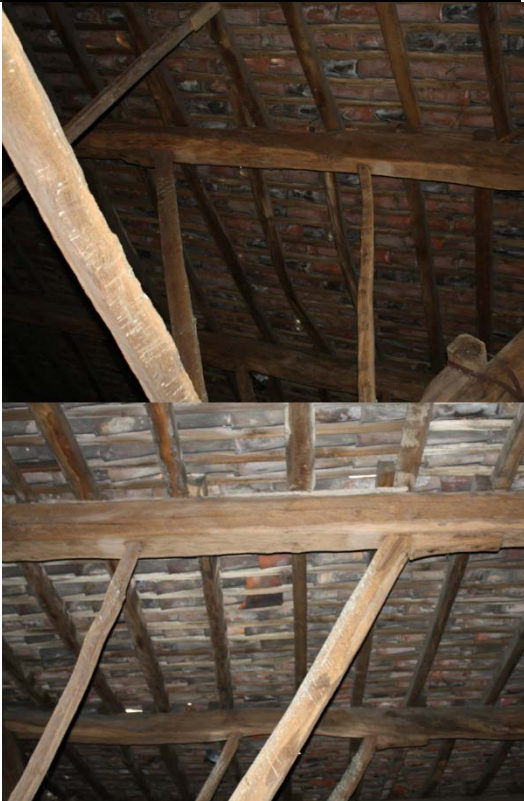
n. Photo	IMG_0725 Knot (king post - chord member)	IMG_0726 / IMG_0727 Knot (rafter - chord member)

Rafter		North Side	
Biological decay	From fungi	Nothing observed	
	From insects	Absent	
Defects	Joints	The joint of the truss on the north side (rafter tie beam) is realised in a zone of sapwood. This is a big problem considering that in this area the sapwood is degraded and the joint cannot work probably.	
	Ring-shakes		
	Twist		
Wooden species	Oak		
Moisture content	21%		
Average dimensions of the element	28 x 28 cm		
	Section	Rectangular	
	Geometric peculiarity	Wane	Nothing observed
		Deformations	
Other characteristics	The rafter is in a good condition. Some knots are visible.		
Rafter		South Side	
Biological decay	From fungi	Nothing observed	
	From insects	Absent	
Defects	Joints	Nothing observed	
	Ring-shakes		
	Twist		
Wooden species	Oak		
Moisture content	According to the surrounding air about 16%		
Average dimensions of the element	24 x 29 cm		
	Section	Rectangular	
	Geometric peculiarity	Wane	Nothing observed

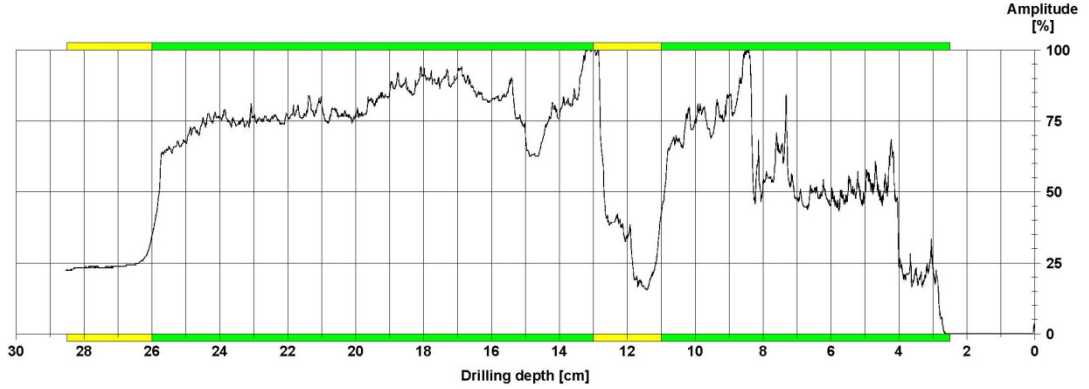
3.12.08	R 21/22	front end south side	underside to top side Inclination 45° (ref. exterior wall)	- Drill 21 and 22 (executed on soft timber): The test was taken on the tie beam, showing the good condition of the structural element.

From 0,0 cm to 2,5 cm :	
From 2,5 cm to 11,0 cm :	good condition
From 11,0 cm to 13,0 cm :	moderate condition
From 13,0 cm to 26,0 cm :	good condition
From 26,0 cm to 28,5 cm :	moderate condition
From 0,0 cm to 0,0 cm :

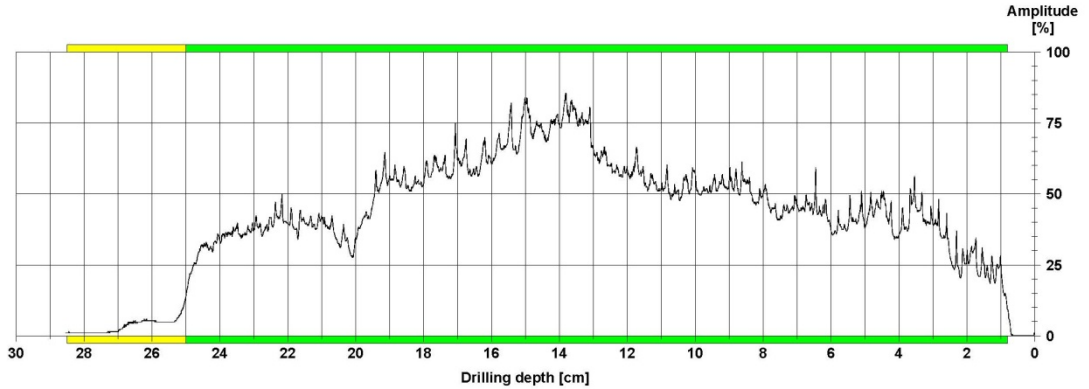
From 0,0 cm to 0,8 cm :	
From 0,8 cm to 25,0 cm :	good condition
From 25,0 cm to 28,5 cm :	moderate condition
From 0,0 cm to 0,0 cm :	
From 0,0 cm to 0,0 cm :	
From 0,0 cm to 0,0 cm :

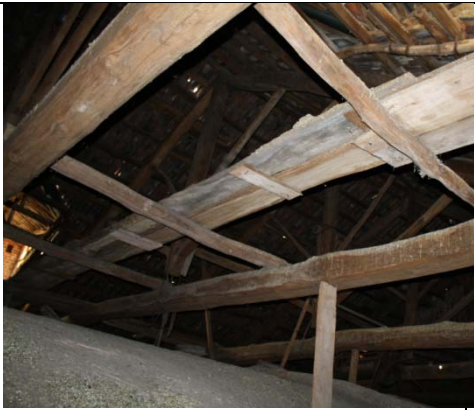
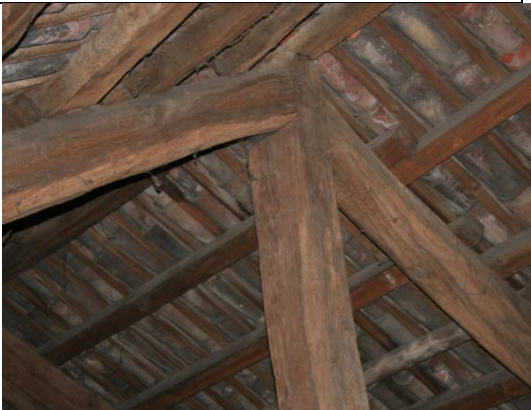
n. Photo	IMG_0689 Truss 4	IMG_7364 Knot (king post - rafter)

Wooden species	Oak		
Moisture content	>30%		
Average dimensions of the element	27 x 27 cm		
	Section	Rectangular	
	Geometric peculiarity	Wane	Knot and wane
Deformations			
Other characteristics	On the rafter on the north side water infiltrations according to an un-tight roof are visible.		
Rafter			
Biological decay	From fungi	Nothing visible	
	From insects	Absent	
Defects	Joints	Moderate	
	Ring-shakes	Nothing observed	
	Twist		
Wooden species	Oak		
Moisture content	According to the surrounding air about 16%		
Average dimensions of the element	28 x 28 cm		
	Section	Rectangular	
	Geometric peculiarity	Wane	Knot and wane
Deformations			
Other characteristics	The rafter is in a moderate condition.		
King Post			
Biological decay	From fungi	Absent	
	From insects	Absent	
Defects	Joints	The connection with the rafters seems to be in a good condition. The metal connection with the tie beam doesn't work anymore. The metal lengthened and doesn't support the tie beam anymore (no tension forces can be transmitted).

Ring-shakes		
	Twist		
Wooden species	Oak		
Moisture content	According to the surrounding air about 16%		
Average dimensions of the element	24 x 26 cm		
	Section	Rectangular	
	Geometric peculiarity	Wane	Wane
Deformations			
Other characteristics	The post is not lined up with the tie beam. The horizontal connections joining the king posts with each other caused a displacement of the timber element. The post is in a moderate condition.		
PHOTO

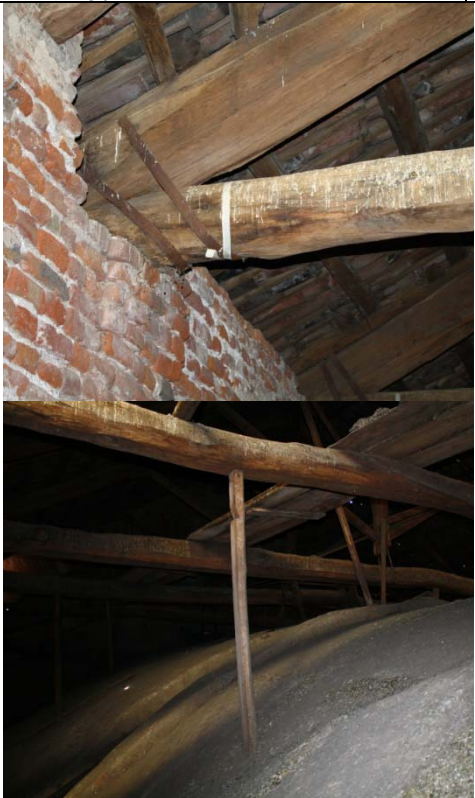
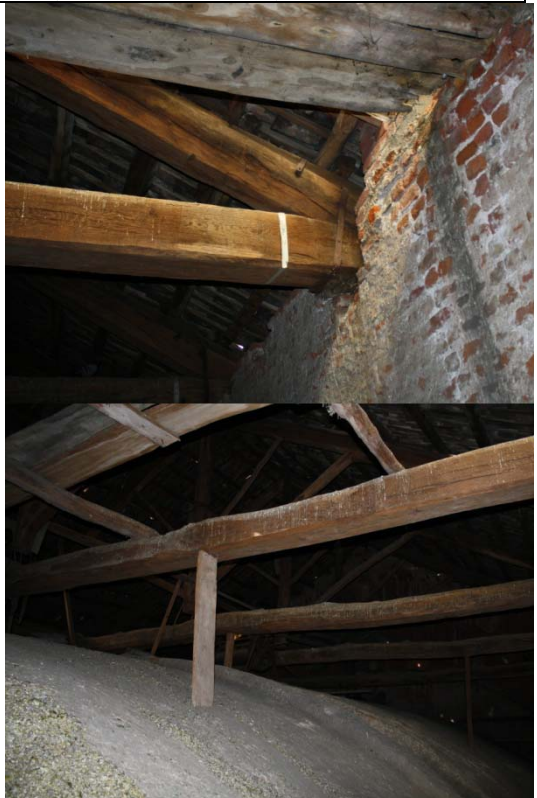
n. Photo	IMG_0643 / IMG_0644 Knot (rafter - tie beam) South side	IMG_0671 / IMG_0672 Knot (rafter - tie beam) Nord side

Rafter	North Side	
Biological decay	From fungi	Nothing visible
	From insects	Absent
Defects	Joints	Moderate
	Ring-shakes	Nothing observed
	Twist

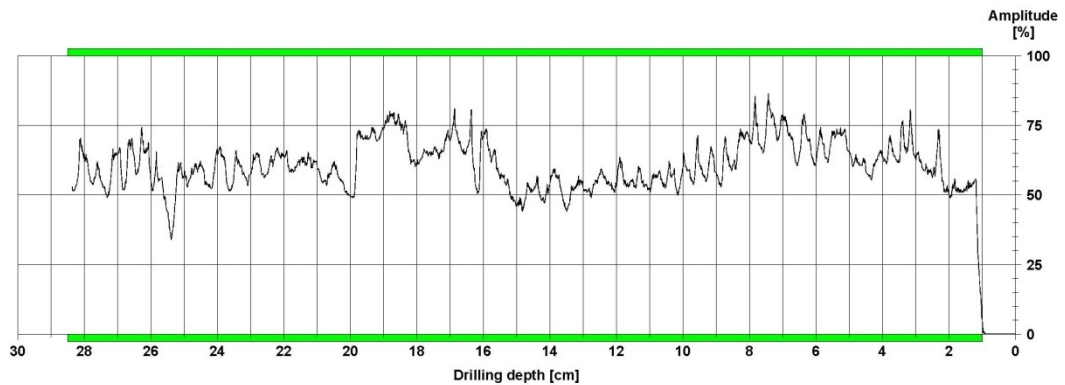
Truss	N. 5	Choir	
Tie-beam			
Biological decay	From fungi	Present (joints)	
	From insects	Absent	
Defects	Joints	See rafter	
	Ring-shakes	Nothing visible	
	Twist		
Wooden species	Oak		
Moisture content	According to the surrounding air about 16%		
Average dimensions of the element	26 x 30 cm		
	Section	Rectangular	
	Geometric peculiarity	Wane	Absent
		Deformations	Absent
Other characteristics	Next to the joint with the rafter the tie beam has a big knot. This leads to a reduction of the effective cross-section. On the south side the tie beam is heavily degraded!

<input type="checkbox"/>	From 0,0 cm to 0,0 cm :
<input checked="" type="checkbox"/>	From 1,0 cm to 28,5 cm : good condition
<input type="checkbox"/>	From 0,0 cm to 0,0 cm :
<input type="checkbox"/>	From 0,0 cm to 0,0 cm :
<input type="checkbox"/>	From 0,0 cm to 0,0 cm :

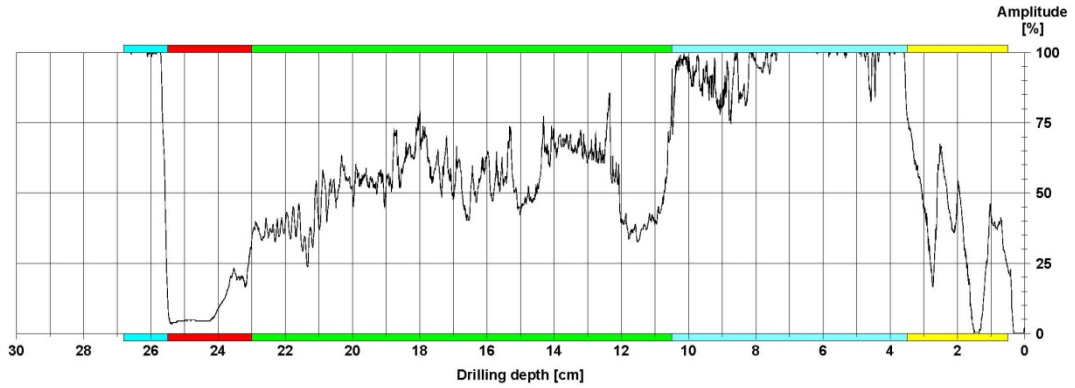
Measurement no. : 19	Time : 12:37:40	Location : Dome Vercelli
Drilling depth : 26,65 cm	Avg. curve : off	Name : Tie beam
Wood species : Soft (1)	Diameter :	Length of cavities : ---
ID number : 10	Level :	Min. width / height : ---
Advance : 27,6 cm/min	Direction : Bottom to top 45°	Start of detecting : ---
Date : 04.12.2008	Object species : Oak	Detect last cavity : ---

From 0,0 cm to 0,0 cm :
From 0,5 cm to 3,5 cm : moderate condition
From 3,5 cm to 10,5 cm : extremely high
From 10,5 cm to 23,0 cm : good condition
From 23,0 cm to 25,5 cm : weak
From 25,5 cm to 26,8 cm : extremely high

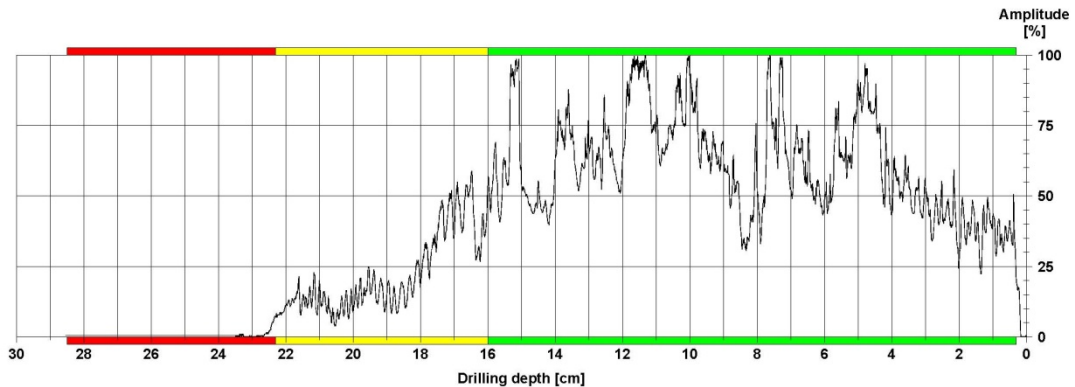
Measurement no. : 20	Time : 12:40:05	Location : Dome Vercelli
Drilling depth : 28,55 cm	Avg. curve : off	Name : Tie beam
Wood species : Soft (1)	Diameter :	Length of cavities : ---
ID number : 10	Level :	Min. width / height : ---
Advance : 27,6 cm/min	Direction : Bottom to top 45°	Start of detecting : ---
Date : 04.12.2008	Object species : Oak	Detect last cavity : ---

From 0,0 cm to 0,0 cm :
From 0,3 cm to 16,0 cm : good condition
From 16,0 cm to 22,3 cm : moderate condition
From 22,3 cm to 28,5 cm : weak
From 0,0 cm to 0,0 cm :
From 0,0 cm to 0,0 cm :

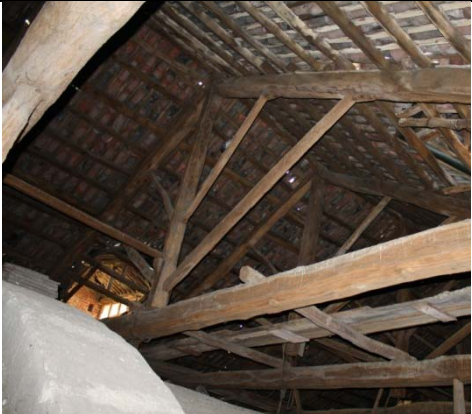
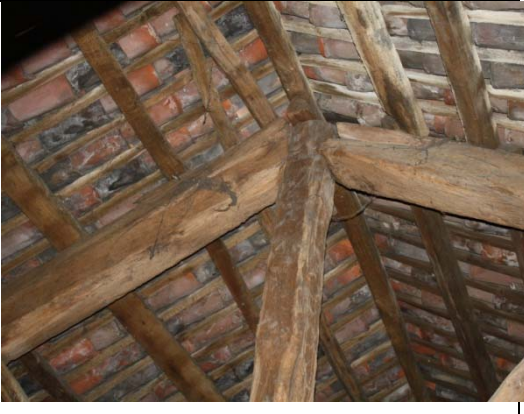
n. Photo	IMG_0690 Truss 5	IMG_0710 Knot (king post - rafter)

King Post			
Biological decay	From fungi	Nothing visible	
	From insects	Absent	
Defects	Joints	The connection with the rafters seems to be in a good condition. The metal connection with the tie beam doesn't work anymore. The metal lengthened and doesn't support the tie beam anymore (no tension forces can be transmitted).	
	Ring-shakes		
	Twist		
Wooden species	Oak		
Moisture content	According to the surrounding air about 16%		
Average dimensions of the element	23 x 21 cm		
	Section	Rectangular	
	Geometric peculiarity	Wane	Nothing visible
		Deformations	
Other characteristics	The post is in a moderate condition. The post is not lined up with the tie beam. The horizontal connections joining the king posts with each other caused a displacement of the timber element.		
PHOTO

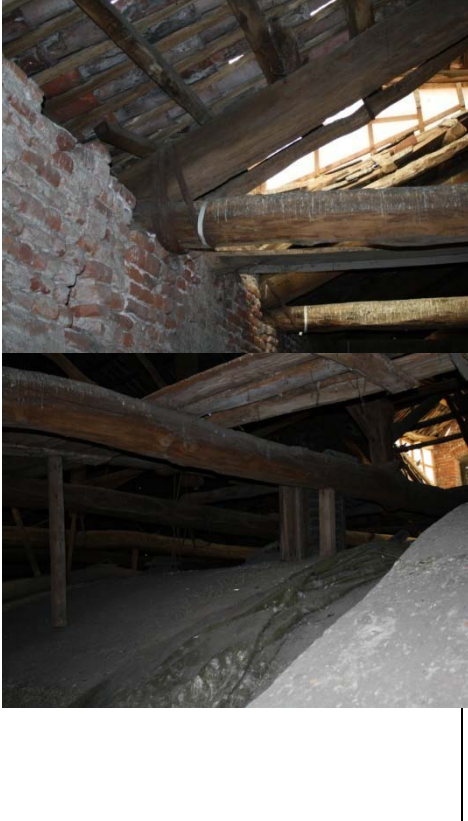
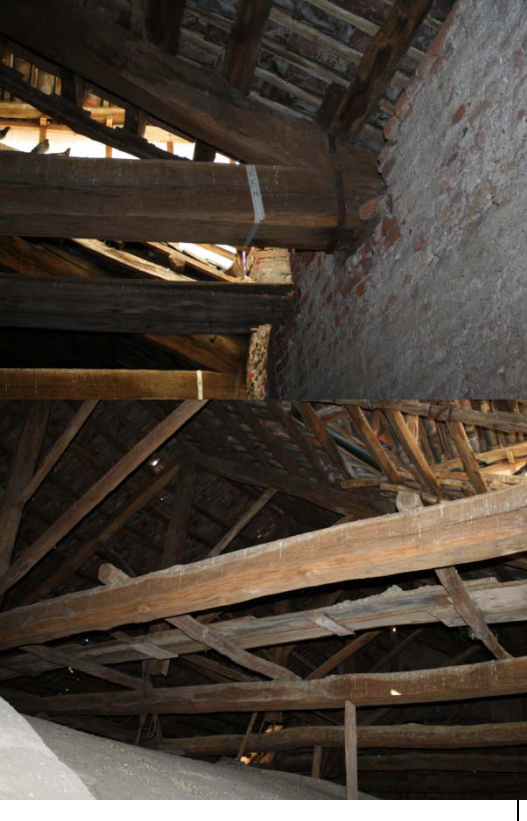
n. Photo	IMG_0640 / IMG_0641 Knot (rafter - tie beam) South side	IMG_0668 / IMG_0669 Knot (rafter - tie beam) Nord side

Defects	Joints	The load bearing capacity of the joint of the truss 5 on the north side (rafter tie beam) seems to be little efficient.	
	Ring-shakes	Nothing visible	
	Twist		
Wooden species	Oak		
Moisture content	According to the surrounding air about 16%		
Average dimensions of the element	20 x 28 cm		
	Section	Rectangular	
	Geometric peculiarity	Wane	Wane and knots
		Deformations	
Other characteristics	There is a superficial degradation on the rafter visible (south side towards the apses), which was caused by water infiltrations (rain).		
Rafter			
South Side			
Biological decay	From fungi	Nothing visible	
	From insects	Absent	
Defects	Joints	Moderate	
	Ring-shakes	Nothing visible	
	Twist		
Wooden species	Oak		
Moisture content	According to the surrounding air about 16%		
Average dimensions of the element	21 x 27 cm		
	Section	Rectangular	
	Geometric peculiarity	Wane	Nothing visible
		Deformations	
Other characteristics	The beam is in a moderate condition.

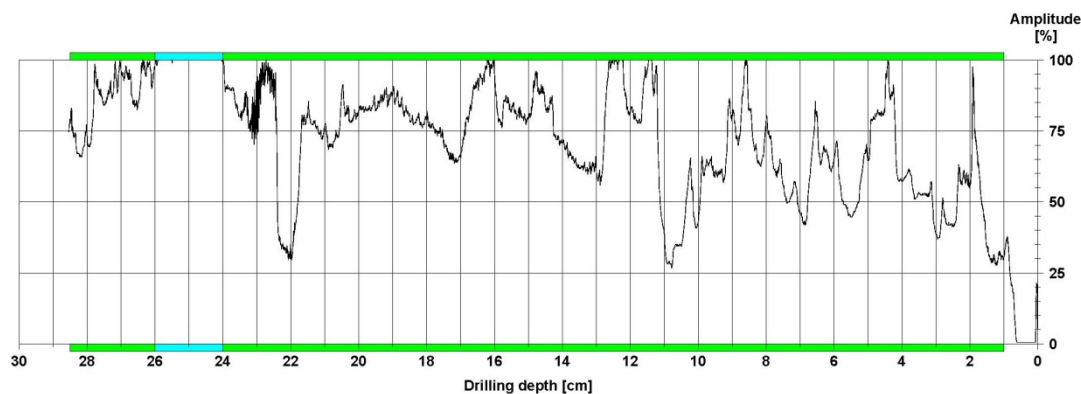
Measurement no. : 9	Time : 13:31:36	Location : Dome Vercelli
Drilling depth : 28,54 cm	Avg. curve : off	Name : Tie beam
Wood species : Soft (1)	Diameter :	Length of cavities : --
ID number : 10	Level :	Min. width / height : --
Advance : 27,6 cm/min	Direction : Bottom to top 45°	Start of detecting : --
Date : 03.12.2008	Object species : Oak	Detect last cavity : --

From 0,0 cm to 0,0 cm :	
From 1,0 cm to 24,0 cm : good condition	
From 24,0 cm to 26,0 cm : very high value	
From 26,0 cm to 28,5 cm : good condition	
From 0,0 cm to 0,0 cm :	
From 0,0 cm to 0,0 cm :

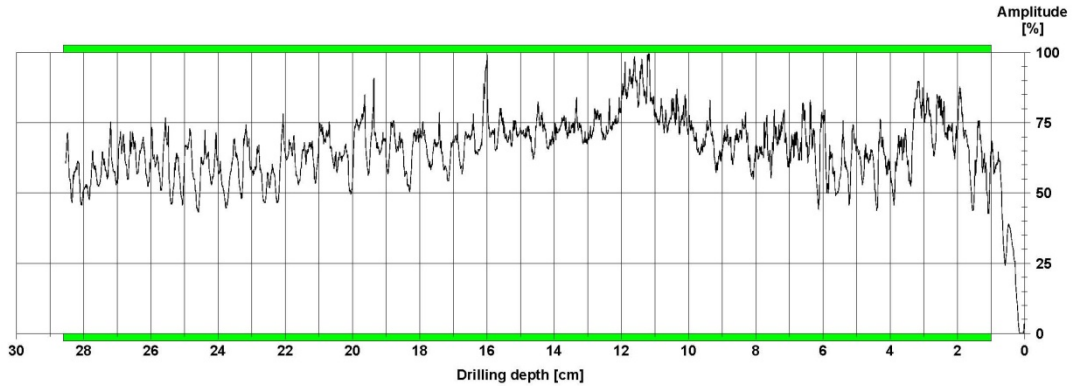
3.12.08	R 18	front end south side	underside to top side Inclination 45° (ref. exterior wall)	Drill 18 (executed on soft timber): the test was taken on the truss 6. The drill showed the good condition of the tie beam.
---------	------	----------------------	--	---

<input type="checkbox"/>	From 0,0 cm to 0,0 cm :
<input checked="" type="checkbox"/>	From 1,0 cm to 28,6 cm : good conditions
<input type="checkbox"/>	From 0,0 cm to 0,0 cm :
<input type="checkbox"/>	From 0,0 cm to 0,0 cm :
<input type="checkbox"/>	From 0,0 cm to 0,0 cm :
<input type="checkbox"/>	From 0,0 cm to 0,0 cm :

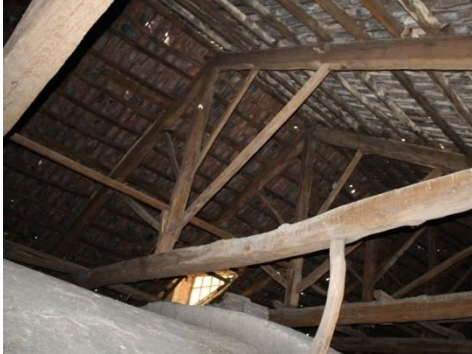
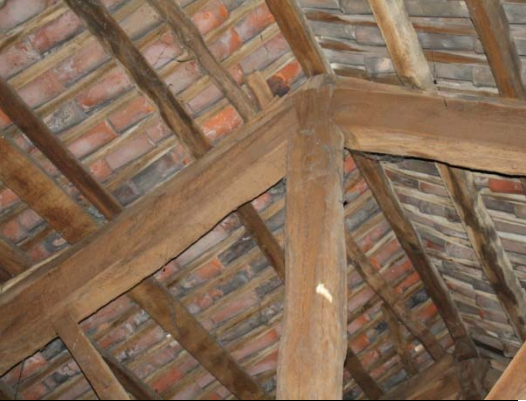
n. Photo	IMG_0691 Truss 6		IMG_0704 Knot (king post - rafter)
PHOTO

Defects	Joints	The connection with the rafters seems to be in a good condition. The metal connection with the tie beam doesn't work anymore. The metal lengthened and doesn't support the tie beam anymore (no tension forces can be transmitted).	
	Ring-shakes	Nothing observed	
	Twist		
Wooden species	Oak		
Moisture content	According to the surrounding air about 16%		
Average dimensions of the element	20 x 26 cm		
	Section	Rectangular	
	Geometric peculiarity	Wane	Wane
Other characteristics	Deformations		
	Some knots are visible. The king post is in a moderate condition. The post is not lined up with the tie beam. The horizontal connections joining the king posts with each other caused a displacement of the timber element.		
PHOTO

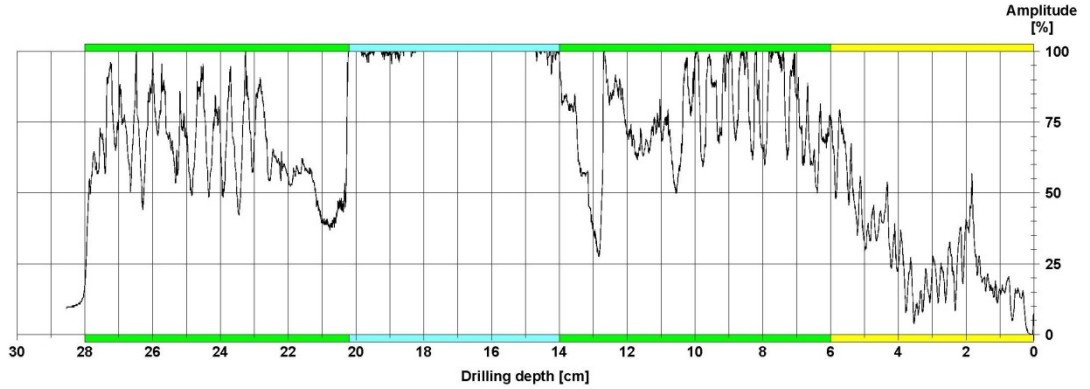
3.12.08	R 17	front end south side	underside to top side Inclination 45° (ref. exterior wall)	The test was executed on soft timber on the truss 7. The drill shows the good condition of the tie beam.

From 0,0 cm to 6,0 cm	: moderate condition
From 6,0 cm to 14,0 cm	: good condition
From 14,0 cm to 20,2 cm	: high values
From 20,2 cm to 28,0 cm	: good condition
From 0,0 cm to 0,0 cm	:
From 0,0 cm to 0,0 cm	:

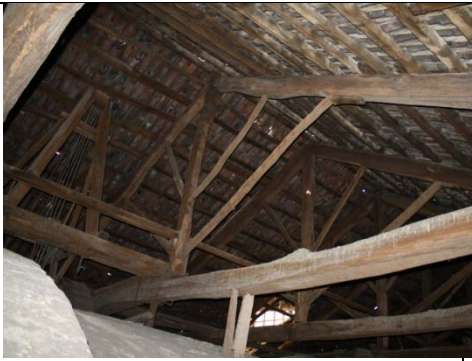
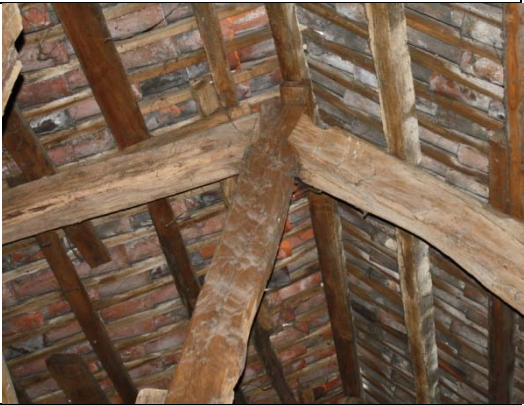
n. Photo	IMG_0692 Truss 7		IMG_0688 Knot (king post - rafter)
PHOTO

Defects	Joints	The joint connecting the rafters to the king beam seems to be in a good condition. The metal connection with the tie beam doesn't work anymore. The metal lengthened and doesn't support the tie beam (no tension forces can be transmitted).	
	Ring-shakes	Nothing observed.	
	Twist		
Wooden species	Oak		
Moisture content	According to the surrounding air about 16%		
Average dimensions of the element	22 x 20 cm		
	Section	Rectangular	
	Geometric peculiarity	Wane	Nothing observed.
	Deformations		
Other characteristics	The post is not lined up with the tie beam. The horizontal connections joining the king posts with each other caused a displacement of the timber element. The post is in a moderate condition. Some knots are visible.		
PHOTO

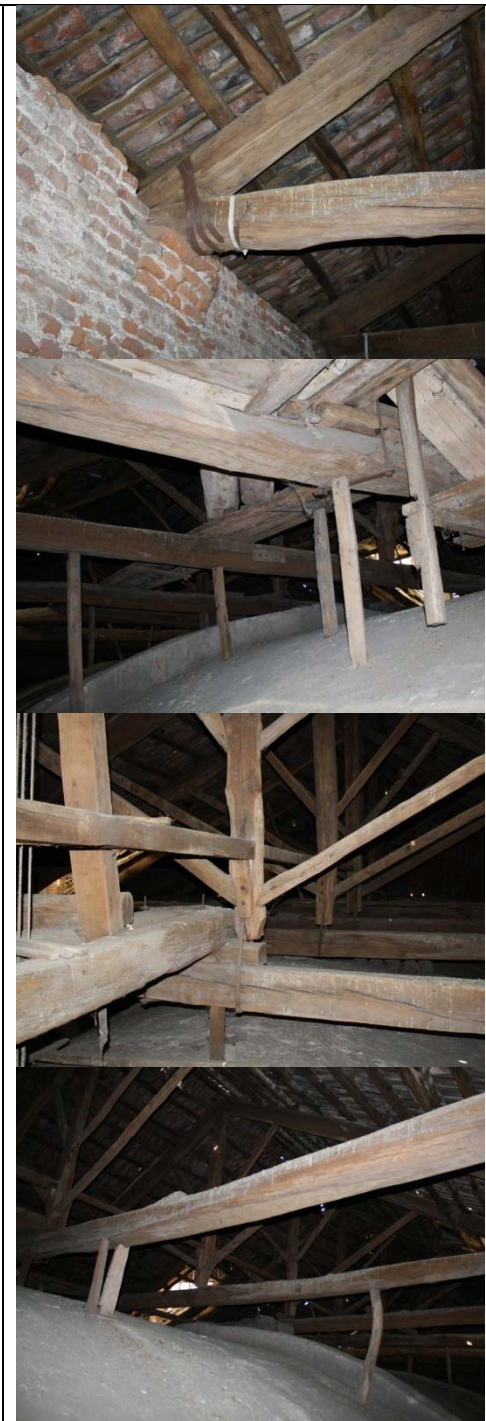
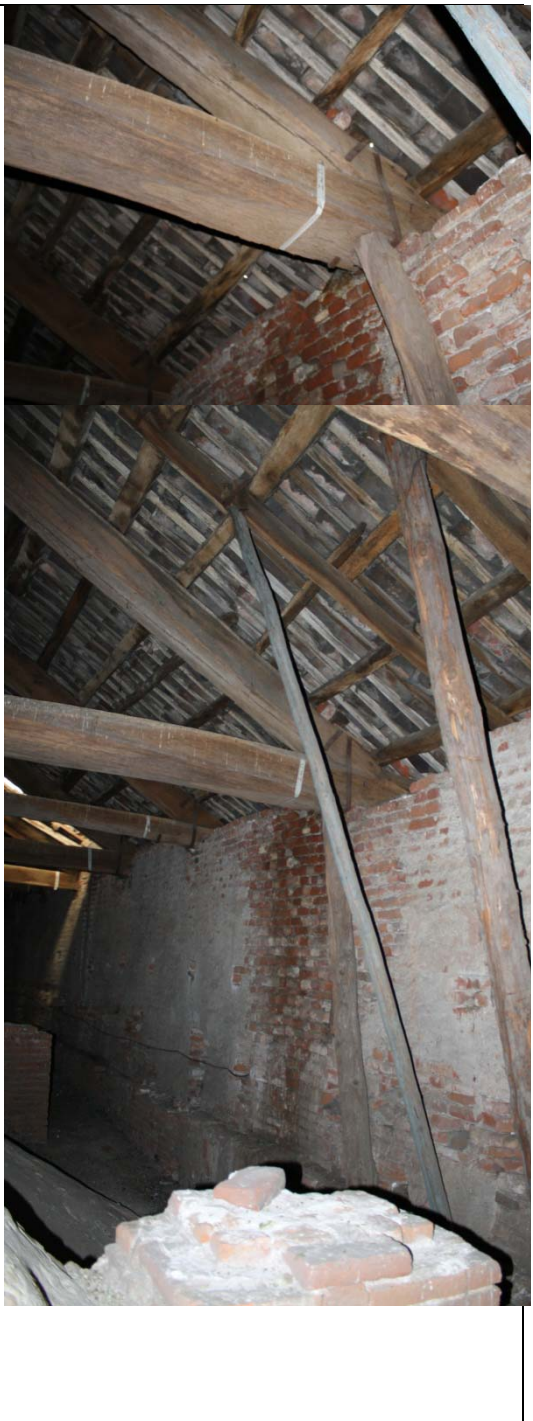
<p>n. Photo</p>	<p>IMG_0633 / IMG_0635 / IMG_0697 / IMG_0663 Knot (rafter - tie beam) South side</p>	<p>IMG_0661 / IMG_0662 Knot (rafter - tie beam) Nord side</p>

Rafter		North Side	
Biological decay	From fungi	Fungi is present (sap wood).	
	From insects	Absent	
Defects	Joints	The joint of the truss on the north side (rafter tie beam) is realised in a zone of sapwood. Considering that in this area the sapwood is degraded, the load bearing capacity of this connection is insufficient.	
	Ring-shakes	Nothing observed.	
	Twist		
Wooden species	Oak		
Moisture content	According to the surrounding air about 16%		
Average dimensions of the element	28 x 26 cm		
	Section	Rectangular	
	Geometric peculiarity	Wane	Nothing observed.
		Deformations	
Other characteristics	The beam is in a moderate condition. Some knots are visible.		
Rafter		South Side	
Biological decay	From fungi	Fungi is present (sap wood).	
	From insects	Absent	
Defects	Joints	Looking at the connection (rafter tie beam) on the south side the matched joint doesn't fit: the tie beam bears only on the final end piece.

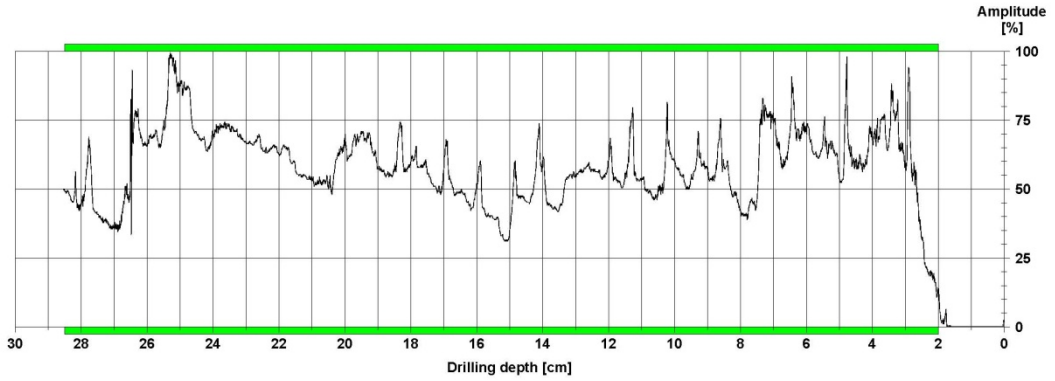
Resistographic profiles				
Data	Profile N°	from	Direction	Observations
12.12.08	R 1	front end north side	-	The test was executed on soft timber on the truss 1. The drill shows the good condition of the structural element. - Necessary intervention: The bearing has to be freed from the material (stones), which have been added at a later moment, to ensure the ventilation.

From 0,0 cm to 0,0 cm :
From 2,0 cm to 28,5 cm : good condition
From 0,0 cm to 0,0 cm :
From 0,0 cm to 0,0 cm :
From 0,0 cm to 0,0 cm :
From 0,0 cm to 0,0 cm :

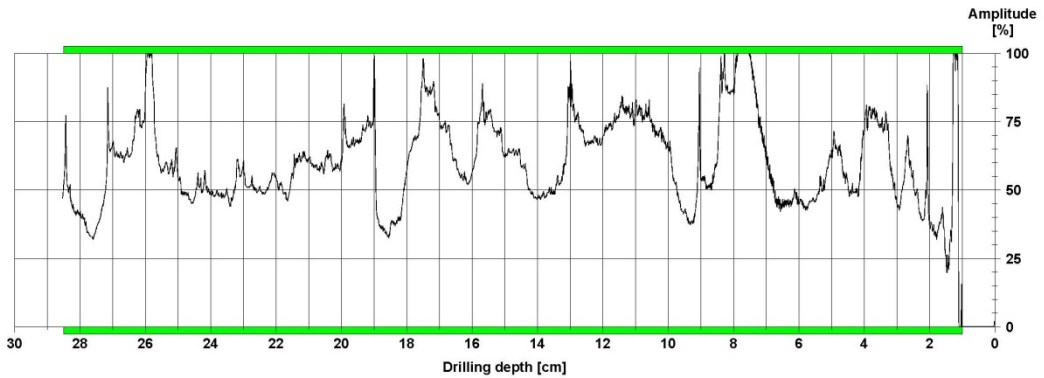
12.12.08	R 7	front end south side	-	The test was executed on soft timber on the truss 1. The drill shows the good condition of the structural element.
----------	-----	----------------------	---	--

From 0,0 cm to 0,0 cm :
From 1,0 cm to 28,5 cm : good condition
From 0,0 cm to 0,0 cm :
From 0,0 cm to 0,0 cm :
From 0,0 cm to 0,0 cm :
From 0,0 cm to 0,0 cm :

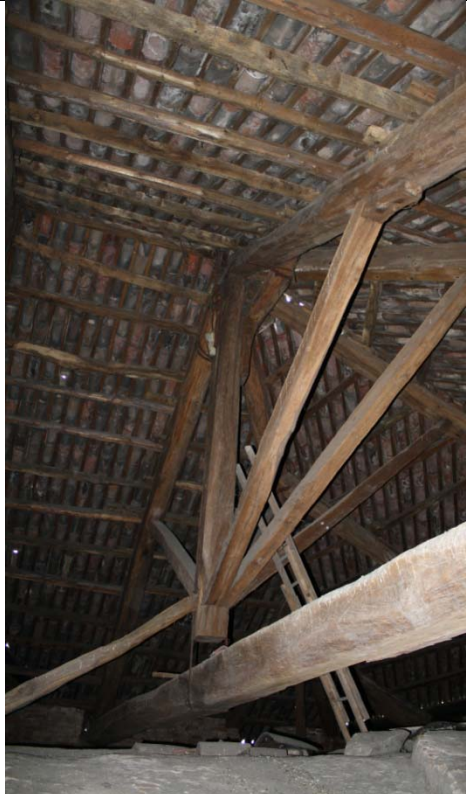
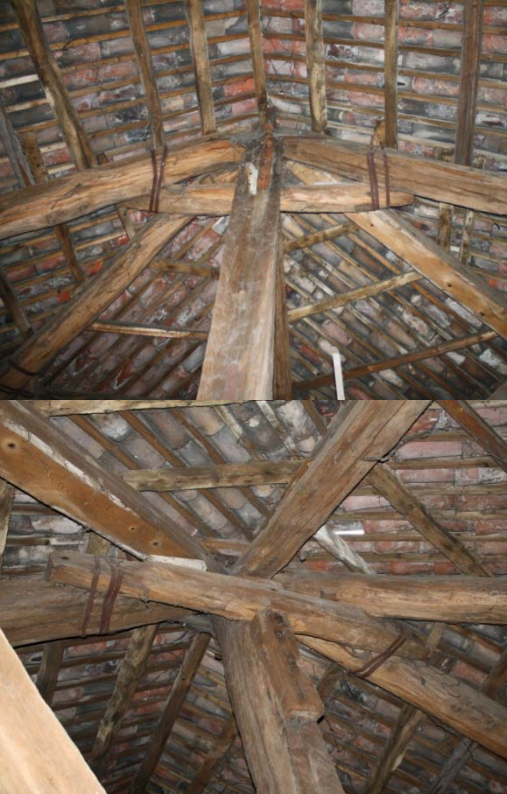
<p>n. Photo</p>	<p>IMG_0478 Truss 1</p>	<p>IMG_0482 / IMG_0486 Knot (king post - rafter)</p>
<p>PHOTO</p>

King Post			
Biological decay	From fungi	No active fungi is visible. Some biological attack may have caused de-colourations.	
	From insects	Absent	
Defects	Joints	The connection with the rafters seems to be in a moderate condition. The two fragile metal elements which are positioned on two sides to reinforce the connection are very interesting (unusual). The metal connection with the tie beam doesn't work anymore. The metal lengthened and doesn't support the tie beam anymore (no tension forces can be transmitted). The two fragile metal elements which are positioned on two sides to reinforce the connection between the two rafters (joint king beam), are very interesting (unusual).	
	Ring-shakes	No signs (absent)	
	Twist	No signs (absent)	
Wooden species	Oak		
Moisture content	According to the surrounding air about 16%		
Average dimensions of the element	35 x 25 cm		
	Section	Rectangular	
	Geometric peculiarity	Wane	No signs (absent)

Deformations			
Other characteristics	The upper part of the post may have suffered because of water infiltrations.

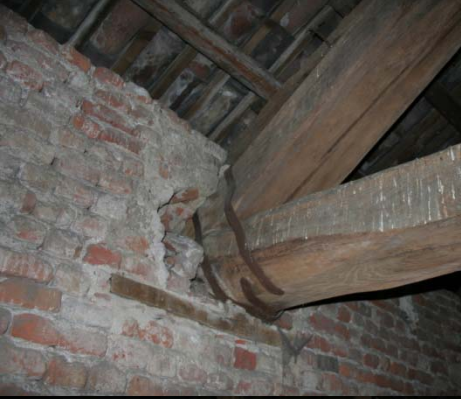
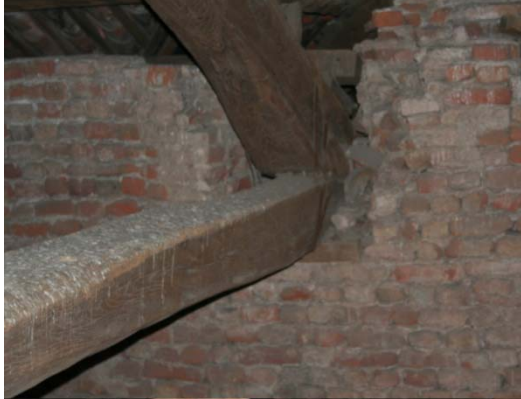
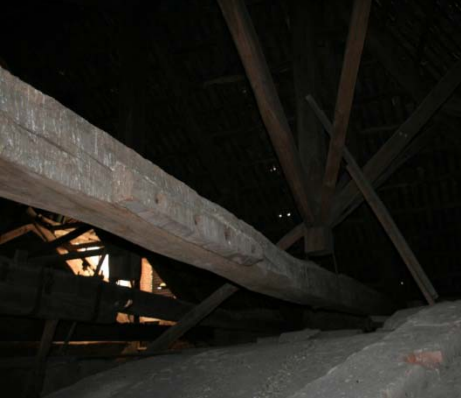
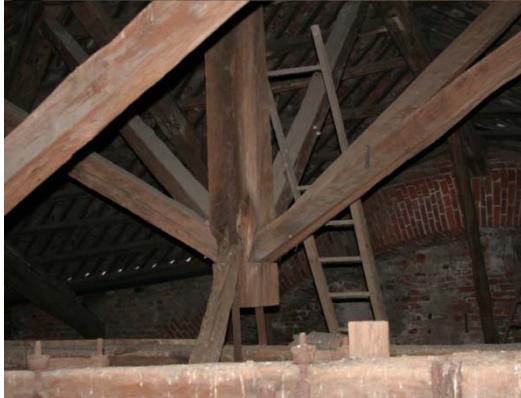
n. Photo	IMG_7397 / IMG_7398 Knot (rafter - tie beam) South side	IMG_7410/ IMG_7433 Knot (rafter - tie beam) Nord side

Rafter	North Side	
Biological decay	From fungi	Fungi may has been present in the superficial part of the element.
	From insects	Absent
Defects	Joints	The bearing has to be freed from the material (stones), which have been added at a later moment, to ensure the ventilation.
	Ring-shakes	No signs (absent)
