Hidden Architecture
The timber roof structure of the dome of Vercelli
Inspection-Diagnostics- Interventions

A Master's thesis submitted for the degree of
"Master of Science"

DI Pia Therese Panosch
0126769

Milan, 05.02.2010

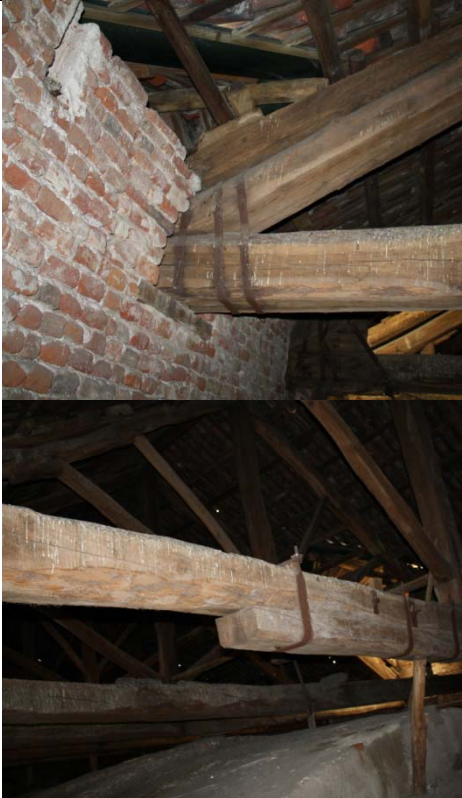
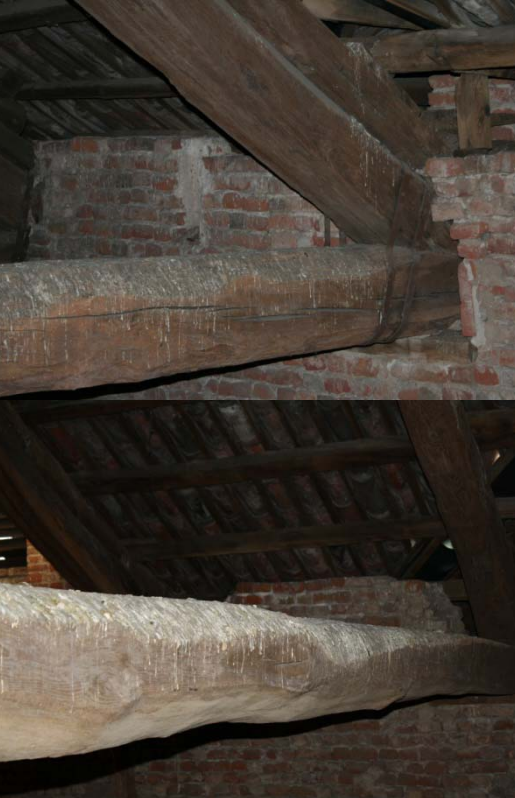
n. Photo	IMG_0510 / IMG_0511 Knot (rafter - tie beam) South side	IMG_4736/ IMG_0515 Knot (rafter - tie beam) Nord side

Truss	N. 2	Main aisle	
Tie-beam			
Biological decay	From fungi	Present in the part inside the masonry.	
	From insects	Absent	
Defects	Joints	Weak on the north side (intervention necessary)	
	Ring-shakes	No signs (absent)	
	Twist	No signs (absent)	
Wooden species	Oak		
Moisture content	According to the surrounding air about 16%		
Average dimensions of the element	30 x 25 cm		
	Section	Rectangular	
	Geometric peculiarity	Wane	Slightly deviation of the fibre direction
Deformations		Slightly deformed	
Other characteristics	The truss shows more buckling than truss one. On the south side the tie beam is divided into two elements and joined with a bar which is fixed on the inferior part of the beam with three spanner nuts. According to the executed tests no particular problems have been found (no drills accomplished)		
Rafter			
North Side			
Biological decay	From fungi	Fungi is present in the superficial part of the element.

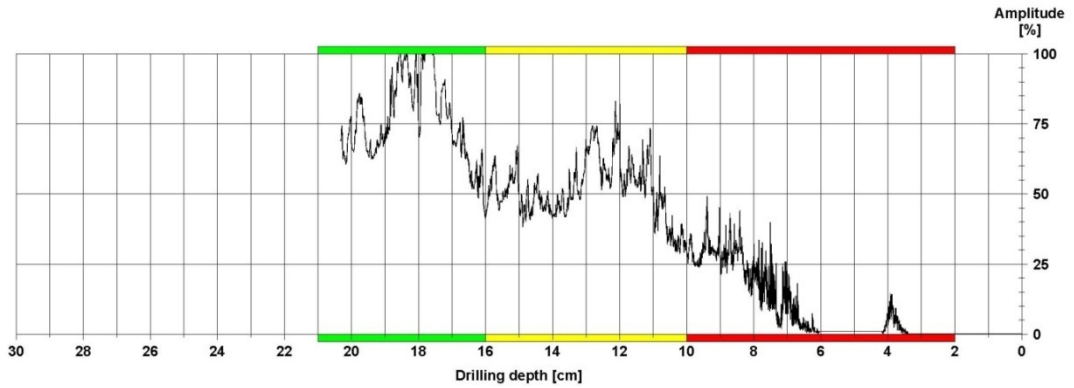
Resistographic profiles				
Data	Profile N°	from	Direction	Observations
12.12.08	R 2	front end north side	underside to top side inclination 45° (ref. exterior wall)	Drill 2 (okay in the central part) the first part doesn't result, because the sap wood is missing in some parts.

From 0,0 cm to 0,0 cm :
From 2,0 cm to 10,0 cm : weak
From 10,0 cm to 16,0 cm : moderate conditions
From 16,0 cm to 21,0 cm : good conditions
From 0,0 cm to 0,0 cm :
From 0,0 cm to 0,0 cm :

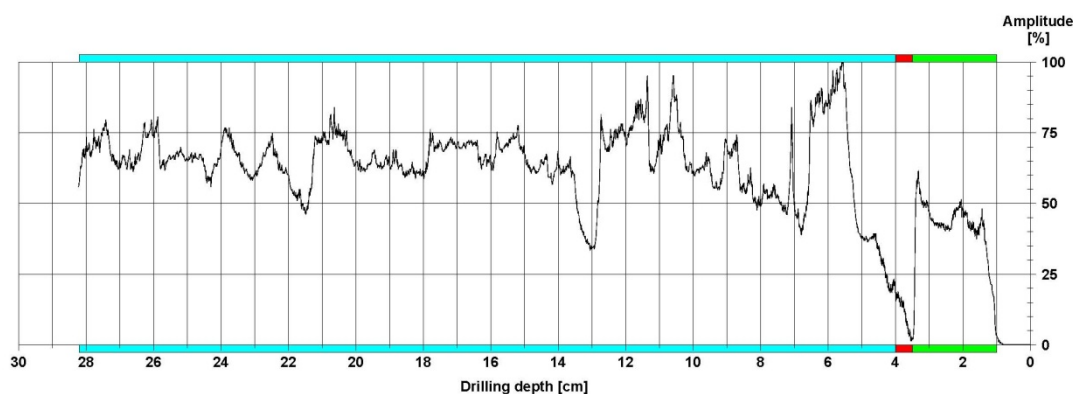
12.12.08	R 8	front end north side	underside to top side inclination 45° (ref. exterior wall)	The test was executed on firm timber. It shows the perfect condition of the timber element.
----------	-----	----------------------	--	---

<input type="checkbox"/>	From 0,0 cm to 0,0 cm :
<input type="checkbox"/>	From 1,0 cm to 3,5 cm : good condition
<input type="checkbox"/>	From 3,5 cm to 4,0 cm : weak
<input type="checkbox"/>	From 4,0 cm to 28,2 cm : very good cond.
<input type="checkbox"/>	From 0,0 cm to 0,0 cm :
<input type="checkbox"/>	From 0,0 cm to 0,0 cm :

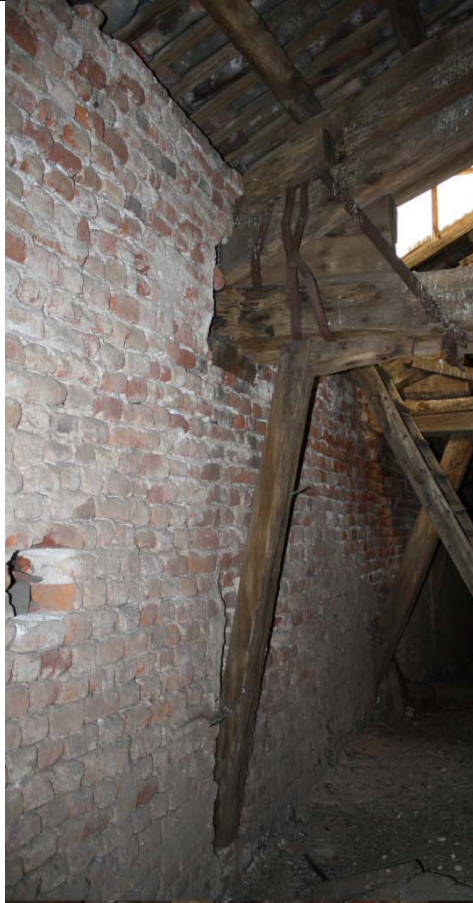
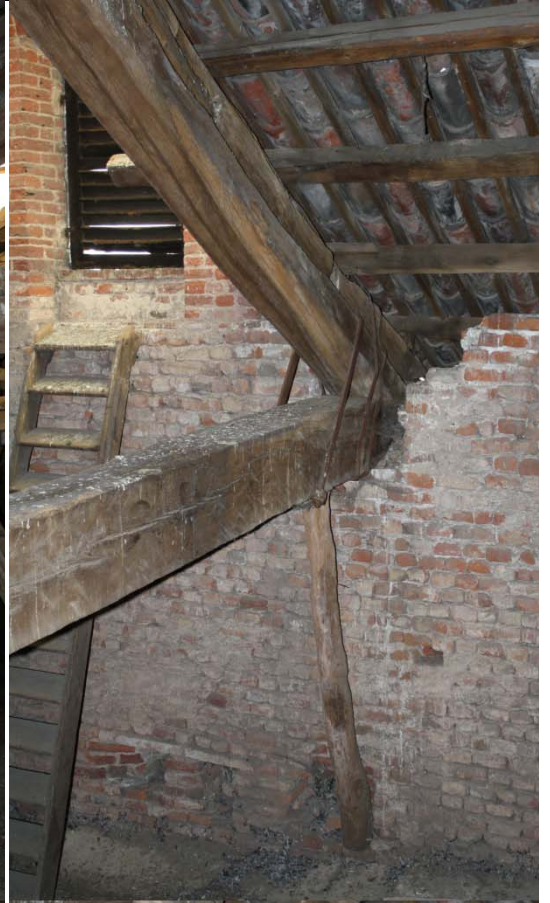
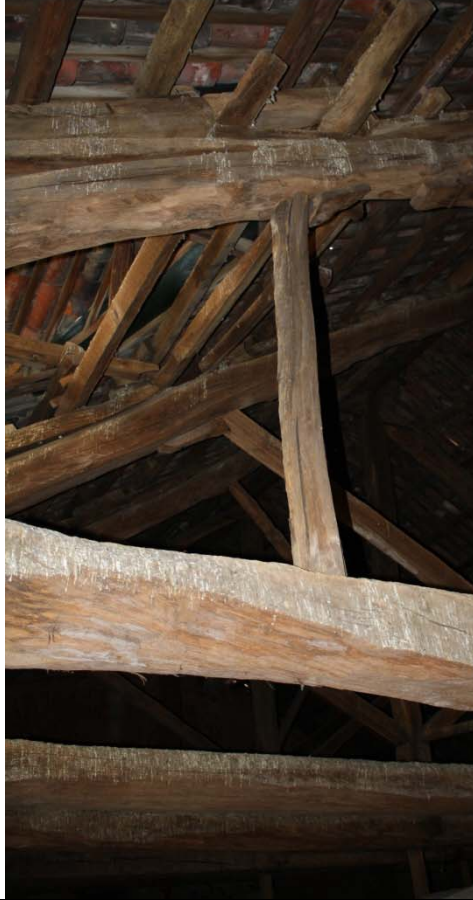
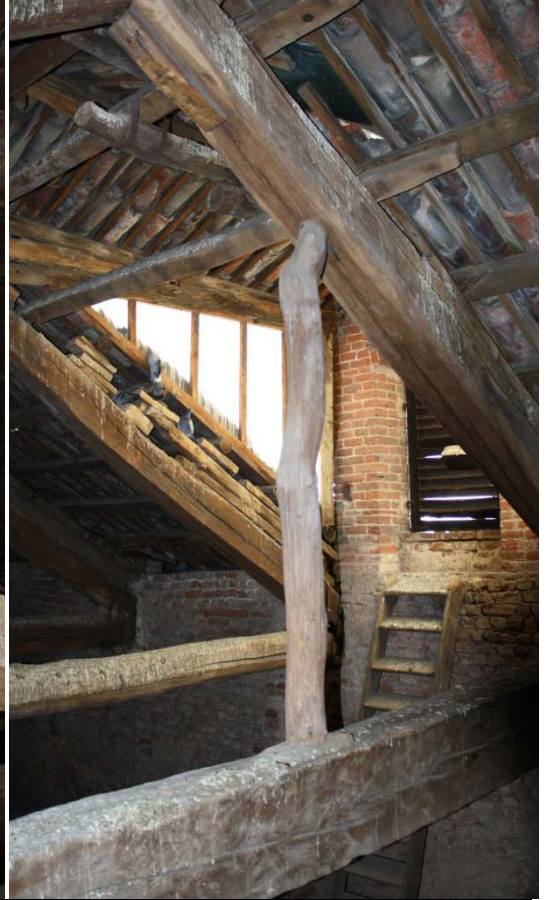
King Post		
Biological decay	From fungi	No active fungi is visible. Some biological attack may have caused de-colourations.
	From insects	Absent
Defects	Joints	The connection with the rafters seems to be in a moderate condition. The metal connection with the tie beam doesn't work anymore. The metal lengthened and doesn't support the tie beam anymore (no tension forces can be transmitted). The two fragile metal elements which are positioned on two sides to reinforce the connection between the two rafters (joint king post), are very interesting (unusual).
	Ring-shakes	No signs (absent)
	Twist	No signs (absent)
Wooden species	Oak	
Moisture content	According to the surrounding air about 16%	
Average dimensions of the element	26 x 23 cm	
	Section	Rectangular
	Geometric peculiarity	Wane Deformations
Other characteristics	The post isn't perfectly lined up with the tie beam. The upper part of the post seems slightly wet. Knots and wane, but the post is generally in a moderate condition.

PHOTO	 	 
n. Photo	IMG_0517 Truss 3	IMG_0522 Knot (king post - rafter)
PHOTO	 	 
n. Photo	IMG_0520 Knot (king post - chord member)	IMG_0521 / IMG_0523 Knot (rafter - chord member)

n. Photo	IMG_0518 / IMG_0519 Knot (rafter - tie beam) South side	IMG_0525/ IMG_0524 Knot (rafter - tie beam) Nord side
----------	--	--

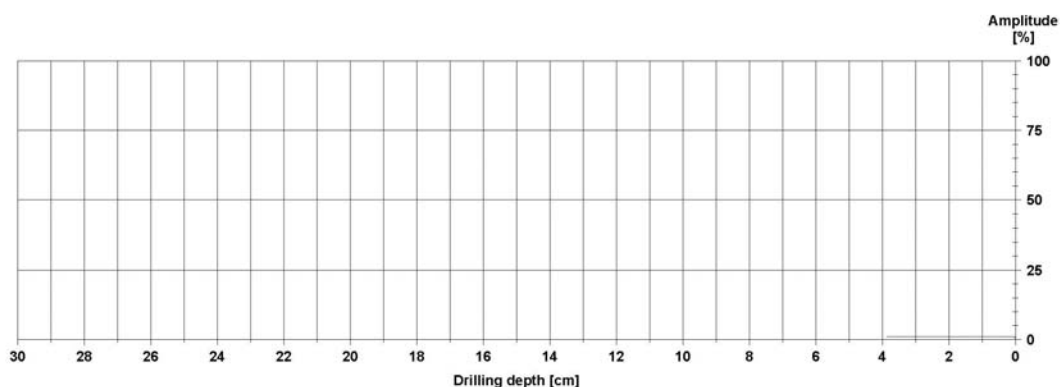
12.12.08	R 3	front end north side	-	The test had to be annulated because of the weak conditions of the timber element.

Measurement no. : 3	Time : 12:35:59	Location : Dome Vercelli
Drilling depth : 3,87 cm	Avg. curve : off	Name : Tie beam
Wood species : Soft (1)	Diameter :	Length of cavities : --
ID number : 10	Level :	Min. width / height : --
Advance : 28,8 cm/min	Direction : Bottom to top 45°	Start of detecting : --
Date : 12.12.2008	Object species : Oak	Detect last cavity : --

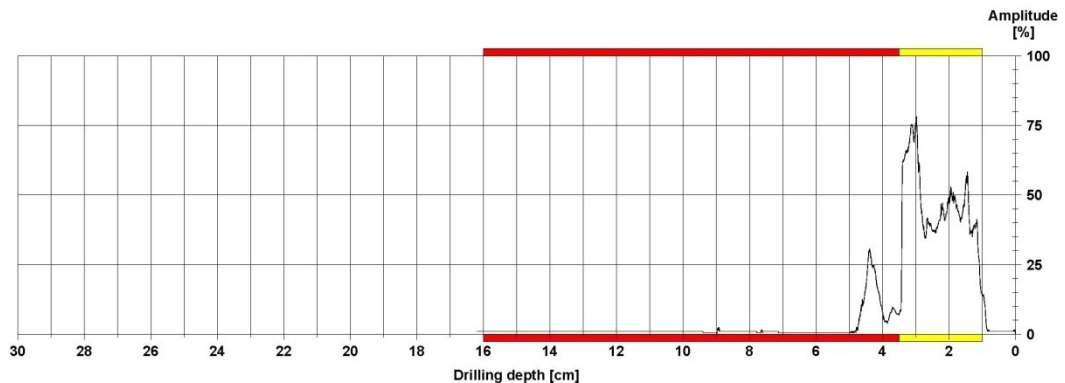
12.12.08	R 4	front end south side	underside to top side Inclination 45° (ref. exterior wall)	The test was executed on soft timber on the trus s4. The drill shows the insufficient situation and the bad condition. - Necessary intervention: Reconstruction of the head of the tie beam and the introduction of two collateral supporting elements on the rafter.
----------	-----	----------------------	--	--

From 0,0 cm to 0,0 cm :	
From 1,0 cm to 3,5 cm : moderate condition	
From 3,5 cm to 16,0 cm : insufficient	
From 0,0 cm to 0,0 cm :	
From 0,0 cm to 0,0 cm :	
From 0,0 cm to 0,0 cm :

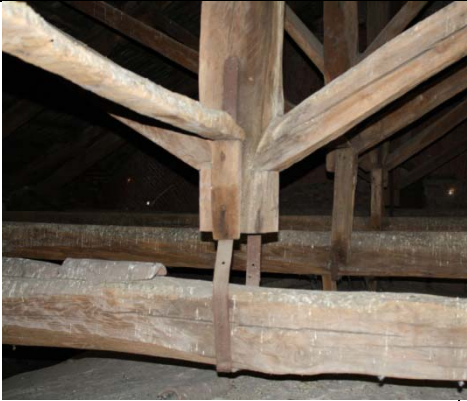
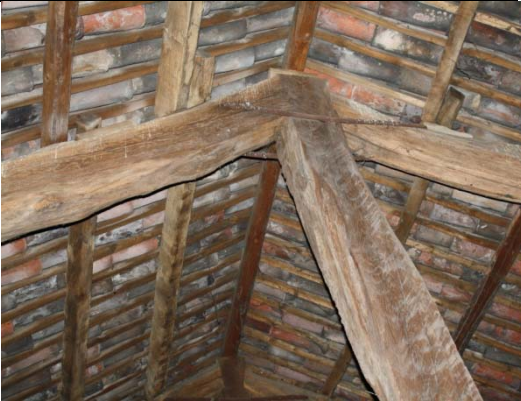
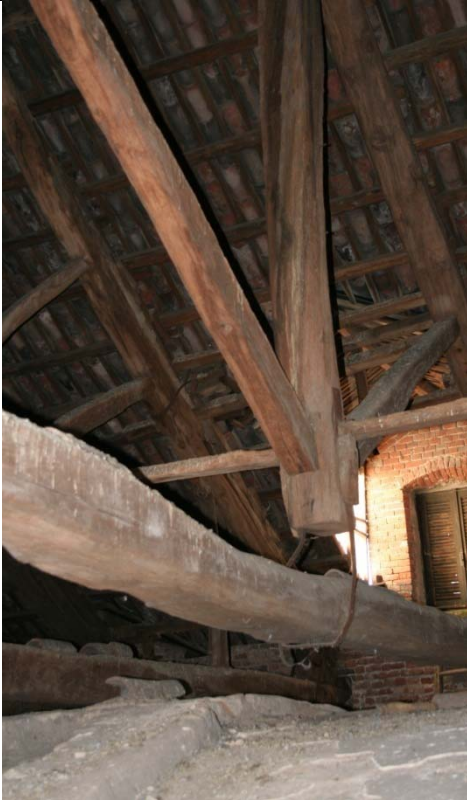
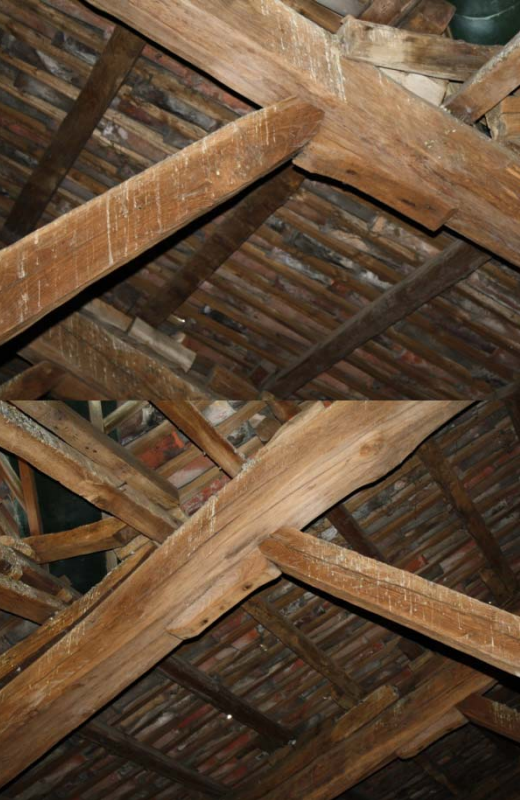
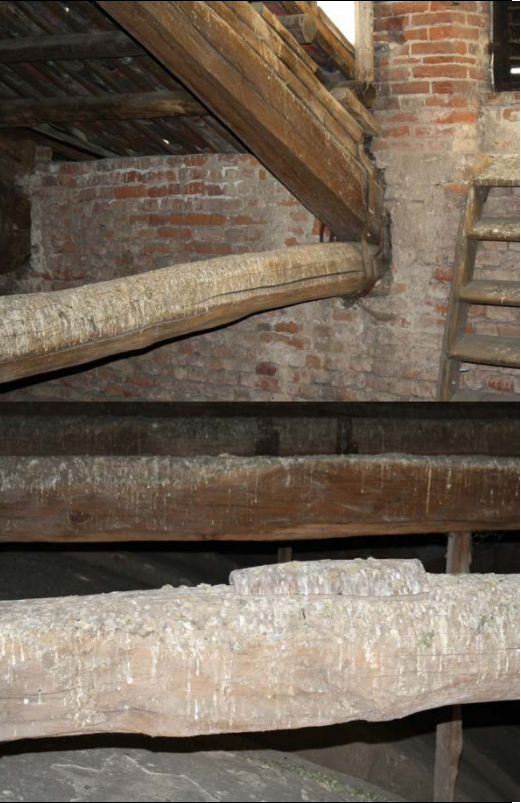
Other characteristics	On the lower part of the rafter next to the bearing on the wall the element is drenched from constant water infiltrations. It is not a major problem because the area is well ventilated. The final part of the beam seems to plunge and there is a fracture which does not continue up to the bearing of the wall. - Necessary intervention: next to the bearing on the wall the tie beam should be hardened.		
King Post			
Biological decay	From fungi	Present in the part inside the masonry. Discolouration	
	From insects	Absent	
Defects	Joints	The connection with the rafters seems to be in a moderate condition. The metal connection with the tie beam doesn't work anymore. The metal lengthened and doesn't support the tie beam anymore (no tension forces can be transmitted). The two fragile metal elements which are positioned on two sides to reinforce the connection between the two rafters (joint king post), are very interesting (unusual).

n. Photo	IMG_0535 Knot (king post - chord member)	IMG_0536 Knot (king post - rafter)

n. Photo	IMG_7426 Truss 4	IMG_0534 / IMG_04537 Knot (rafter - chord member)
PHOTO

n. Photo	IMG_0538 Knot (rafter - tie beam) South side	IMG_0527/ IMG_0533 Knot (rafter - tie beam) Nord side

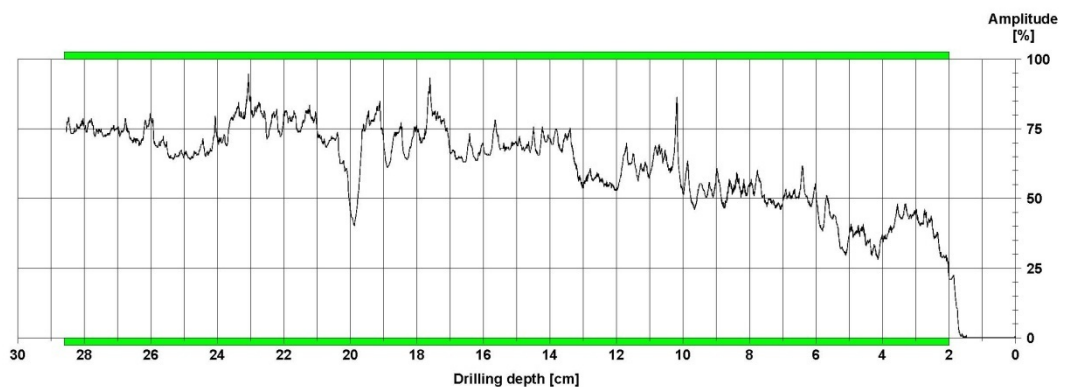
Truss	N. 5	Main aisle		
Tie-beam				
Biological decay	From fungi	No active fungi is visible. Some biological attack may have caused de-colourations.		
	From insects	Absent		
Defects	Joints	moderate , (former intervention at the joint tie beam- king post)		
	Ring-shakes	No signs (absent)		
	Twist	deviation of the fibre direction		
Wooden species	Oak			
Moisture content	According to the surrounding air about 16%			
Average dimensions of the element	32 x 33 cm			
	Section	Rectangular		
	Geometric peculiarity	Wane	Wane	
		Deformations	Slightly curved	
Other characteristics	The tie beam is supported by various struts, which bear on the cupola.			
Resistographic profiles				
Data	Profile N°	from	Direction	Observations
12.12.08	R 5	front end north side	underside to top side inclination 45° (ref. exterior wall)	The drill shows the good conditions of the timber element.

From 0,0 cm to 0,0 cm :
From 2,0 cm to 28,6 cm : good condition
From 0,0 cm to 0,0 cm :
From 0,0 cm to 0,0 cm :
From 0,0 cm to 0,0 cm :
From 0,0 cm to 0,0 cm :

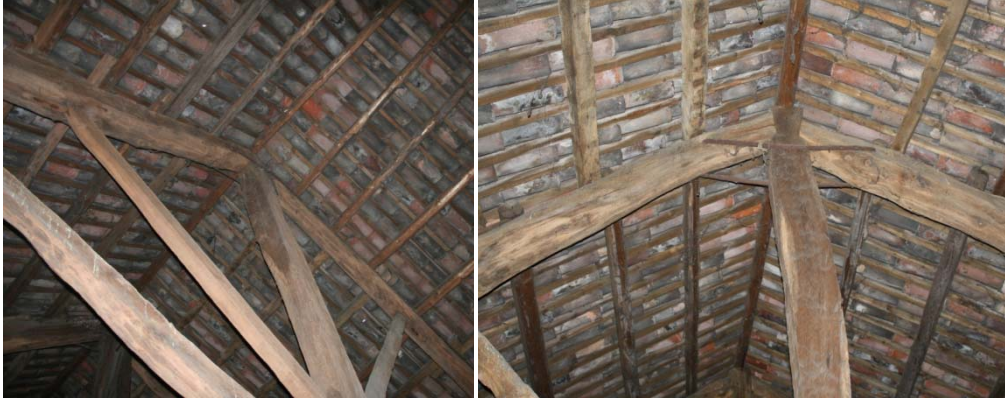
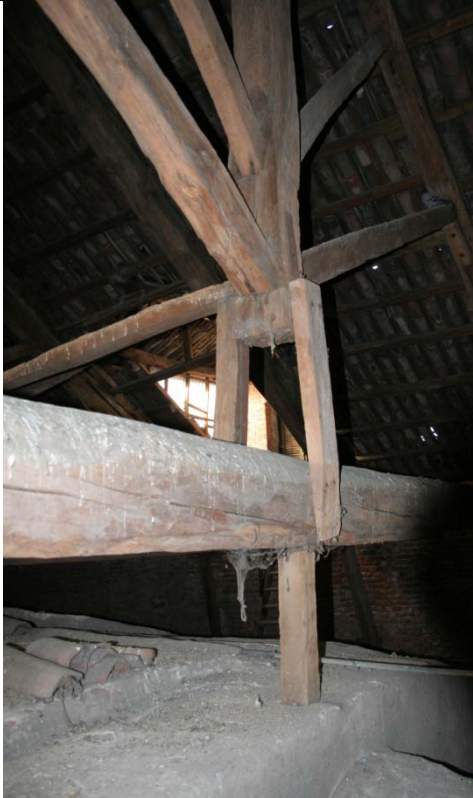
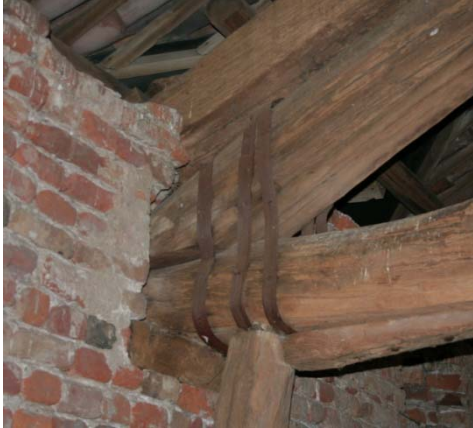
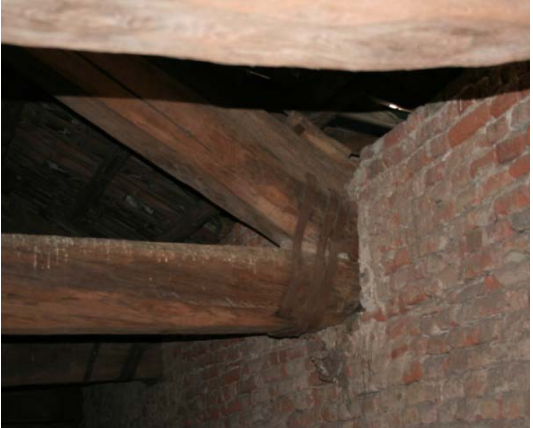
King Post		
Biological decay	From fungi	No active fungi is visible. Some biological attack may have caused de-colourations.
	From insects	Absent
Defects	Joints	The connection with the rafters seems to be in a moderate condition. The metal connection with the tie beam doesn't work anymore. The metal lengthened and doesn't support the tie beam anymore (no tension forces can be transmitted). That for two timber pieces have been placed on each side of the post (connecting the post with the tie-beam) to maintain it in the right position and to transmit loads. The two fragile metal elements which are positioned on two sides to reinforce the connection between the two rafters (joint king post), are very interesting (unusual).
	Ring-shakes	No signs (absent)
	Twist	No signs (absent)
Wooden species	Oak	
Moisture content	According to the surrounding air about 16%	
Average dimensions of the element	26 x 23 cm

n. Photo	IMG_7424 Truss 5

n. Photo	IMG_7425 Knot (king post - chord member)
PHOTO

n. Photo	IMG_7440 Knot (rafter - tie beam) South side

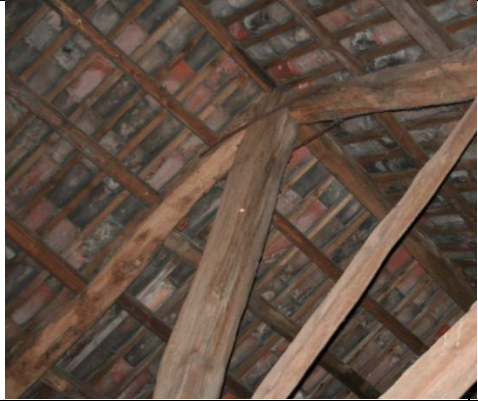
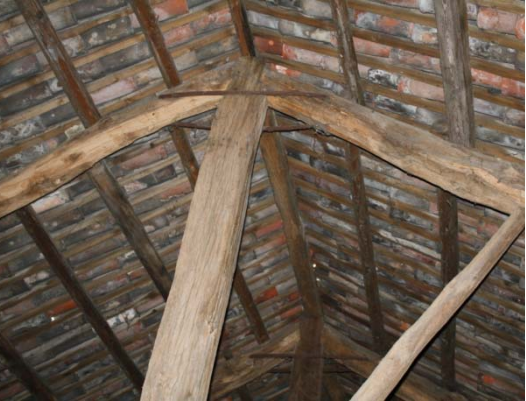
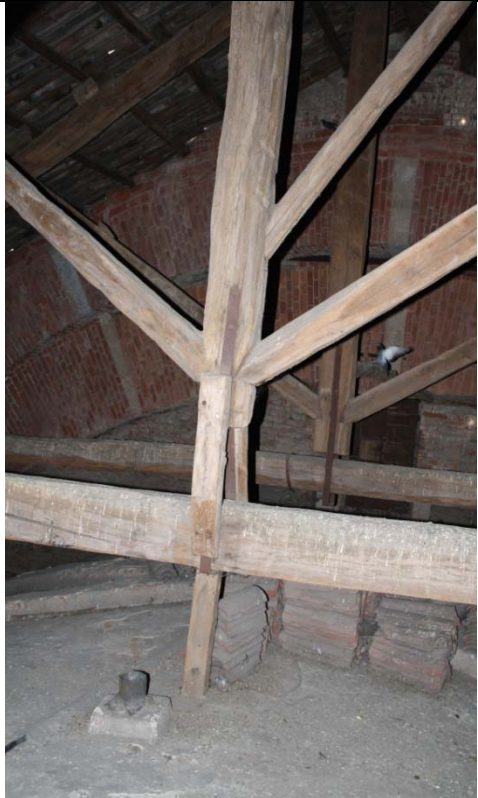
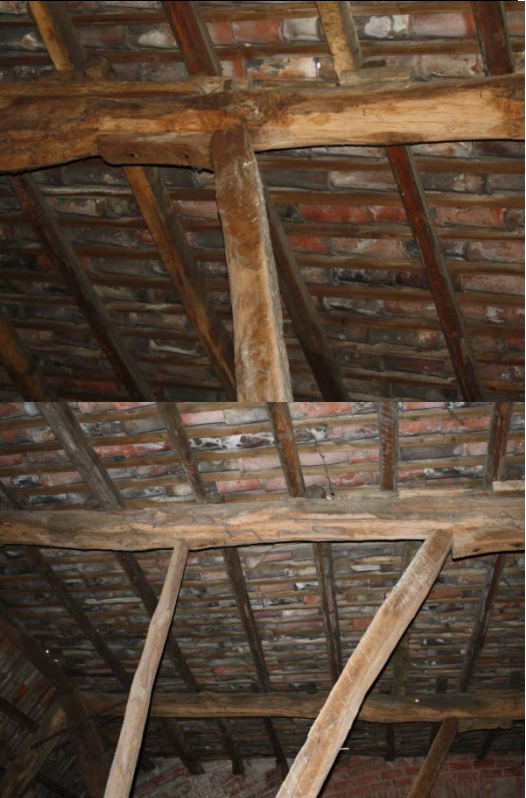
King Post			
Biological decay	From fungi	No active fungi is visible. Some biological attack may have caused de-colourations.	
	From insects	Absent	
Defects	Joints	The two fragile metal elements which are positioned on two sides to reinforce the connection between the two rafters (joint king post-rafter), are very interesting (unusual). The connection between the tie beam and the post hasn't been working anymore, that fore two timber pieces have been placed on each side of the post (connecting the post with the tie-beam) to maintain it in the right position and to transmit loads.	
	Ring-shakes	No signs (absent)	
	Twist	No signs (absent)	
Wooden species	Oak		
Moisture content	According to the surrounding air about 16%		
Average dimensions of the element	20 x 22 cm		
	Section	Rectangular	
	Geometric peculiarity	Wane	Wane
Deformations			
Other characteristics	generally in a moderate condition

n. Photo	IMG_7422 Truss 6	IMG_0552 Knot (king post - rafter)
PHOTO

n. Photo	IMG_0550 Knot (king post - chord member)	IMG_0554 / IMG_0551 Knot (rafter - chord member)

On the truss 6 a chord member is missing it would be useful to reconstruct it to ensure the symmetry of the structure.

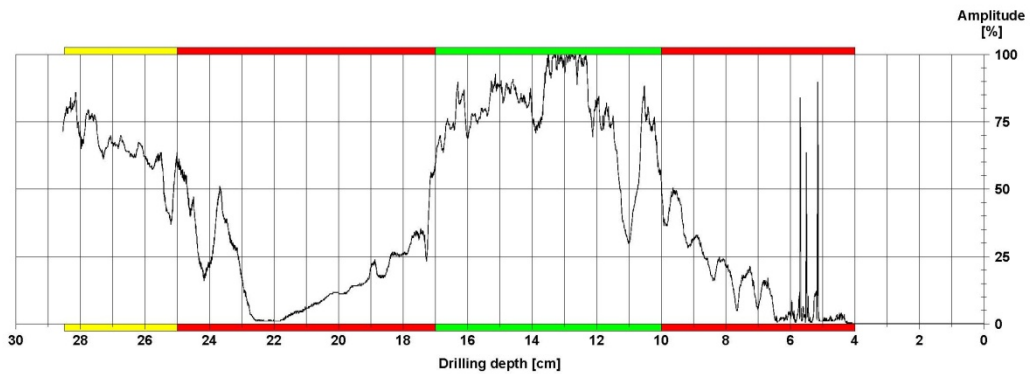
12.12.08	R 6	front end north side	underside to top side inclination 45° (ref. exterior wall)	Drill 6 (insufficient - bad condition) There are high values for 2 cm around the 13 th cm. This doesn't influence the result significantly.
----------	-----	----------------------	--	--

From 0,0 cm to 0,0 cm :	
From 4,0 cm to 10,0 cm :	weak
From 10,0 cm to 17,0 cm :	good condition
From 17,0 cm to 25,0 cm :	weak
From 25,0 cm to 28,5 cm :	moderate condition
From 0,0 cm to 0,0 cm :

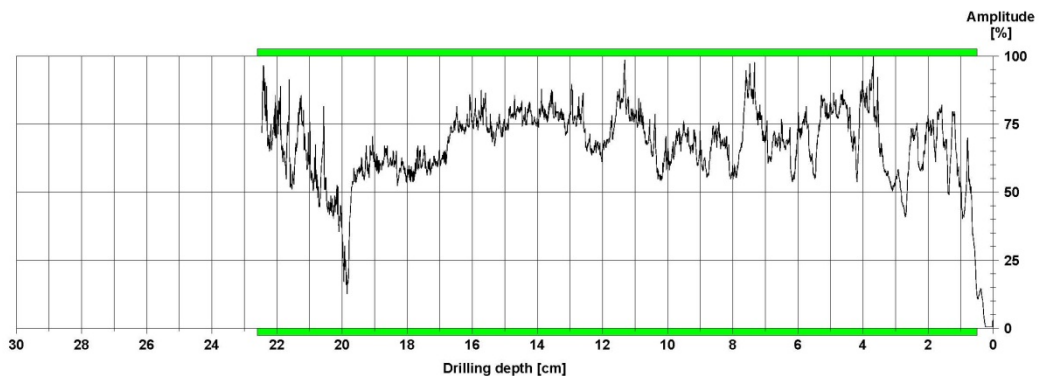
12.12.08	R 9	front end south side	underside to top side Inclination 45° (ref. exterior wall)	The test was executed on soft timber on the truss 7. The drill 9 shows that after the weakened bearing the element is in good conditions.
----------	-----	----------------------	--	---

From 0,0 cm to 0,0 cm :	
From 0,5 cm to 22,6 cm :	good condition
From 0,0 cm to 0,0 cm :	
From 0,0 cm to 0,0 cm :	
From 0,0 cm to 0,0 cm :	
From 0,0 cm to 0,0 cm :

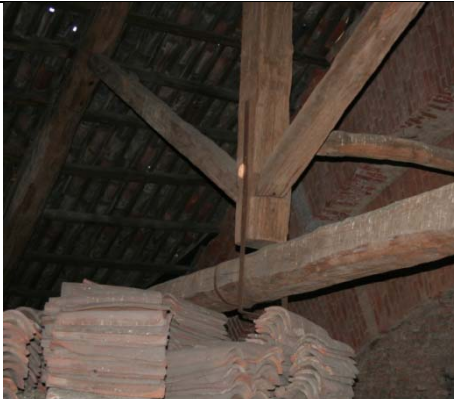
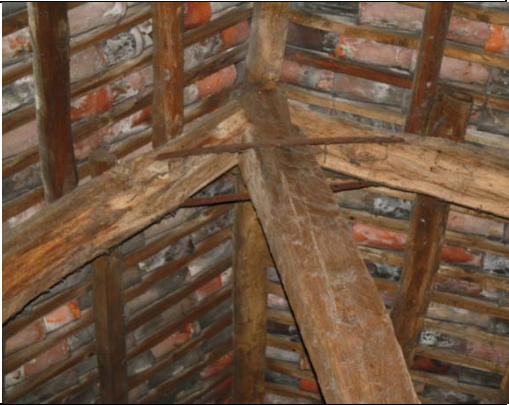
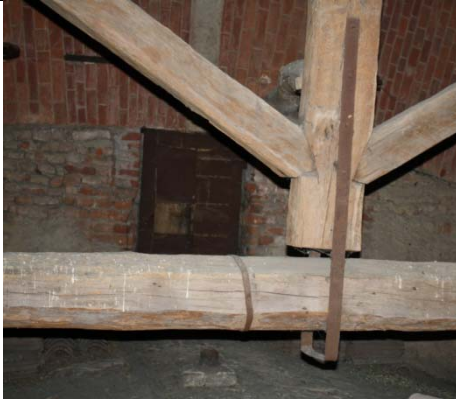
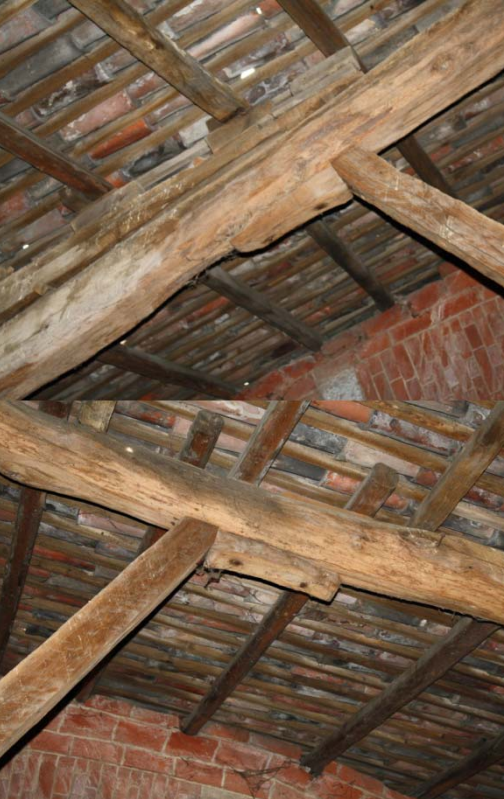
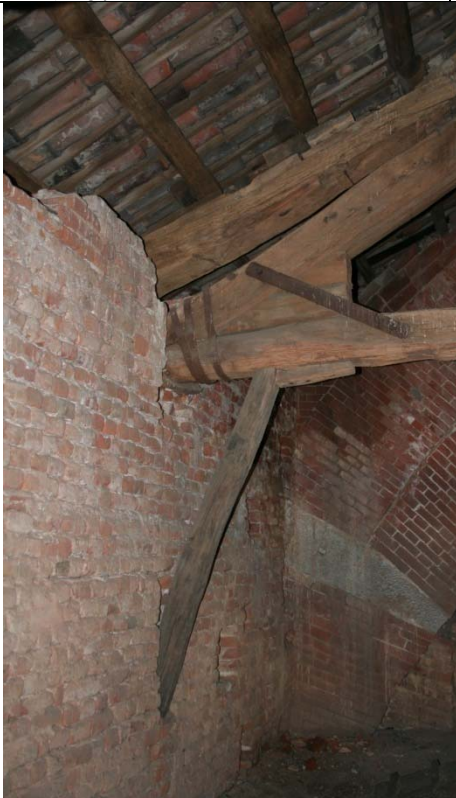
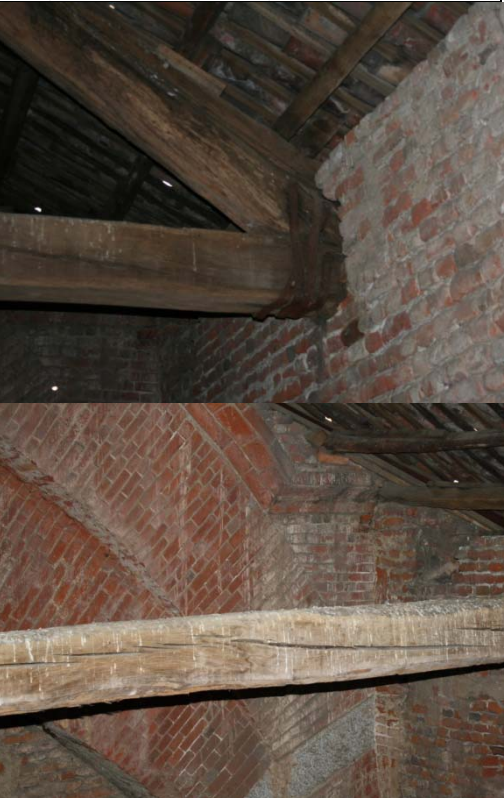
Section	Rectangular	
	Geometric peculiarity	Wane	Wane
		Deformations	
Other characteristics	On the lower part of the rafter next to the baring on the wall the element is drenched from constant water infiltrations. It is not a major problem because the area is well ventilated. The final part of the beam seems to plunge and there is a fracture which does not continue up to the bearing of the wall.		
King Post			
Biological decay	From fungi	Some biological attack has caused de-colourations.	
	From insects	Absent	
Defects	Joints	The connection with the rafters seems to be in a moderate condition. The metal connection with the tie beam doesn't work anymore. The metal lengthened and doesn't support the tie beam anymore (no tension forces can be transmitted).	
	Ring-shakes	No signs (absent)	
	Twist	No signs (absent)	
Wooden species	Oak		
Moisture content	According to the surrounding air about 16%		
Average dimensions of the element	25 x 20 cm

n. Photo	IMG_7417 Truss 7	IMG_0561 Knot (king post - rafter)
PHOTO

n. Photo	IMG_0553 Knot (king post - chord member)	IMG_0560/ IMG_0562 Knot (rafter - chord member)
PHOTO

n. Photo	IMG_7442 Knot (rafter - tie beam) South side	IMG_0564 Knot (rafter - tie beam) Nord side

The heads of the beams on the south side are generally in a better condition, mainly because they are better ventilated in the external wall.

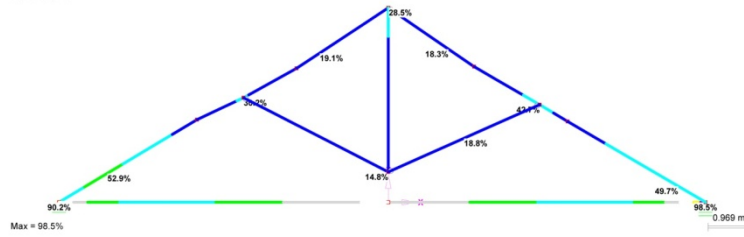
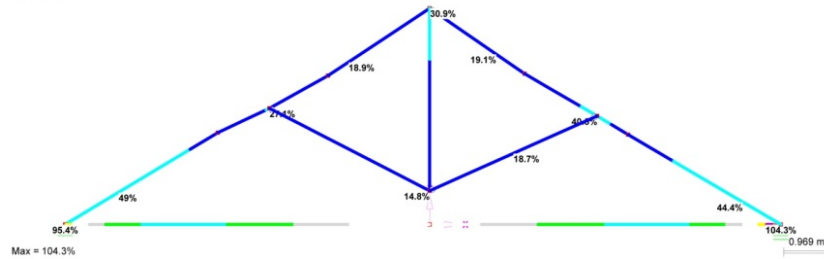
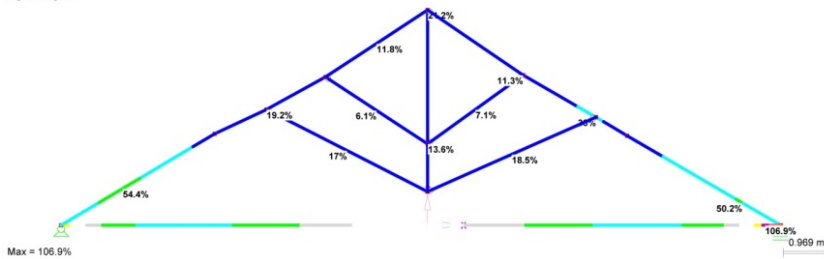
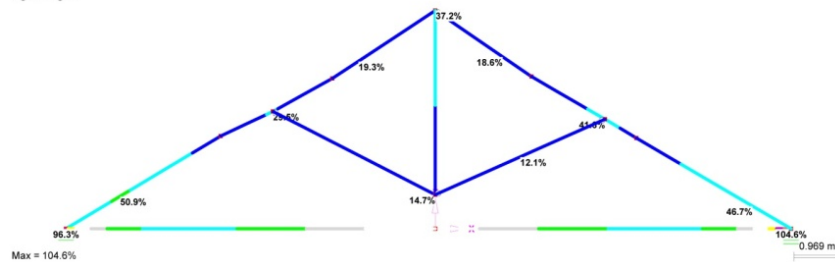
The stress analyses show that the elements seem to be generally in a better condition than in the choir. The maximum values lay in between 98 and 128% of the load capacity.

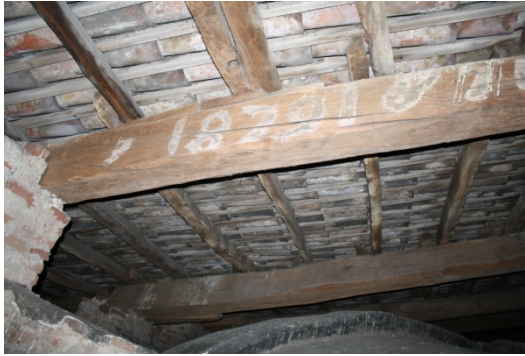
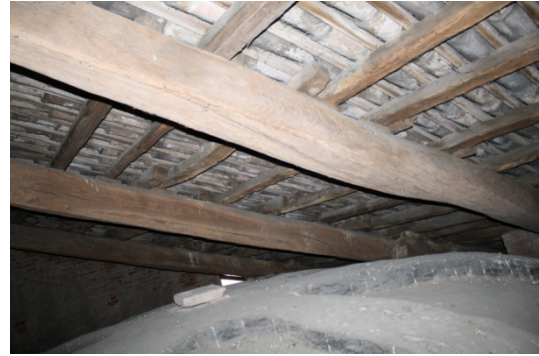
T1

The heads of the rafters couldn't be valued because of their difficult position, but the heads of the girders are generally in a good condition, mainly because they are ventilated, but the beam of the timber structure one has to be checked, because of it's eventually dangerous conditions caused by ring shake.

The rest of the primary and secondary structure seems to be in quite good conditions. The battens are quite degraded and should be changed.

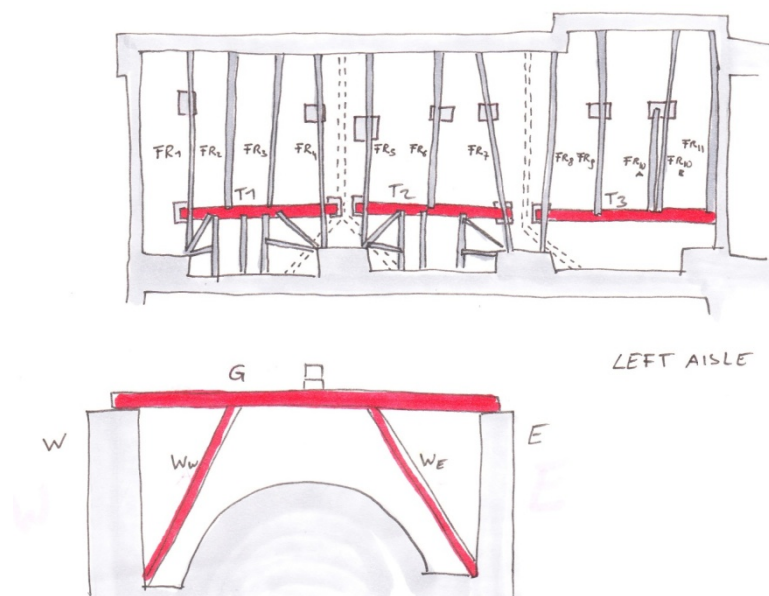
sketch 28

Table 2. Results of the resistance qualification for the examined timber elements of the trusses.

Identification	Minimum measured cross-section b x h [cm]	Average moisture content of the connections [%]	Defects, disconnections, fractions which have determinate the classification	Note	Category according UNI 11119	
T1*	G 1	32 x 35	\	big knots, ring shake?	\	N. I.
	W E-1	\	\	\	\	\
	W w-1	\	\	\	\	\
T2*	G -2	28 x 30	\	small cracks	\	//
	W E-2	\	\	\	\	\
	W w-2	8 x 12	\	small cracks	Sapwood: fungi attack	//
T3*	G -3	28 x 33	\	heavy degrade, displacement	Sapwood: fungi attack	III
	W E-3	17 x 15	> 30%	big cracks	ev. water infiltration	III
	W w-3	14 x 15	\	small cracks	insect attack	III
T4*	FR 1	26 x 28	> 30%	joint (S) heavy degrade,	fungi (water infiltration)	N. I.
	FR 2	26 x 28	\	big knots	\	II

FR 3	26 x 28	\	small cracks	\	II
FR 4	26 x 28	\	big cracks	\	III
FR 5	35 x 35	\	big knots, small cracks	\	III
FR 6	36 x 28	\	\	above joint (S) missing tile -> water infiltration	III
FR 7	30 x 30	\	big knots	\	II
FR 8	27 x 23	\	small knots	insect attack	III
FR 9	24 x 25	\	knots	Sapwood: fungi attack	III
FR 10	22 x 25	\	big knot-> whole, small cracks	\	III
FR 10a	25 x 24		small cracks	Sapwood: fungi attack	III
FR 11	9 x 9	\	heavy degrade	water infiltration	N. I.
S	15 x 15		mostly heavy degrade	fungi, insects	N. I.

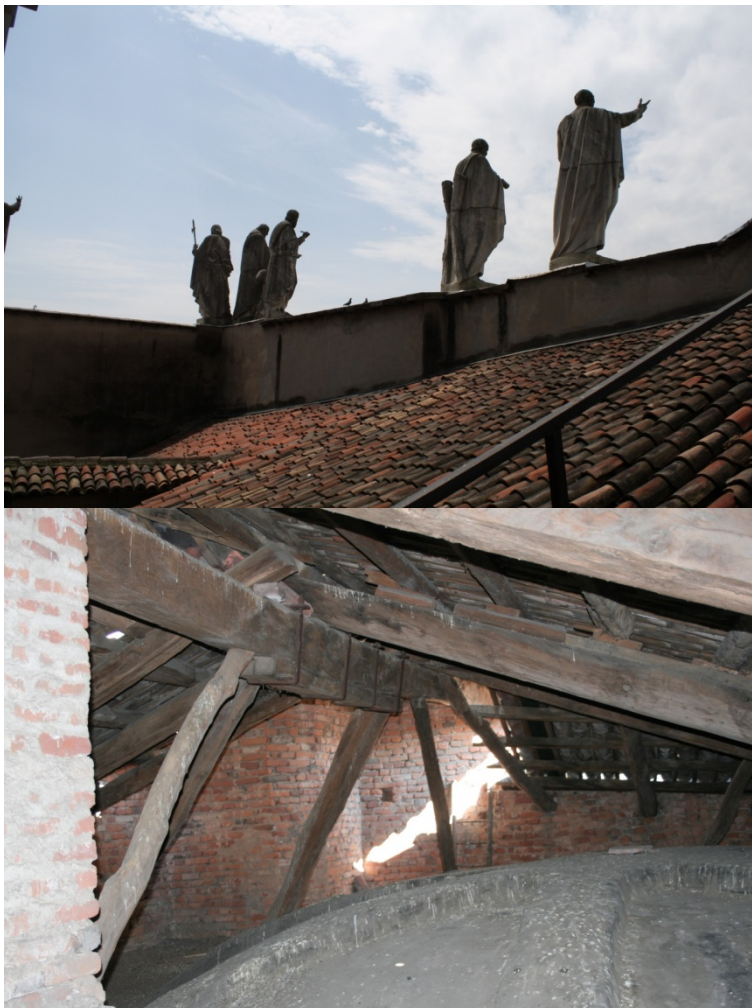
7 right aisle

The right aisle has nearly the same amount of fungi attack as the aisle on the left side, although viewer water infiltrations occur. Generally it has similar problems for example a ridge with a ring shake...

Most of the timber elements are in worse conditions, also because of the amount of elements with insect attack, which generally occurs rarely in the structures of the dome of Vercelli. The insects however are not active anymore and haven't caused mayor damage. Additionally it is to say that the elements in the worst conditions are not of great importance for the whole timber structure and some of them are missing entirely in the aisle on the left side.

This means that the general condition of the right aisle is quite fine, but should be controlled frequently.

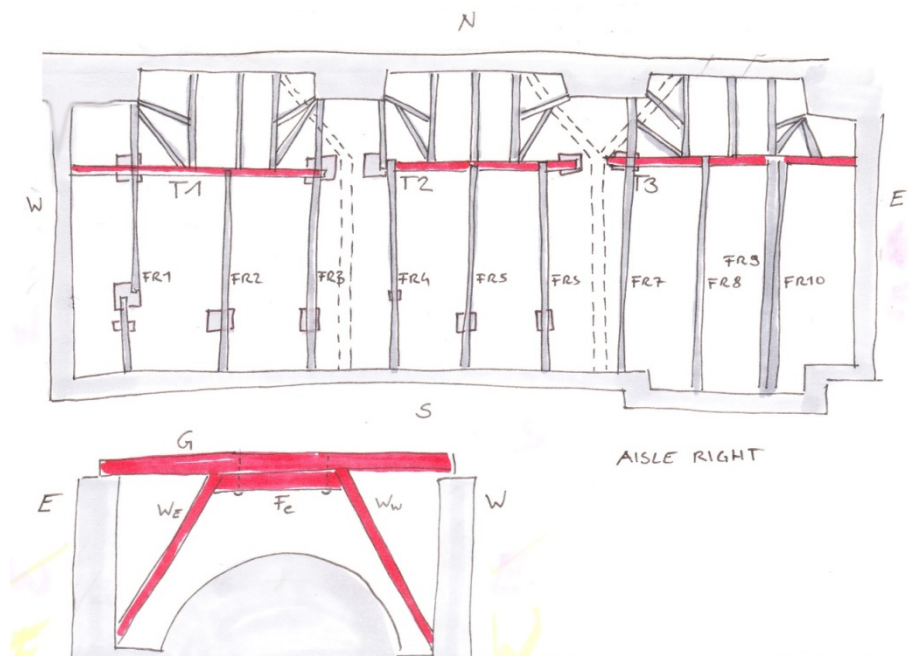
sketch 29

Table 3. Results of the resistance qualification for the examined timber elements of the trusses.

Identification	Minimum measured cross-section b x h [cm]	Average moisture content of the connections [%]	Defects, disconnections, fractions which have determinate the classification	Note	Category according UNI 11119	
T1*	G 1	28 x 23	\	knots	insect attacks	III
	Fe 1	8 x 12	\	\	insect attacks	III
	W E-1	15x 10	\	death	insect attacks	N. I.
	W w-1	12 x 13	\	heavy degrade (photo)	N.V.	N. I.
T2*	G -2	28 x 30	\	lots of knots, ring shake, crack not parallel to fibre!!!	Sapwood: fungi attack	N. I.
	Fe 2	10 x 13	\	\	Sapwood: fungi attack	III
	W E-2	13 x 13	\	\	\	//
	W w-2	13 x 12	\	small cracks	insect attacks	//
T3*	G -3	28 x 29	\	big knots, small cracks	\	III
	Fe 3	8 x 12	\	\	\	-
	W E-3	12 x 12	\	knots, curved	\	//

W w-3	13 x 13	\	knots, curved	\	//
T4*	FR 1	23 x 20	\	small knots and cracks		//
	FR 2	23 x 23	\	\	insect attacks	II
	FR 3	27 x 27	\	\	active fungi (joint wall)	II
	FR 4	28 x 18	\	big knots	insect attacks	III
	FR 5	25 x 20	\	small knots and cracks	\	II
	FR 6	23 x 20	\	small knots and cracks	\	II
	FR 7	26 x 25	\	knots	\	II
	FR 8	20 x 20	\	\	\	II
	FR 9	20 x 20	\	crack 15mm	Sapwood: fungi attack	III
	FR 10	20 x 20	\	big wholes	insect attacks	III
	S	15 x 15		mostly heavy degrade	fungi, insects	N. I.

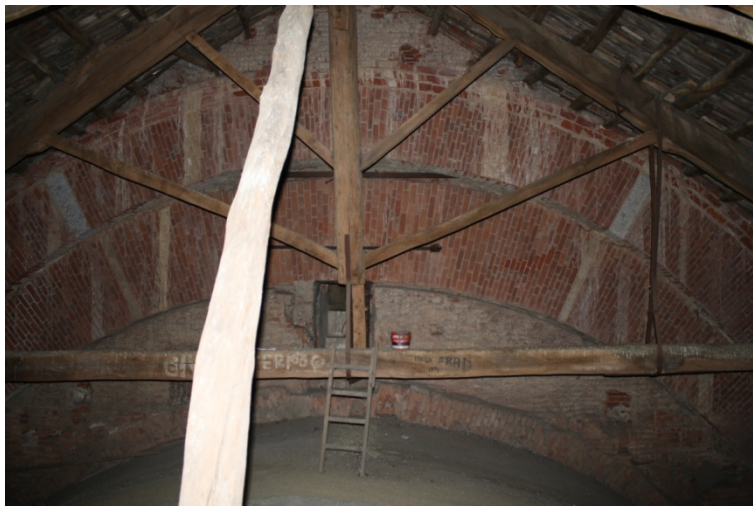
10 transept truss

Some of the diagonal timber elements are drenched with water and therefore the general condition is mediocre. The timber structure has some gaps and problems, an intervention to maintain the whole structure has to be carried out fast to avoid further amplified damage which can quicken and if the water infiltrations continue.

The major part of the beams (structurally tertiary order) has to be substituted.

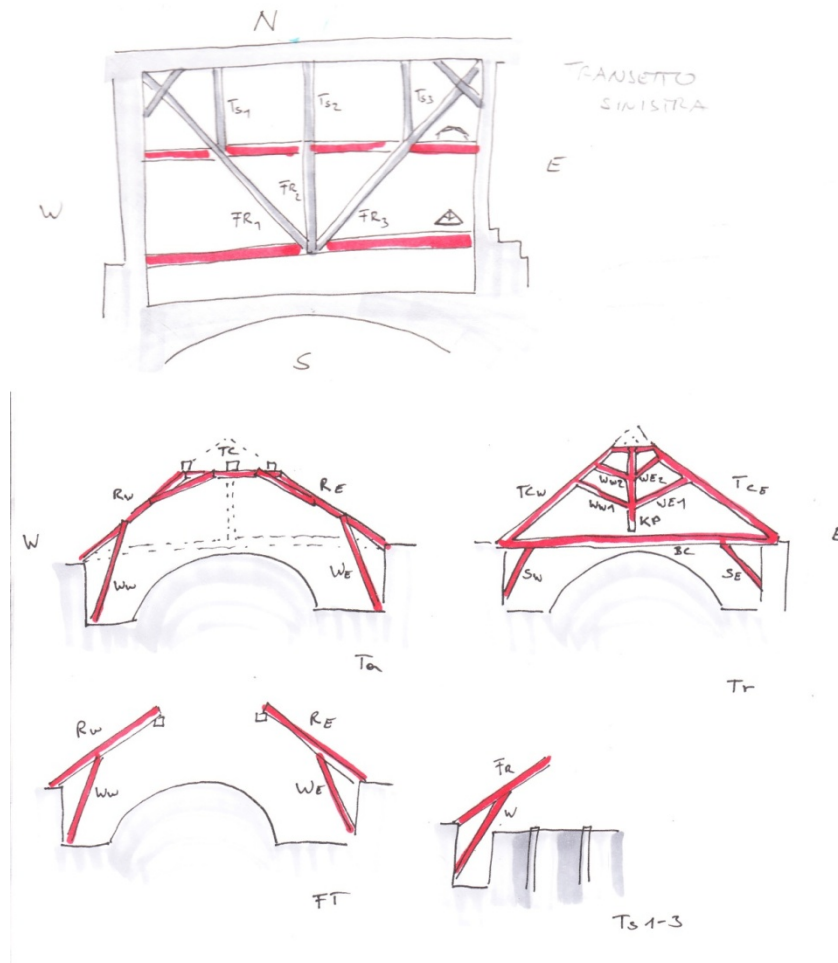
sketch 30

Table 4. Results of the resistance qualification for the examined timber elements of the trusses.

Identification	Minimum measured cross-section b x h [cm]	Average moisture content of the connections [%]	Defects, disconnections, fractions which have determinate the classification	Note	Category according UNI 11119	
Tr*	Bc1	25 x 26	\	seems newer because very square, small fractures, Problem: knot (former intervention)	\	III
	Tc w-1	30x 30	\	first half (wall), false edge ca. 20cm	\	III
	Tc e-1	30 x 30	\	first half (wall), false edge ca. 20cm	\	III
	KP-1	27 x 27	\	\	\	II
	W-1w1	14 x 8	\	\	\	II
	W-1w2	12 x 8	\	\	\	II
	W-1e1	14 x 8	\	\	\	II
	W-1e2	12 x 8	\	\	\	II
	S-1w	15 x 15	\	\	\	II
S-1e	10 x 12	\	\	\	II

FT*	R - w	30 x 30	\	\	\	III
	R - e	30 x 30	\	small cracks	\	III
	W - w	14 x 12	\	small knots	\	II
	W - e	17 x 14	\	curved	insect attacks	II
Ta*	TC	33 x 33	\	\	\	N.V.
	R - w	15 x 20	high moisture content	heavy degrade	Sapwood: fungi attack	III
	R - e	21 x 18	\	cracks (30mm), knots	insect attacks	III
	W - w	10 x 20	\	\	\	II
	W - e	10 x 20	\	\	Sapwood: fungi attack	III
FR1 *	Fr	30 x 30	\	shrinkage fractures	\	III
FR2 *	Fr	30 x 40	\	shrinkage fractures	\	II
FR3 *	Fr	30 x 30	\	knots	\	III
Ts1*	Fr	25 x 25	\	small fractures	\	III
	W	18 x 18	\	deformation, big knots	insect attacks	III
Ts2*	Fr	27 x 23	slightly wet	crack (23mm)	fungi (joint wall)	III
	W	15 x 15	\	curved, small cracks (13mm)	\	II
Ts3*	Fr	19 x 22	\	big cracks, intervention visible (False edge)	\	III
	W1	12 x 10	\	bad quality of working progress some parts have only 10x8cm cross-section, small cracks	insect attack	III

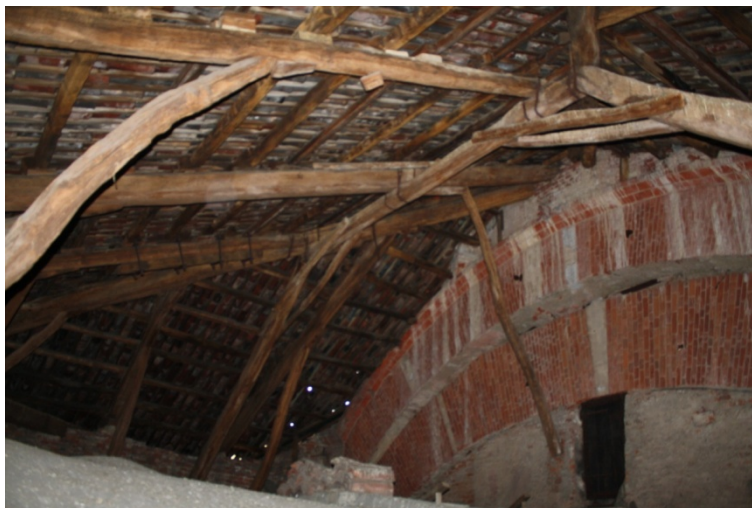
12 transept

Some of the diagonal timber elements are drenched and the general condition is alarming. The timber structure has many gaps and problems, an intervention to maintain the whole structure has to be carried out fast to avoid further amplified damage which can quicken and if the water infiltrations continue.

The material is mainly not classifiable some may enter in the fourth category, only some elements can be recycled and reused.

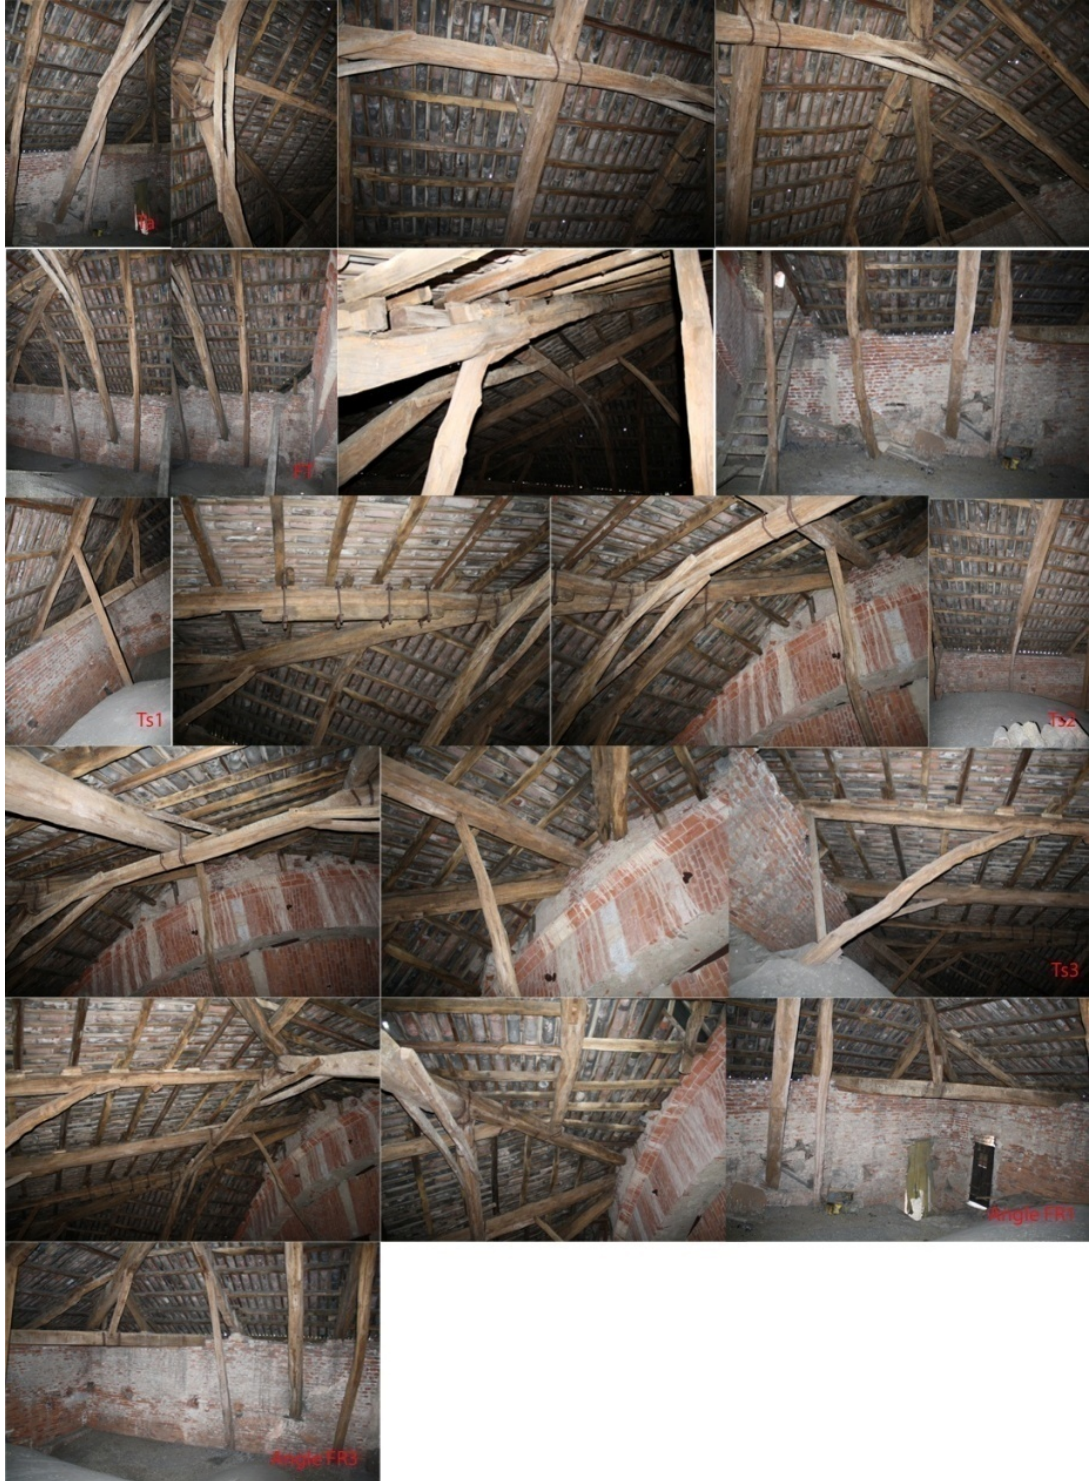
13 transept

The second rafter, the one in the middle, has bigger dimensions than the first and the third rafter. The beam shows shrinkage fractures, but in general it seems to be in a good condition. It is the only element in this area which can be classified in the second category.

The beam shows 50cm from the bedding on the wall extended to a third of the dimensions a false edge with a softened wooden element fixed with four turnbuckles. In correspondence to the added bar the beam suffered breakage on the intrados part of the structural element where the horizontal spacing of the fibres is enlarged. Only the lower part of the beam is affected by the fracture, an intervention including an iron cramp and a longish metal piece should be foreseen. The apex beam on the north side is of big dimensions and is slightly weakened and softened only in the zone of the sap wood.
