Hidden Architecture
The timber roof structure of the dome of Vercelli
Inspection-Diagnostics- Interventions

A Master's thesis submitted for the degree of
"Master of Science"

DI Pia Therese Panosch
0126769

Milan, 05.02.2010

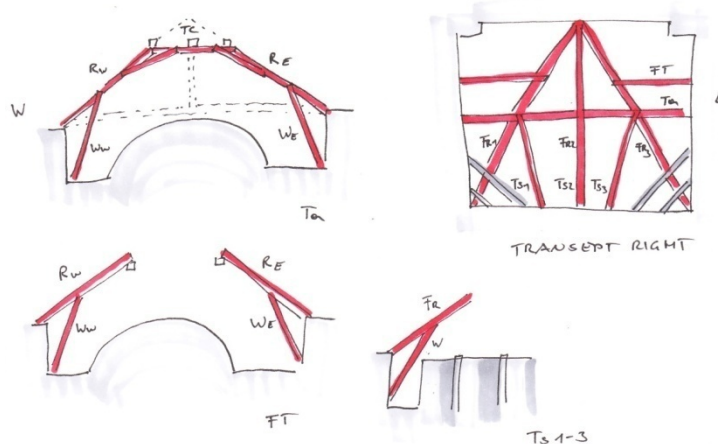
sketch 31

Table 5. Results of the resistance qualification for the examined timber elements of the structure.

Identification		Minimum measured cross-section b x h [cm]	Average moisture content of the connections [%]	Defects, disconnections, fractions which have determinate the classification	Note	Category according UNI 11119
FT1*	R - w	30 x 30	\	N. V.	\	N. V.
	R - e	25x 30	\	N. V.	\	N. V.
	W - w	16 x 12	\	\	\	II
	W - e	19 x 16	\	heavy degrade	fungi and insect attacks	III
FT2*	R - w	30 x 30	\	recycled	\	N. V.
	R - e	25 x 30	\		\	N. V.
	W - w	15 x 15	\	heavy degrade, knots	fungi and insect attacks	III
	W - e	20 x 15	\	heavy degrade, knots	fungi and insect attacks	III
Ta*	TC	30 x 25	\	slightly softened	Intervention necessary	N. V.
	R - w	30 x 25	high moisture content	Recycled, cracks, knots	Sapwood: insect attack	III
	R - e	30 x 25	high moisture content	recycled , heavy degrade, Knots, wholes	fungi and insect attacks	III
	W - w	10 x 20	\	\	\	II
	W - e	10 x 20	\	\	Sapwood: fungi attack	III
FR1 *	Fr	33 x 33	\	caries	\	III

FR2 *	Fr	30 x 40	\	shrinkage fractures	\	II
FR3 *	Fr	33 x 33	\	breakage	Former intervention	N. I.
Ts1*	Fr	20 x 20	high moisture content	heavy degradation	fungi	II
	W1	18 x 18	\	deformation, (huge wholes)	fungi and insect attacks	III
	W2	r = 10cm round	\	\	insect attacks	III
Ts2*	Fr	25 x 25	slightly wet	knots	\	III
	W	r = 14cm round	\	curved, small cracks	\	II
Ts3*	Fr	20 x 20	\	big cracks, intervention visible (False edge)	Sapwood: fungi attack	III
	W1	12 x 12	\	recently exchanged (new)	\	III

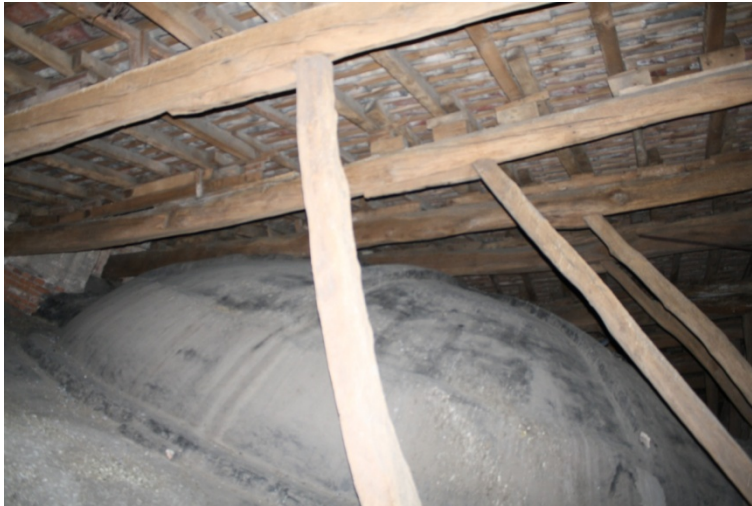
14 attic

The environment is very wet. This is influencing the timber structure in a negative way. Already some fungi started to grow and it is necessary to repair the roof covering immediately to avoid water infiltrations and further damage. The windows/doors of the attic should be kept open to ensure ventilation which can help the structure to dry. Some of the bearings where the web members are connected with the wall have been filled with concrete. This may cause damage in future, because eventually water infiltrations are going to be locked in the timber element and will cause damage.

Anyhow the structure is still in a quite moderate condition.

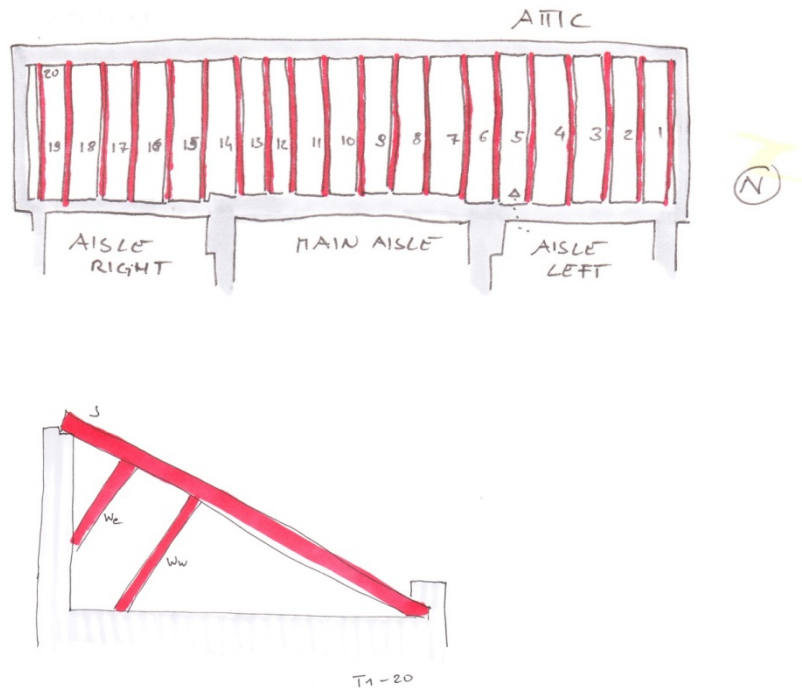
sketch 32

Table 6. Results of the resistance qualification for the examined timber elements of the structure.

Identification	Minimum measured cross-section b x h [cm]	Average moisture content of the connections [%]	Defects, disconnections, fractions which have determinate the classification	Note	Category according UNI 11119	
T1*	J	29 x 29	\	Caries upper part	Water infiltrations	III
	W1w	20 x 20	\	Curved, deviation of the fibre	\	II
	W2e	15 x 15	\	Buckling fractures	\	II
T2*	J	29 x 29	\	Knot, caries bearing bottom	\	III
	W1w	20 x 20	\	\	Part bottom drenched with water	N. I.
	W2e	15 x 15	wet	Knots	\	II
T3*	J	29 x 29	wet	Knots	\	II
	W1w	20 x 20	\	Knots, buckling, displacement	\	II
	W2e	15 x 15	\	Small cracks	\	II
T4*	J	29 x 29	wet	Knots	Sapwood: fungi attack	III
	W1w	20 x 20	\	Small knots	\	II
	W2e	15 x 15	\	\	\	II

T5*	J	29 x 29	wet	Knots	Water infiltration bearing	III
	W1w	20 x 20	\	Buckling	\	II
	W2e	15 x 15	\	Small cracks	\	II
T6*	J	29 x 29	wet	Deviation of the fibre, cracks	\	II
	W1w	20 x 20	\	Crack	\	II
	W2e	15 x 15	\	Small single knot	\	II
T7*	J	29 x 29	wet	Deviation of the fibre, cracks	Caries	III
	W1w	20 x 20	\	Curved buckling	\	II
	W2e	15 x 15	\	Curved, loses cross-section in the upper part	\	II
T8*	J	29 x 29	\	N. V.	\	N. V.
	W1w	20 x 20	\	N. V.	\	N. V.
	W2e	15 x 15	\	\	\	II
T9*	J	29 x 29	wet	Knots, deviation of the fibre, cracks	\	II
	W1w	20 x 20	\	Curved, buckling	\	II
	W2e	15 x 15	\	Crack	\	II
T10*	J	29 x 29	wet	Big knots	Sapwood: fungi attack	III
	W1w	20 x 20	\	Small cracks	\	II
	W2e	15 x 15	\	Deviation of the fibre, buckling	\	III
T11*	J	29 x 29	wet	\	Active Fungi	N. I.
	W1w	20 x 20	wet	Small knots	\	II
	W2e	15 x 15	wet	Curved	\	II
T12*	J	29 x 29	\	Knots	\	II
	W1w	20 x 20	\	Small knots	\	II
	W2e	15 x 15	\	Slight torsion	\	II

T13*	J	29 x 29	wet	Rot, caries	Sapwood: fungi attack	N. I.
	W1w	20 x 20	\	\	\	II
	W2e	10 x 10	\	Small cracks, diminution of the cross-section	\	II
T14*	J	29 x 29	wet	Small cracks, fibre deviation	Discolouration (fungi)	III
	W1w	20 x 20	\	Buckling.	\	II
	W2e	15 x 15	\	Small cracks	\	II
T15*	J	29 x 29	\	Curved, deviation of fibre, cracks	\	II
	W1w	20 x 20	\	Knots, bad condition	Caries, fungi attack	III
	W2e	15 x 15	\	\	\	II
T16*	J	29 x 29	\	Knots, cracks	Water infiltrations	III
	W1w	20 x 20	\	Curved, buckling, knots	\	II
	W2e	15 x 15	\	\	Water infiltrations	II
T17*	J	29 x 29	\	Deviation of the fibre, cracks	Caries	III
	W1w	20 x 20	\	Crack	\	II
	W2e	15 x 15	\	Displacement	\	II
T18*	J	29 x 29	wet	Buckling, knots	Sapwood: fungi attack	III
	W1w	20 x 20	wet	\	\	II
	W2e	15 x 15	\	Small cracks	\	II
T19*	J	29 x 29	wet	Extremely degraded	Caries	N. I.
	W1w	20 x 20	\	Slight deviation of the fibre	\	II
	W2e	15 x 15	\	\	\	II

T20*	J	29 x 29	wet	Cracks, Knots	Caries	III
	W1w	20 x 20	\	\	\	II
	W2e	15 x 15	\	Curved, buckling	\	II

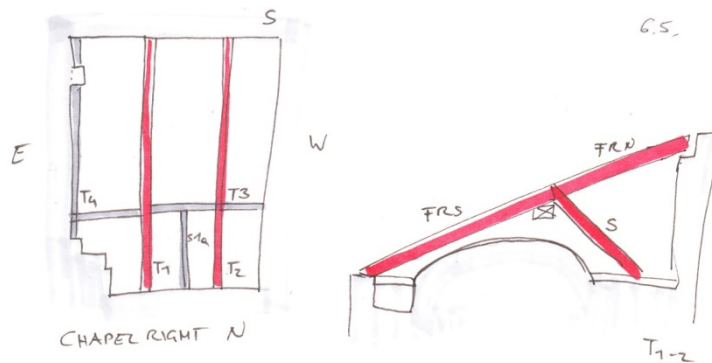
sketch 33

Table 7. Results of the resistance qualification for the examined timber elements of the structure.

Identificat	Minimum measured cross-section b x h [cm]	Average moisture content of the connections [%]	Defects, disconnections, fractions which have determinate the classification	Note	Catego UNI 11	
T1*	Fr1-l	25 x 22	\	small cracks, grain direction	II	
	Fr 1-s	20 x 22	\	\	Sapwood: fungi attack	III
	S1	15 x 20	\	small cracks	\	II
	S1a	20 x 20	\	small cracks, slightly bended, curved	\	II
T2*	Fr 2-l	25 x 22	\	small cracks	insect attacks	III
	Fr 2-s	15 x 22	\	small cracks	\	II
	S2	20 x 22	\	small cracks	insect attacks	III
	Fe	18 x 18	\	heavy degrade especially connection pavement	Sapwood: fungi attack	N.I.
T3*	J3	30 x 30	\	huge cross section, cracks, grain direction	\	II
T4*	J4	15 x 15	wet	heavy degrade	Sapwood: fungi attack, insect attacks	N.I.
T=	B	8 x 8	\	heavy degrade	\	N. V.
	CB	4 x 4	\	heavy degrade	\	N. V.

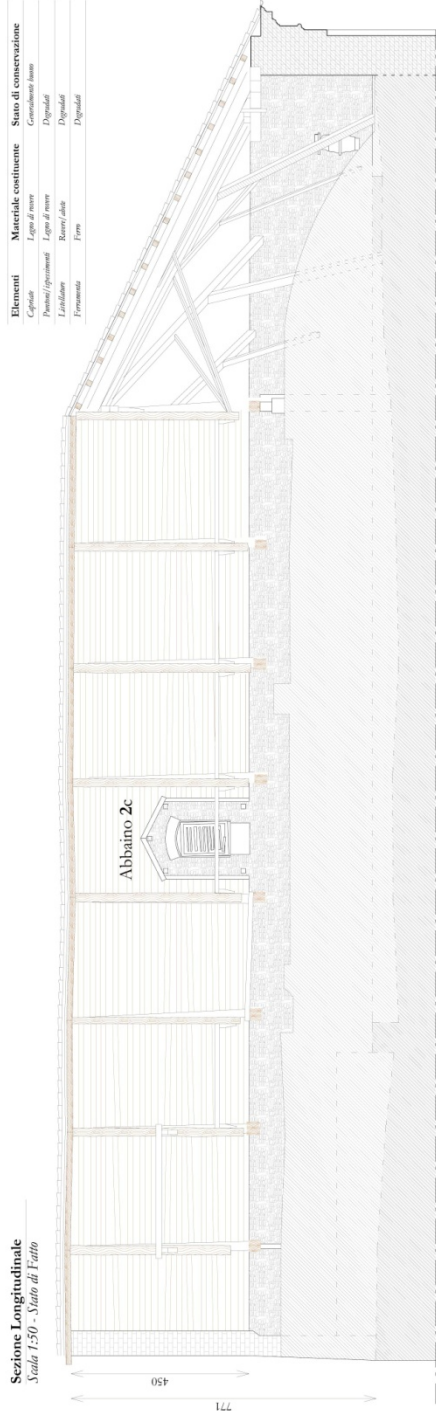
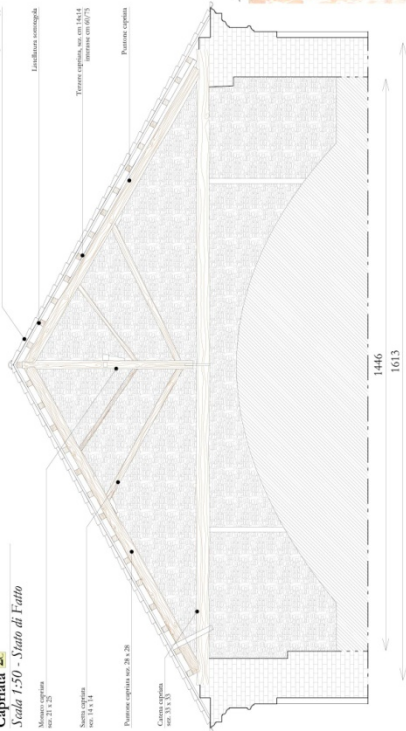
Sezione Longitudinale
Scala 1:50 - Stato di Fatto

Elementi	Materiale costituente	Stato di conservazione
Capriata	Legno di pino	Conservato
Pannone/Impregnato	Legno di pino	Conservato
Livellatore	Rivetti/Chiodi	Degradato
Formatura	Fieno	Degradato

Dettaglio tipo - stato di consistenza - orditura lignea copertura

Il presente progetto si riferisce al tipo di copertura in legno di pino, a struttura capriata, in opera da oltre 100 anni. L'edificio partecipante in opera è in stato di conservazione medio-buono. Al di sotto della copertura, si trova un ambiente di deposito di materiali, dove si sono verificati danni di natura meccanica, dovuti all'umidità, alla mancanza di ventilazione e alla presenza di acqua stagnante. L'obiettivo del progetto è quello di restituire all'edificio il suo stato di conservazione medio-buono, attraverso la sostituzione della copertura in legno di pino, con una struttura in legno di pino, a struttura capriata, in opera da oltre 100 anni. L'obiettivo del progetto è quello di restituire all'edificio il suo stato di conservazione medio-buono, attraverso la sostituzione della copertura in legno di pino, con una struttura in legno di pino, a struttura capriata, in opera da oltre 100 anni.
