Fatigue crack initiation in the presence of stratified surface layers on rail wheels

This work presents a study on the fatigue crack initiation in the presence of stratified surface layers (SSL) – a combination of white and brown etching layer – on rail wheels. Reproducible SSLs comparable to field samples are created by a defined mechanical load and two consecutive laser surface treatments on discs made from two wheel materials (ER7, ER9). Fatigue testing is done by a twin disc tribometer, where the wheel discs with SSLs are driven against discs made from R260 rail material. The results show significant fatigue crack initiation and propagation in the presence of the SSLs, exclusively on the leading edge of the SSL, more pronounced for the wheel grade ER9. Based on topographical, light optical and scanning electron microscopy analysis an explanatory model is presented, describing fatigue crack morphologies and outpointing the relevance of SSLs on rail wheels to fatigue crack initiation.

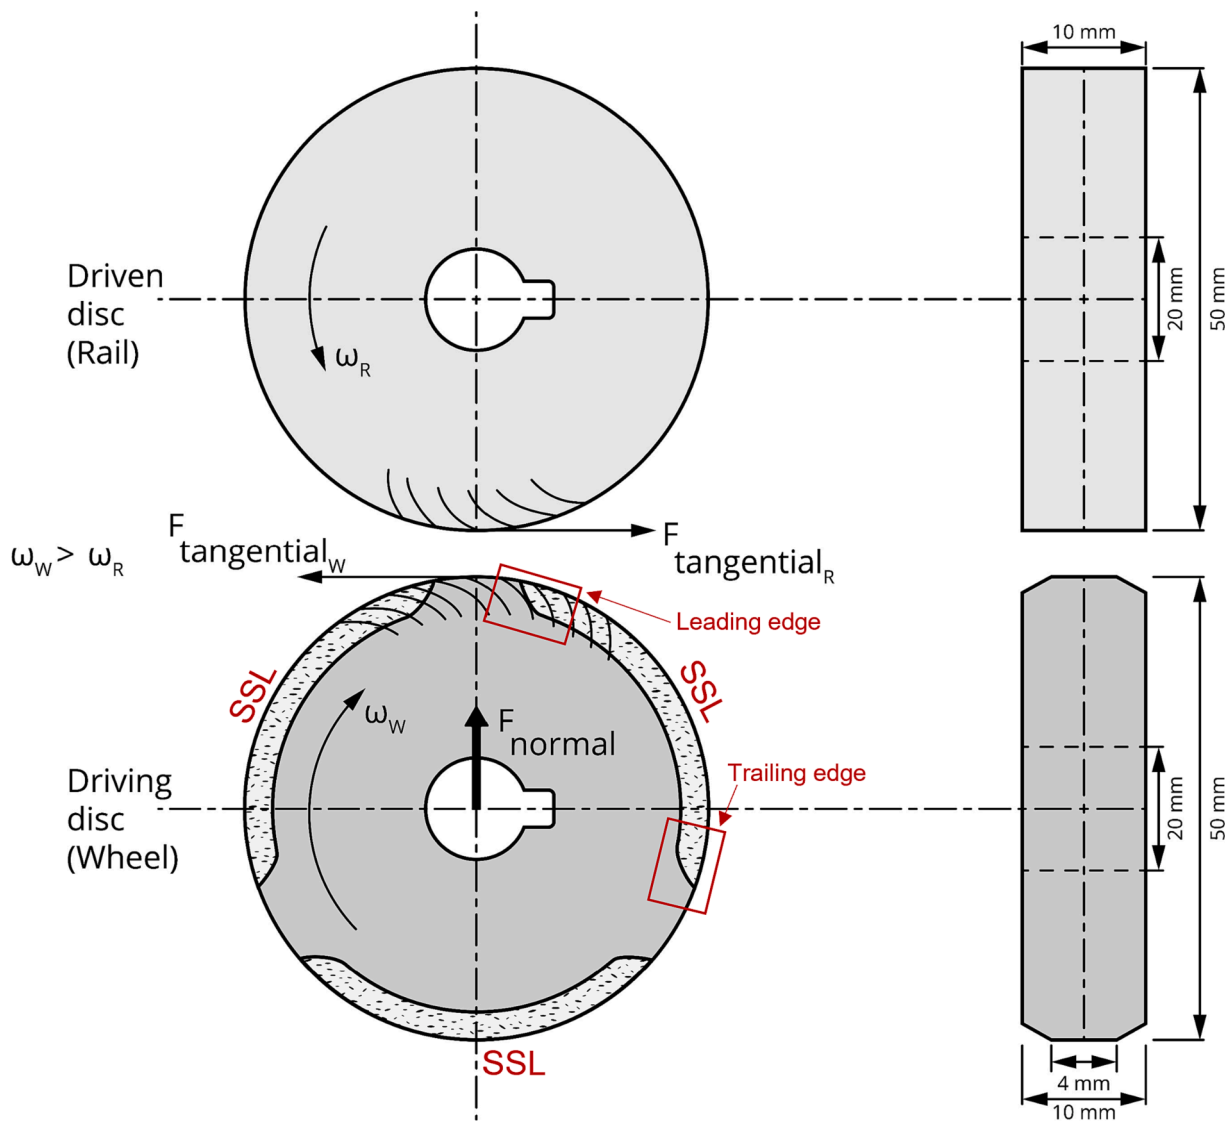
Fig. 1. The configuration of the twin disc tribometer used for the initial mechanical loading before the thermal loadings, and for the fatigue testing of the created SSLs. The driving disc (wheel material, grade ER7/ER9) is pressed with a normal load F_{normal} towards the driven disc (rail material, grade R260). The wheel samples for the fatigue testing feature three SSL sections, whereby the leading edge of the SSL is named side A and the trailing edge side B.

system of the IRC5 (ABB, Austria)) can precisely be positioning and moved. The starting temperature of the surface for each laser-treated track was room temperature, and along the circumference of the discs three sections were treated by moving the laser spot with a constant speed of 12 mm/s, Fig. 1 and Fig. 2. Pre-studies showed that for a field-

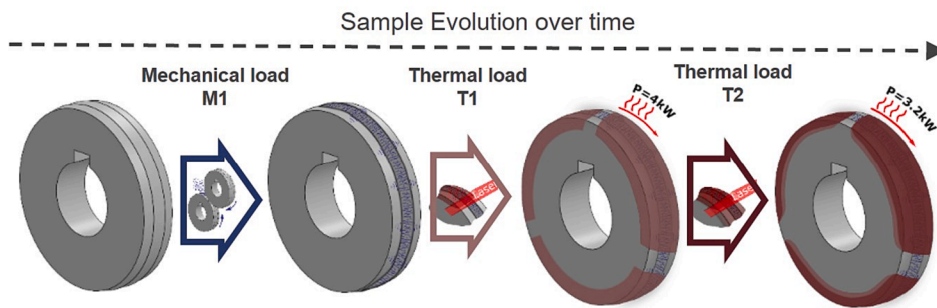
Fig. 2. Approach to imitate reproducible SSLs with defined loading history: In the first step, the material is mechanically deformed by a twin disc tribometer run (M1), followed by two thermal loads with different laser energy powers in three distinctive regions of the sample (T1: $P = 4.0$ kW, T2: $P = 3.2$ kW).

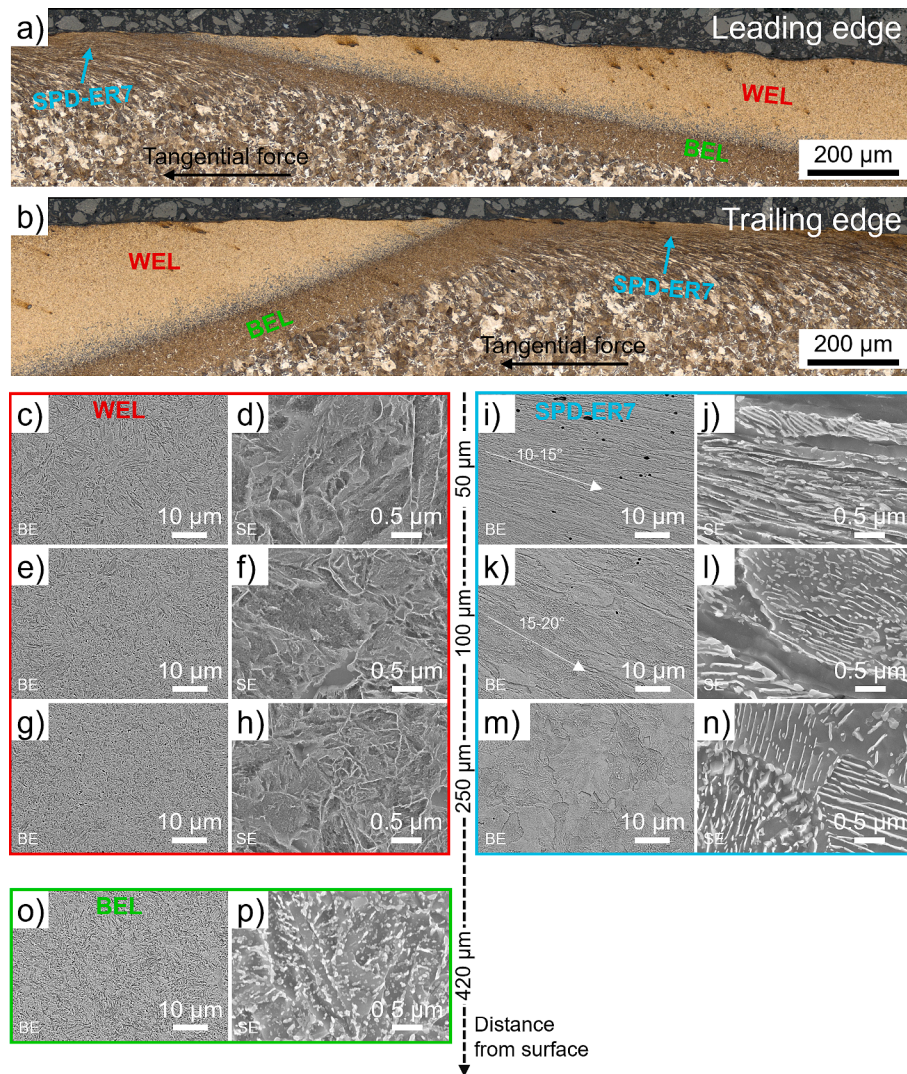
Fig. 3. (a), (b): LOM images of the transition regions showing the initial ER7 microstructure deformed by mechanical loading (M1) (SPD-ER7) and the thermally induced SSL consisting of the WEL and BEL. Detailed BE and SE images in various depths from surface are presented for the WEL ((c)–(h)), the SPD-ER7 ((i)–(n)) and the BEL ((o),(p)).

Combining a twin disc tribometer with a diode laser system allows the imitation of a SSL with distinctive regions of WEL and BEL, see Fig. 3 and Fig. 4, respectively. The initial mechanical load (M1) by the twin disc tribometer leads to an SPD near-surface microstructure (SPD-ER7) within a distance of ~ 200 μm from surface, see the cross-sectional cuts of a representative SSL on ER7 wheel material given in Fig. 3a and b. The following laser treatments cause thermal loads (T1, T2) leading to the formation of an SSL with an average thickness of ~ 500 μm . The transition zones along the surface (SPD-ER7 – BEL – WEL) shows no severe cracking due to residual stresses within the treated regions.

Within the SSL, a WEL and BEL region can be identified, where the WEL comes up with an average thickness of ~ 350 μm . The martensitic microstructure in various depths from surface can be seen through BE and SE images, Fig. 3c and d (50 μm), Fig. 3e and f (100 μm), and Fig. 3g and h (250 μm), respectively. Even though the initial degree of deformation of the ER7 wheel material before the thermal loads (Fig. 3i–n) is different, no significant difference in the martensitic microstructure can be identified. The BE image of the SPD-ER7 microstructure in a depth of

50 μm from surface (Fig. 3i) shows an SPD microstructure with an alignment of $10\text{--}15^\circ$ to the surface. The higher magnification SE image (Fig. 3j) indicates deformation, fracture, and alignment of the cementite lamellae. In a depth of 100 μm from the surface (Fig. 3k and l) the degree of deformation is decreasing, and the alignment angle is increasing ($15\text{--}20^\circ$). An undeformed ferritic-pearlitic microstructure can be identified in a depth of 250 μm from the surface (Fig. 3m and n). The BEL region of the SSL can be clearly seen due to its brownish appearing microstructure in the LOM images (Fig. 3a and b) and reveals a thickness of $\sim 150\ \mu\text{m}$. Analysis of the microstructure in the middle of the BEL region (420 μm from surface) indicates a trend for an increased grain size (Fig. 3o) in comparison with the WEL microstructure, and the SE image (Fig. 3p) shows a proceeded cementite spheroidization (Fig. 3o).

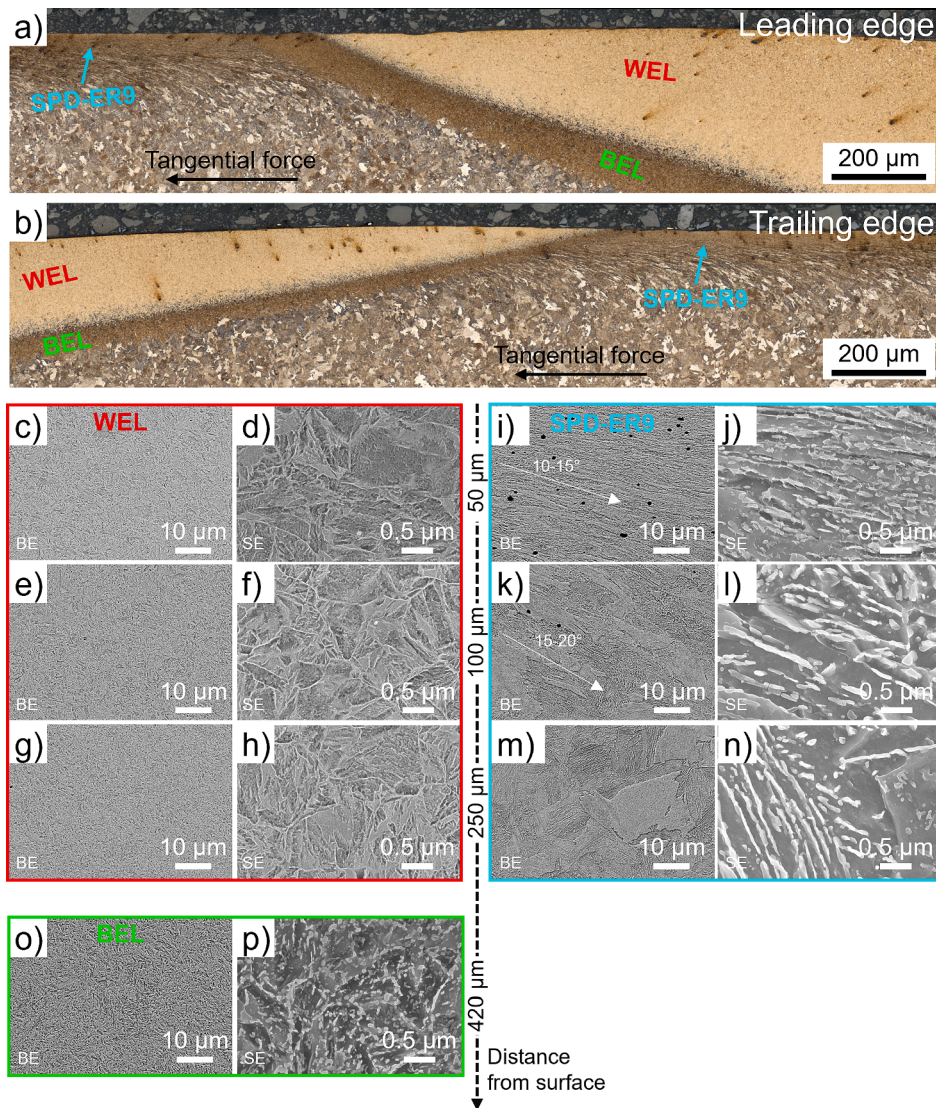
Fig. 4. (a), (b): LOM images of the transition regions showing the initial ER9 microstructure deformed by mechanical loading (M1) (SPD-ER9) and the thermally induced SSL consisting of the WEL and BEL. Detailed BE and SE images in various depths from surface are presented for the WEL ((c)–(h)), the SPD-ER9 ((i)–(n)) and the BEL ((o),(p)).

Images of the cross-sectional cuts after the initial mechanical loading (M1) and followed thermal loads (T1, T2) for the wheel grade ER9 are given in Fig. 4. Comparable SSLs (WEL + BEL) with thicknesses of $\sim 510\ \mu\text{m}$ on an initially deformed microstructure (SPD-ER9) and crack-free transitions are present (Fig. 4a and b). The BE and SE images of the WEL region (Fig. 4c–h) show a martensitic microstructure without significant differences for the presented depths from the surface (50, 100, and 250 μm). Fig. 4i–n show the related initial ER9 microstructure

before the thermal loads. Deformed and fractured cementite lamellae can be identified, with an alignment angle of $10\text{--}15^\circ$ in a depth of 50 μm and $15\text{--}20^\circ$ to the surface in a depth of 100 μm . In a depth of 250 μm from surface the ER9 microstructure is mechanically unaffected. The brownish appearing BEL region within the LOM images comes up with an average thickness of 140 μm and a tempered martensite microstructure (Fig. 4o and p) with globular cementite particles due to spheroidization during the second thermal load (T2).

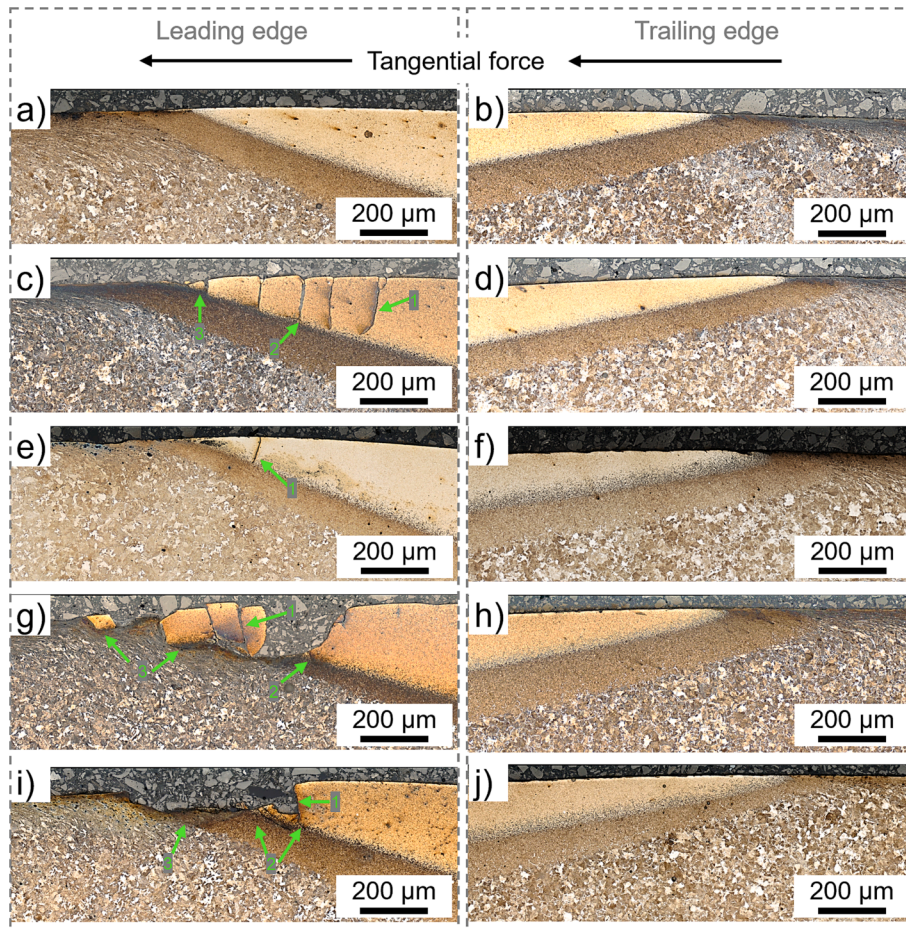
Fig. 7. LOM images of the transition zones from base material to SSLs in cross-sectional cuts for wheel material ER9. The leading edges of the SSLs show failure patterns for 4/5 transition zones: Crack initiation and propagation under 90° to surface within the WEL (1), branching at the WEL/BEL interface (2), and deformation of the BEL due to WEL fragments (3). For the trailing edge, no cracking patterns are detected, but plastic material flow of the base material over the WEL region.

In the transition zones of the SSLs to the base material ER9 after twin disc tribometer testing, fatigue cracks are present in 4 out of 5 transition zones at the leading edge of the SSLs, see the LOM images of the cross-sectional cuts given in Fig. 7a, c, e, g, i. The damage patterns exhibit similar characteristics to those of the ER7 discs (Fig. 5) but more severe. The crack propagating $\sim 90^\circ$ to the surface within the WEL region, Fig. 7e, is a sign of the first stage of fatigue damage of the SSLs. The tip of the crack (which seems to have no branching) is just before the WEL/BEL interface. Within the transition zone multiple cracks perpendicular to the surface formed (Fig. 7c: 1), which branch at the WEL/BEL interface (Fig. 7c: 2). As described for the ER7 wheel material, one crack branch propagates along the WEL/BEL interface in the direction of the tangential force, while the other propagates under a certain angle into the BEL in opposite direction. In addition, there is severe deformation of the BEL and an almost loose WEL fragment (Fig. 7c: 3). The features present in the transition zone indicate an already proceeded stage where the initial cracks within the WEL (Fig. 7g: 1) branched at the WEL/BEL interface (Fig. 7g: 2). Subsequent joining of the cracks leads to the formation of WEL fragments, followed by a deformation of the underlying BEL (Fig. 7g: 3). Similar characteristics are present in the regions shown

in Fig. 7i. There, the WEL fragments already spalled, and a massive pit is formed. The LOM images for the trailing edge of the SSLs (Fig. 7b, d, f, h, j) show no crack initiation at the transition zone, but plastic deformation and material flow in direction of the tangential force with some amount of material plastically deformed over the SSL.

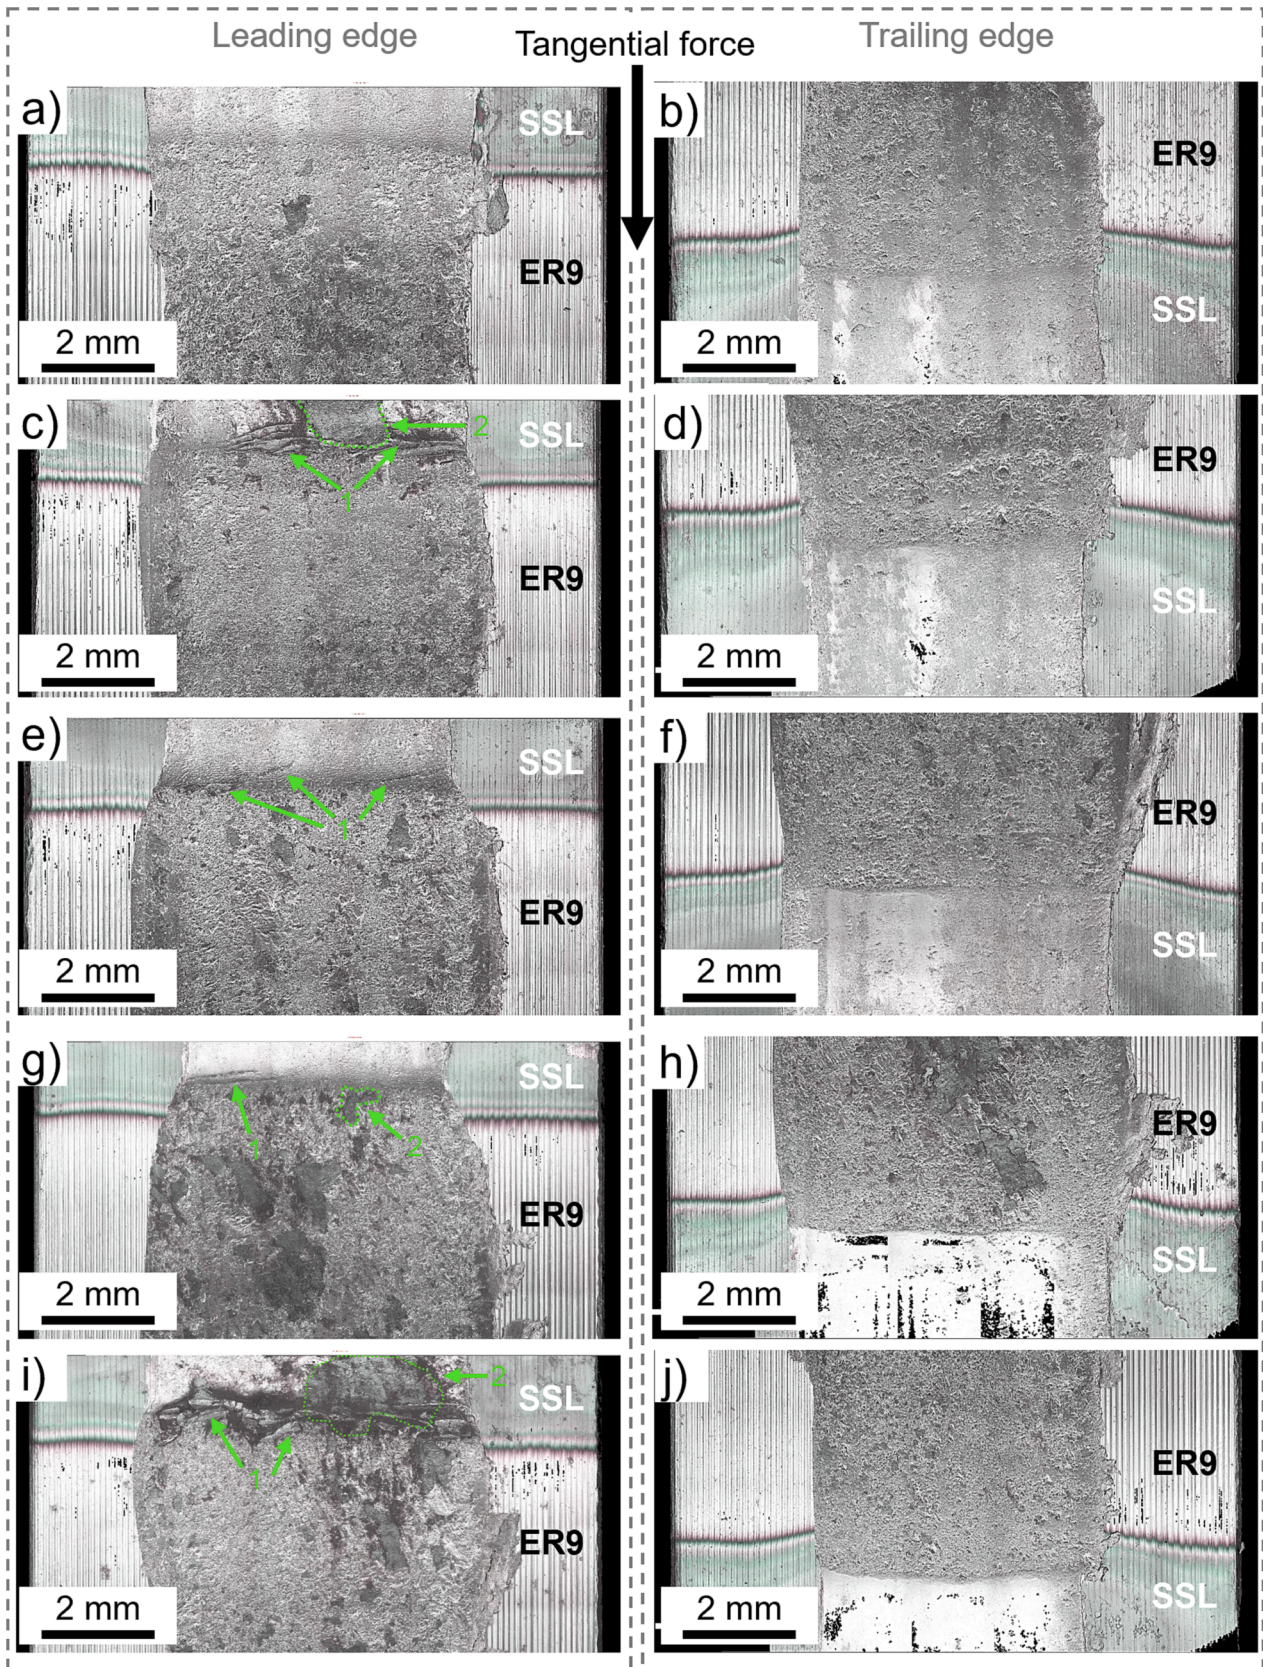
Fig. 8. Surface images (focus-variation microscope) at the transition regions of the run ER9 wheels. The leading edges of the SSLs show crack initiation at the interface (1) for 5 out of 6, in some cases massive breakouts of SSL fragments (2) can be detected. In contrast, the trailing edges do not show significant damage patterns at the interfaces.

As for the ER7 discs, the wear track along the grey-blue appearing region (SSL) is significantly smaller, see the surface images of the tested ER9 discs, Fig. 8. Radial cracks origin from the transition from the ER9 base material to the SSL extend throughout the SSL at the leading edge (Fig. 8a, c, e, g, i). This is impressively shown in Fig. 8c: 1 (the corresponding cross section is given in Fig. 7c), which regularly cause the spallation of large areas (labelled with 2 in Fig. 8c). Corresponding characteristics are present in the region captured by Fig. 8g (the corresponding cross-section is Fig. 7g) and in a more severe stage in the region shown by Fig. 8i (the corresponding cross-section is Fig. 7i). Radial cracks but no spallation is present in the region presented in Fig. 8e (the corresponding cross-section is Fig. 7e). As for the ER7 discs, there is no severe damage in the transition regions of the trailing edge (Fig. 8b, d, f, h, j). Within the wear track, oxide lamella and adhered debris are present, with some amount of ploughing. This is more significant within the wear track of the ER9 base material.

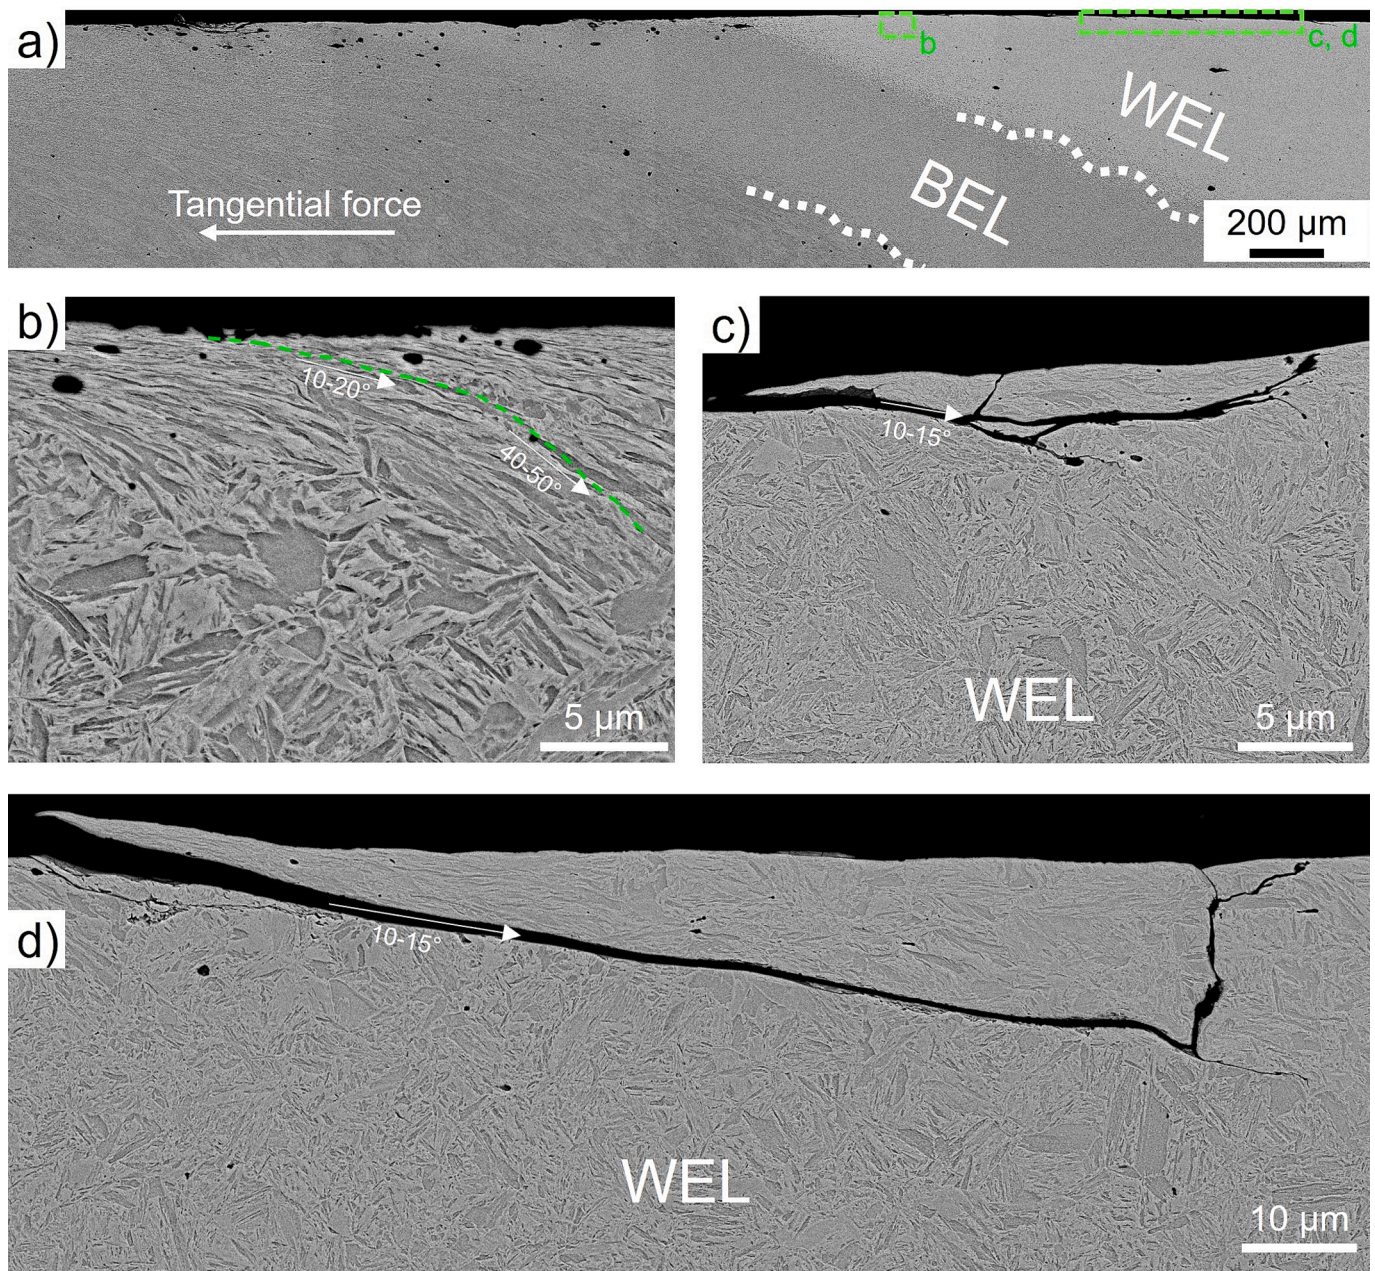
Fig. 9. BE images of the leading edge of the SSL at *Stage I*: (a) No crack initiation within the transition zone of the SSL and the deformed wheel base material. (b) shows the plastic deformation of the WEL within $\sim 20 \mu\text{m}$ from surface and the alignment of the martensite microstructure. Micro-crack initiation occurs along the WEL surface, cracks under shallow angles ($10\text{--}15^\circ$ to the surface) either changing their direction towards the surface (c) or branch and propagate towards the surface (d). In both cases, detachment of wear debris is the result.

The first stage (*Stage I*) is characterized by a dominating gradual wear without crack formation in the transition zone of the SSL to the deformed wheel base material (Fig. 9a). At this stage, the mechanical load of the twin disc tribometer caused plastic deformation and detachments of wear debris. For the wheel material, the deformation is obvious down to $\sim 200 \mu\text{m}$ from the surface, as described above (Figs. 3 and 4). Besides its hard and brittle nature, the WEL of the SSL shows plastic deformation down to $\sim 10 \mu\text{m}$ from the surface with aligned martensite grains (increasing angle to the surface with increasing depth (Fig. 9b)). The WEL region exhibits micro-cracks, which shallowly propagate at an angle of $10 - 15^\circ$ to the surface. At a certain point, the cracks tend to grow towards the surface leading to the formation of small, detached particles (Fig. 9c and d). This cracking mechanism is present along the WEL surface of the whole disc and is not related to the transition zones. It is the result of wear-related micro-crack formations, which are also present in regions without SSLs. However, no macroscopic cracks are formed and hence, no critical fatigue crack initiation takes place at this stage.

advantage to reduce the crack propagation. But this unfortunately also lead to chipping-off of some WEL or BEL material (Fig. 9). Our results about the branching characteristics of the cracks at the boundaries of the WEL to the underlying rail material are in agreement with reports of Pereira et al. [46], about RCF on ex-service rails with detected WELs. They actually suggested that the microstructural heterogeneity

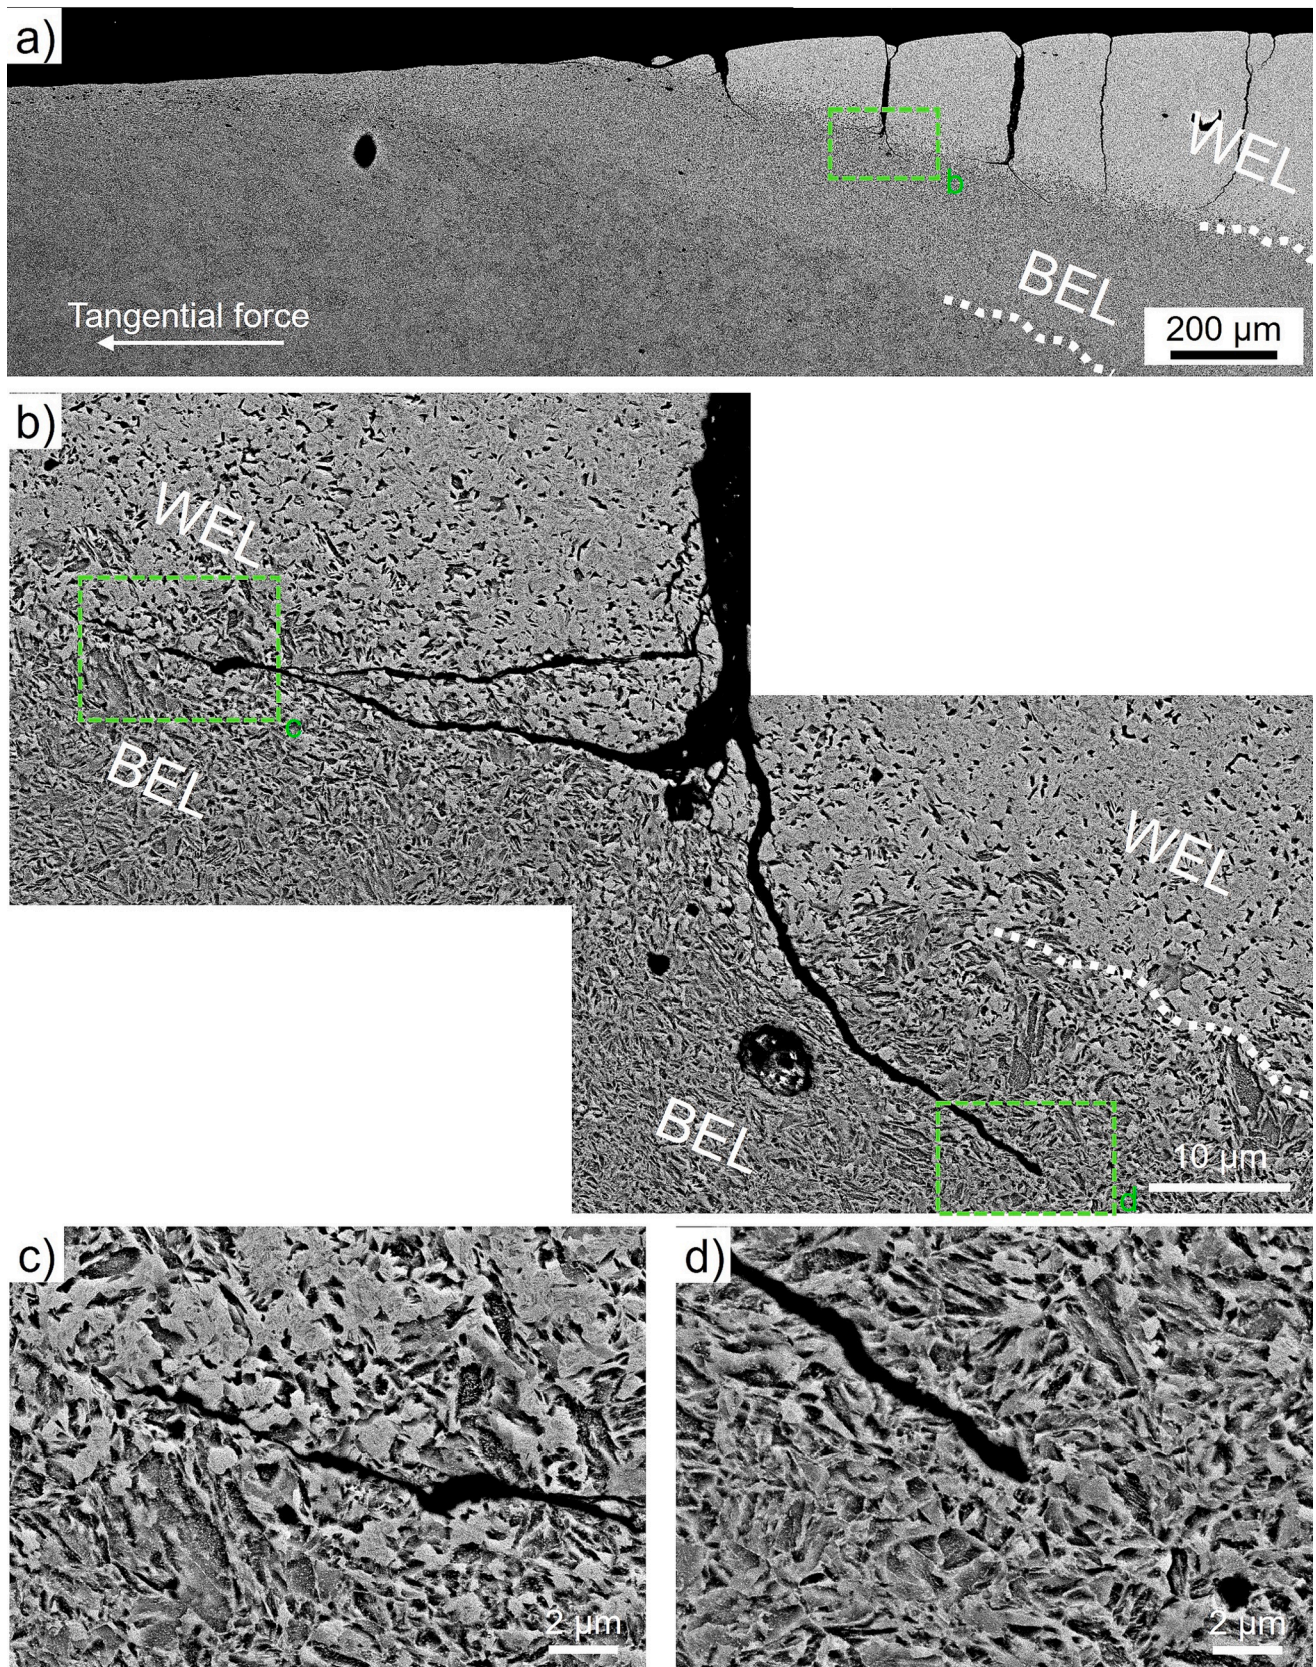
Fig. 11. BE images of the leading edge of the SSL at *Stage III*: Multiple cracks are evident in the WEL next to the transition zone (a), with crack branching at the WEL/BEL interface (b). One crack branch propagates along the WEL/BEL interface in direction of the tangential force and is characterized by a sharp crack tip (c), the other propagates into the BEL showing a minor crack length and a blunt crack tip (d).

Multiple macroscopic cracks initiated within the first $\sim 500 \mu\text{m}$ of the WEL at the leading edge of the SSL (Fig. 11a) enters the next stage, named *Stage III*. Investigations show that some cracks propagated to the WEL/BEL interface, where they branch. Two major crack-branches are identified: One crack-branch propagates along the WEL/BEL interface along the tangential force, the other in the opposite direction into the BEL (Fig. 11b). Taking a closer look at the crack tips of these two

branches shows a sharp crack tip in the WEL/BEL interface (Fig. 11c), contrary to the blunted crack tip present in the BEL (Fig. 11d). This, in combination with the increased length of the crack-branches within the WEL/BEL interface, indicates a faster crack growth there.

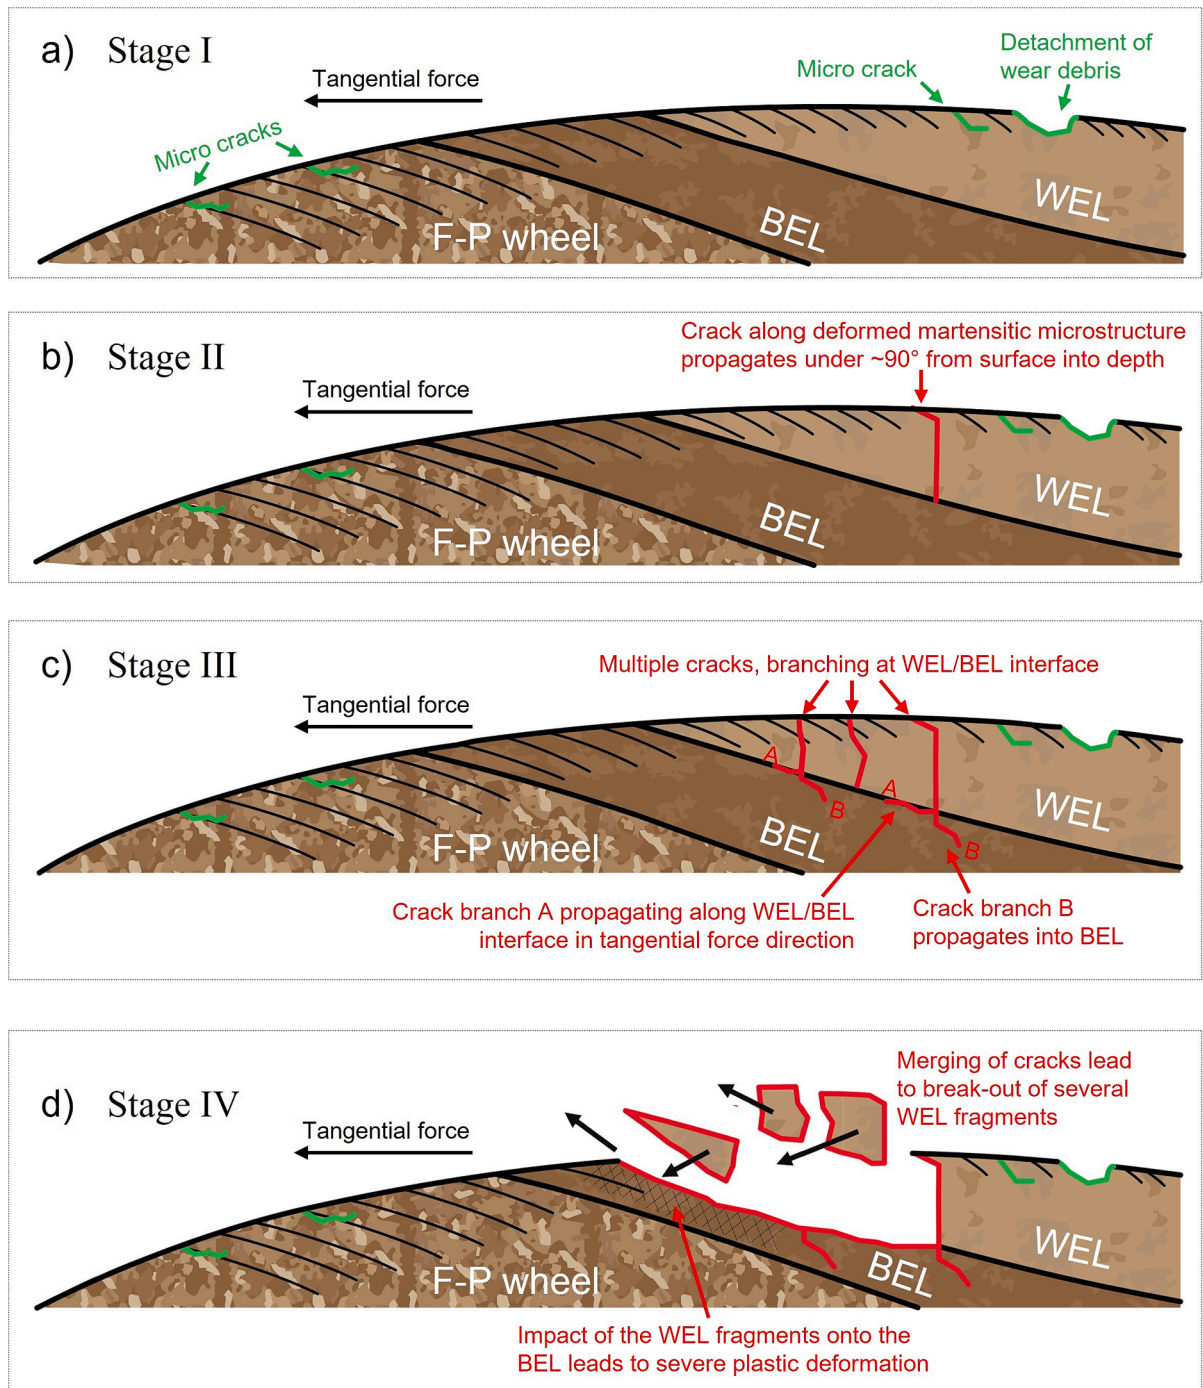
Fig. 15. Explanatory model of fatigue crack initiation at the leading edges of SSLs on wheel materials: The wear dominated *Stage I* (a) shows no macroscopic crack in the transition zone of the ferritic-pearlitic wheel material (F-P wheel), to the BEL and the WEL. The depth of plastic deformation is decreasing with increasing hardness (F-P wheel \rightarrow BEL \rightarrow WEL). Micro-cracks can be observed along the disc surface, stopping, or turning towards the surface resulting in detachment of wear debris. At *Stage II* (b) a vertical crack is initiated within the WEL next to the transition zone. Initiated at the surface, the crack first propagates along the aligned martensite grains and further under $\sim 90^\circ$ from surface into depth until the WEL/BEL interface. *Stage III* is representing multiple cracks initiated within the WEL near the transition zone, with branching occurring at the WEL/BEL interface. One crack branch (A) propagates along the WEL/BEL interface in the direction of the tangential force, the other (B) in opposite direction downwards into the BEL. Finally, at *Stage IV*, the crack branches merge and fragments of the WEL break out. At least some WEL fragments get pushed against the underlying BEL, leading to a severe plastic deformation of the BEL.

Based on the results of the analysis so far, a schematic overview of the explanatory model of fatigue crack initiation of SSLs on rail wheel materials is presented in Fig. 15.

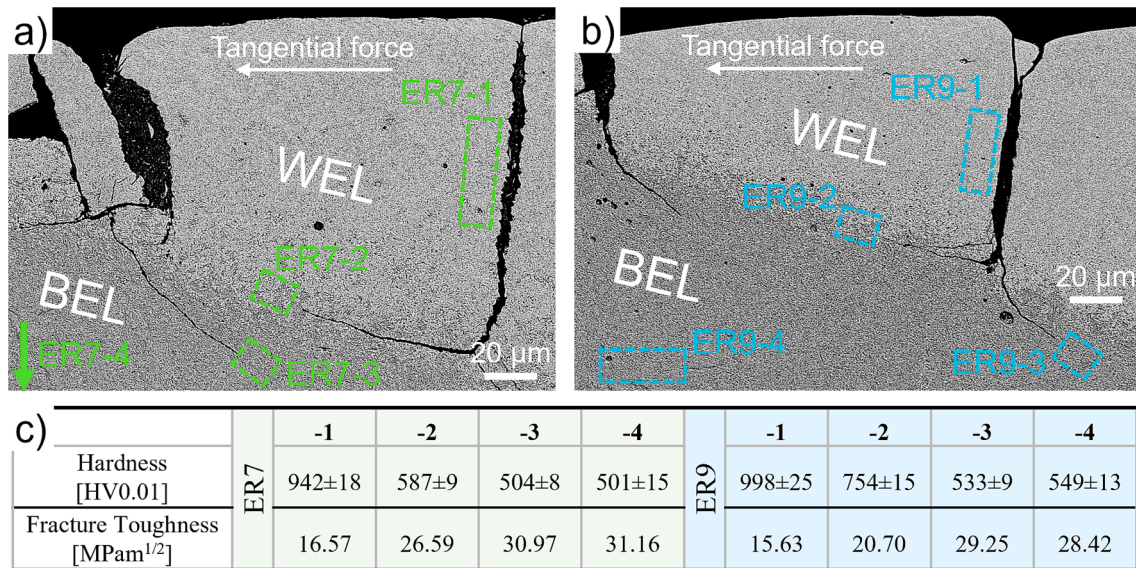
Fig. 16. Microhardness measurements are conducted in specific regions at the leading edge of SSL at Stage III on the (a) ER7 wheel steel, and (b) ER9 wheel steel. The obtained hardness values and the estimated local fracture toughness values are given in (c).

by microhardness measurements (Fig. 16a and b). The different regions at the cross sections around the WEL and BEL borders, Fig. 16a and b, show pronounced differences in Vickers hardness. In addition to hardness, the local fracture toughness K_Q is commonly used to get a sense of potential RCF crack initiation risk in wheel and rail materials [36–38]. Since small-scale fracture toughness experiments would go beyond the scope of the current work, K_Q is estimated according to [38] within this section as follows:

with microhardness HV , and fitting constants $A = 15,600 \text{ MPam}^{1/2}$ and $B = 1.0$. For easier comparison and correlation, these data are presented directly within Fig. 16c. The martensitic WEL regions provide highest

hardness (thus lowest K_Q) of 942 ± 18 and $998 \pm 25 \text{ HV0.01}$, see ER7-1 and ER9-1. Within these regions the crack propagates almost perpendicular from the surface towards the WEL/BEL interface, where it is deflected. There, the HV0.01 values are only 587 ± 9 (504 ± 8) and 754 ± 15 (533 ± 9), see ER7-2 (ER7-3) and ER9-2 (ER9-3). In general, the individual regions of ER7 are softer than the corresponding ones of ER9. This is supposed to originate on the higher carbon content of ER9, however, this is not clearly understood so far due to the controversially proposed formation mechanisms of BELs. If we use the common estimation of fracture toughness through the inverse relation with hardness mentioned above, results suggest the lowest fracture toughness within the WEL and a trend of higher fracture toughness values for SSL regions of the ER7 wheel material.
