# Full scale evaluation of diffuser ageing with clean water oxygen transfer test

J. Krampe

South Australian Water Corporation, 250 Victoria Square, Adelaide SA 5000, Australia (E-mail: joerg.krampe@sawater.com.au), former Institute for Sanitary Engineering, Water Quality and Waste Management (ISWA), University of Stuttgart, Germany

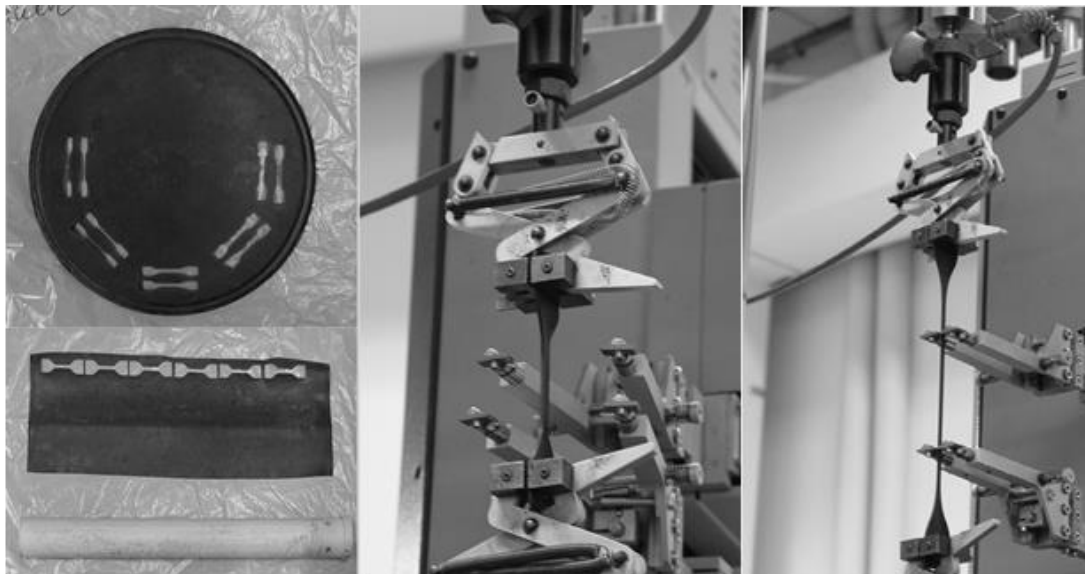
Figure 1: Material sampling method from disc (left top) and tube diffusers (left bottom) and implementation of the stress strain tests (right)

In addition to the oxygen transfer test, the material properties of the diffuser membranes and their changes were measured. The material analyses were carried out in cooperation with the IKP (Institute for Polymer Technology, University of Stuttgart, Germany). For each trial the mechanical properties of the diffuser membranes (hardness, tensile strength and elongation) were explored. Therefore stress strain behaviour and Shore A hardness tests were carried out. Similar tests were used by other groups (e.g. Frey, 2006, Kaliman et al., 2008) to measure the ageing of diffuser membranes. The stress strain tests were conducted according to DIN 53504. For these tests the sample preparation is very important, because the results differ depending on the different directions of the perforation. The test only produces reproducible and meaningful results if the slits are arranged in parallel to the central part of the sample. Figure 1 (left side) shows the preparation of the samples for different diffuser types. A tension testing machine was used for the tests (Figure 1, right side). The sample was concluded with a speed of 500 mm/minute for tube diffusers and 200 mm/minute for disc diffusers with a force of 2 Newton. The storage of samples and the tests were carried out under standard conditions according to DIN EN ISO 291-23/50-2. Of interest for future considerations are the tensile strength and the ultimate elongation. Additionally Shore A hardness testing was performed at the IKP with the same samples. The tests were carried out in accordance with DIN 53505. This test was performed in a non-slit area of the diffuser membrane.

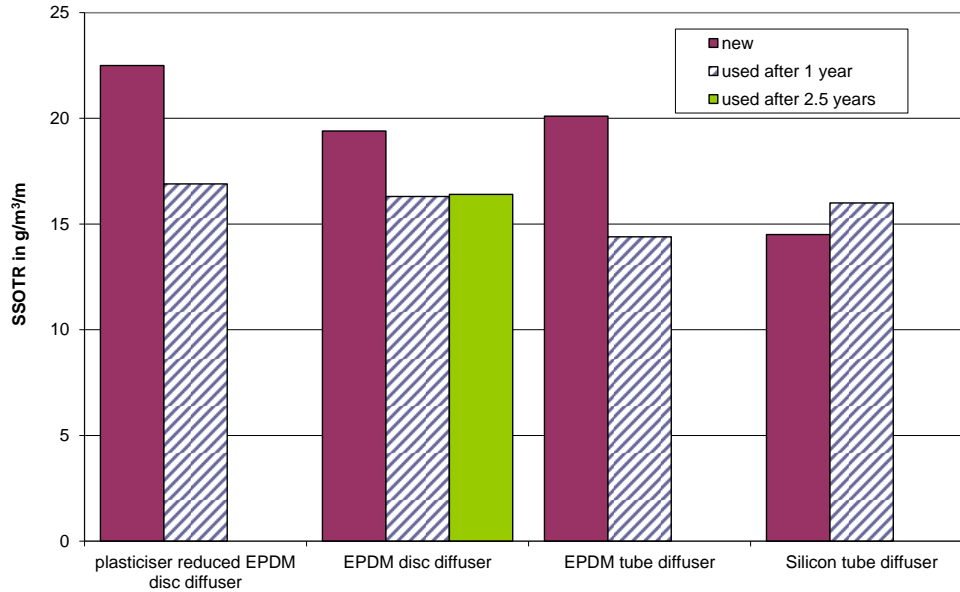
Figure 2: Specific Standard Oxygen Transfer Rate for all tests in comparison

The results are compared based on the Specific Standard Oxygen Transfer Rate (SSOTR) in g/m<sup>3</sup>/m. In the subsequent Table 3, the results for the individual materials in new condition and after approximately one year of operation are summarised. The table also shows the result for the test after 2.5 years at Heilbronn WWTP. To give a benchmark for the results of the new diffusers, the reference values of Wagner (2000) are stated as well. All tested EPDM diffusers achieved values which are in the range for favourable conditions. Alone the investigated silicone tube diffusers achieved average performance. It has to be highlighted that all diffusers were tested after a sufficient time of pre aeration. Looking at the results after a year of operation, a significant decrease of SSOTR is obvious for all EPDM diffusers. Only the silicone tube diffuser showed an increase for the oxygen transfer. Regardless of the installation situation and the diffuser type, all systems achieve almost the same specific standard oxygen after one year of operation, although each started with different results. No further reduction had occurred after 1.5 additional years of operation. This situation is illustrated graphically in Figure 2.

Heilbronn WWTP		Plieningen WWTP	
	Plasticiser reduced EPDM disc	EPDM disc	EPDM tube	Silicone tube
SSOTR g/m <sup>3</sup> /m new	22.5	19.4	20.1	14.4
SSOTR g/m <sup>3</sup> /m used	16.9	16.3	14.4	16.0
percentage change	-25 %	-16 %	-28 %	+11 %
SSOTR g/m <sup>3</sup> /m after 2.5 years		16.4		
	Reference SSOTR values under clean water conditions (Wagner, 2000)			
	mixing and aeration *		area wide diffuser coverage **	
favourable	20.0		23.9	
average	15.0		17.9
